**MARYLAND HISTORICAL TRUST
DETERMINATION OF ELIGIBILITY FORM**

Property Name: SHA Small Structure No. 04019X0 Inventory Number: CT-1184
 Address: MD 262 over Chew Creek Historic district: yes no
 City: West of Sunderland Zip Code: 20639 County: Calvert
 USGS Quadrangle(s): Lower Marlboro
 Property Owner: Maryland State Highway Administration Tax Account ID Number: N/A
 Tax Map Parcel Number(s): N/A Tax Map Number: 10
 Project: MD 262 over Chew Creek Agency: Maryland State Highway Administration
 Agency Prepared By: Maryland State Highway Administration
 Preparer's Name: Matt Manning Date Prepared: 11/26/2012

MARYLAND INVENTORY OF HISTORIC BRIDGES
HISTORIC BRIDGE INVENTORY
MARYLAND STATE HIGHWAY ADMINISTRATION/
MARYLAND HISTORICAL TRUST

SHA Bridge No. 4014 Bridge name MD 262 over Chew Creek

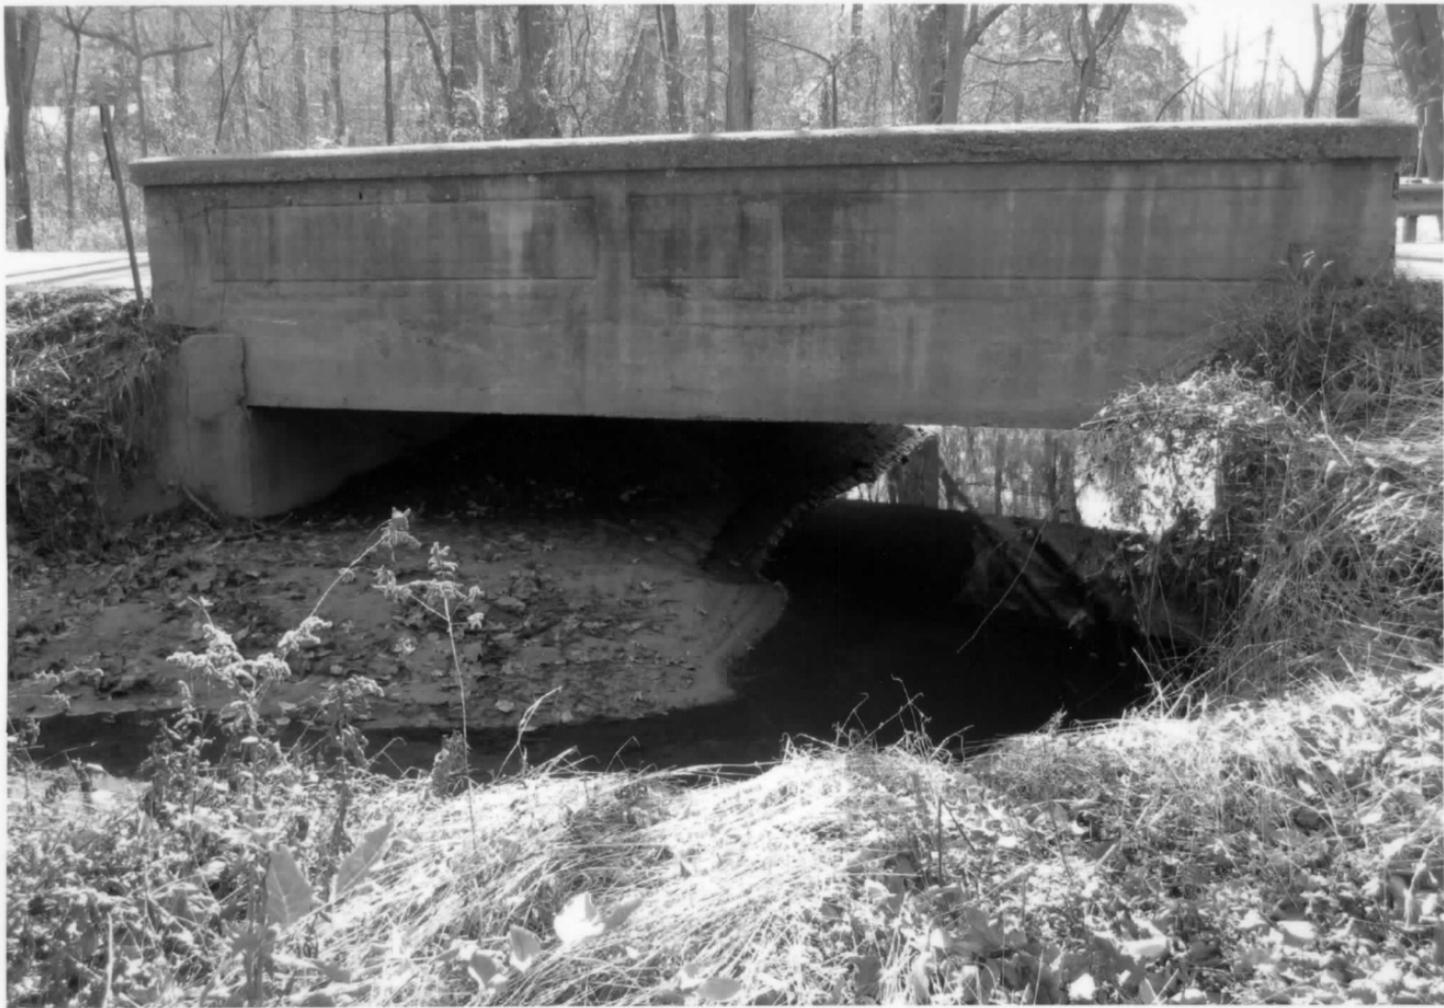
2/6

North elevation

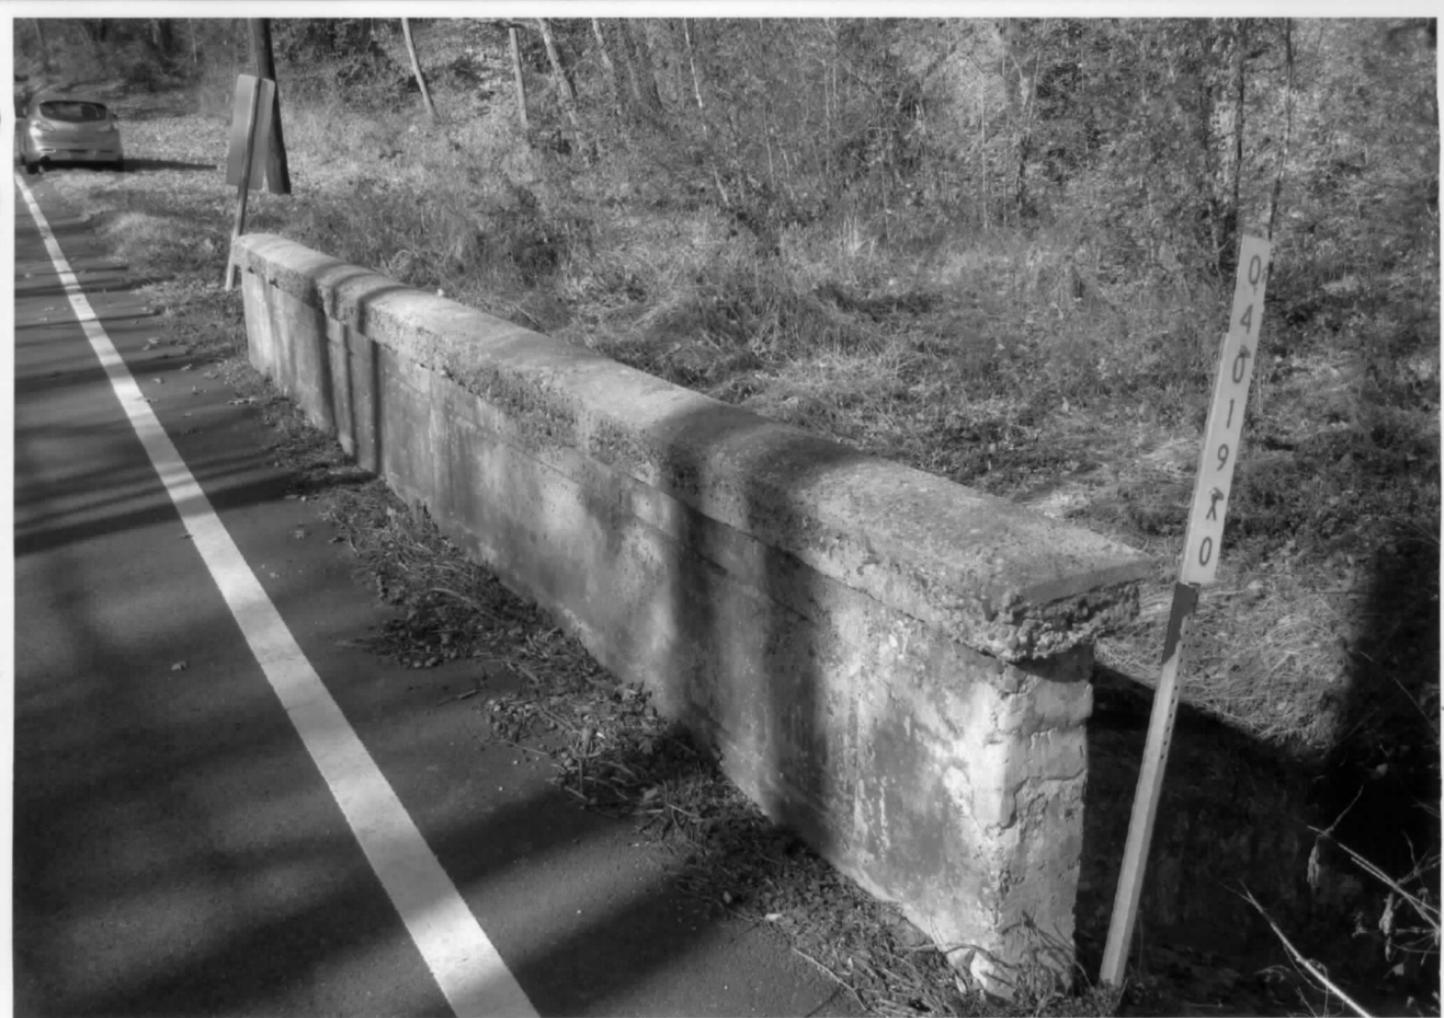
3/6

Standard Plans, used to construct SHA Small Structure No. 04019X0, were the first to specify solid parapet walls with incised rectangular panels; in the 1928 Standard Plans, open handrail parapets replaced the solid parapet walls.

North parapet from MD 262

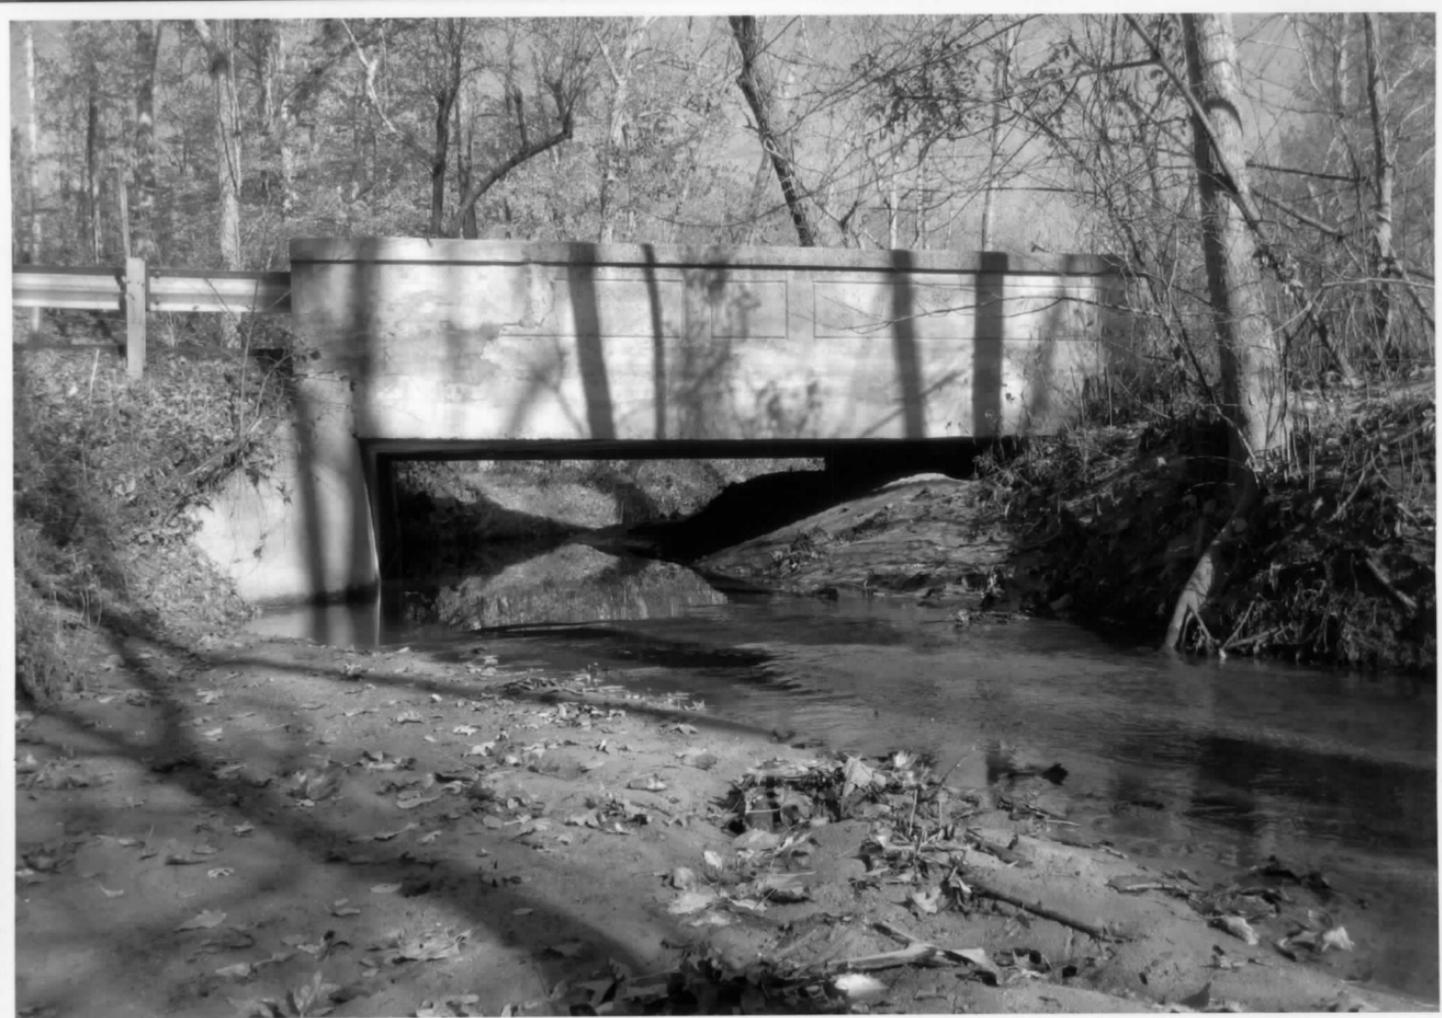
4/6

South elevation

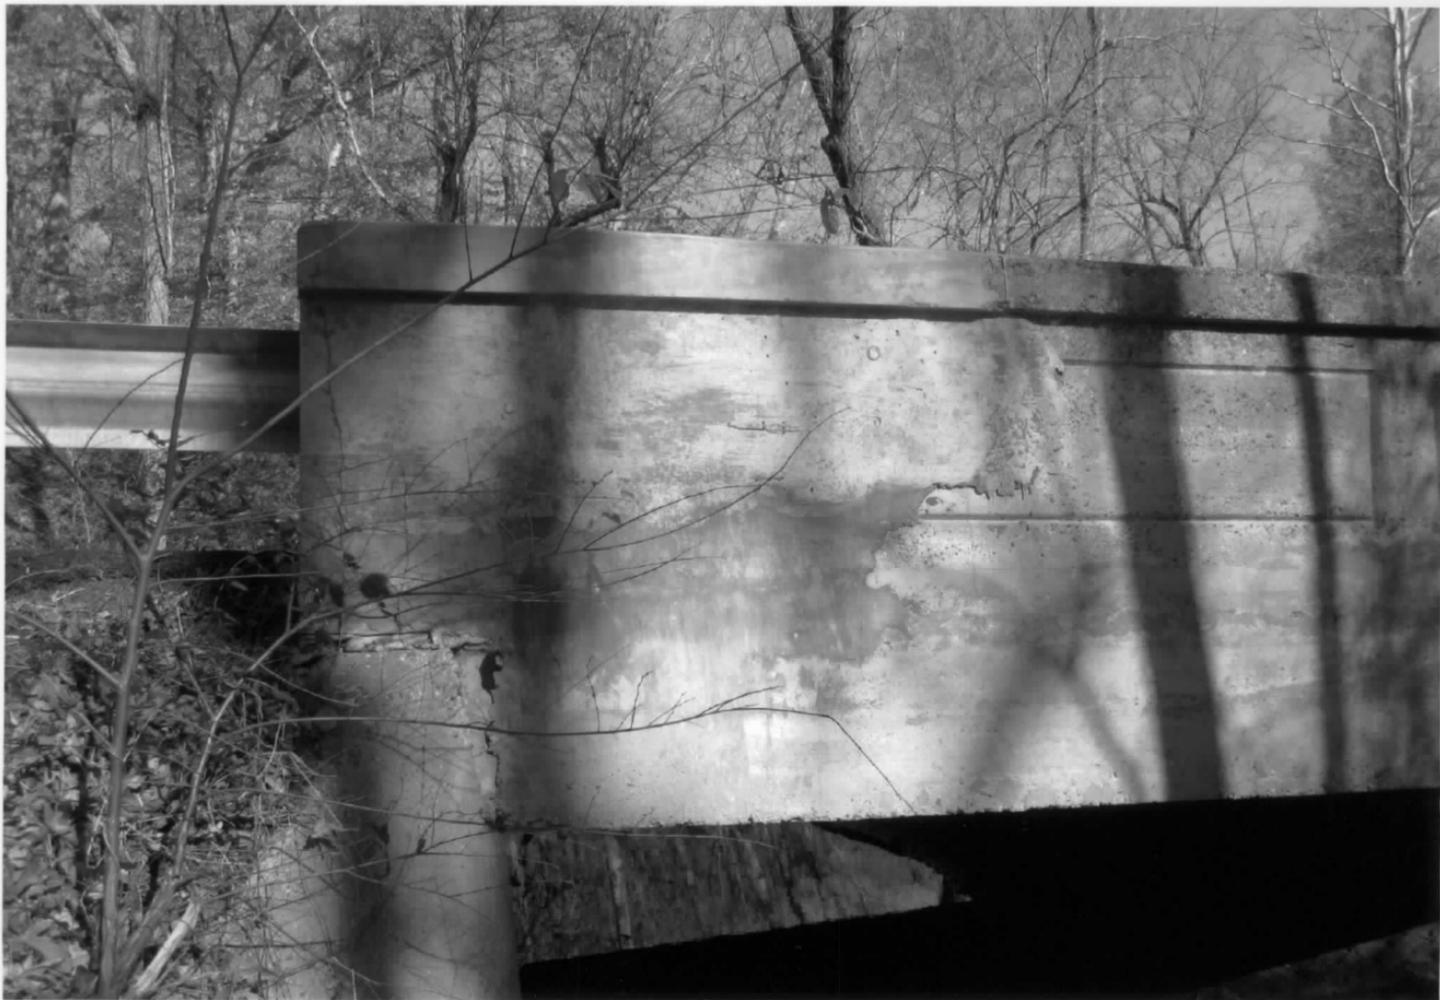
5/6

Concrete slab structures are common along Maryland's roadways, and SHA Small Structure No. 04019X0 shows evidence of repairs and alterations. Guardrail has been affixed to the west end of the structure's south parapet, where the incised paneling, a character-defining element, has been covered with a concrete patch. The concrete coping at this location has also been replaced. Additional patching is apparent on both parapets. As a result, the structure has lost its integrity of design, materials, and feeling. Research did not identify events or persons of local, state, or national significance associated with the structure, and SHA Small Structure No. 04019X0 is not eligible for inclusion in the National Register of Historic Places under Criteria A or B. Although SHA Small Structure No. 04019X0 is an example of the 1924 Standard Plan for concrete slabs, it lacks integrity and is not of exceptional importance; the structure is not eligible for the NRHP under Criterion C. NRHP Criterion D was not included in this study. Based on the evaluated Criteria, SHA Small Structure No. 04019X0 is not eligible for listing in the NRHP.

Concrete patching & repair at south parapet (view north)

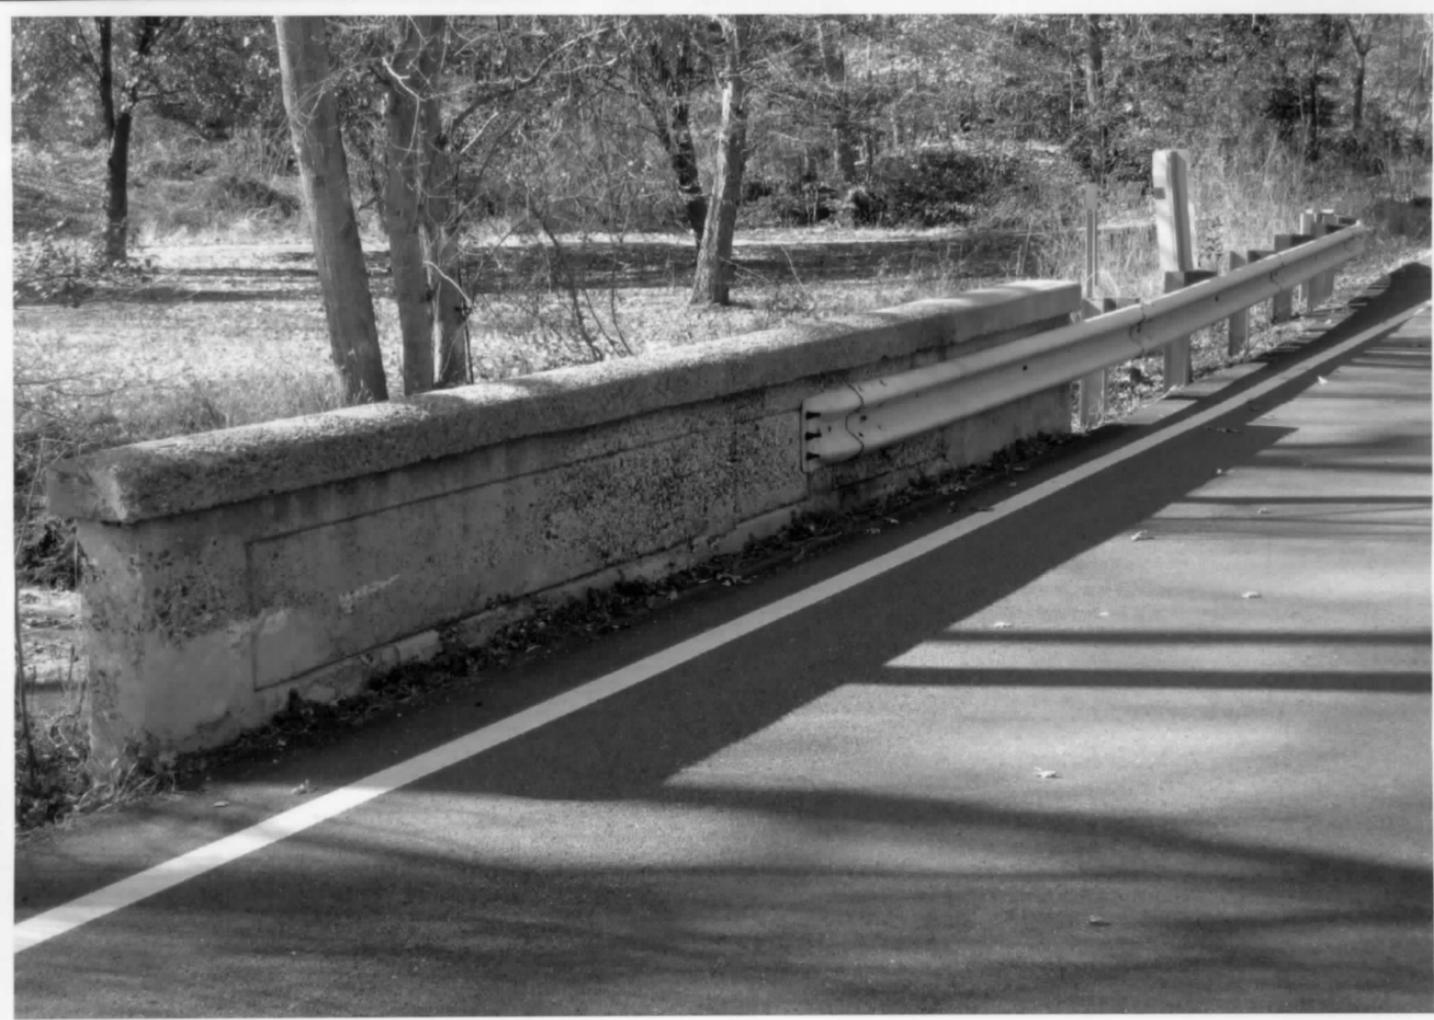
6/6

South parapet and guardrail; view SW from MD 262

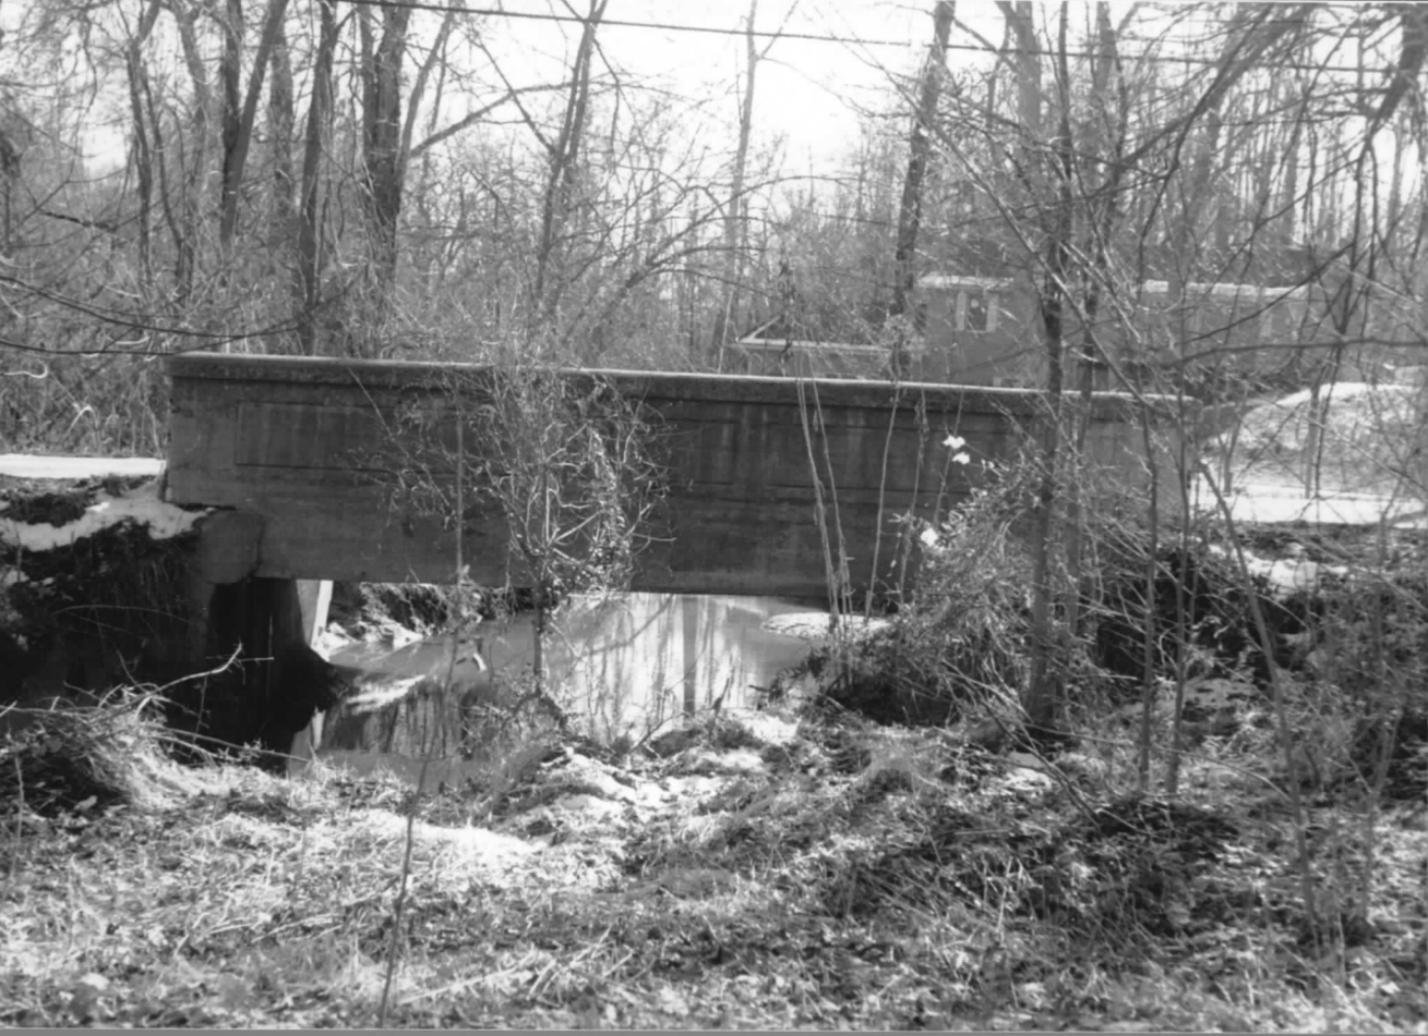
2 OF 4

Bridge No. 4014 over Chew Creek in Calvert County is a single span concrete slab bridge built in 1926. The span length is 20'. The superstructure, consisting of the slab, the roadway and the parapet, is in a deteriorated condition. The underside of the deck has many areas of serious spalling, efflorescence and transverse cracking. The west side of the deck has spalling 6' long and 3" deep, exposing the rebar, and hollow sounding areas throughout. The outside, northwest corner has spalling 2' long, also exposing a rebar. The bridge is posted at 58,000 lbs for single units, and 80,000 for combination units. The bituminous roadway has a longitudinal crack at the centerline and light vegetation and hollow sounds at the gutter line. The parapets are solid concrete, with a saddleback coping and panel ornamentation that follows standard 1924 plans for concrete slab bridges. They are not load bearing and rest upon the slab. The north parapet has random areas of spalling with an exposed rebar along the base. The south parapet has one area of spalling 2' long, 10" high and 2" deep with an exposed and corroded rebar. The finish coat on the parapets has deteriorated and is uniformly rough in texture.

LOOKING SOUTH (UPSTREAM FACE)

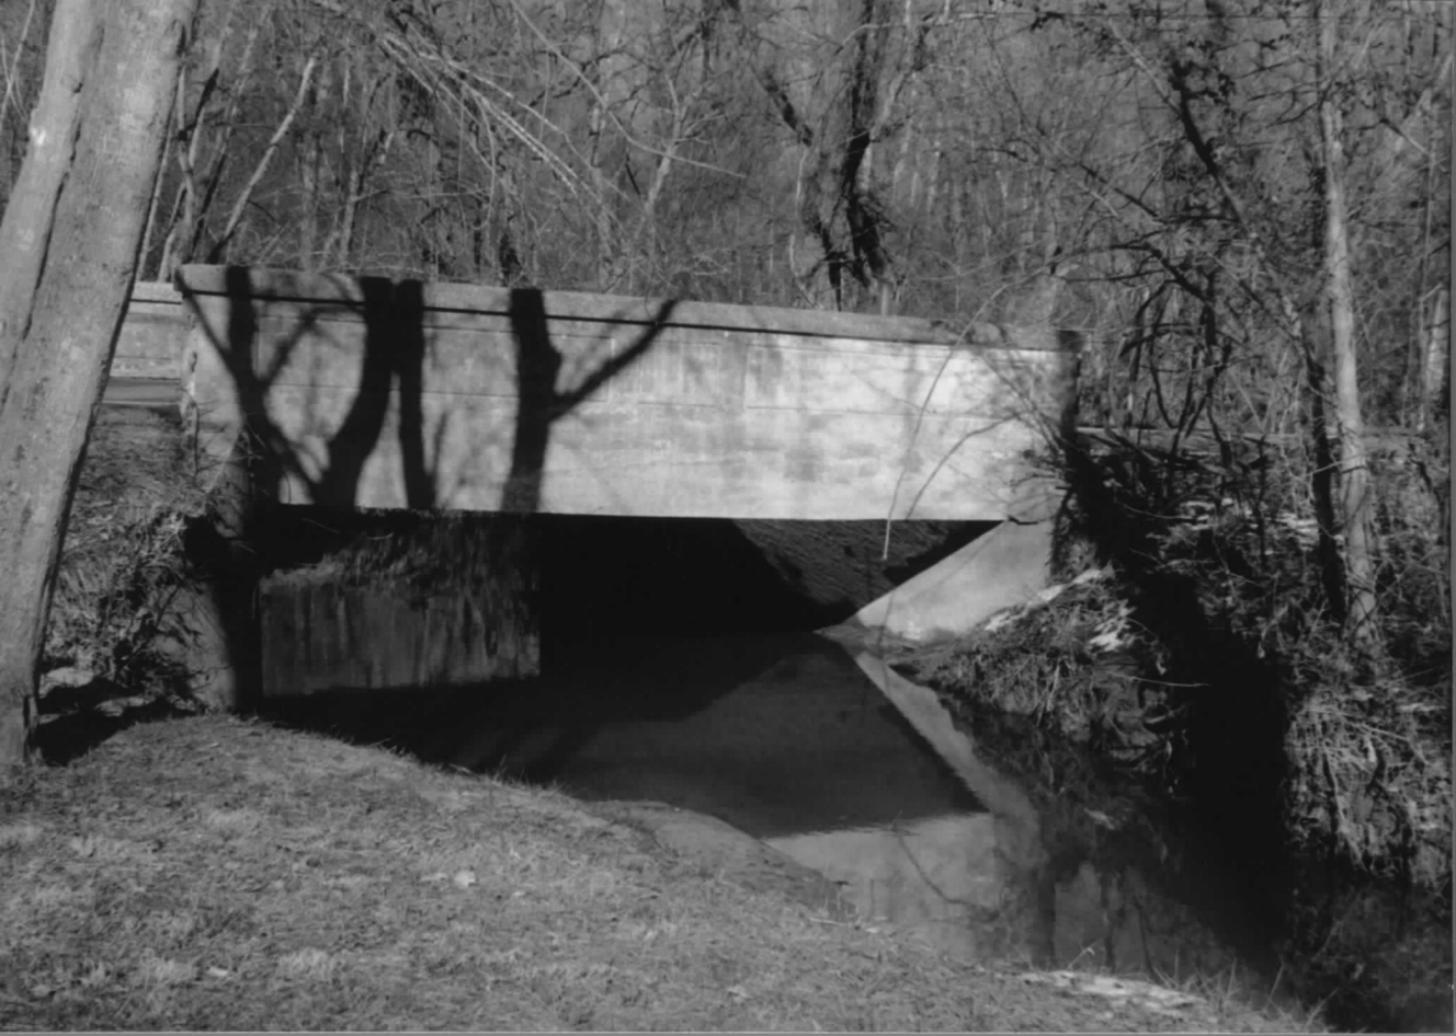
4 of 4

The substructure consists of abutments and wingwalls. The abutment faces have light map cracking. The west abutment has minor erosion at the water line with 8" of the footing exposed and spalling at the deck-abutment intersection 6' long, exposing a rebar. All faces of the wingwalls have fine map cracking. The southeast and northwest wingwalls have full-width horizontal cracks, with the top 2' of the wingwall above the cracks completely detached. The stream channel runs along the west wingwalls and abutments causing most of the structural problems.

LOOKING NORTH (DOWNSTREAM FACE)
