**MARYLAND HISTORICAL TRUST  
NR-ELIGIBILITY REVIEW FORM**

Property Name: Town of Huntingtown Inventory Number: CT-1278

Project: Sprint PCS WA54XC 704-C Agency: FCC

Capsule Summary: Town of Huntingtown  
Old Town Road and Huntingtown Road  
Huntingtown, Maryland  
Ca. 1860-2001  
Multiple Private Properties

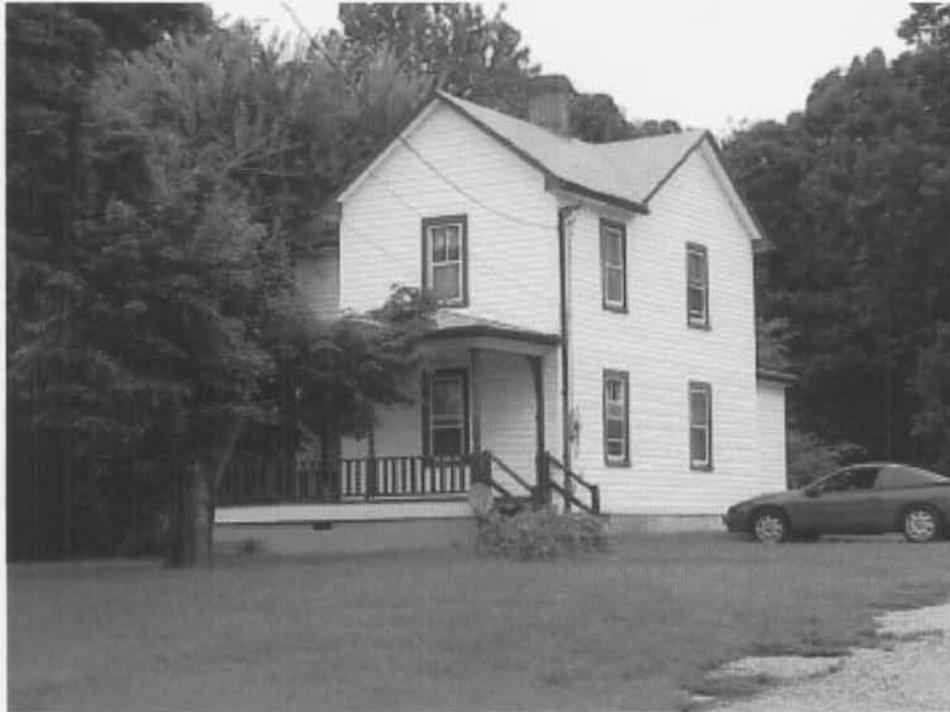
**PHOTOGRAPH 1**

— This site consists of a single-family dwelling (Photograph 1). The main block is L-shaped and displays a wrap around porch with turned posts and sawn wood brackets. Two/two double hung sash are the primary window light. Late twentieth century alterations, which include aluminum siding, aluminum window capping and a rear deck, have seriously compromised the structure's historic integrity.

View looking northeast at dwelling - 4125 Old Town Road (July 2001).

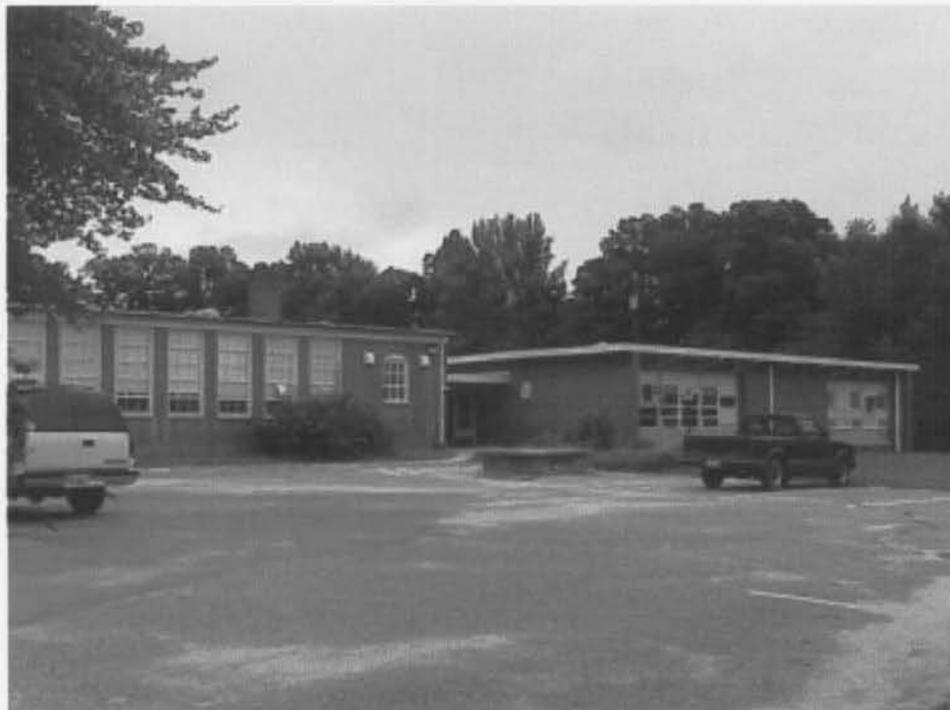
**PHOTOGRAPH 2**

This site consists of one standing resource, the Huntingtown School (Photograph 2). The school is a brick, single-story building which was constructed in two sections. The original structure was built in 1944 as a consolidated elementary school for white students of the Huntingtown area. Fenestration consists primarily of fifteen tall light wood frame windows, which are closely spaced. In 1960, a single story brick addition was erected south of the existing school. The structure is largely unaltered and presently serves as the administrative office for Calvert County schools (McVarish).

View looking southeast at Huntingtown School - 4105 Old Town Road (July 2001).

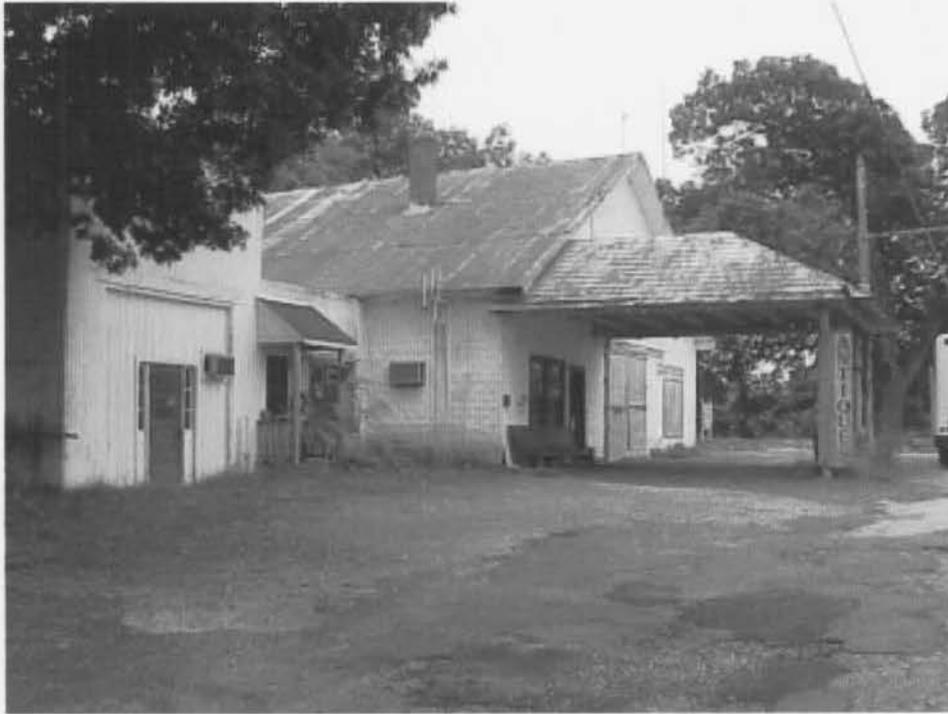
**PHOTOGRAPH 3**

A vacant early twentieth century building occupies this site. Constructed as a garage by the Bowen Family in 1927, this now deteriorating frame structure (Photograph 3) is a representative example of early twentieth century vernacular design. The exterior is faced in sheet metal designed to look like rough faced ashlar block. A hip roofed port-cochere dominates the facade. The main block rises one and a half stories and is covered by an expansive gable roof with a pronounced overhang (Wells, Antique Center and Sign Shop).

View looking southeast at 4001-4009 Old Town Road (July 2001).

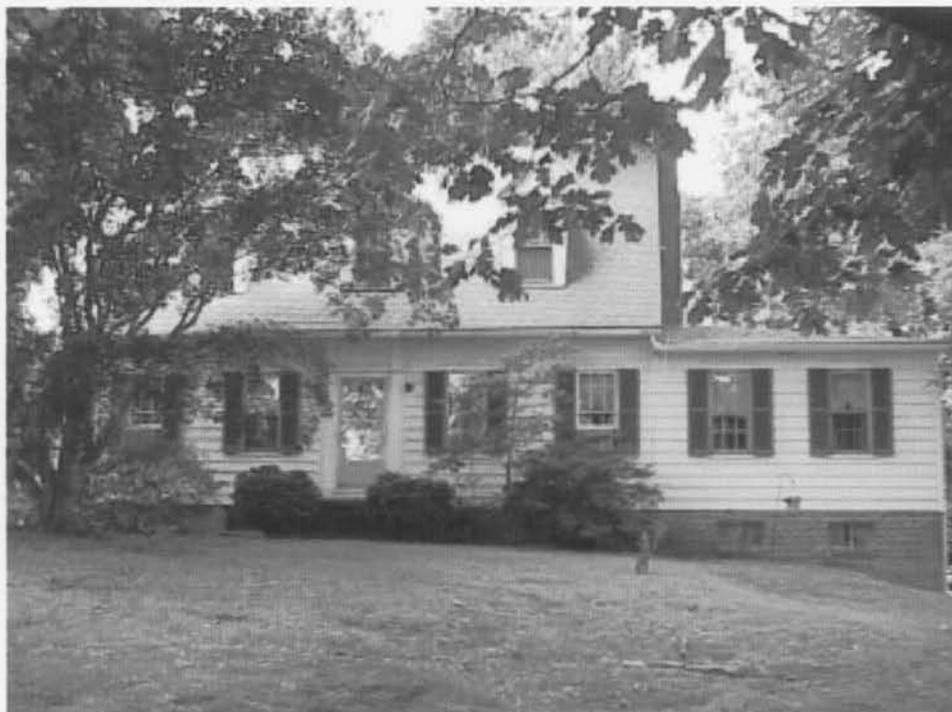
**PHOTOGRAPH 6**

This site consists of a single family dwelling and garage. The frame house (Photograph 6) was constructed about 1940 and is a representative example of Colonial Revival design. The main block rises one and a half stories to a steeply pitched gabled roof; hip roofed ell's flank each side. The main entrance is centered on the five bay facade. Pedimented gabled dormers puncture the front elevation roofline; a shed dormer carries across the rear elevation. Exterior elevations are covered in weatherboard. Six/six double hung sash are the primary window light. The garage (Photograph 7) is located at the rear of the house. The frame structure was constructed about 1940, is sheathed in German siding and gable roofed.

View looking northwest at dwelling - 4290 Old Town Road (July 2001).

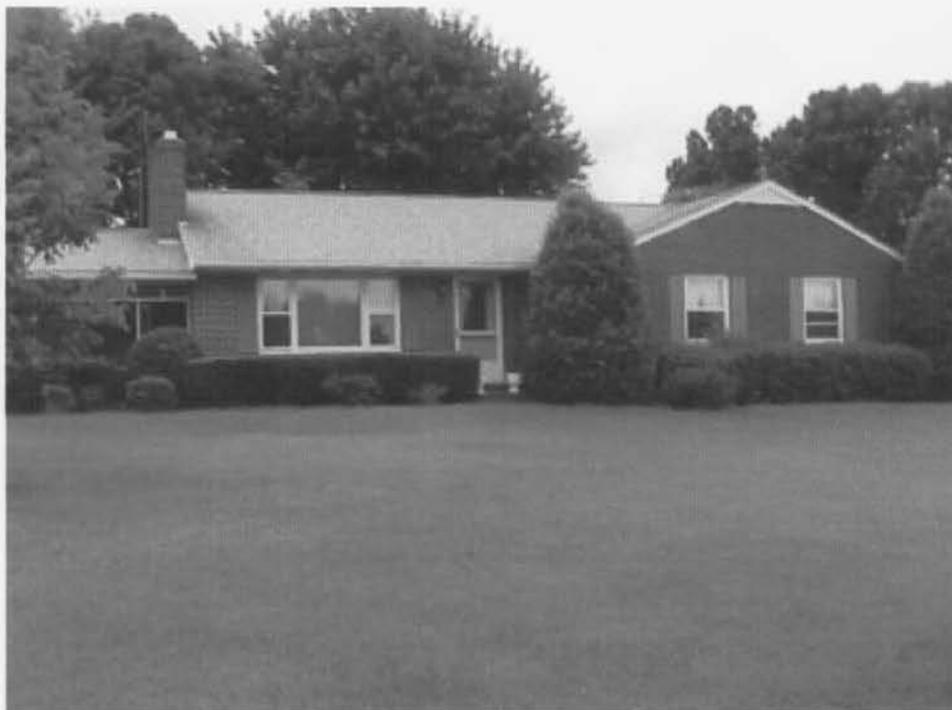
**PHOTOGRAPH 8**

— This site consists of a dwelling and two outbuildings. Constructed about 1960, this single-family house (Photograph 8) is a representative example of a ranch style dwelling. The shed (Photograph 9) is a contemporary of the house and is constructed of cinderblock. The frame barn (Photograph 10) was constructed about 1900; the structure is covered in vertical flush board and rises to a steeply pitched gabled roof.

View looking west at dwelling - 4250 Old Town Road (July 2001).

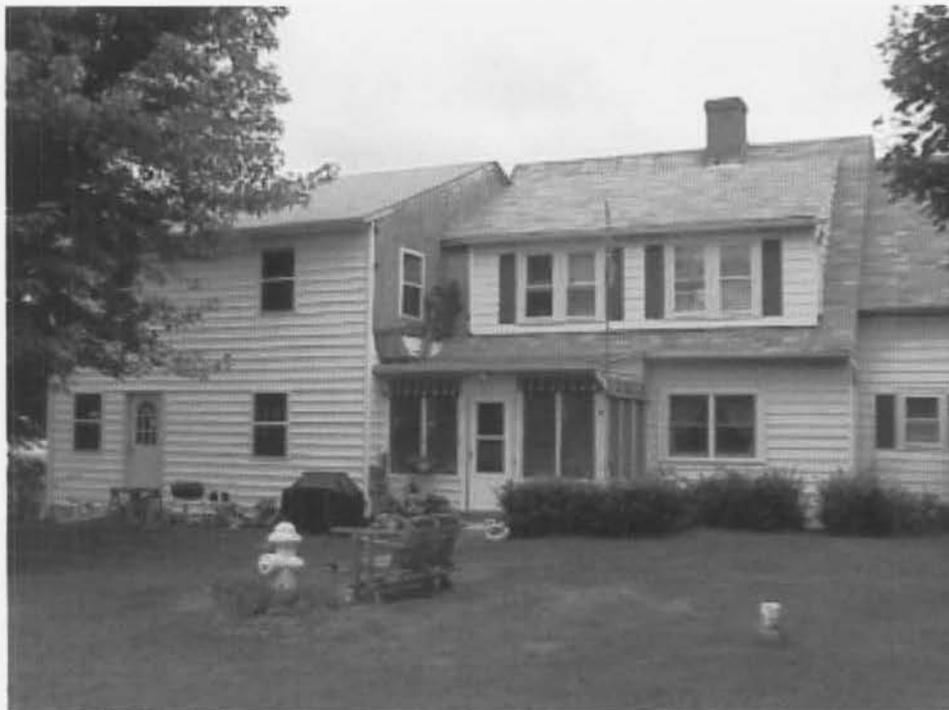
**PHOTOGRAPH 12**

This site consists of a ca. 1930 dwelling (Photograph 12) and two associated frame outbuildings, each dating from the mid twentieth century. As originally constructed, the single-family residence was an example of a modified Colonial Revival dwelling. Recent alterations, including aluminum siding and the construction of a two story gabled ell, have seriously compromised the structure's historic integrity. Two frame sheds (Photograph 13), at the rear of the dwelling, also appear to date from about 1930.

View looking southwest at dwelling - 4230 Old Town Road (July 2001).

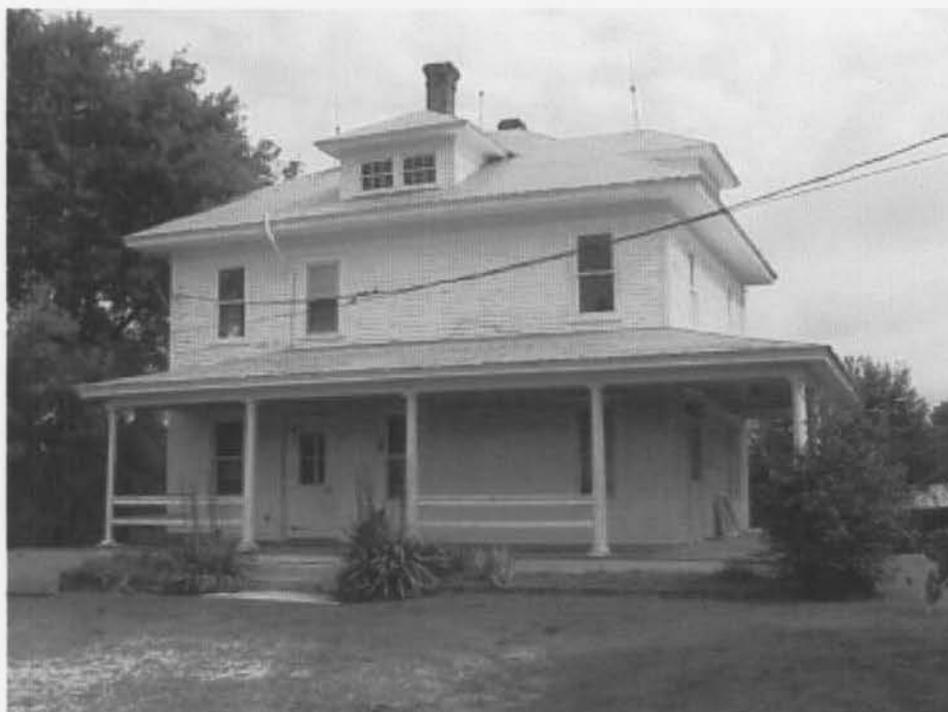
**PHOTOGRAPH 14**

This site consists of a single family dwelling (Photograph 14) and three associated outbuildings, all of which appear to date from the early twentieth century. The frame dwelling is a representative example of a four square house and displays typical stylistic elements including a hip roof with extended overhang and hip roofed dormers. A wrap around porch carries across the front and down the south elevation. The simply executed outbuildings include two frame sheds and a concrete generator.

View looking southwest at dwelling - 4214 Old Town Road (July 2001).

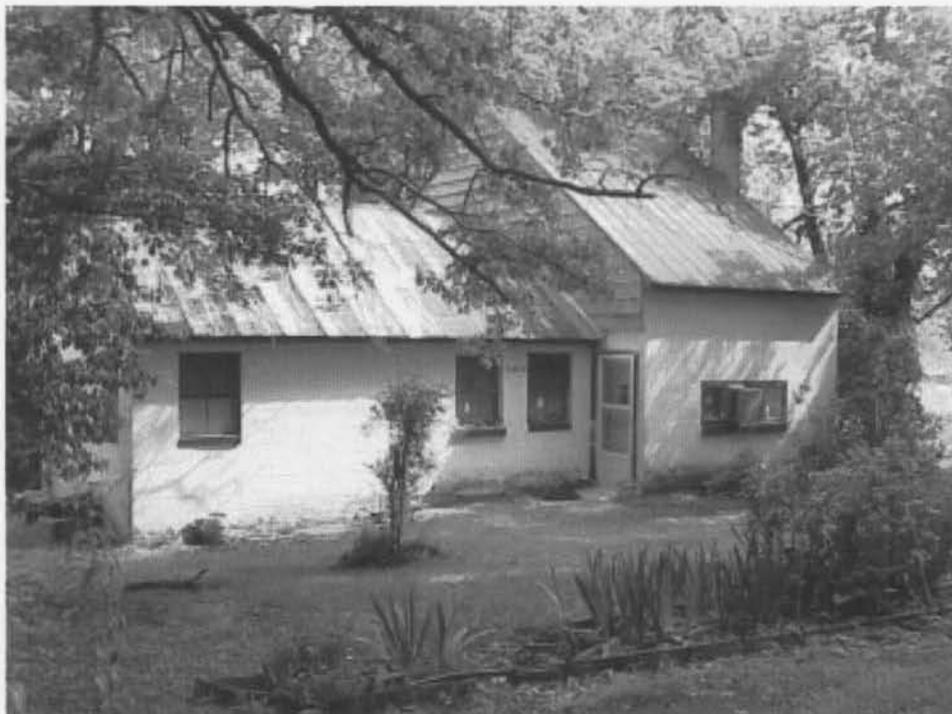
**PHOTOGRAPH 15**

- This site is recessed from Old Town Road and contains a single-family vernacular dwelling and a frame barn. The mid-twentieth century house (Photograph 15) consists of two adjoining gabled ells of varying height, each constructed of concrete block, and simply executed. The barn (Photograph 16) appears to date from the turn of the twentieth century. The frame structure is sheathed in vertical flush board and covered by a tin gabled roof.

View looking northeast at dwelling - 4210 Old Town Road (July 2001).

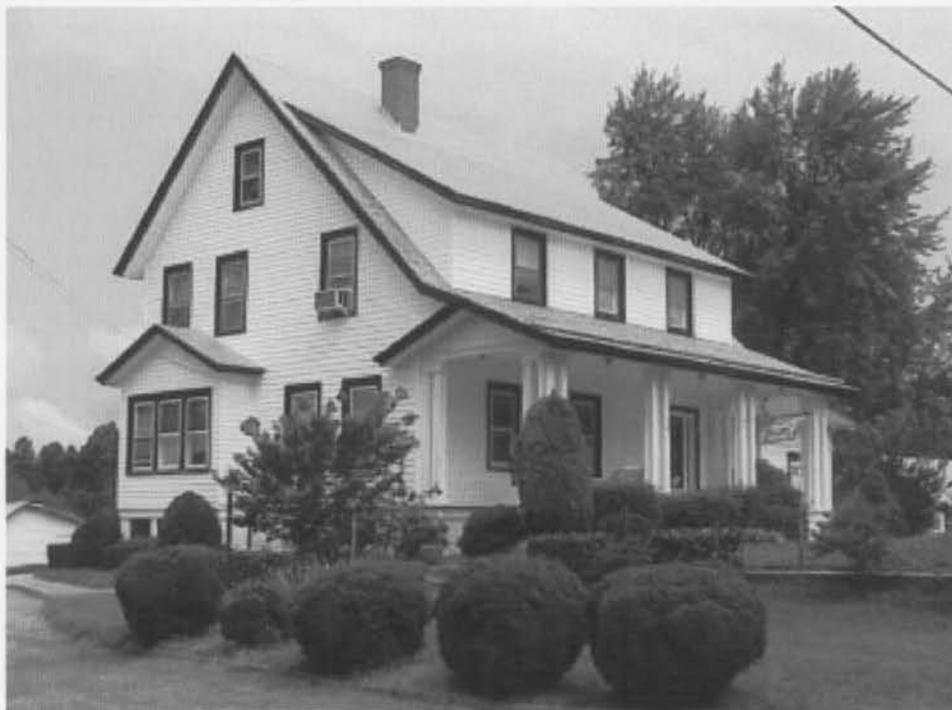
**PHOTOGRAPH 30**

The two and a half story dwelling (Photograph 30) draws its inspiration from the bungalow style. Late twentieth century alterations, particularly vinyl siding and aluminum cornice capping, have compromised the structure's historic integrity. Contemporary outbuildings (Photograph 31) include a frame shed, which has partially been covered in vinyl siding, a cinderblock hen house, and a cinderblock garage.

View looking northwest at dwelling - 4110 Old Town Road (July 2001).

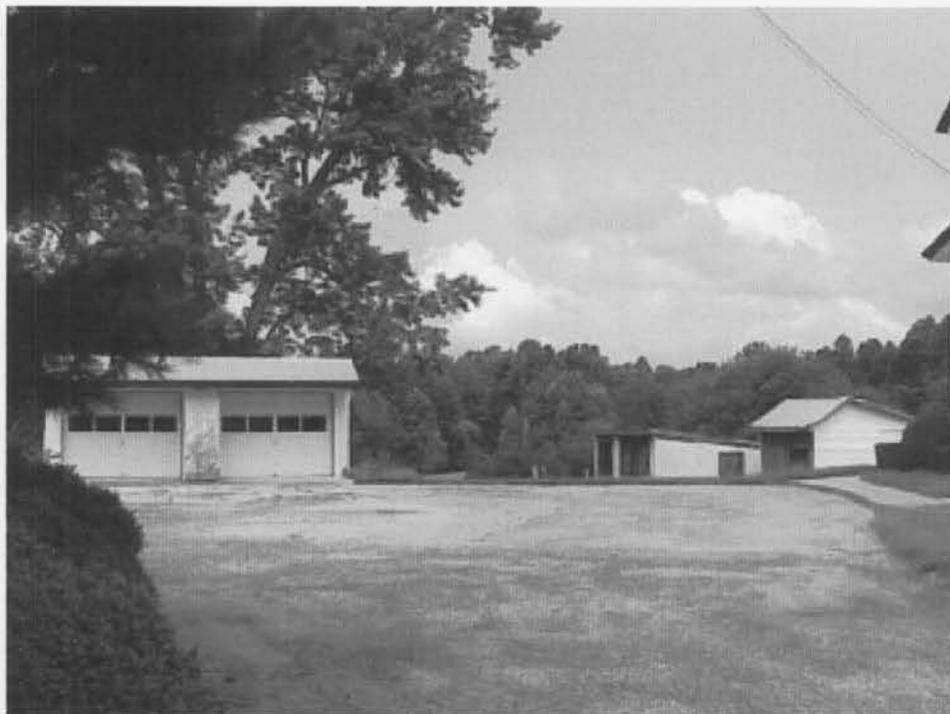
**PHOTOGRAPH 31**

View looking west at out buildings - 4110 Old Town Road (July 2001).

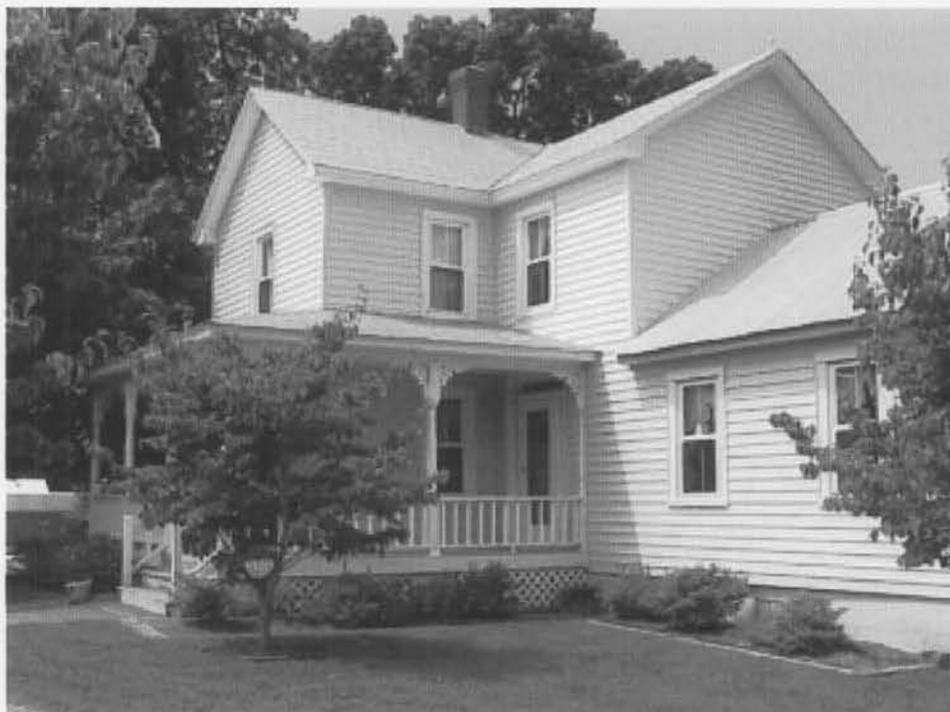
**PHOTOGRAPH 32**

Constructed about 1910, this L-shaped dwelling (Photograph 32) displays a wrap around porch with turned posts and sawn wood brackets. Significant late twentieth century alterations, which include a rebuilt porch balustrade, vinyl siding, aluminum sided cornice and vinyl replacement windows, have compromised the structure's historic integrity. Outbuildings include an early twentieth century frame shed and a late twentieth century two bay garage, which is covered in vinyl siding.

View looking southwest at dwelling - 4090 Old Town Road (July 2001).

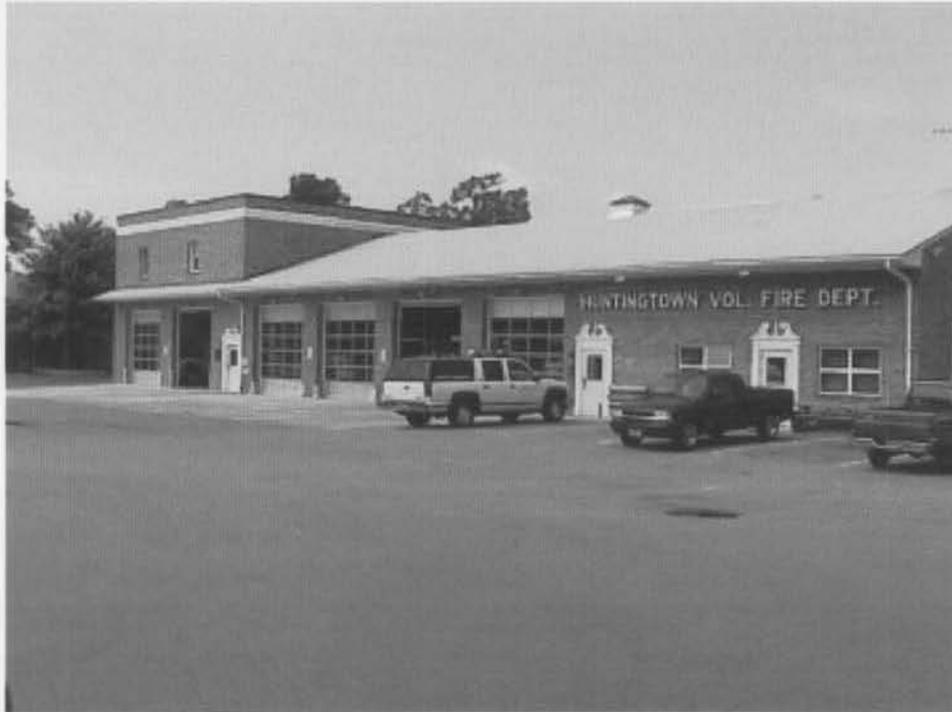
**PHOTOGRAPH 33**

This late twentieth century firehouse (Photograph 33) was constructed in two stages. The one-story building displays some Colonial inspired detailed but its appearance is predominantly functional.

View looking southwest at Huntingtown Volunteer Fire Department - 4030 Old Town Road (July 2001).

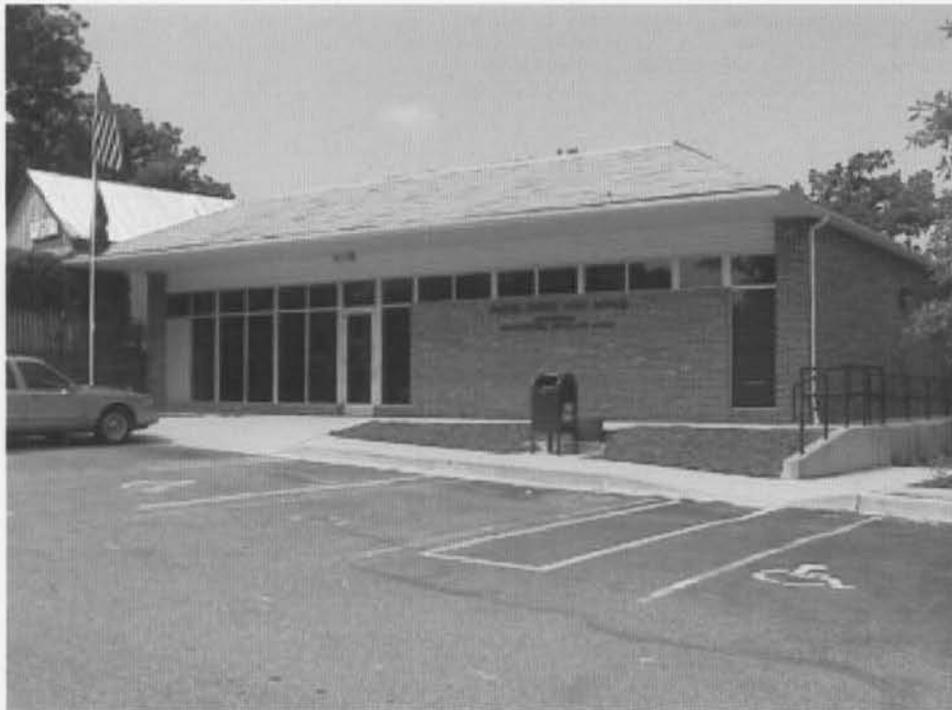
**PHOTOGRAPH 34**

This single story building (Photograph 34) is a representative example of a late twentieth century post office designed for rural and small town locations.

View looking southwest the United States Post Office - 4020 Old Town Road (July 2001).

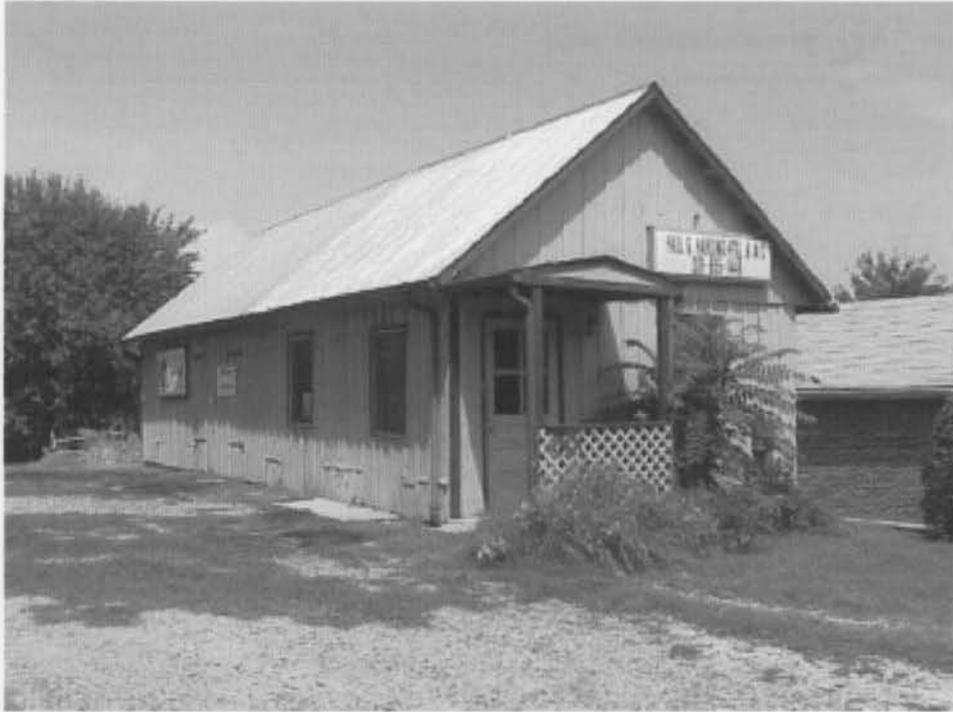
**PHOTOGRAPH 35**

This frame commercial building (Photograph 35) was constructed about 1900. The rectangular structure is sheathed in board and batten siding and covered by a tin gabled roof. The gabled entrance hood is a later addition as are the six/six double hung replacement sash.

View looking northwest at Harding's Inc. Heating and Air Conditioning - 4010 Old Town Road (July 2001).

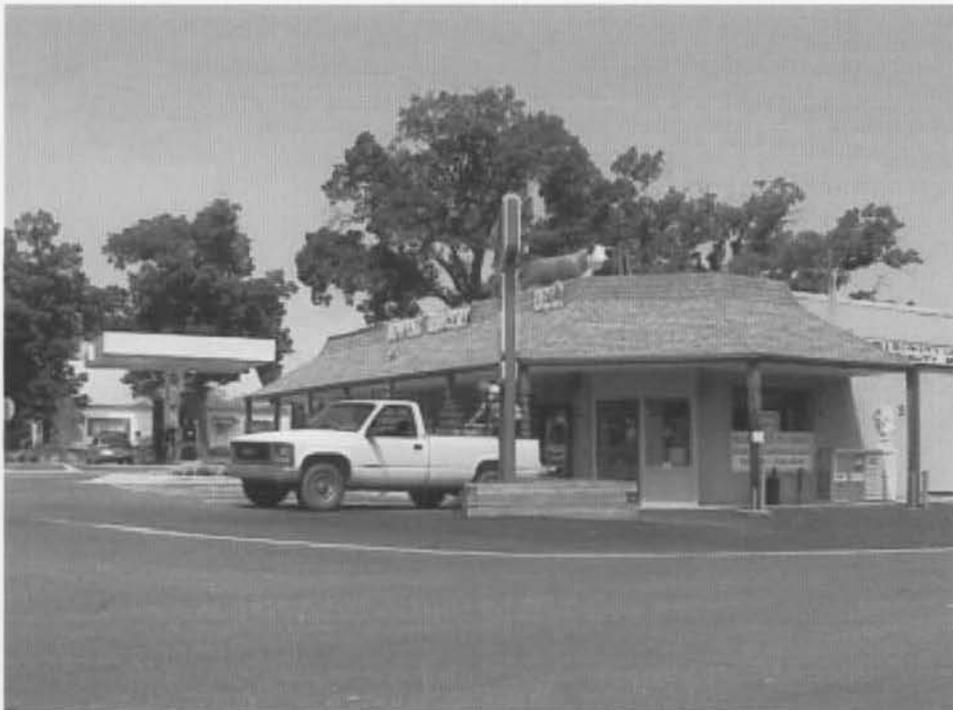
**PHOTOGRAPH 36**

This site contains a convenience store and gas pumps. (Photograph 36). The Bowen Family has operated a store on this site since the 1930s; the present structure assumed its current appearance in the late twentieth century.

View looking northwest at Bower's Grocery/Deli - 4300 Huntingtown Road (July 2001).

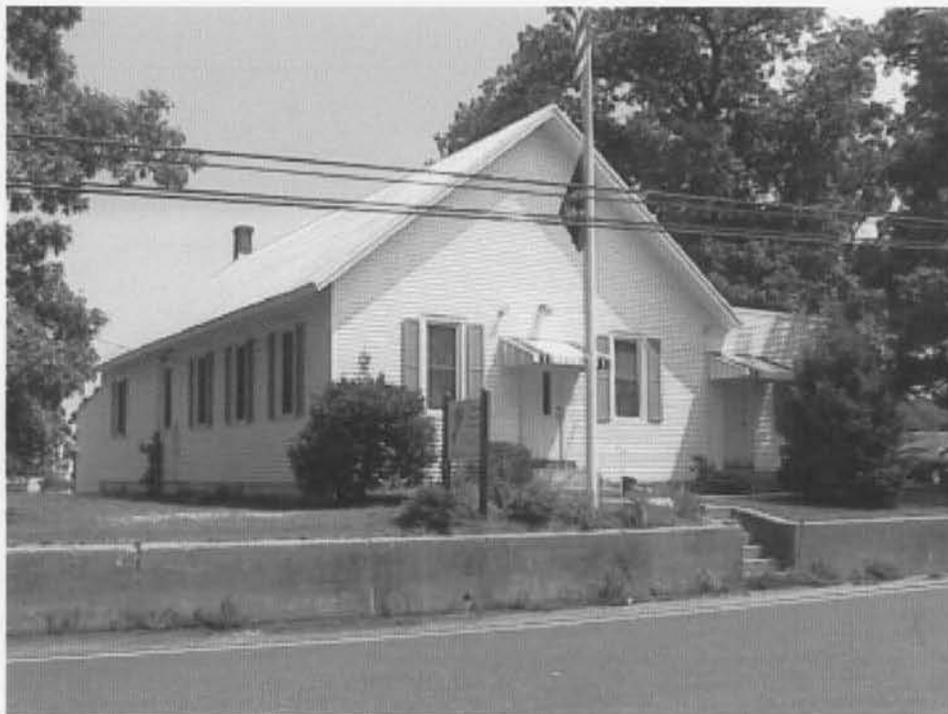
**PHOTOGRAPH 37**

This site includes an early twentieth century meeting hall and an adjacent shed. The gabled structure (Photograph 37) is simply executed. Constructed about 1920, it has long served as the home the Calvert Post # 85 of the American Legion (Wells: American Legion Hall). A stuccoed addition to the east side and a concrete block rear ell appear to date from the mid-twentieth century. Late twentieth century alterations, which include the installation of vinyl windows and shutters, the aluminum cornice capping, and exterior vinyl siding, have seriously compromised the structure's historic integrity. A frame shed, which appears to date from the late twentieth century, stands to the rear of the hall.

View looking northeast at American Legion Hall - 4290 Huntingtown Road (July 2001).

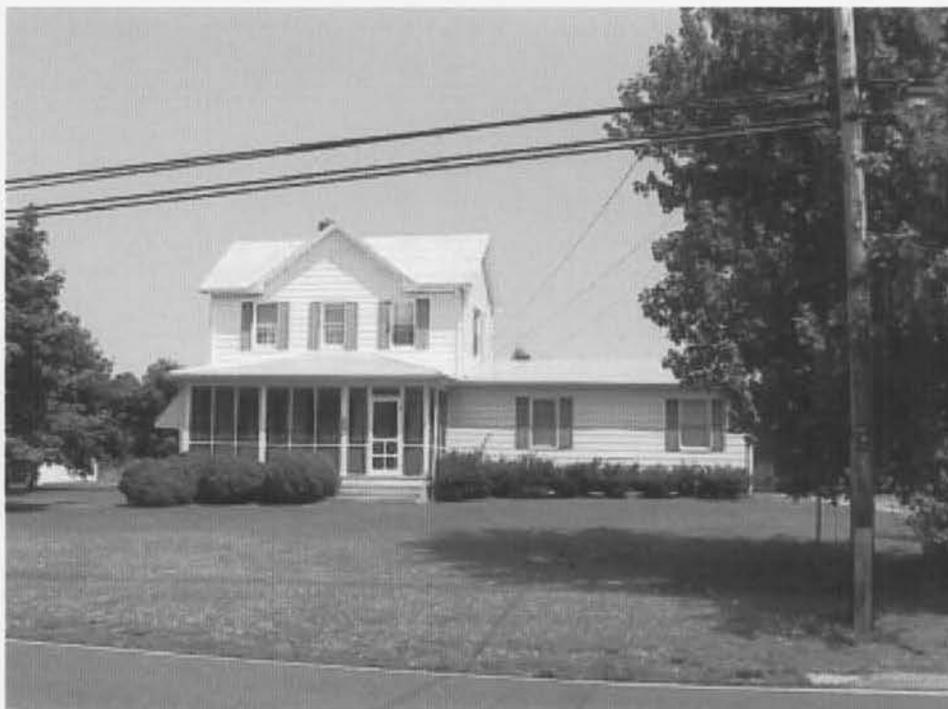
**PHOTOGRAPH 38**

This residential site includes a single-family dwelling, a cinderblock garage and a frame barn. The modified and altered Gothic cottage (Photograph 38) was constructed in the mid nineteenth century but largely assumed its present appearance by the mid twentieth century. Recent alterations include an application of aluminum siding and installation of vinyl windows. The garage is constructed of cinderblock and dates from the mid-twentieth century. The frame barn (Photograph 39) was constructed about the turn of the twentieth century and is sheathed in board and batten siding.

View looking north at dwelling - 4280 Huntingtown Road (July 2001).

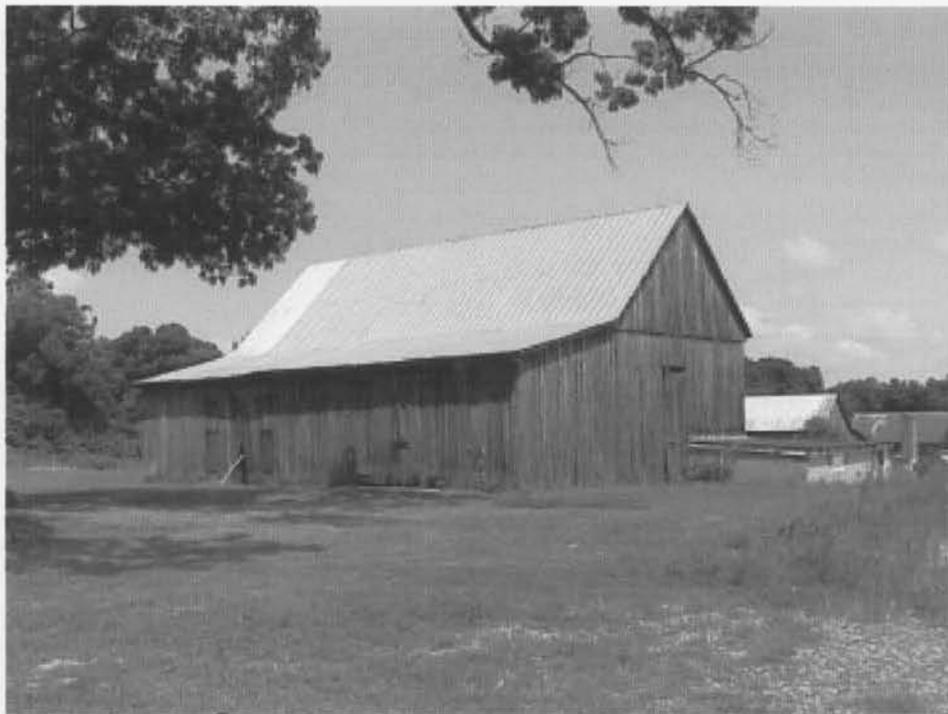
**PHOTOGRAPH 39**

View looking northwest at barn - 4280 Huntingtown Road (July 2001).

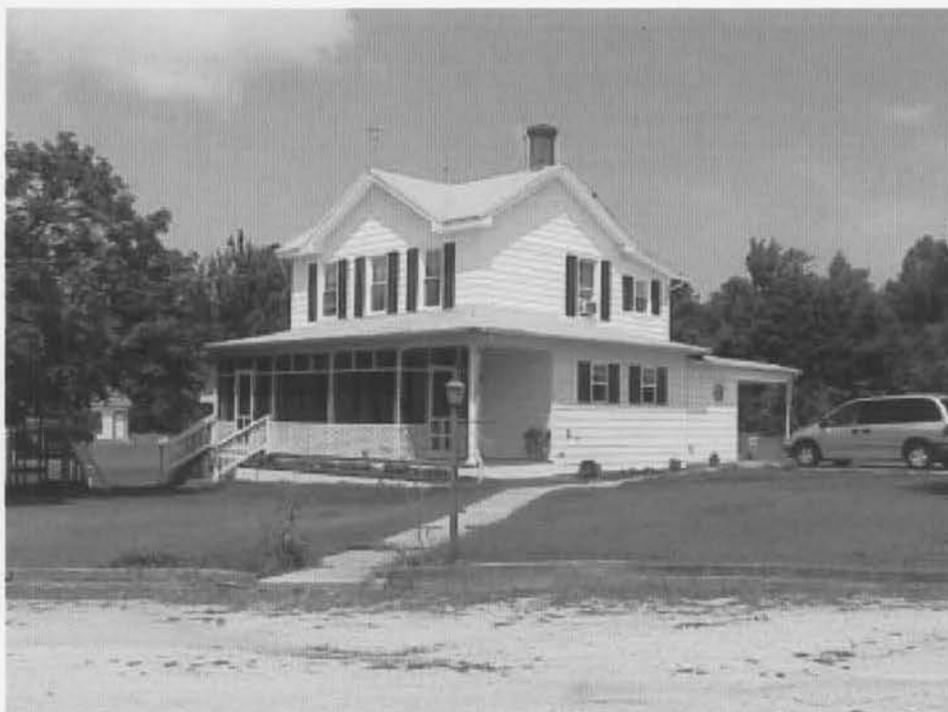
**PHOTOGRAPH 40**

The form of this single family residence (Photograph 40) is similar to that of the adjacent dwelling (4280 Huntingtown Road) The original house was a modified Gothic Revival cottage. Significant alterations, which include front, side and rear additions, aluminum siding, an aluminum capped cornice and four/four vinyl windows, have compromised the structure's historic integrity. Paired gabled frame sheds (Photograph 41) are similarly executed, are covered in flush vertical board, and appear to date from the early twentieth century. Remaining outbuildings, which include a tractor shed, are constructed of cinderblock and date from the mid twentieth century.

View looking northwest at dwelling - 4270 Huntingtown Road (July 2001).

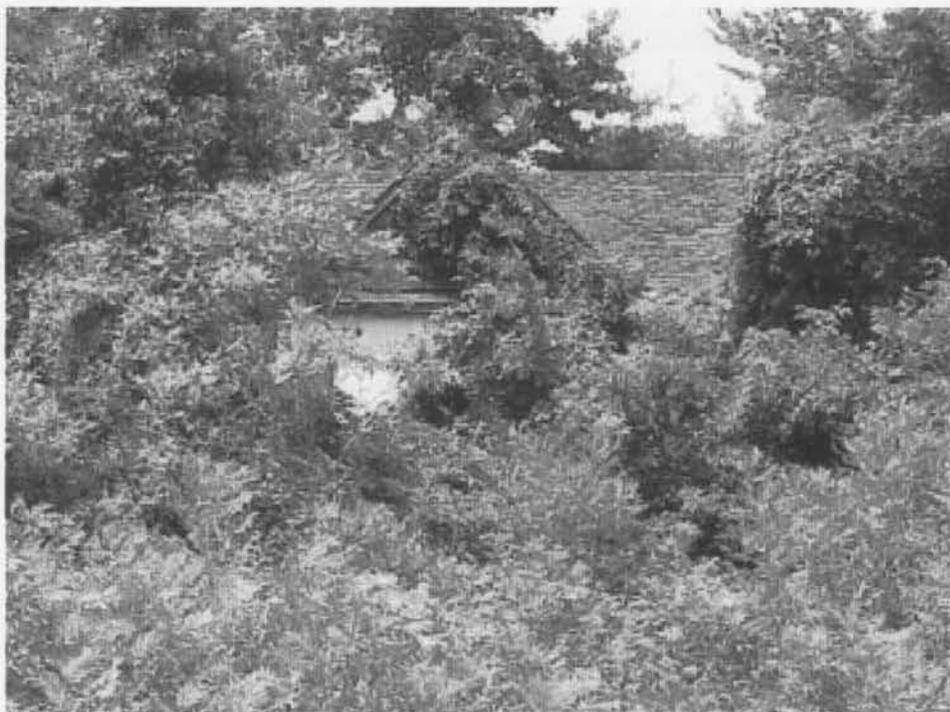
**PHOTOGRAPH 42**

This overgrown site contains one resource, a vacant and deteriorating dwelling (Photograph 42). The one-time single family residence appears to date from the late nineteenth century and is largely obscured by vegetation.

View looking west at dwelling - 4260 Huntingtown Road (July 2001).

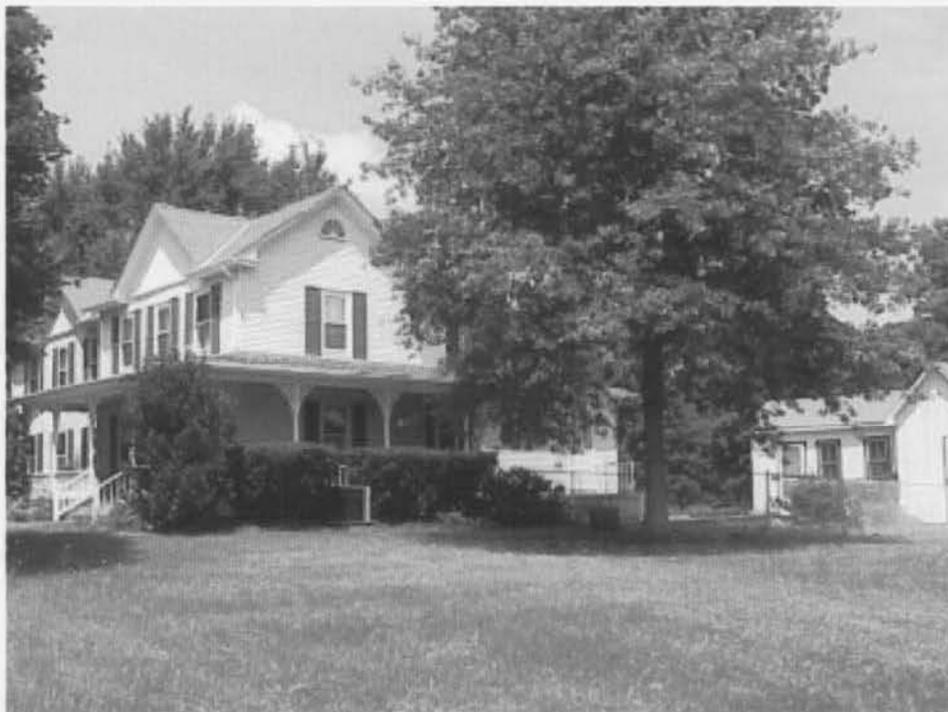
**PHOTOGRAPH 43**

This site consists of a single-family house, three frame sheds and a swimming pool. The dwelling (Photograph 43) appears to have been constructed in the late nineteenth century and displays substantial twentieth century alterations and additions, the most recent being the installation of vinyl siding. Two sheds (Photograph 44) are located west of the dwelling; an additional shed stands east of the dwelling adjacent to the swimming pool. Each shed is covered in board and batten siding and appears to have been built in the late nineteenth century.

View looking northwest at dwelling and shed - 4250 Huntingtown Road (July 2001).

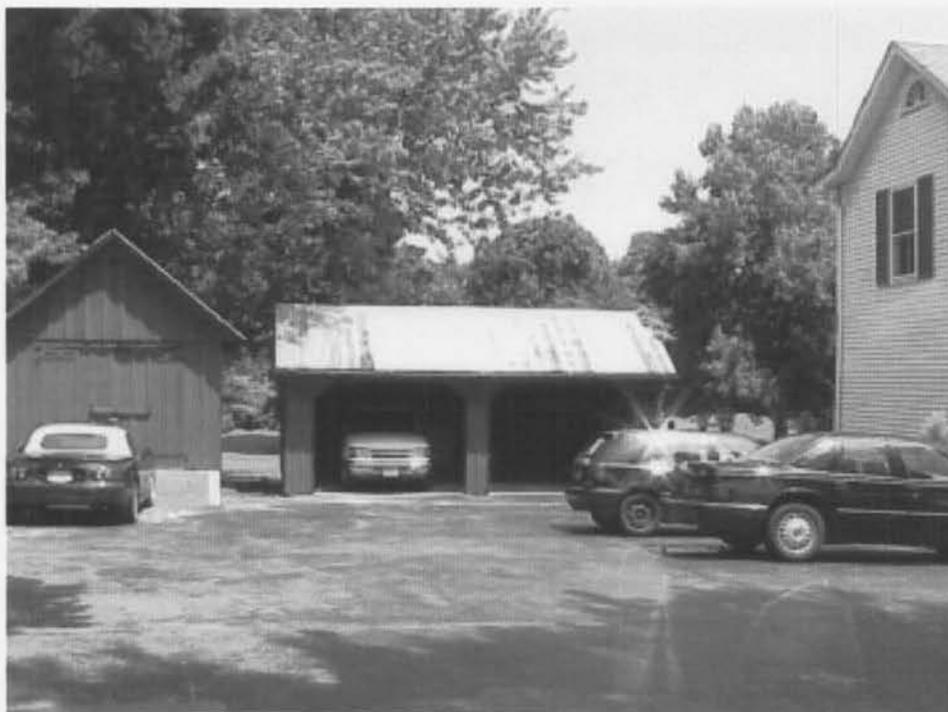
**PHOTOGRAPH 44**

View looking north at sheds - 4250 Huntingtown Road (July 2001).

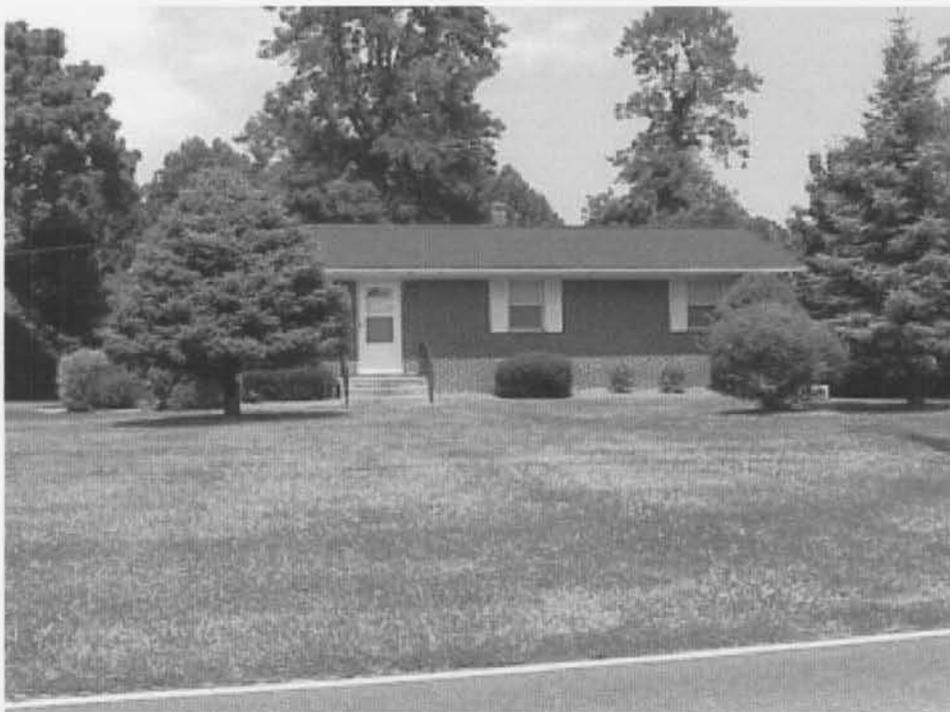
**PHOTOGRAPH 45**

This site consists of a ca. 1970 brick ranch (Photograph 45) and a gabled cinderblock shed which dates from the same period.

View looking north at dwelling - 4230 Huntingtown Road (July 2001).

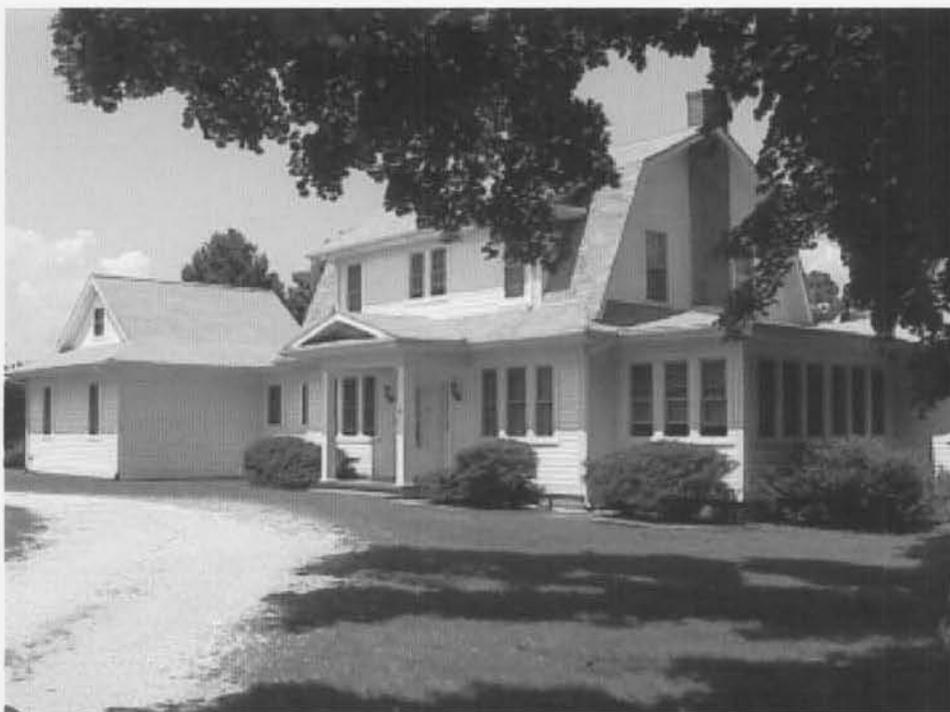
**PHOTOGRAPH 46**

John Leitch constructed this Dutch Colonial Revival dwelling (Photograph 46) in 1932; the property remains in the Leitch Family (Leitch Family, Personal Communication, July 31, 2001). The main block reflects its style in the use of a gambrel and pent roofs, shed dormers and six/one double hung sash. Late twentieth century alterations include one story front and rear additions, aluminum siding, aluminum cornice treatment and six/one vinyl windows. Outbuildings, which include a frame barn, cinderblock garage and two frame sheds, are representative examples of vernacular building from the early to mid twentieth century.

View looking northwest at dwelling - 4170 Huntingtown Road (July 2001).

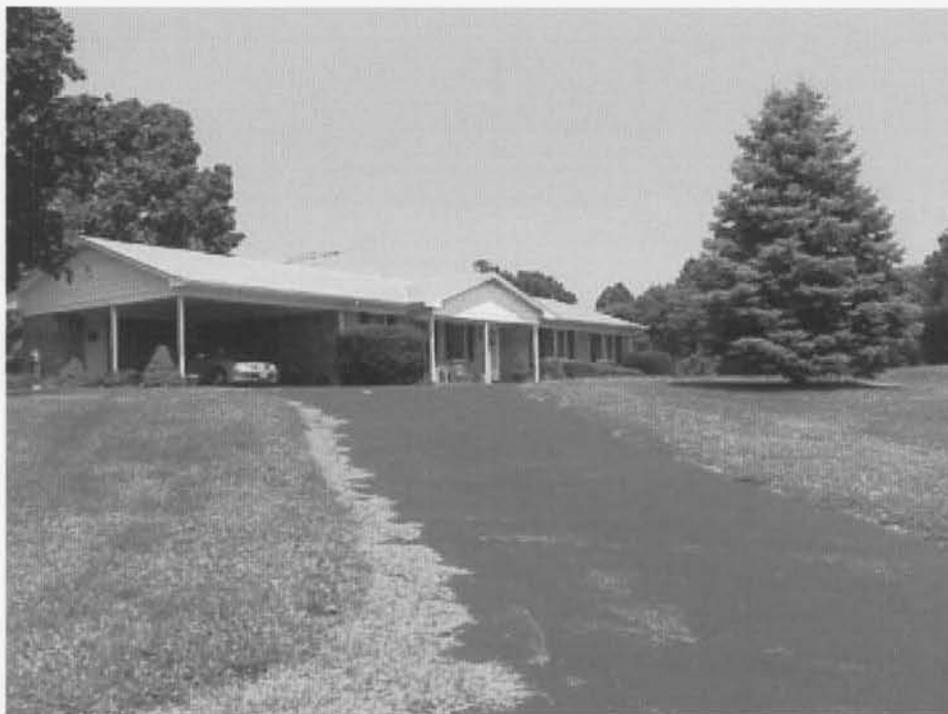
**PHOTOGRAPH 47**

This site contains one resource, a ranch house (Photograph 47) which is a representative example of a suburban style dwelling from the late twentieth century.

View looking northeast at dwelling - 4040 Huntingtown Road (July 2001).

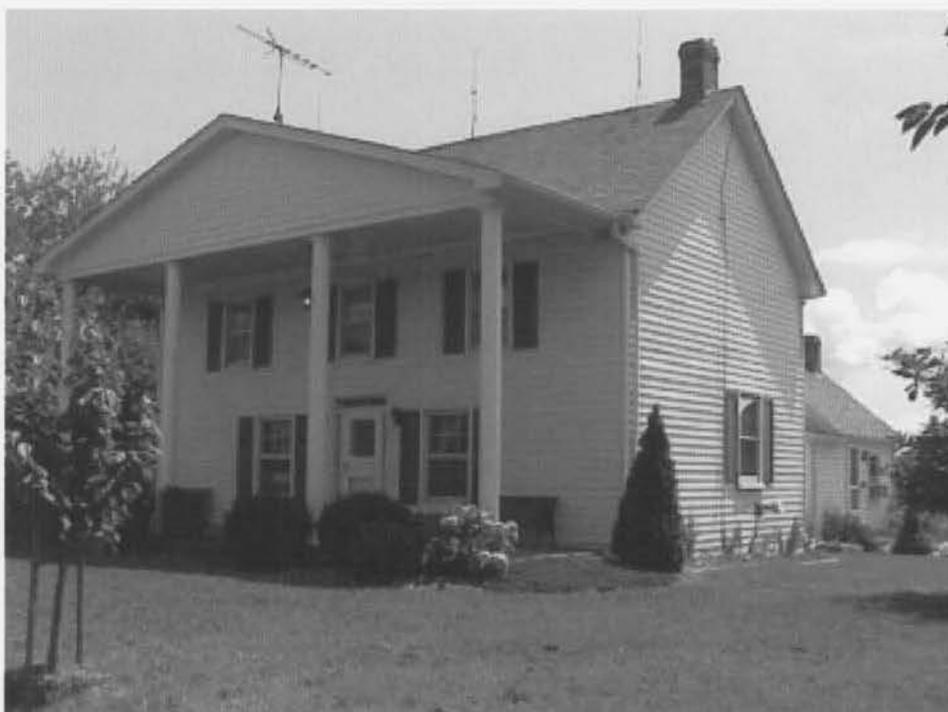
**PHOTOGRAPH 48**

This site consists of a two and a half story frame dwelling, a now attached summer kitchen, and a frame barn. The house (Photograph 48) may have been constructed in the late nineteenth century. Late twentieth century alterations, which include the six/six vinyl windows, aluminum siding, aluminum cornice treatment, and the two story front porch and gable, have obliterated nearly all trace of historic fabric. Possibly constructed as a tobacco barn, the frame outbuilding (Photograph 49) is largely unaltered and displays a steeply pitched gabled roof and flush vertical board siding.

View looking southeast at dwelling - 4110 Huntingtown Road (July 2001).

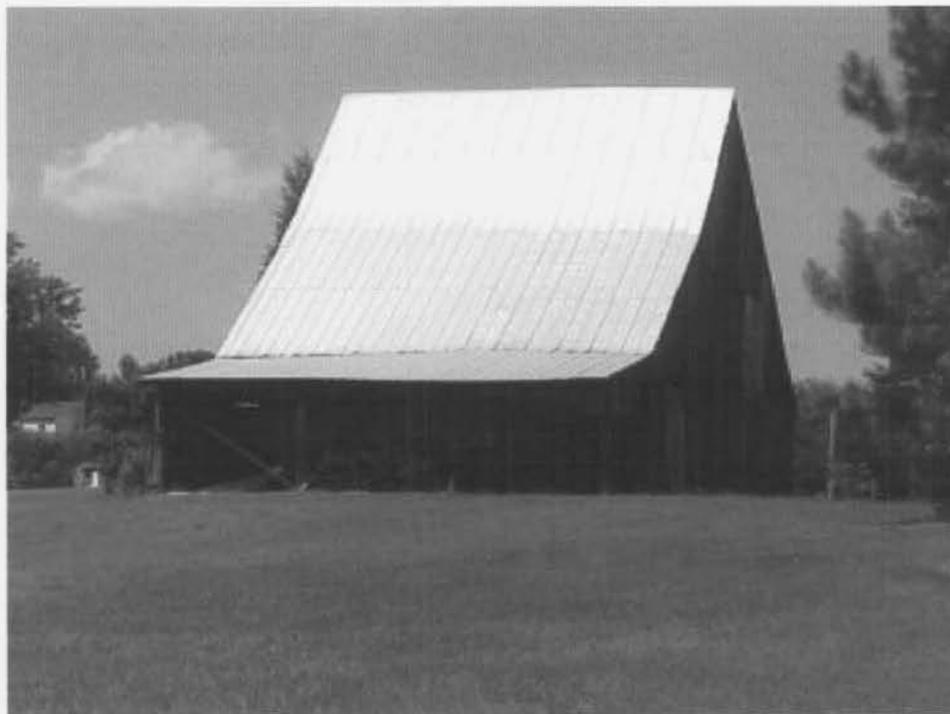
**PHOTOGRAPH 49**

View looking west at tobacco barn - 4110 Huntingtown Road (July 2001).

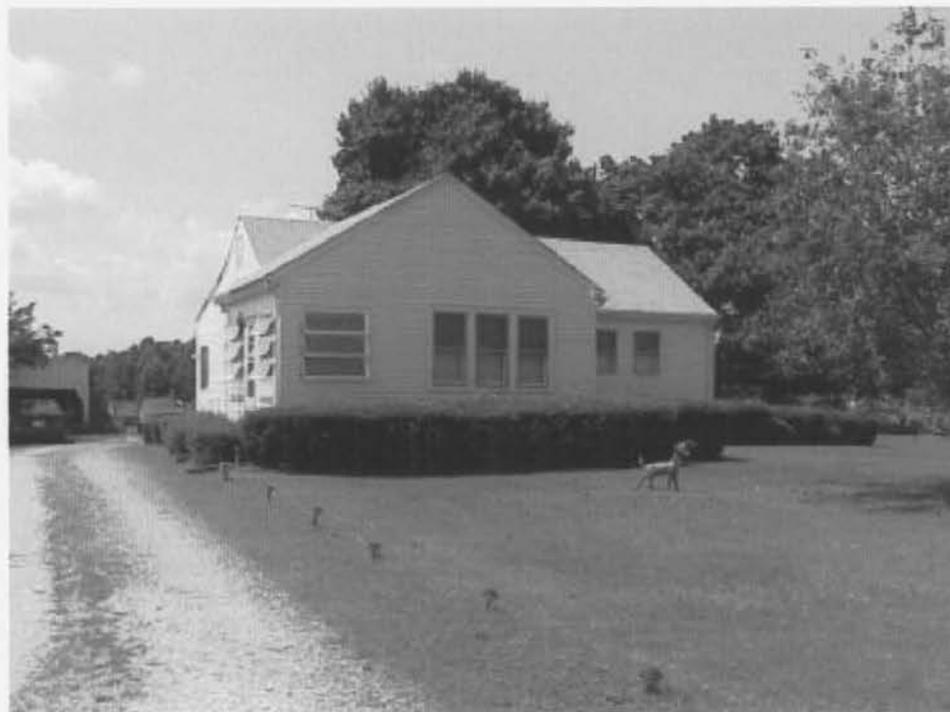
**PHOTOGRAPH 50**

This site consists of a mid-twentieth century vernacular dwelling (Photograph 50) and an adjacent frame garage. The single family residence displays six/one double hung sash and has been covered in vinyl siding.

View looking west at dwelling and garage - 4034 Hunting Creek Road (July 2001).
