**MARYLAND HISTORICAL TRUST  
NR-ELIGIBILITY REVIEW FORM**

Property Name: Town of Huntingtown Inventory Number: CT-1278

Project: Sprint PCS WA54XC 704-C Agency: FCC

Capsule Summary: Town of Huntingtown  
Old Town Road and Huntingtown Road  
Huntingtown, Maryland  
Ca. 1860-2001  
Multiple Private Properties

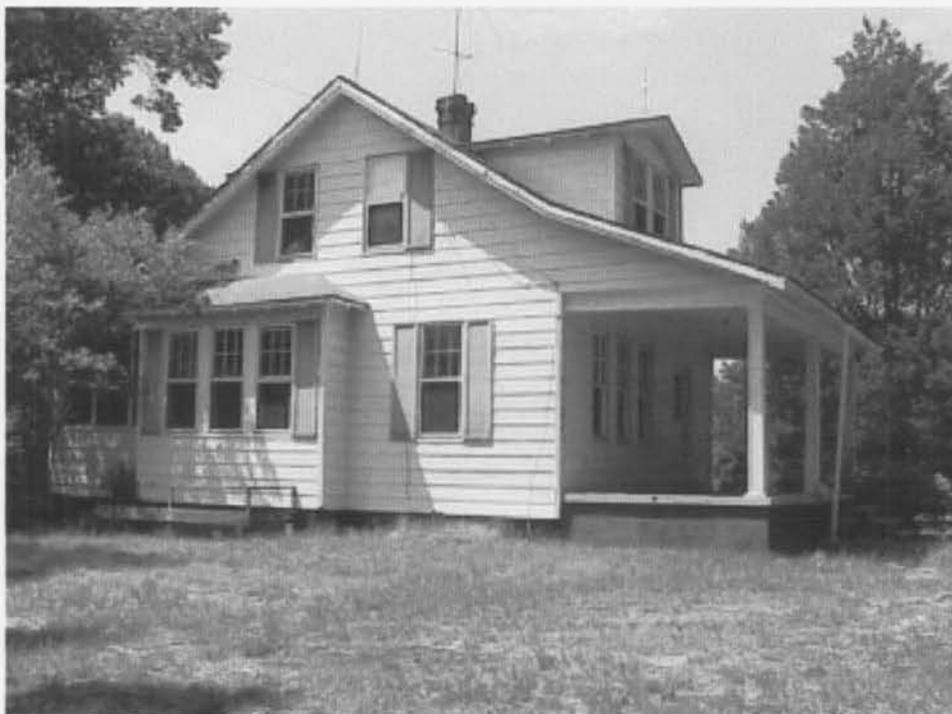
**PHOTOGRAPH 54**

This single-family dwelling (Photograph 54) is a representative example of the bungalow style. The house was constructed about 1930 and later covered in aluminum siding.

View looking northwest at dwelling - 4145 Hunting Creek Road (July 2001).

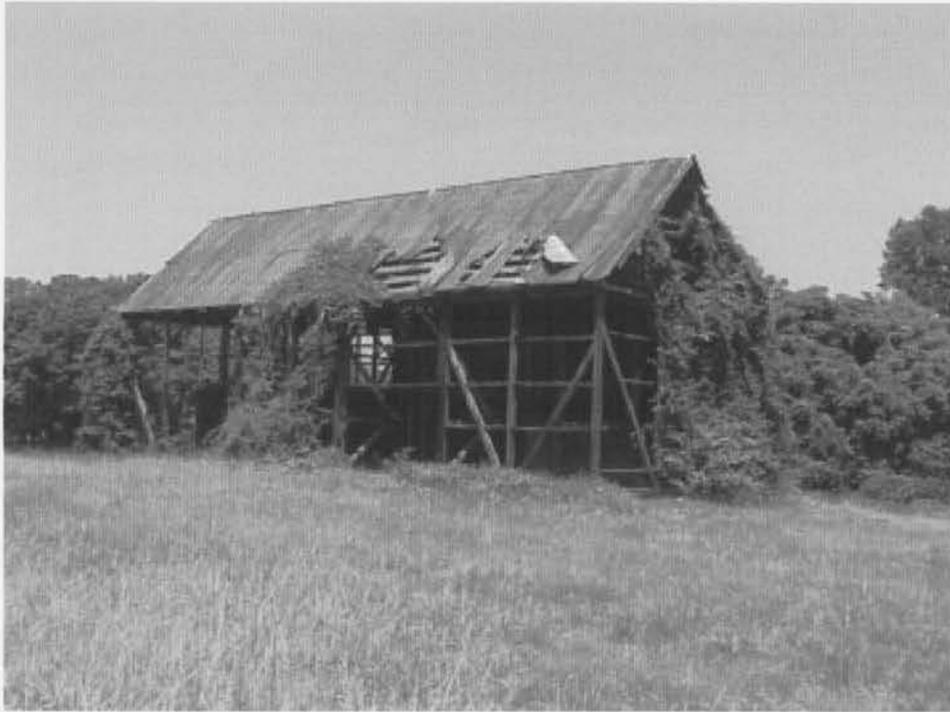
**PHOTOGRAPH 55**

The site contains one resource, the deteriorating remains of a once substantial barn (Photograph 55). Surviving elements suggest a mid to late nineteenth century construction date. The tin roof is deteriorating; exterior sheathing has been removed. There is no associated dwelling or ancillary structure.

View looking northeast at barn - 3070 Huntingtown Road (July 2001).

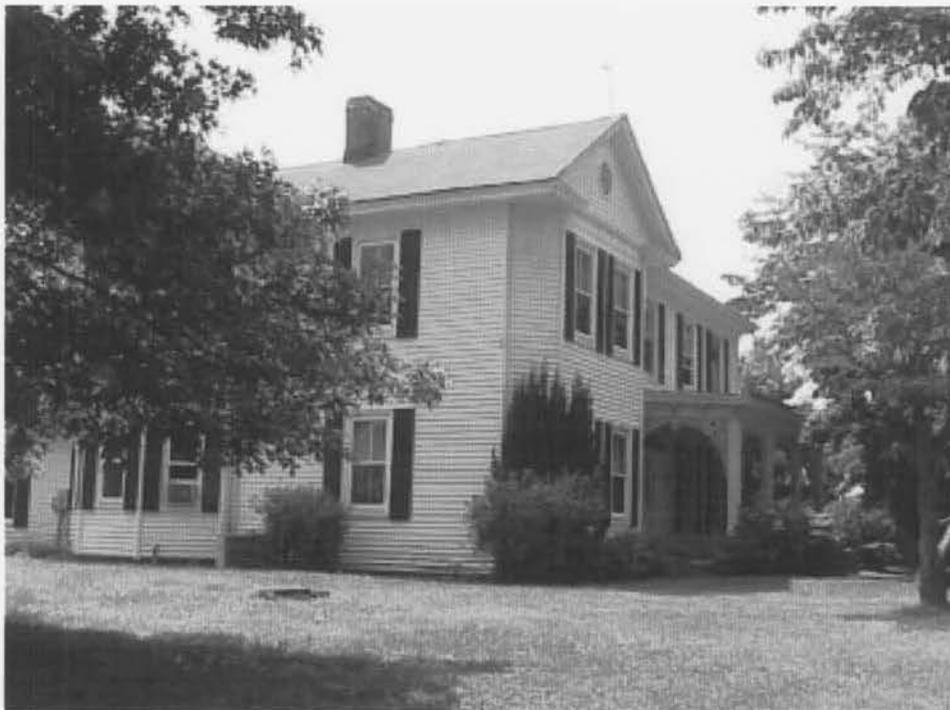
**PHOTOGRAPH 56**

This residential site includes a nineteenth century frame dwelling and a late twentieth century garage. The single-family house (Photograph 56) was constructed about 1840 and largely assumed its present size about

View looking southwest at dwelling - 4145 Huntingtown Road (July 2001).

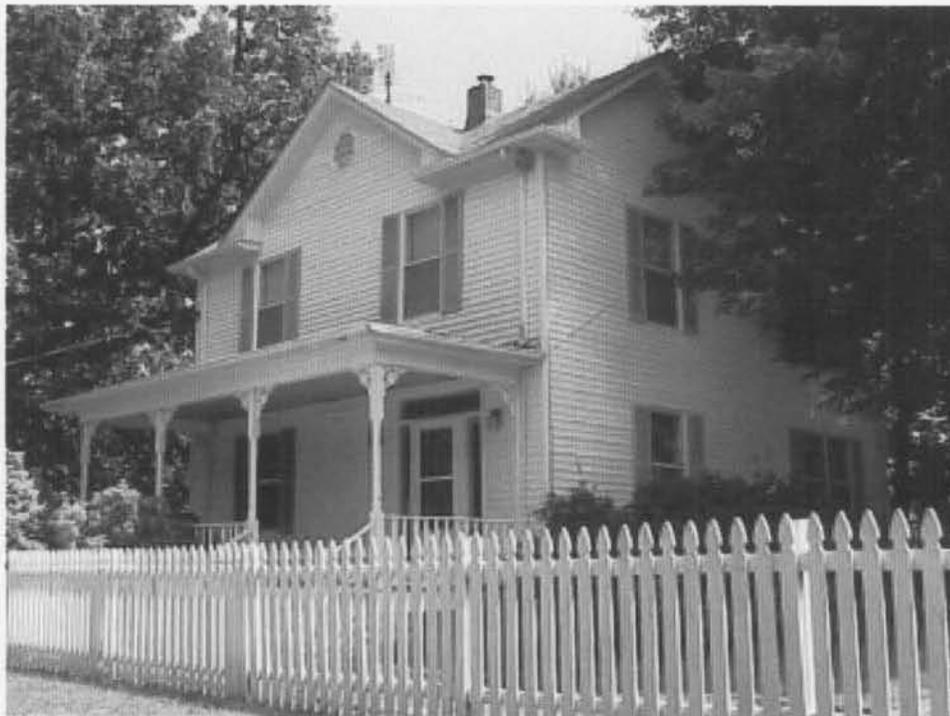
**PHOTOGRAPH 61**

The single-family dwelling (Photograph 61) sits atop a hilltop overlooking Huntingtown Road. The frame structure rises two and a half stories to a gabled roof with a peaked facade gable. Late twentieth century alterations, most prominently vinyl siding, aluminum cornice treatment, and vinyl windows, have compromised the structure's historic integrity. The three bay garage is gable roofed and stands west of the house.

View looking southeast at dwelling - 4245 Huntingtown Road (July 2001).

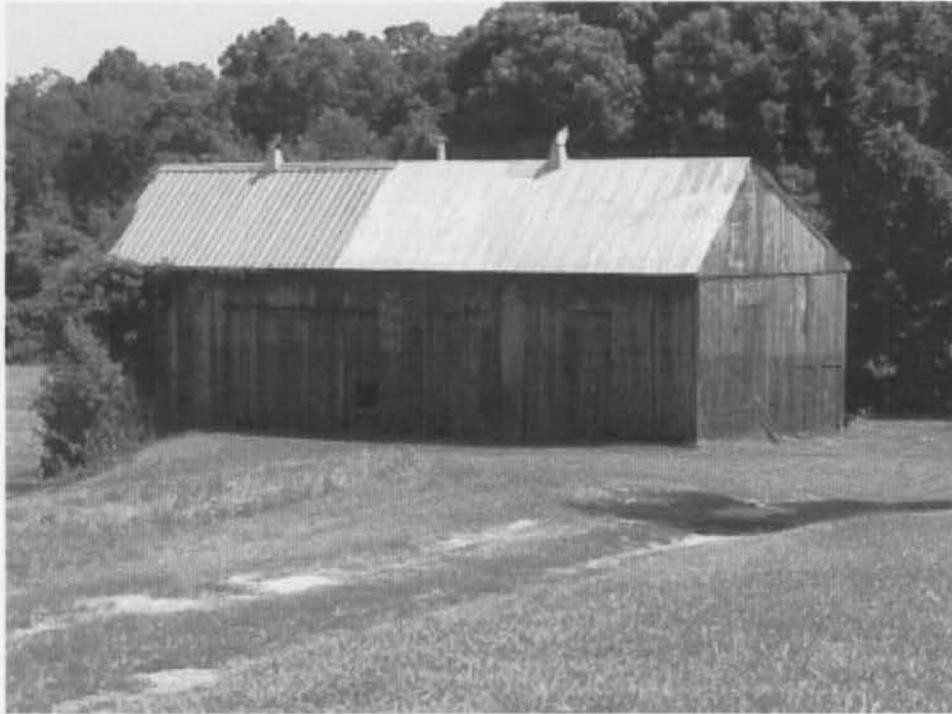
**PHOTOGRAPH 63**

This property contains a recently constructed single family dwelling (Photograph 62) and a frame barn (Photograph 63) which appears to date from the early twentieth century. The barn is simply detailed, sheathed in flush vertical board and covered by a tin gabled roof.

View looking southeast at barn - 4265 Huntingtown Road (July 2001).

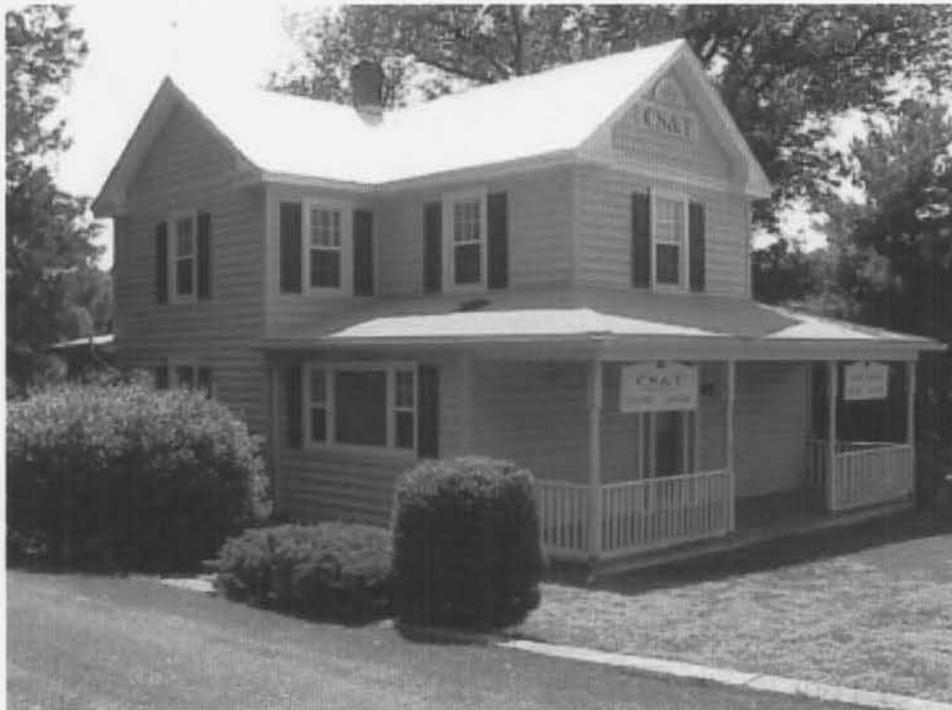
**PHOTOGRAPH 64**

- This site consists of a dwelling, now converted to commercial use, and a frame shed. The former residence (Photograph 64) is an example of a popular turn of the twentieth century house form; its integrity has been significantly compromised by late twentieth century alterations which include vinyl siding, vinyl windows, capped window surrounds, new shutters, and an aluminum covered cornice. The shed (Photograph 65) is contemporary with the house, is sheathed in board and batten siding and features a rear frame addition and carport.

View looking southwest at dwelling - 4275 Huntingtown Road (July 2001).

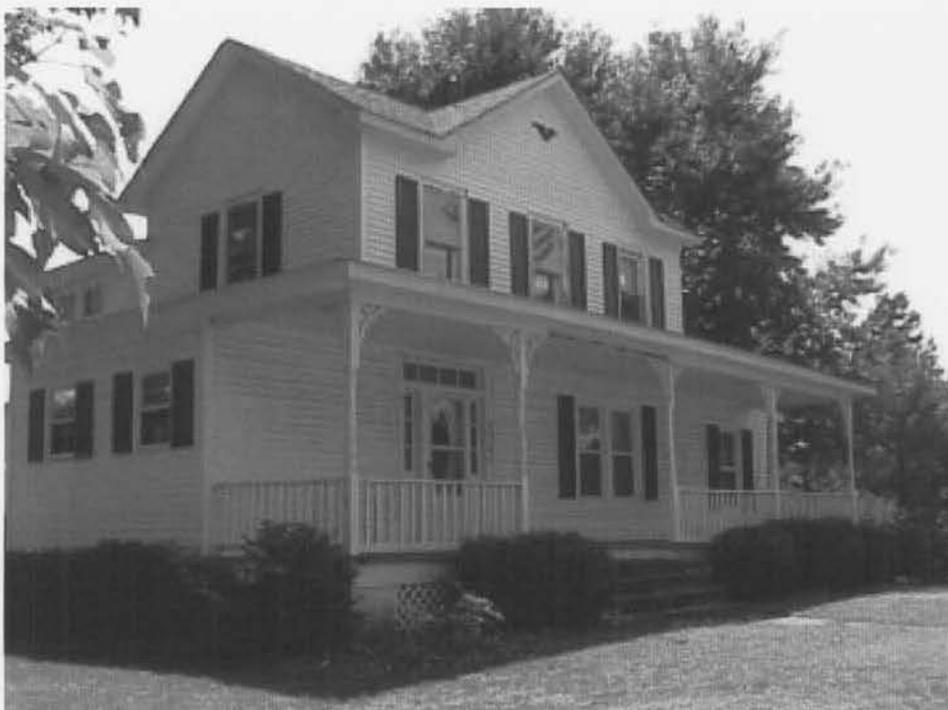
**PHOTOGRAPH 66**

This site includes a single-family dwelling and two sheds. The turn of the century house (Photograph 66) displays a cross gable roof and a front porch with turned posts and sawn wood brackets. Unsympathetic late twentieth century alterations, which include vinyl siding and vinyl windows, have hindered this resource's ability to appropriately convey its past. An early twentieth century garage (Photograph 67) and a larger late twentieth century metal shed stand to the rear of the house.

View looking southwest at dwelling - 4285 Huntingtown Road (July 2001).

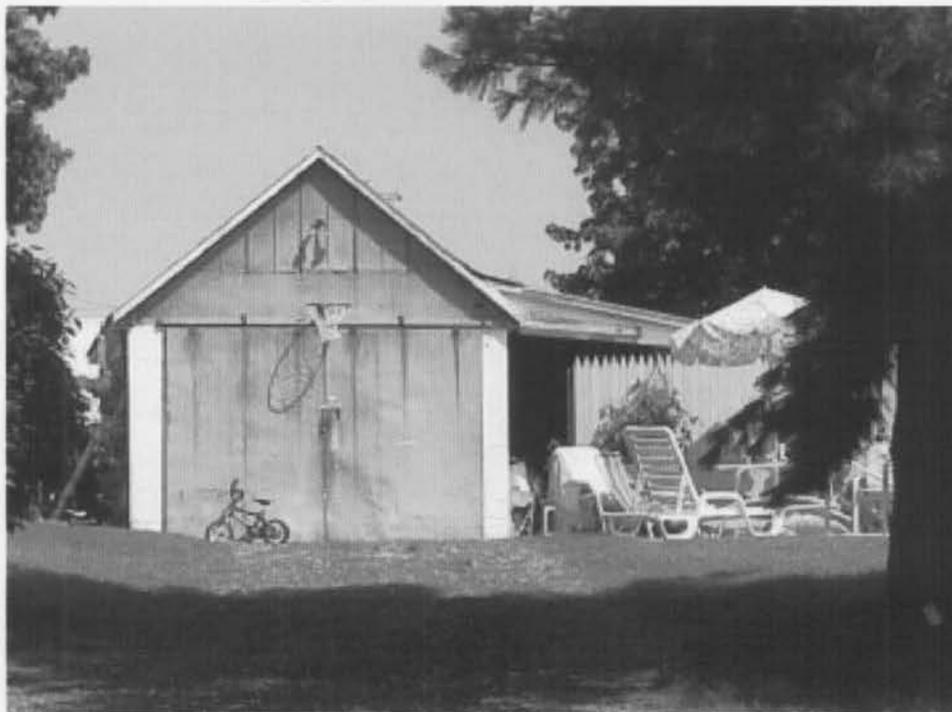
**PHOTOGRAPH 67**

View looking east at garage - 4285 Huntingtown Road (July 2001).

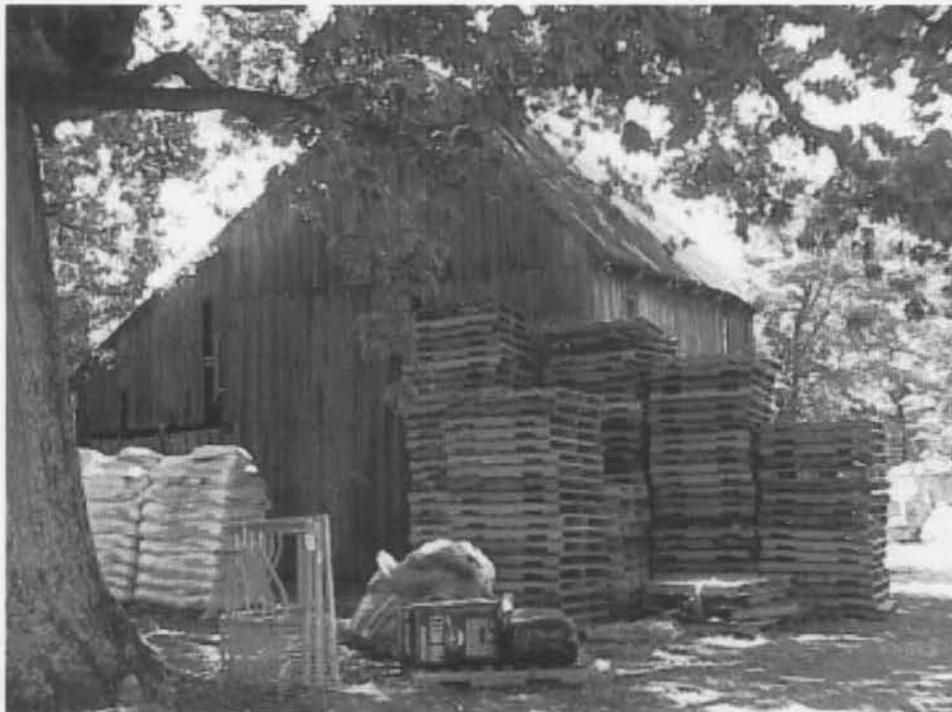
**PHOTOGRAPH 69**

This site is home to Hatcher Supply, purveyors of landscaping items, and contains three structures, a late twentieth century gabled store/office (Photograph 68), a smaller frame shed, and a deteriorating barn (Photograph 69). The frame shed is faced in tin and appears to date from the mid twentieth century. The barn's massing and detailing suggests an early twentieth century construction date.

View looking north at barn of Hatcher Supply - 140 Thanksgiving Lane (July 2001).

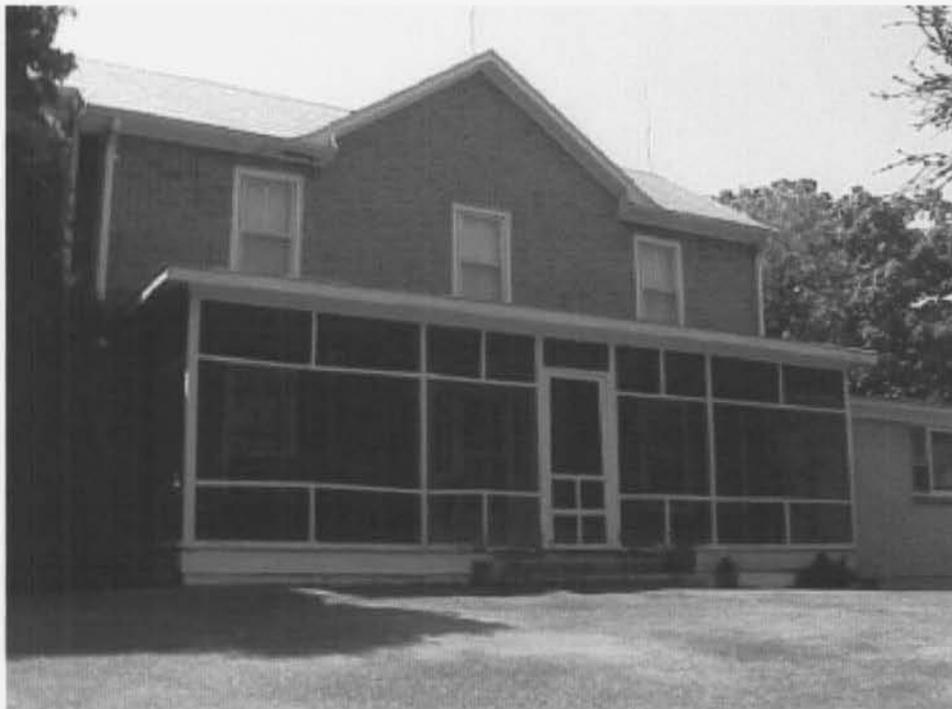
**PHOTOGRAPH 70**

— This site consists of a frame century dwelling and two frame sheds, all of which appear to date from the mid to late nineteenth century. The dwelling (Photograph 70) is rectangular shaped and rises two and a half stories to a cross-gabled roof; exterior elevations are covered in asphalt siding. The porch likely replaced an earlier porch of similar dimensions. A deteriorating gabled shed (Photograph 71), which appears to date from the late nineteenth or early twentieth century, and a late twentieth century gabled shed stand to the rear of the house.

View looking northwest at dwelling - 120 Thanksgiving Lane (July 2001).

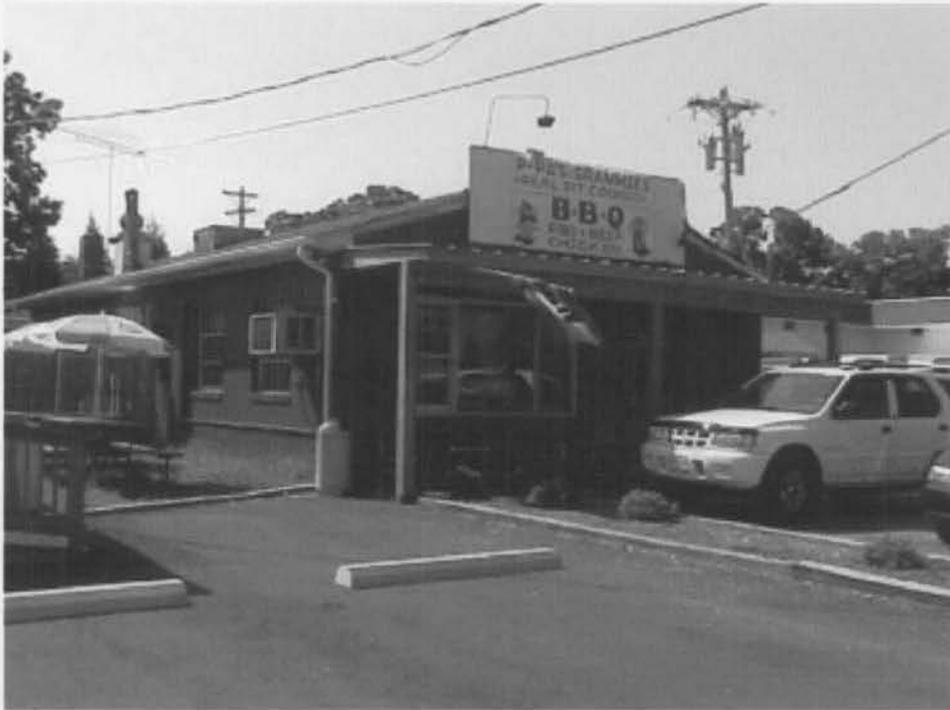
**PHOTOGRAPH 73**

This site contains a one story building (Photograph 73) which is an undistinguished example of mid-twentieth century commercial design. The main block is constructed of cast concrete block and is gable roofed. The front porch dates from the latter part of the twentieth century.

View looking northwest at P-Pa's & Grammie's Real Pit Cooked BBQ - 3930 Old Town Road (July 2001).

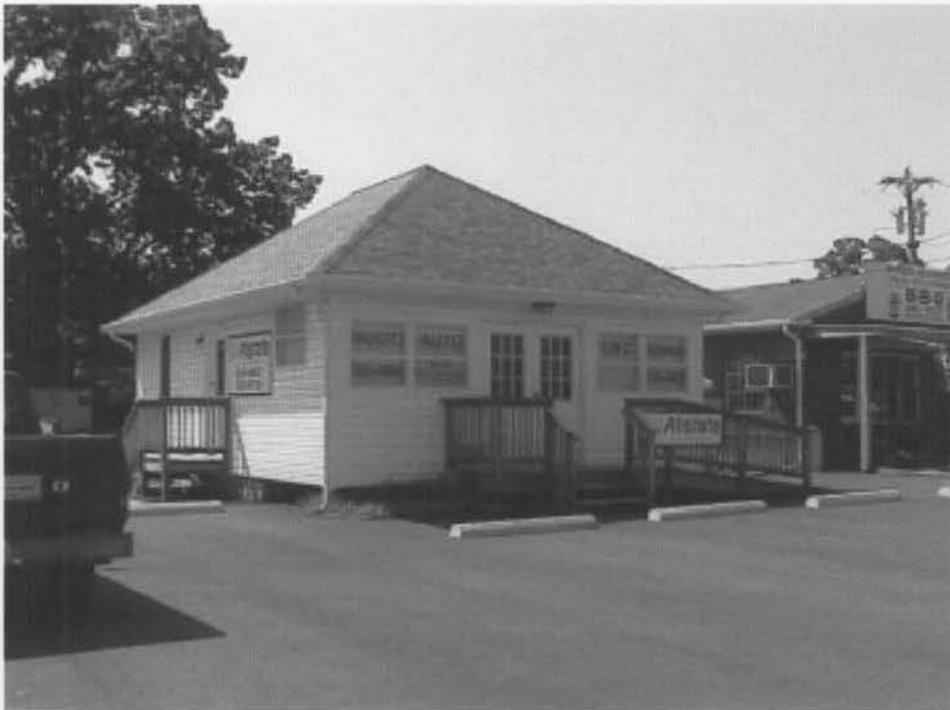
**PHOTOGRAPH 74**

- A single story building occupies this site. The frame structure (Photograph 74) assumed its present appearance in the later part of the twentieth century. The outline of a cast stone foundation suggests the dimensions of the original structure, whose appearance is unknown.

View looking northwest at Allstate Insurance - 3920 Old Town Road (July 2001).
