CAPSULE SUMMARY
CT-1361
Blankenship House
7041 Briscoe Turn Road
Owings, Calvert County, Maryland
1924
Private

Maryland Historical Trust Maryland Inventory of Historic Properties Form

Inventory No. CT-1361

Name Blankenship House
Continuation Sheet

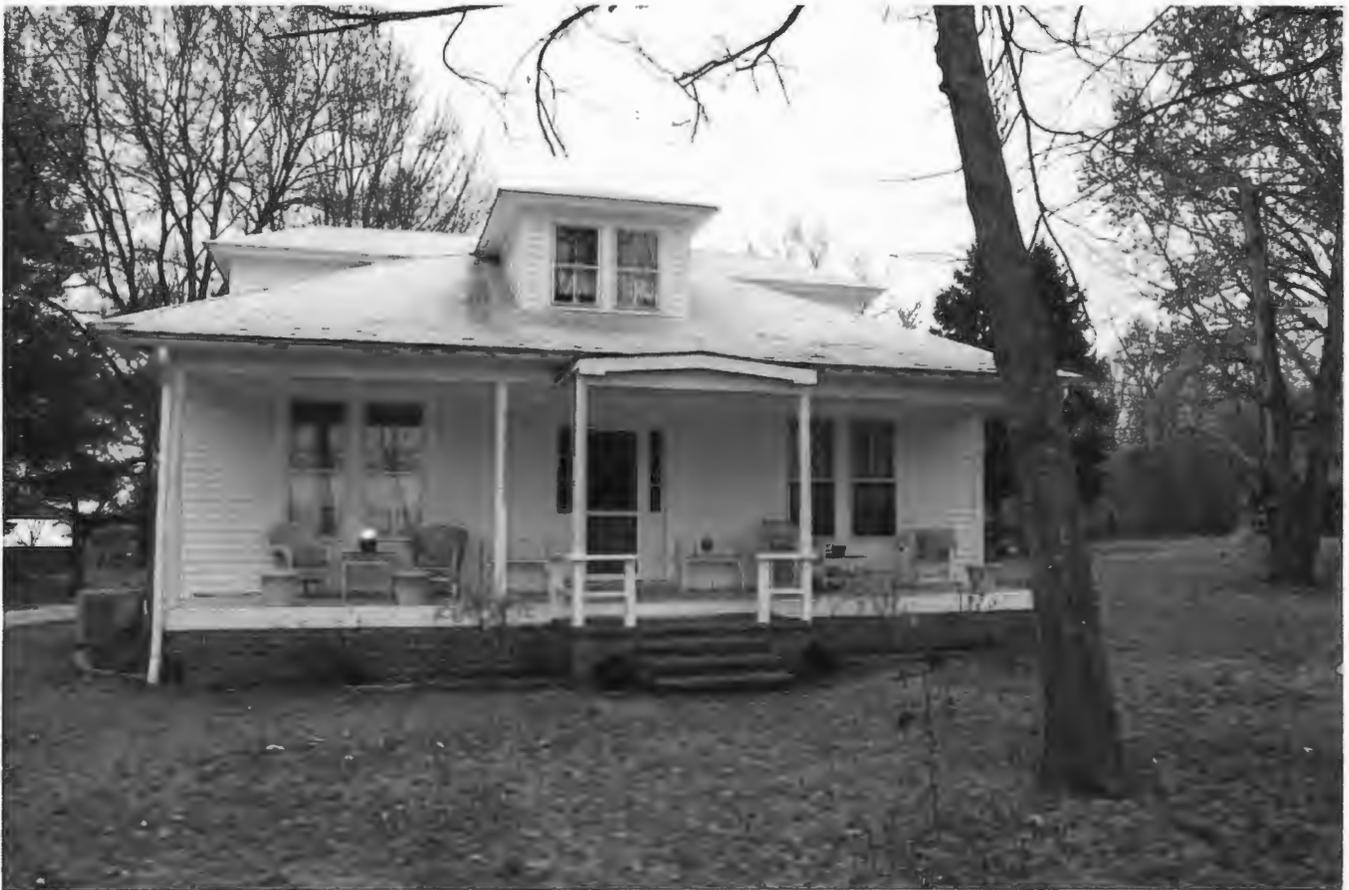
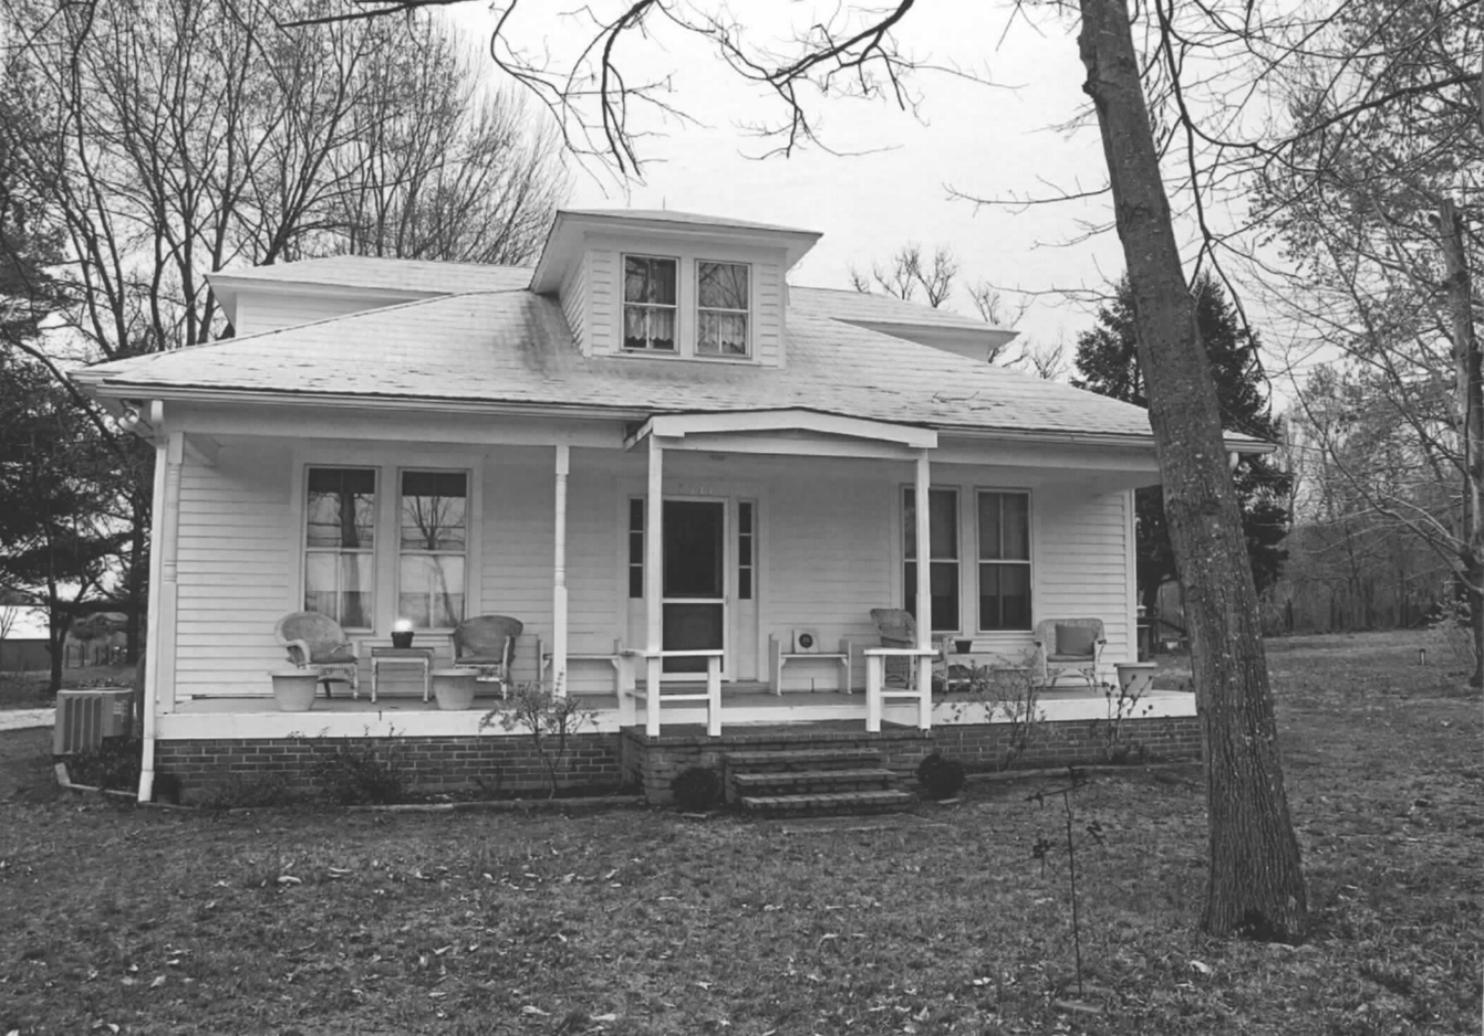
The Blankenship House consists of a one-and-one-half-story Colonial Revival-style dwelling constructed in 1924 (Photograph 1). The dwelling sits atop a full concrete block foundation, which features evenly spaced single-light, awning-sash windows. The exterior walls of the dwelling are clad in white-painted clapboard siding. A hipped roof sheathed in pressed tin shingles caps the dwelling. Hipped-roof dormers pierce each of the roof slopes. A central interior brick chimney extends from the central roof peak. The dwelling is lit by two-over-two, double-hung, wood-sash windows, except where noted.

The northwest elevation (façade) measures three-bays wide. A one-story porch extends the full width of the façade (Photographs 1 and 2). The porch roof is integral to the hipped roof of the main dwelling. The porch retains its original wood floor, although the brick foundation has been repointed and the four evenly spaced turned spindle wood posts were recently replaced. The porch features a central brick landing that extends approximately one-bay outward from the porch itself. Three brick steps lead to the landing, which is sheltered by an asphalt shingle-clad low-pitched gable roof supported by two wood posts. A simple wood railing sits atop the landing. The landing leads to the main entry into the dwelling, which occupies the center bay. The entry consists of a single-leaf, one-light over wood panel door flanked by three-light over one-panel sidelights. The entry is set into a simple classical wood surround. A set of paired typical windows occupies the northern and southern bays of the first story. The central dormer features an additional set of paired typical windows.

Photograph 1: Blankenship House, northwest elevation, view looking southeast. March 2012.

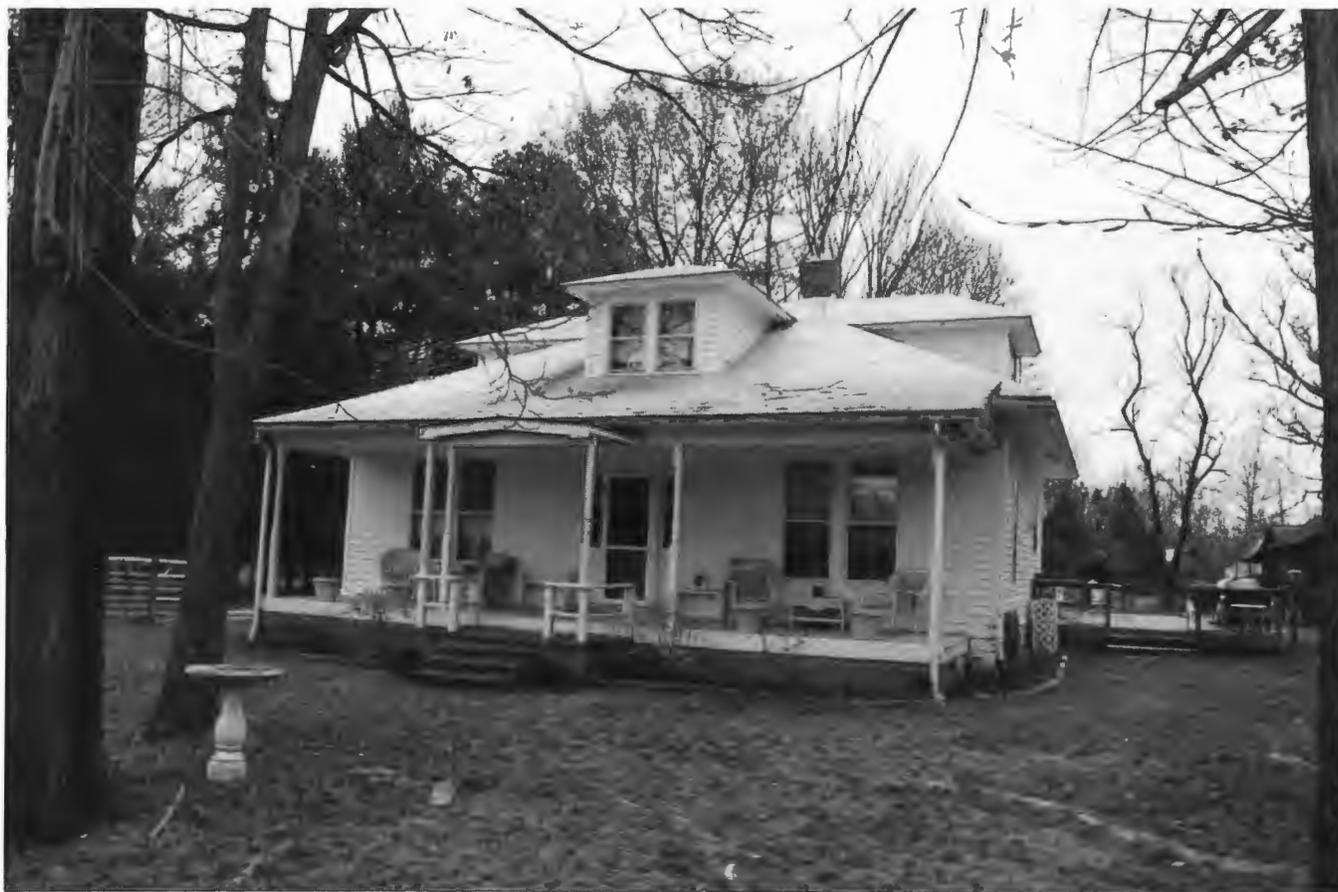
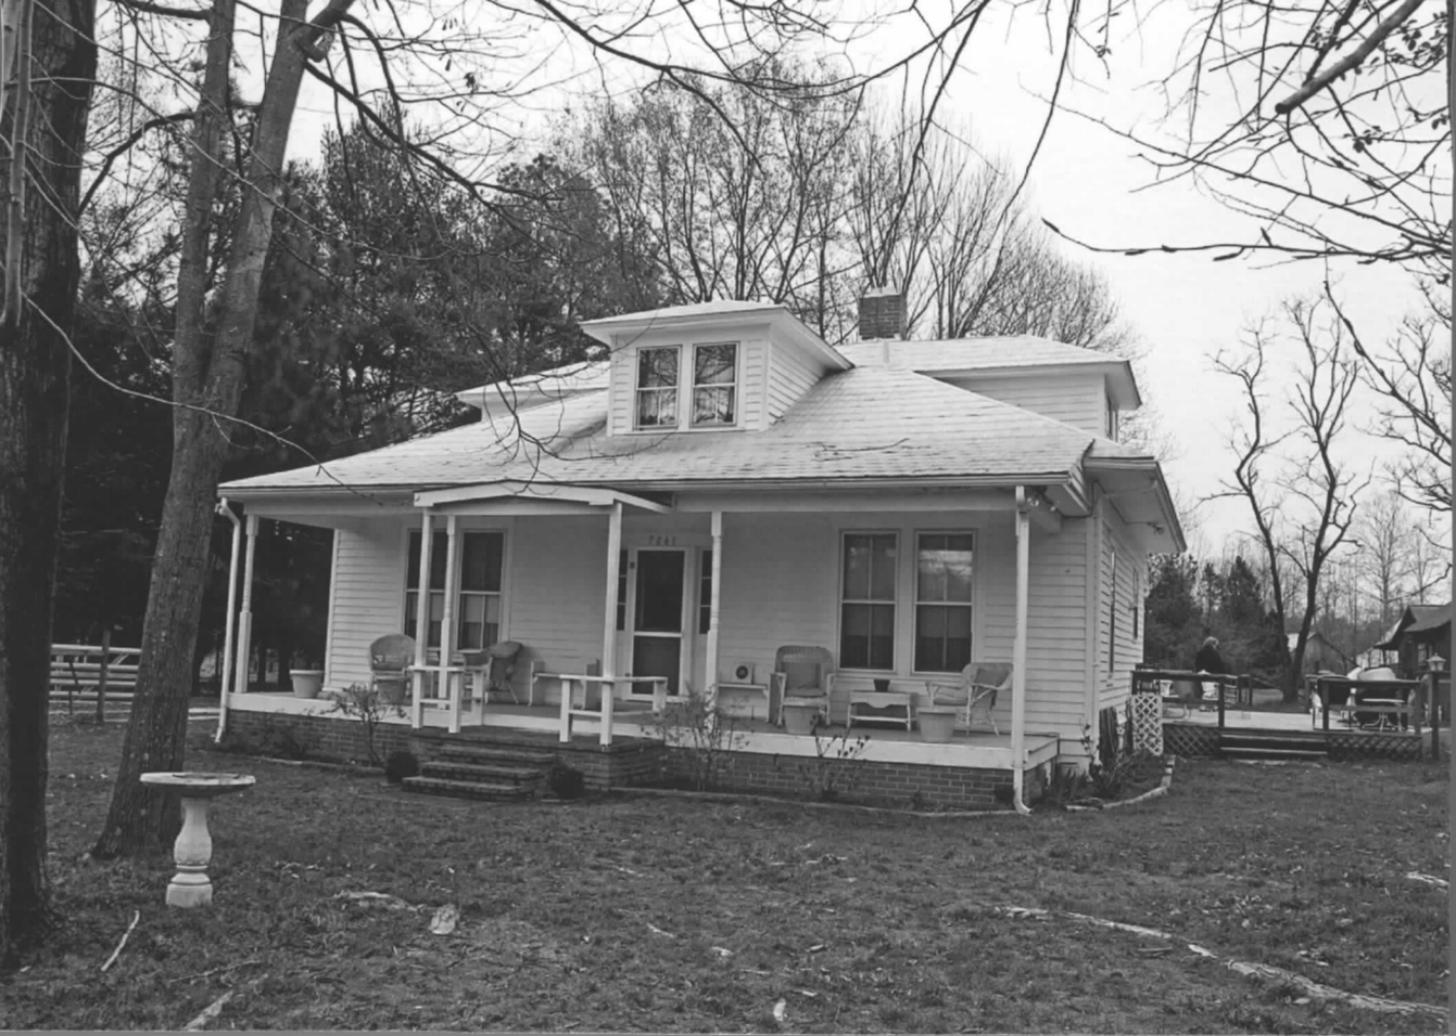
Photograph 2: Blankenship House, northwest elevation, view looking east. March 2012.

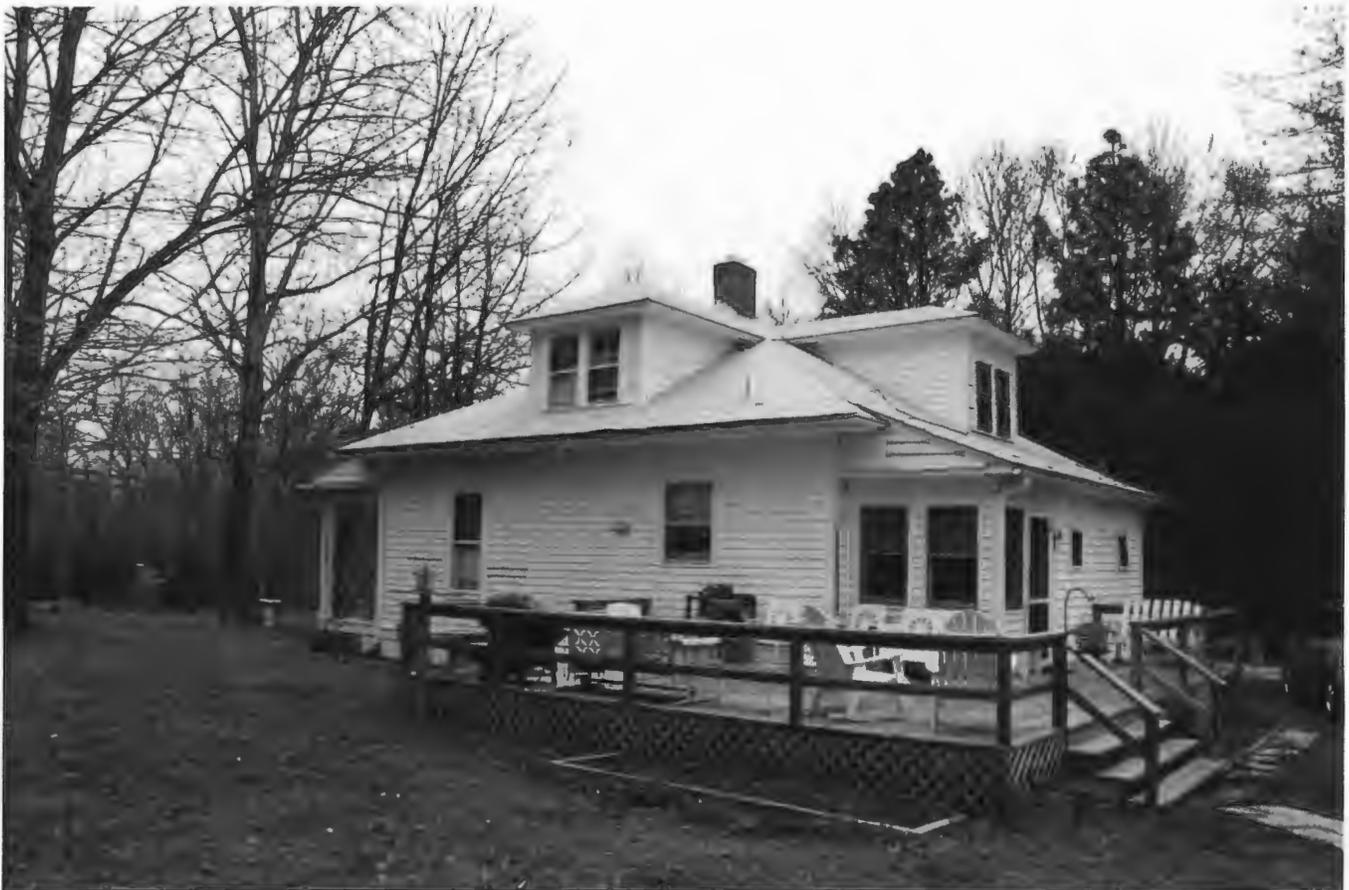
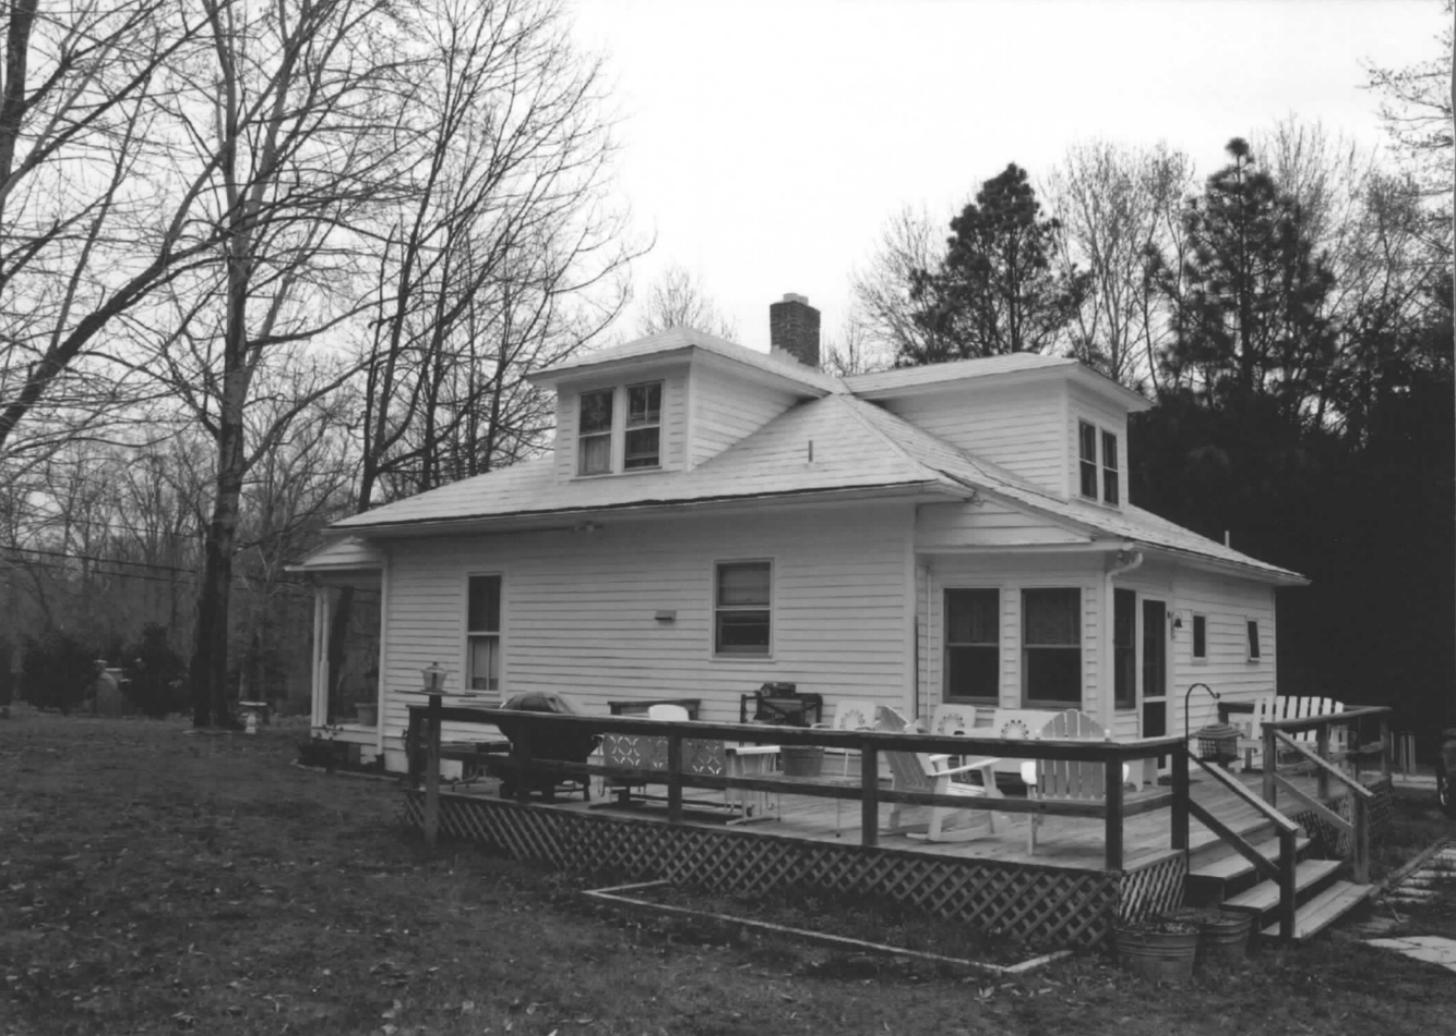
The southwest elevation of the Blankenship House contains two evenly spaced bays (Photograph 3). The westernmost bay contains a typical window, whereas the southernmost bay is inset with a one-over-one light, double-hung, wood-sash window. Two one-over-one light, double-hung, wood-sash windows are situated in the rear enclosed porch addition. The central dormer features a set of paired typical windows.

Photograph 3: Blankenship House, southwest elevation, view looking north. March 2012.

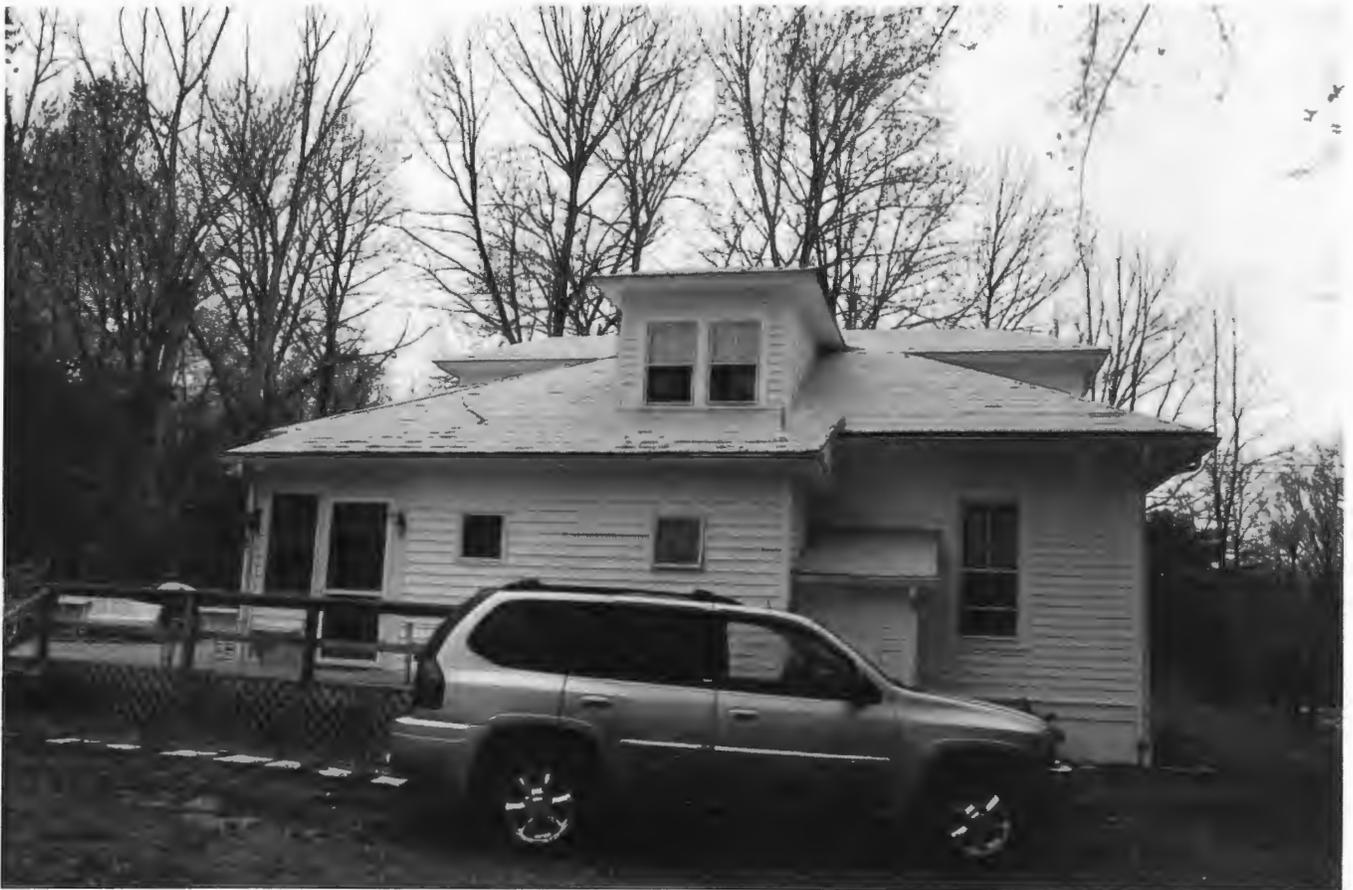
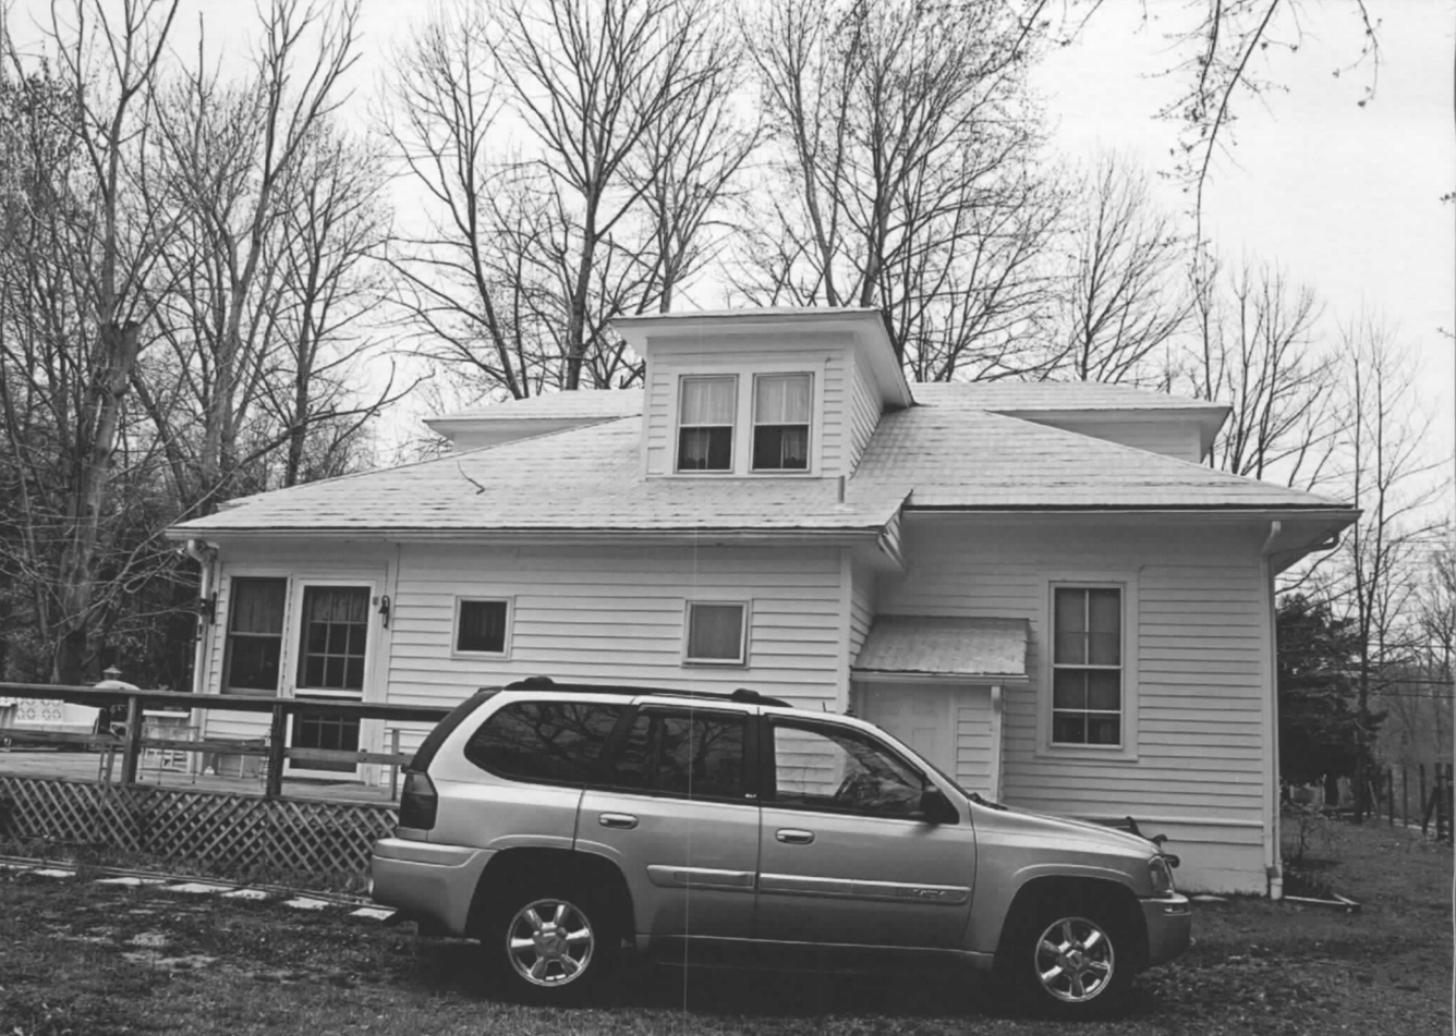
The rear (southeast) elevation contains a wood deck, added in 2005, at the south corner (Photograph 4). The deck leads to a rear porch addition, enclosed in the 1950s, that occupies the south corner of the elevation.¹ A secondary entry consisting of a single-leaf, 15-light door is situated near the south end of the porch addition. A single one-over-one light, double-hung, wood-sash window is located to the south (left). Two smaller, single-light, awning-sash windows occupy the remaining openings in the rear porch addition, to the north (right) of the

secondary entry. A small one-story, one-bay, shed-roof addition, which provides exterior access to the basement, appends the north elevation of the rear porch addition. A single-leaf, wood-paneled door in the southeast elevation provides the only opening. A typical window occupies the northernmost bay of the southeast elevation of the main dwelling. The central dormer above features a set of paired typical windows.

Photograph 4: Blankenship House, southeast elevation, view looking west. March 2012.

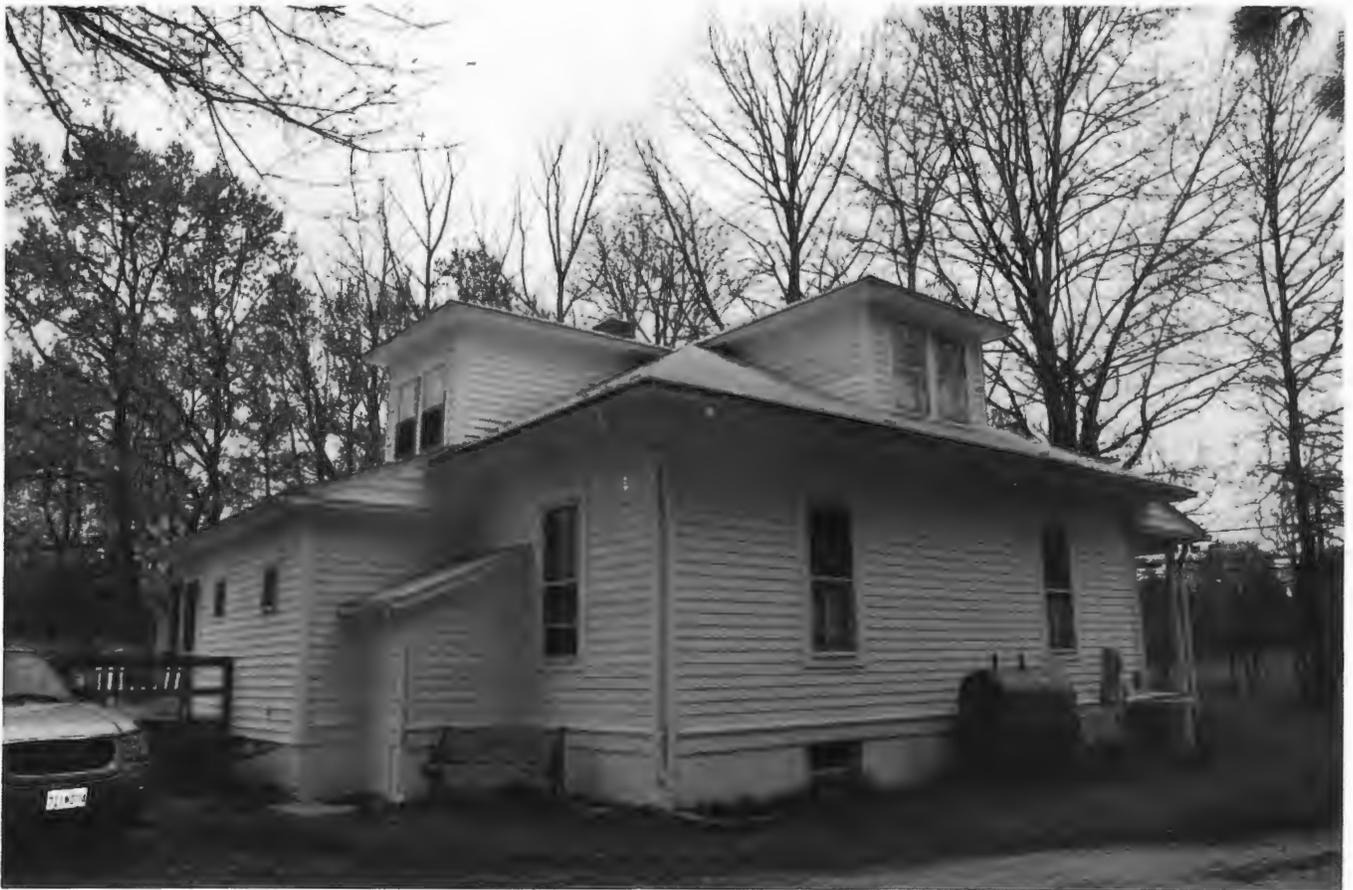
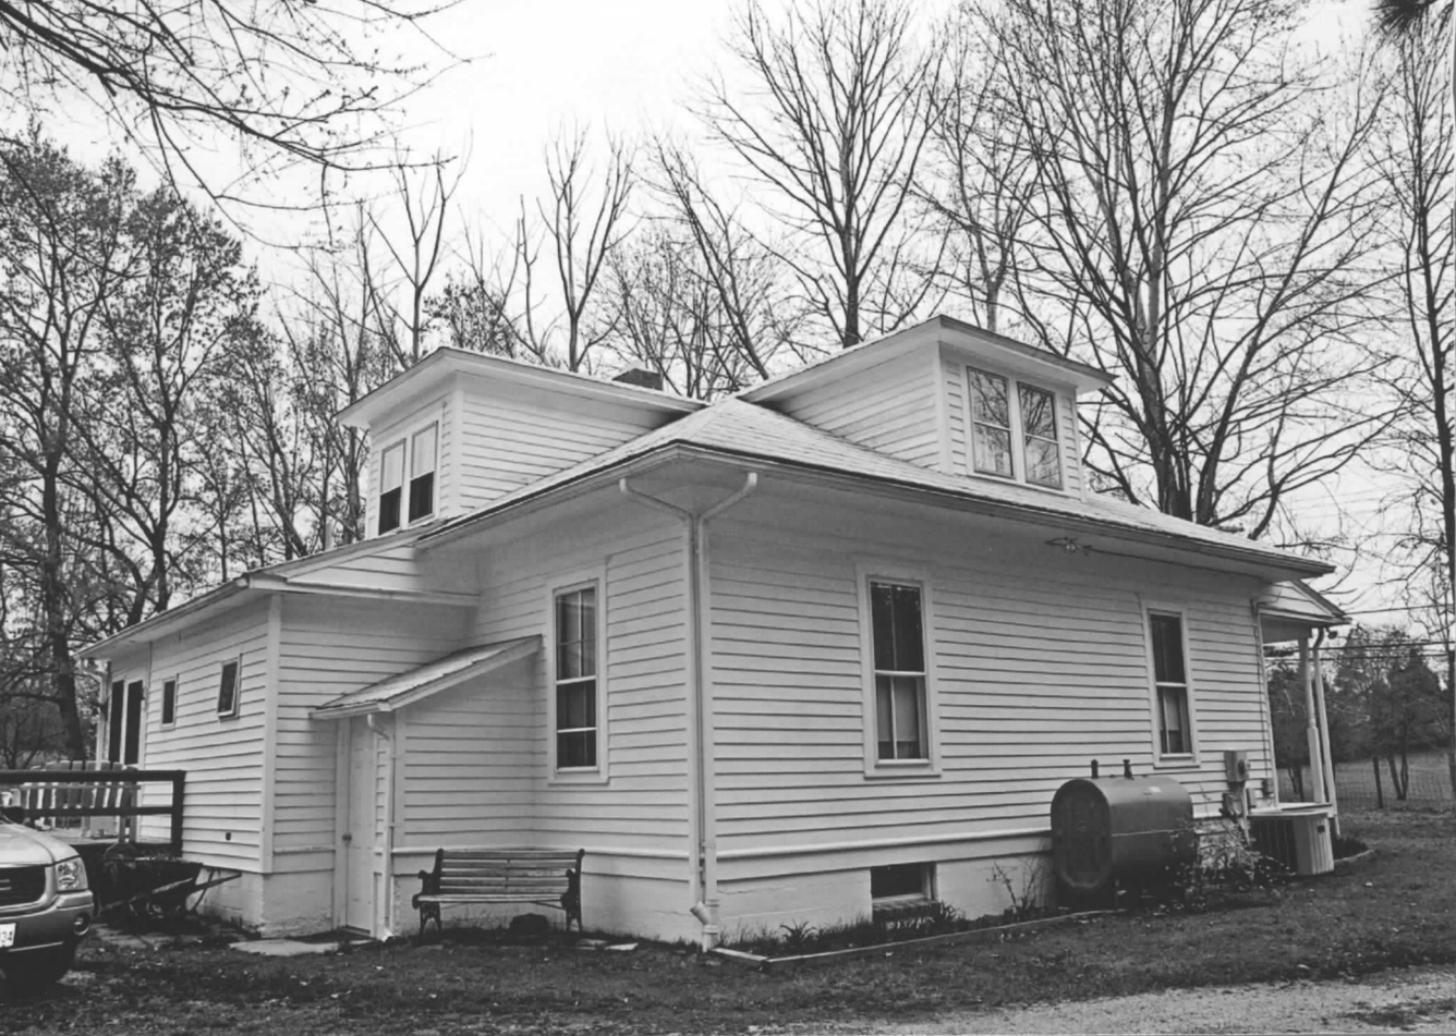
The northeast elevation contains two evenly spaced single typical windows in the first story. The central dormer features a set of paired typical windows (Photograph 5).

Overall, the dwelling, which continues to serve as a single-family dwelling, is in good condition.

Photograph 5: Blankenship House, southeast and northeast elevations, view looking west. March 2012.

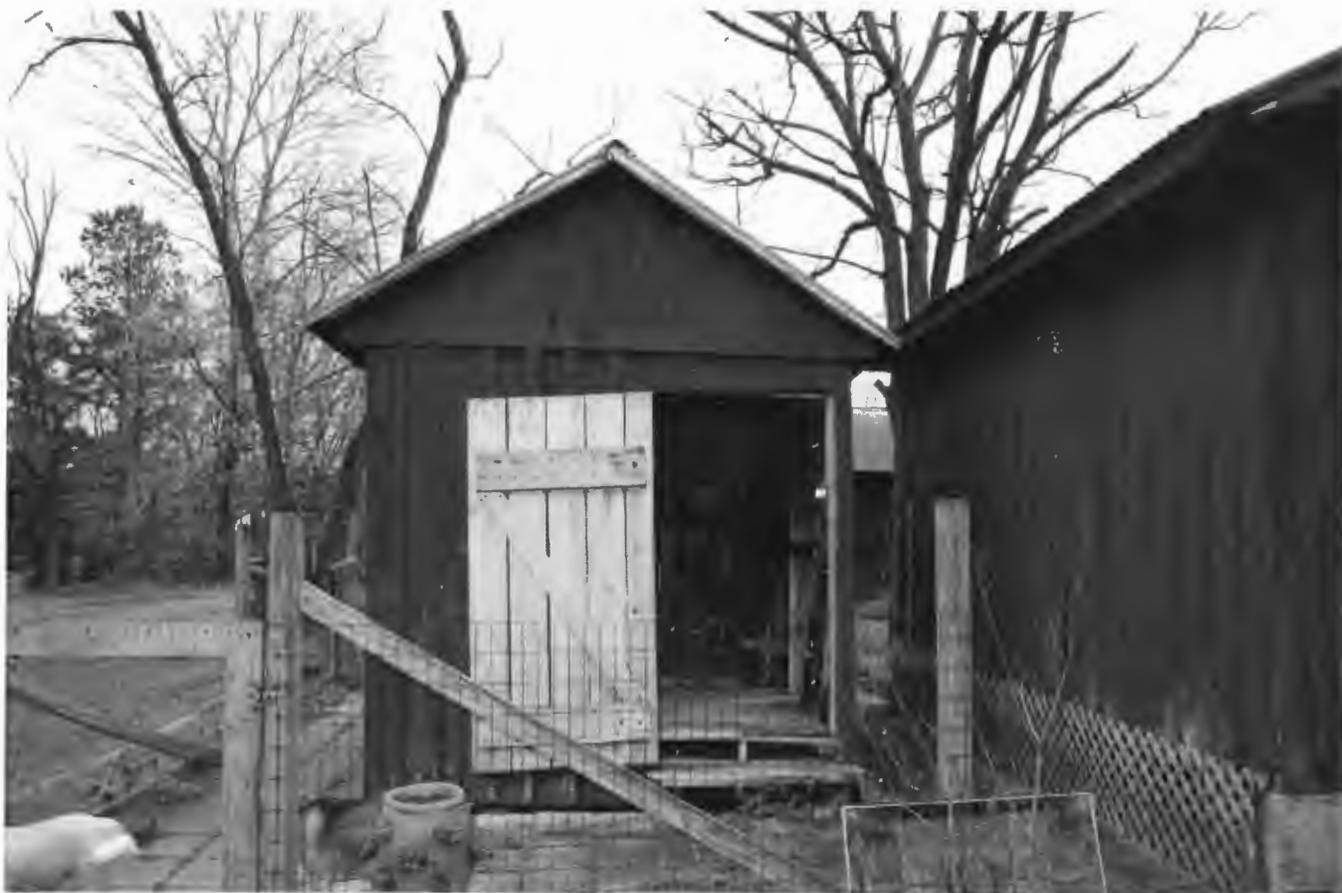
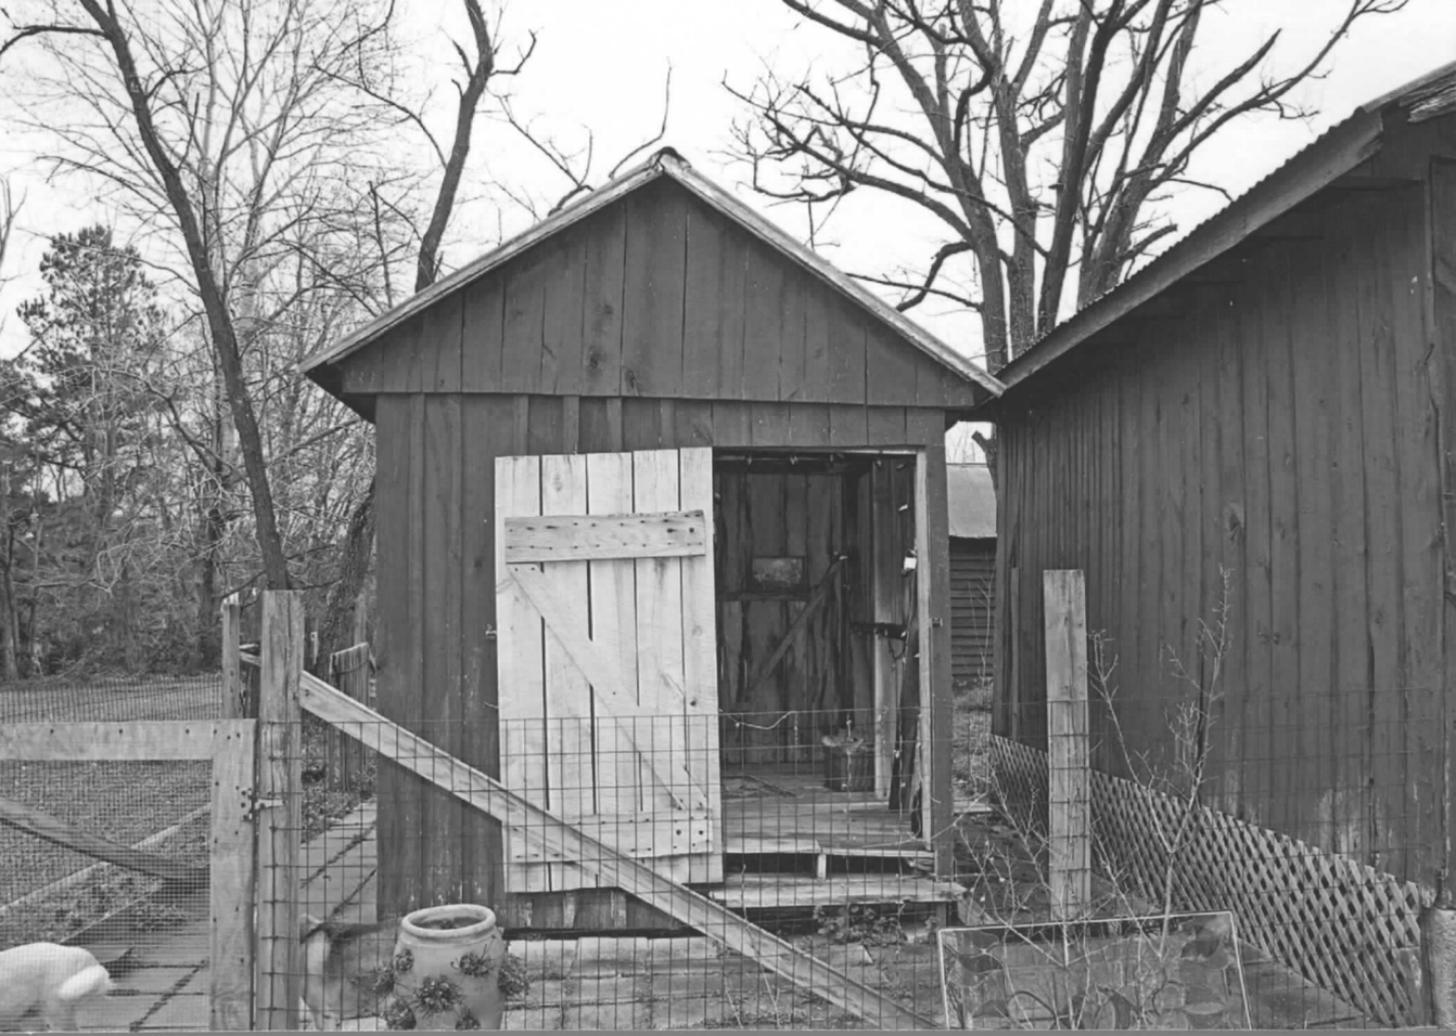
A small one-story ca.-1931 frame shed is located to the southeast of the dwelling (Photograph 6). The shed lacks a foundation, and board-and-batten siding comprises the exterior walls. The gable-front roof is covered in corrugated metal. A single-leaf door, attached with metal strap hinges, provides the only opening, which is located in the northwest elevation. Overall, the shed, which is used for storage, is in good condition.

Photograph 6: Blankenship House, shed, west elevation, view looking east. March 2012.

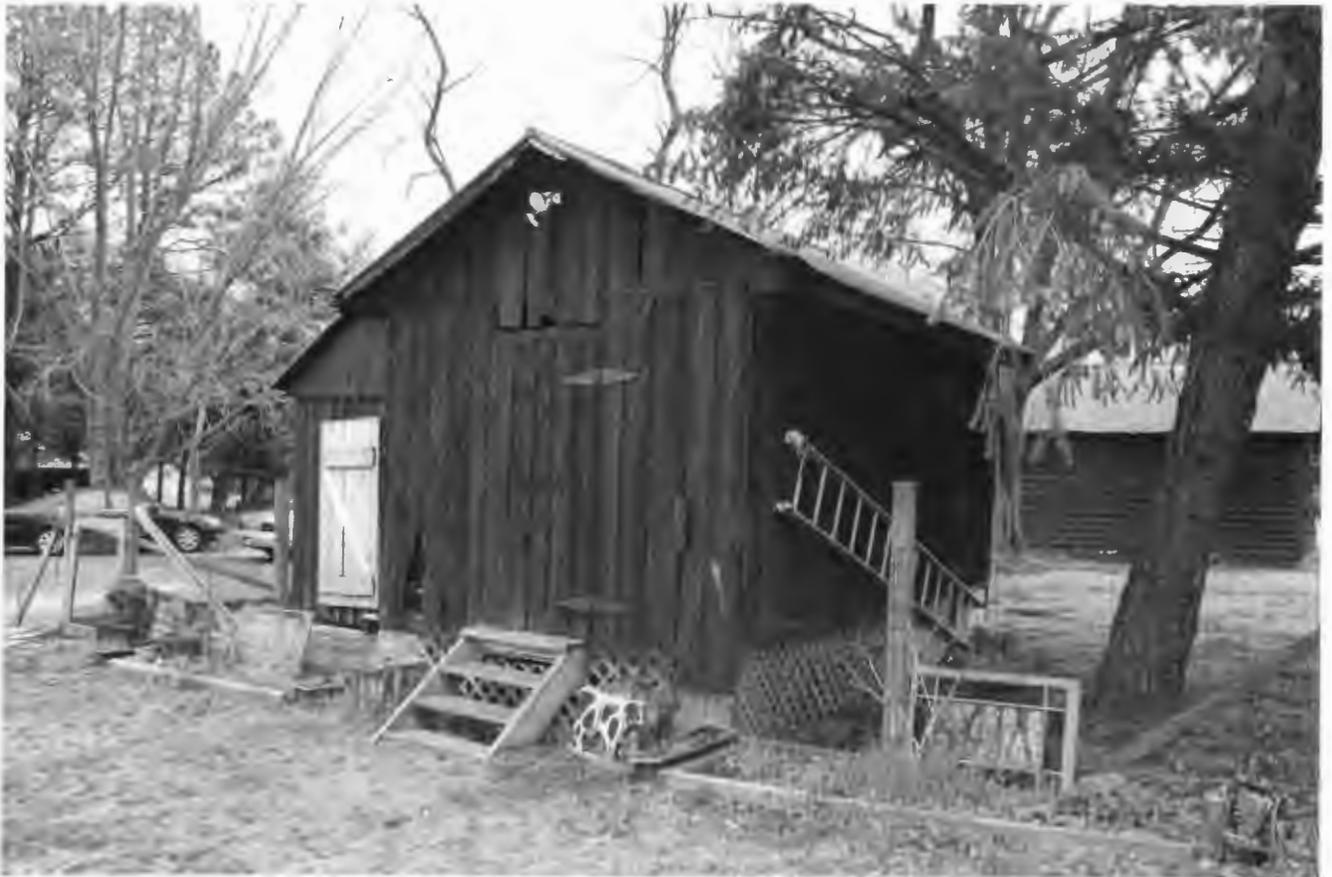
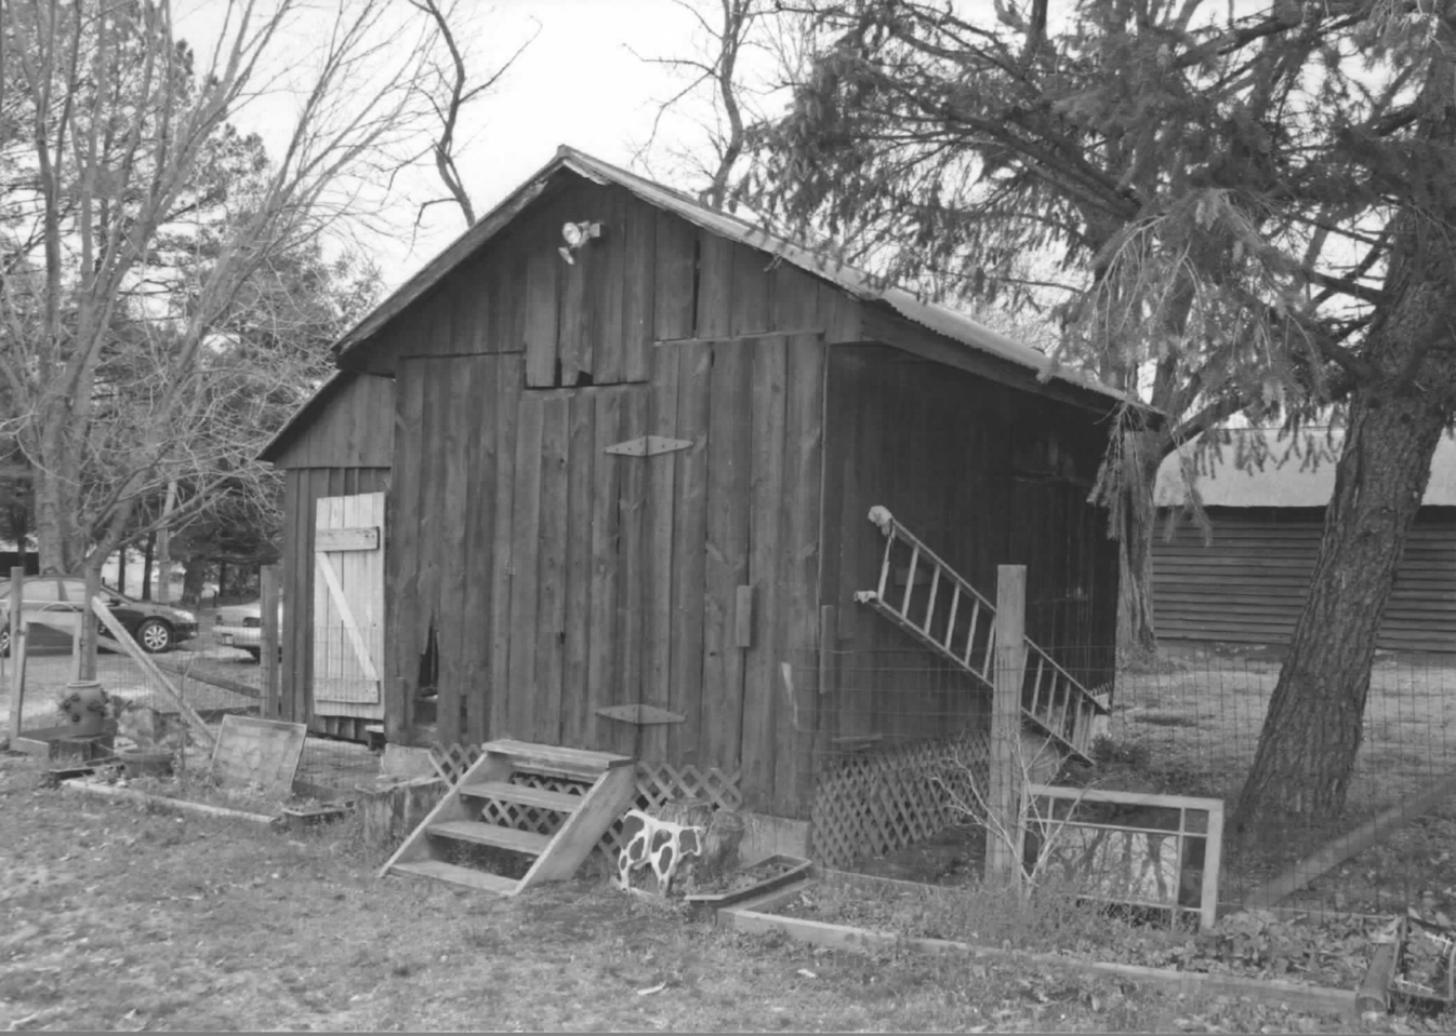
A small one-story, ca.-1931 corncrib is situated immediately to the south of the shed (Photograph 7). The corncrib sits atop concrete block piers. Board-and-batten siding comprises its exterior walls, except at the rear elevation, which consists of the open vertical slats necessary for drying corn. A gable-front roof, sheathed in corrugated metal, caps the building. Four wooden steps lead to a single-leaf door, attached with metal strap hinges, situated in the northwest elevation that provides the only access into the interior. The corncrib, which is currently used for storage, is in good condition.

Photograph 7: Blankenship House, corncrib, west elevation, view looking east. March 2012.
