CAPSULE SUMMARY
CT-1361
Blankenship House
7041 Briscoe Turn Road
Owings, Calvert County, Maryland
1924
Private

Maryland Historical Trust Maryland Inventory of Historic Properties Form

Inventory No. CT-1361

Name Blankenship House
Continuation Sheet

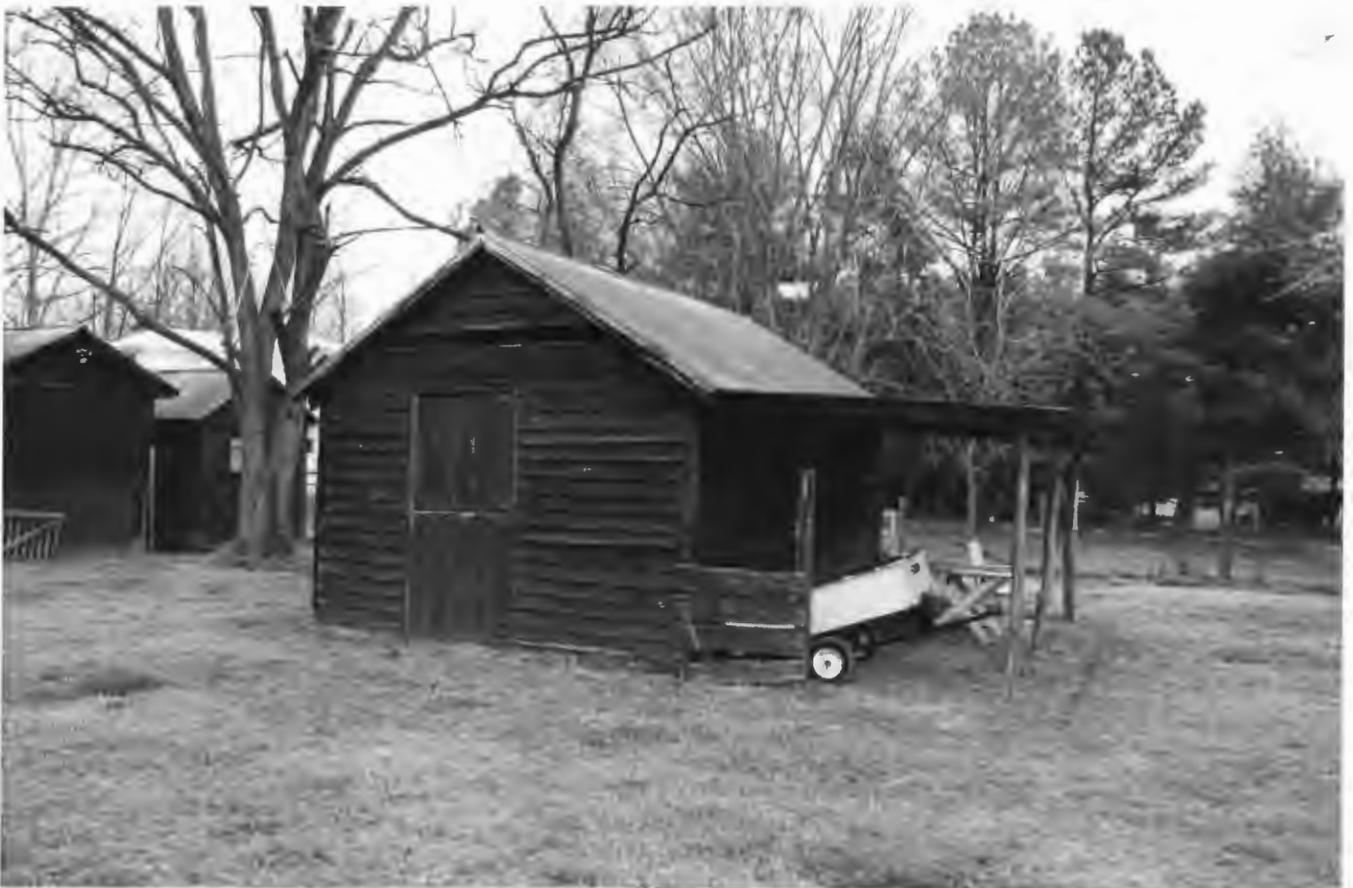
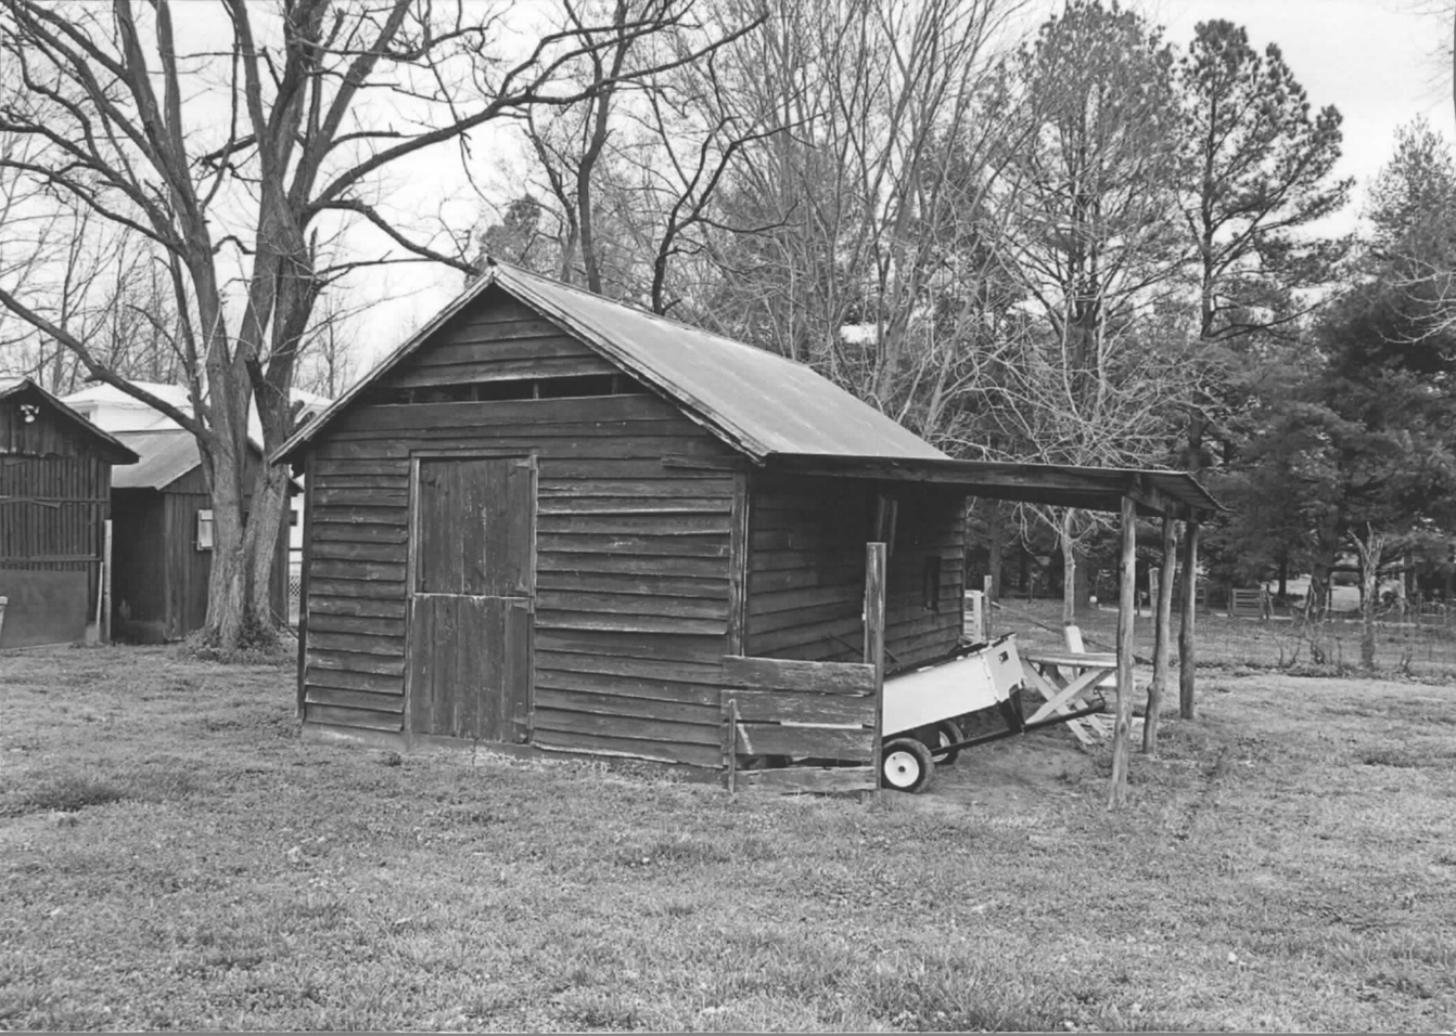
A one-story, ca.-1931 animal shed is located within the center of a large fenced-in area to the southeast of the outbuildings (Photograph 8). The animal shed consists of a poured concrete foundation, horizontal wood siding, and a gable-front roof clad in corrugated metal. The date "1931" is written in the northeast threshold. Three roughly hewn logs support a lean-to that extends from the southeast elevation. A set of Dutch-style doors, attached with metal strap hinges, are located in the northeast and southwest elevations. The animal shed, currently used for storage, is in good condition.

Photograph 8: Blankenship House, animal shed, southwest and southeast elevations, view looking north. March 2012.

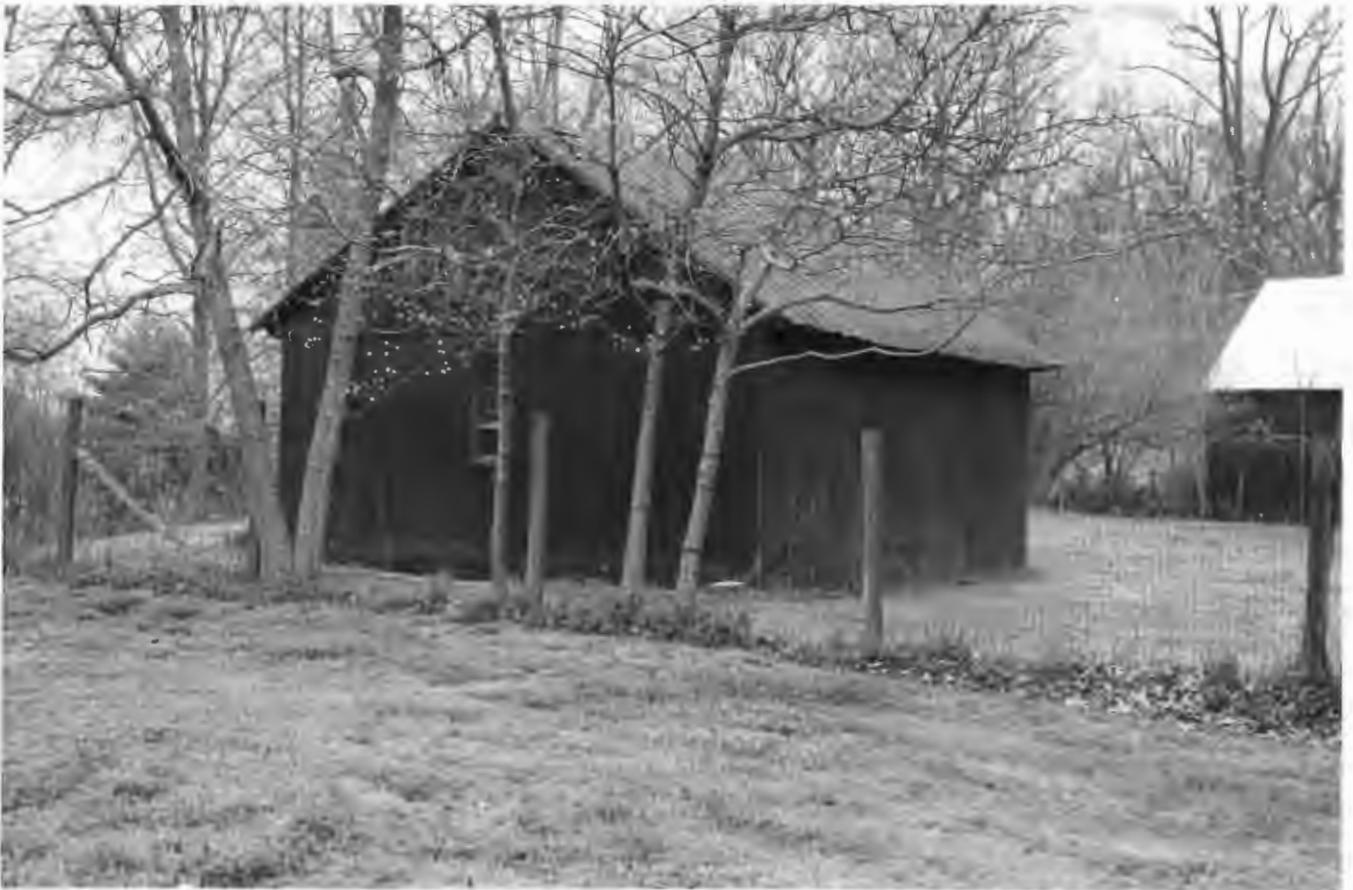
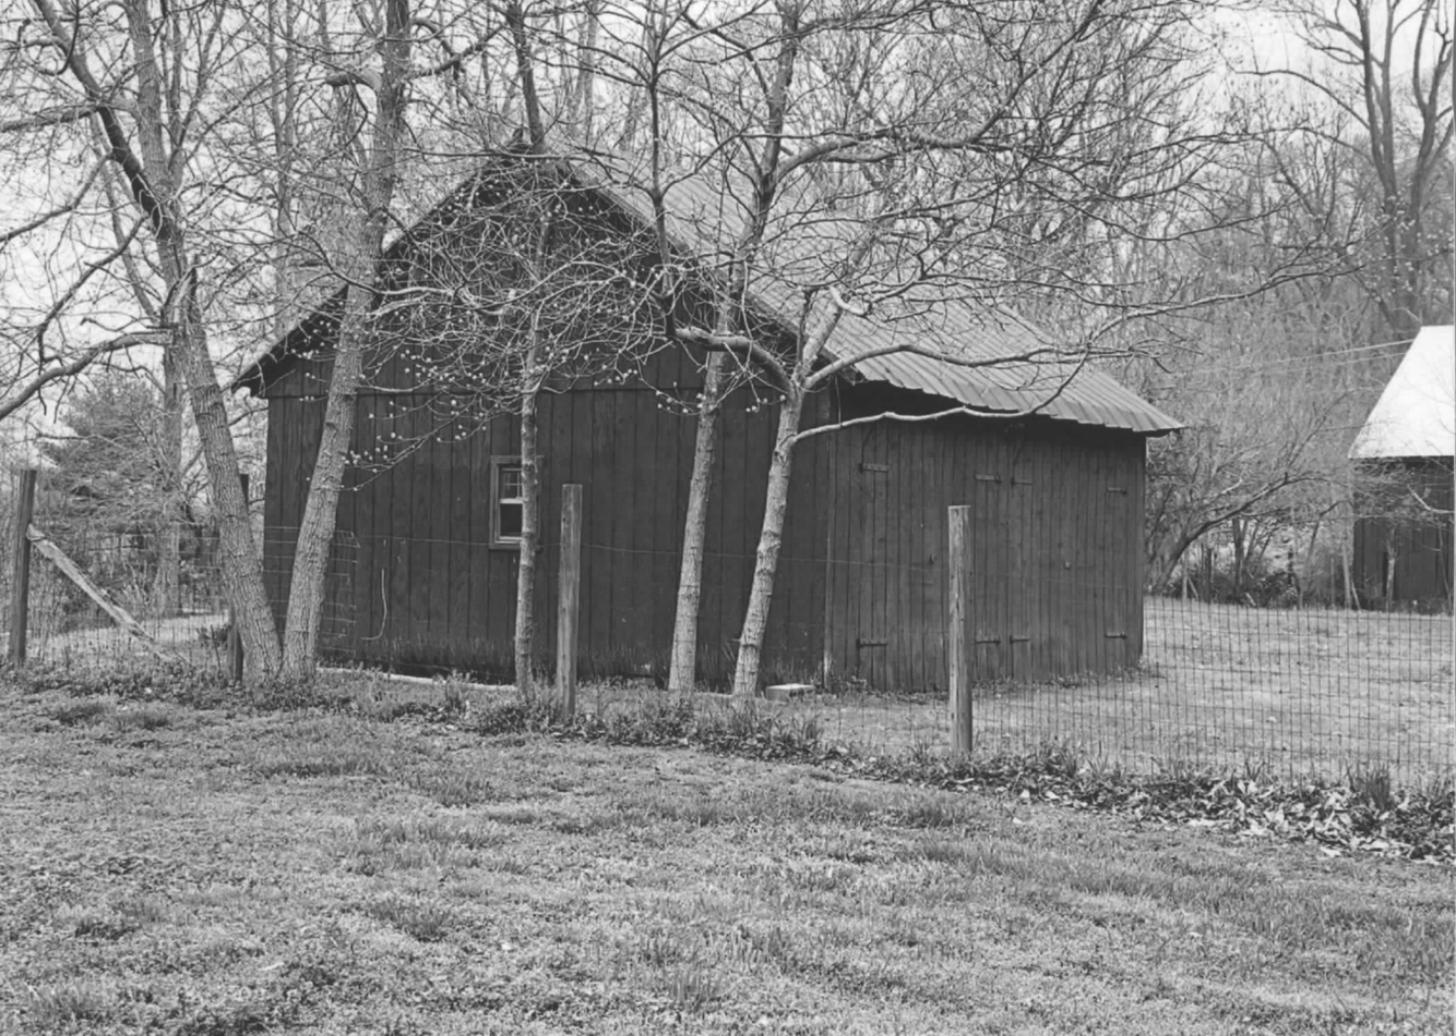
A one-story, frame machine shed, constructed ca. 1931, is situated outside the fenced-in area, to the southwest of the outbuildings. Two sets of double-leaf doors, attached with metal strap hinges, are located in the northeast elevation (Photograph 9). A small four-over-one light, double-hung, aluminum sash window is situated in the northwest and southeast elevations. A six-over-six light, double-hung, aluminum-sash, replacement window occupies the northernmost bay in the southwest elevation, and a one-over-one light, double-hung, aluminum-sash, replacement window is located in the southernmost bay (Photograph 10). The machine shed, which is currently used for storage, is in good condition.

Photograph 9: Blankenship House, machine shed, southeast and northeast elevations, view looking west. March 2012.

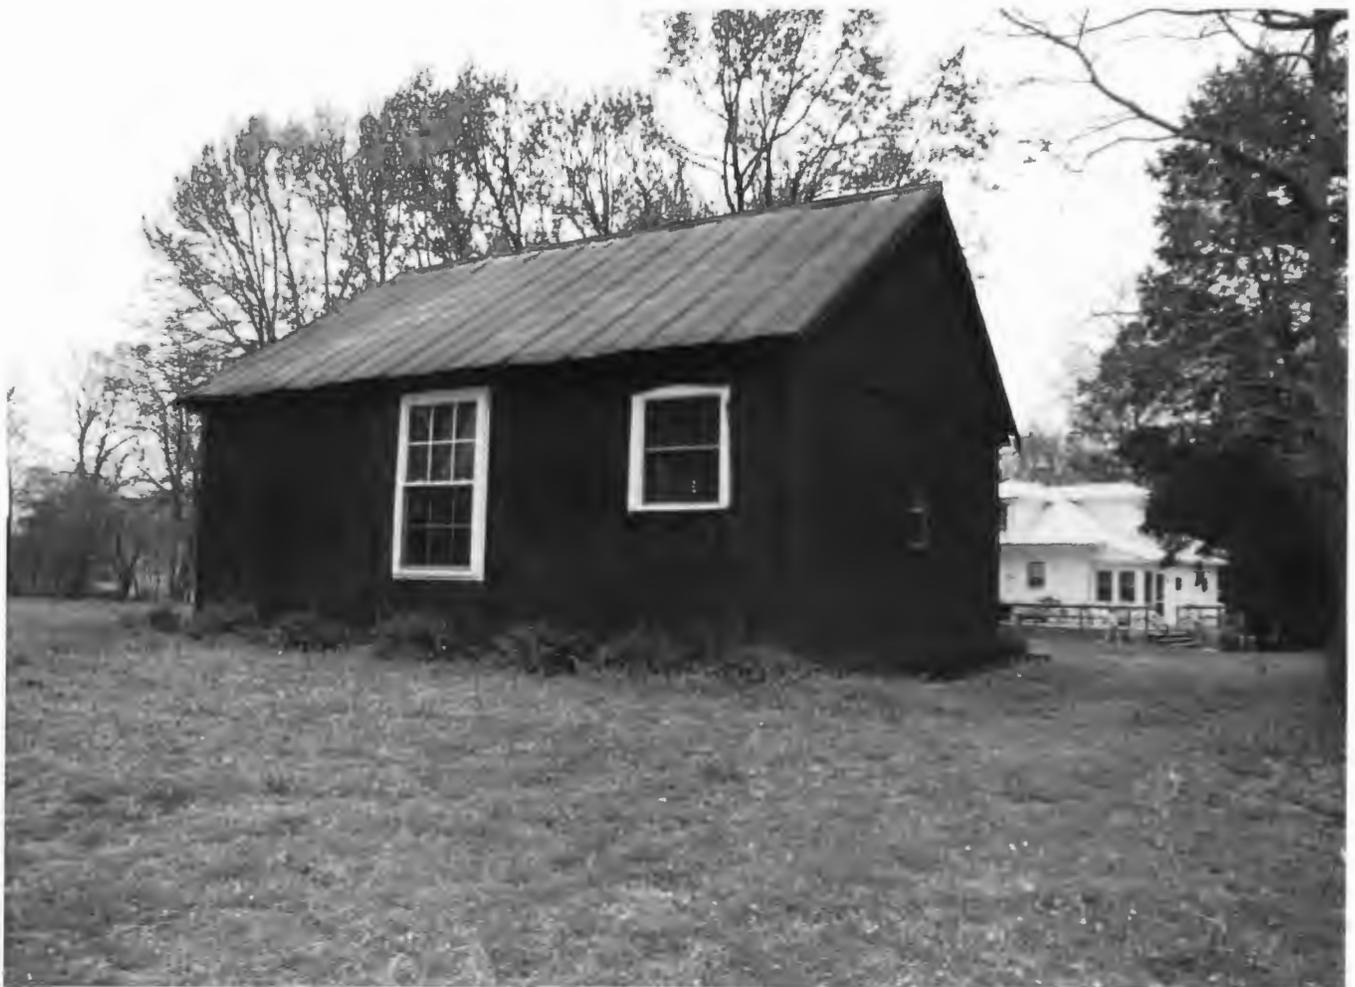
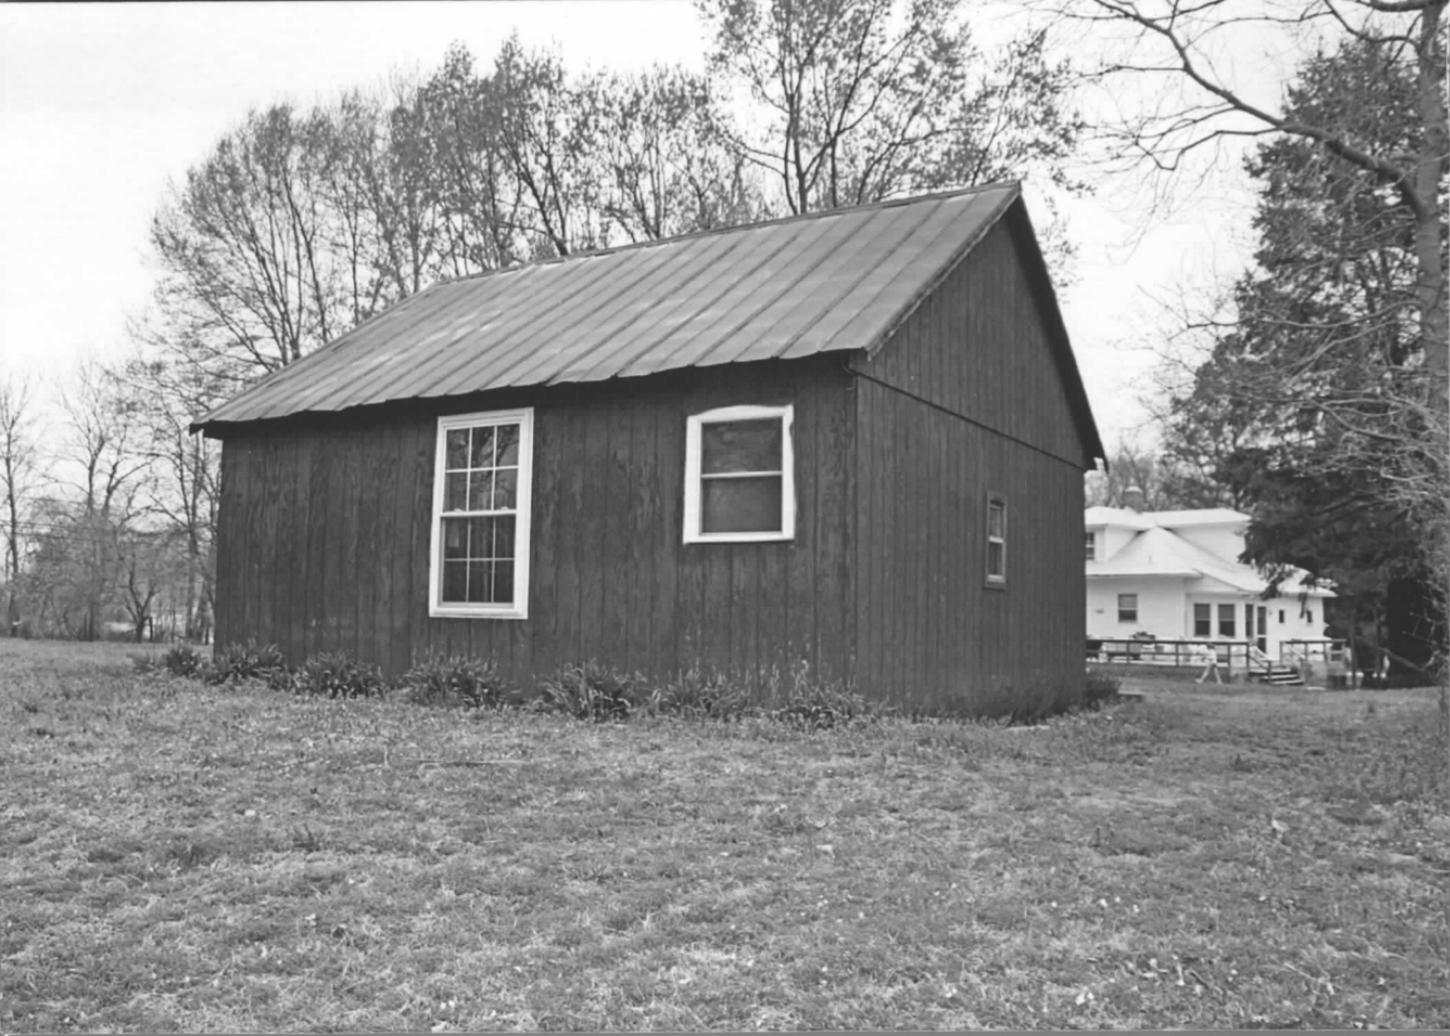
Photograph 10: Blankenship House, machine shed, southwest and southeast elevations, view looking north. March 2012.
