**MARYLAND HISTORICAL TRUST
DETERMINATION OF ELIGIBILITY FORM**

Property Name: Letchworth's Chance Inventory Number: CT-25
 Address: 2608 Ridge Road Historic district: yes no
 City: Huntingtown Zip Code: 20639 County: Calvert
 USGS Quadrangle(s): Prince Frederick
 Property Owner: Todd L. Clement, Yvette C. Neeld, & Mark Comings Tax Account ID Number: 0502016362
 Tax Map Parcel Number(s): 0073 Tax Map Number: 0019
 Project: MD 263 at Ridge Road Agency: SHA
 Agency Prepared By: SHA
 Preparer's Name: Rebecca Crew Date Prepared: 07/02/2007

**Letchworth's Chance
CT-25
2608 Ridge Road
Huntingtown, Maryland
Amy Bolasky Skinner
The Ottery Group, Inc.
August 10th, 2009**

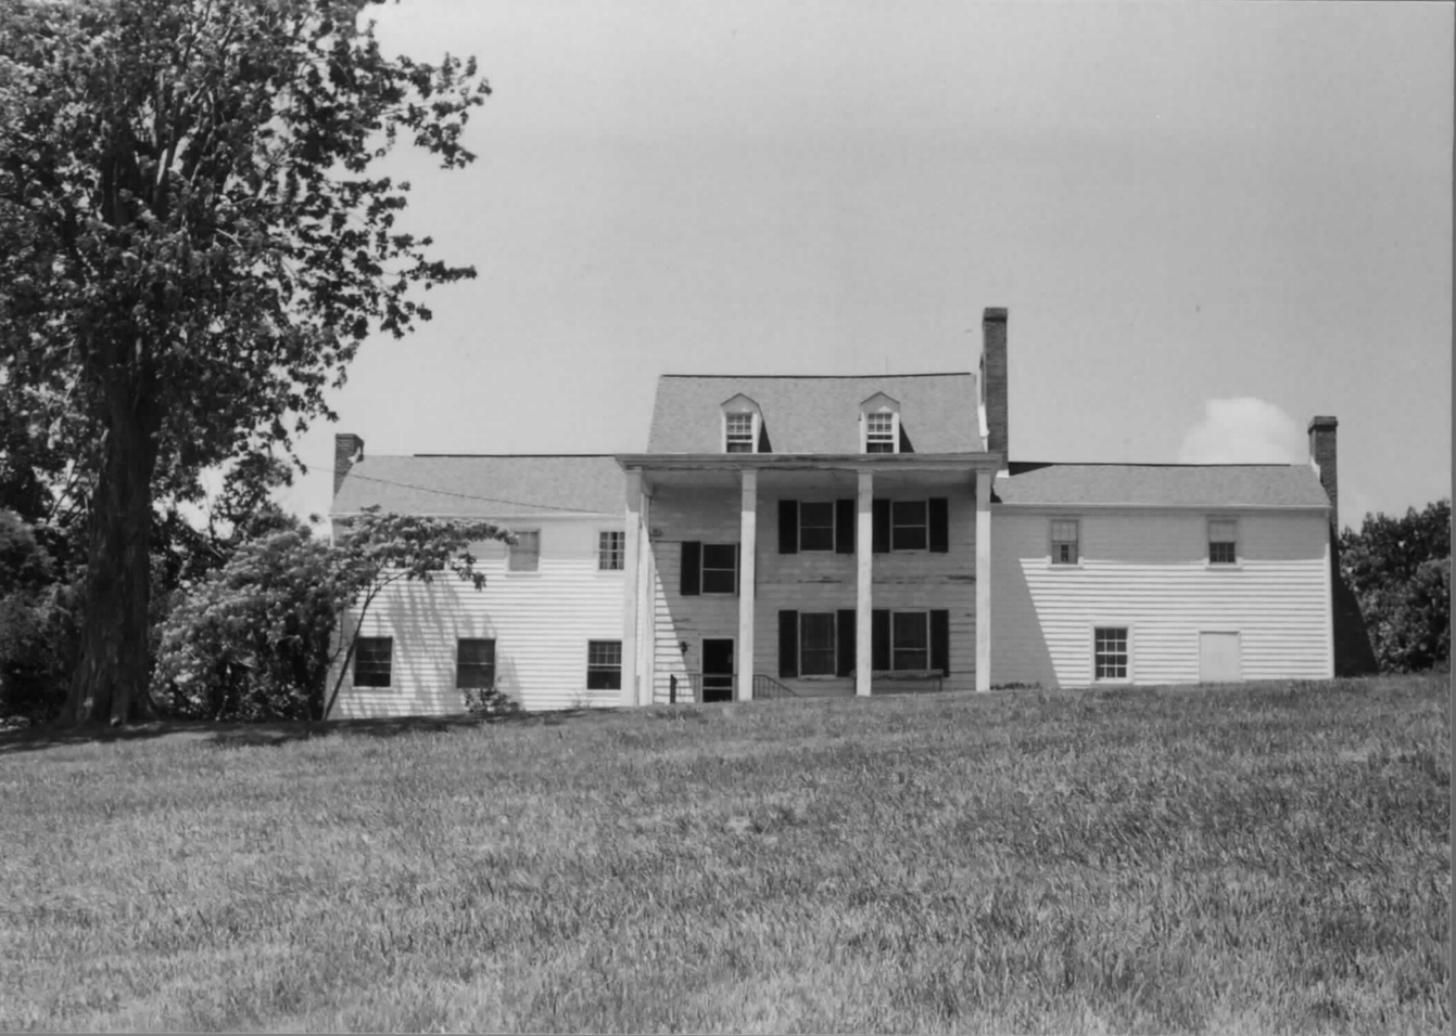
#1 of 12

Facing west towards dwelling

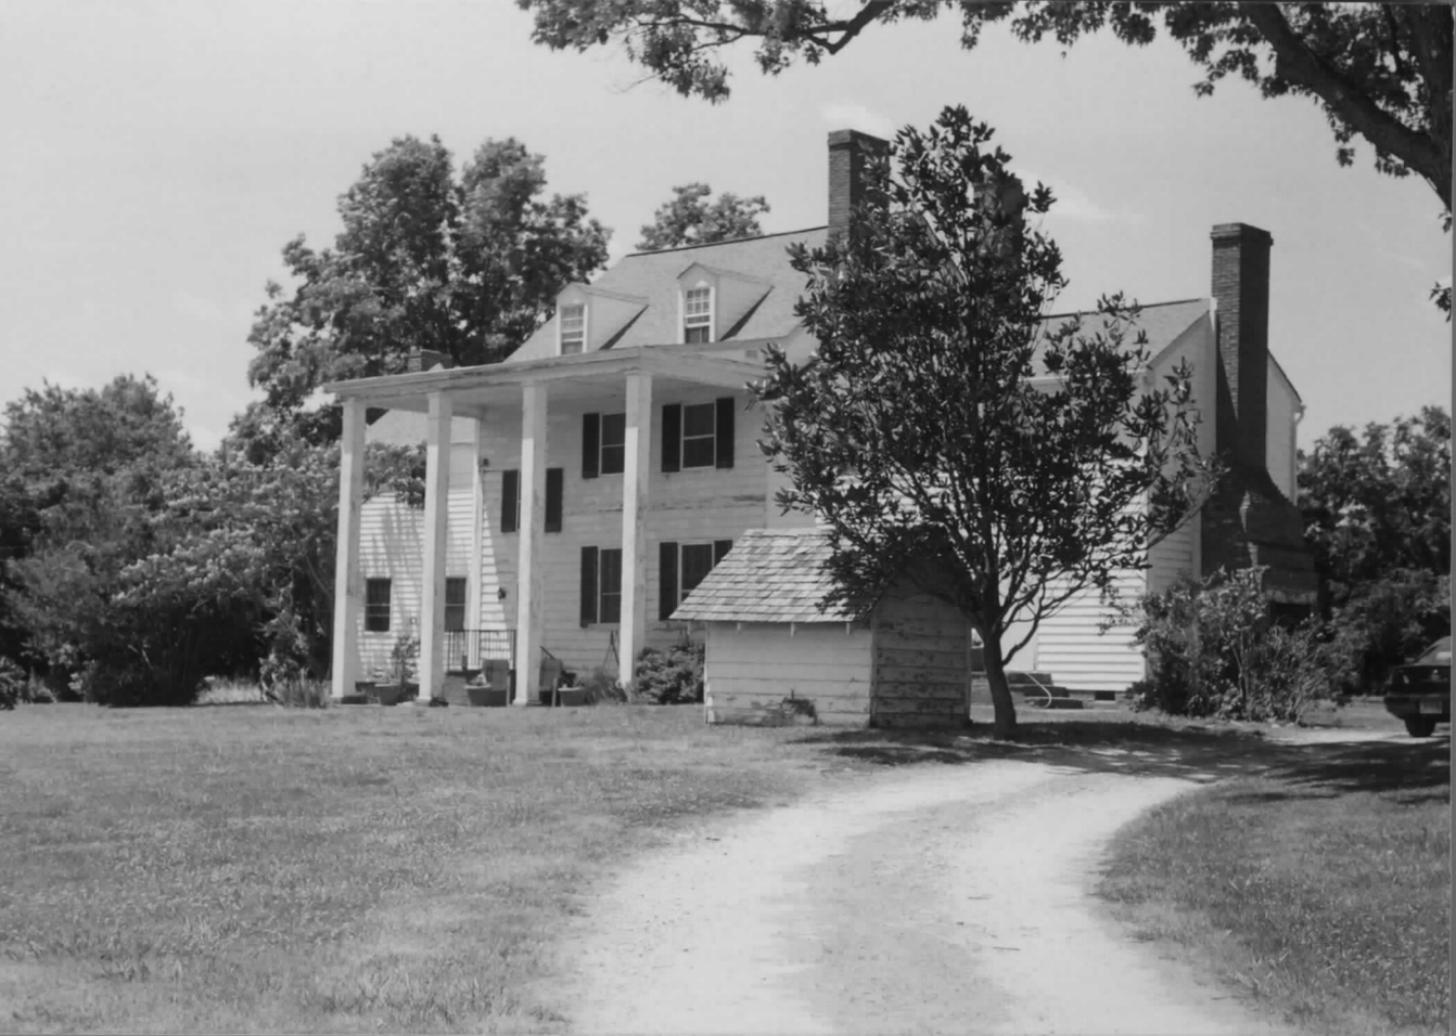
#2 of 12

Facing southwest towards dwelling

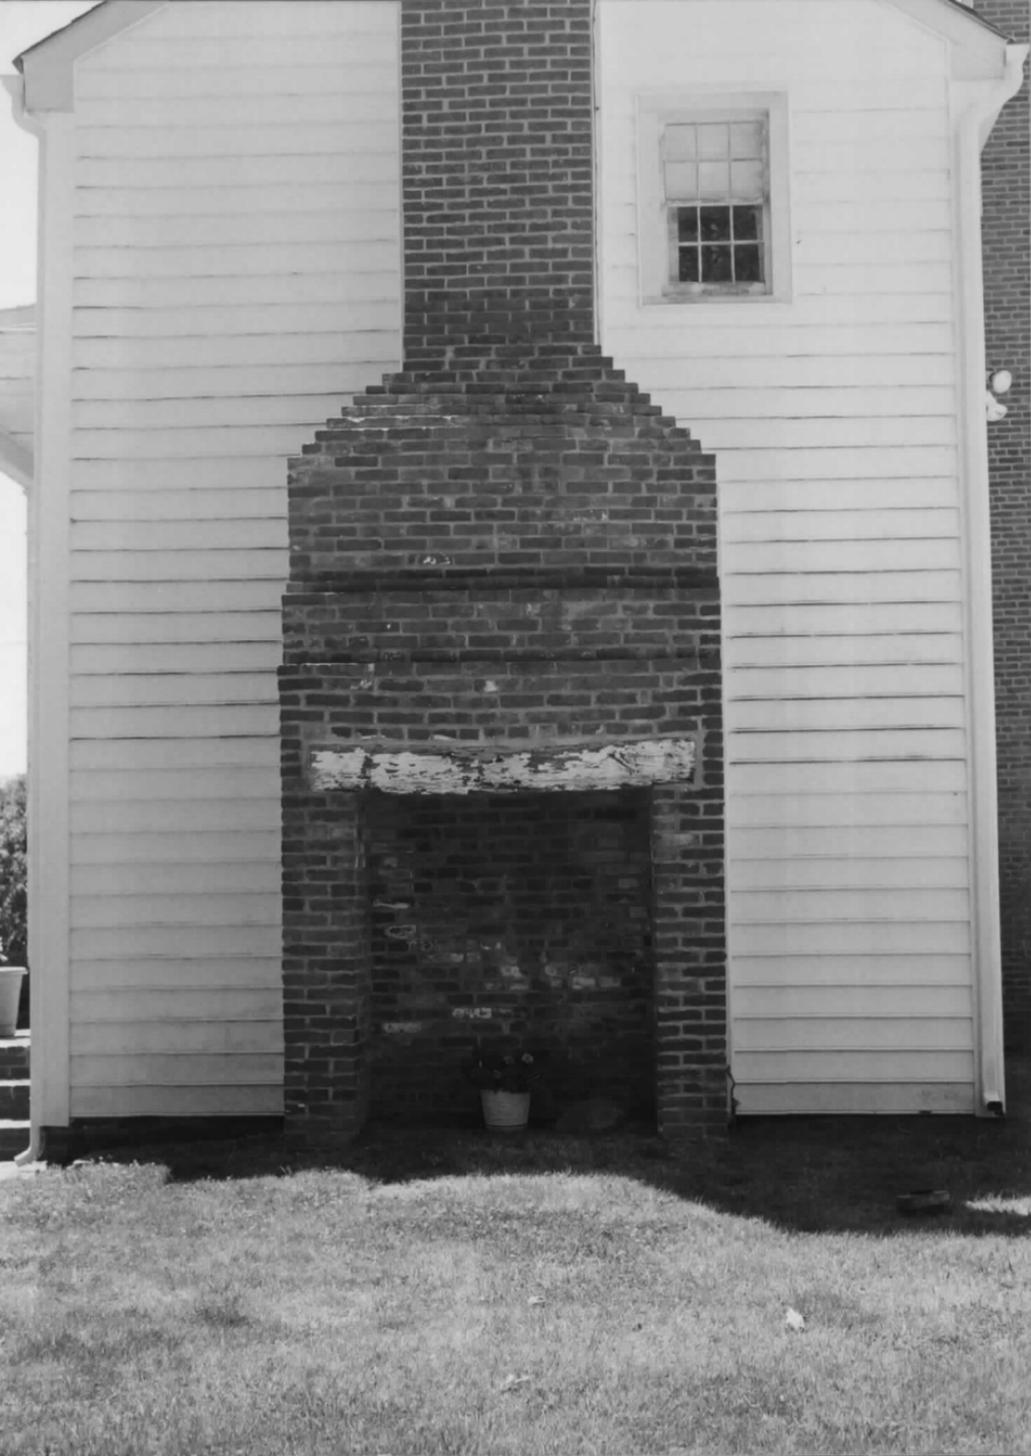
Facing south towards exterior fireplace
3 of 12

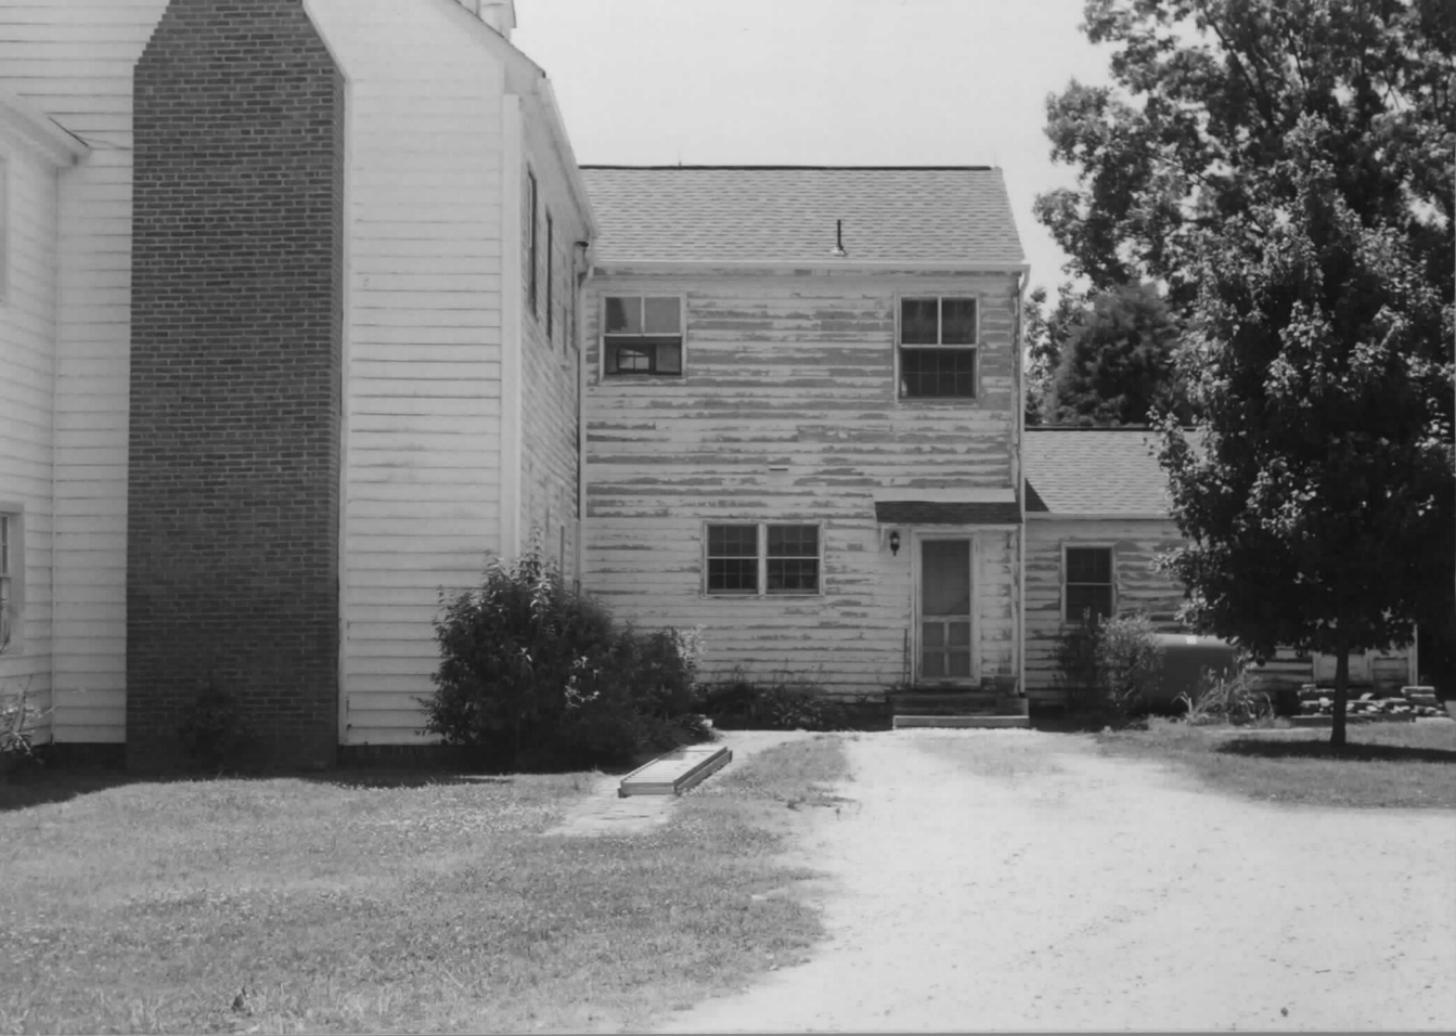
#4 of 12

Facing south towards rear of dwelling

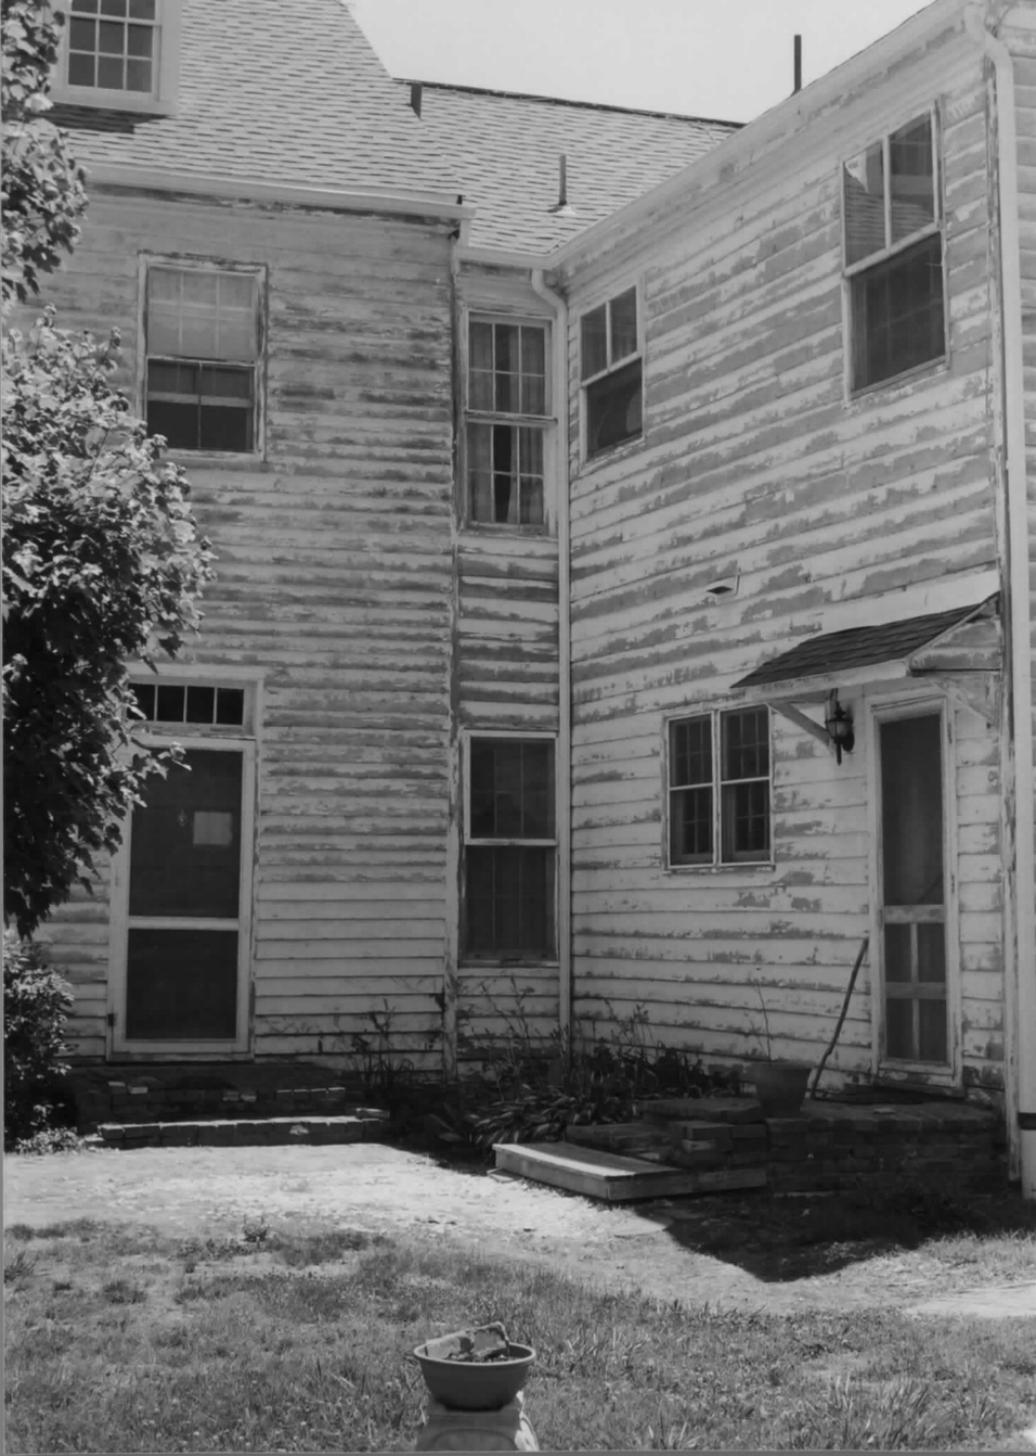
#5 of 12

Detail east side between main block,
south addition, and rear ell

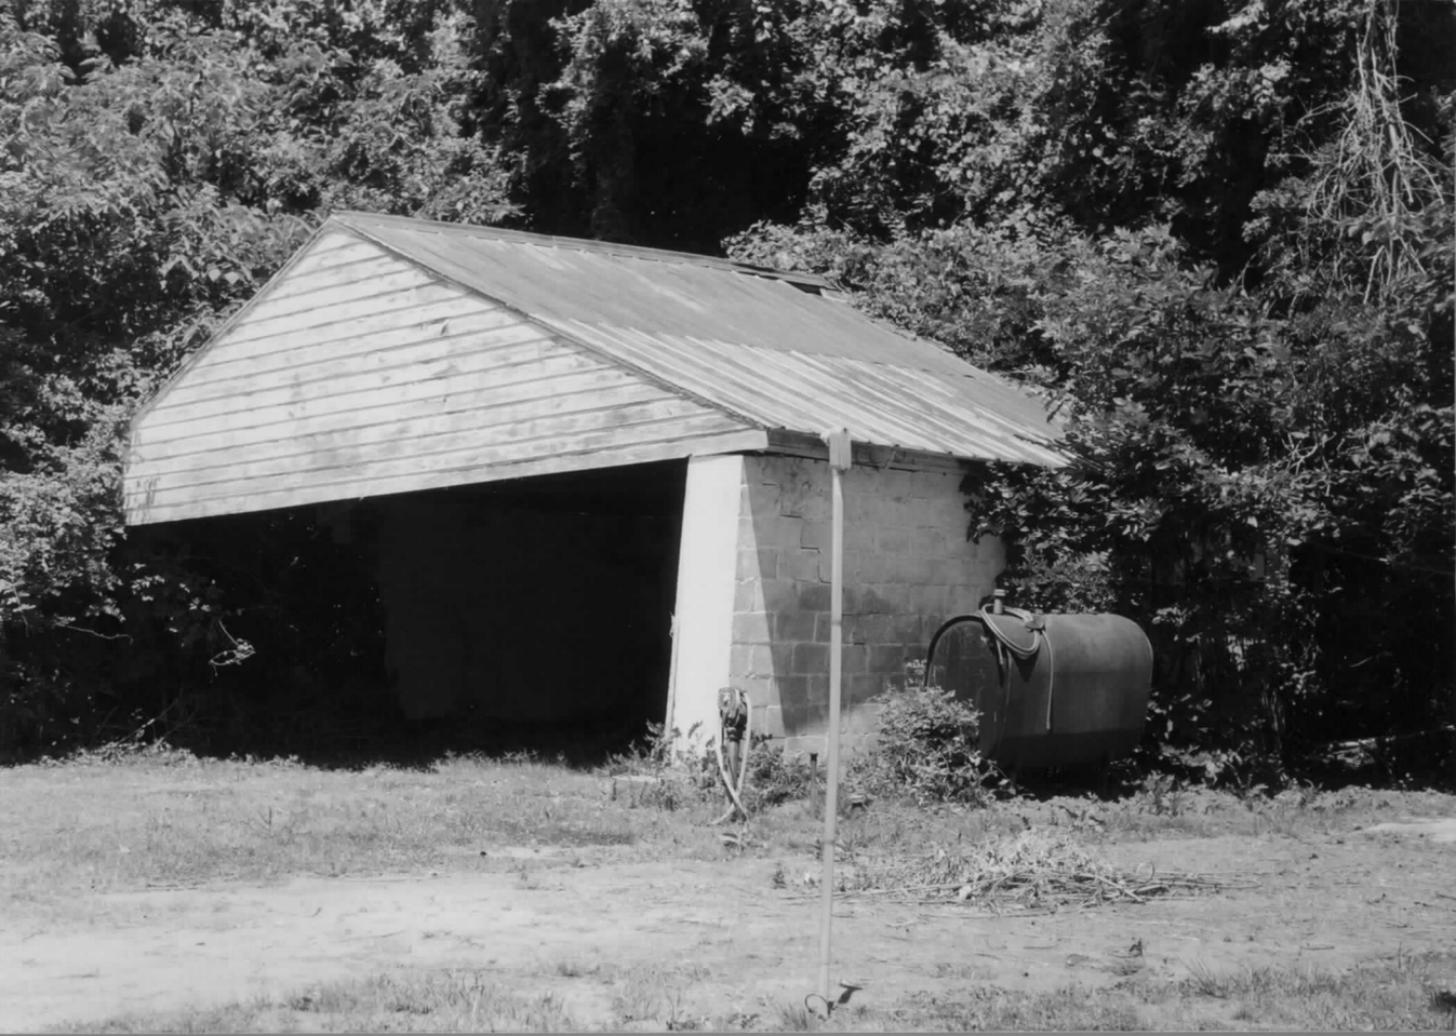
#6 of 12

The site also hosts several outbuildings. A CMU-constructed open two-bay garage is located northwest of the house. A frame, side-gabled roof shed is adjacent to the garage. The small shed is a single bay in length and width and is clad with flush wood planking. A brick spring house remains on the property just north of the main house. A front gabled roof shelters the structure. The MIHP form indicates the spring house was a dairy and was rebuilt in 1922. An additional small frame outbuilding is found just east of the north section of the house. A front gabled roof extends over the walls to create deep eaves and shaded elevations. Lapped wood planks clad the structure. This outbuilding is likely a well or pump house.

Facing northwest towards garage

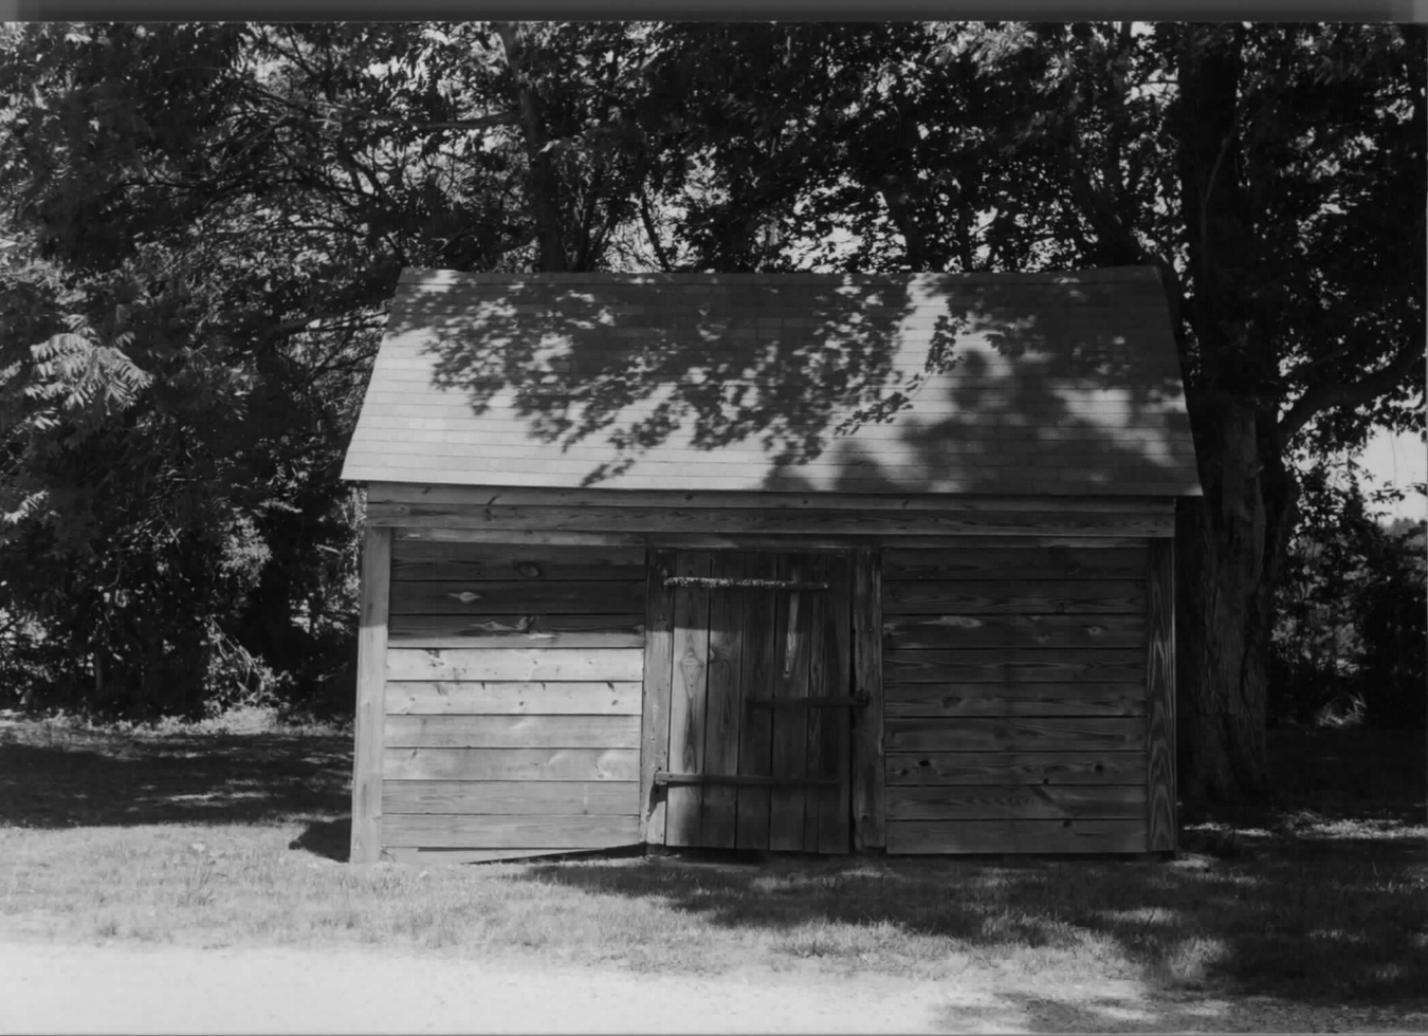
#7 of 12

Facing north towards shed

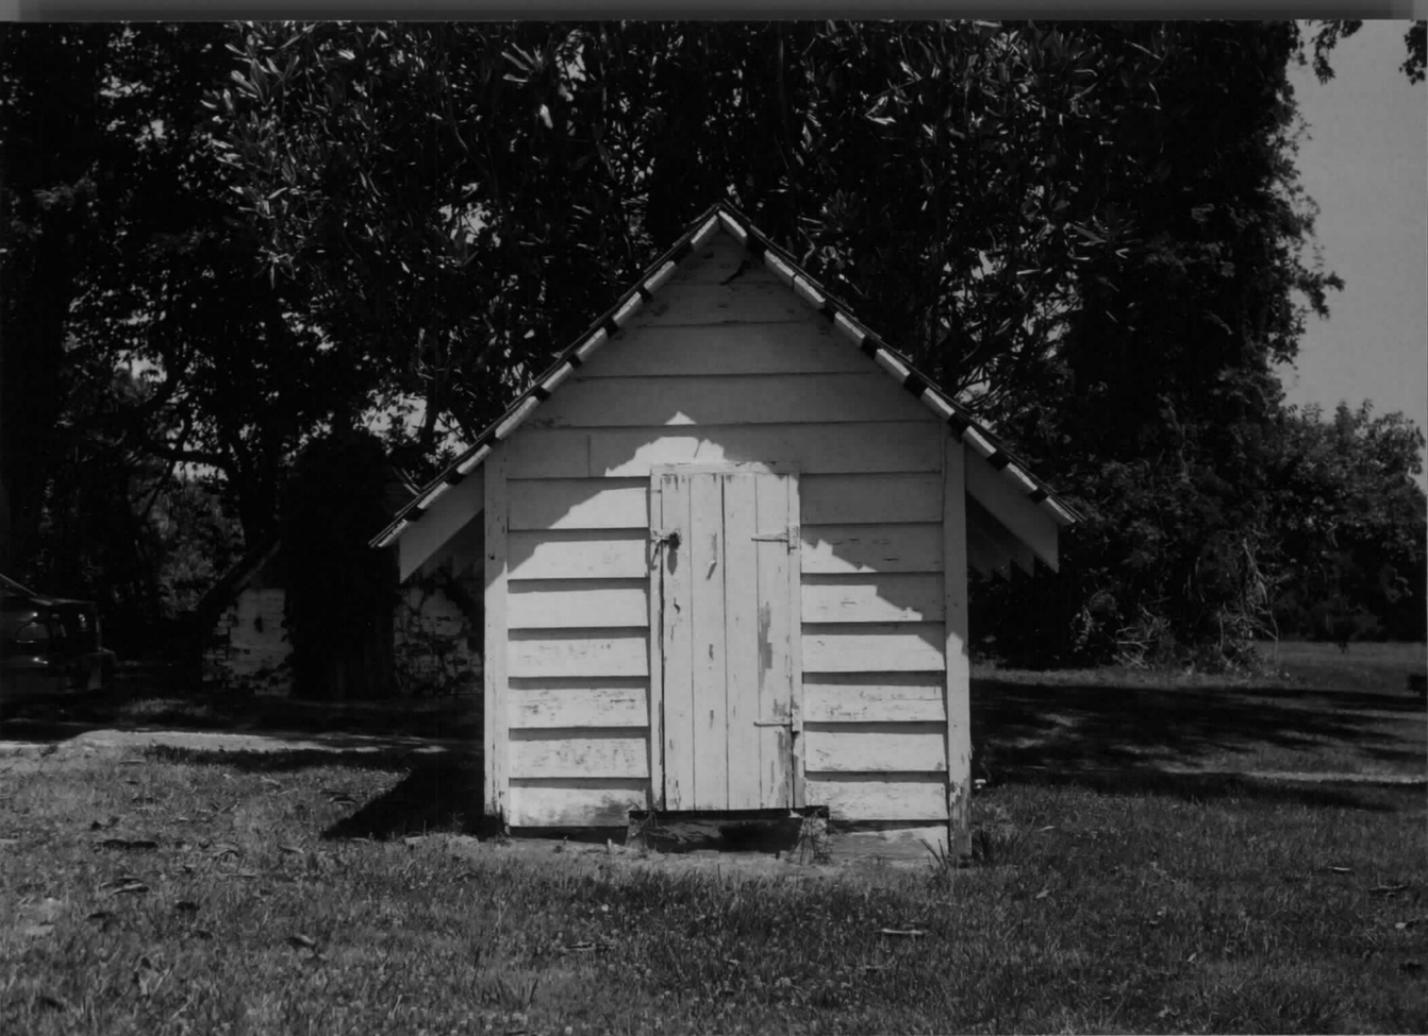
#9 of 12

Facing north towards pump house

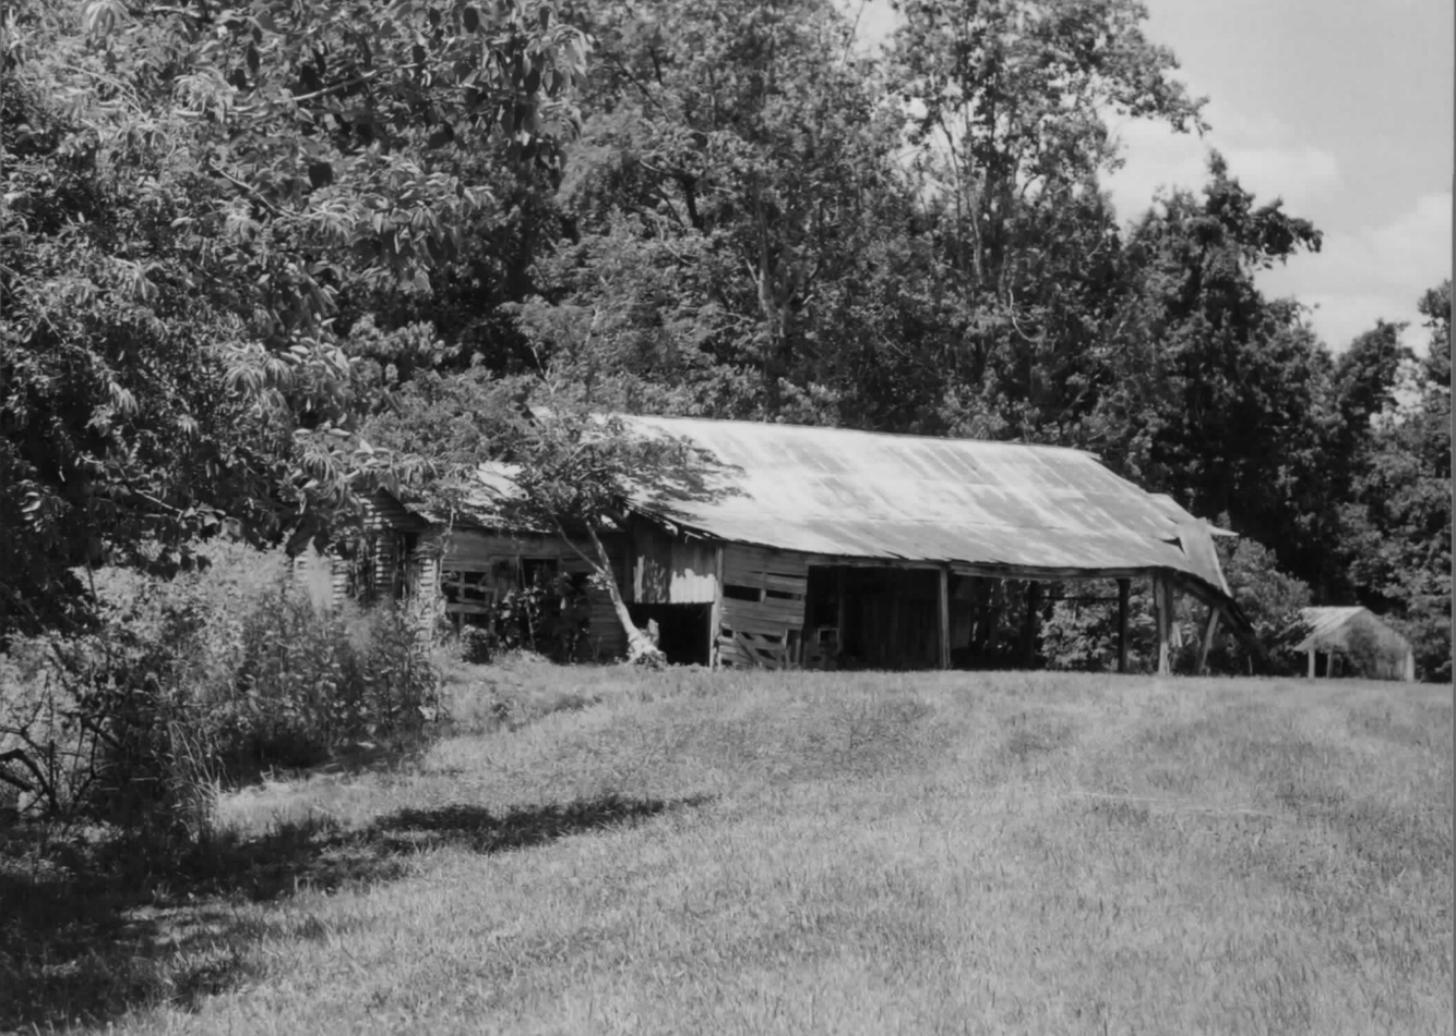
Facing northwest towards barns
#10 of 12

The barn has a steeply pitched, metal standing seam, front-gable roof. The exterior is clad in machine-cut, vertical planks that are not flush and vary in width. Like many twentieth century tobacco barns, the barn's exterior vertical planks have ventilation doors. The barn is wood frame, the trussing system of drying poles is indicative of the barn's use as a tobacco barn. The stripping room was a separate structure southwest of the barn and has been demolished. The foundation is concrete block piers. There are single, batten, wood plank doors on the south façade and north elevations. There are double, batten wood plank doors on the east and west elevations. All doors are secured by a wooden latch. The doors sizes imply that it was not possible to drive modern, twentieth century farm equipment into the barn.

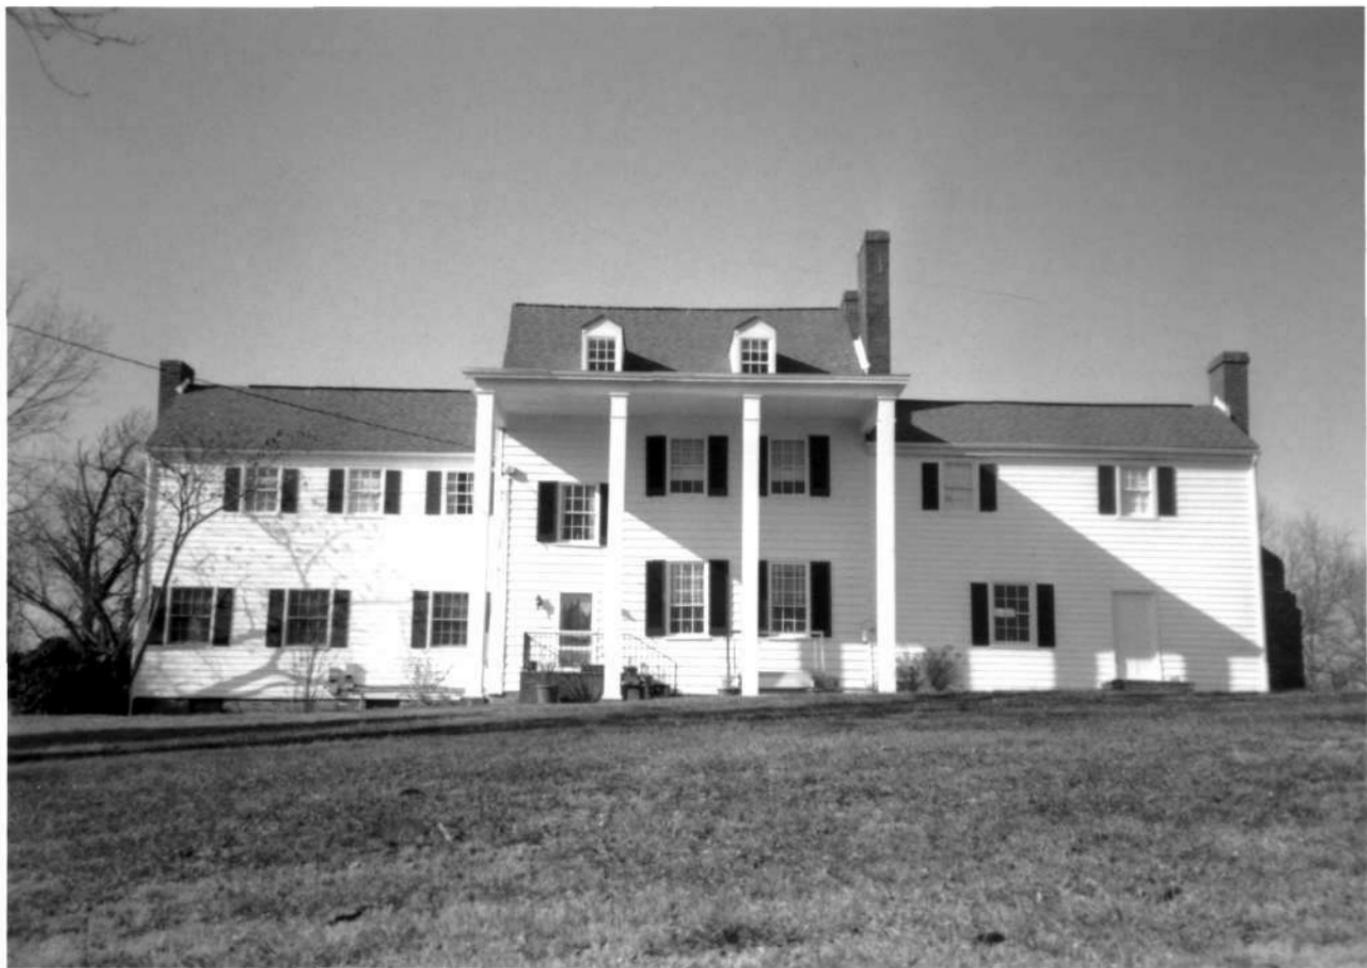
1 of 23

The main house is two-and-a-half story, three-by-two bays with a steeply pitched, side-gable roof clad with asphalt shingles. There are four, shallow pitched, front-gable dormers in the roof, two on the east façade and two on the west elevation. The dormer roofs are steeply pitched and clad with asphalt shingles. The dormer's exteriors are clad with a secondary sheathing of aluminum siding. There are single, six-over-six, double-hung sash wood windows in each dormer. There are two, exterior end brick chimney's with corbelled caps on the north elevation. The house is of wood-frame construction with an English basement of brick. The façade's exterior is clad with beaded weatherboard on the east façade only. The rear, west elevation is clad with a secondary sheathing of aluminum siding. The exterior has corner board. The façade's fenestration is asymmetrical. Windows on the first story are nine-over-six, double-hung sash wood with wood casing. Windows on the second story are six-over-six, double-hung sash wood with wood casings. The asymmetrically placed window lights the stairwell and hall.⁷ All façade windows are flanked by louvered shutters with metal shutter braces. In the 1950s a two-story portico was added to the east façade. The portico has a flat roof with overhanging eaves supported by two-story square columns. The entrance is on the south bay up three brick stairs to a landing. The door is paneled wood with a surround.

Main Facade East

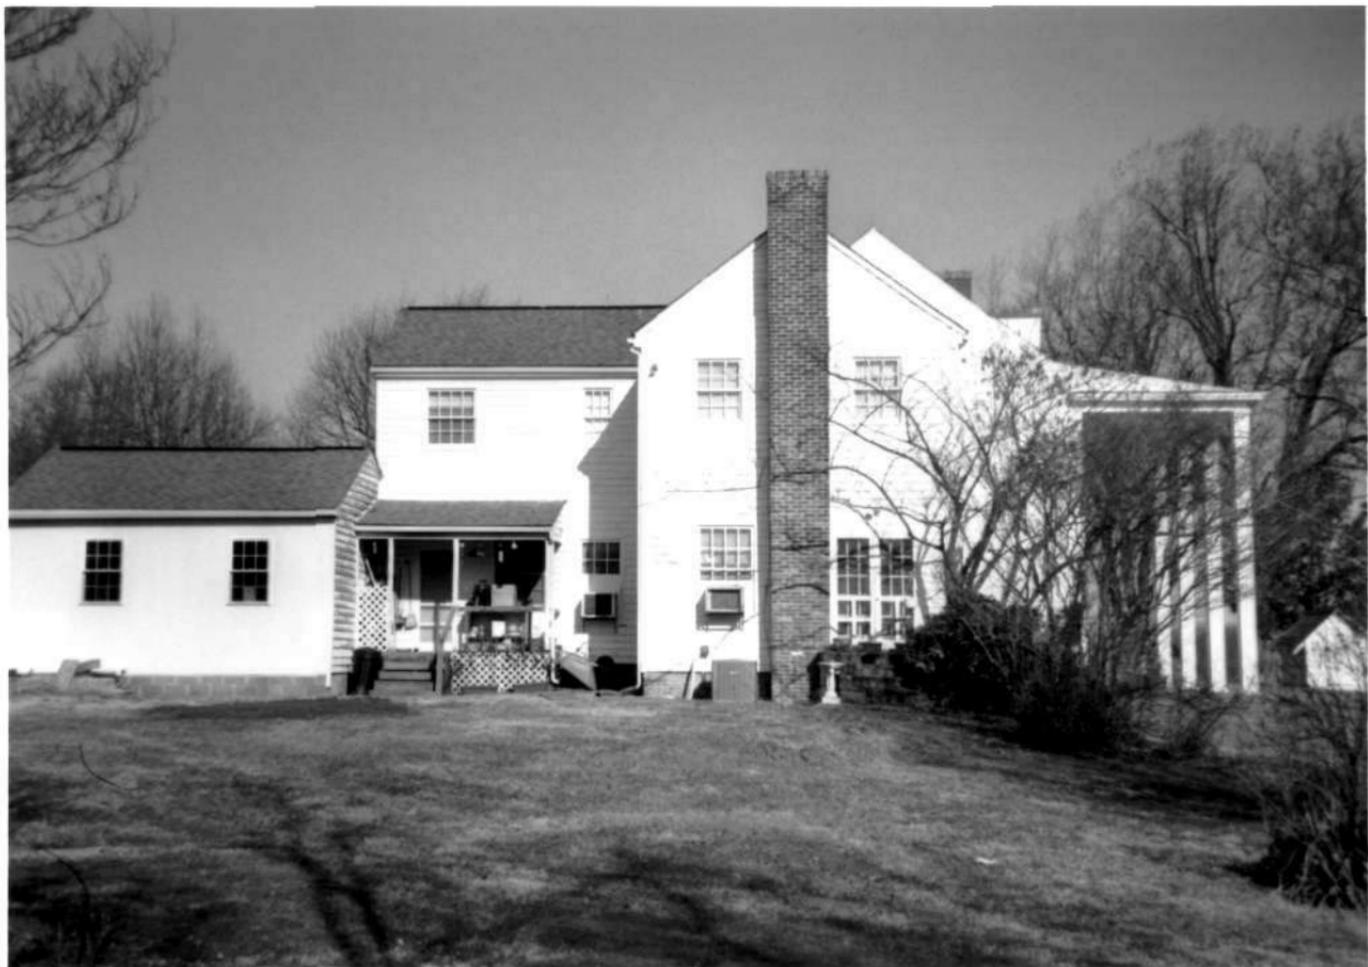
4 of 23

The south wing is an ell-shaped two-story, three-by-two bay wing with a steeply pitched, side-gable roof clad with asphalt shingles. The rear addition projects to the west and has a gable-roof clad with asphalt shingles. There is an exterior end brick chimney with a corbelled cap on the south elevation. The south ell is of wood-frame construction with a brick foundation. The exterior is clad in a secondary sheathing of aluminum siding with corner boards. The fenestration is asymmetrical. Windows on the first story of the east façade are eight-over-eight, double-hung wood sash; windows on the second story of the east façade are six-over-six, double-hung wood sash. All windows on the façade are flanked by louvered shutters. There is a set of French, multi-light doors on the south elevation of the south wing. The doors lead to a brick patio with stairs to the side, south yard. Windows on the rear ell are six-over-six, double-hung sash on the first story and eight-over-eight, double-hung sash on the second story. There is a one-story, one-bay shed-roof entry porch on the south elevation of the rear ell. It is clad with asphalt shingles and has overhanging eaves and a cornice with boxed returns. The porch is supported by two, wood posts. There is another shed-roof entry portico on the north elevation of the rear ell.

Elevation South

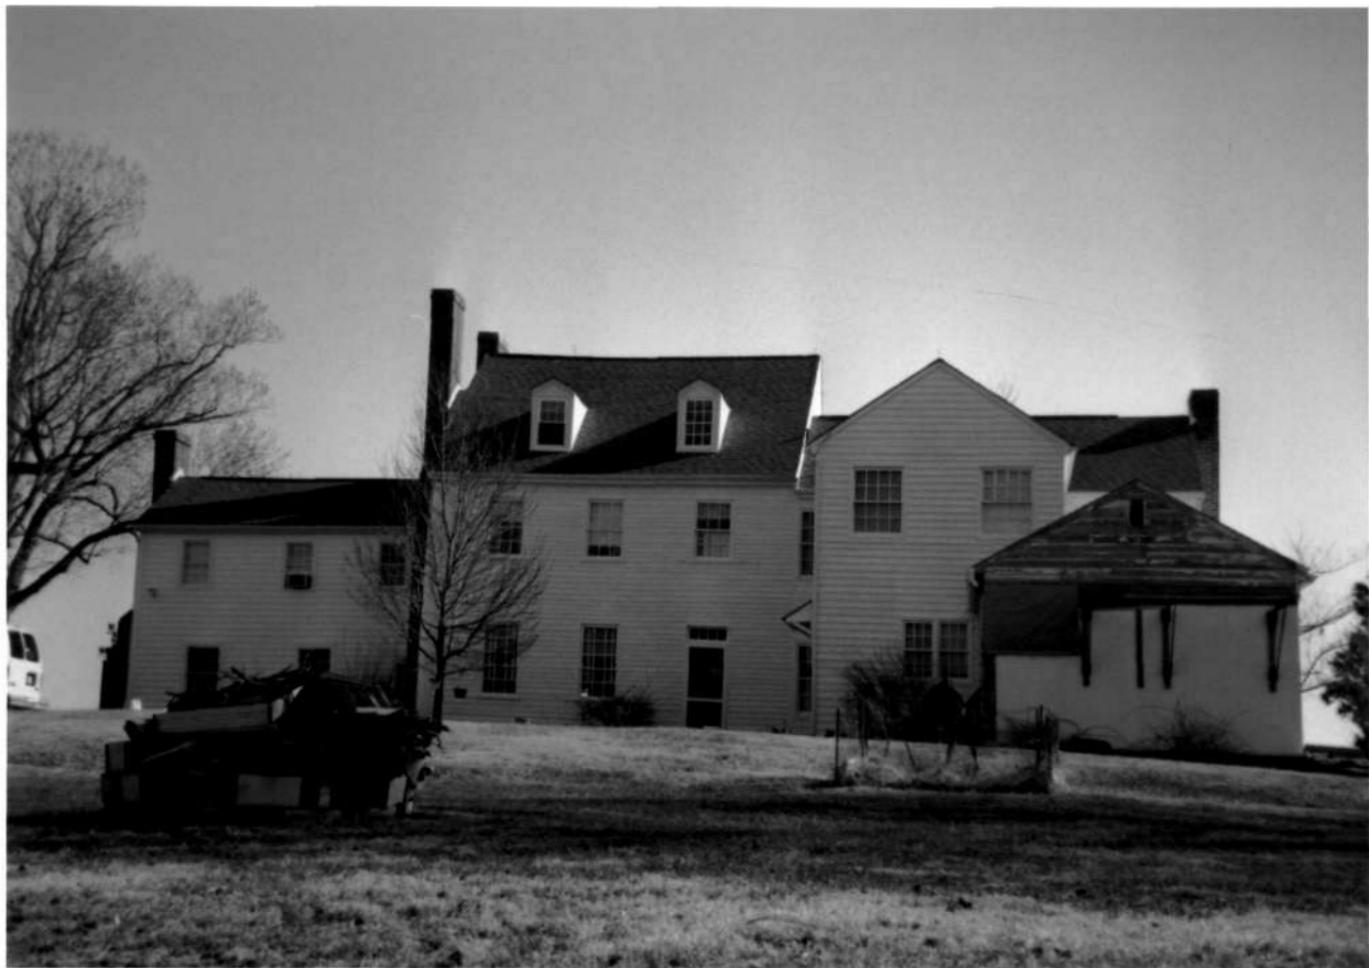
5 of 23

Rear Elevation West

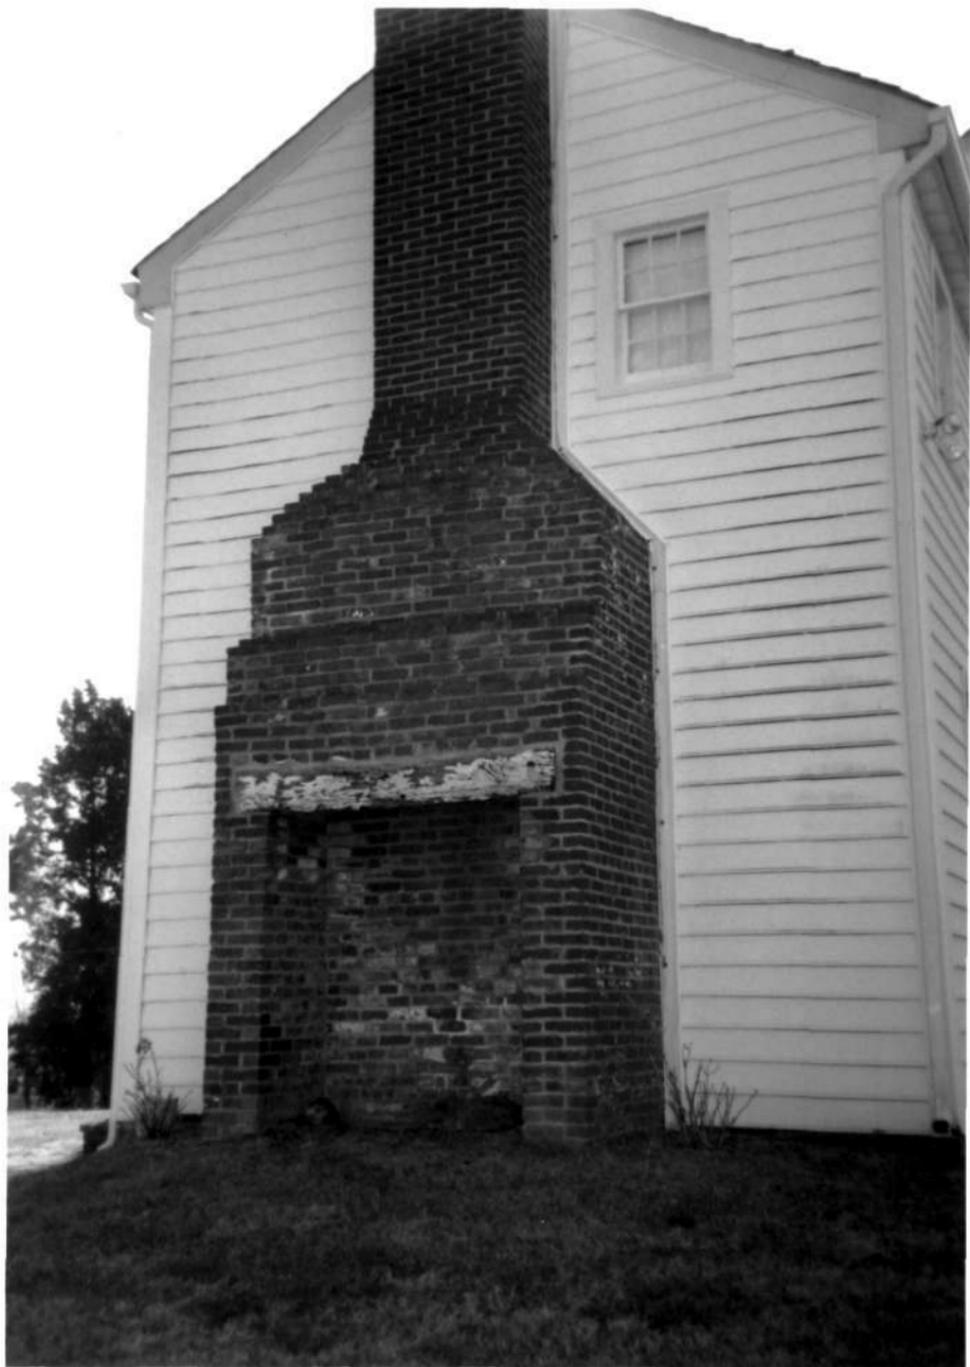
6 of 23

The oldest house block to the north is a two-story, two-by-two bay wing with a shallowly pitched, side-gable roof clad with asphalt shingles.⁹ The roof has slightly overhanging eaves and a cornice with boxed returns. There is an exterior end brick chimney with a corbelled cap on the north elevation. The chimney's large fireplace and wood lintel is visible from the exterior. The chimney is located where a log kitchen connected to the main house building. The house block is of wood-frame construction with a brick foundation. The exterior is clad in a secondary sheathing of aluminum siding and has corner boards. The fenestration is asymmetrical. Windows are six-over-six, double-hung sash with wood casings. All façade windows are flanked by louvered shutters. There is an entry on the north bay of the main facade. Two brick stairs lead to a landing and a wood panel door.

Chimney North Elevation

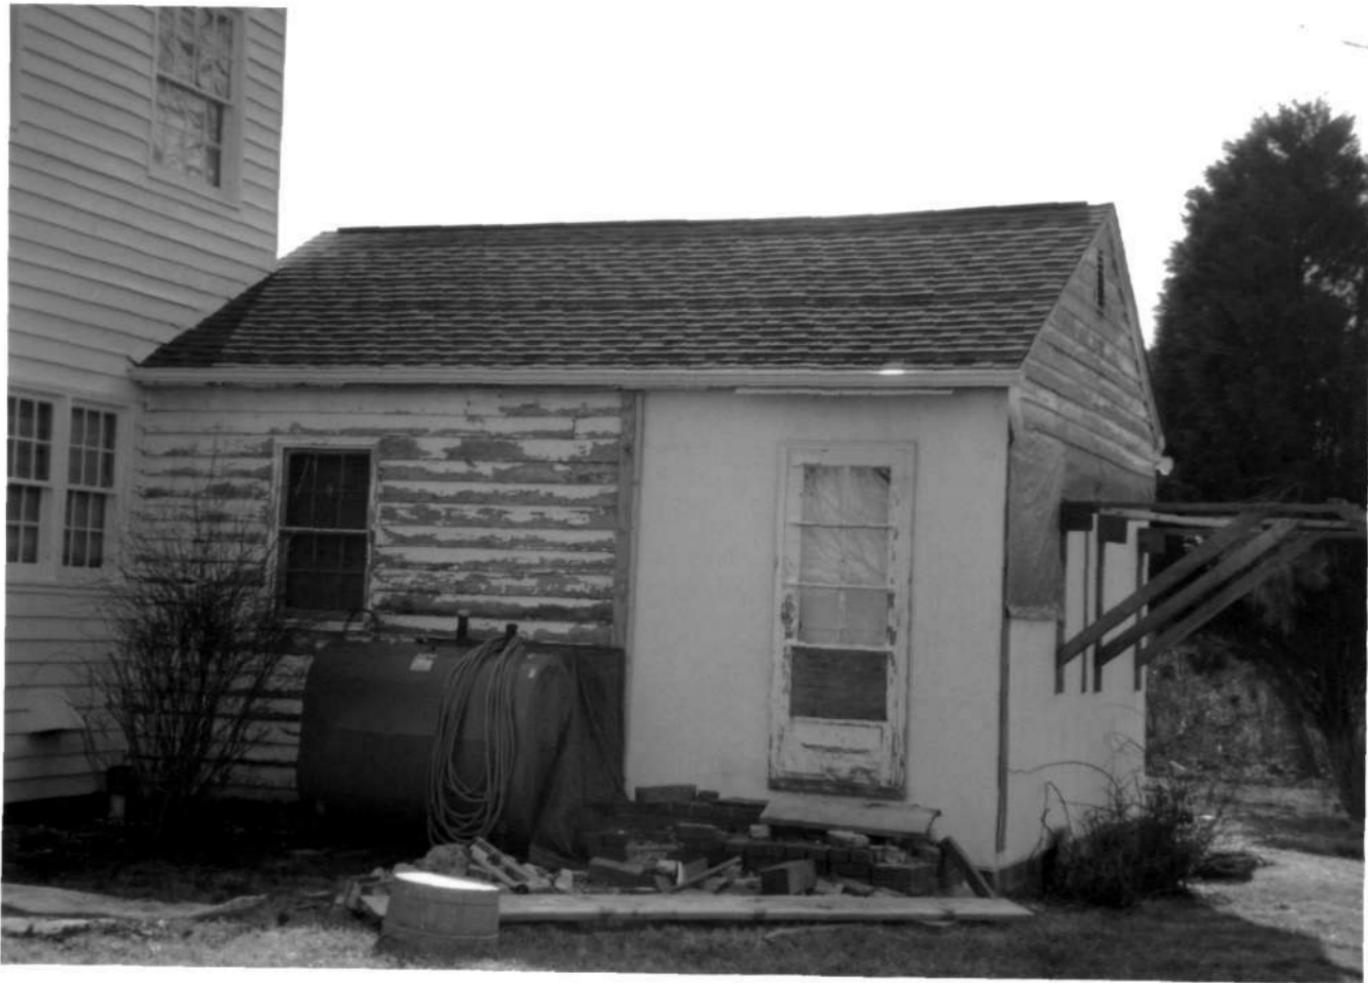
8 of 23

There is a one-story, two-by-two bay addition to the west off of the rear ell. The addition has a shallow roof clad with asphalt shingles. It is of wood-frame construction with a concrete block foundation. The exterior is being replaced with smooth concrete. The original weatherboard sheathing is visible on the east and north elevations. The west gable-end is clad in weatherboard. The addition has single, six-over-six, double-hung sash vinyl windows.

Small addition of west
