**MARYLAND HISTORICAL TRUST
DETERMINATION OF ELIGIBILITY FORM**

Property Name: Letchworth's Chance Inventory Number: CT-25
 Address: 2608 Ridge Road Historic district: yes no
 City: Huntingtown Zip Code: 20639 County: Calvert
 USGS Quadrangle(s): Prince Frederick
 Property Owner: Todd L. Clement, Yvette C. Neeld, & Mark Comings Tax Account ID Number: 0502016362
 Tax Map Parcel Number(s): 0073 Tax Map Number: 0019
 Project: MD 263 at Ridge Road Agency: SHA
 Agency Prepared By: SHA
 Preparer's Name: Rebecca Crew Date Prepared: 07/02/2007

**Letchworth's Chance
CT-25
2608 Ridge Road
Huntingtown, Maryland
Amy Bolasky Skinner
The Ottery Group, Inc.
August 10th, 2009**

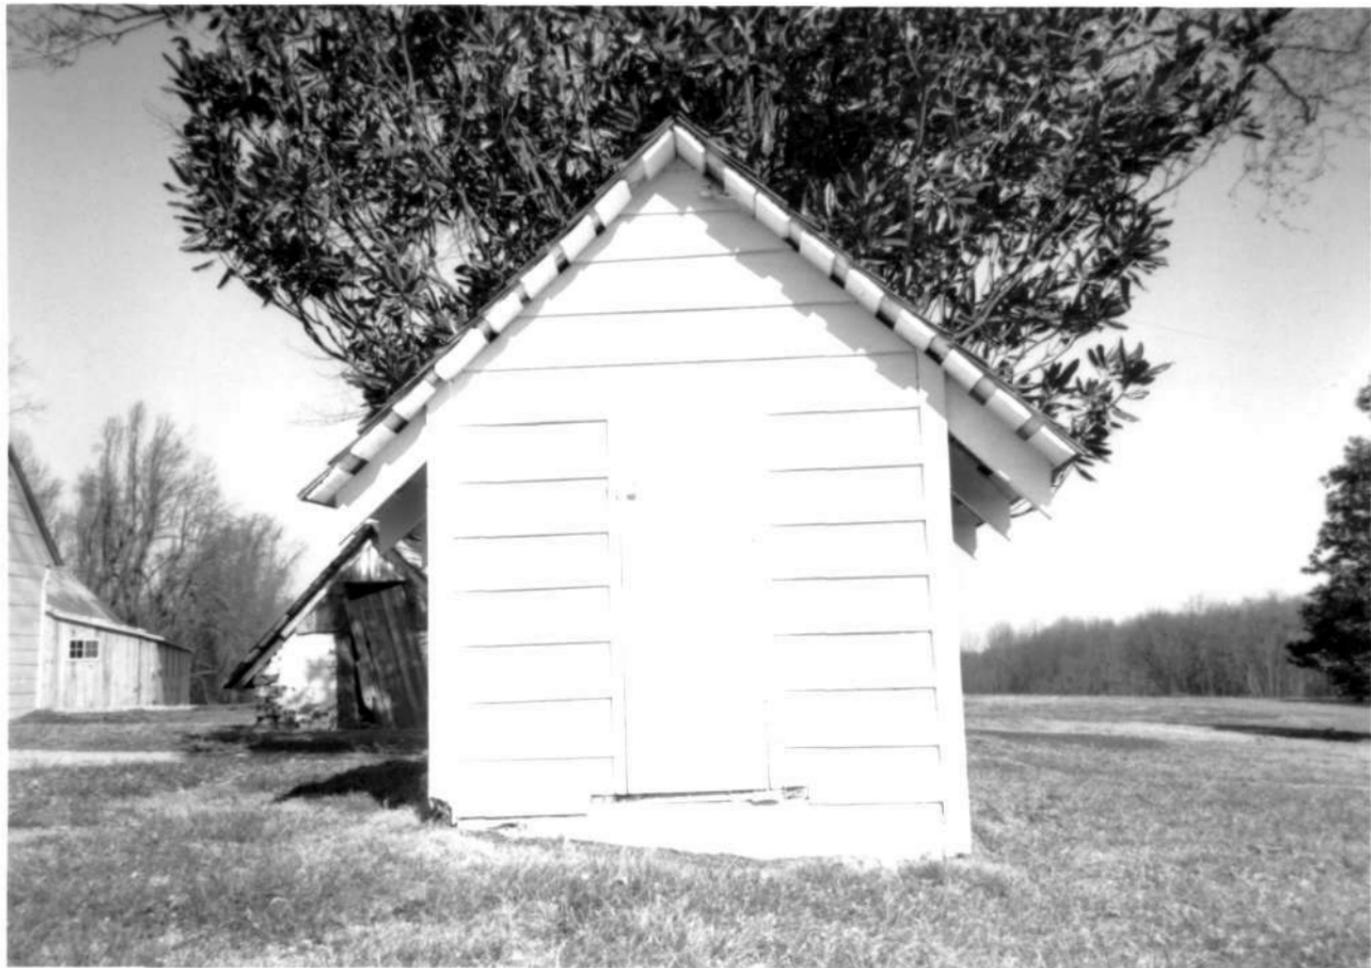
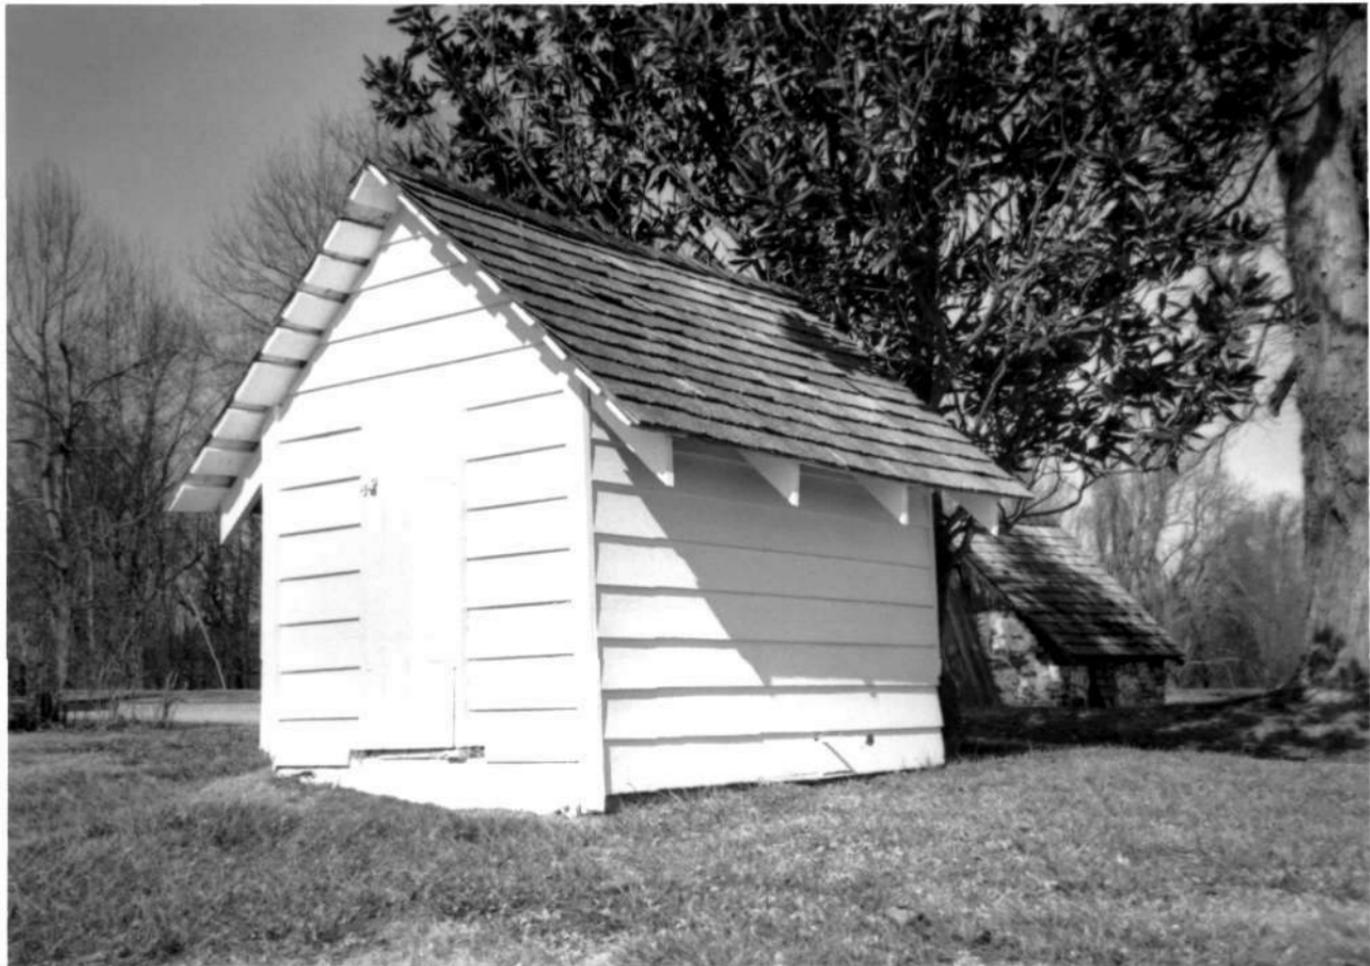
The closest outbuilding to the house is located to the northeast, just past the oldest portion of the house. It is the only outbuilding located to the south of the gravel driveway. The outbuilding is one-story, one-by-one bays with a rectangular plan. The front-gable roof is clad with wood shingles and has overhanging eaves and exposed rafter tails. The building is of wood-frame construction with a brick foundation. The exterior is clad in wide, pit sawn weatherboard. There is a board and batten entry door on the south façade with wrought iron hinges. There is a spigot off of the foundation on the east elevation. Due to its close proximity to the main house and the existence of a spigot, it is likely that outbuilding one was a wellhouse. The wellhouse is in good condition, both stabilized and weatherproofed.

Well house Facade S

Well House Elevation Southeast

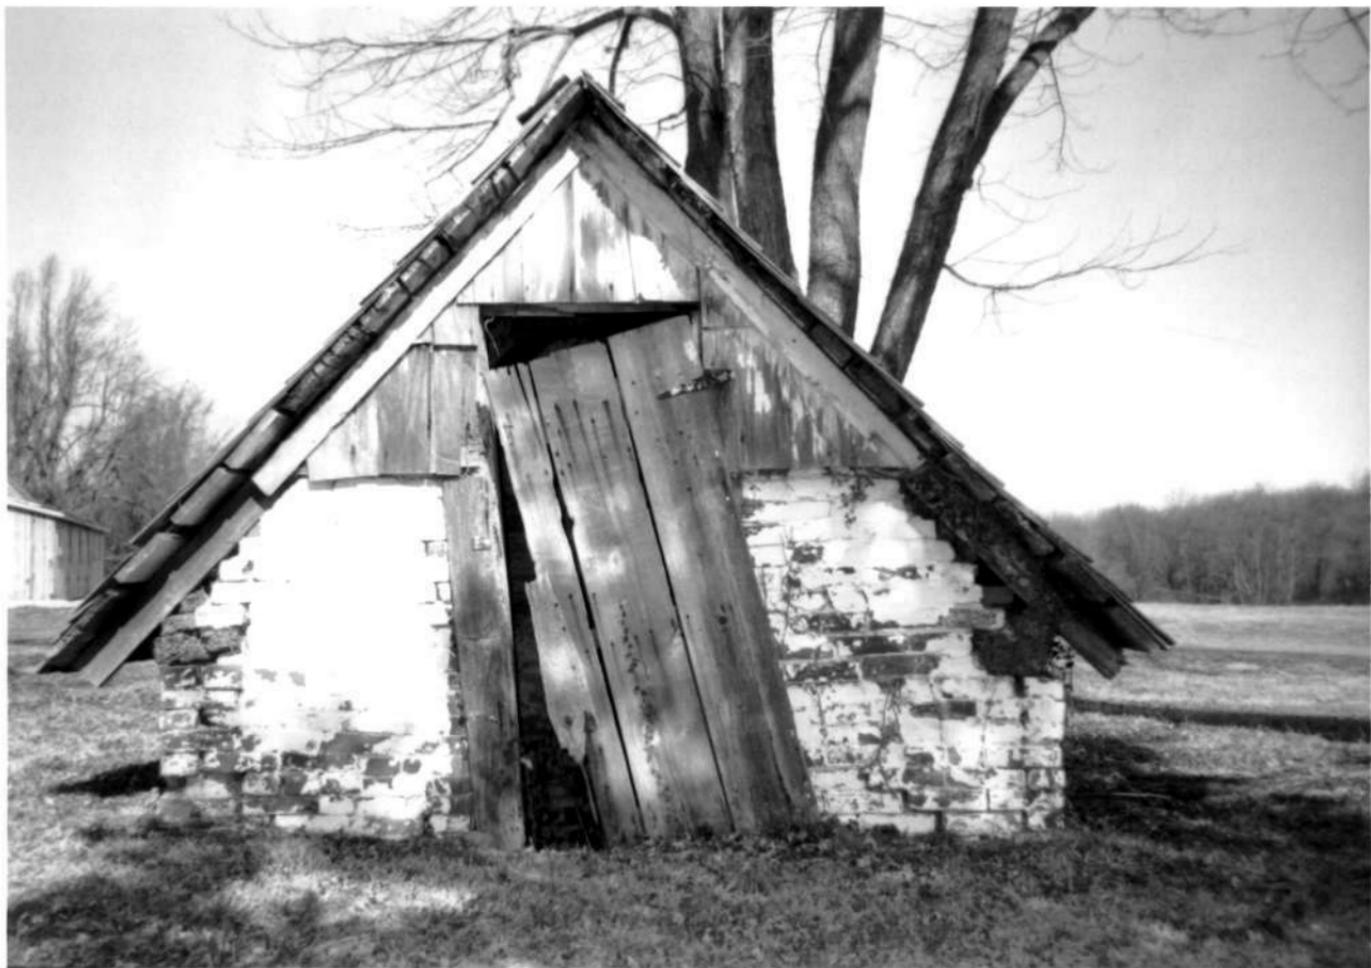
12 of 23

A dairy outbuilding is located to the north, just past the oldest wing of the house and the wellhouse. The dairy is located slightly west of an old growth tree on the north side of the gravel driveway. The building was rebuilt in 1922 when the conical roof was replaced with the existing steeply pitched, front-gable roof. The roof is clad with wood shingles and has deep overhanging eaves that end two feet from ground level. The dairy is of brick-masonry construction with thick brick walls and a deep brick foundation. There are "window vents" on the east, west, and north elevations. The vents have horizontal wood plank shutters with iron hinges. The gable ends are clad with wide wood shingles. Access to the dairy's interior is on the south façade by a board and batten door. The dairy is in need of stabilization and weatherproofing as it is rapidly deteriorating.

Dairy Facade South

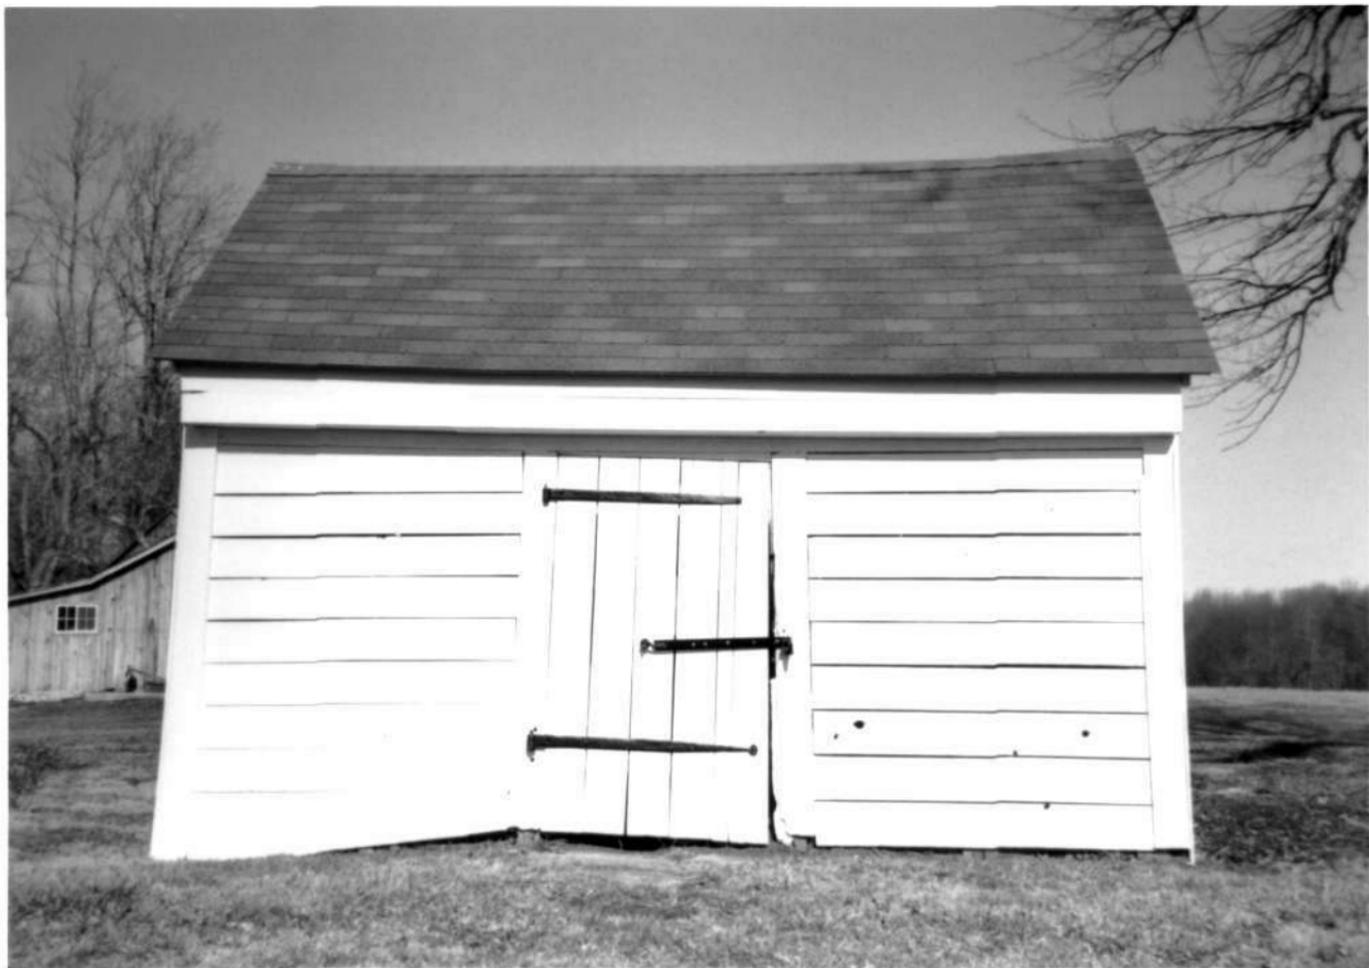
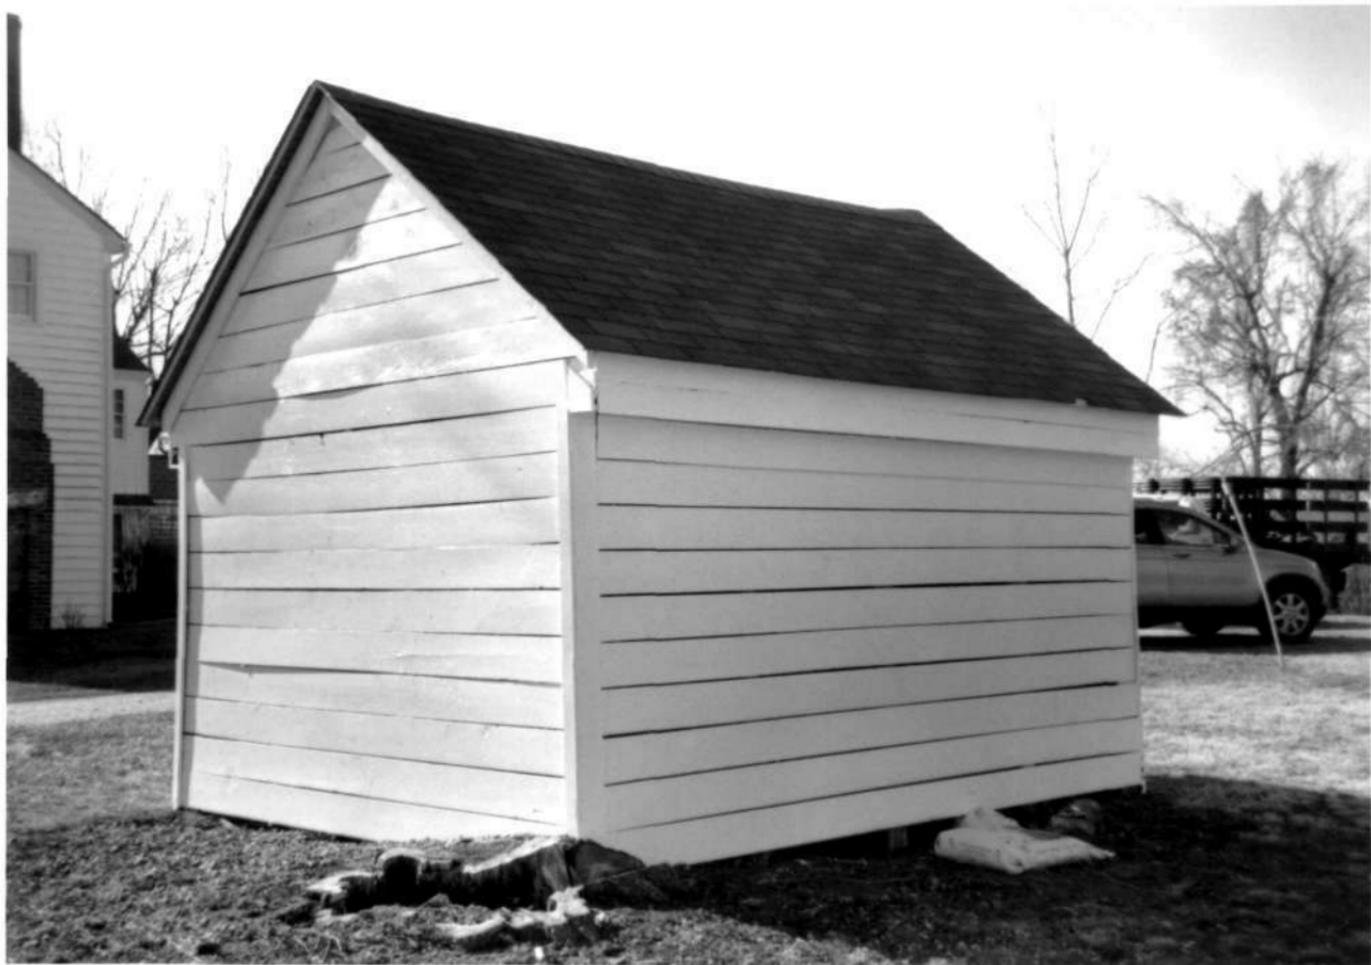
To the west of the dairy outbuilding, north of the oldest wing of the house is the property's meathouse. The meathouse is located just north of the gravel driveway before an extensive, rolling agricultural field. The meathouse is one-story, one-by-one bays with a steeply pitched, side-gable roof. The roof is clad with replacement asphalt shingles and has a boxed cornice return. The meathouse is of wood-plank construction. Although described as originally being clad with "random width feather edge weather board" the exterior appears to have been rewrapped with standard width machine cut wood weatherboard. The entry door is on the south façade; the door is board and batten with 'strap and loop' hinges. The meathouse on Letchworth's Chance is similar in form, massing, and location to the

meathouse on the neighboring Ireland Farm (CT-26). The meathouse is in good condition however has been altered with modern or reused materials.

Meat House Facade South

Meet House Elevation Northeast

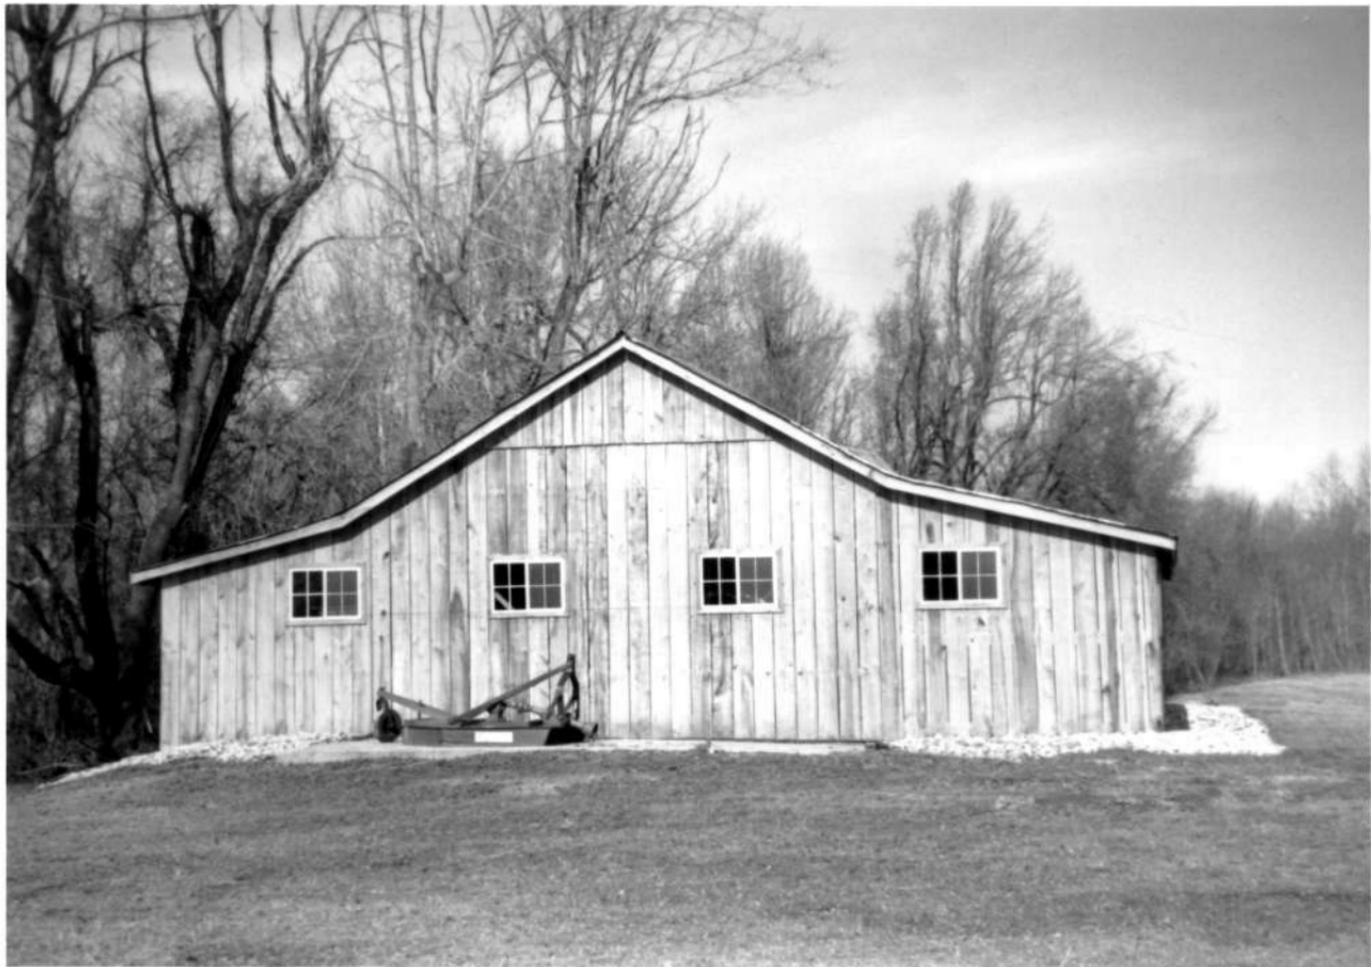
17 of 23

Northwest of the outbuildings, approaching the forest line is a modern shed that is non-contributing to the property. The location of the modern shed was chosen as the reconstruction of an existing equipment and machine shed buildings were converted to the modern shed. The shed has a front-gable roof with two shed-roof side bays on the east and west elevations. The roof is clad with corrugated metal sheets. The shed is of wood-frame construction and is clad with vertical wood boards. There are pairs of four-pane vinyl windows in each elevation.

Modern Shed Facade South

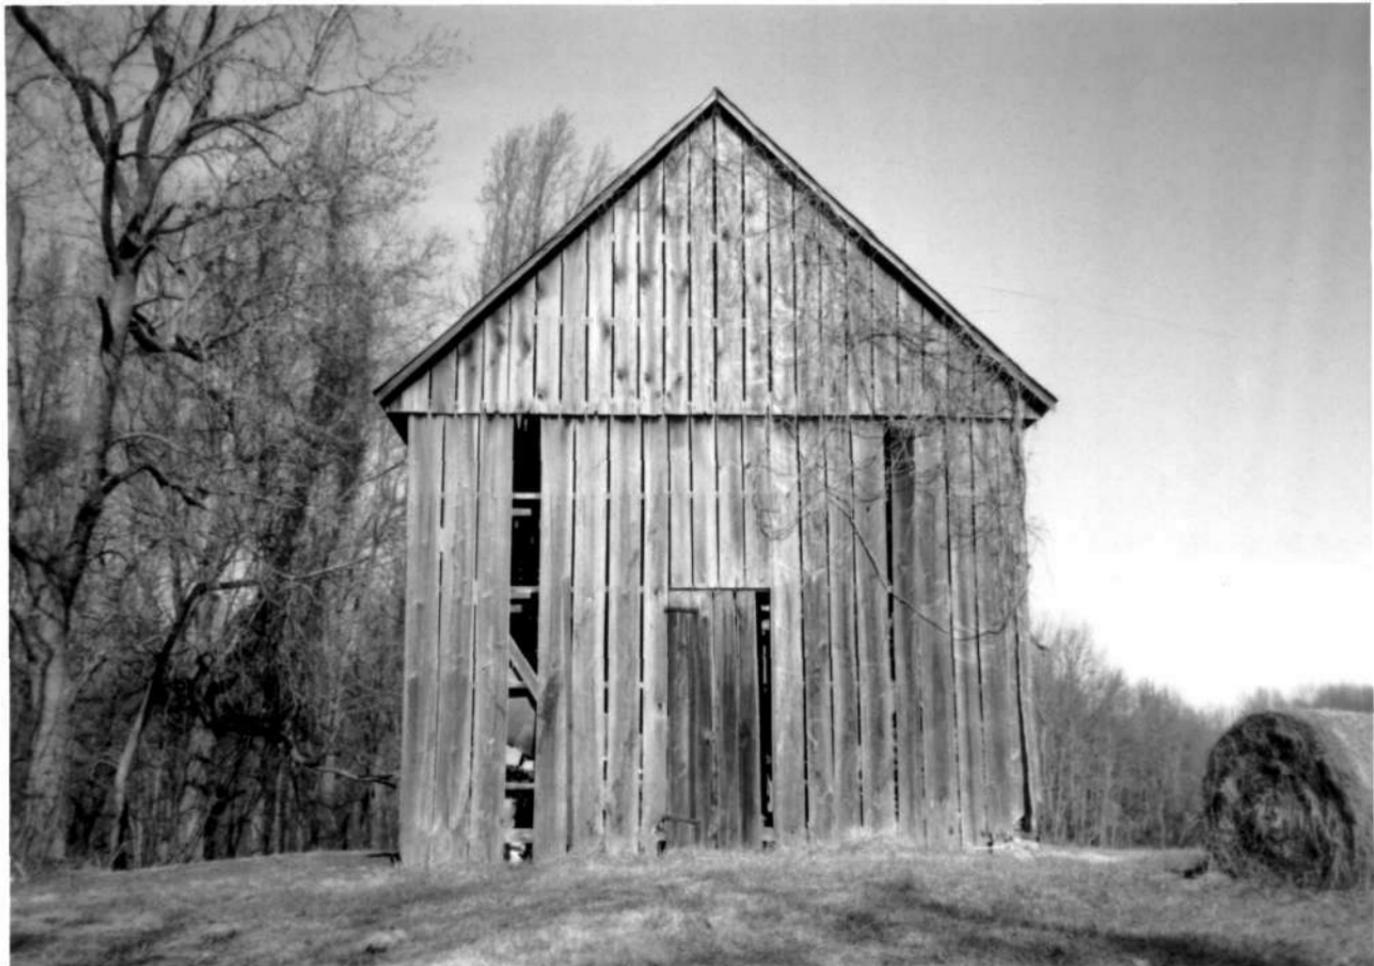
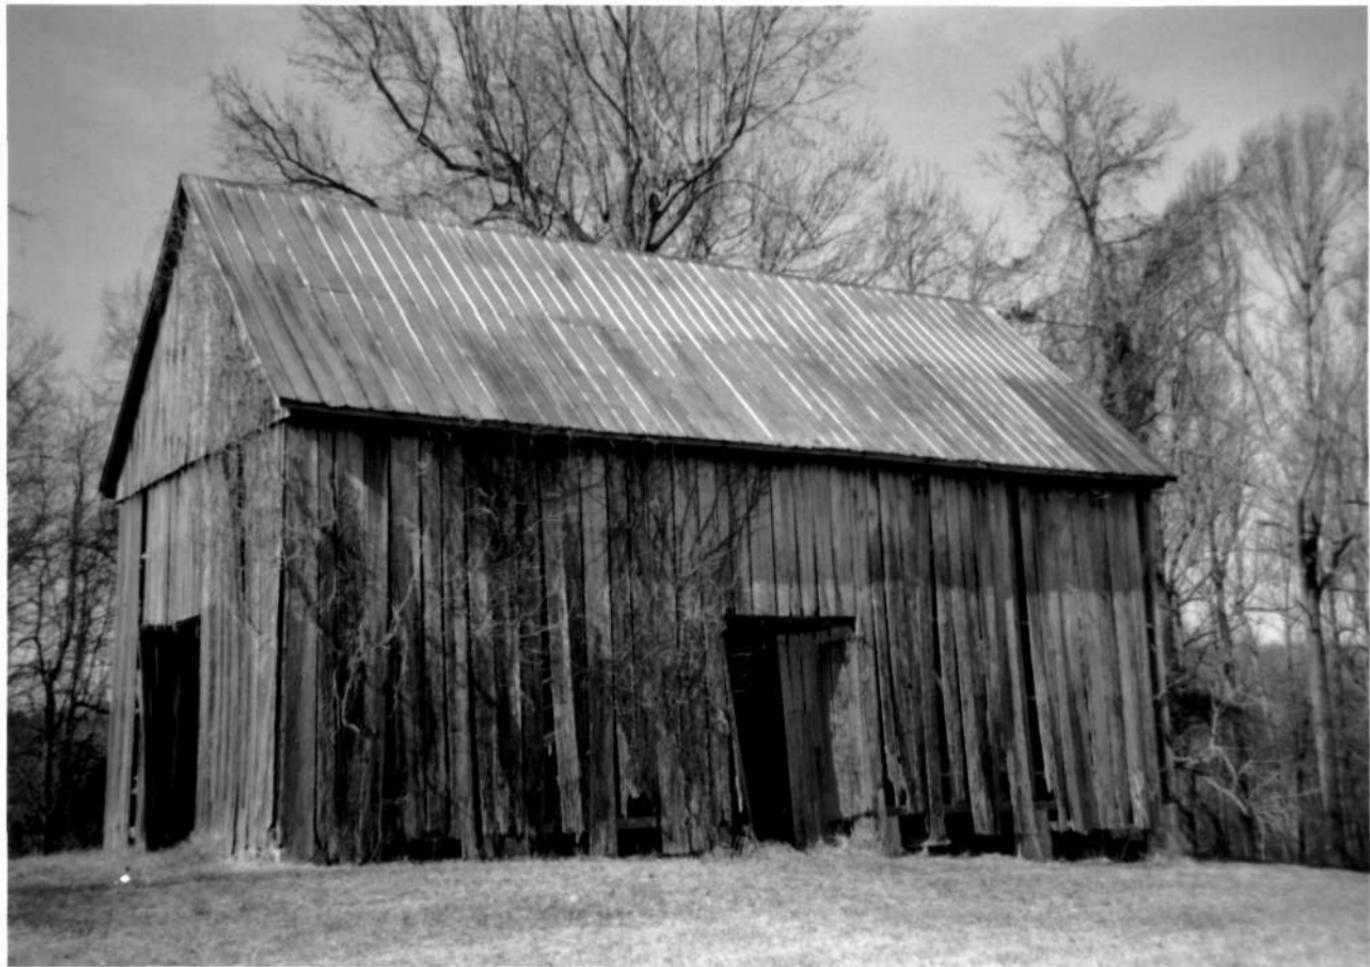
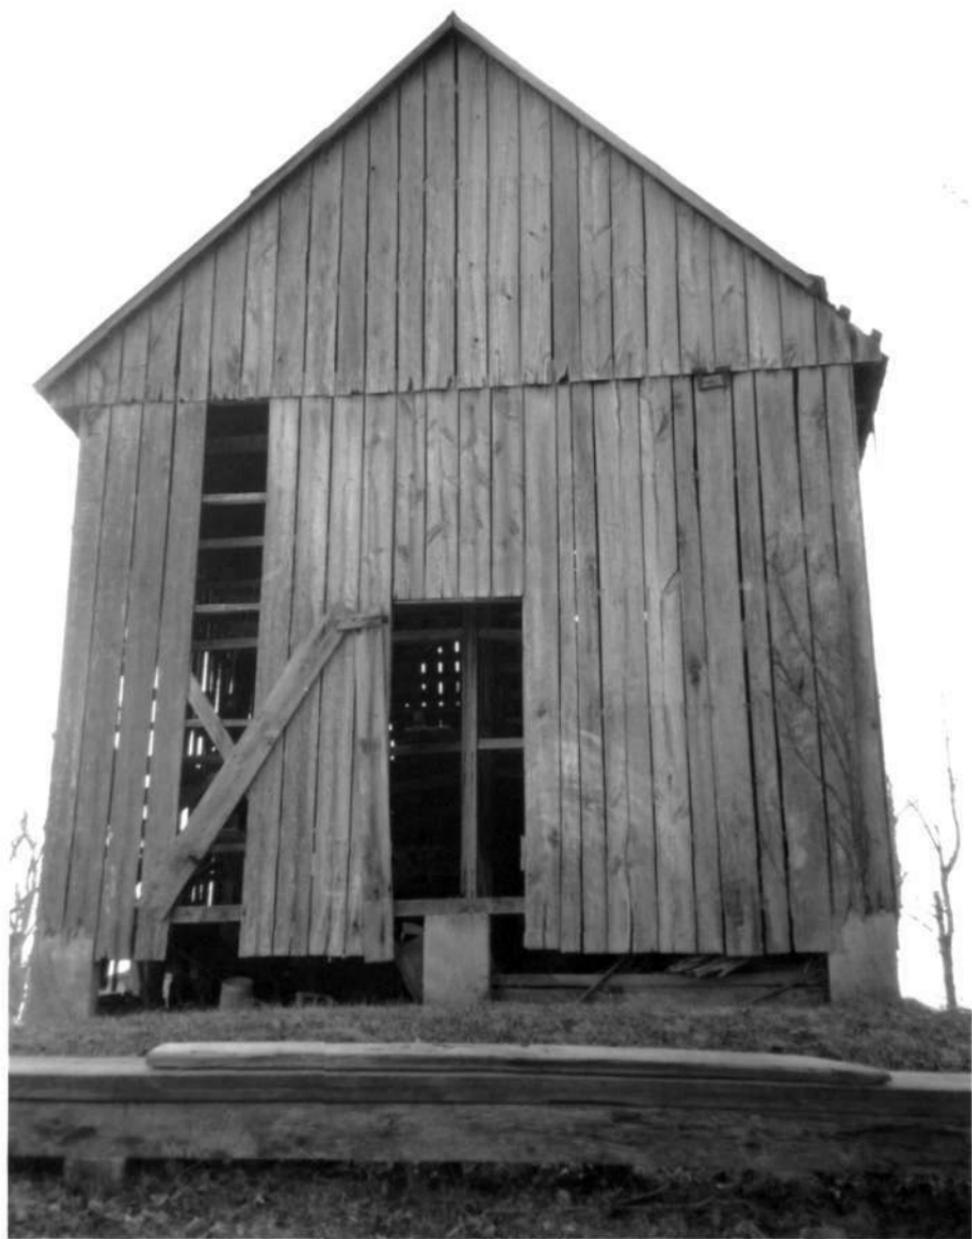
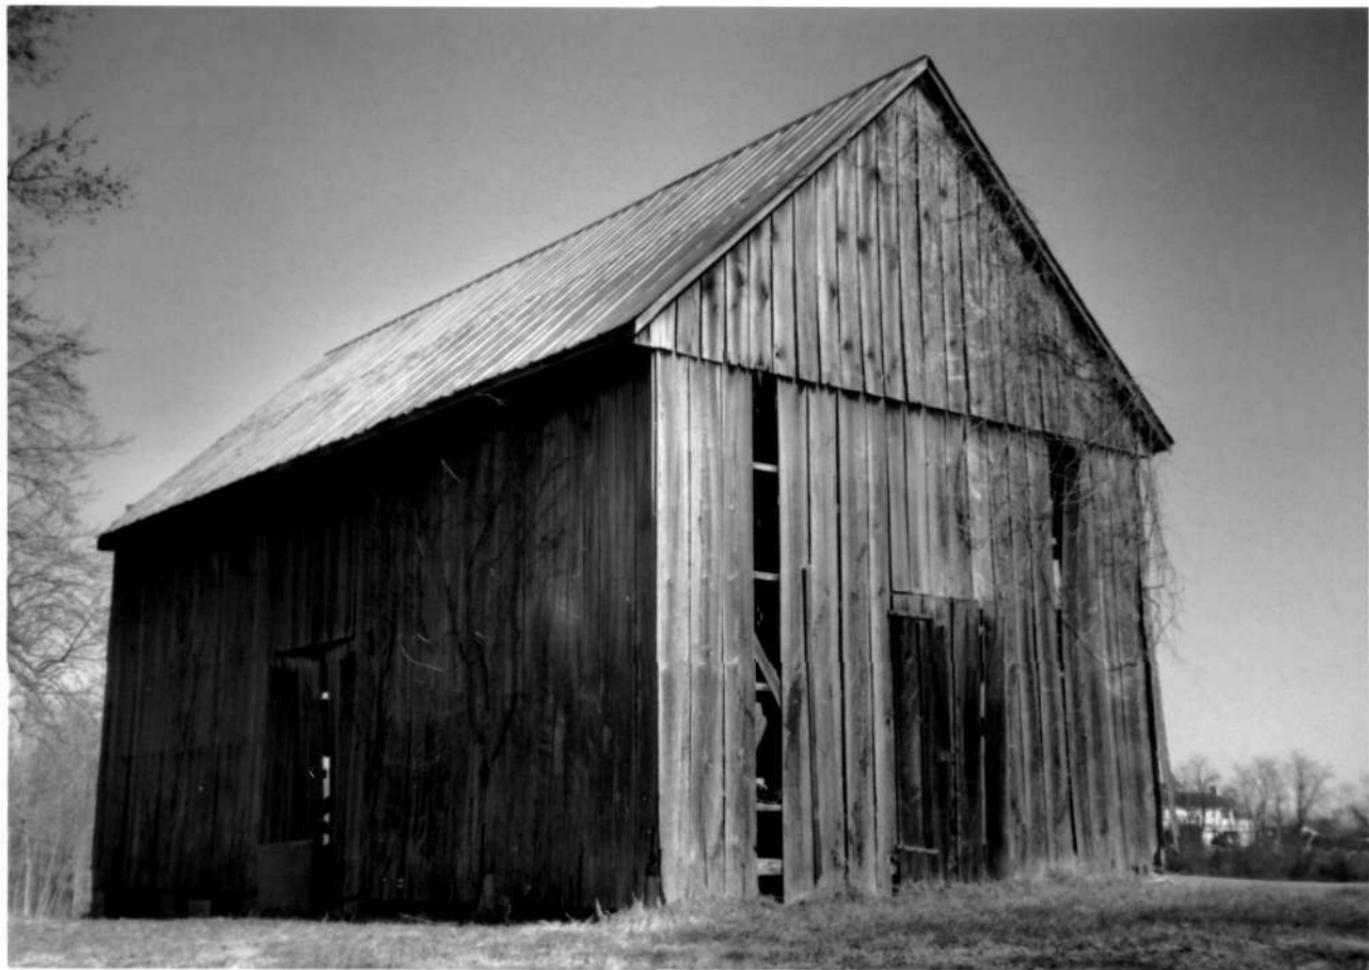
There is one extant tobacco barn on the Letchworth's Chance property.¹¹ It is located in the north agricultural field near the forest tree line to the west. It was built in the early-to mid-twentieth century for the purposes of drying tobacco.

The barn has a steeply pitched, metal standing seam, front-gable roof. The exterior is clad in machine-cut, vertical planks that are not flush and vary in width. Like many twentieth century tobacco barns, the barn's exterior vertical planks have ventilation doors. The barn is wood frame, the trussing system of drying poles is indicative of the barn's use as a tobacco barn. The stripping room was a separate structure southwest of the barn and has been demolished. The foundation is concrete block piers. There are single, batten, wood plank doors on the south façade and north elevations. There are double, batten wood plank doors on the east and west elevations. All doors are secured by a wooden latch. The doors sizes imply that it was not possible to drive modern, twentieth century farm equipment into the barn.

Tobacco barn Facade South

Tobacco barn Elevation East

Tobacco Barn Elevation North

Tobacco Barn Rehabilitation West

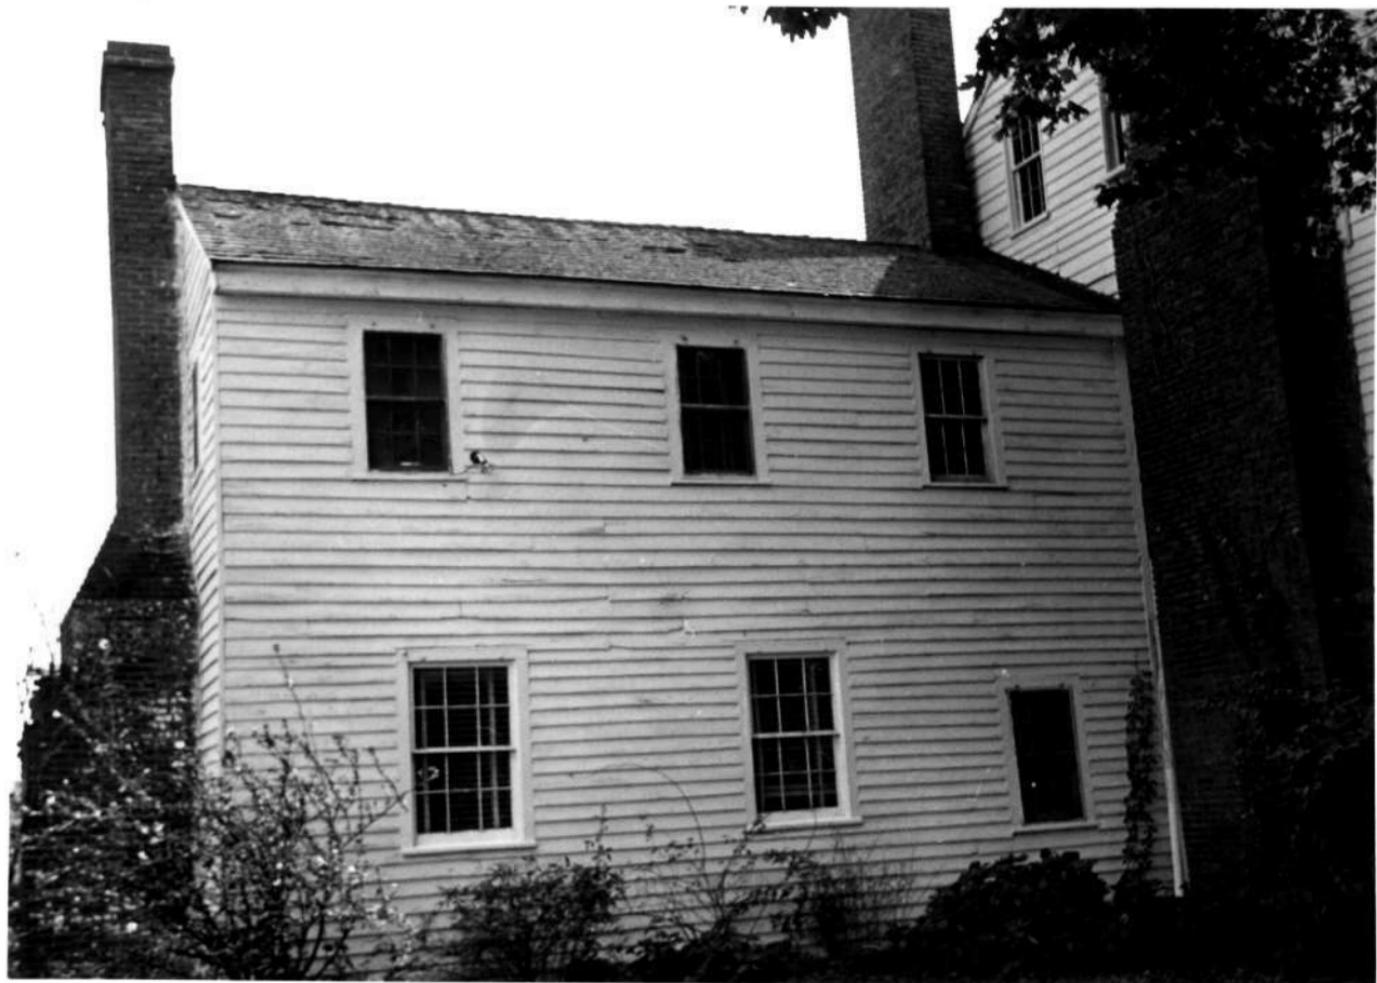
CT-25
REYNOLDS
CHANGE

W. FACADE OF
N. END
