CT-27

Baden-Anderson (Jones) House and Dairy Barn
1506 Wilson Road
Huntingtown, Calvert County, Maryland
Stacy Montgomery
The Ottery Group, Inc.
August 10, 2009

Section 7. Description

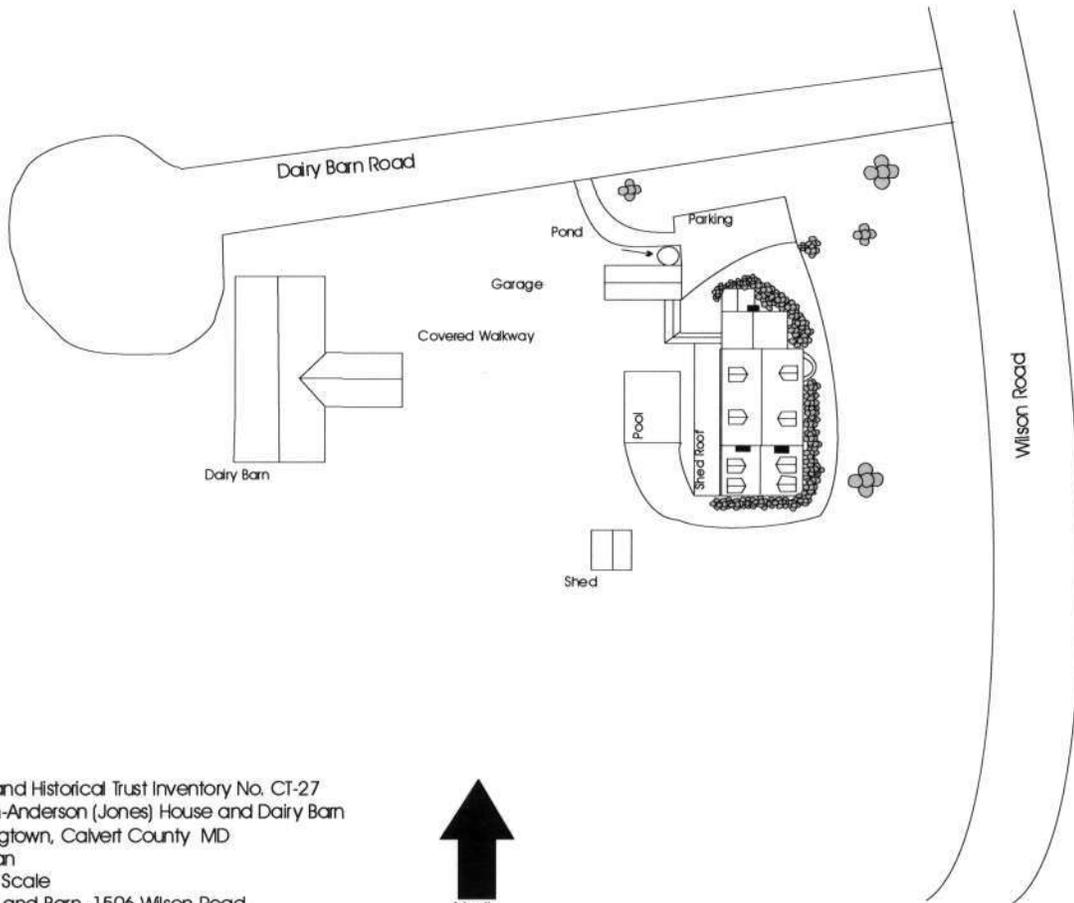
Maryland Historical Trust Inventory No. CT-27
Baden-Anderson (Jones) House and Dairy Barn
Huntingtown, Calvert County MD
Site Plan
Not to Scale
House and Barn, 1506 Wilson Road

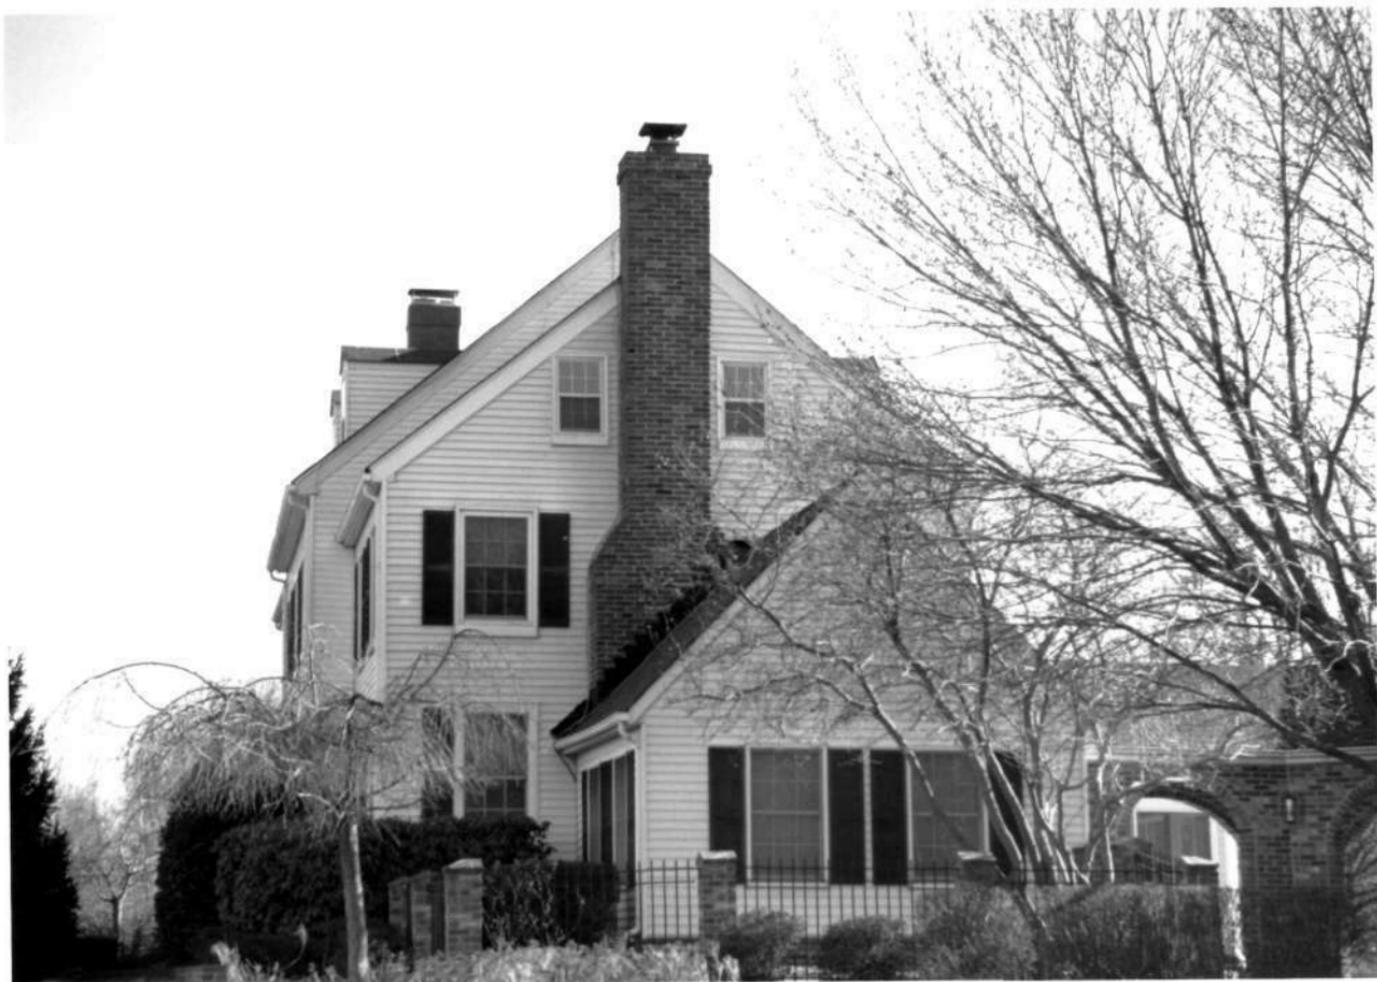
1 of 11

North Elevations

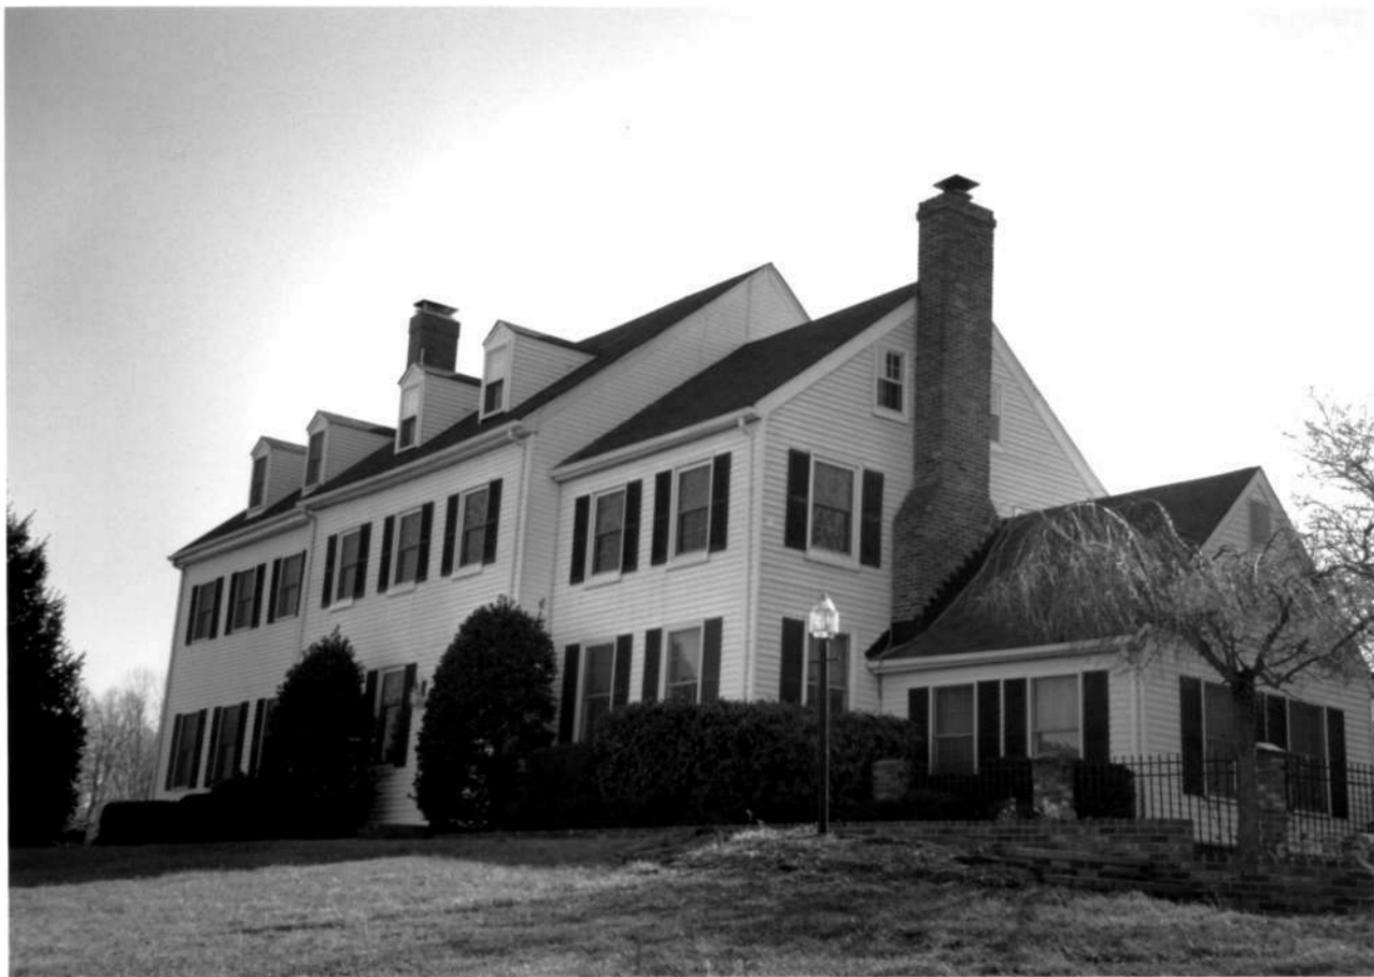
2 of 11

Northeast Elevation

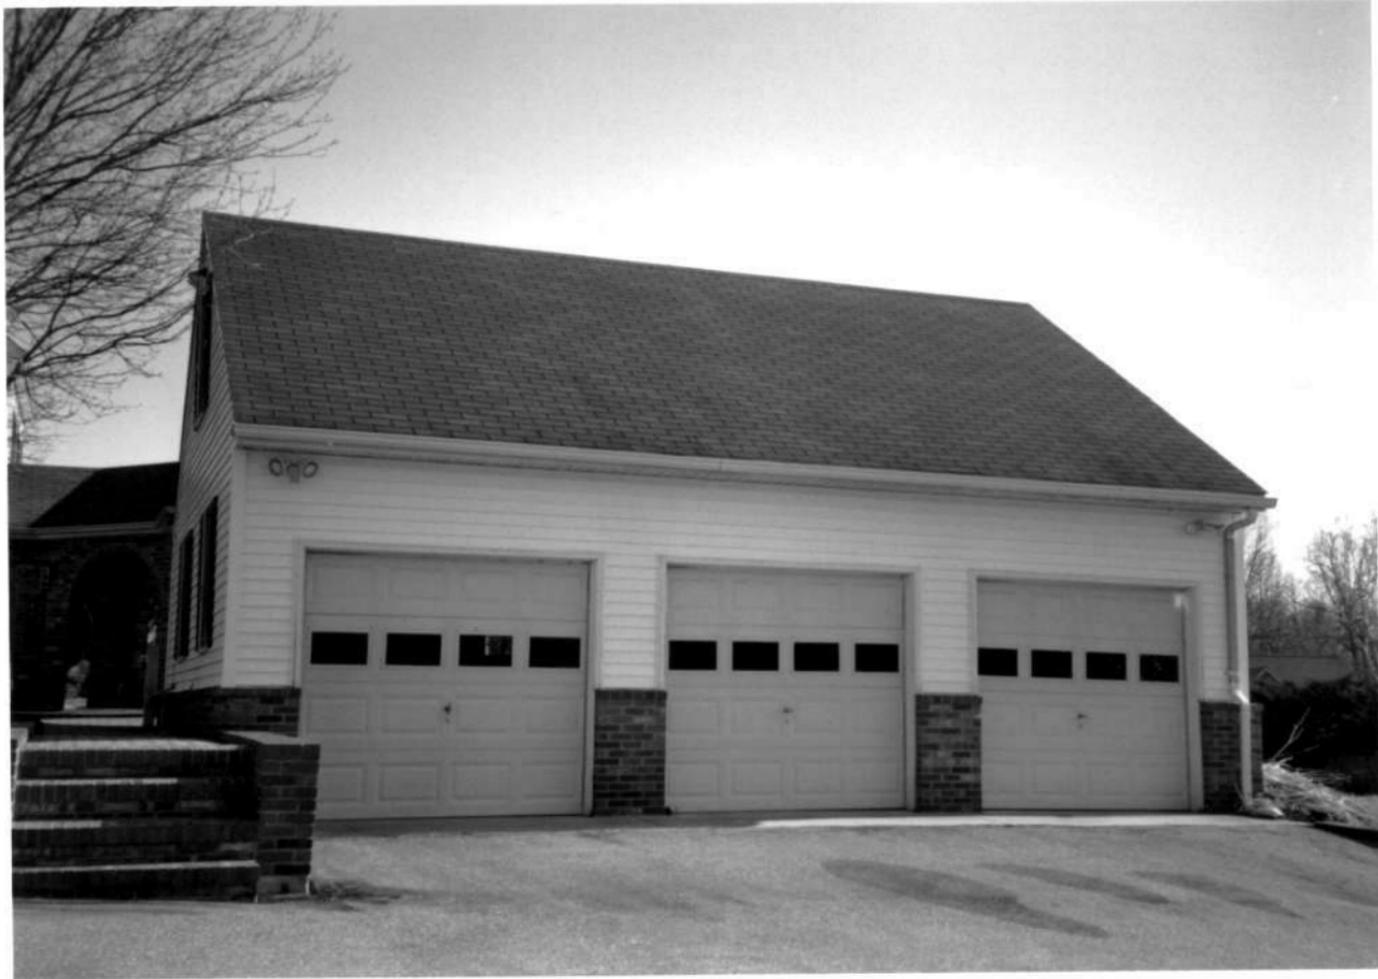
3 of 11

Garage (Non-contributing) North Elevation

There are two small outbuildings associated with the house, both of which are modern and non-contributing. The first is a three-by-two bay, one-story garage located to the north of the main house. The three-car garage has a side gable roof and is clad like the main house with a raised brick foundation and vinyl siding. The windows have shutters like the main house. The garage doors are each paneled and glazed with a string of lights near the top of each door. A brick covered walkway with arches leads from the house to the garage.

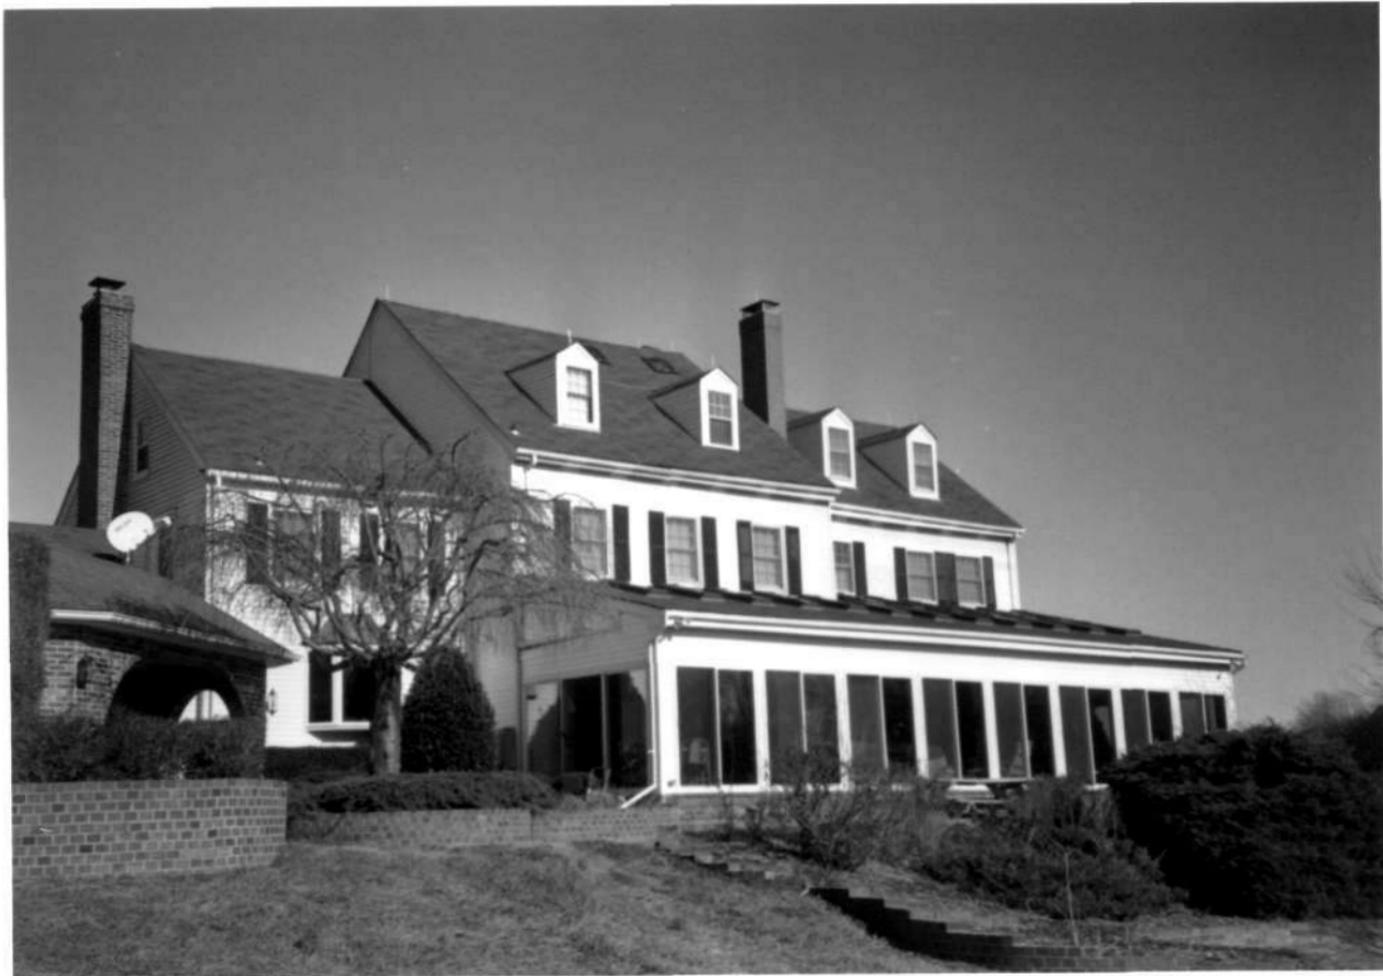
4 of 11

West Elevation

The fourth addition is a full-length, six-by-one bay, one story, shed-roof sunroom on the west elevation. The addition is clad like the house. A ribbon of sliding glass windows runs across the west elevation.

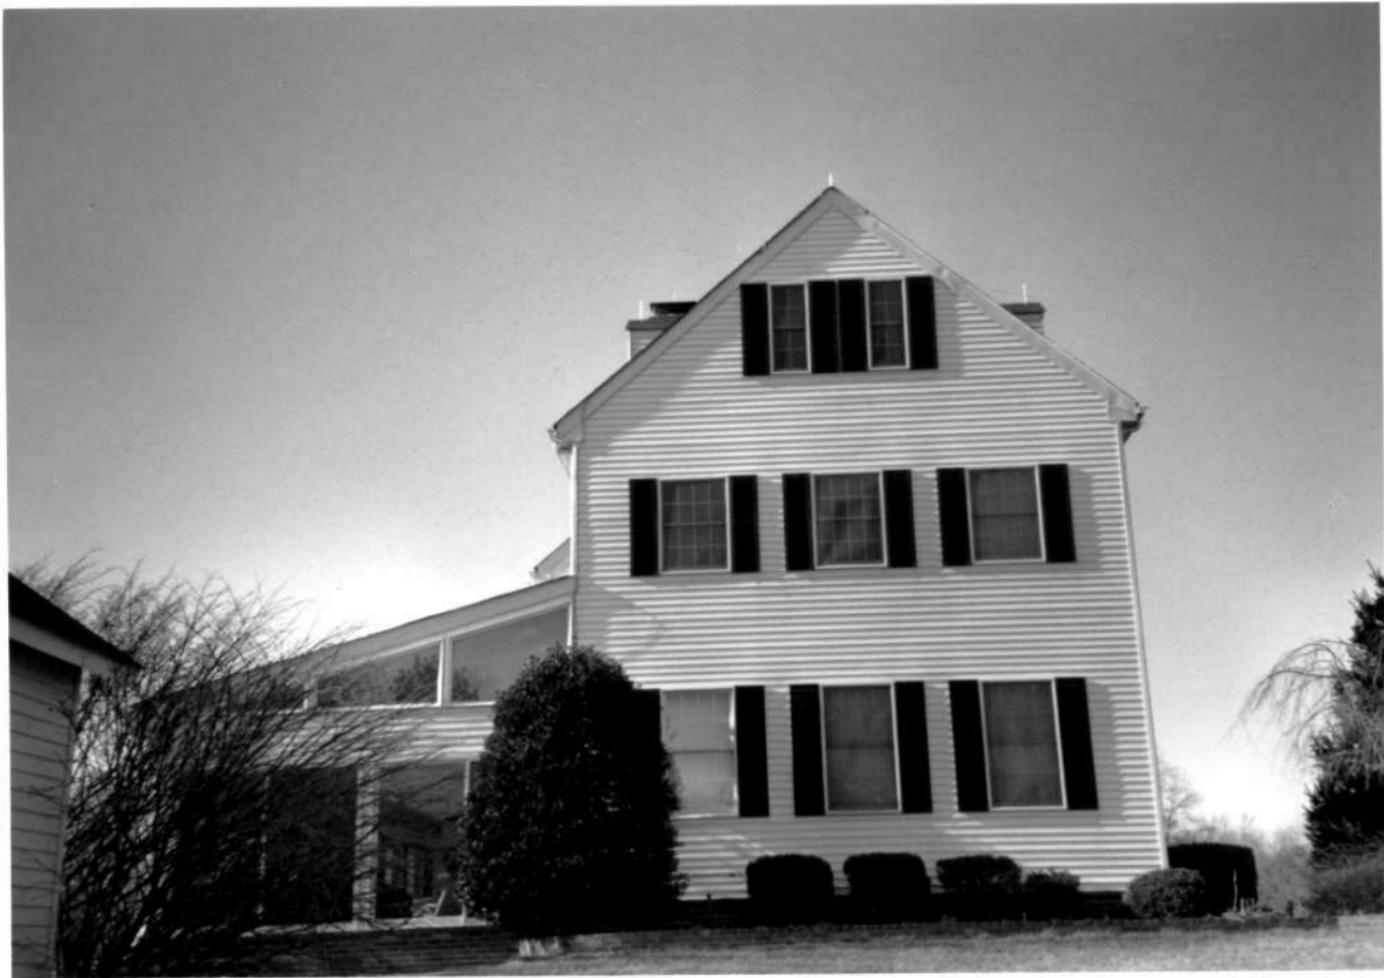
5 of 11

South Elevation

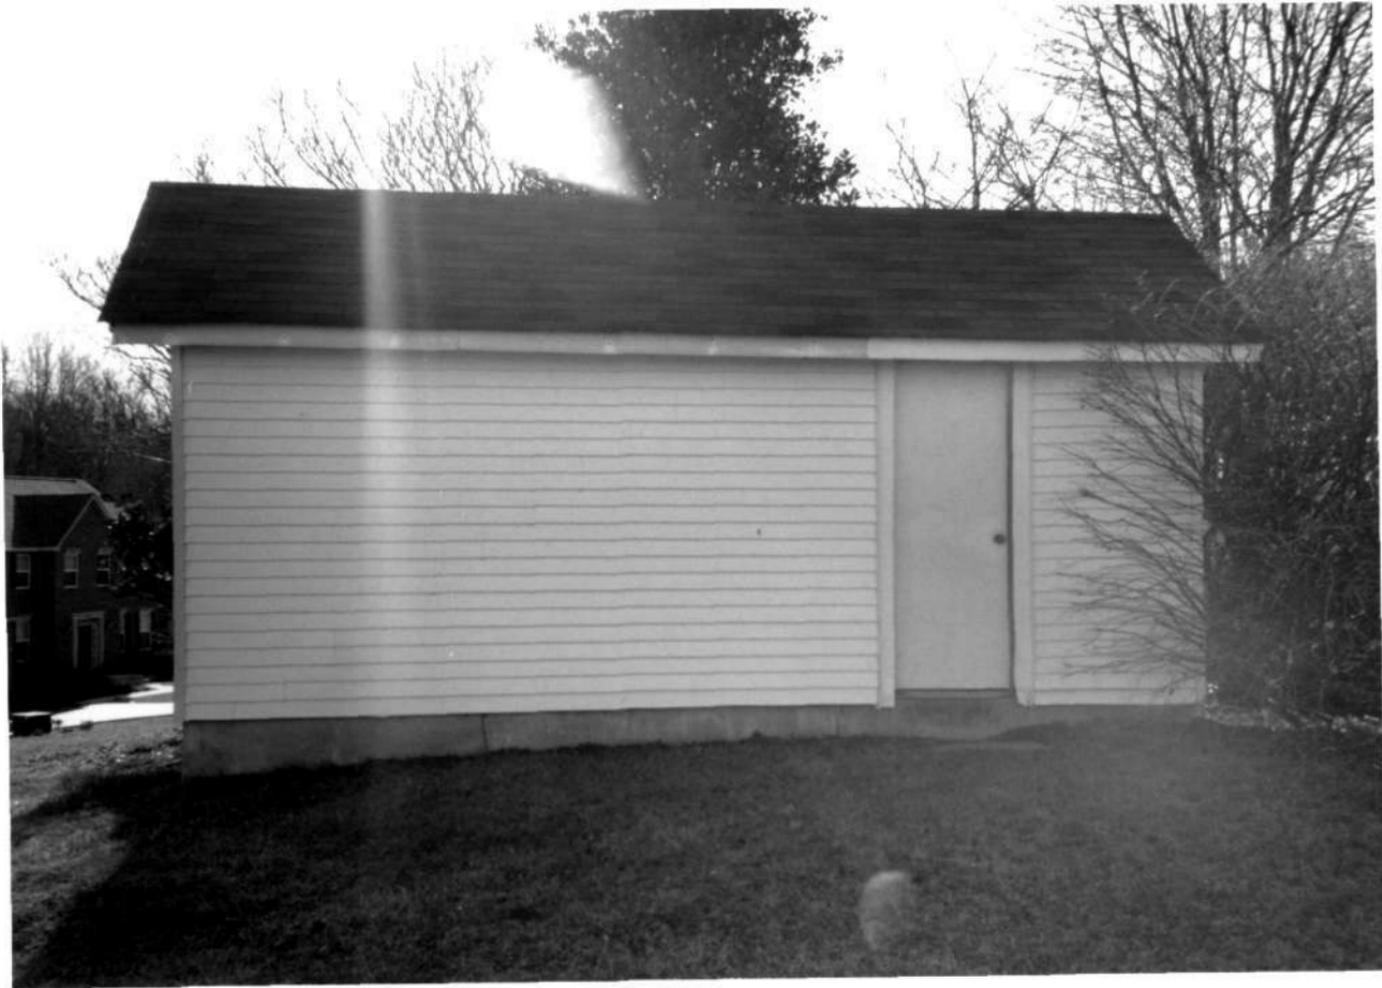
6 of 11

Shed East Elevation

The second outbuilding is a one-by-one bay, one-story shed that has a side gable roof and is clad like the house with a raised concrete foundation and vinyl siding. The entry door is flush and located on the east façade.

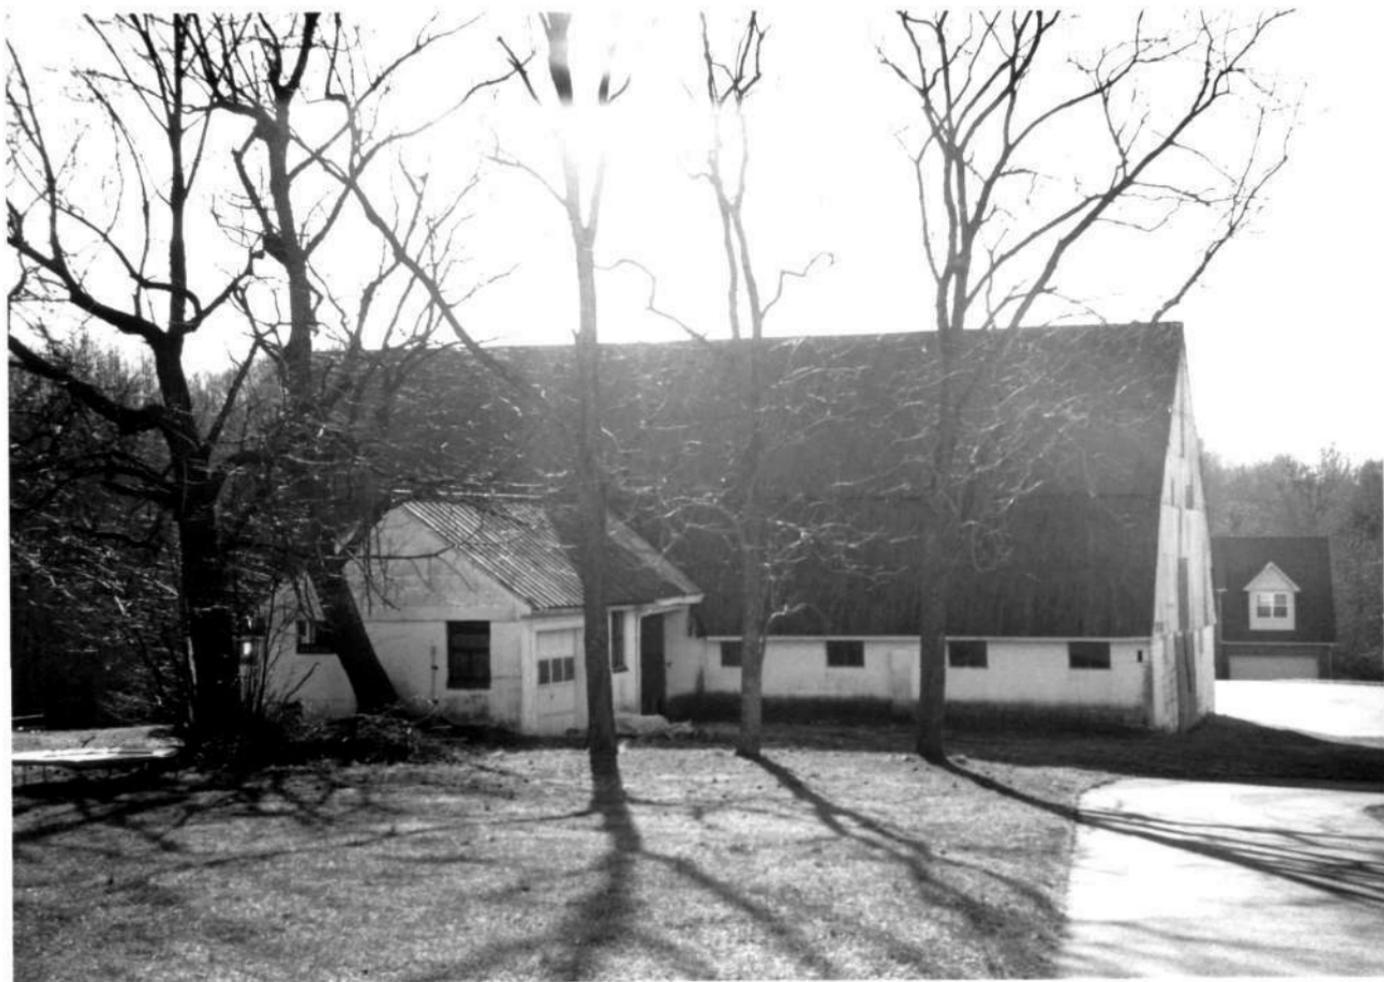
7 of 11

Dairy Barn East Elevation

The Baden-Anderson Dairy Barn is located to the northwest of the main house in a small, open field by the cul-de-sac of Dairy Barn Drive. The barn is a three-by-nine bay, two-story, rectangular double-aisle plan with a steeply pitched gambrel roof clad in corrugated metal on the top pitch and standing seam metal on the lower pitch. The roof has overhanging eaves and exposed rafter tails. The barn is concrete block construction with a concrete block foundation and exterior walls that extend to the roofline. The gambrel ends are clad in vertical wood siding attached with wire nails. Some boards have been replaced over time. There are two-pane, fixed metal windows in each bay of the east

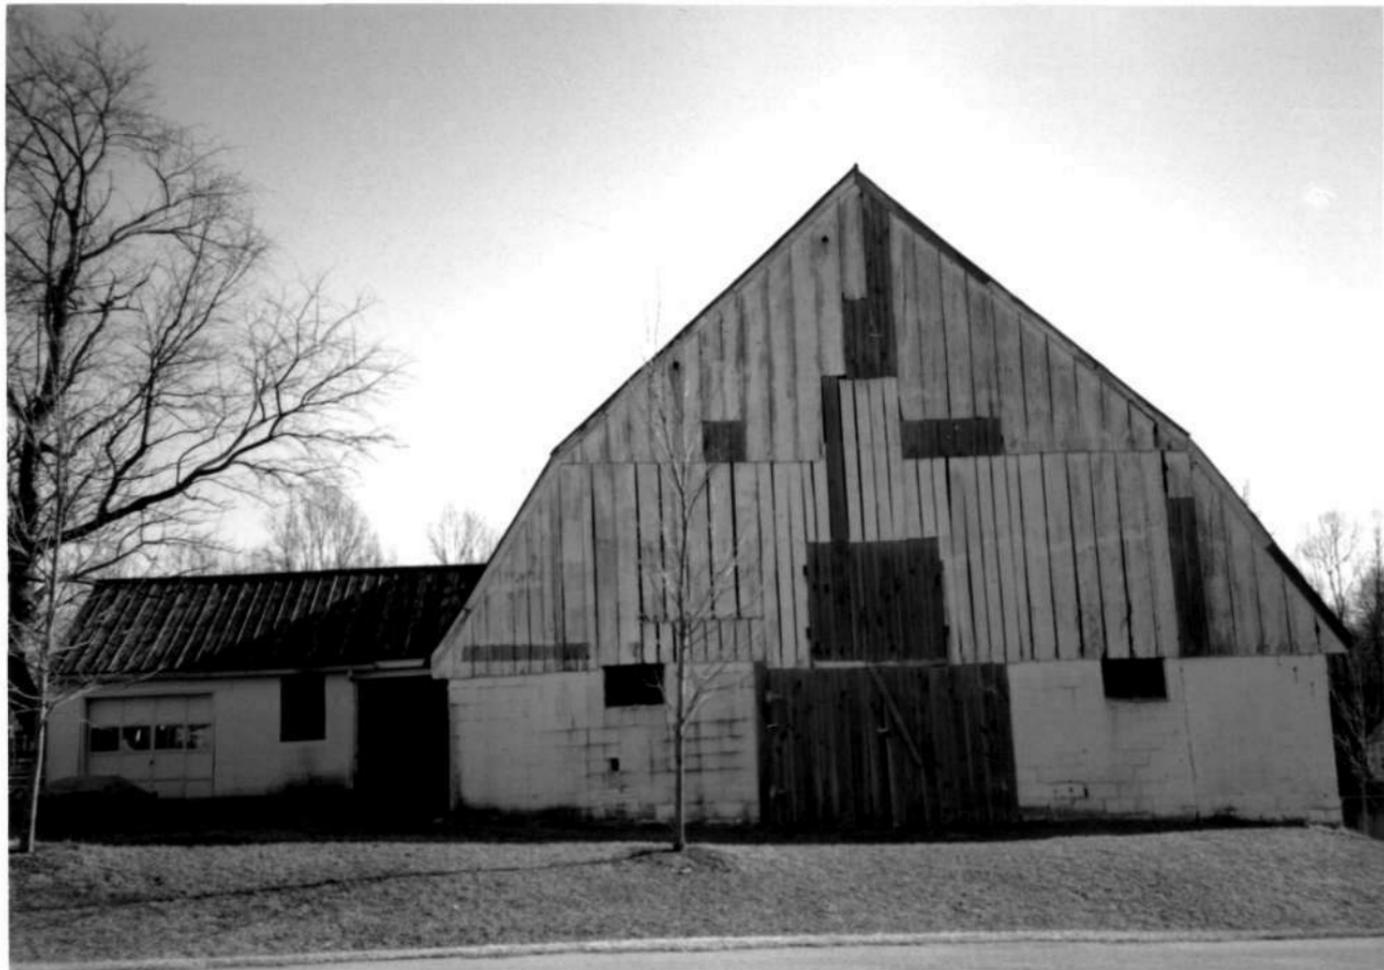
8 of 11 -

Dairy Barn North Facade

and west elevations, and surrounding the doors on the north and south elevations. There are paired vertical wood doors on the north and south elevations. The concrete block construction of the barn, the double entry doors, and the wire nails are an indication that the barn dates to the twentieth century, when standards for dairy farming were enforced and automobile use in farming was more common.

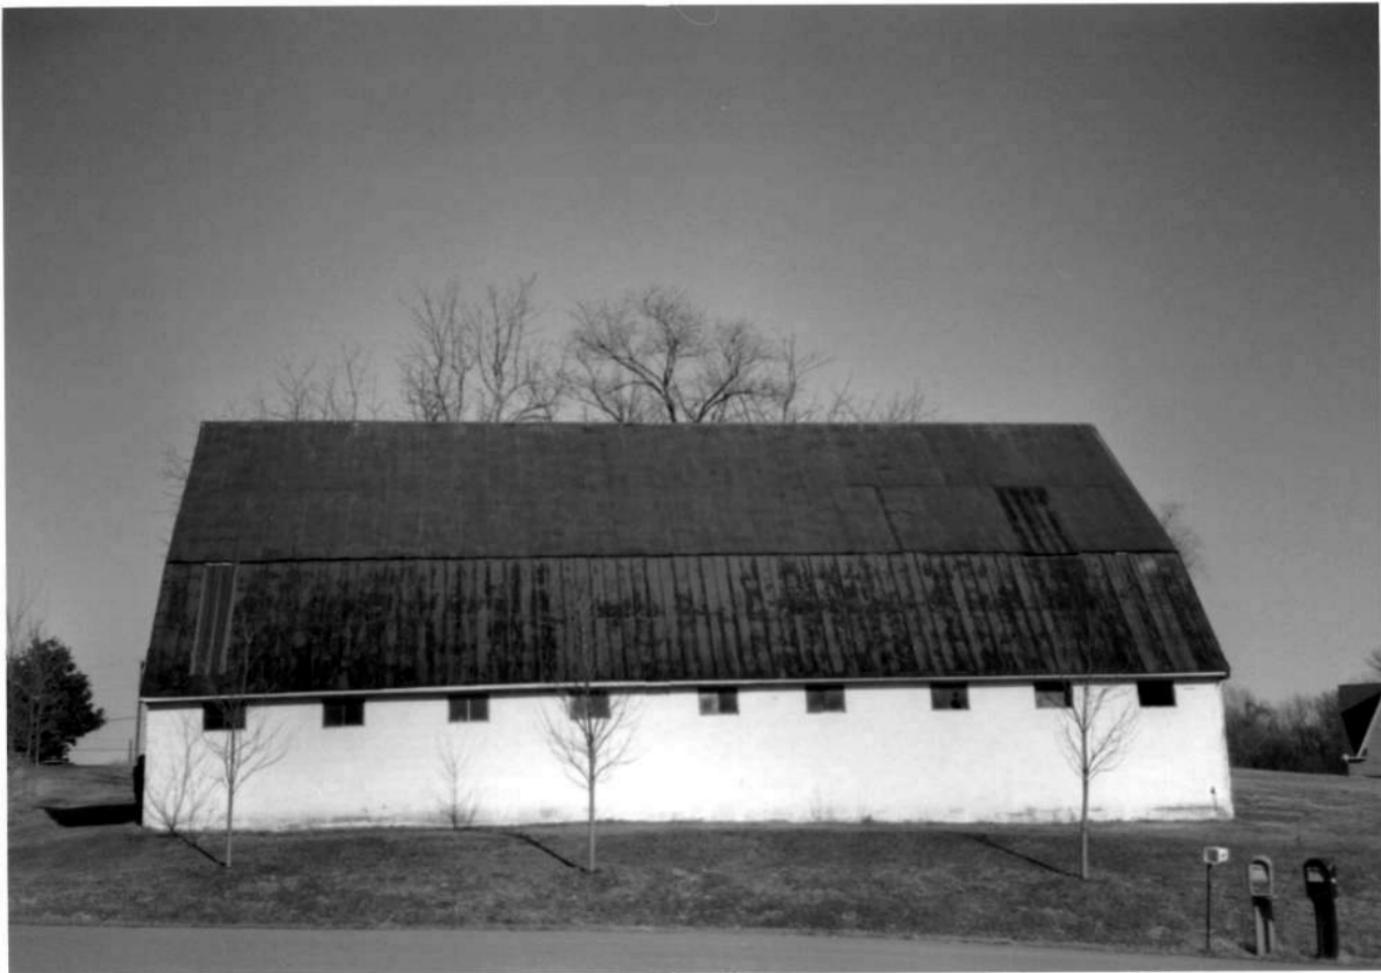
9 of 11

Dairy Barn West Elevation

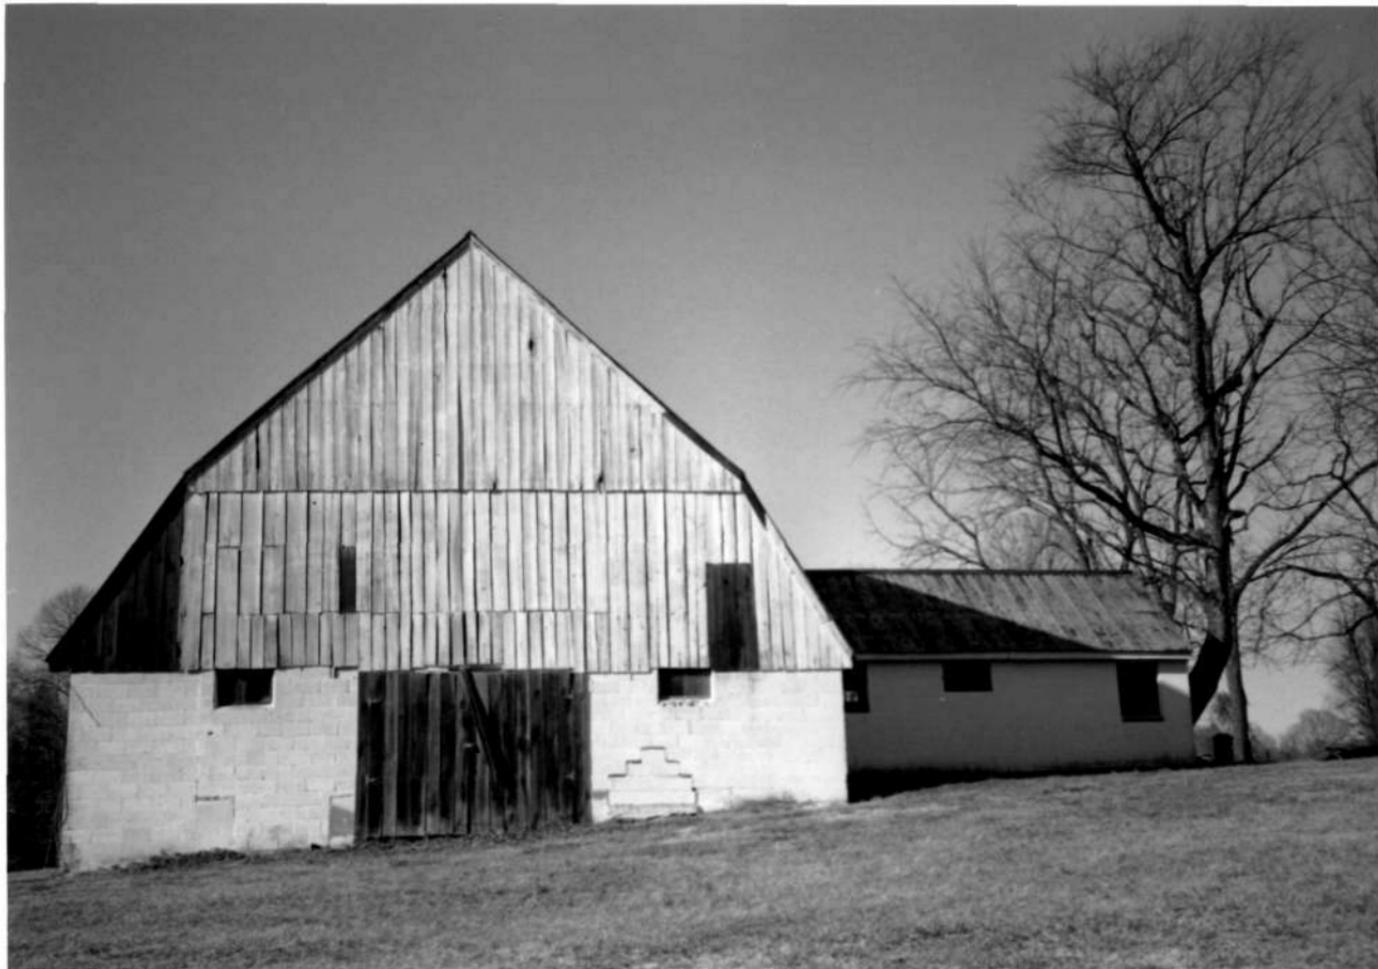
10 of 11

Dairy Barn South Elevation

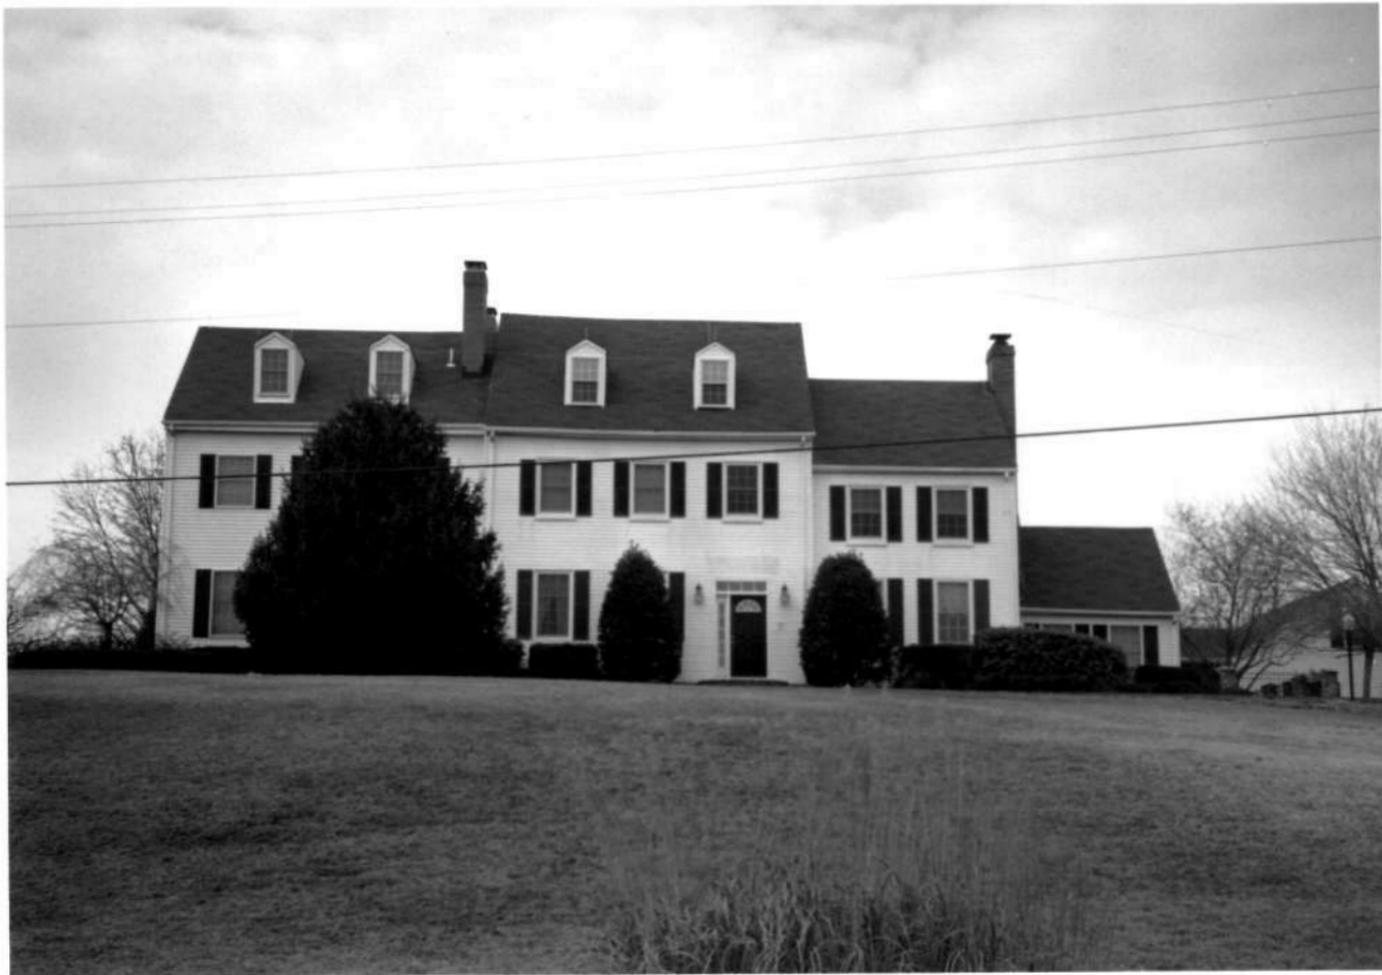
11 of 11

East Facade
