CT-296

Fannie Gibson House

INVENTORY FORM FOR STATE HISTORIC SITES SURVEY

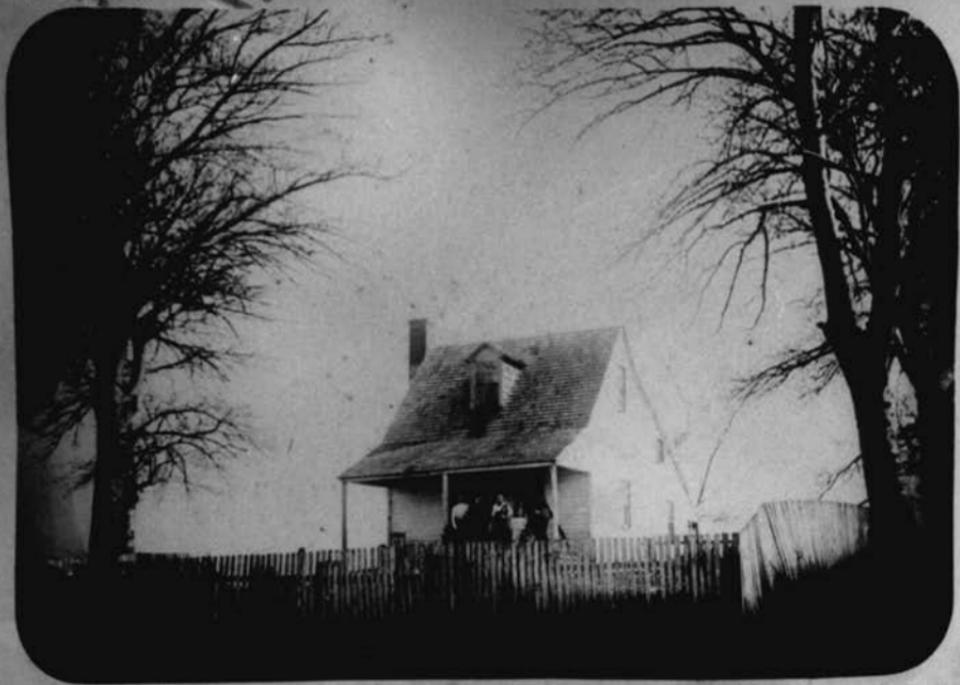
Fannie Gibson Hs.
(from old photo)

Although this appears to be a simple early 20th century frame house, an extant photograph shows the building's original appearance as a one-room, one-story cottage with a rear shed addition. Later another section was added to the south, and finally all three parts were raised to two full stories early in this century. The original rear addition sits over a stone cellar. The late 19th century photograph shows an exterior chimney and a single dormer. A picket fence surrounds the house, whose front porch shelters six people with their dog. An enormous contraption supporting a set of swings takes up most of the porch.

The original house was heated by a large exterior chimney at the north gable end. On the front elevation, a door occupied the north bay while a 9/6 sash window lit the south bay. This house comprised the north parlor and the stair hall of the present house. The south addition's interior chimney at the south end, visible in the attic, retains metal flashing for the gable of a 1 or 1½ story house.
