CT-44

LITTLE COVE FARM

INVENTORY FORM FOR STATE HISTORIC SITES SURVEY

**NATIONAL REGISTER OF HISTORIC PLACES  
INVENTORY -- NOMINATION FORM**

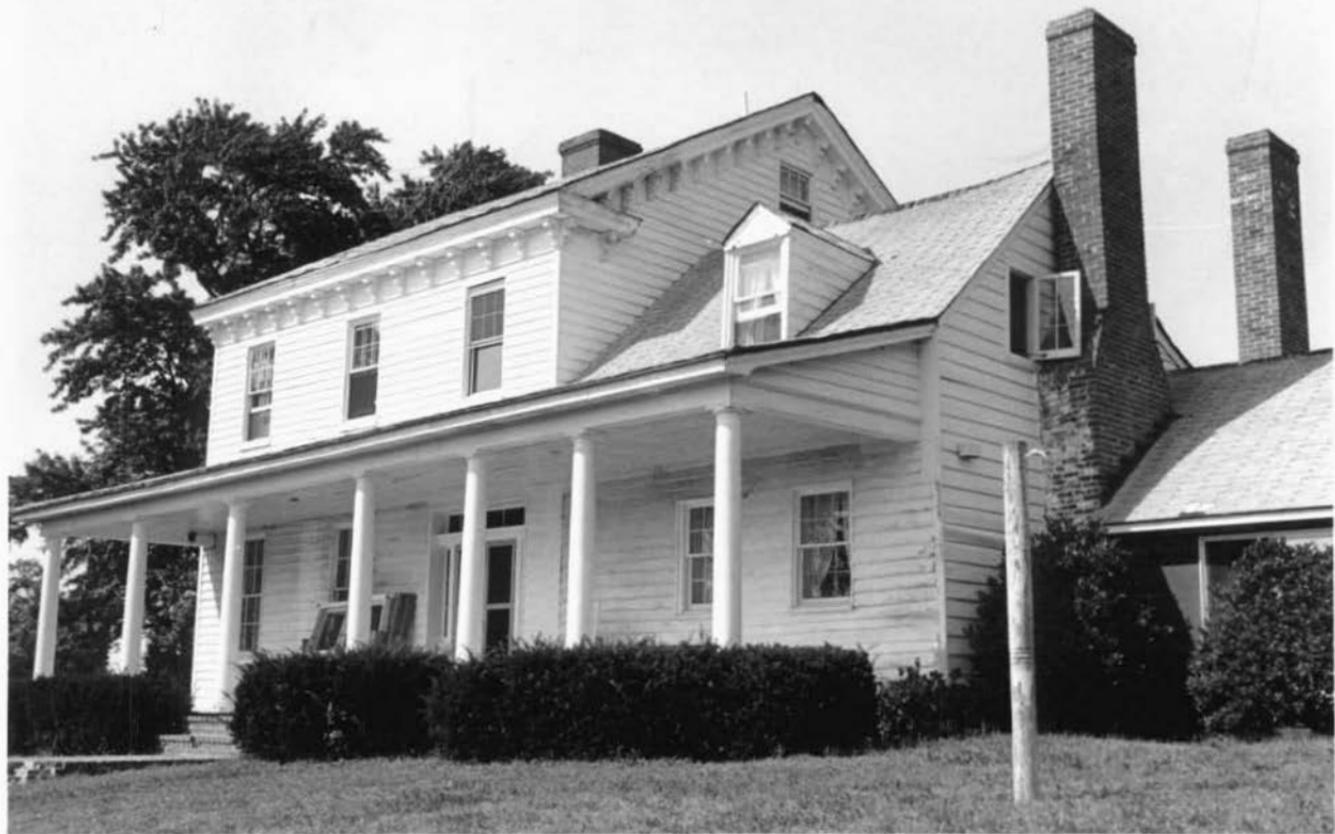
CT - 44

What is presumed to be the main entrance to this house is on the southwest (towards river) side. Large double doors are framed by a transom with sidelights. These are filled with rose colored glass which creates a specific mood, especially towards the end of the day. These doors and the single door at the opposite end of the hall (north) have an obvious advantage in the summer.

This is a large house with a rather gently sloping A-roof. It is 3 bays wide and 2 bays deep. All of the windows are 6/6 sashes. The door occupies the left front bay and has an overlight and sidelights. There is a heavy Greek Revival cornice with a row of elaborate brackets under it. There is an exterior brick chimney at the right end of the house which is separated from the wall.

LITTLE COVE FARM  
S.

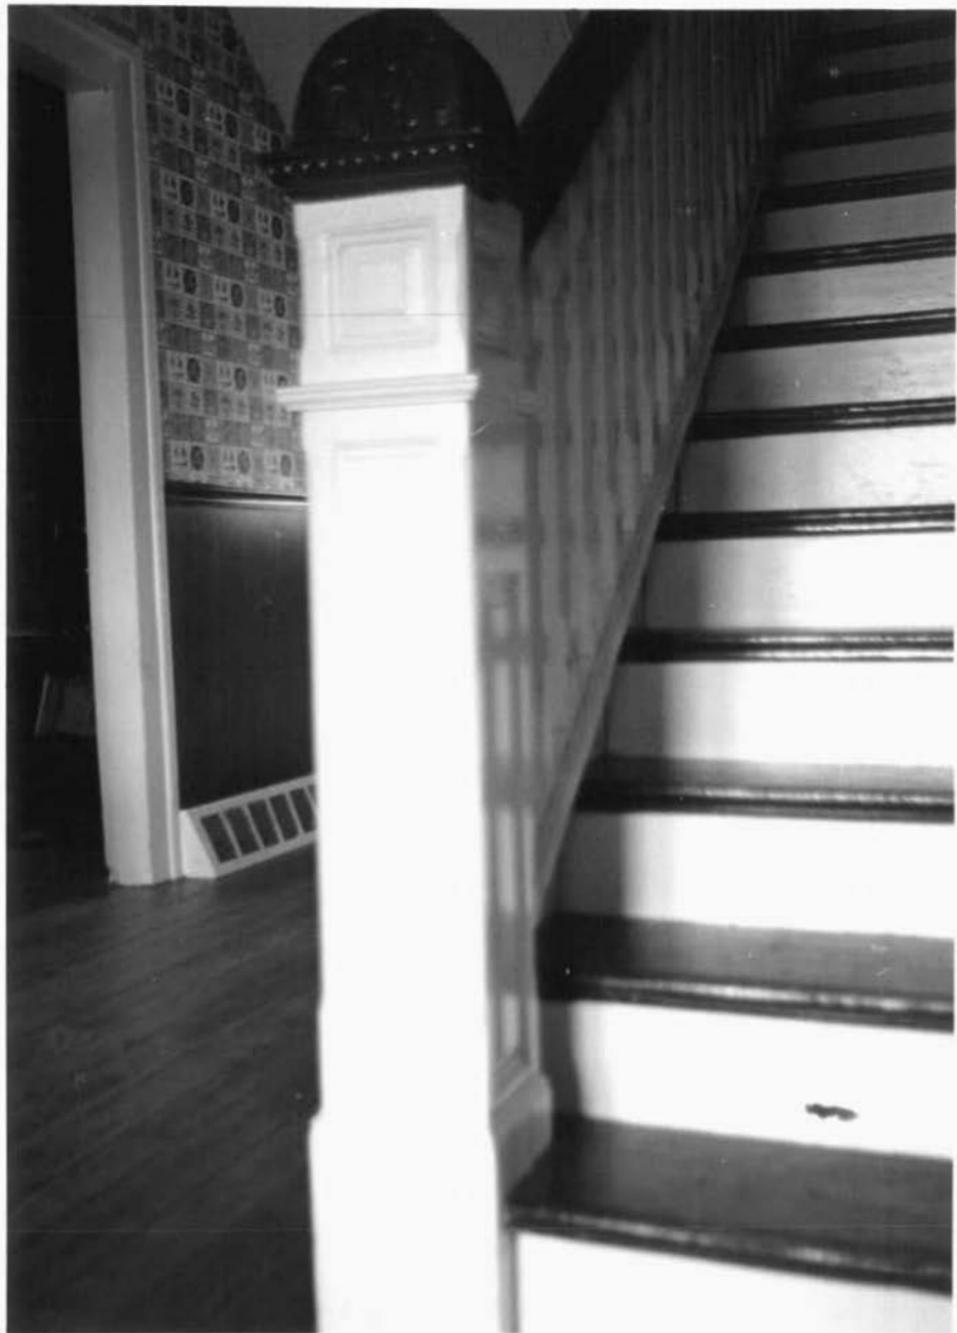
The portion of this house which literally and figuratively brings the east and west wings together is the hall. In many ways, it is the most architecturally expressive "room" of all. It features a grand staircase and entrances on opposite ends. One enters the old and the newer portions of the house by opposite side doors. The stairs have a panelled enclosure which contains a storage space. It is made nearly elegant by a newel post with an ornate oak cap that suggests the second Empire by its rounded Mansard Shape. These stairs serve all three levels where there are a total of four bedrooms. All but one of these has its own fireplace.

CT-44  
LITTLE COVE FARM  
INT. OF HALL
