**MARYLAND HISTORICAL TRUST  
DETERMINATION OF ELIGIBILITY FORM**

Property Name: Parran's Park Inventory Number: CT-58  
 Address: 1650 Calvert Cliffs Parkway Historic district:  yes  no  
 City: Lusby Zip Code: 20657 County: Calvert  
 USGS Quadrangle(s): Cove Point  
 Property Owner: Constellation Energy Tax Account ID Number: 000578  
 Tax Map Parcel Number(s): 9 Tax Map Number: 35  
 Project: Phase I Cultural Resources Survey Agency: NERC  
 Agency Prepared By: GAI Consultants, Inc.  
 Preparer's Name: Matthew G. Hyland Date Prepared: 3/9/2007  
 Documentation is presented in: Phase IB Cultural Resources Investigation

LOCATION OF  
CT-58 PARRAN'S PARK  
CALVERT CLIFFS NUCLEAR  
POWER PLANT PROJECT

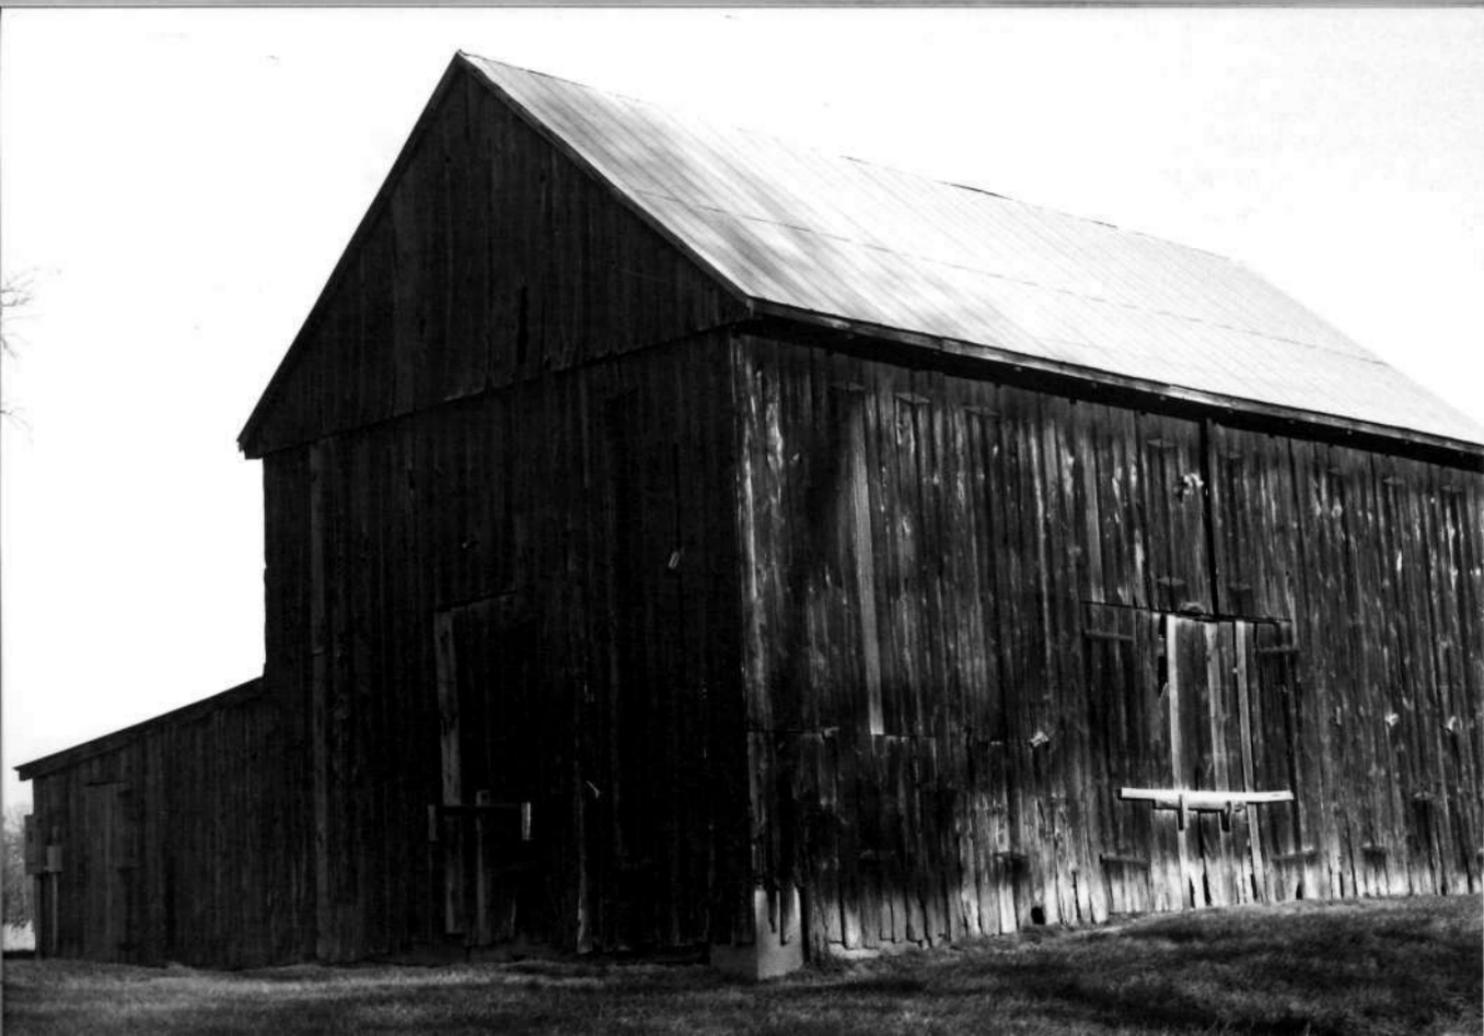
1 of 6

CT-58  
Structure #3  
Parron's Park  
Calvert County MD  
Matthew G. Hyland  
December 2006  
M.D. S.H.P.O.

SW & SE elevations of tobacco barn,  
facing N

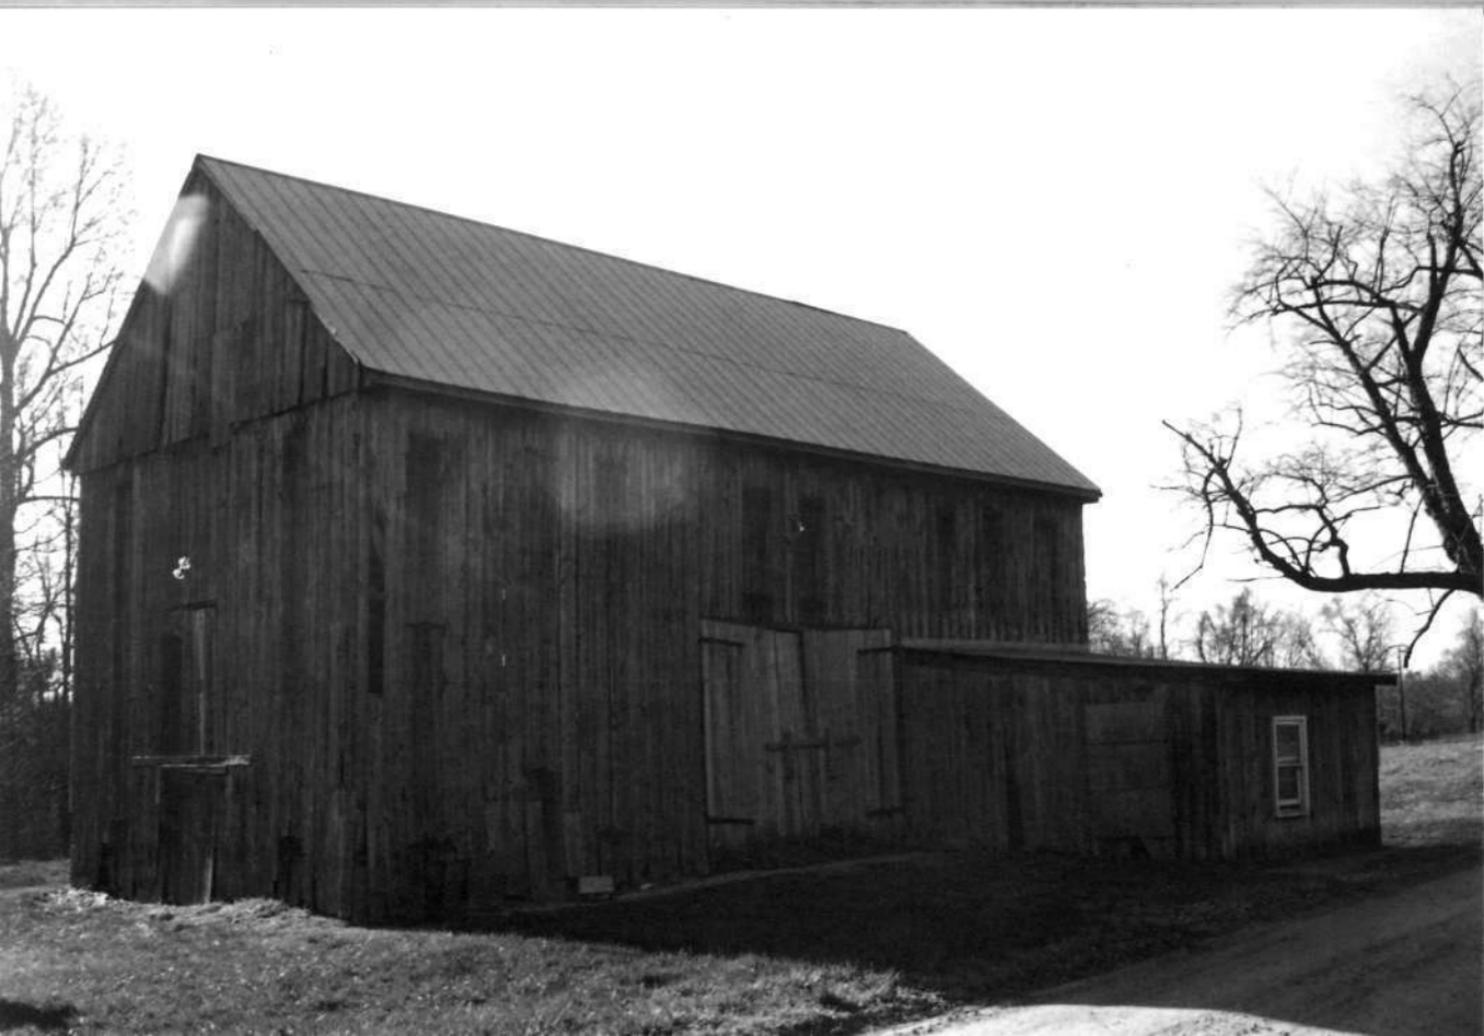
2 of 6

ET - 58  
Structure #3  
Carron's Park  
Calvert County, MD  
Matthew J. Hyland  
December 2006  
M D S H P U

NW + NE elevations of tobacco  
barn, facing S

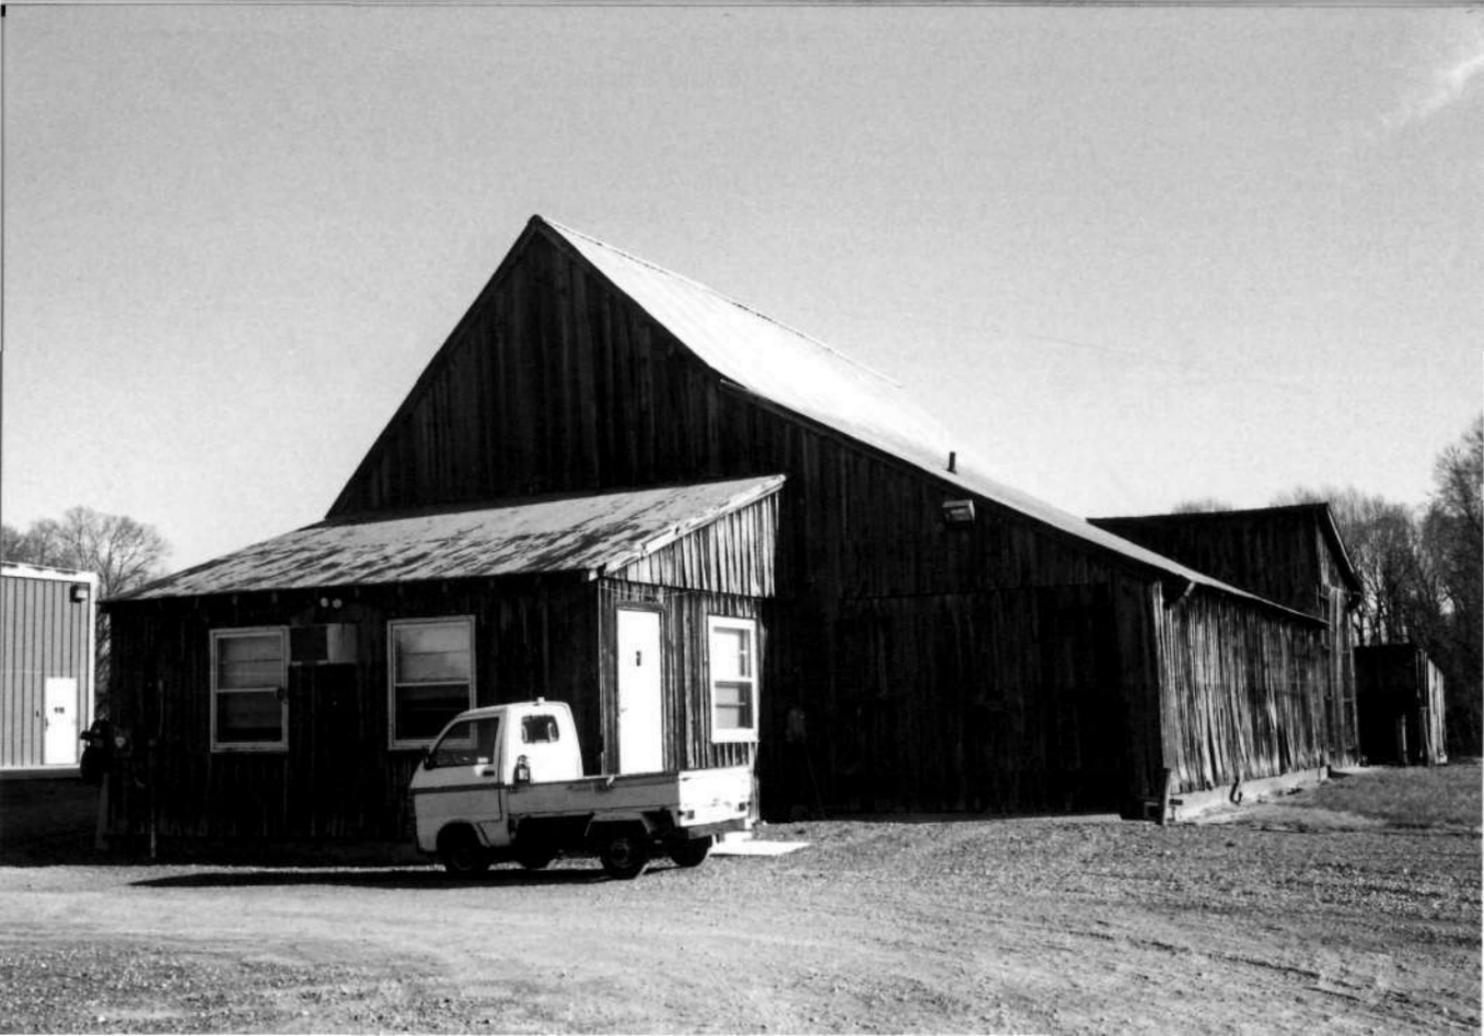
3 96

Structure #4 at CT-58, which dates from the early twentieth century, is a gable-roof building framed with wood and standing on a continuous concrete block foundation. In the past, it was used as a tobacco barn. Presently, Structure #4 is three-bays wide and four-bays deep. Entrance apertures have been let into each elevation. Structure #4 is clad in vertical wood siding planks and roofed wood rafters (whose tails are covered with fascia boards) with corrugated metal. The doorway apertures and siding planks feature metal strap hinges. One-story, shed-roof additions (perhaps a former stripping room or prize room) have been appended to the northeast, southeast, and southwest elevations. The additions feature exposed rafter tails. The fenestration of the southwest addition consists of two-over-two, double-hung, wood sash windows. Poured concrete ramps and improved foundations have been built to allow vehicle access to the former tobacco barn. Updates to the barn also include the installation of utilities, as the building also serves as a small office for fire suppression teams at the nuclear power plant.

CT-58  
Structure #4  
Parson's Park  
Calvert County, MD  
Matthew S. Hyland  
December 2006  
MD S&PO

SW + S elevations of tobacco  
barn, facing NE

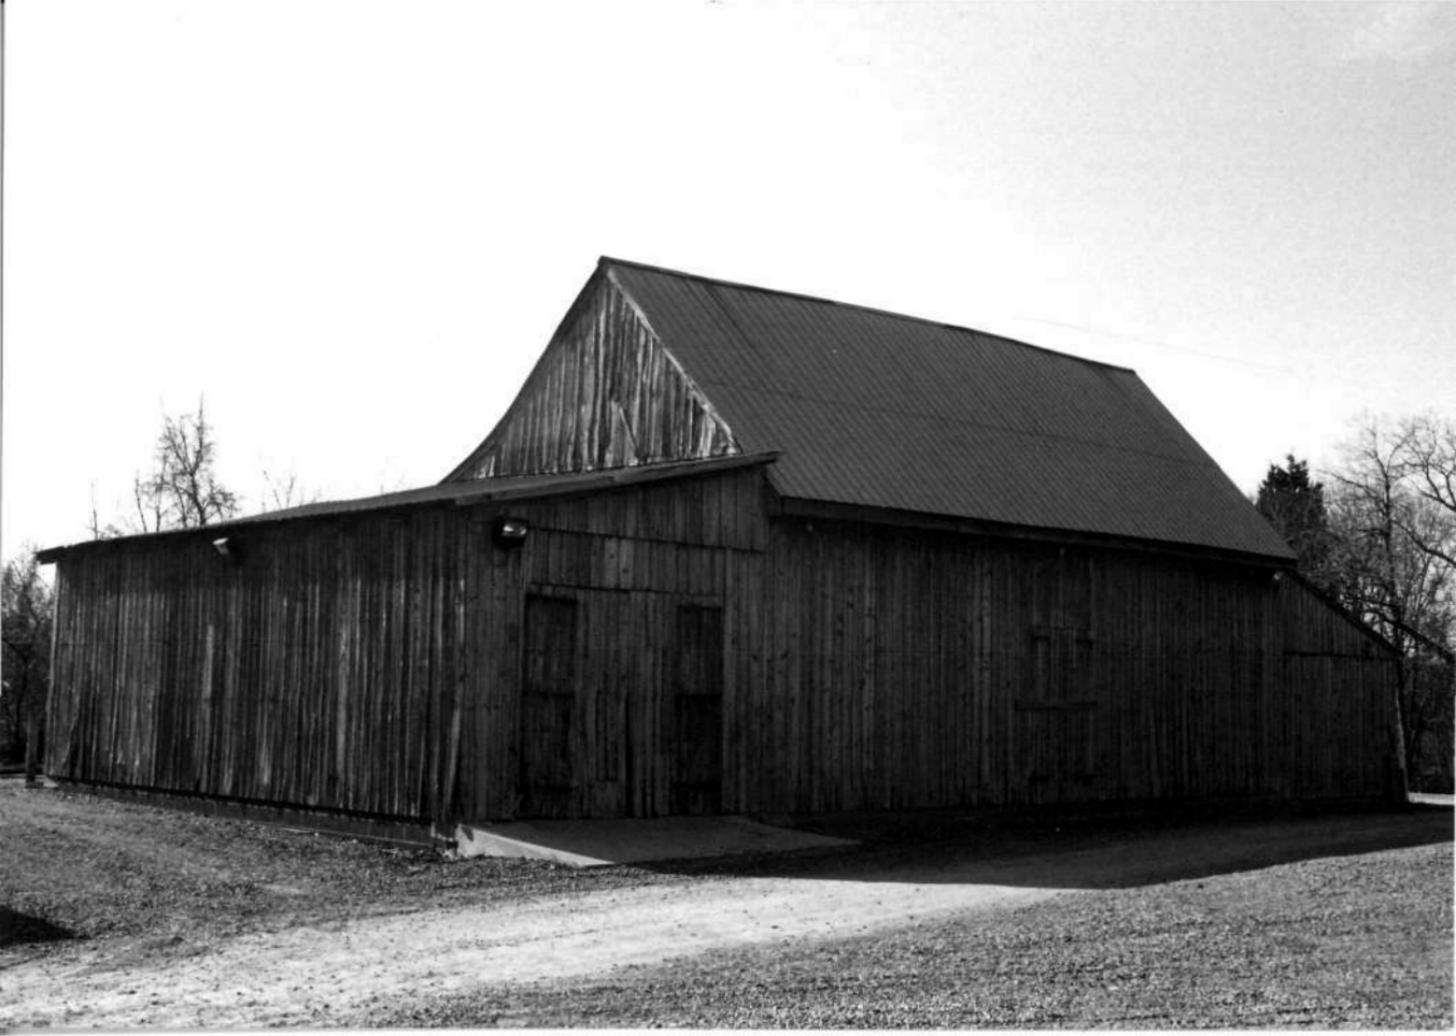
4 of 6

CT. 58  
Parrow Park  
Structure #4  
Calvert County, MD  
Matthew G. Hyland  
December 2006  
MD SHPO

NW + NE elevations of tobacco barn,  
facing S

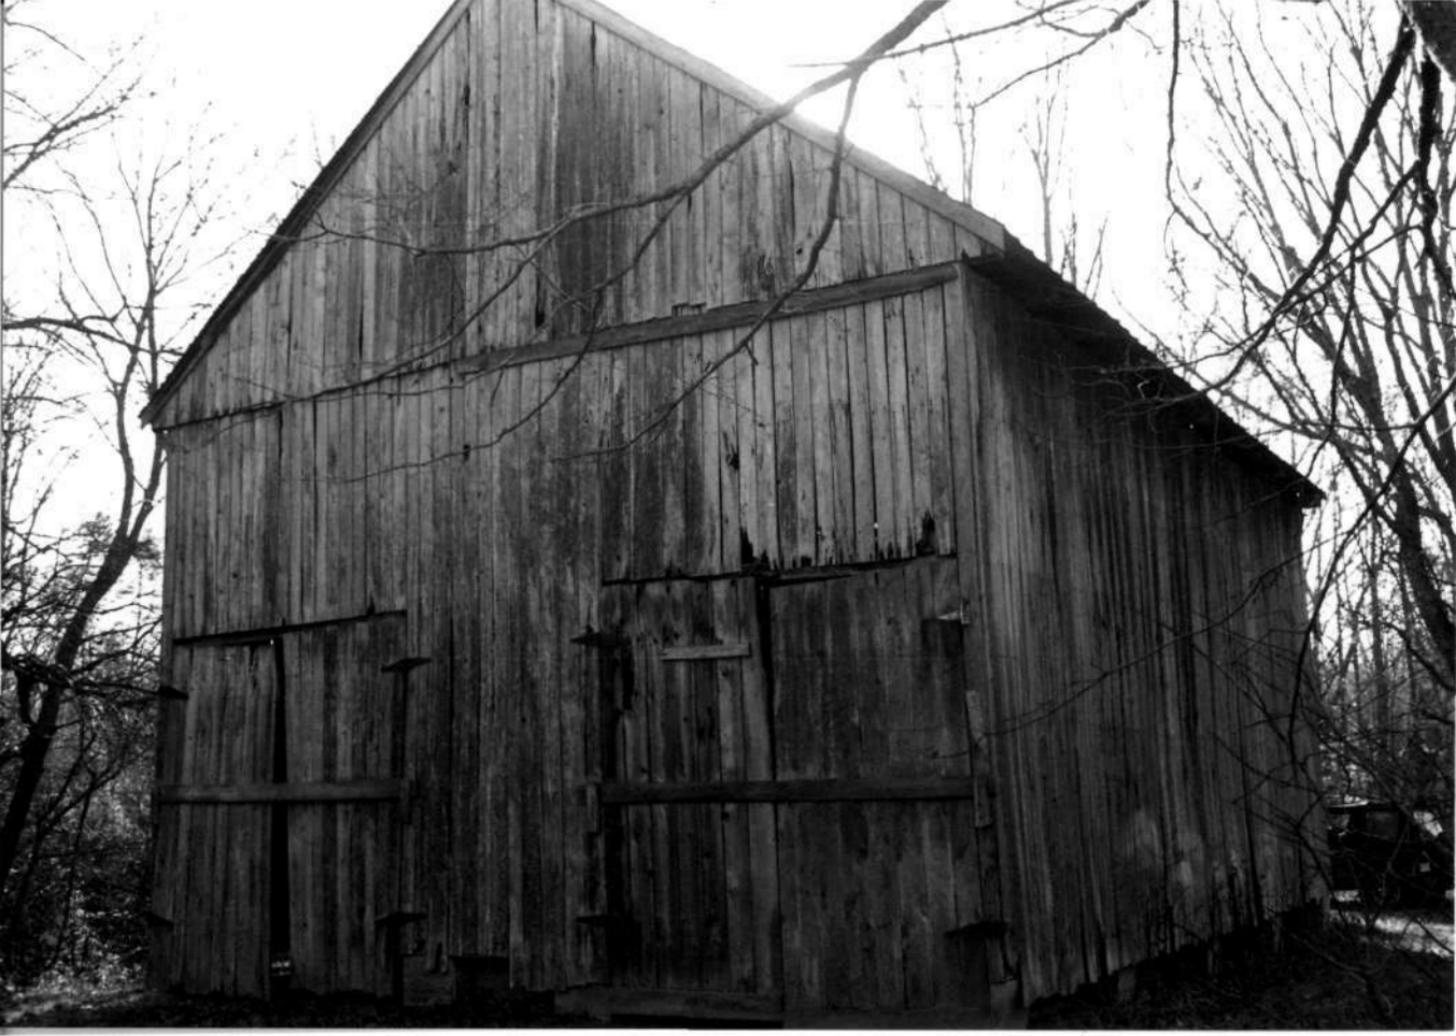
5 of 6

Structure #5, which dates from the early twentieth century, is a gable-roof tobacco barn framed with wood and standing on a concrete pier foundation. In the past, it was used as a tobacco barn. Structure #5 is two-bays wide and four-bays deep. Structure #5 is clad in vertical wood siding planks and roofed wood rafters (whose tails are exposed) with corrugated metal. The doorway apertures feature metal strap hinges.

NW + NE elevations of tobacco  
barn, facing S

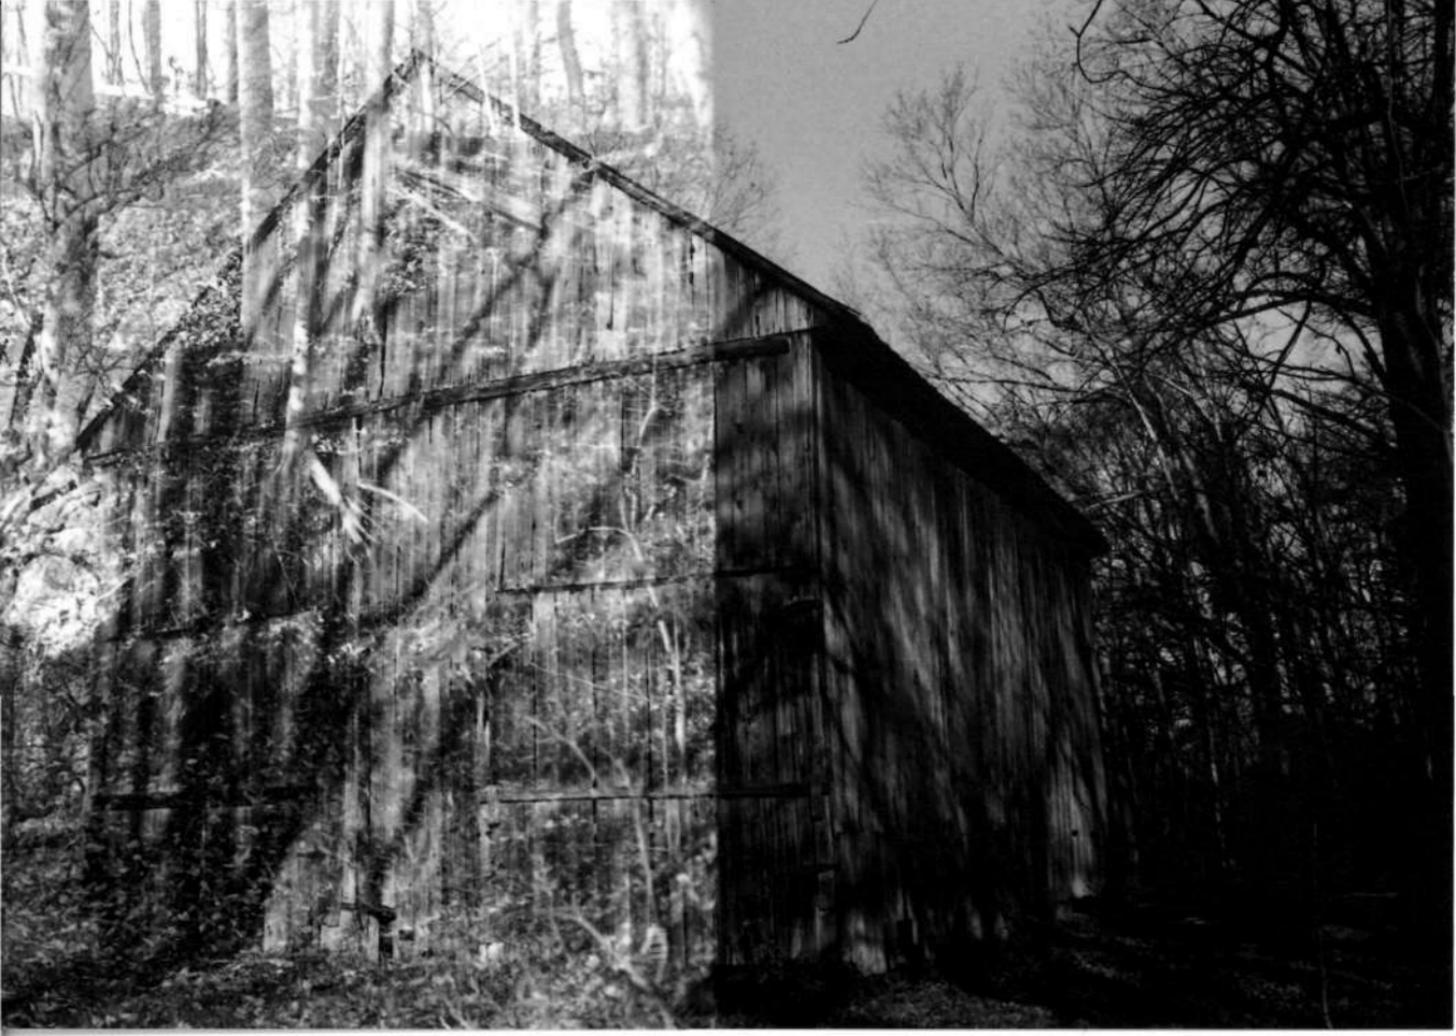
6 of 6

Parrons Park  
CT-58  
Structure #5  
Calvert County MD  
Matthew S. Hyland  
December 2006  
MD SHPO

SW and SE elevations of tobacco  
barn, facing N
