CT-96
VICTORIAN HOUSE
(Early 20th Century)
Sunderland
Private

INVENTORY FORM FOR STATE HISTORIC SITES SURVEY

Victorian House, and Barn, Pushaw

Morsell Victorian House [and Barn (CT-1151)]

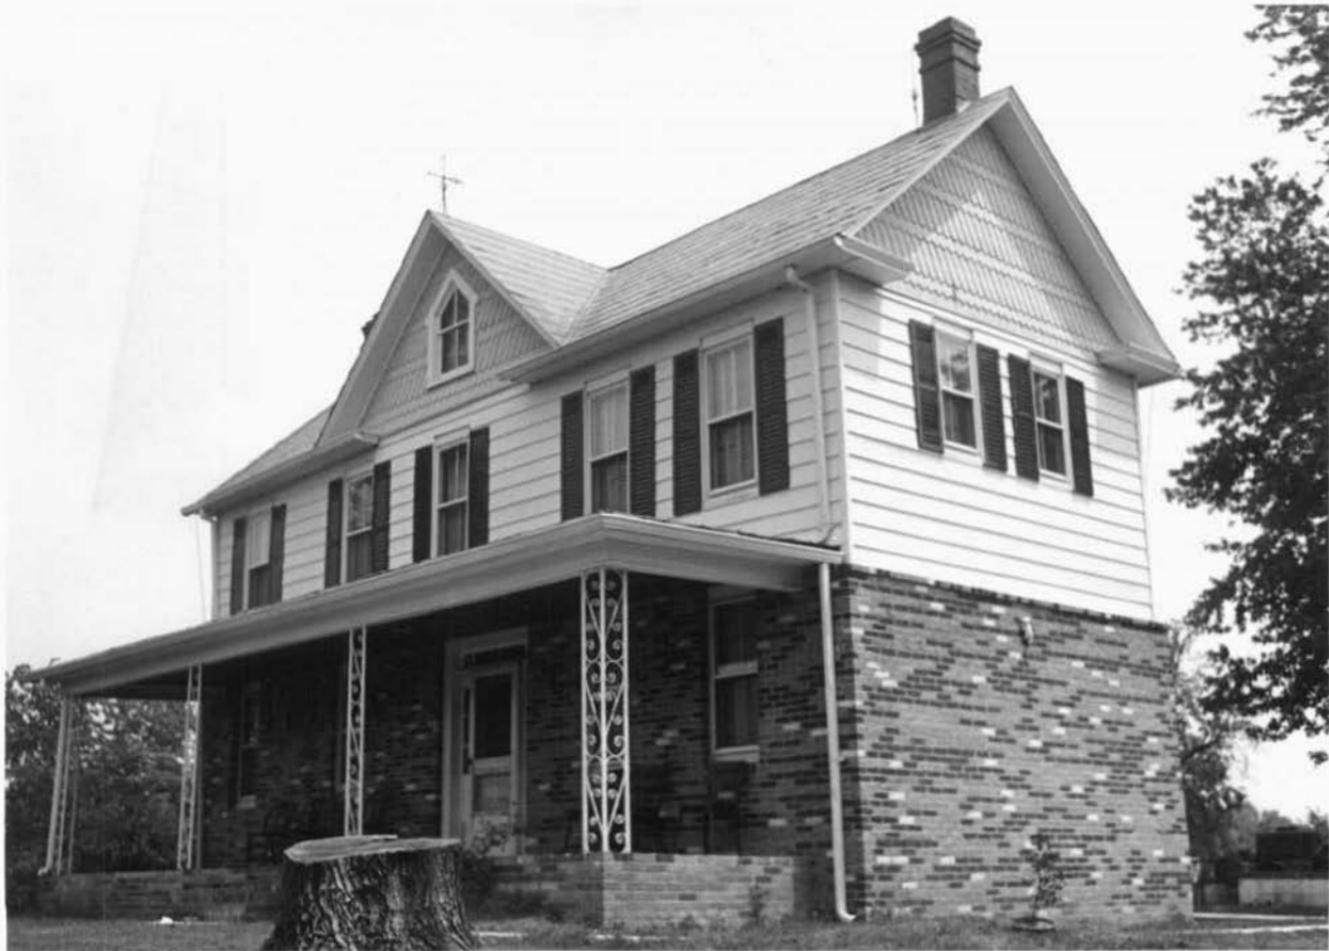
CT-96
VICT. HSC.
S.W. CORNER

Modern brick siding on the first story has altered the original appearance of this clapboard siding farmhouse. Wrought iron porch supports have replaced what were probably turned columns; there may have been scroll work decorations as well.

The five-bay, gable-end roof, central pediment and rear wing (L-plan) and 2/2 windows is common to the area. It is not uncommon either for the gables to be decorated although in this case the usual fishscale pattern has been reworked to make a more individual scroll-type design. Deep cornices and a pointed arch window in the central pediment complete the late Victorian design.

It should be noted that the five bays are not symmetrical which in some instances is indicative of additions or alteration of original plan.

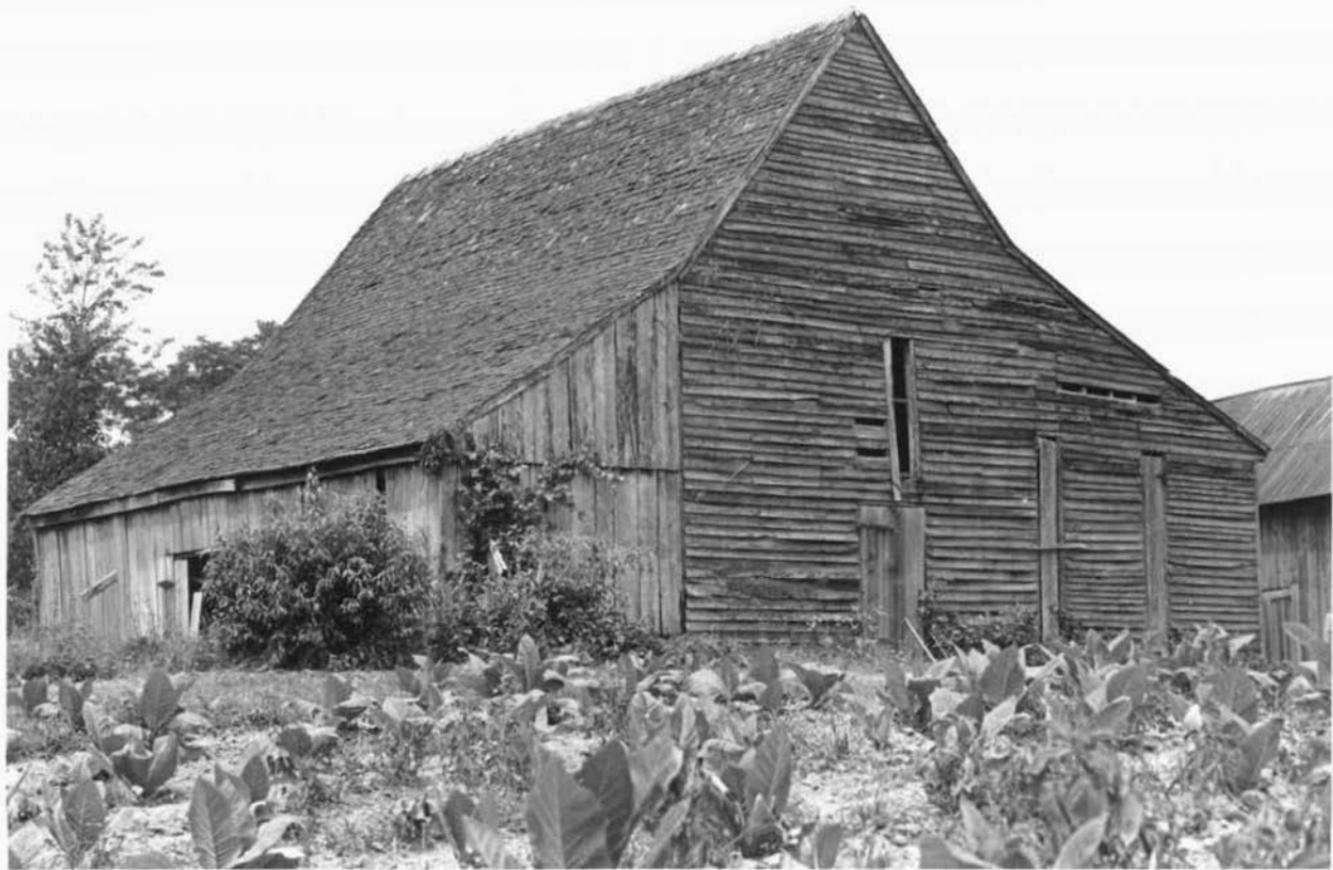
CT-96
Tiebe BANN

(CT-1151) The barn has three transverse sills which divide the building into thirds. A fourth transverse sill, as in other barns, may have been removed. The whole frame is post-and-beam construction with hewn timbers joined by mortise and tenon with trunnels. The south sill and one of the plates are continuous but the north sill has been cut, probably to accommodate a wagon.

There are additions on the north and south sides, the original measurements appear to have been the standard 24' x 40'. Racks are eight tiers high and ten rooms deep. 8' doors are opposite each other on all four sides and were probably originally intended for ventilation as much as entry since continuous sills make entry difficult. Additional ventilation is provided by lift-vents cut into the east side of the north shed, which is one of those with horizontal siding. Louvres can be seen in the west gable.

The east doors have forged loop-end strap hinges.

It is assumed that the south shed pre-dates the north shed because the latter contains modern machine cut structural members whereas the south shed has hand hewn rafters and plates.
