CAR-116
Leonard House
Greensboro
Private

National Register of Historic Places Registration Form

historic name Second Methodist Church Parsonage
other names/site number Leonard House (preferred) ~~CP-116~~

The Leonard House is a small 1 1/2 story frame dwelling with an original L-plan, constructed c. 1832 presumably as the parsonage for the second Methodist church of Greensboro. The building faces west, toward Main Street and the site of the former church; it stands three bays wide, with a transomed entrance in the northernmost bay and two 9/6 windows to the right. There are two 6/6 gabled dormers on the west slope of the roof, above a boxed cornice. A large brick chimney rises from the ridge to left of center, expressing a highly unusual placement and interior plan. The building rests on a brick foundation and is sheathed with beaded siding. A one-story ell extends from the southern portion of the rear elevation, flush with the south gable end, comprising an original kitchen and a late-19th-century extension. The interior of the main house is laid out around the central chimney in a four-room plan, with a small entrance vestibule in the northwest corner opening into a long narro

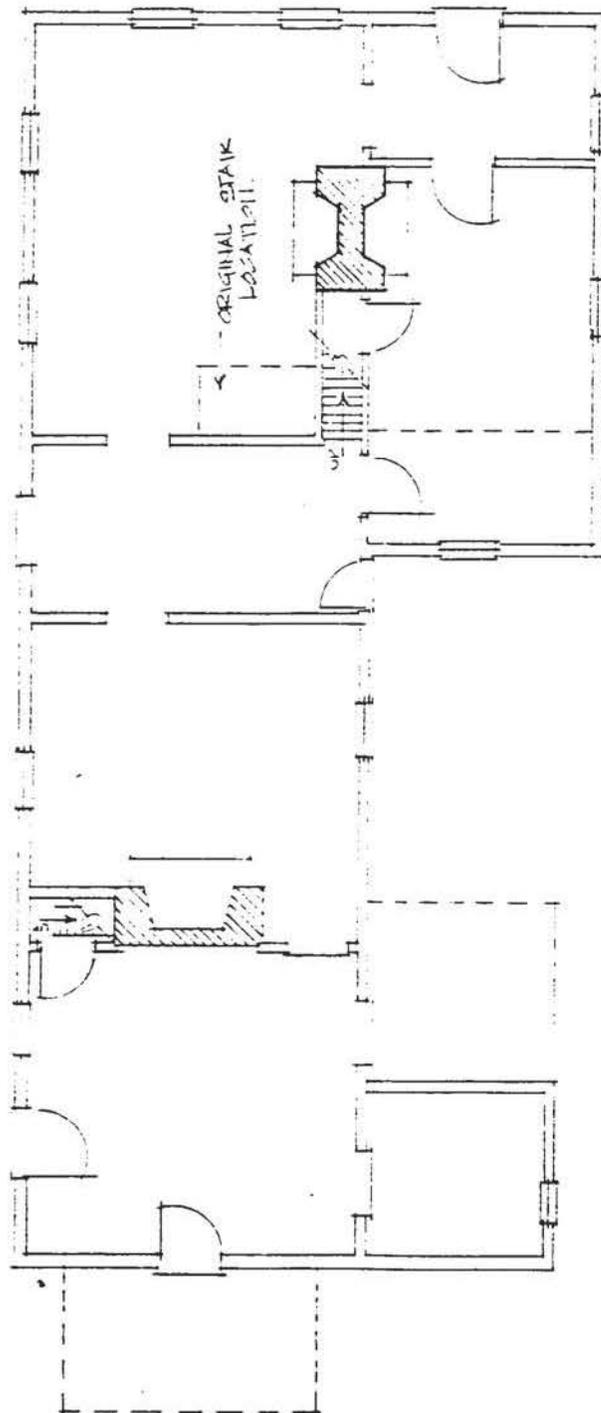
- FIRST FLOOR PLAN

SCALE - 1/8" = 1'-0"

The interior is laid out in a highly unusual center-chimney plan, with a small entrance vestibule in the northwest corner, opening into a long narrow room across the north side and a larger parlor to the south. The central chimney stack provides fireplaces for both the main rooms. The back passage

extends across the rear of the parlor to the north room. A steep narrow stair off the north end of the passage ascends to two chambers in the half-story; this represents a reconfiguration of the original stair, which rose against the east partition wall of the parlor and turned. This plan is unique in Caroline County, and indeed no precise analogues are known elsewhere in Maryland.

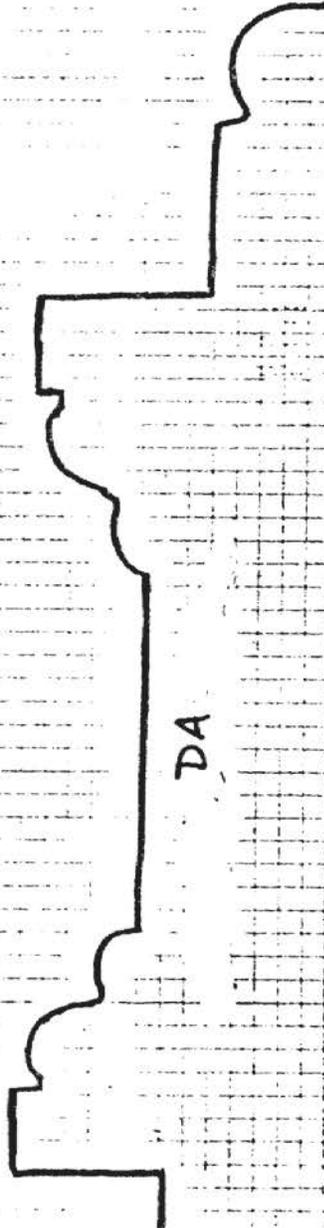
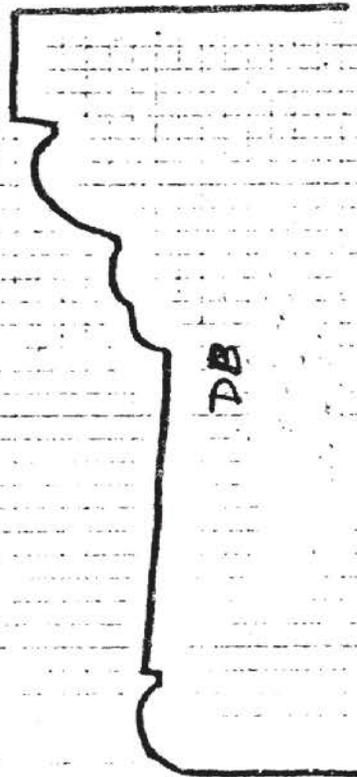
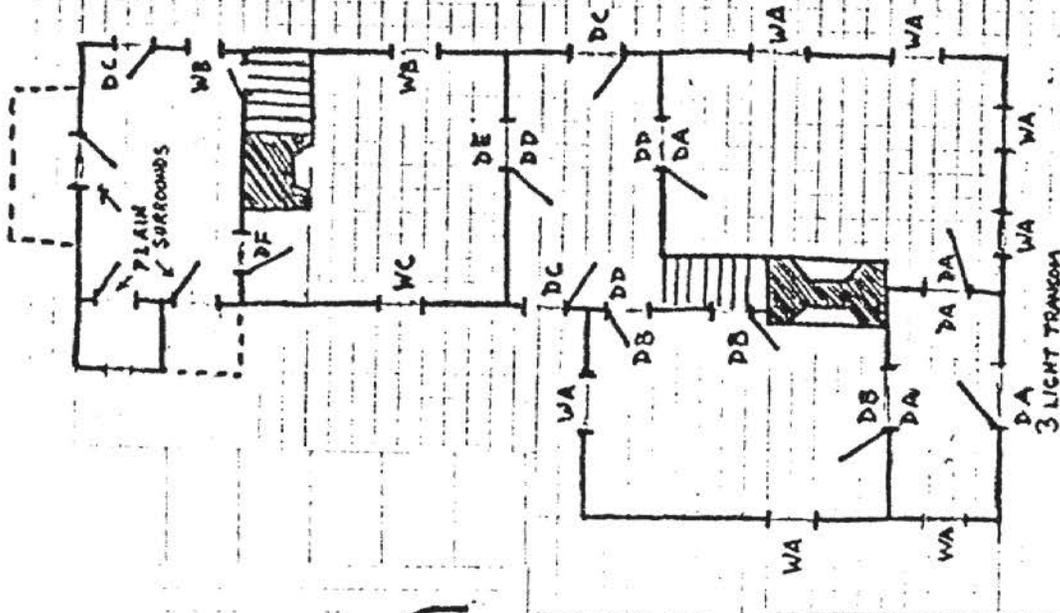
CAR-116 MOLDING PROFILES

DOOR SURROUNDS

(2nd FLOOR ALL DC, WB)

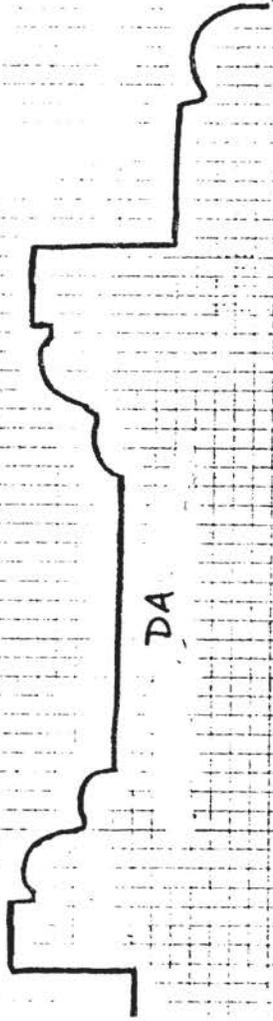
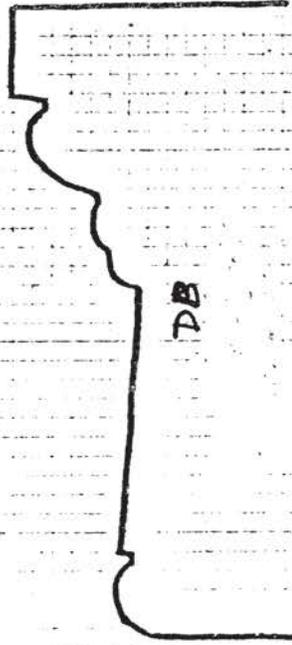
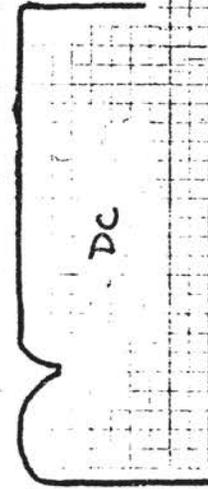
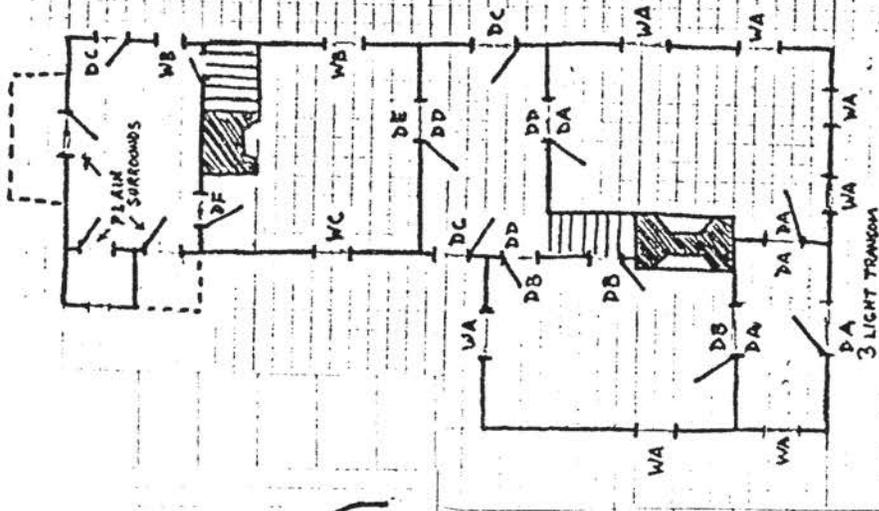
CAR-116 MOLDING PROFILES

Door Surrounds

(2nd FLOOR ALL DC, WB)

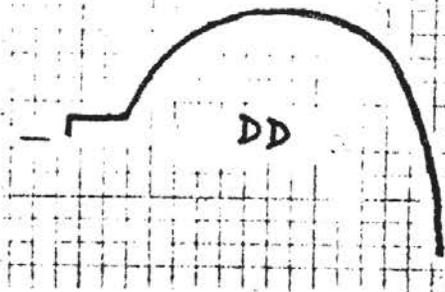
CORNER BLOCKS
DA + WA

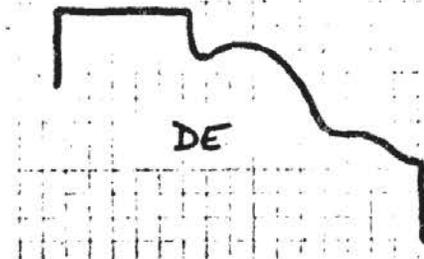
WINDOW SURROUNDS

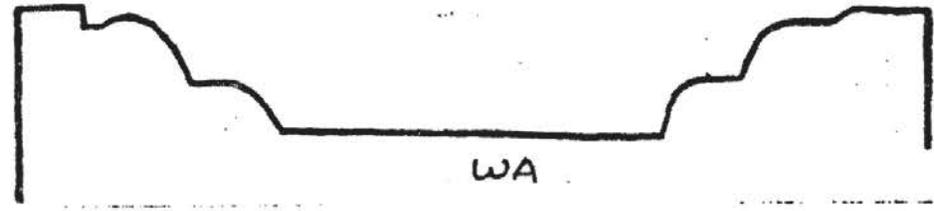
MUNTINS
1ST FLOOR - 9 OVER 6
2ND FLOOR - 6 OVER 6
