Maryland Inventory of Historic Properties Number: CAR-298

Name: C-0005 / Mason Bridge Rd over Mason Br.

MARYLAND INVENTORY OF HISTORIC BRIDGES
HISTORIC BRIDGE INVENTORY
MARYLAND STATE HIGHWAY ADMINISTRATION/
MARYLAND HISTORICAL TRUST

SHA Bridge No. C-0005/Q-0036 Bridge name Mason Bridge Road (Mason Branch Road) over
Mason Branch

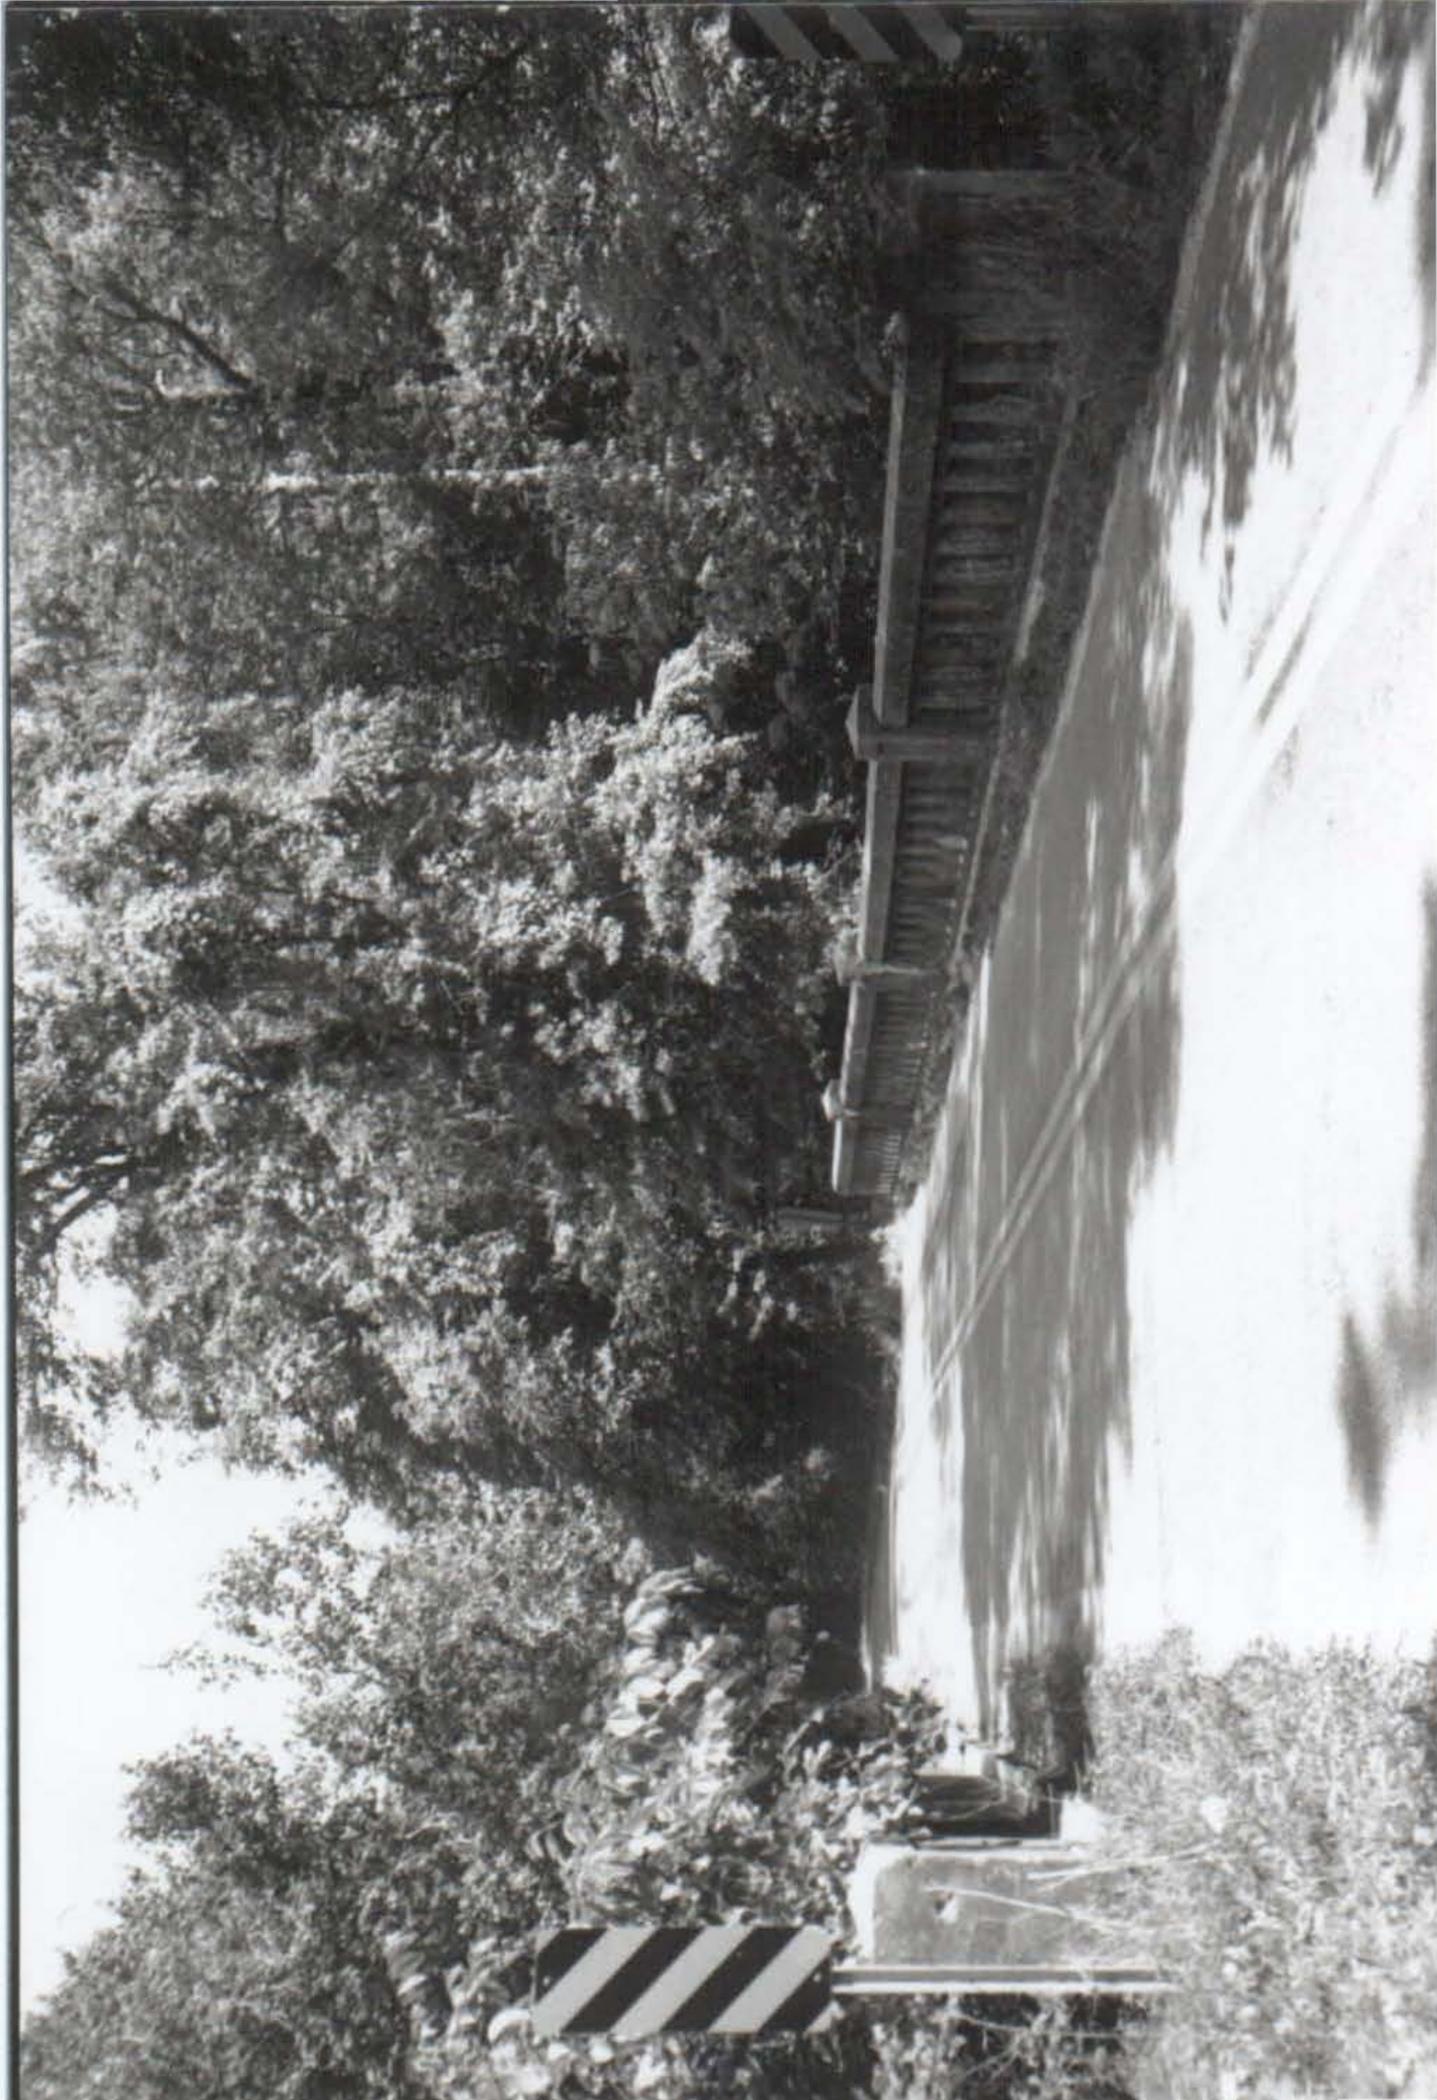
1. CAR-298
2. MASON BRIDGE ROAD OVER MASON BRANCH
3. CAROLINE CO. / QUEEN ANNE'S CO., MD
4. CAROLINE HALL
5. JUNE 1997
6. MD SHPO
7. NORTH ROADWAY APPROACH
8. 1 OF 6

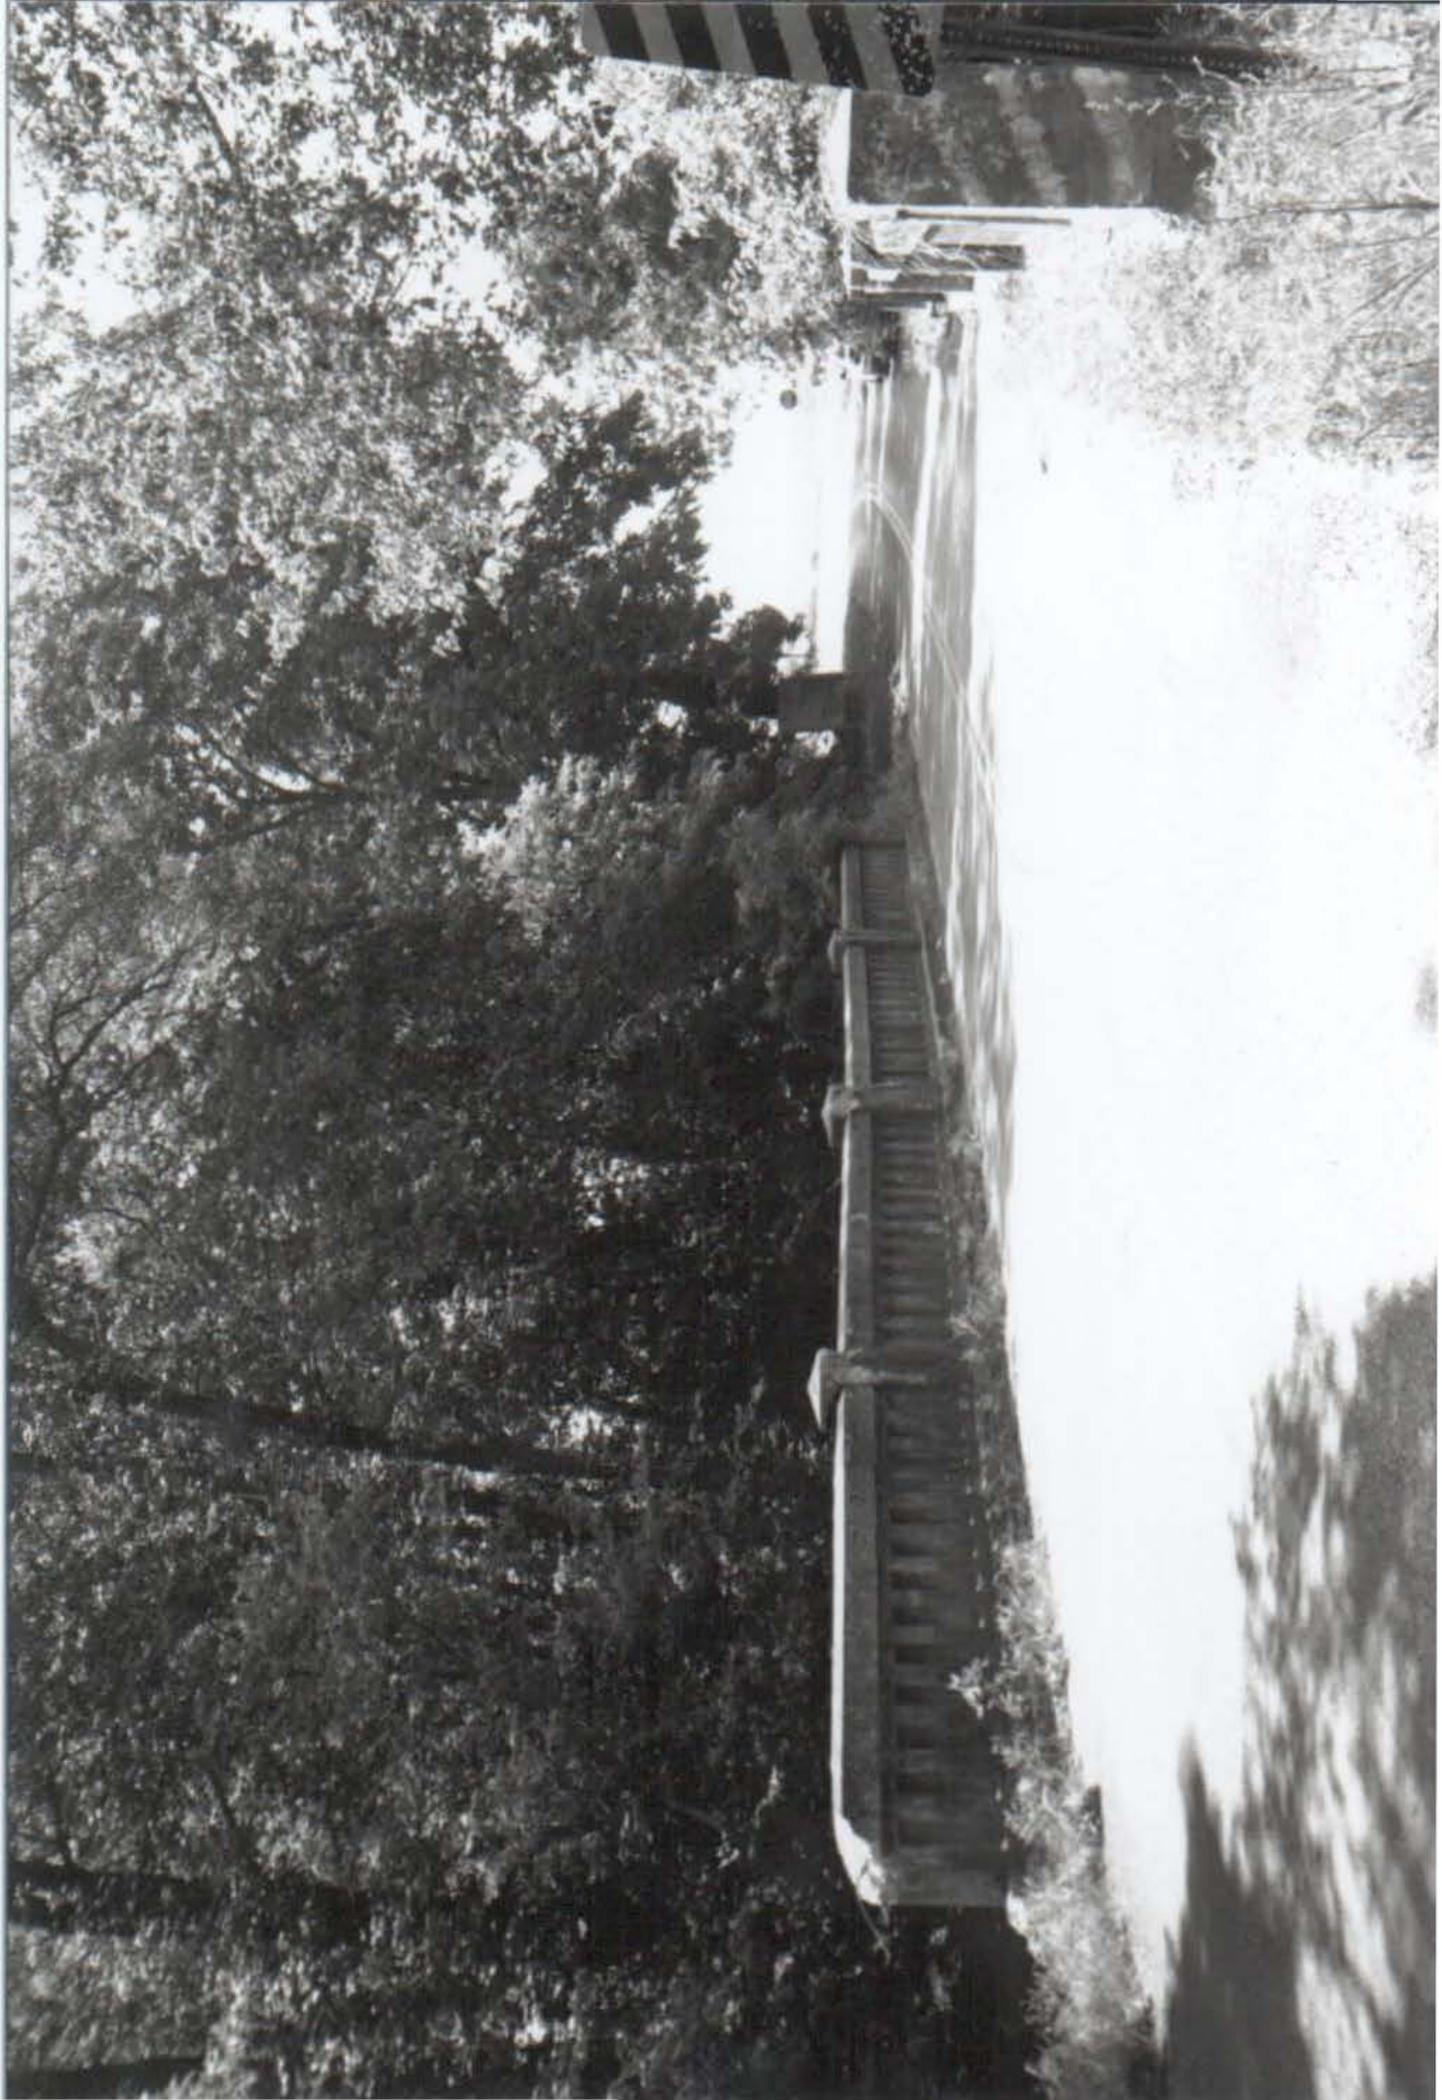
1. CAR-298
2. MASON BRIDGE ROAD OVER MASON BRANCH
3. CAROLINE CO. / QUEEN ANNE'S CO., MD
4. CAROLINE HALL
5. JUNE 1997
6. MD SHPO
7. SOUTH ROADWAY APPROACH
8. 2 OF 6

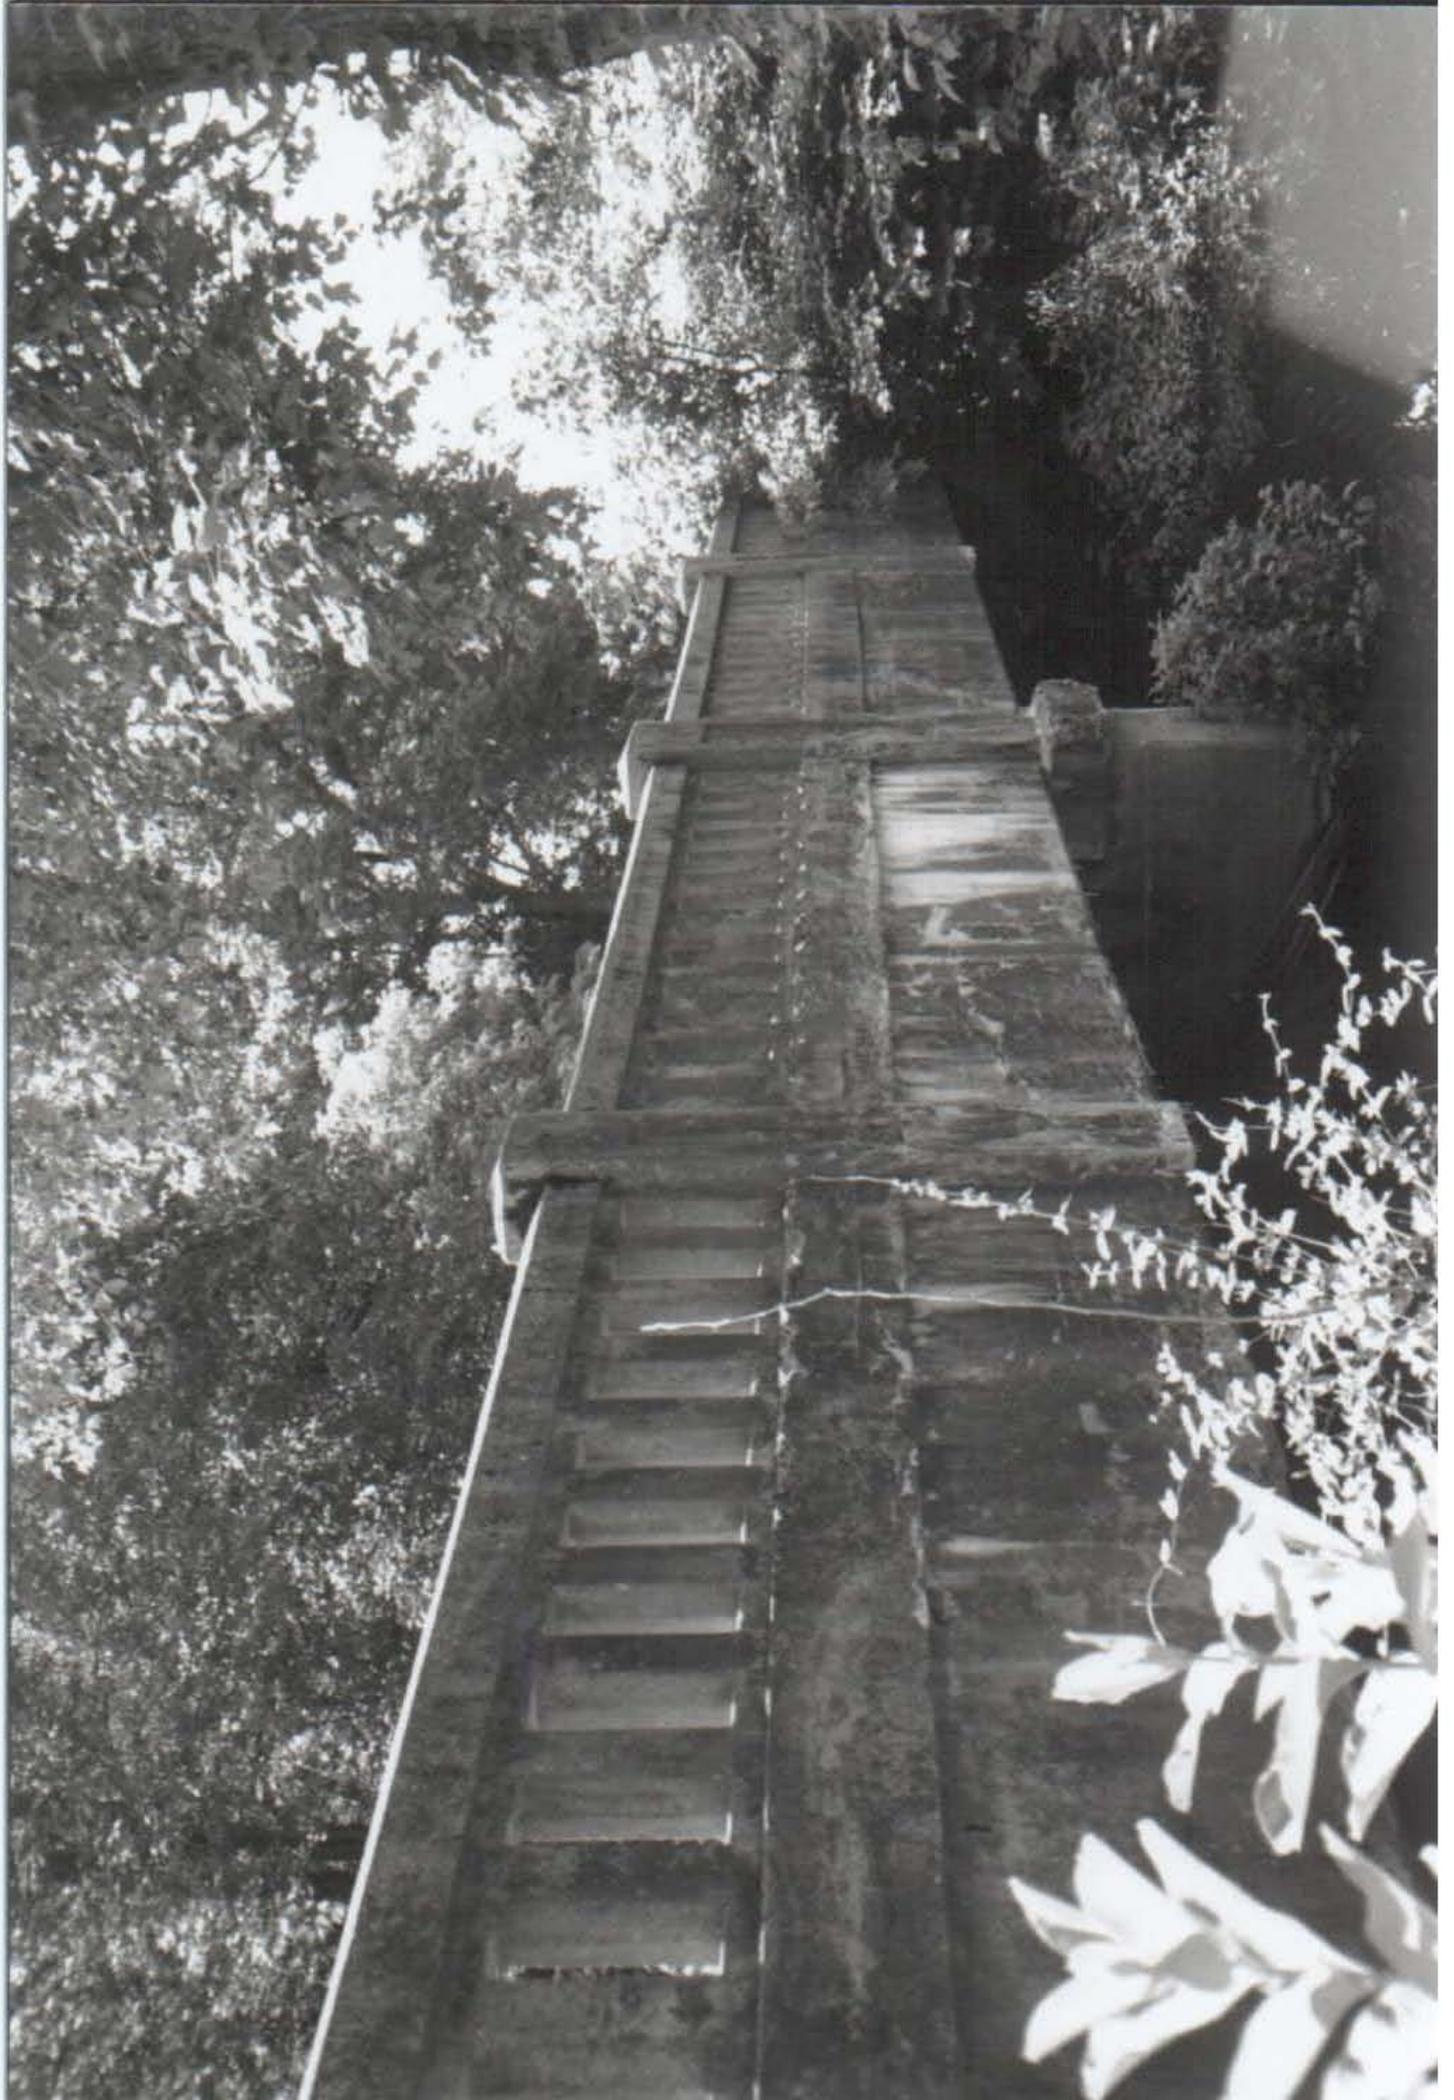
1. CAR-298
2. MASON BRIDGE ROAD OVER MASON BRANCH
3. CAROLINE CO. / QUEEN ANNE'S CO., MD
4. CAROLINE HALL
5. JUNE 1997
6. MD SHPO
7. SOUTHEAST PATIAPET WALL
8. 3 OF 6

According to the 1995 Caroline County inspection report (inspection conducted in February and April of 1996) and the 1994 Queen Anne's County inspection report, this structure is in fair condition. The asphalt wearing surface has some worn areas and debris accumulation and the concrete deck has some surface deterioration and exposed reinforcing bars on the underside. The concrete beams are in fair condition with surface deterioration and cracking. Stalactites have formed on the west span exterior beams and the reinforcing bars are exposed on the sides of the exterior beams. The concrete abutments have minor surface deterioration with minor spalling and cracking in the beam seat areas and the wingwalls have minor cracking and minor erosion. The concrete pier is in poor condition with severe deterioration at the upstream (northeast) corner. The top of the pier between beams number 4 and 5 is deteriorated and the areas under beams number 3 and 4 are spalled approximately 1/2-inch. A 1991 inspection report indicated extensive scour and undermining of the pier. The concrete parapet is in fair condition with minor spalling and exposed reinforcing bars. The integral curb of the parapet is in poor condition with large spalls and the end post at the west end of the northeast parapet is missing.

There have been no major alterations to Bridge C-0005/Q-36. A section of the parapet is missing and a concrete jersey-barrier was placed at the location of the missing parapet at the time of the 1995 inspection. The jersey-barrier has since been removed, however, and the parapet has not been repaired or replaced. In addition, stone riprap was placed around the concrete pier following a 1991 inspection.

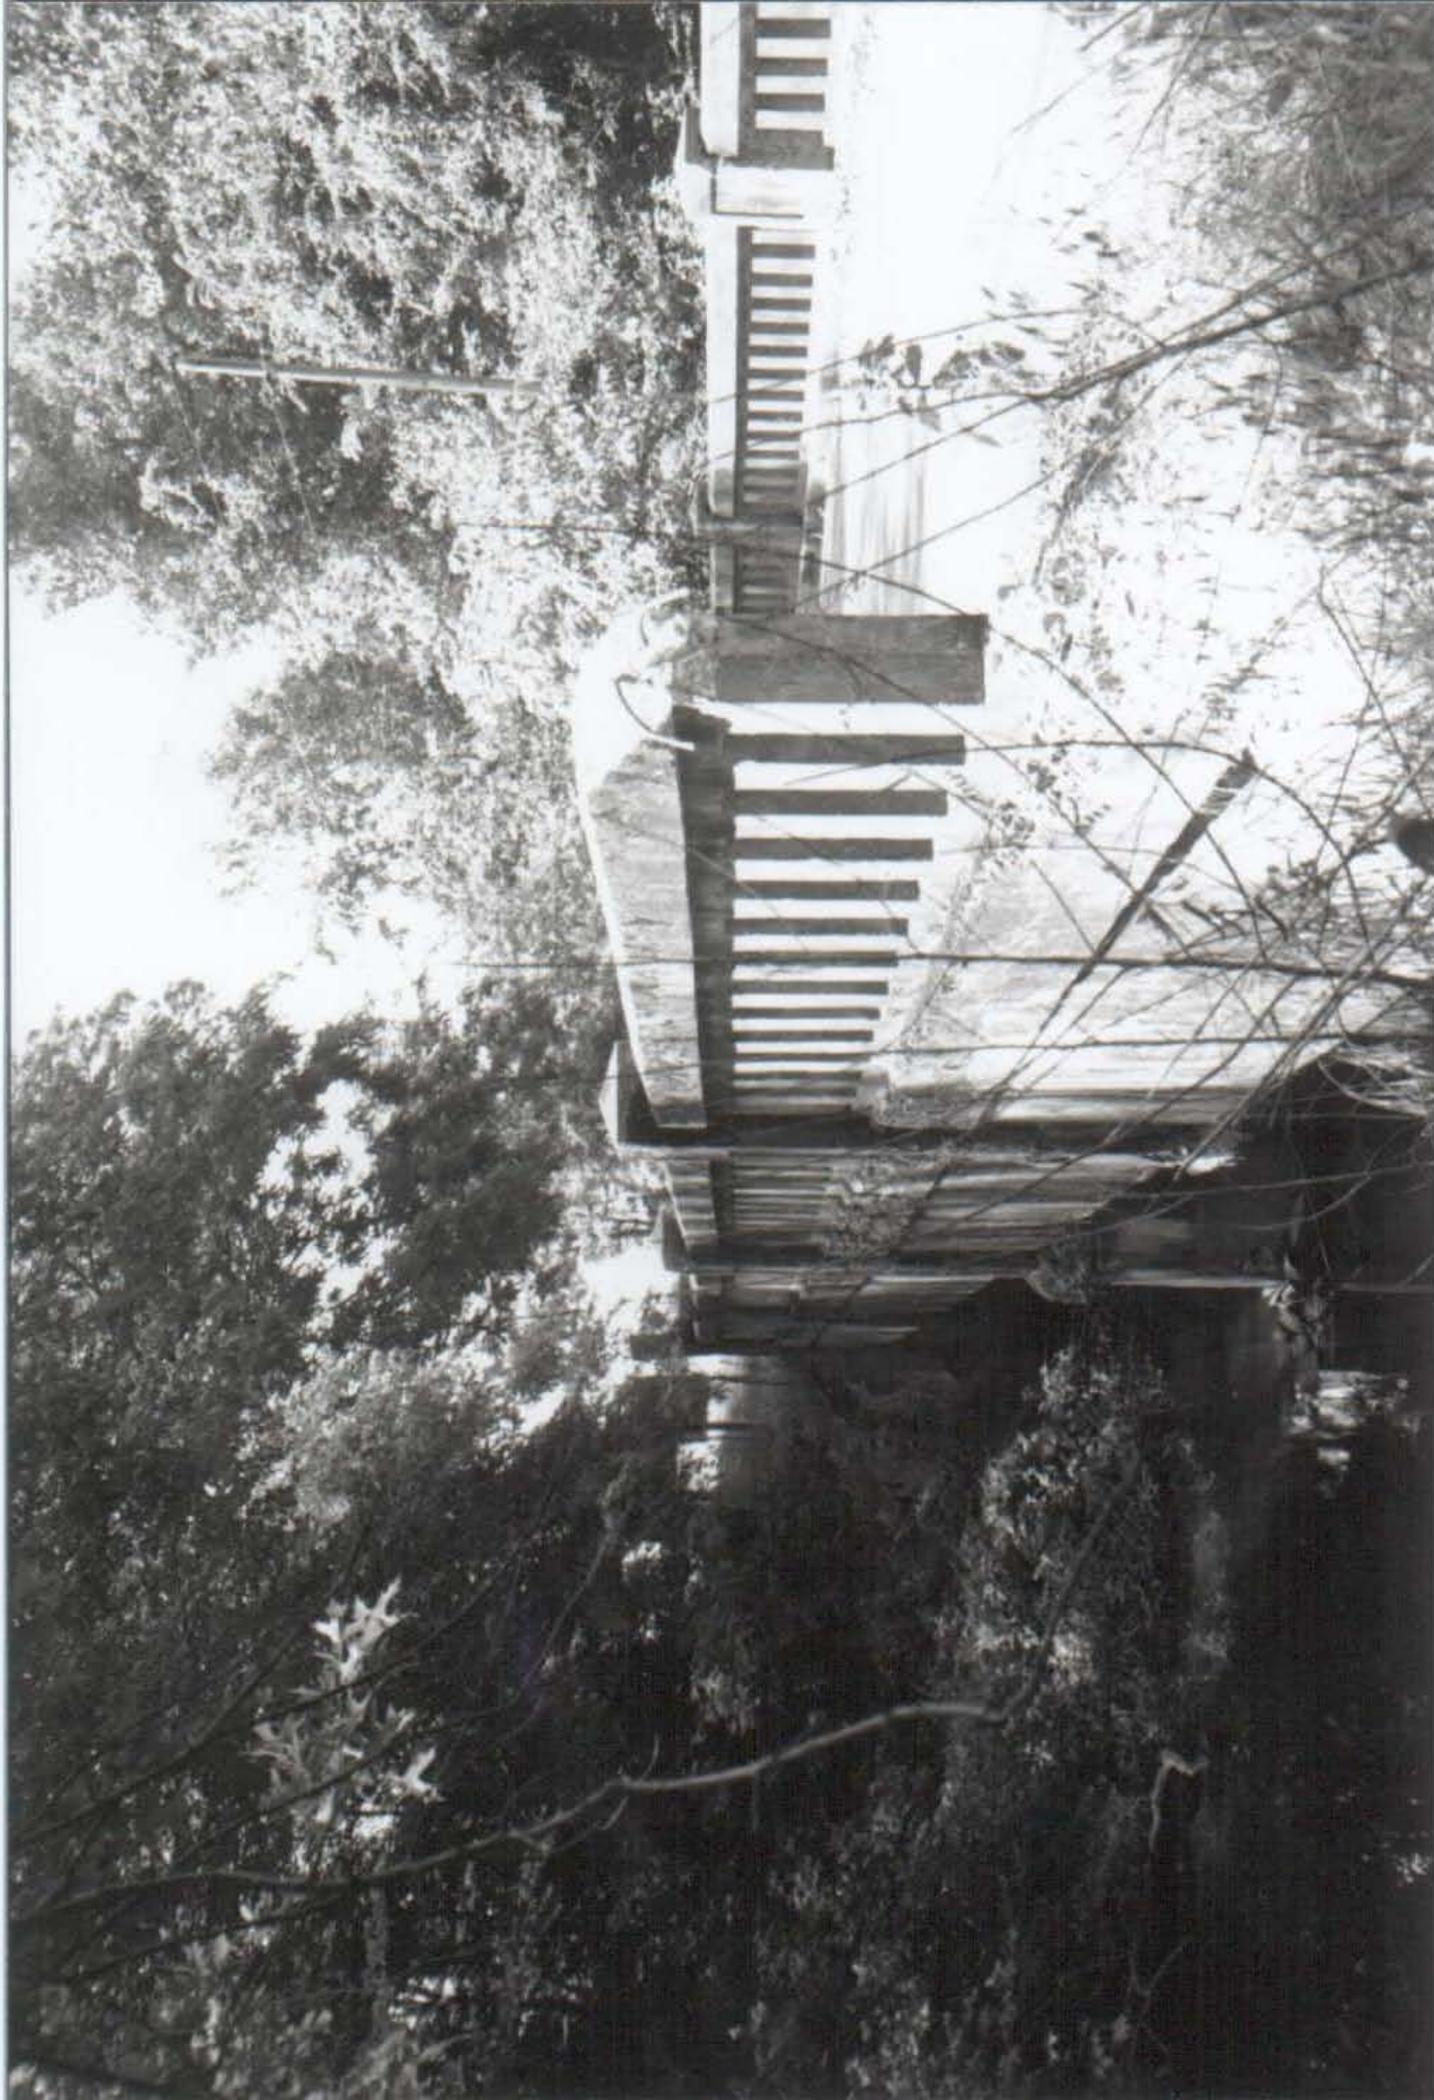
1. CAR-298
2. MASON BRIDGE ROAD OVER MASON BRANCH
3. CAROLINE CO. / QUEEN ANNE'S CO., MD
4. CAROLINE HALL
5. JUNE 1997
6. MD SHPO
7. SOUTH WEST PARAPET WALL
8. 4 OF 6

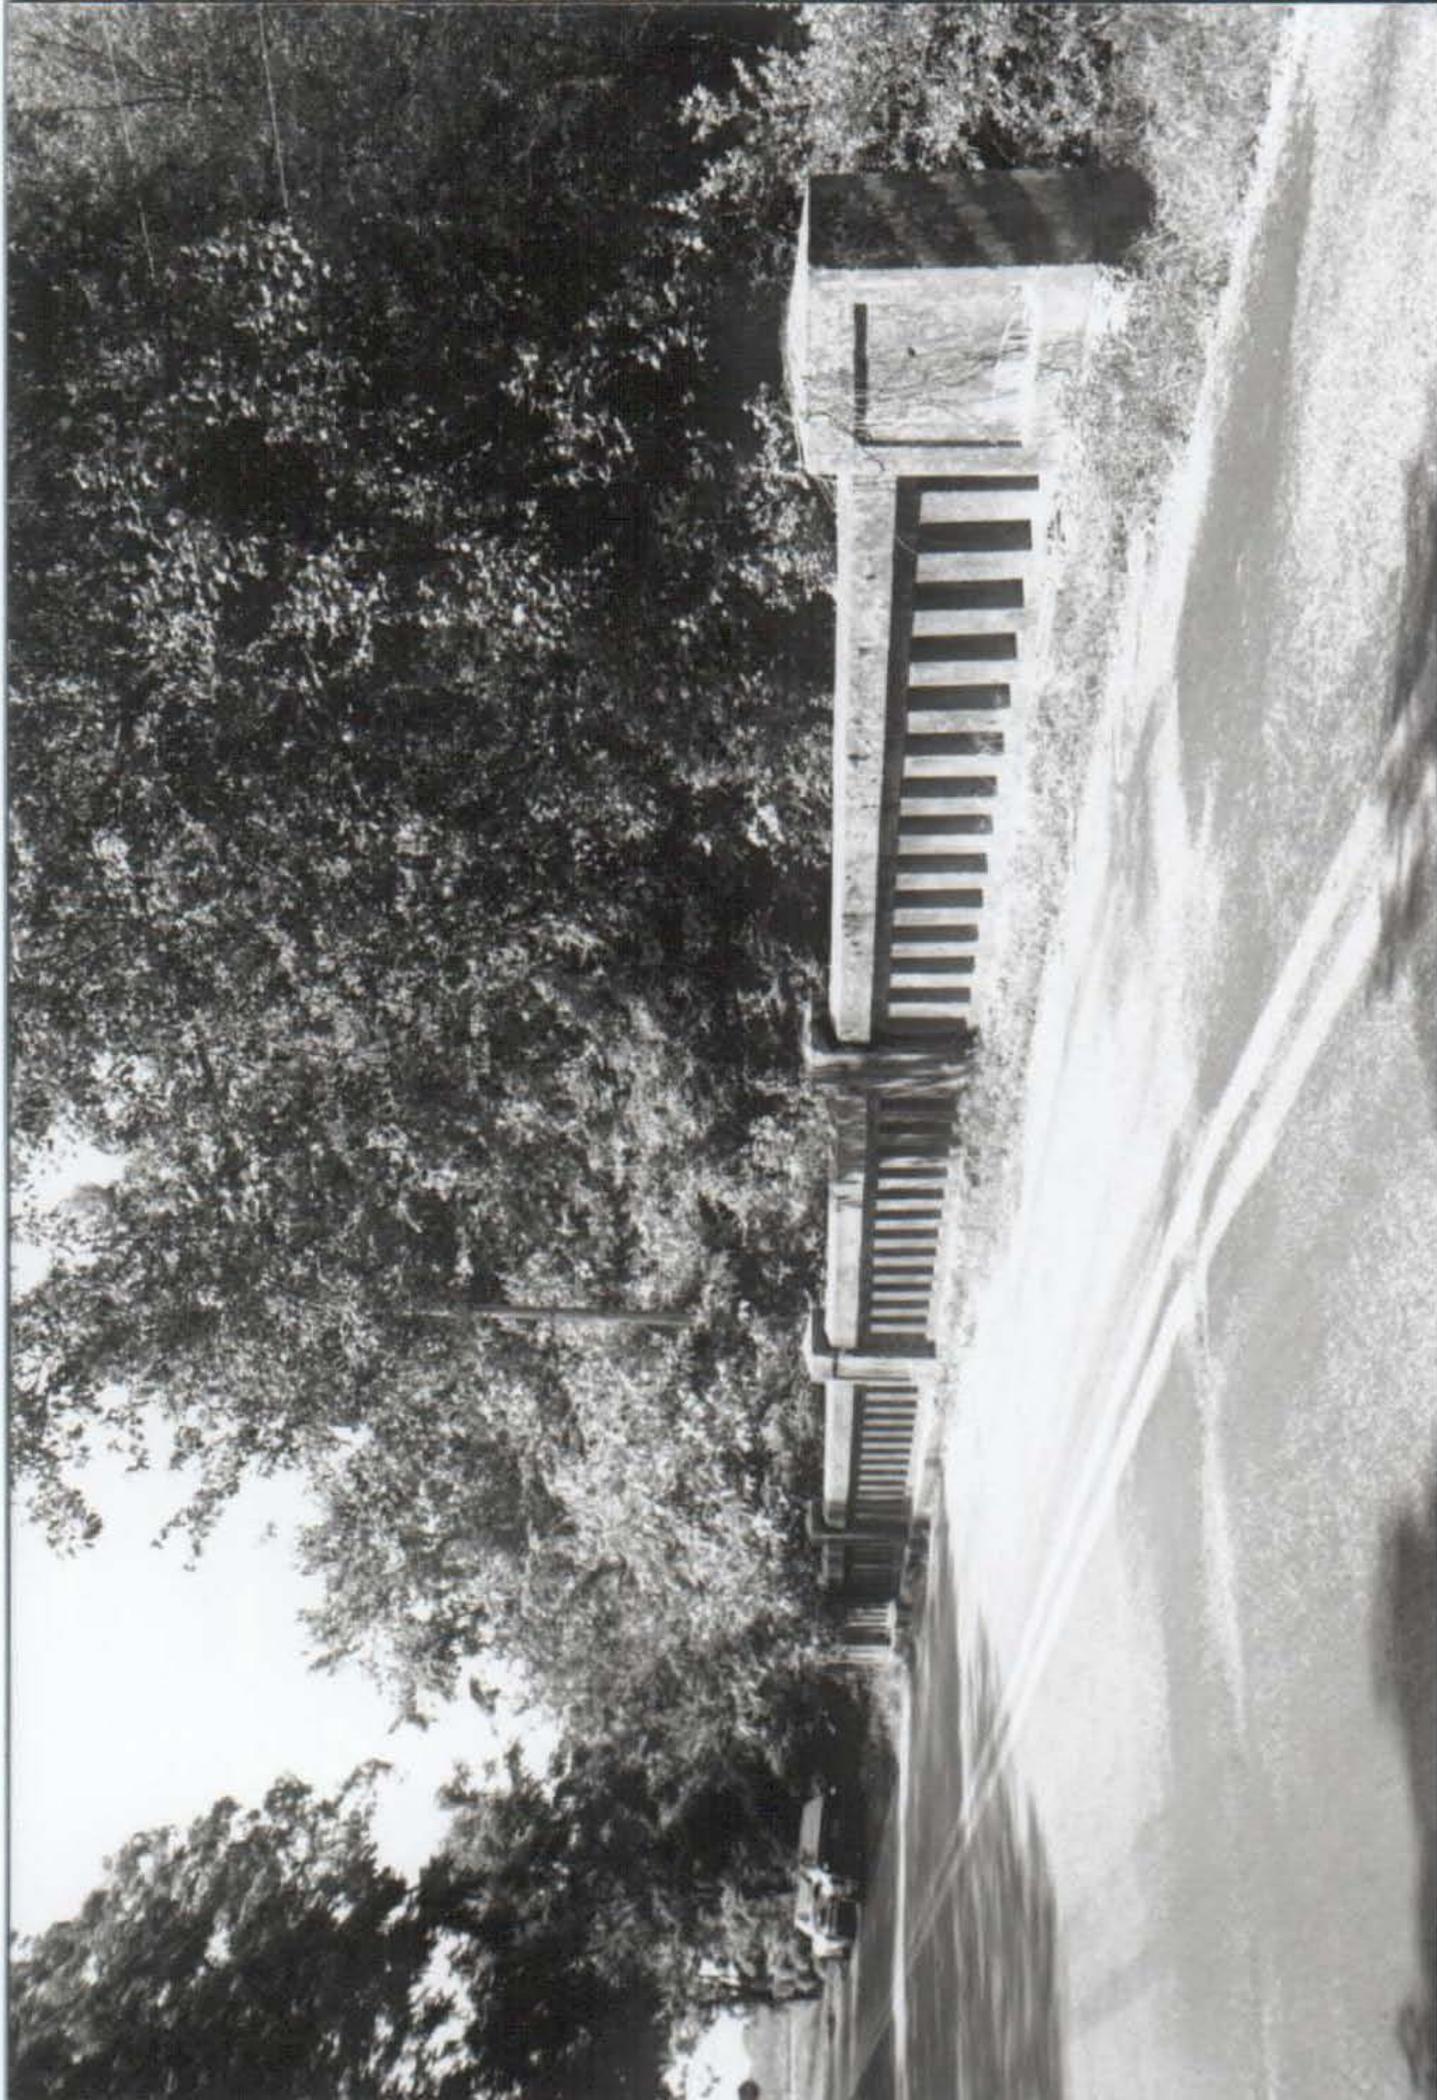
1. CAR-298
2. MASON BRIDGE ROAD OVER MASON BRANCH
3. CAROLINE CO. / QUEEN ANNE'S CO., MD
4. CAROLINE HALL
5. JUNE 1997
6. MD SHPO
7. SOUTHWEST PARAPET WALL
8. 5 OF 6
