Maryland Inventory of Historic Properties Number: CAR-299

Name: #CO-0027/Double Hill Rd over Watts Creek

MARYLAND INVENTORY OF HISTORIC BRIDGES
HISTORIC BRIDGE INVENTORY
MARYLAND STATE HIGHWAY ADMINISTRATION/
MARYLAND HISTORICAL TRUST

SHA Bridge No. C-0027 Bridge name Double Hill Road over Watts Creek

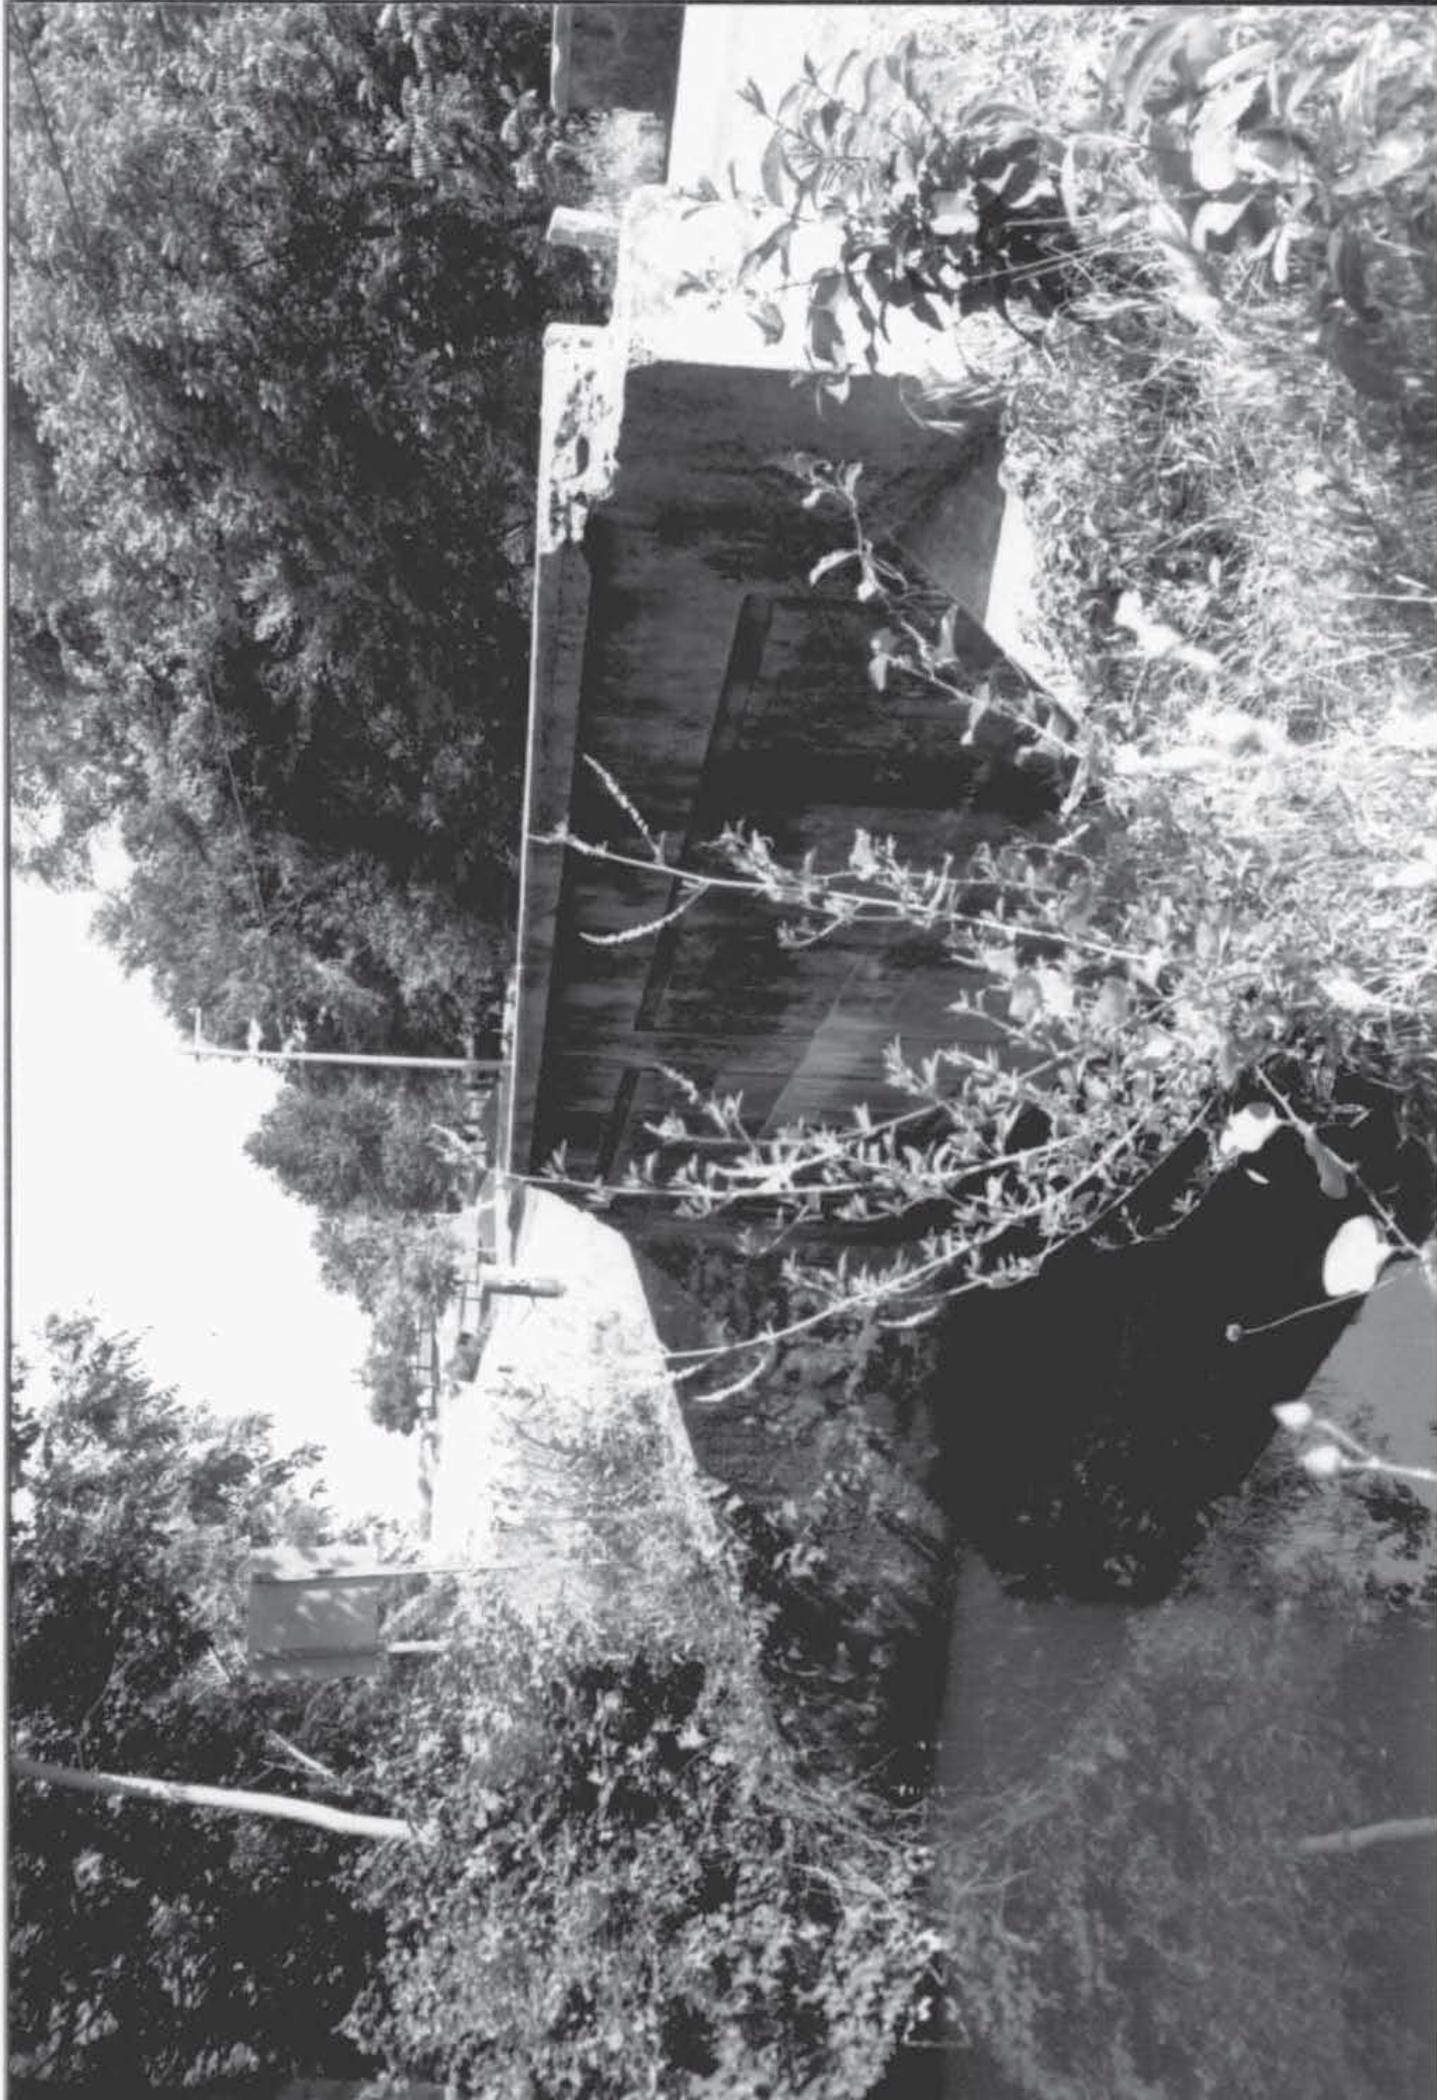
1. CAR-299
2. DOUBLE HILL ROAD OVER WATTS CREEK
3. CAROLINE CO., MD
4. CAROLINE HALL
5. JUNE 1997
6. MD SHPO
7. NORTHWEST PARAPET WALL
8. 3 OF 6

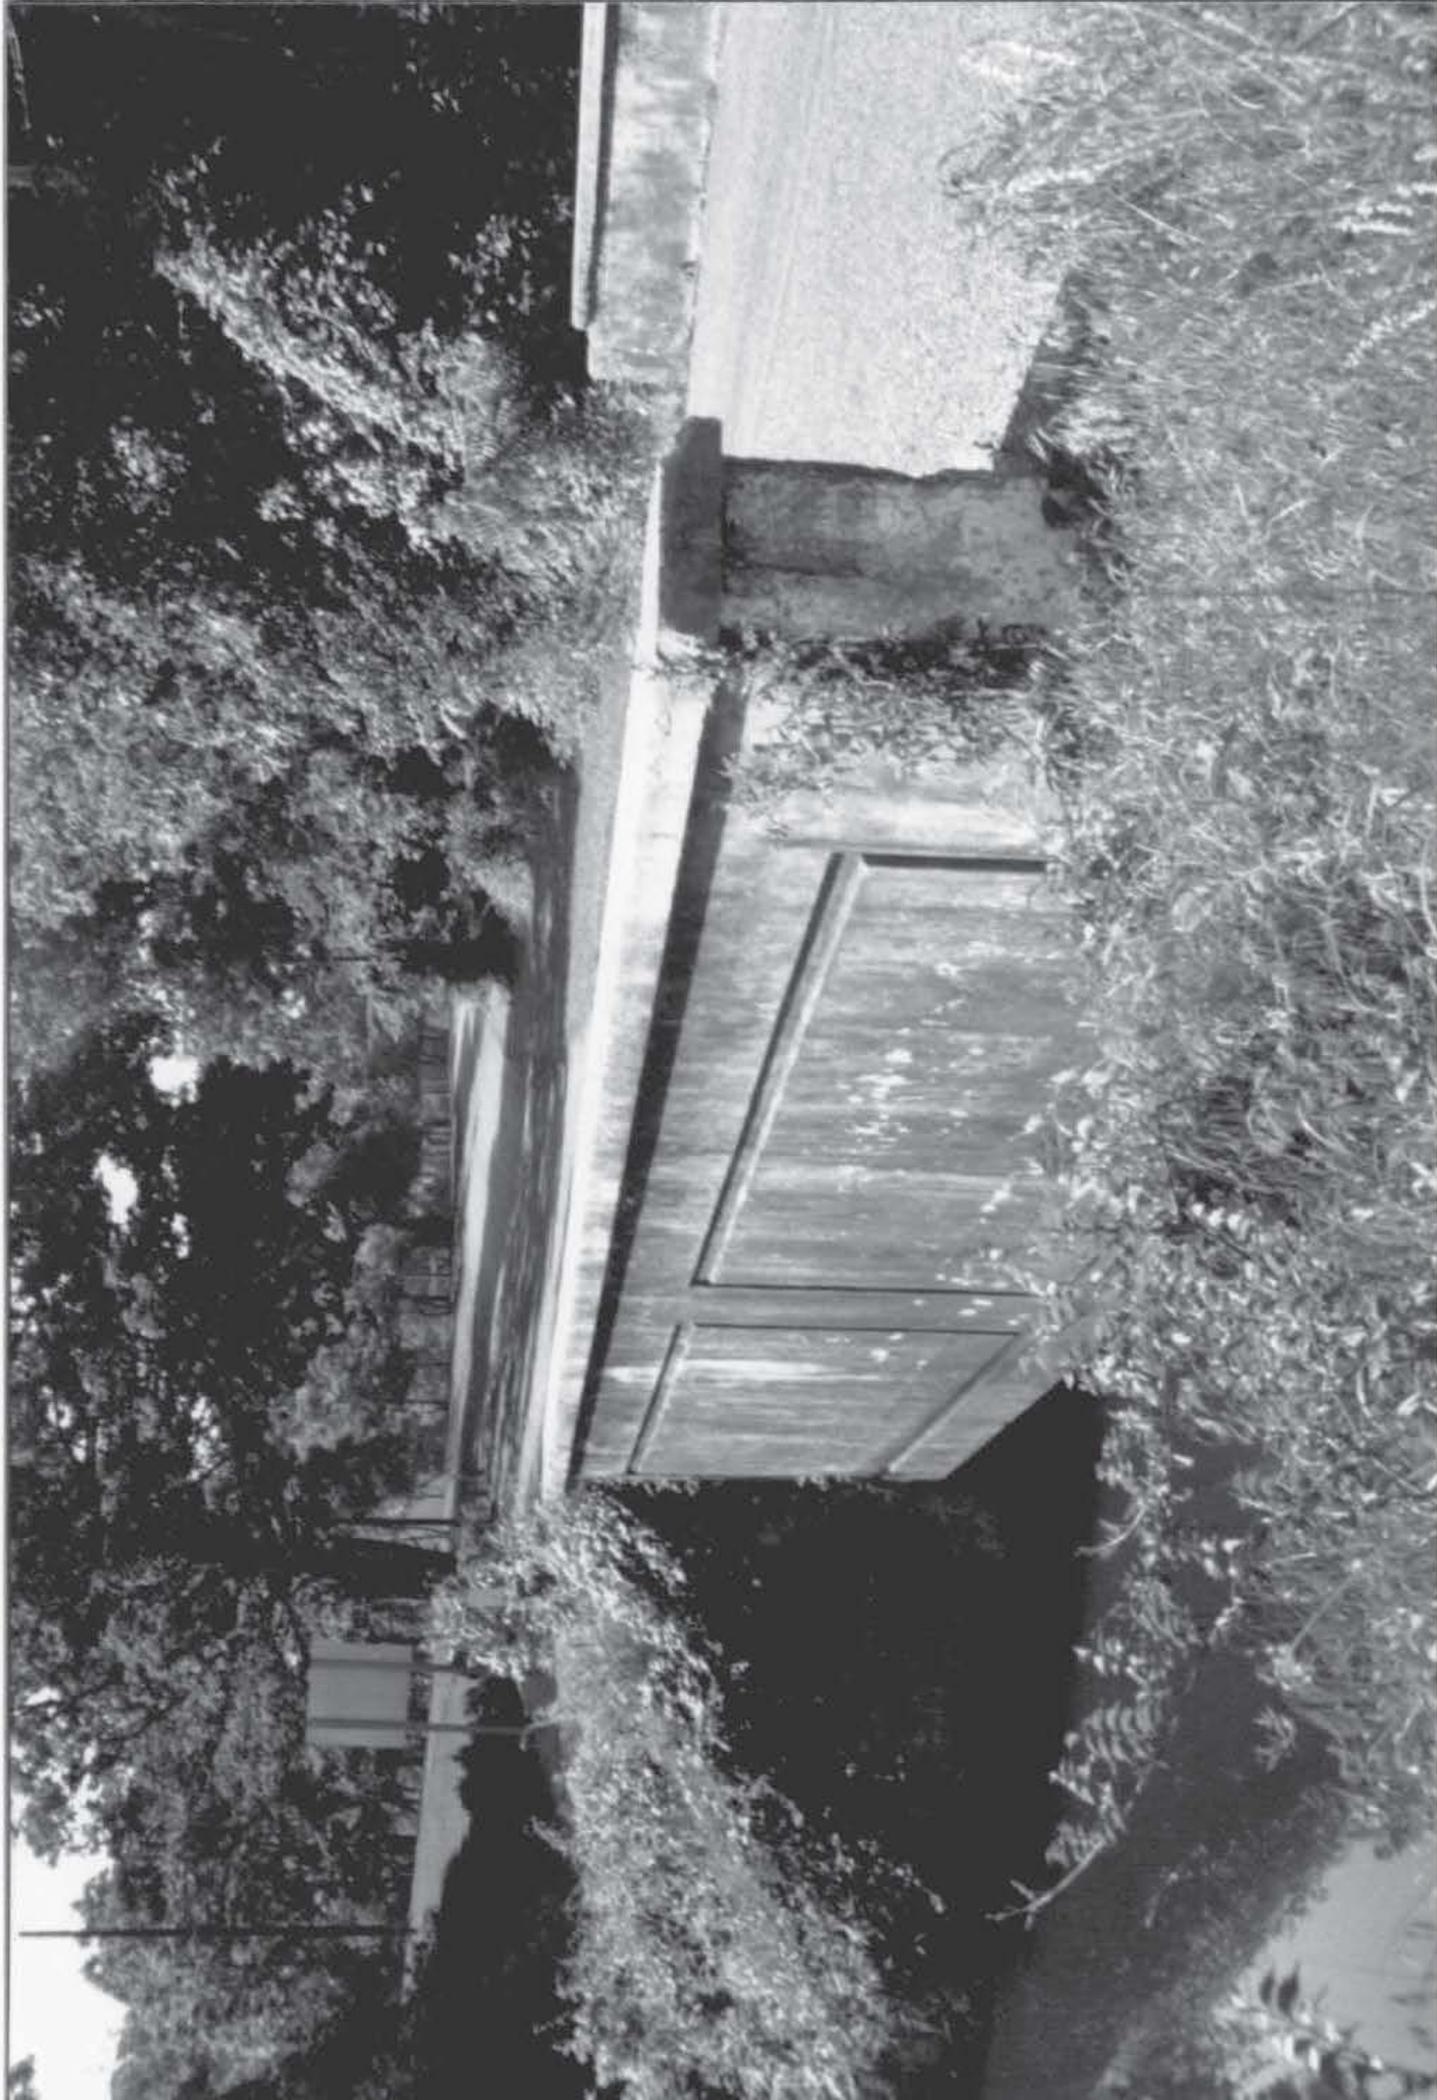
1. CAR-299
2. DOUBLE HILL ROAD OVER WATTS CREEK
3. CAROLINE Co., MD
4. CAROLINE HALL
5. JUNE 1997
6. MD SHPO
7. SOUTHEAST PARAPET WALL
8. 4 OF 6

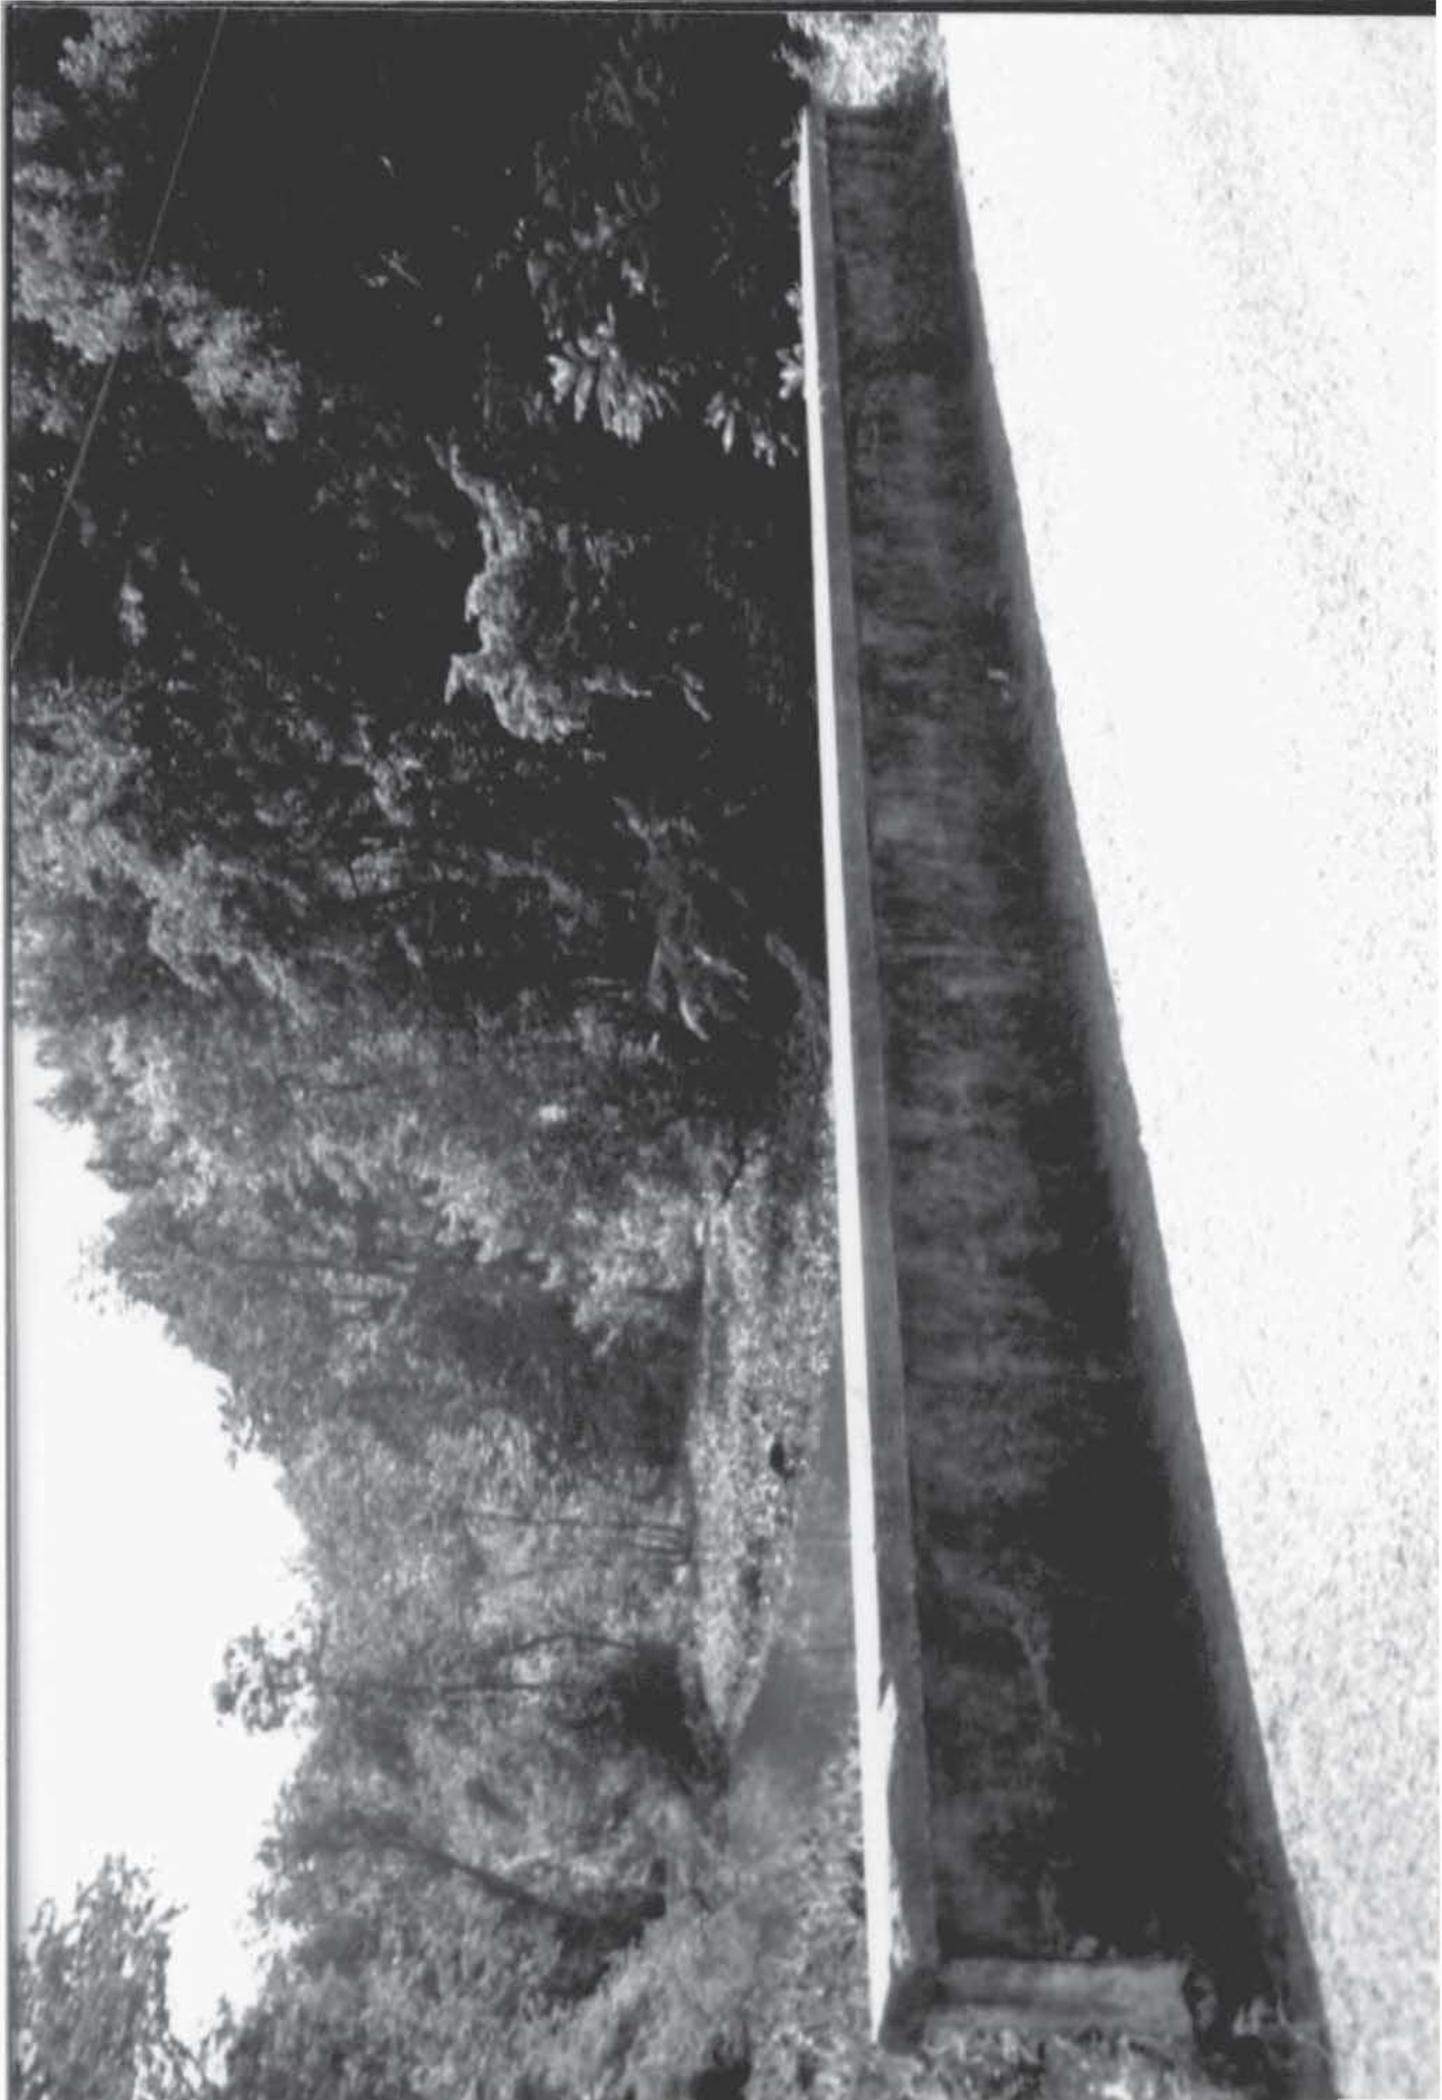
1. CAP-299
2. Double Hill Road over Watts Creek
3. CAROLINE CO., MD
4. CAROLINE HALL
5. JUNE 1997
6. MD SHPO
7. NORTHEAST VIEW OF NORTH PARADET
8. 6 OF 6
