Maryland Inventory of Historic Properties Number: CAR-300

Name: C-0049 / Double Hill Rd over Herring Run

SHA Bridge No. C-0049 Bridge name Double Hill Road over Herring Run

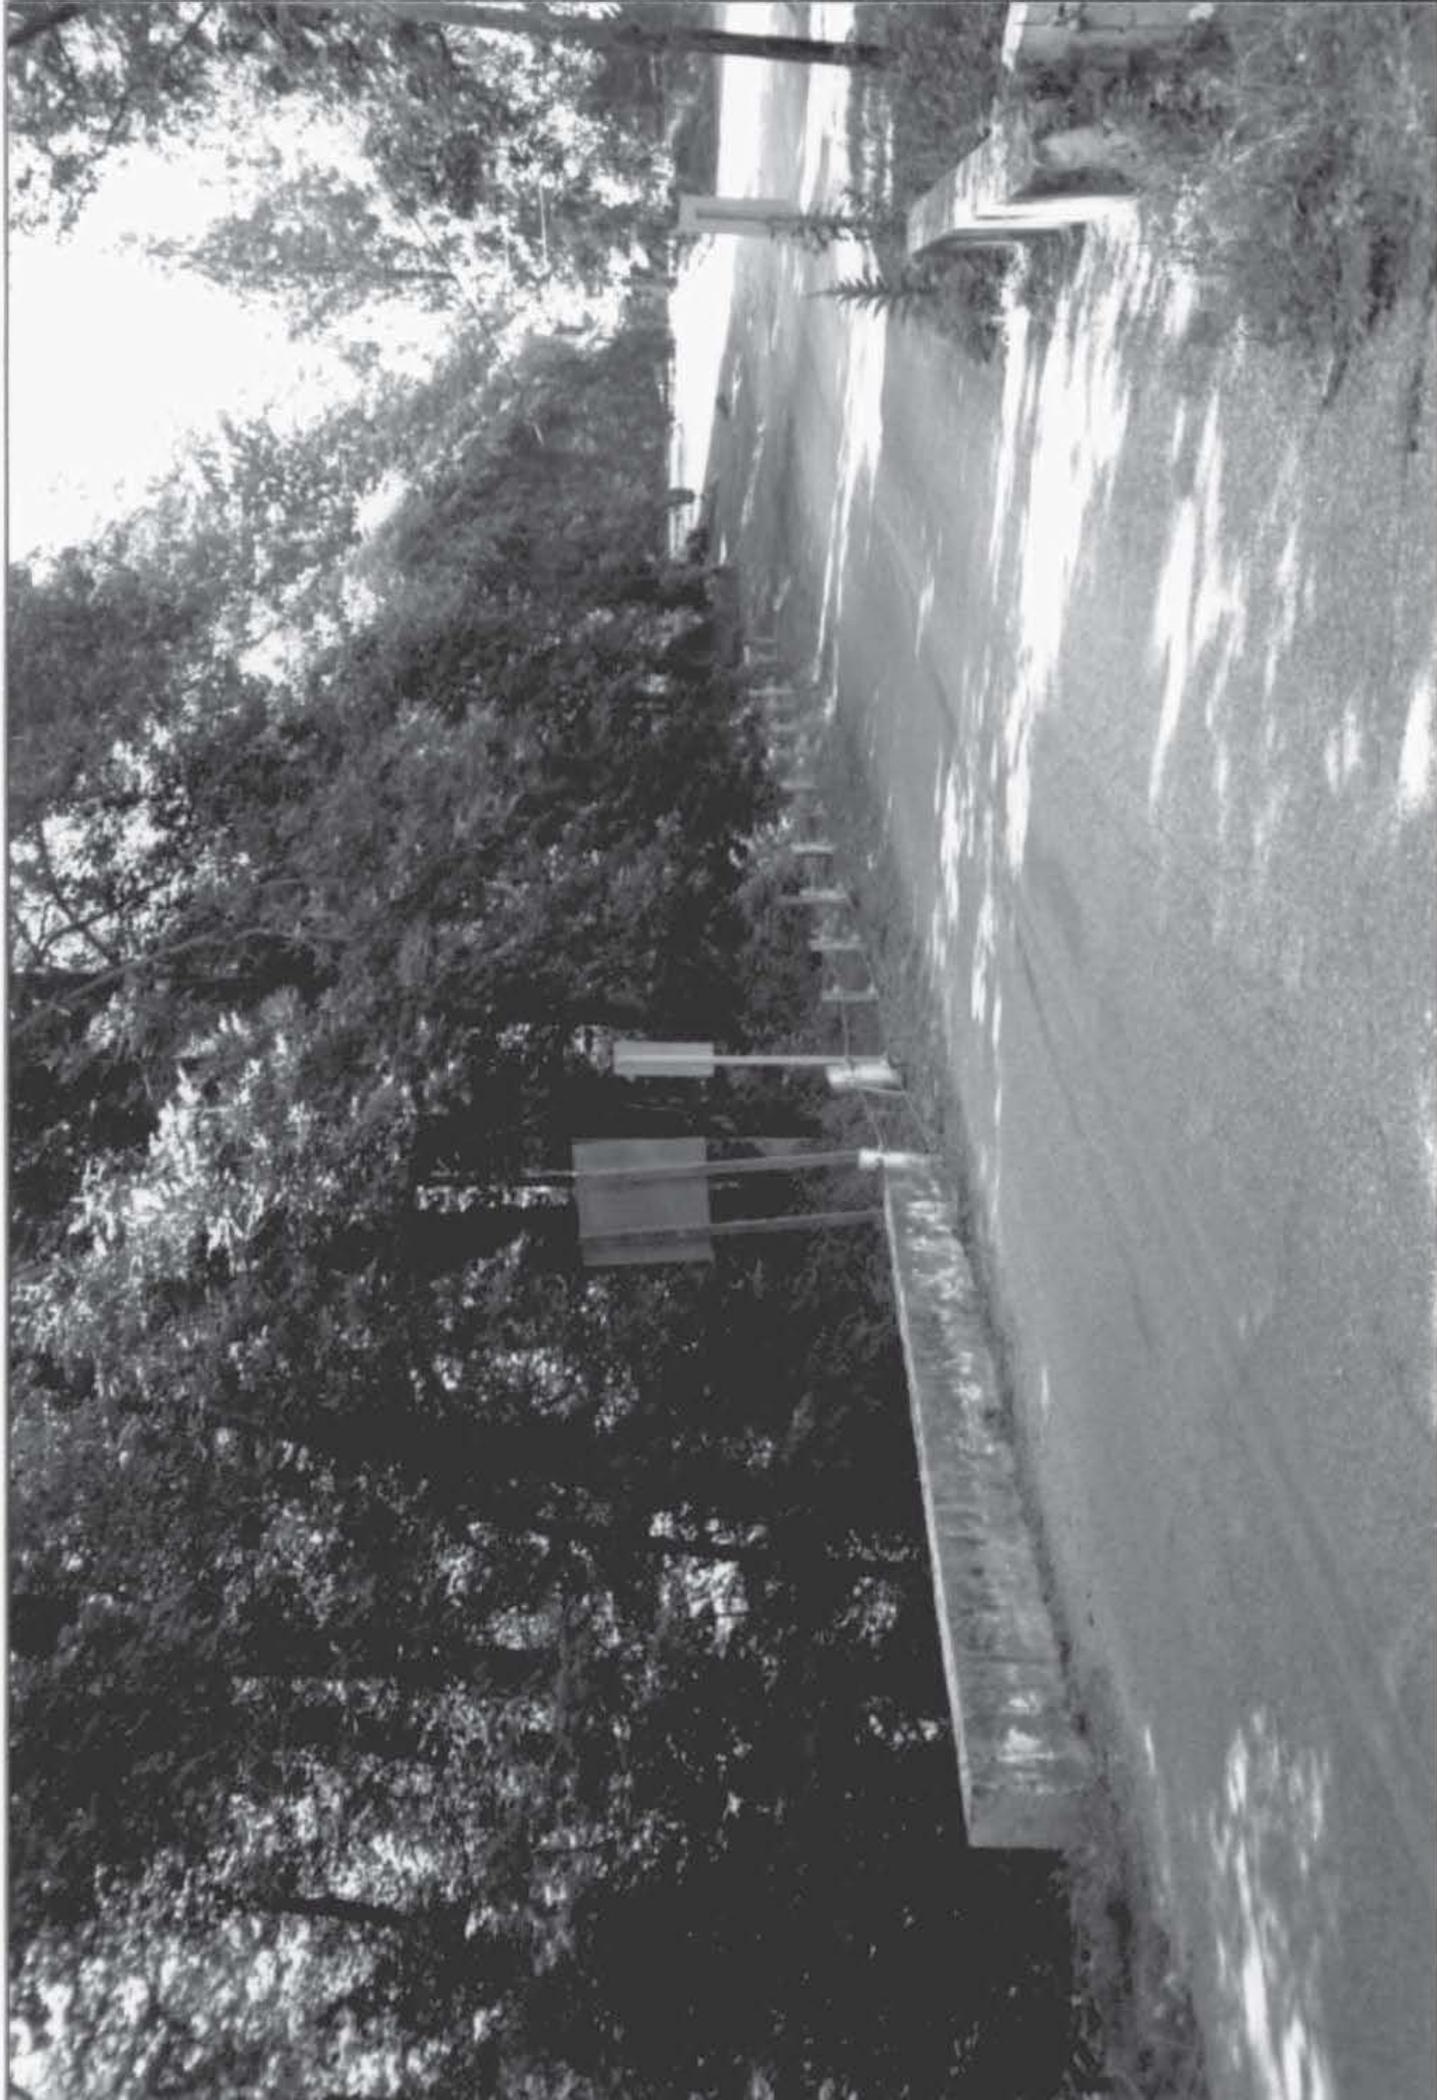
1. CAR-300
2. DOUBLE HILL ROAD OVER HERRING RON
3. CAROLINE Co., MD
4. CAROLINE HALL
5. JUNE 1997
6. MD SHPO
7. SOUTH ROADWAY APPROACH
8. 1 OF 6

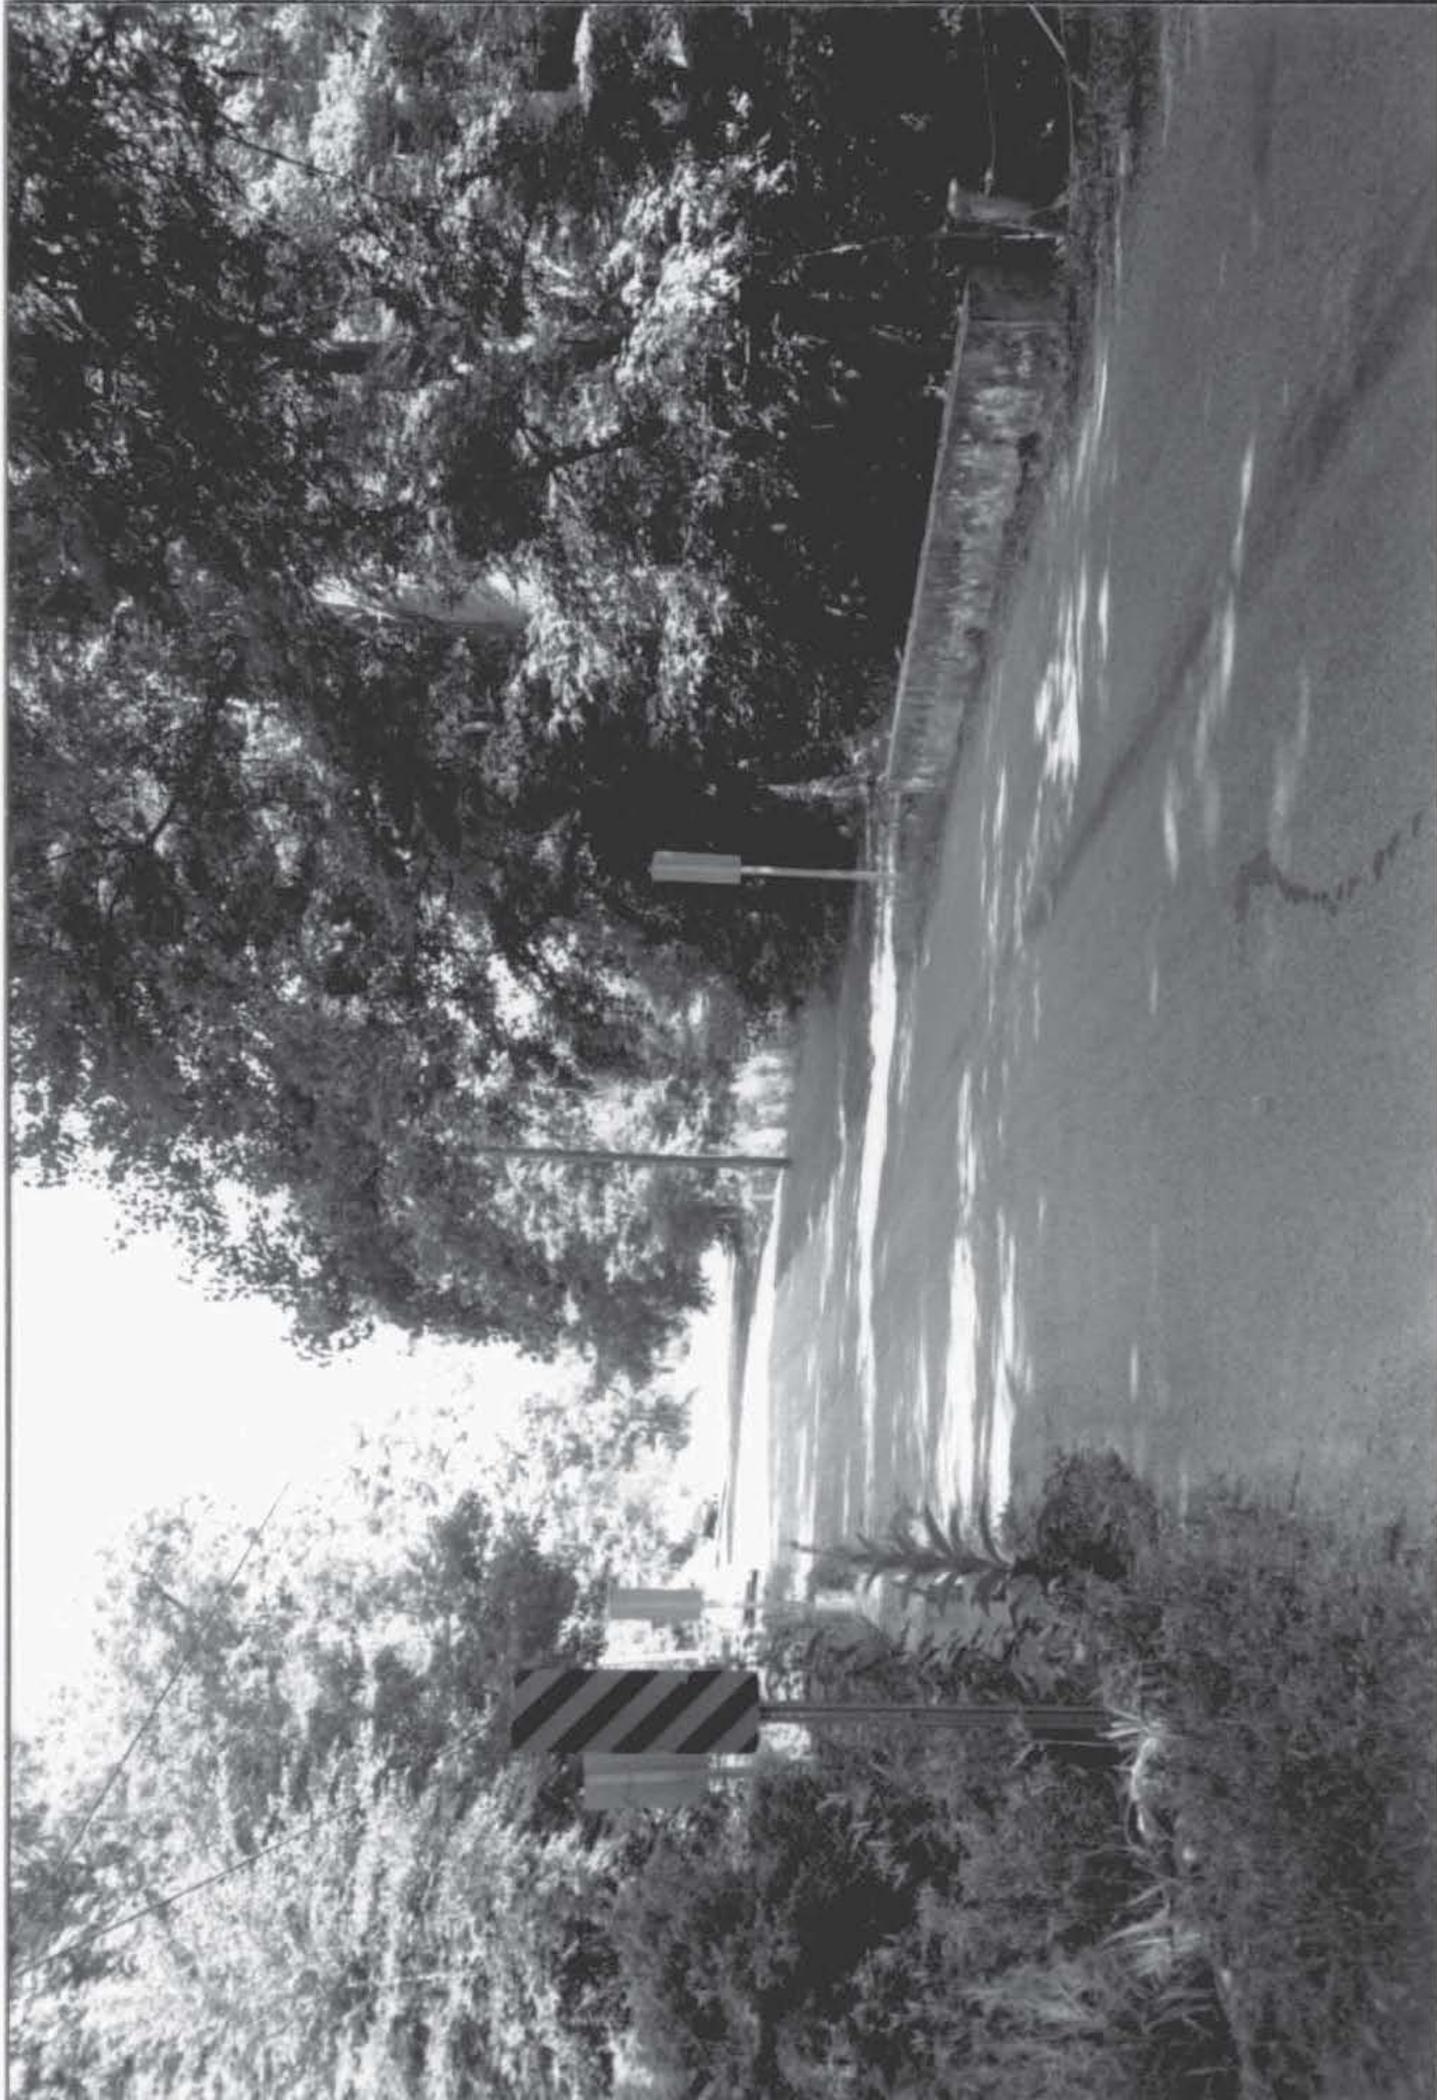
1. CAR-300
2. DOUBLE HILL ROAD OVER HERRING RUN
3. CAROLINE CO., MD
4. CAROLINE HALL
5. JUNE 1997
6. MD SHPO
7. NORTH ROADWAY APPROACH
8. 2 OF 6

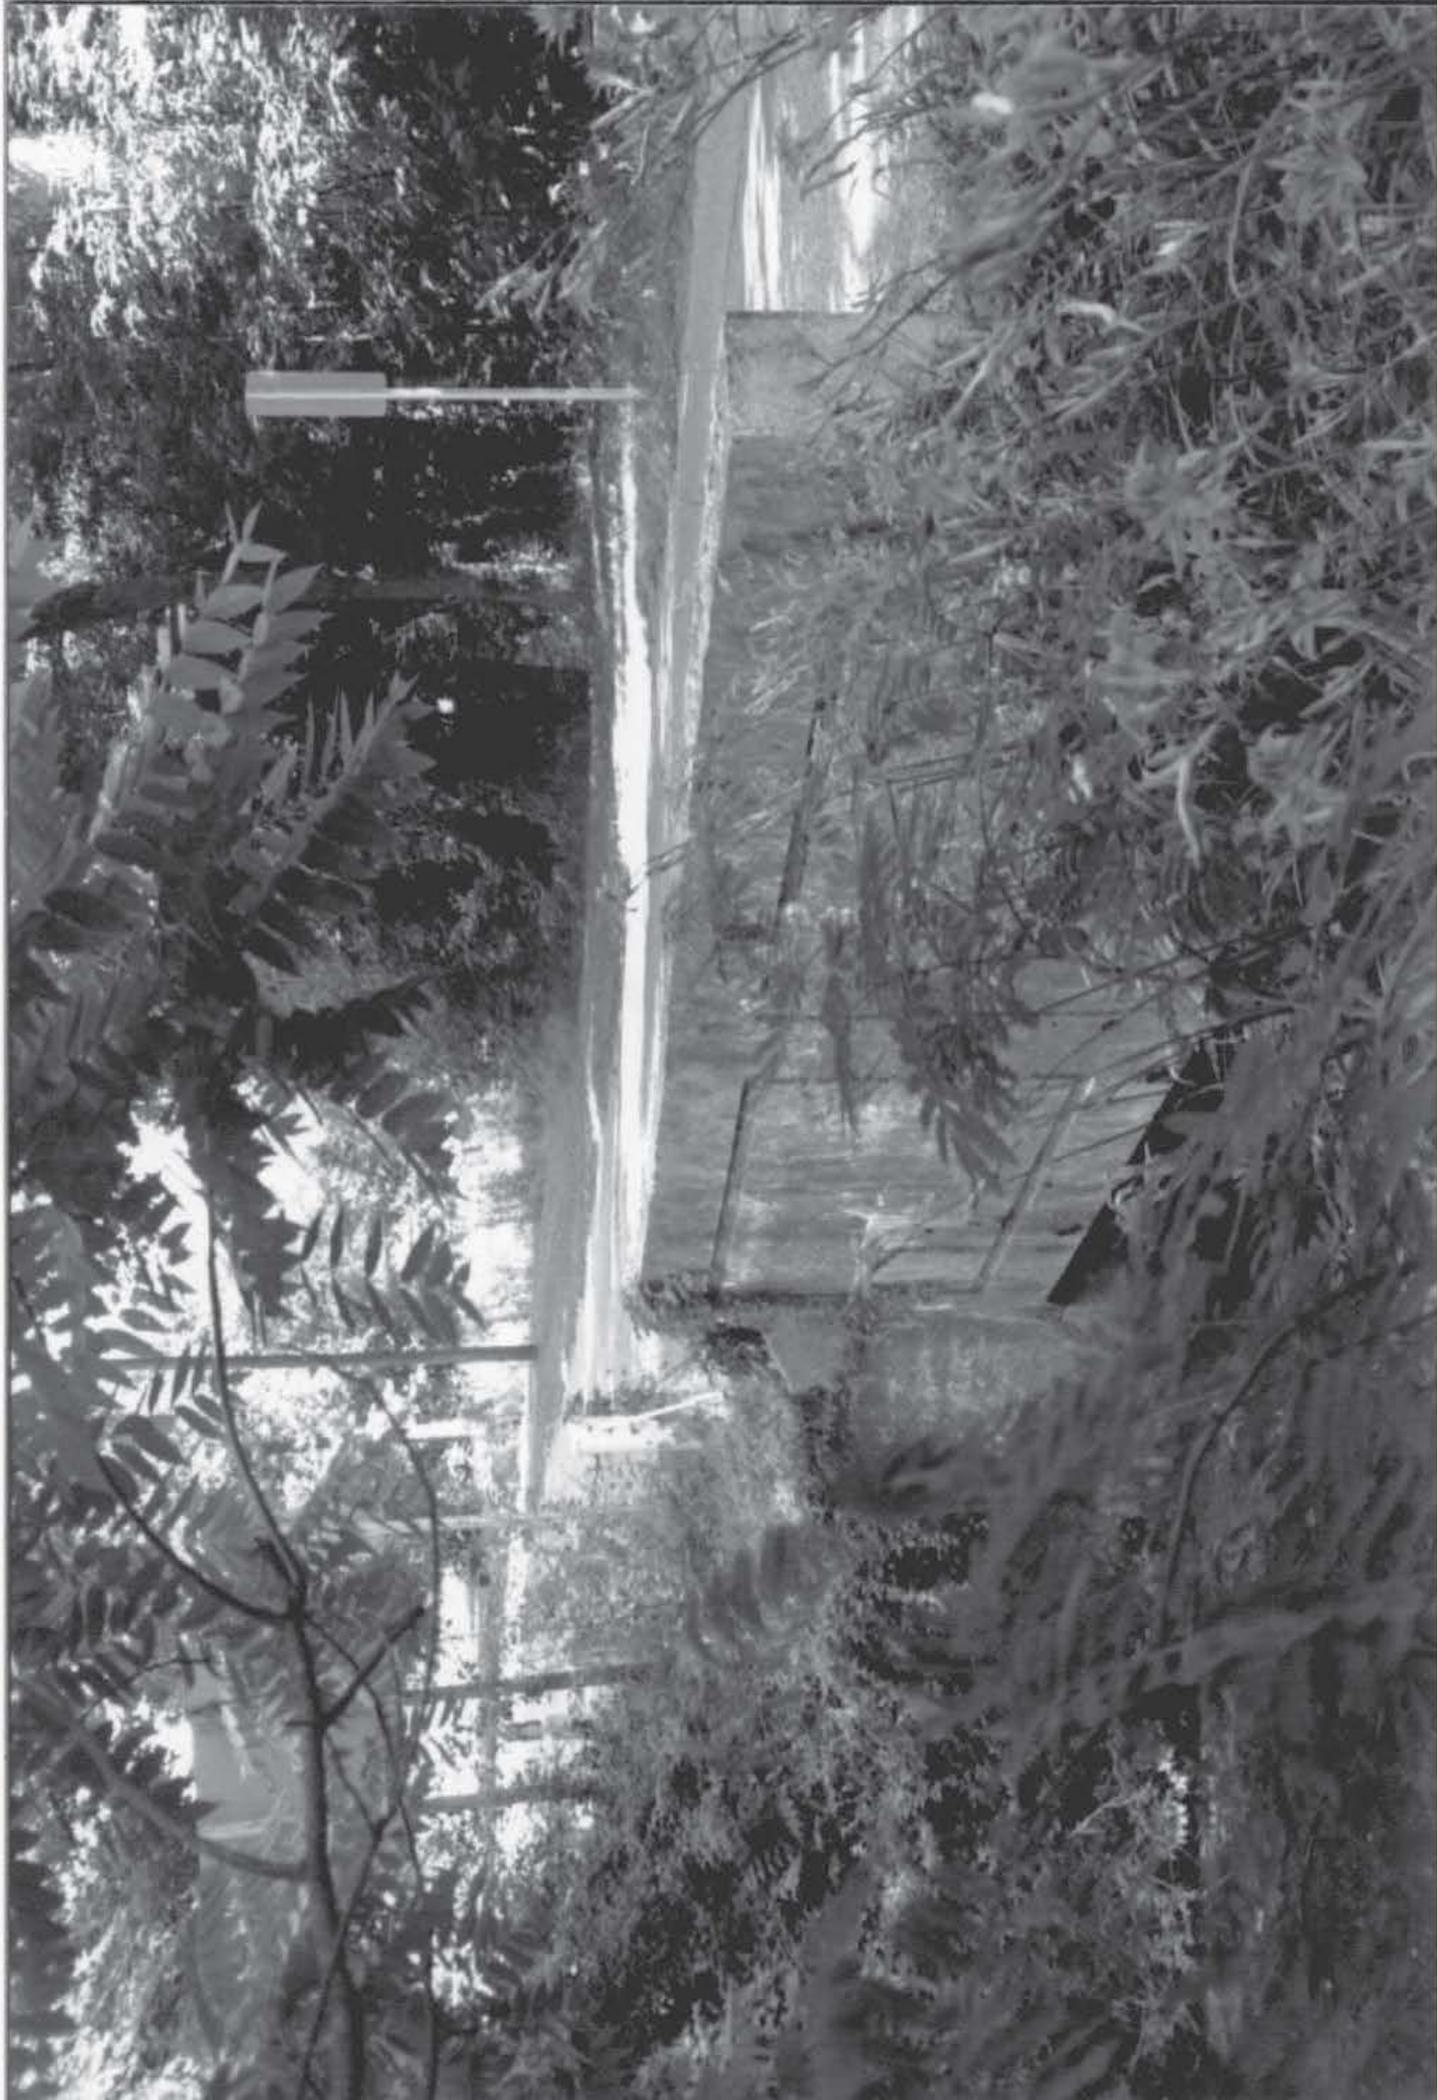
1. CAR-300
2. DOUBLE HILL ROAD OVER HERRING RUN
3. CAROLINE CO., MD
4. CAROLINE HALL
5. JUNE 1997
6. MD SHPO
7. NORTH EAST PARADET WALL
8. 3 OF 6

According to the 1995 inspection report (inspection conducted in February 1996), this structure is in fair condition. The asphalt wearing surface is uneven with gravel along the edges and the concrete deck is in good condition. The concrete beams are in good condition with minor longitudinal cracks. The abutments have minor scaling along the waterline and the horizontal construction joints are spalled. The wingwalls have minor scaling at the waterline and the downstream wingwalls (west) have full-height cracks at their intersection with the abutments. The concrete parapets are in poor condition, with collision damage at the north end of the west parapet and a 5 foot long horizontal crack with efflorescence at the base of the parapet. The concrete caps on both the east and west parapets have broken.

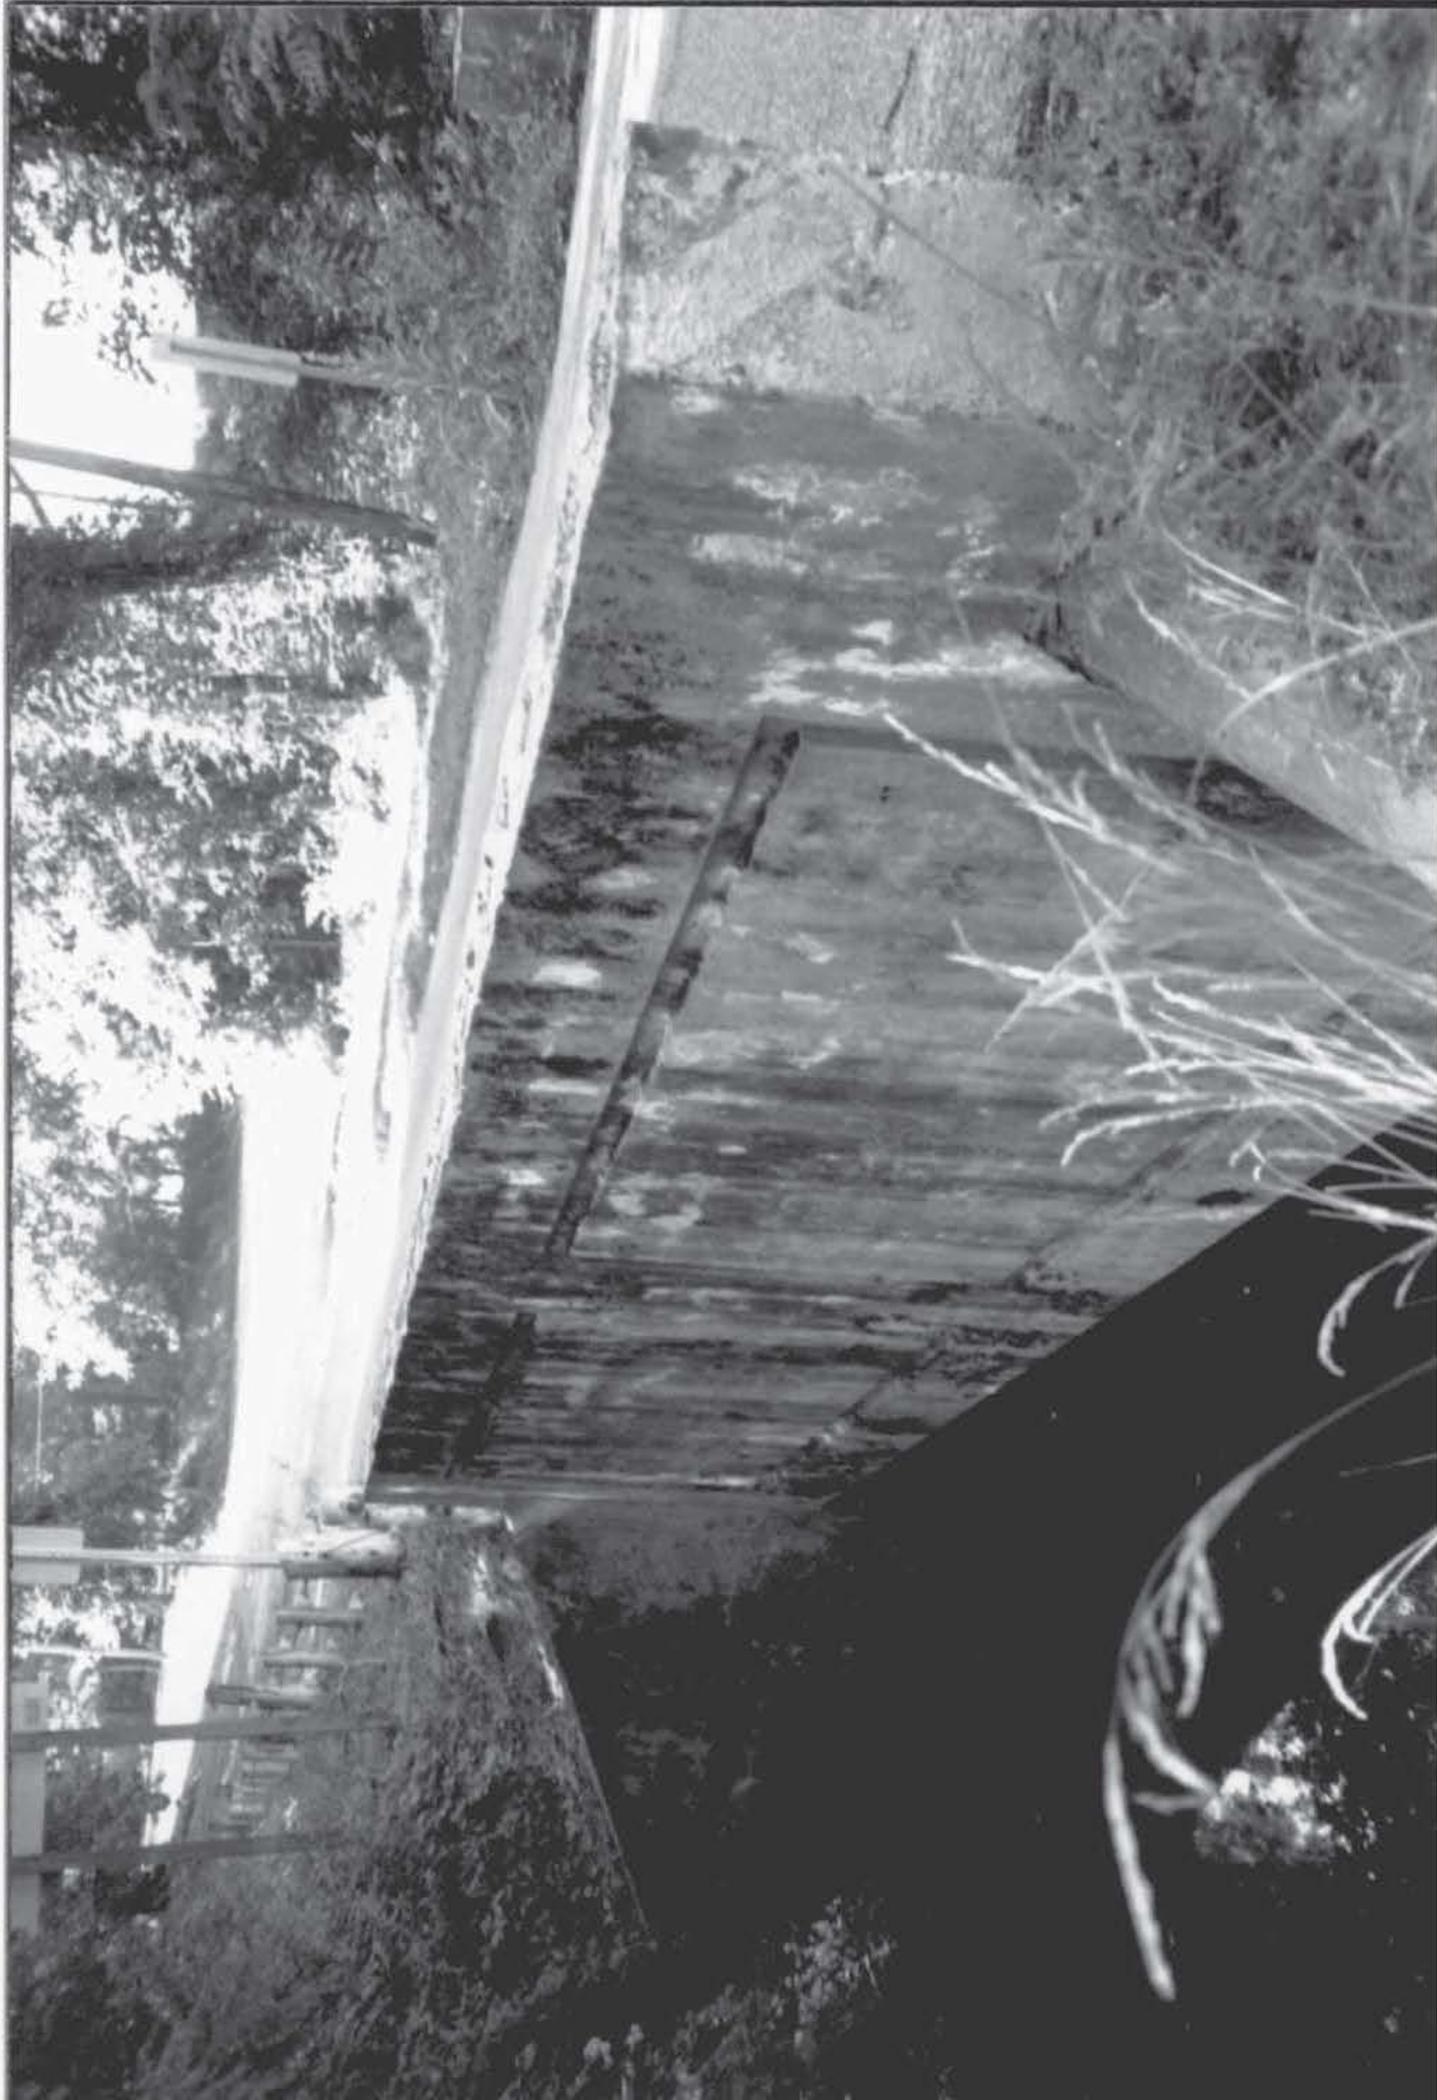
1. CAR-300
2. DOUBLE Hill ROAD over HERRING RUN
3. CAROLINE Co., MD
4. CAROLINE HALL
5. JUNE 1997
6. MD SHPO
7. SOUTHWEST PARAPET WALL
8. 4 OF 6

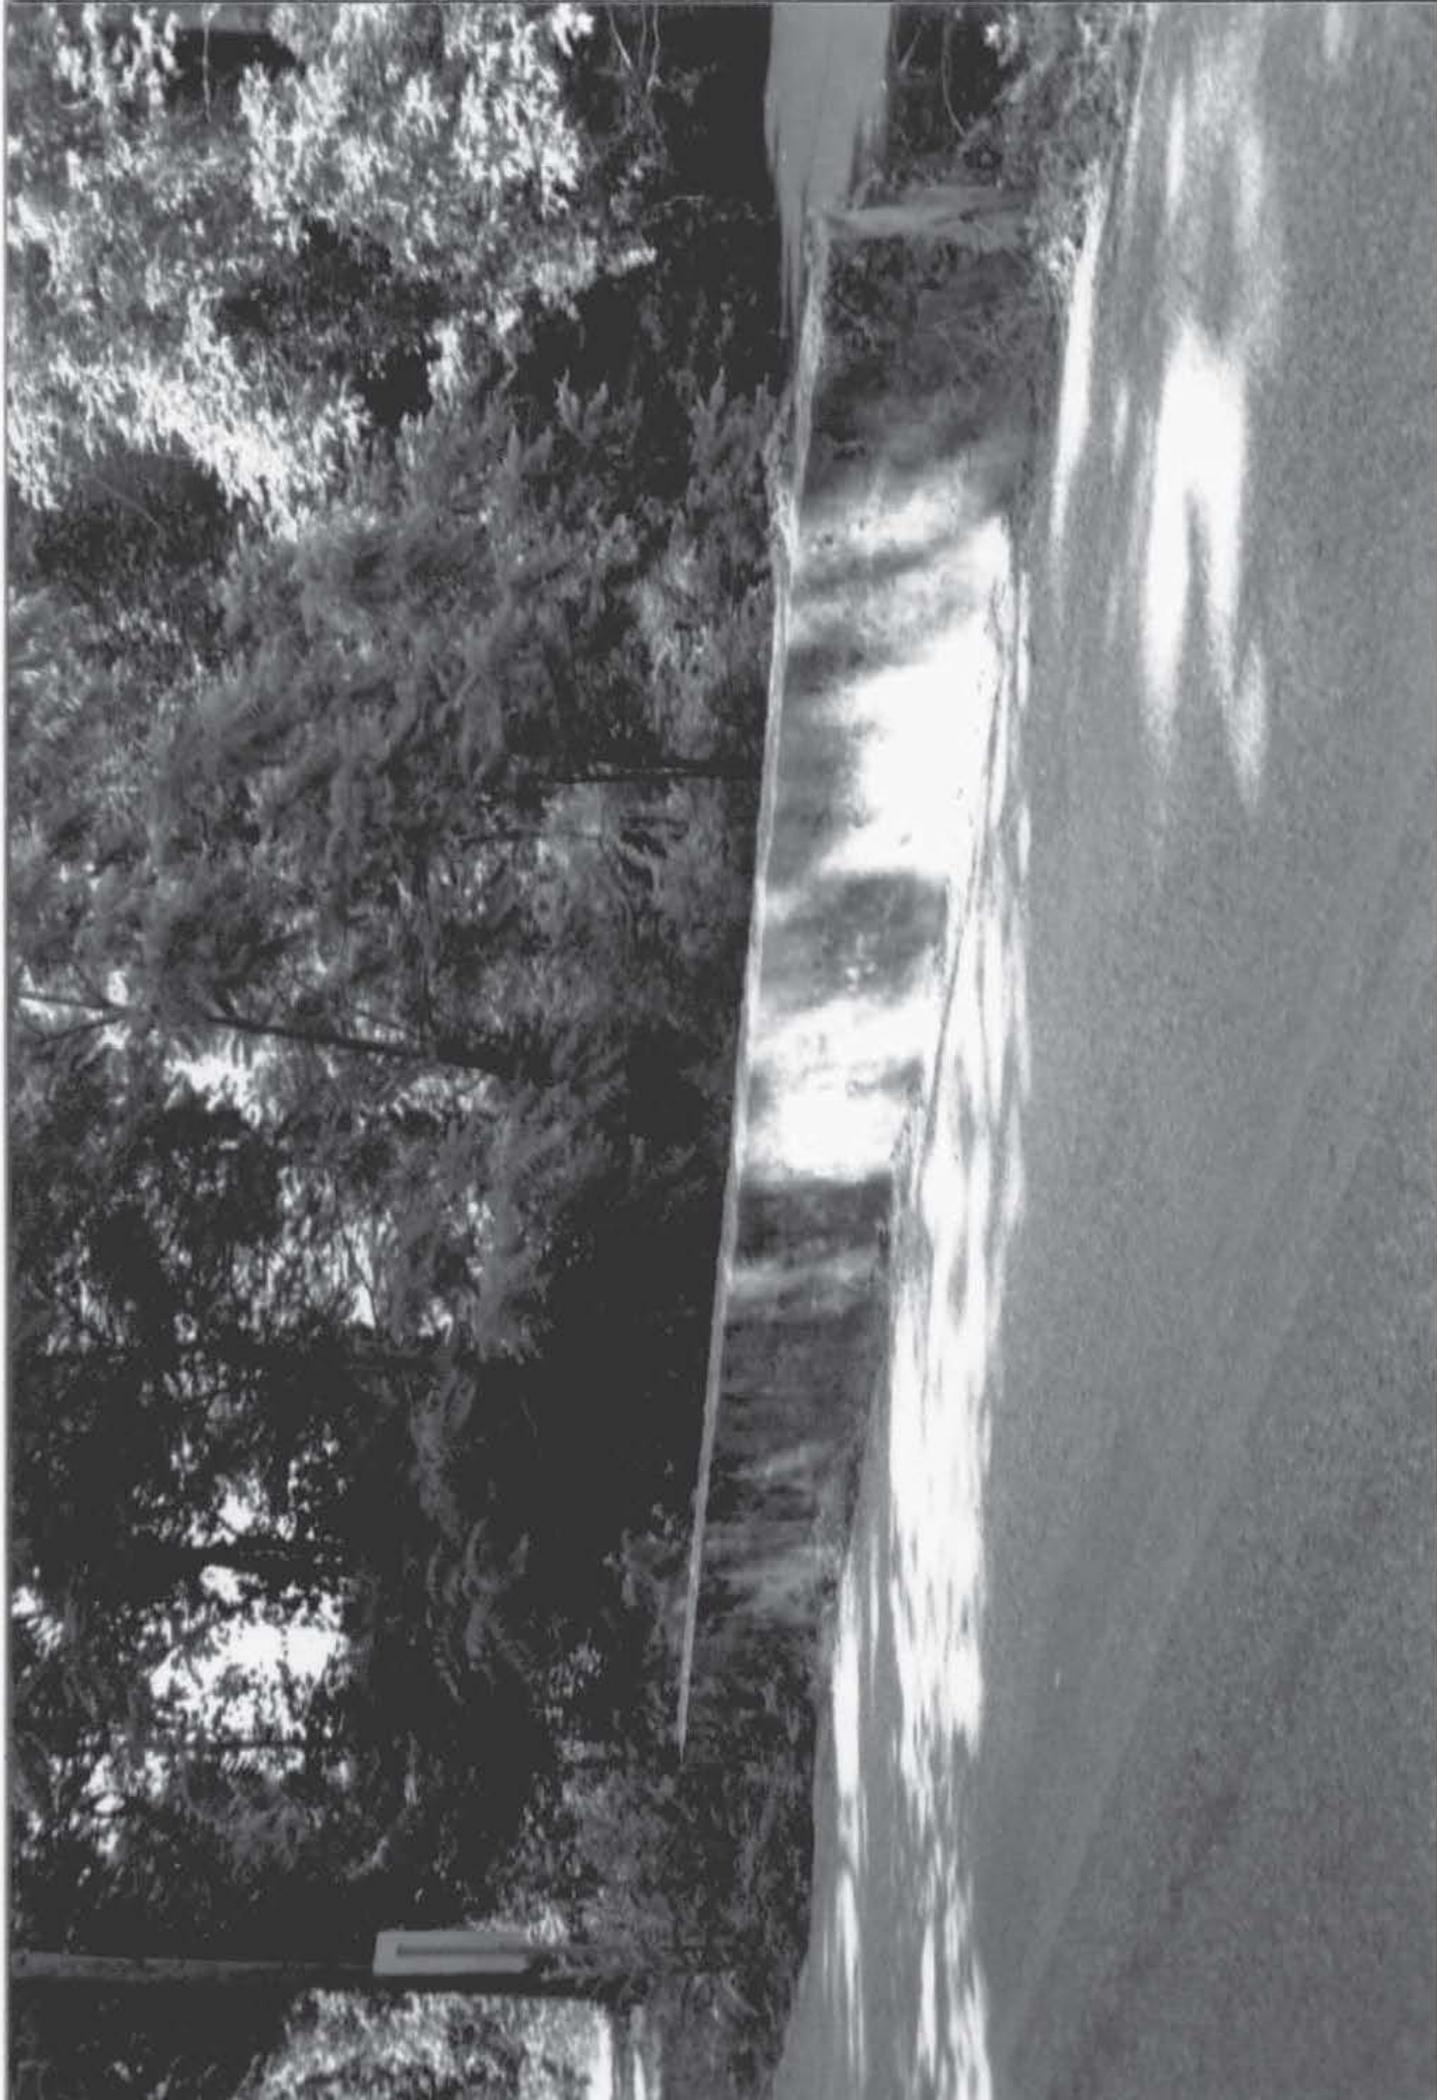
1. CAR-300
2. DOUBLE HILL ROAD OVER HERRING RUN
3. CAROLINE CO., MD
4. CAROLINE HALL
5. JUNE 1997
6. MD SHPO
7. SOUTHWEST PARAPET WALL
8. 5 OF 6

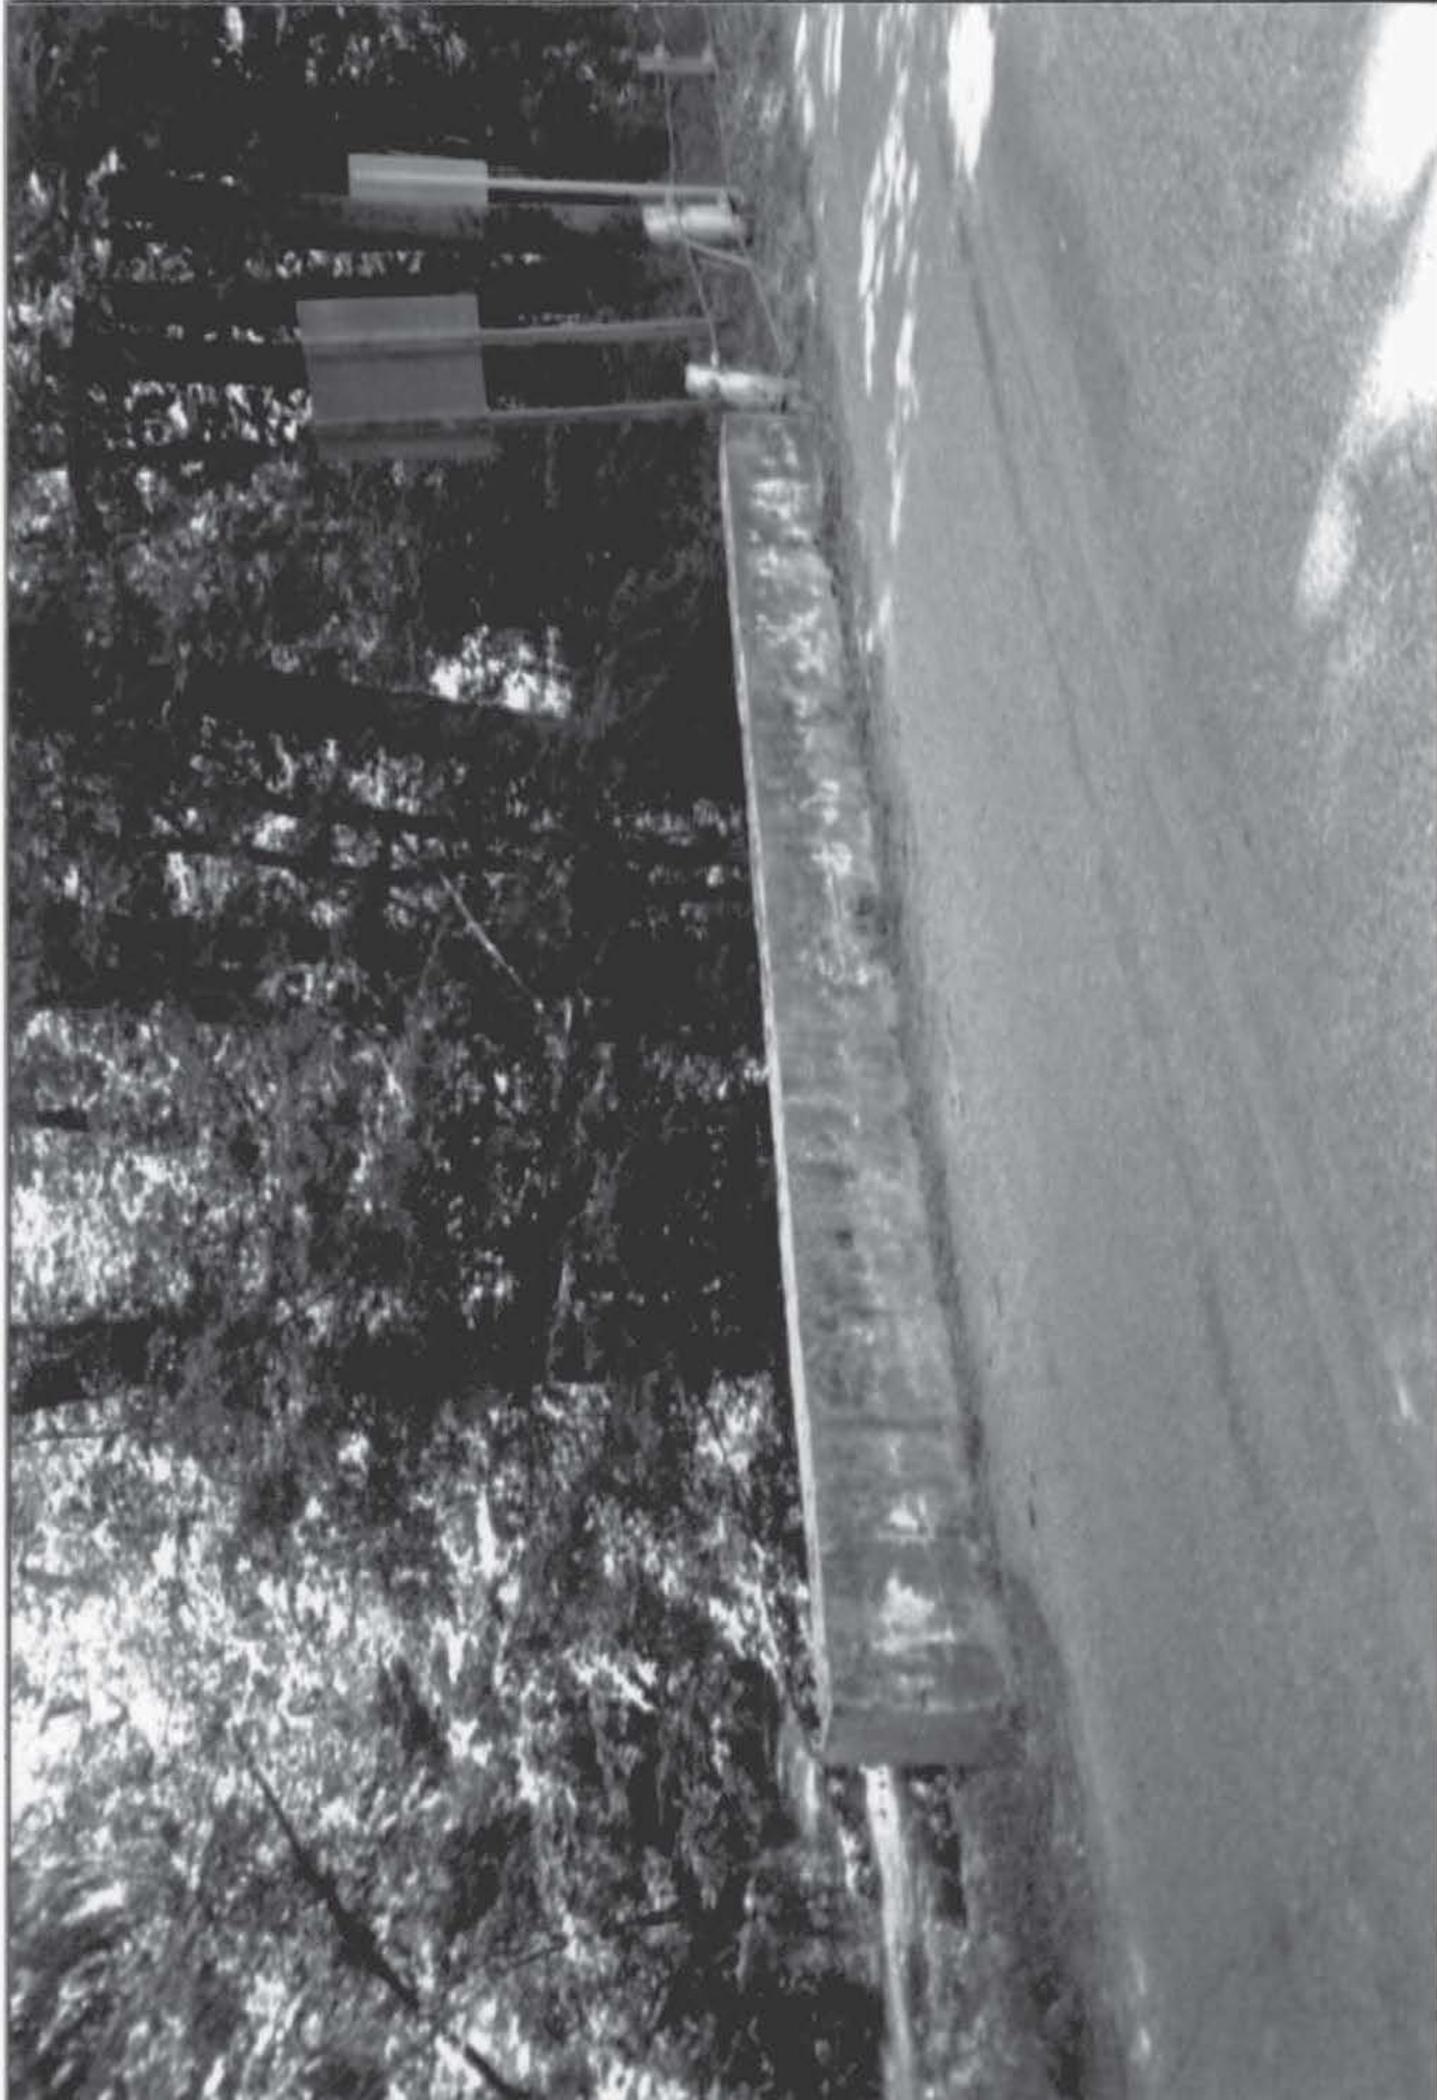
1. CAR-200
2. Double Hill Road over HERRING RUN
3. CAROLINE CO., MD
4. CAROLINE HALL
5. JUNE 1997
6. MD SHPO
7. SOUTH EAST PARAPET WALL
8. 60 F 6
