CARR-1013

Harmony Grove M. P. Church
Klees Mill Road

c.1862

Maryland Historical Trust State Historic Sites Inventory Form

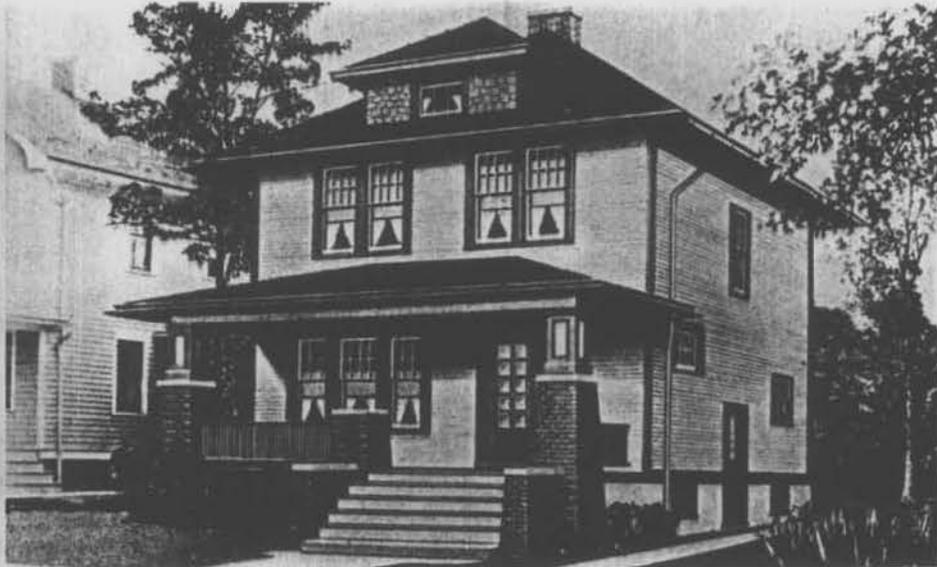
THE FULLERTON

This style of home has become very popular in the past few years. It adapts itself equally well to city lots or country estates, and in few other styles can you get so much space for such a small outlay of money.

Details and features: Six rooms and one bath. Full-width front porch with hipped roof supported by brick and wood piers; hipped-gable dormer; glazed front door. Fireplace in living room; open stairs.

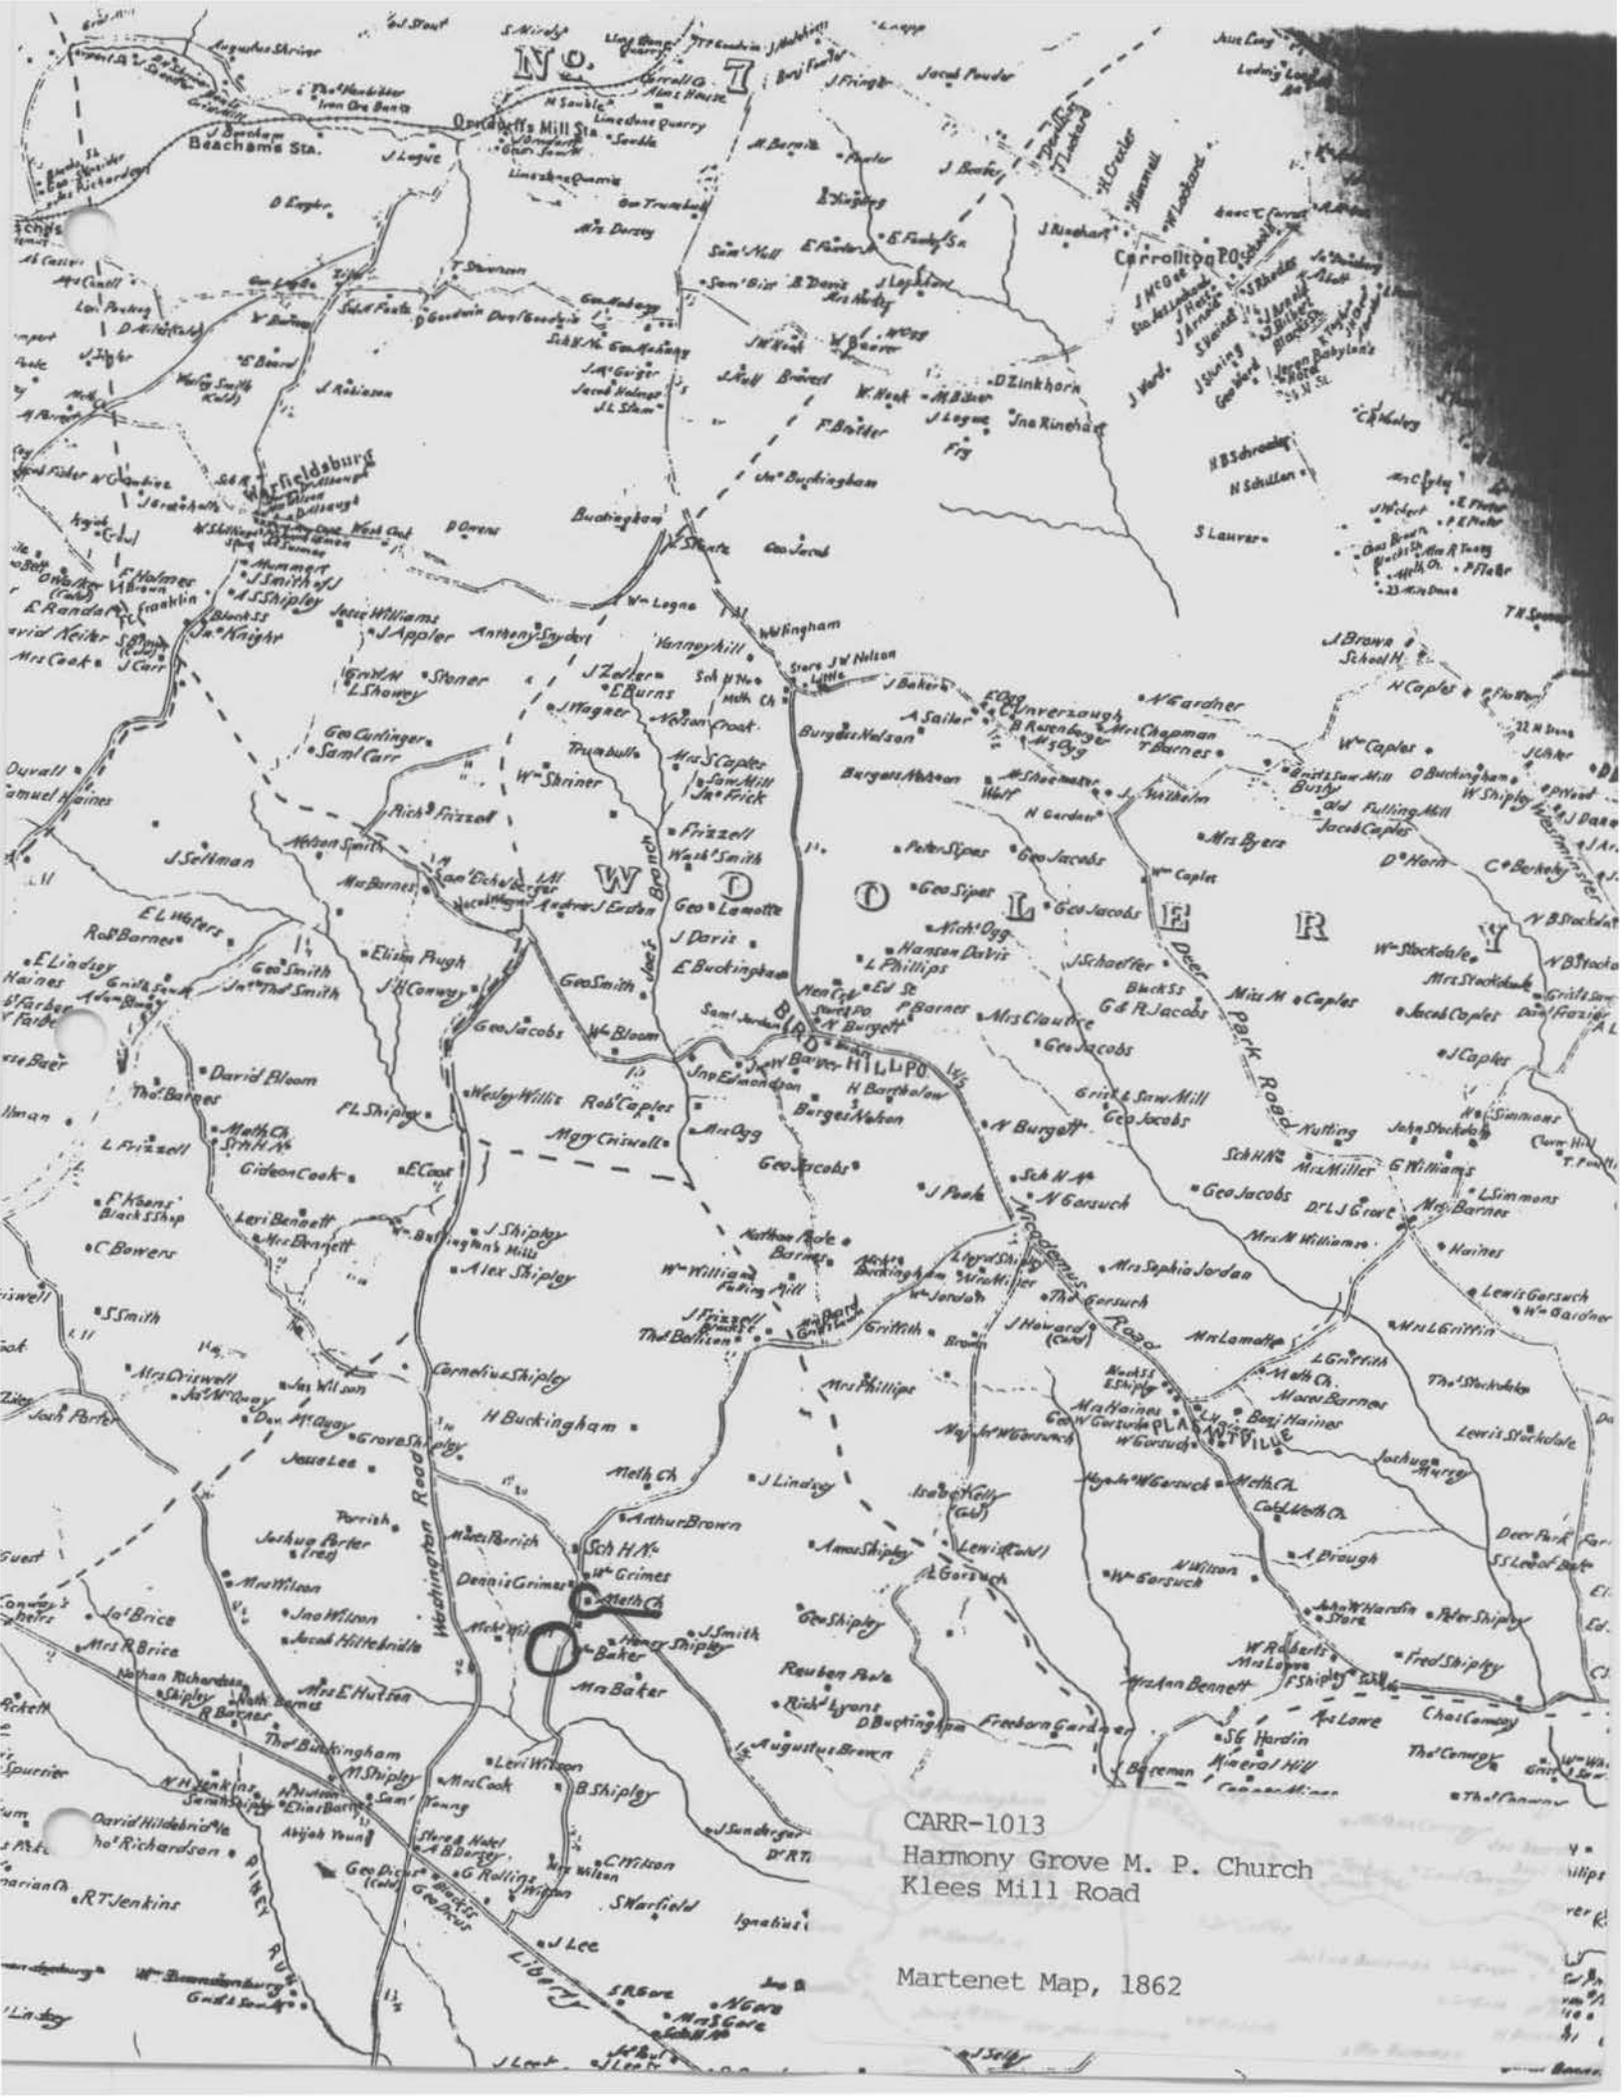
Martenet Map, 1862

According to Scharf, a Methodist Protestant church was built just south of "Pleasant Gap" about 1840. The 1862 map shows this church to have been on the east side of Klees Mill Road, just south of Bartholow Road. Nicholas Wilson sold 1½ acres of land to the Trustees of the M. P. Church "at or near Pleasant Gap School House" for \$1.00 in 1860. The date painted on the church is 1860, but the source of this information is unknown. More likely, the church was built or moved here a year or two later, just after the map was drawn up. In 1923 a new circuit was created, consisting of Harmony Grove, Zion, and Brandenburg churches. Sam Wilson donated land next to Harmony Grove church, and in July 1928 the new parsonage was built. The plan and details of the house are remarkably similar to the Sears, Roebuck and Co. mail order house called "The Fullerton". It was advertised in the "Modern Homes" catalogue between 1925 and 1933. Harmony Grove is a very pristine, simple example of rural vernacular churches in Carroll County, although it will shortly get new vinyl siding. Most early churches in Carroll County were built of logs, but few survive, having been replaced with newer structures. The survival of this log church is notable.

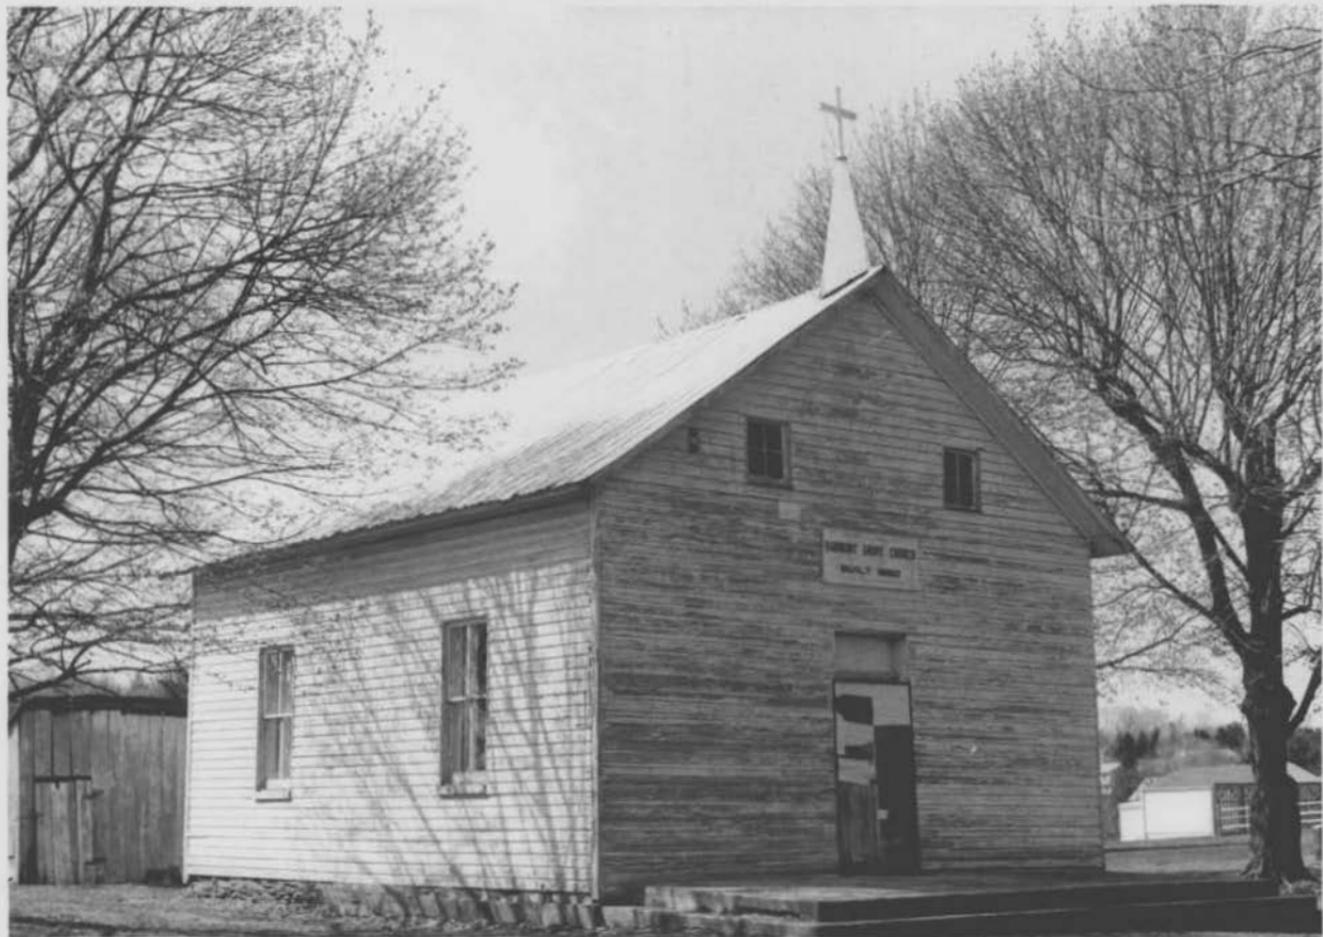
1/4

Harmony Grove M. P. Church is located on the west side of Klees Mill Road about 3½ miles northwest of Eldersburg and about 3½ miles east of Winfield, in south-central Carroll County. The church faces east, toward the road. It is a one-story, one-bay by two-bay log structure with a rubble stone foundation, German siding with corner boards, and an inverted-V-seam metal gable roof with an east-west ridge. The logs are hewn on the sides only and have V-notch corners. The chinking has medium-size stones laid predominantly horizontally in a fairly hard old mortar that contains gravel. The chinking has whitewash or paint, but the logs do not. There is mill-sawn vertical lath nailed to the logs with cut nails. Many chases have been hacked into the logs where the lath is, and there are wedges placed between the logs and lath in other places. The German siding is mill-sawn, too, and is nailed to the lath with cut nails. At the door opening the logs butt up against a board about one inch thick. It is not possible to tell if the board is pegged to the logs. The door frame projects forward from the face of the logs about three inches, which makes it flush with the siding. The east elevation has new, flush, center double doors. Above them is a two-light transom that has been painted over. There is a painted sign over the door that reads "Harmony Grove Church Built 1860." There are two four-light sash in the gable end. Both the north and south elevations have two 2/2 double-hung sash. The north elevation also has a stovepipe that comes out of the wall west-of-center, and goes up to near the eave. The west elevation used to have one opening, but it is now covered with German siding.

Neg. Loc.: Maryland Historical Trust
South: east elevations

The trustees of the church continue to maintain it, even though it is no longer used for worship. The front doors will shortly be replaced, and vinyl or aluminum siding is to be put on the walls.

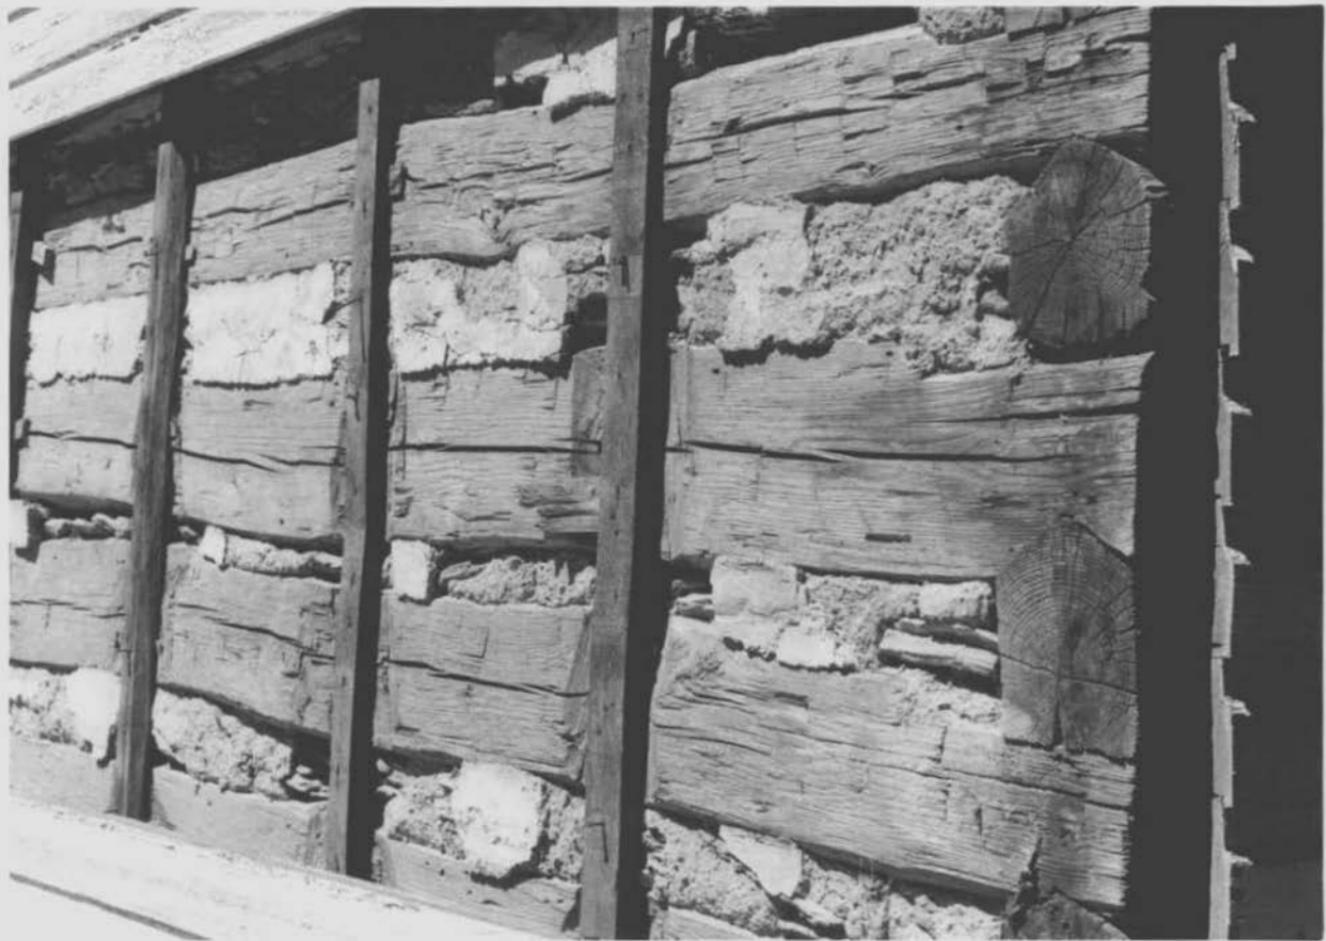
2/4

Church - east elevation - detail of
log structure

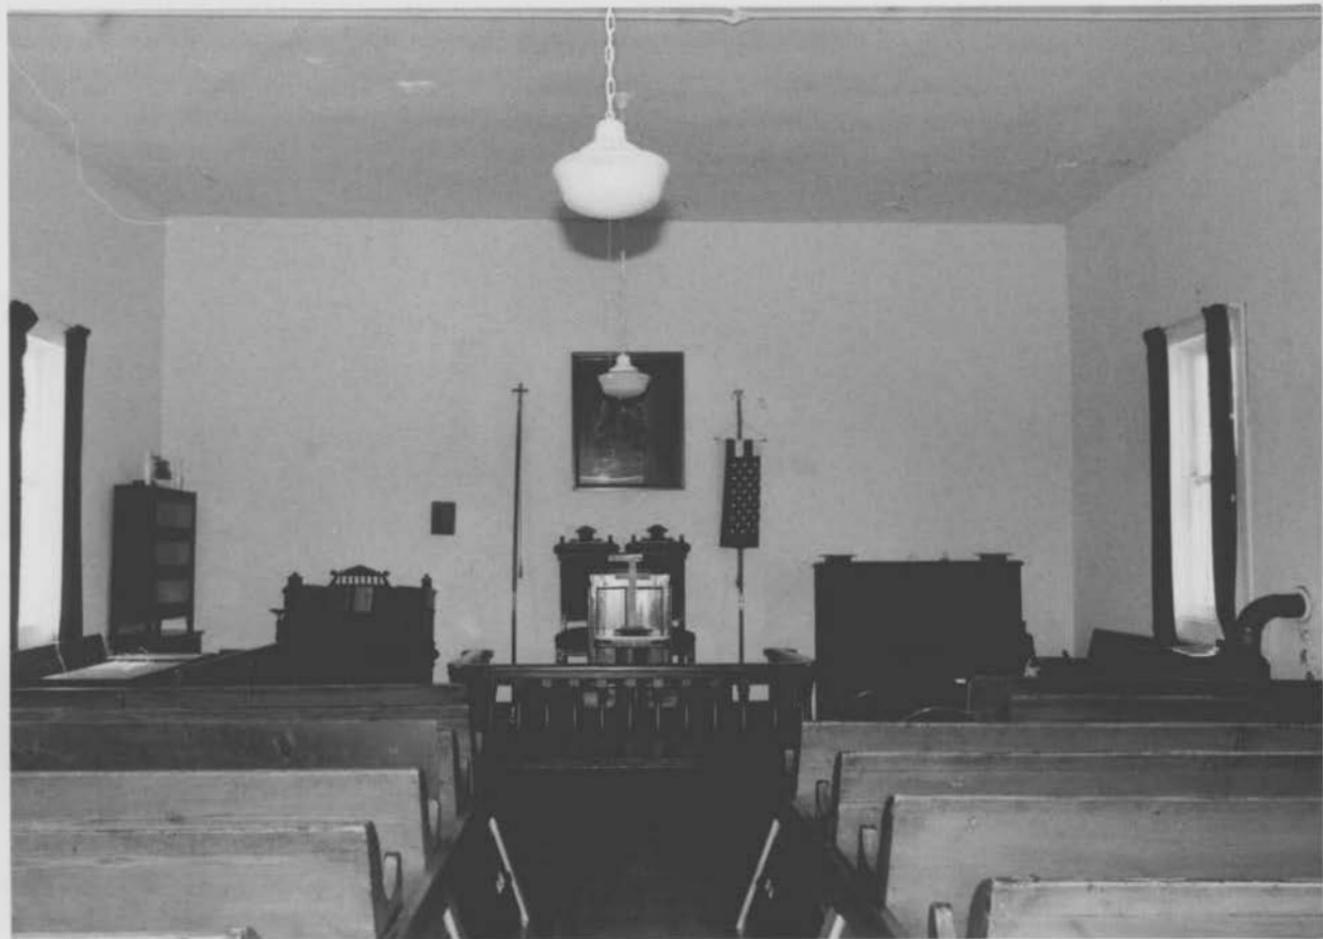
3/4

The sanctuary has a carpeted floor, plastered walls with plain baseboards, window surrounds with a beaded-interior edge, and a flat plaster ceiling. There is a tie rod just below the ceiling that runs north-south. The pews are laid out with a center aisle. The pew ends are boards that are plainly cut with a deep curve from the back of the bench

down to a low point and up to the end of the arm rest. On the west end is a raised dais with an altar rail on three sides. It is curved at the corners, has turned balusters, and appears to be pine. The pulpit is set up on a second raised podium. It has raised panels and is grained, apparently to imitate pine. Behind the pulpit are two walnut chairs with red velvet upholstery. There is also an original small free-standing organ in an ornate oak cabinet, and an old piano that appears to be walnut.

Neg. Loc.: Maryland Historical Trust
interior - view west

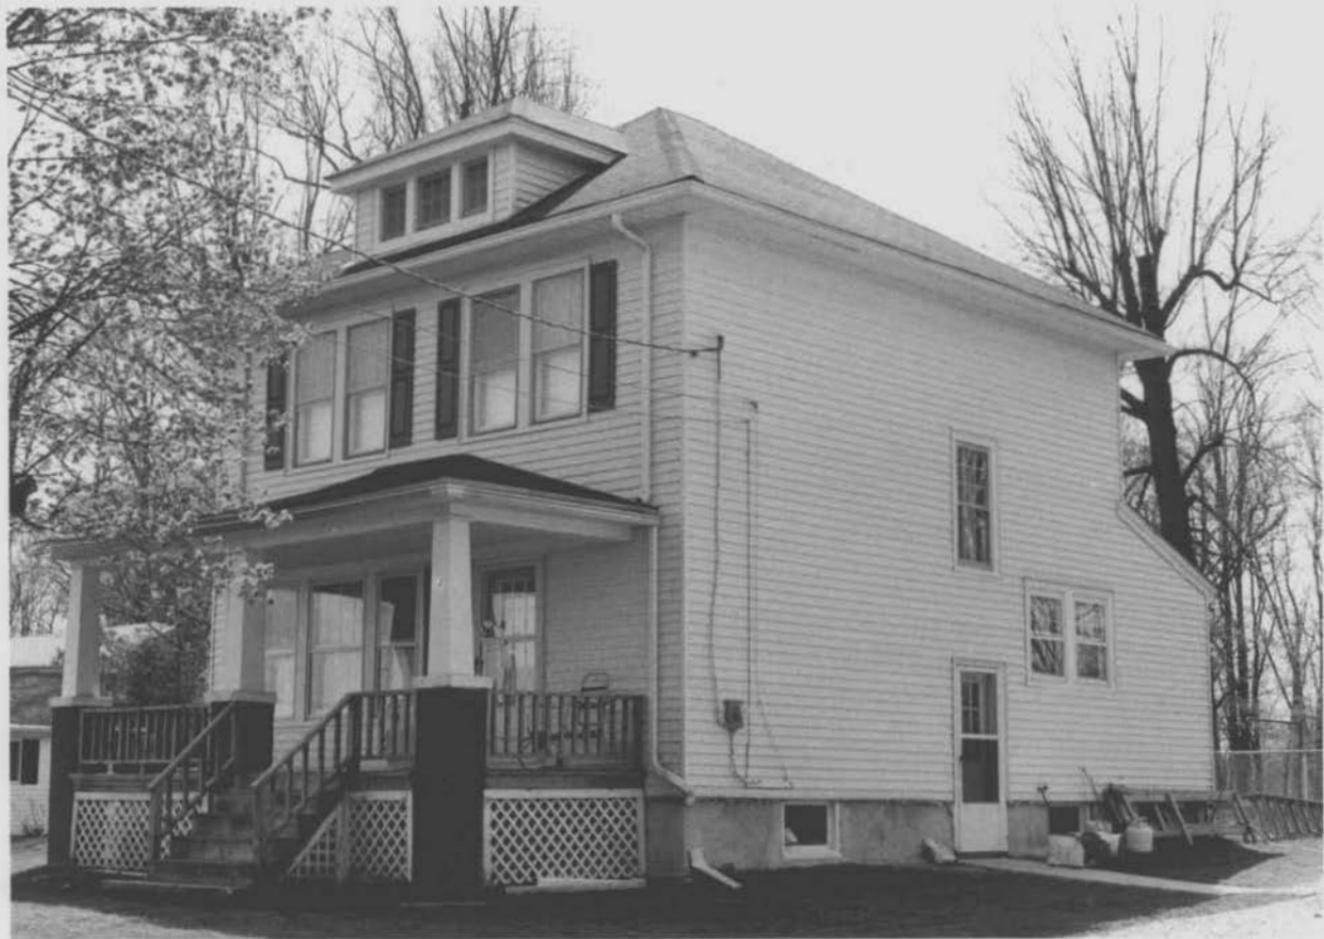
7/1

South of the church, at 130 Klees Mill Road, is the former parsonage. It is a 2½-story, two-bay foursquare, and has a parged foundation, aluminum siding, and a hip roof with asphalt shingles. The house faces east, toward Klees Mill Road. The first story of the east elevation has a tripartite window, with 9/1, 12/1 and 9/1 sash, in the south bay. The north bay has a new door. Each bay of the second story has paired 9/1 sash. There is a hipped dormer that has a six-light sash in the center, with a four-light sash on either end. There is a one-story porch across the front. It has battered posts on brick piers, a new deck and railings, and a concave bellcast half-hip roof with asphalt shingles.

The south elevation has two one-light sash in the cellar. The first story has paired 9/1 in the west bay and a single 12/1 in the east bay. The second story has two 9/1 sash. There is an exterior CMU chimney placed west-of-center. The north elevation has two one-light sash in the cellar, too. The first story has a new door in an original opening in the center of the house. Above it, between the first and second stories, is a 9/1 sash. The west bay of the first story has paired, short 9/1 sash. The west elevation has a shed-roof one-story wing to the north. It has a 9/1 sash, a new door, and a new window to the south. It appears that the wing was originally smaller than one bay, and was added onto. South of the wing on the first story is a 9/1 sash. The second story has a small 9/1 sash to the north, and a 9/1 sash to the south.

Neg. Loc.: Maryland Historical Trust
Parsonage - east : north elevations
