# Maryland Historical Trust State Historic Sites Inventory Form

historic Benjamin Bowser Farm

street & number 4864 Schalk Road One  not for publicationcity, town Alesia  vicinity of congressional district

Survey No. CARR-1149

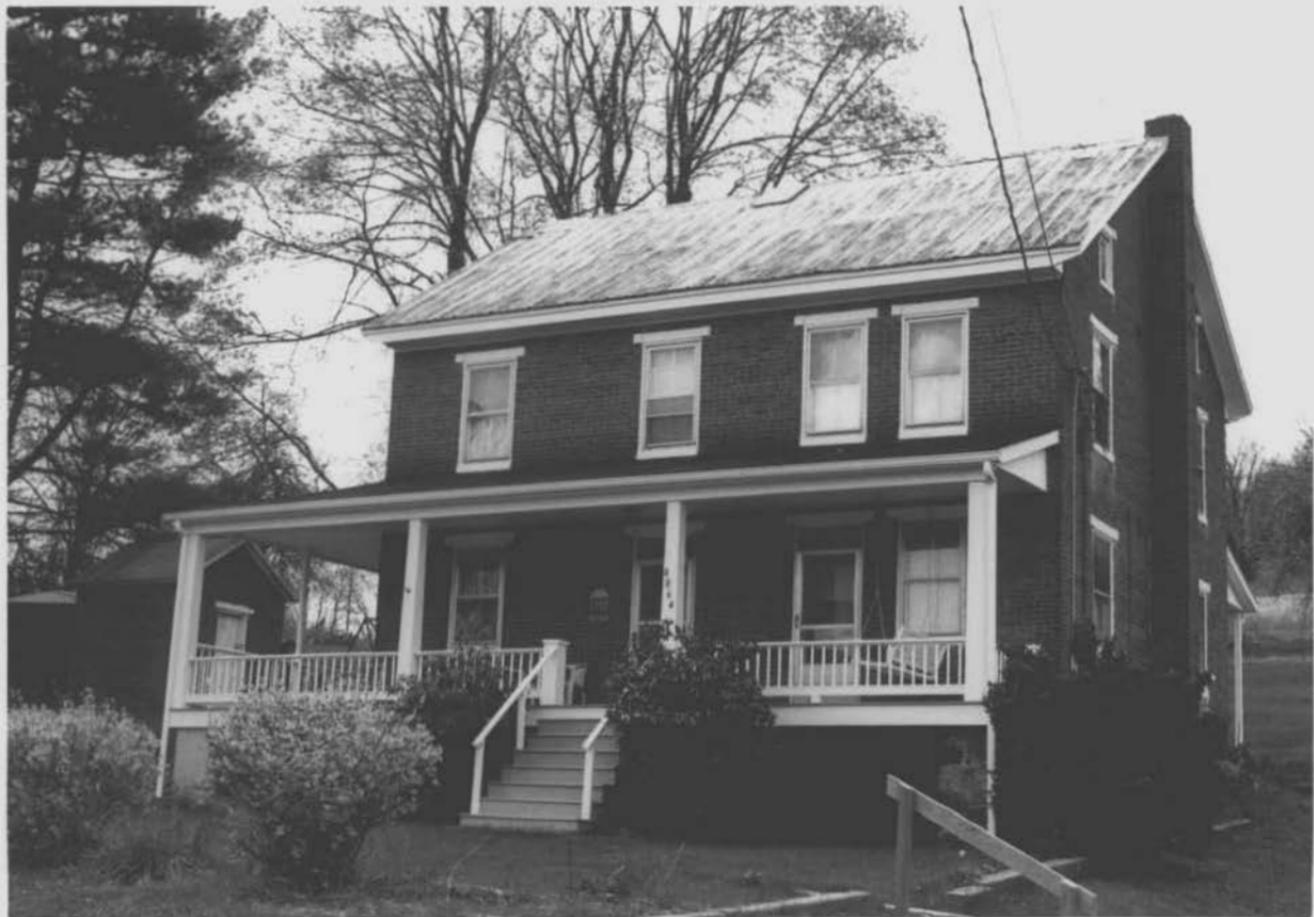
1/11

Neg. Loc.: Maryland Historical Trust  
House - east: north elevs.

The house faces east, toward Schalk Road, and is a two-story, four-bay by two-bay building of 5-1 common bond brick on a rubble stone foundation. It is banked into the hill on the west. The exposed east cellar wall has one six-light sash in the south bay. The first story has two center entrances with three-light transoms and doors with one light over two vertical panels. The windows have 2/2 double hung sash with beaded-edge frames, and wood sills, lintels, and corner blocks. The openings are not spaced regularly, the two north bays being close together. The gable roof has inverted-V-seam

metal and a boxed cornice. There is a raised one-story porch that wraps around the east, south, and west elevations. Stone and brick piers support the deck. The posts on the east have been boxed and the balusters on the south replaced, but original posts survive on the south. They are chamfered, with tripartite capital blocks. The original balusters on the east are vertical, and are square in plan. The steps are off the center of the east porch. The south elevation of the house is two bays, with two small four-light windows in the gable end and a semicircular date panel painted "Built 1878 By B. Bowser." Between the first story windows is a smaller one-light sash with a bullnose frame, and wood sill, lintel and corner blocks. The mortar joints show evidence of striping, some of which is missing around the small window, suggesting it was cut into the wall later, and new bricks toothed in. There is a door in the eastern-most end of the south elevation of the cellar. The north elevation has identical windows in the gable, but has an external brick chimney centered on the wall, and a six-light sash in the east bay of the cellar. An old aerial photograph in the owners possession shows an internal brick chimney at each end, and apparently a wood shingle roof. There were no steps east of the porch, which had six posts and balusters between them across the whole front.

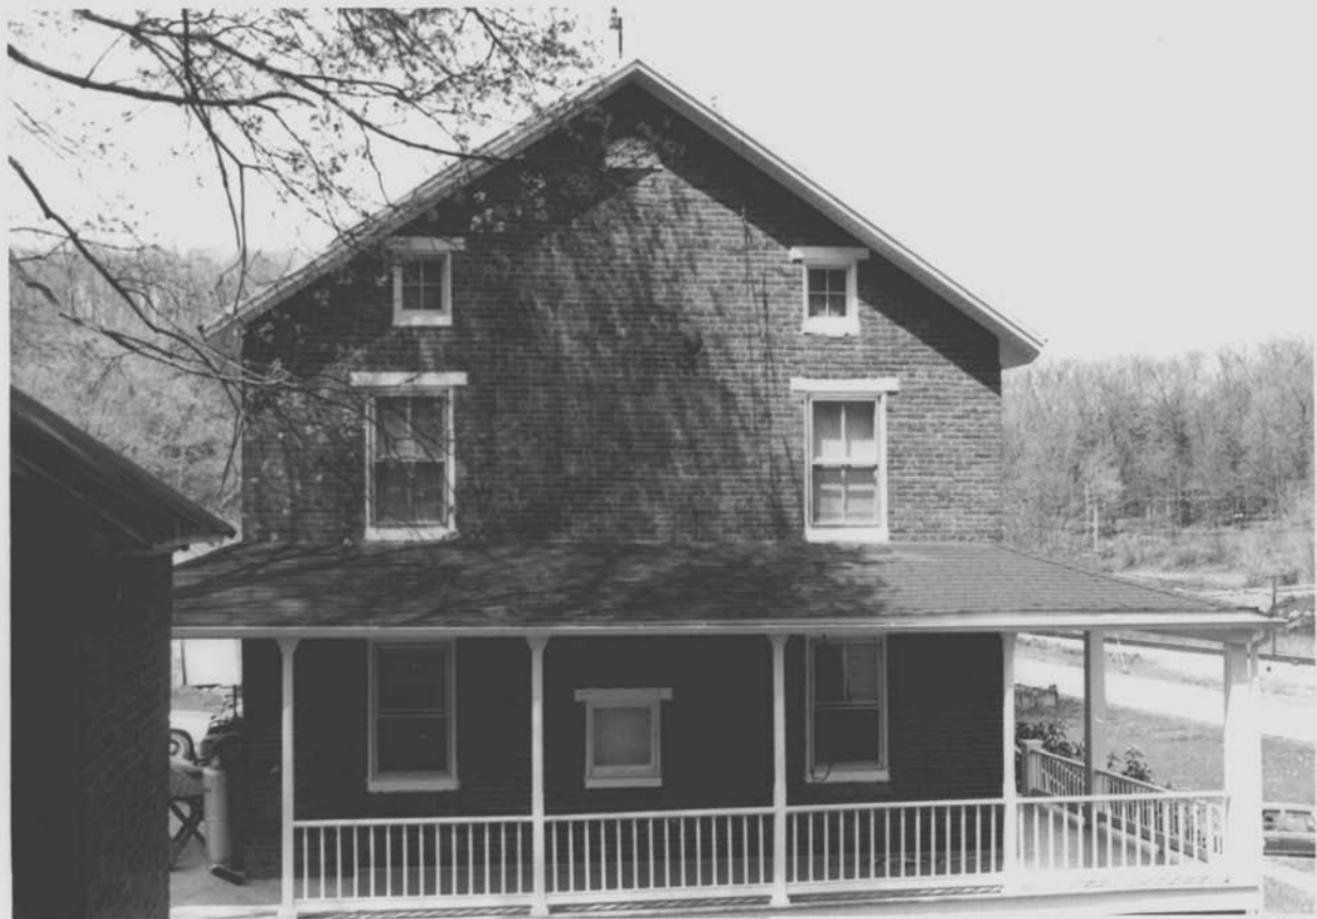
2/11

Neg. Loc.: Maryland Historical Trust  
House - south elev.

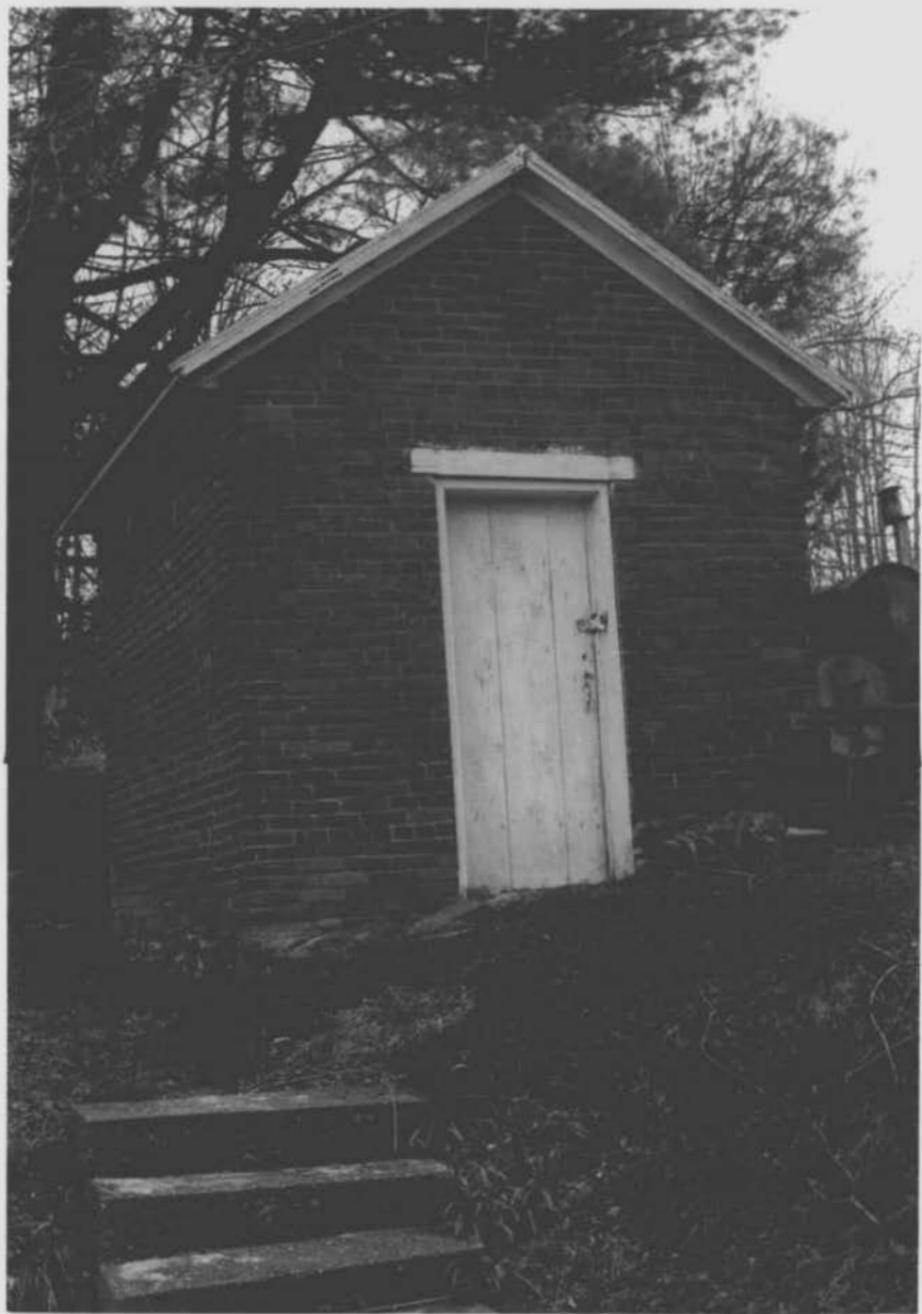
5/11

Neg. Loc.: Maryland Historical Trust  
Smokehouse - east: north elevs.

South of the house is a 5-1 common bond brick smokehouse on a rubble stone foundation. The north elevation has a vertical board door with wood lintel and corner blocks. Above four bricks were omitted in the gable end for ventilation, but these are

now filled by loose bricks. The same arrangement is on the south gable end, as well. The gable roof has an inverted V-seam covering and a box cornice. The interior retains its tree, which is a square post with three levels of racks. Each rack has four arms that support a diamond frame holding the hooks for the meat. The remains of a large brick fire pit are inside.

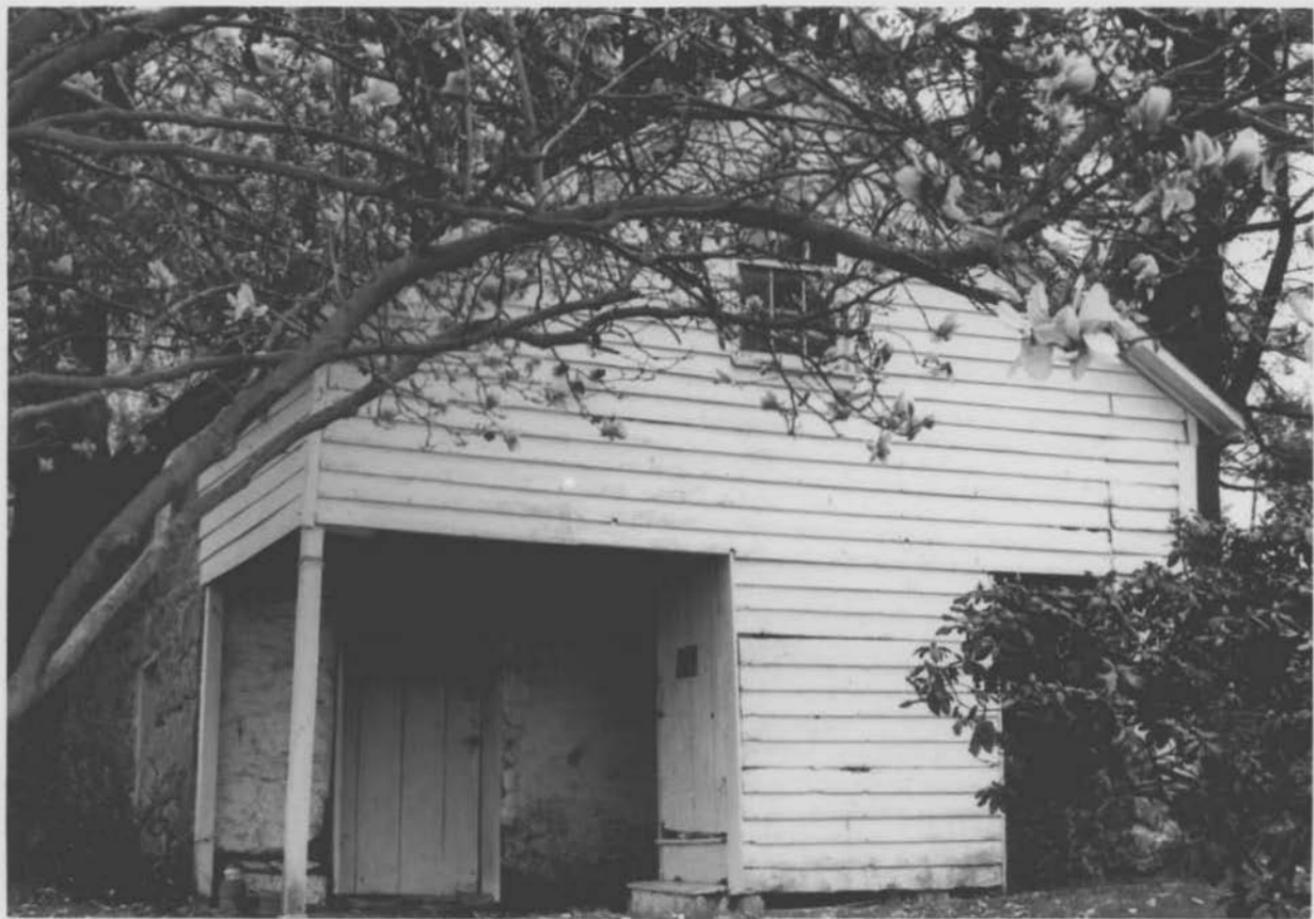
4/11

Neg. Loc.: Maryland Historical Trust  
Springhouse / Summer Kitchen - east: north elevs.

East of the smokehouse is a stone and frame combination springhouse and summer kitchen banked into a hill on the southwest corner. The building is a rubble stone one-story structure with a cantilevered frame attic on the north side that is clapboarded. There is a 6/6 double hung sash in the north gable end. Under the cantilevered section is an enclosed stair that is centered east to west on the north wall, and is flush with the north wall of the attic above. The clapboard is carried down to cover only the central section below the attic, where the stairs are. On the east side of the enclosed stairs are two risers and a vertical board door above them that leads to the remaining stairs. The sections east and west of the stairs, under the cantilevered north wall, are left open. The east bay of the north elevation has a vertical board door in a mitered wood frame set in the stone wall under the cantilever. There is a square wood post under the northeast corner of the cantilever. The east elevation has a 6/3 double hung sash north of center in the stone section. The east wall of the cantilevered section is covered in clapboard. The south elevation has clapboard in the gable end, with a 6/6 sash west of center. The west elevation has six-light sash north of center and a brick wall on a stone foundation from ground level to the plate of the cantilevered section. The stone and brick are not tied into the stone wall of the main structure, and are severely cracked. The north end girt of the cantilevered section projects through the brick wall.

The lower story has plastered walls inside and a concrete floor with concrete trough on the west wall. There is a large brick fireplace in the southeast corner with a wood mantel tree and the original cranes still hanging in it. The joists are hewn on top and bottom. There are wood lintels over the windows and doors in the interior. In the attic story the brick chimney is corbelled toward the ridge but the top has collapsed and no longer projects through the roof. The stone walls project about 2½ feet above the floor level. The large plates are one piece, spanning the entire length from the south wall to the end of the north wall of the cantilever. The north attic girt is hewn and has a central tenon set in a mortise in each plate and pegged. The framing on the north end is nailed. The rafters are sawn and mitered at the ridge.

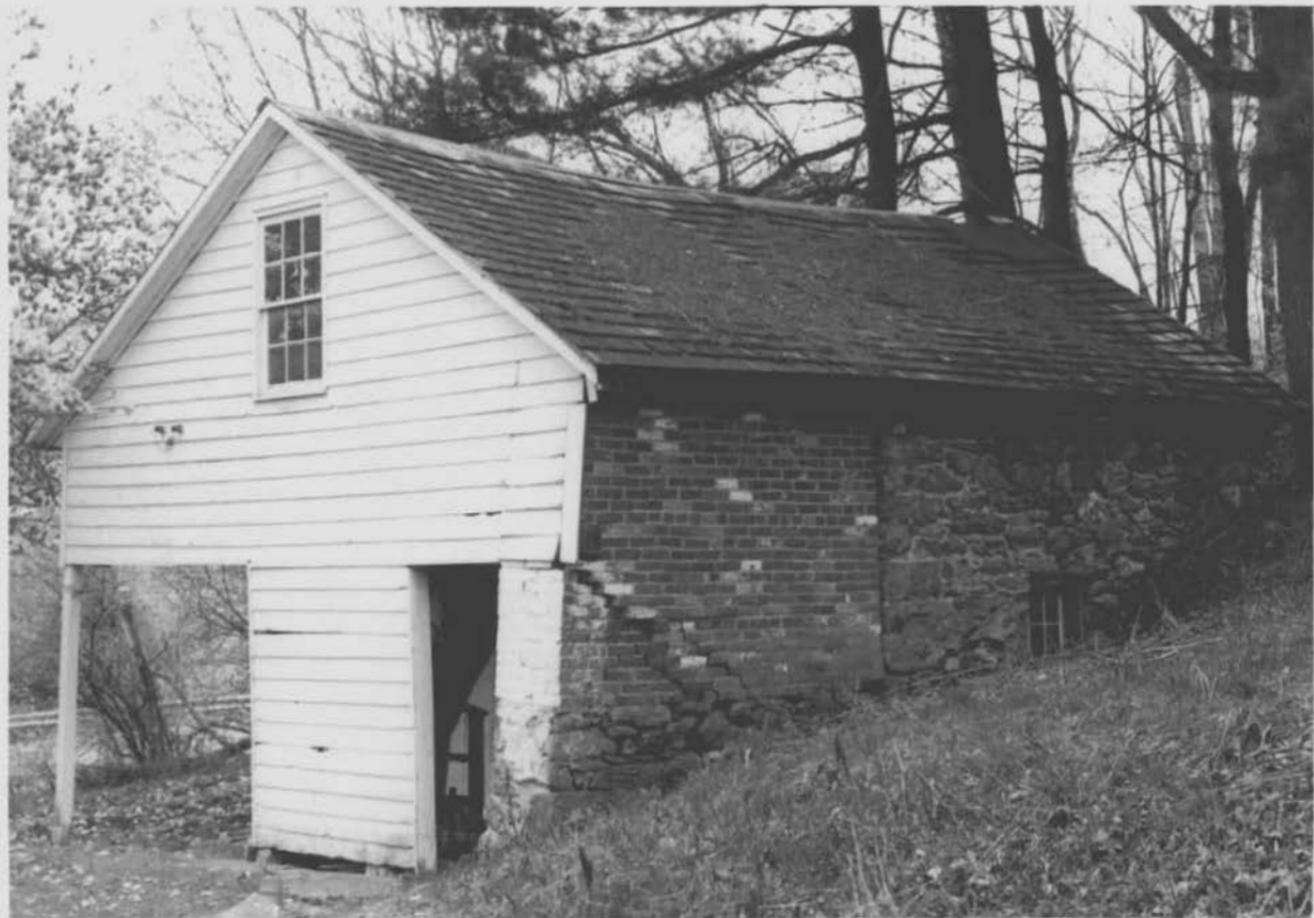
5/11

Springhouse (summer kitchen - north & west elevs.)

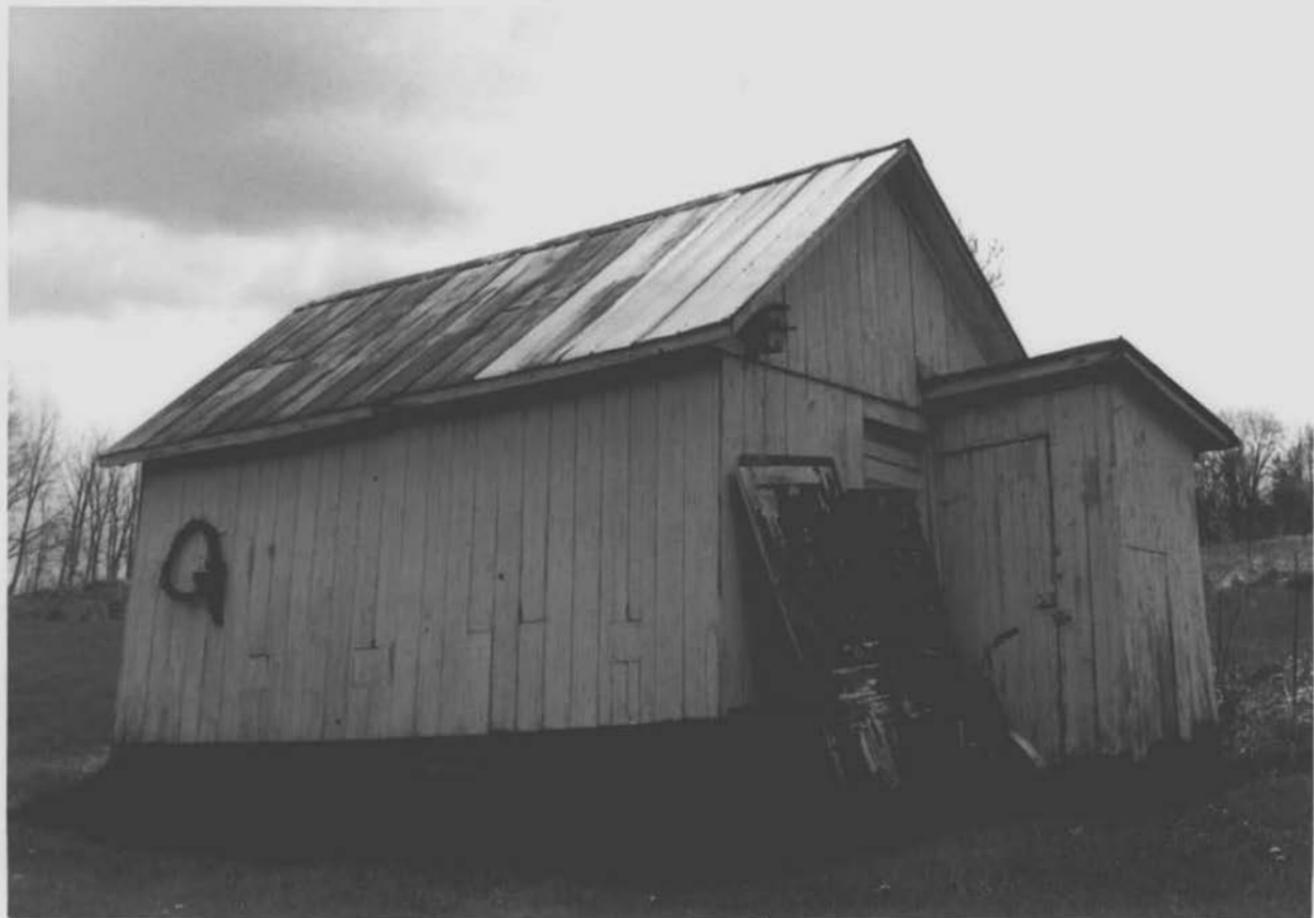
6/11

Shed: privy - east: north elevs.

North of the house is a wagon shed with nailed 2x4 frame and beaded-edge-and-center vertical board siding. The south end is open, only the pintles of the former doors that were here surviving. The shed is set on wood piers and has a gable roof with

corrugated metal on the west half and inverted V-seam on the east. On the north end is a boarded-over opening in the center, and a privy attached to the wall west of the opening. The siding, and the door on the east, are the same as the wagon shed. The shed roof of the privy is inverted V-seam.

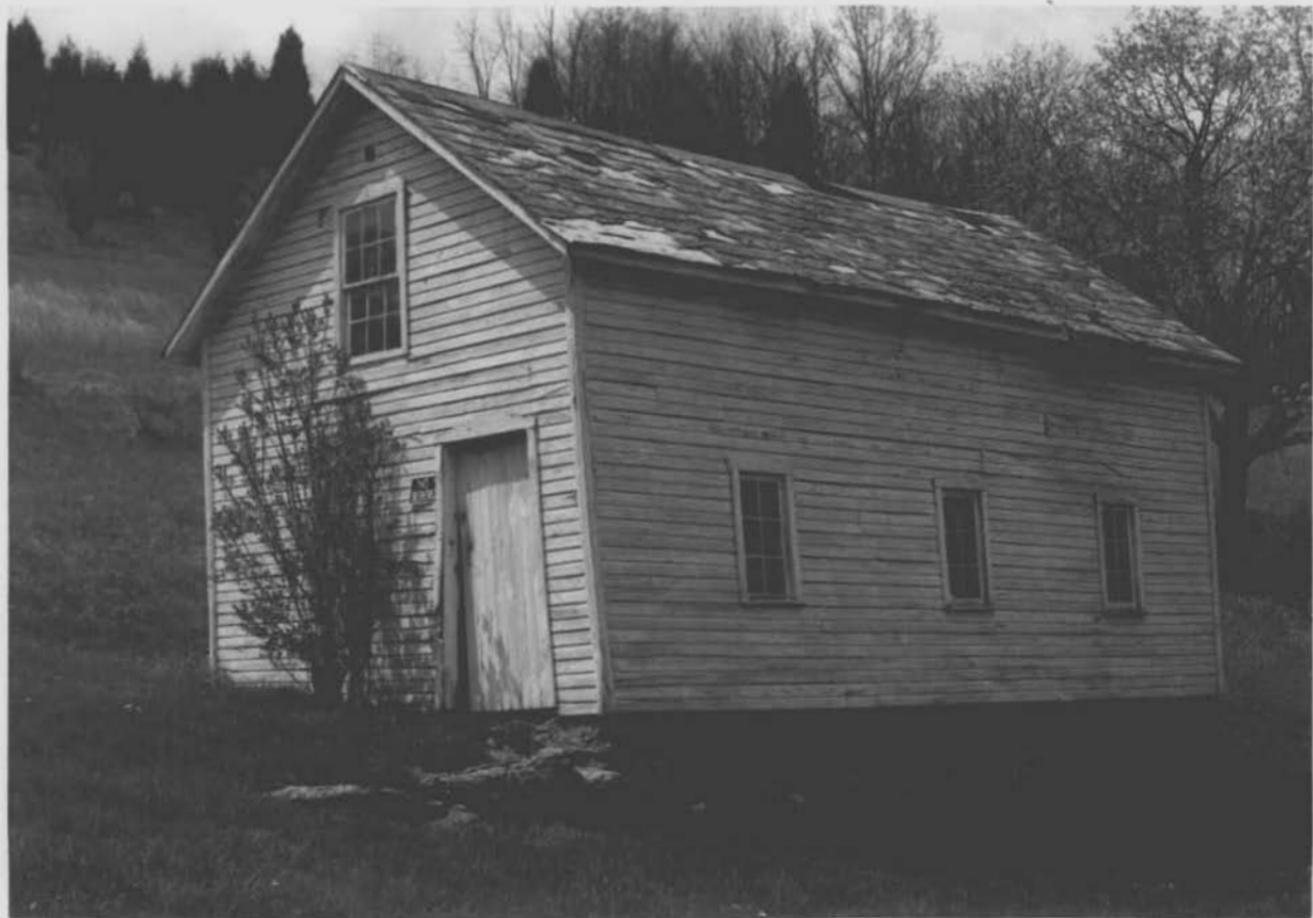
7/11

Neg. loc.: Maryland Historical Trust  
shop - south: east elevs.

Just north of the wagon shed is a frame shop building with slate gable roof and rubble stone foundation. It is one bay by three bays, with an east-of-center entrance on the south gable end, and a 6/6 double hung sash in the center of the gable end. It is one-and-one-half stories tall, having a raised attic, and is covered in German siding. The door is of vertical, beaded-edge-and-center boards. The east elevation has three six-light sash. All openings have flat surrounds with gabled tops. The north elevation has a 6/6 sash centered in the gable end. The west elevation is vertical boards with several openings cut into it. The shop is built of 2x4 studs on the east and 4x4 studs on the west. The studs are full height, with 1x6 clamps nailed to them and 2x6 sawn joists that rest on the clamps. The floor is concrete. There are three posts down the middle of the building, on a north-south line. The straight run stairs begin in the northeast corner and run along the north wall. There is a trap door at the top of the stairs. The rafters are circular sawn 2x4's that are mitered at the ridge.

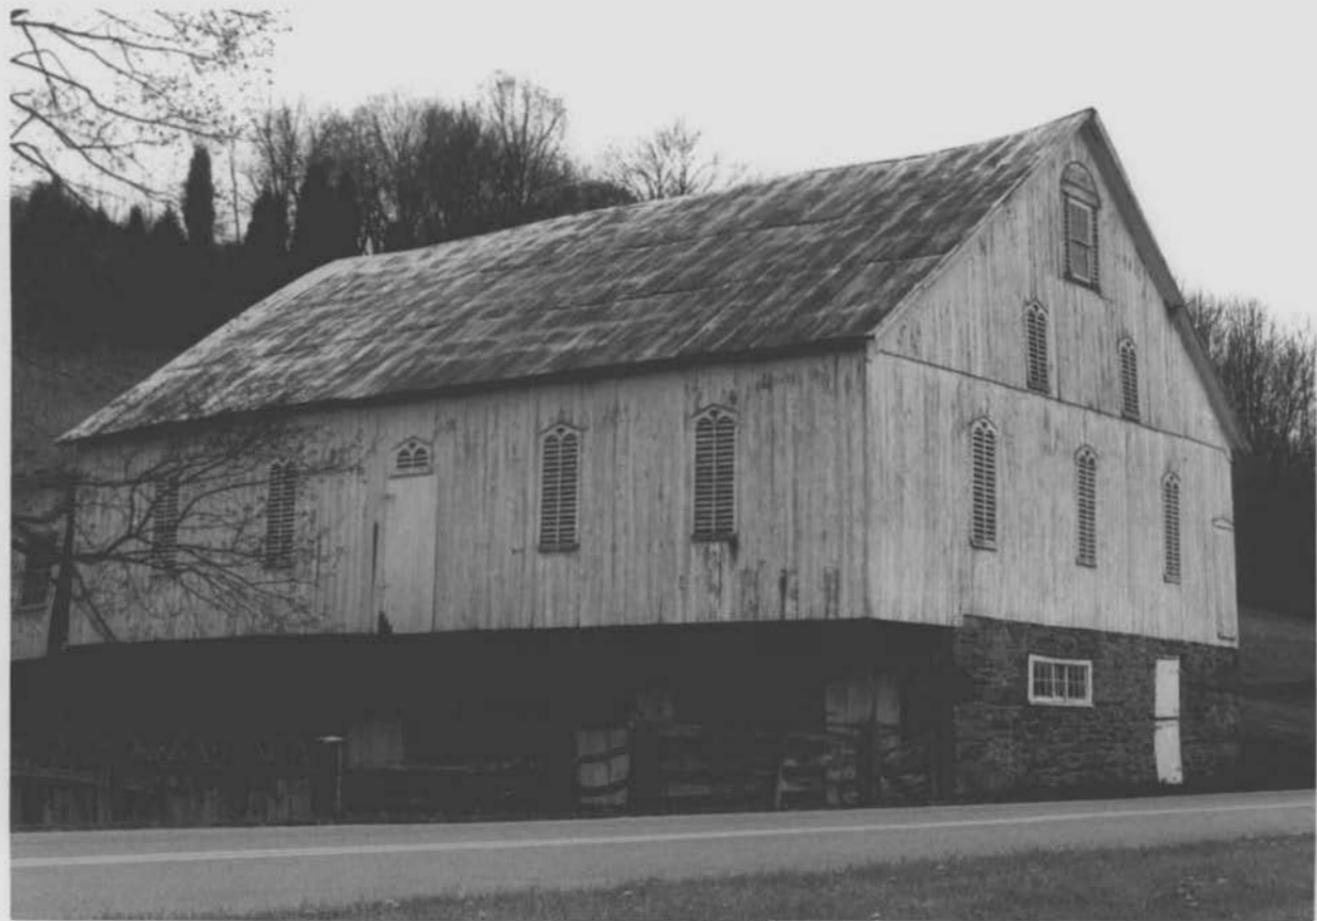
8/11

Barn - South: east elevs.

North of all these structures, and set very close to the road, is the barn complex. The banked barn has the forebay facing south. The foundation is of rubble stone on all sides, with quoins at the corners. The lower story of the south elevation has a vertical board dutch door on strap hinges, a wood vent with louvers of diamond section, a beaded-edge vertical board dutch door on strap hinges, a similar vent, stone infill where a door was formerly, and two more vertical board dutch doors on strap hinges separated by a similar wood vent. The upper story is five bays, with two gabled wood vents at each end and a center door with the top portion of a gabled vent set above it. The siding is vertical, beaded-edge-and-center, tongue-and-groove boards. The east elevation has a new window in the south bay, with a four-light sash between two six-light sash. The north bay has a beaded-edge-and-center vertical board dutch door on strap hinges. Above is a row of three vents, and a door with gabled surround in the north corner. Above this is a row of two vents, and in the gable end a 6/6 sash with wood vent on either side, all topped by semi-circular wood trim. The north elevation has the ramp. The east bay of the lower story has an adjustable wood-louvered vent. In the upper story a six-light window with gabled surround flanks each side of the center double wagon doors. These doors match the siding, and have a smaller door inset in the west door. The west

elevation has one 6/6 sash with gabled surround in the gable end. There is a foundation for a silo here, with rubble stone set on a brick base, and an opening into the lower story. Attached to the southwest corner of the barn is a poultry house. The interior of the lower story has been altered some, but retains the feed boxes, troughs, and hay racks. The large joists are hewn on top and bottom, and are supported by two summer beams. The upper story has a central threshing floor with a hay mow on each side and a granary in the northeast corner. Some of the original framing has been cut out, and some new members have been added. There are three-quarter round log rafters joined at the ridge with a central tenon in mortise, and pegged. The roof has several wind braces of small section.

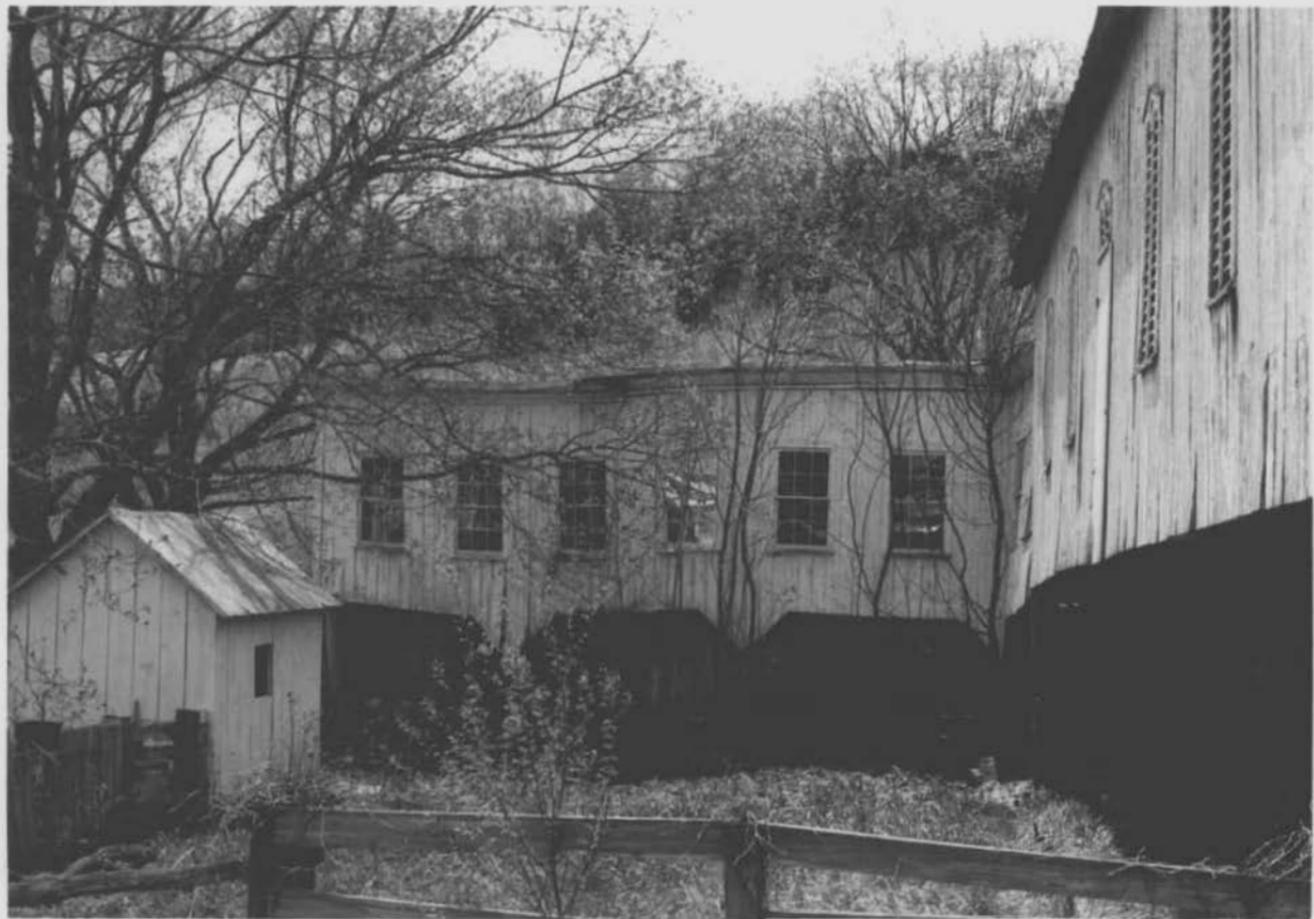
9/11

Hog pen, poultry house, : barnyard - vw. from east

South of the barn is a vertical board, wood-shingled gabled-roof hog pen. It has a large door and a small door on the west, and one low opening for hogs on the east, at the south corner. This building helps to define the barnyard. There are the remains of fences west of the pen to the poultry house, and east of the pen to the road. Part of the eastern section of fence is wide, picket cut boards on horizontal rails. Horizontal rail and horizontal board fences and gates run along the road and enclose the east side of the barnyard.

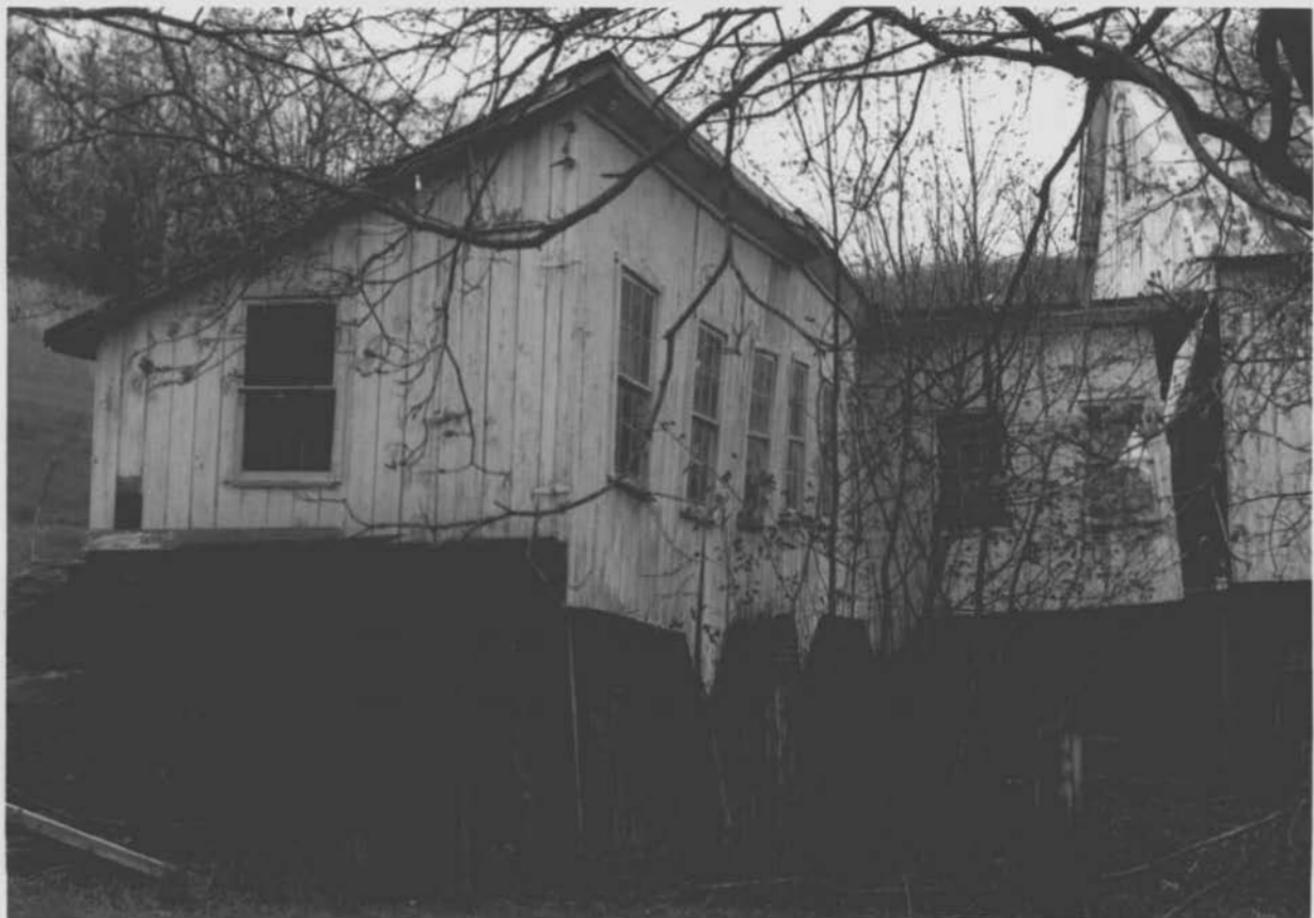
10/11

Poultry house - South: east elevs.

The poultry house is a large ell that encloses the west end of the barnyard. The short section of the ell is attached to the barn, with the long section running south from the end of it. It is two stories and is banked into the hill, with a stone wall on the west and north sides of the lower story. The south and east sides are open, and have posts with braces that support the structure above. The upper story has a shed roof, with vertical board and batten siding on the north and west and beaded-edge-and-center vertical board siding on the south and east. The south elevation of the long section has a 6/6 sash and a board door to match the siding, while the short section has two 6/6 sash. The east elevation of the upper story has six 6/6 sash. The joists are hewn top and bottom, but the frame and rafters are sawn and nailed 2x4's. The west side of this structure is collapsing and it is slated to be demolished this summer (1992).

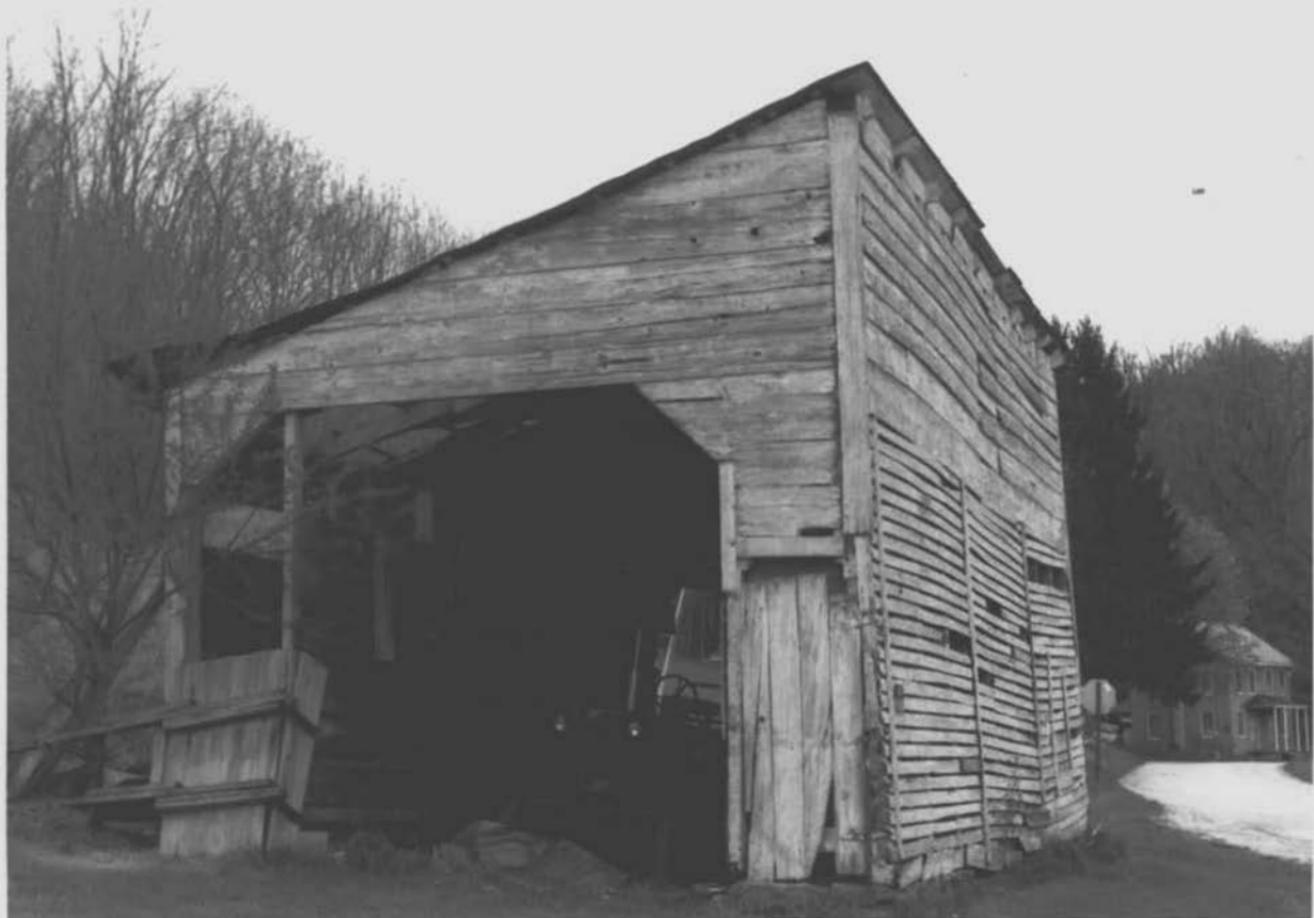
1/11

Neg. loc.: Maryland Historical Trust  
corn crib - south: east elevs.

North of the barn is a wagon shed with corn cribs on the east and west sides, and open ends on the north and south. It has a shed roof with inverted V-seam on lath. The foundation is dry-laid stone. There are horizontal laths on the east and north sides, with clapboard above. The west and south sides have clapboard only, with a vertical board door to each crib on the south side. The west crib has been rebuilt. The structure is built of sawn and nailed 4x4's.
