CARR - 1166

7569 MIDDLEBURG ROAD

FIELD SHEET--HISTORIC RESOURCES SURVEY

SURVEY NUMBER: CARR-1166

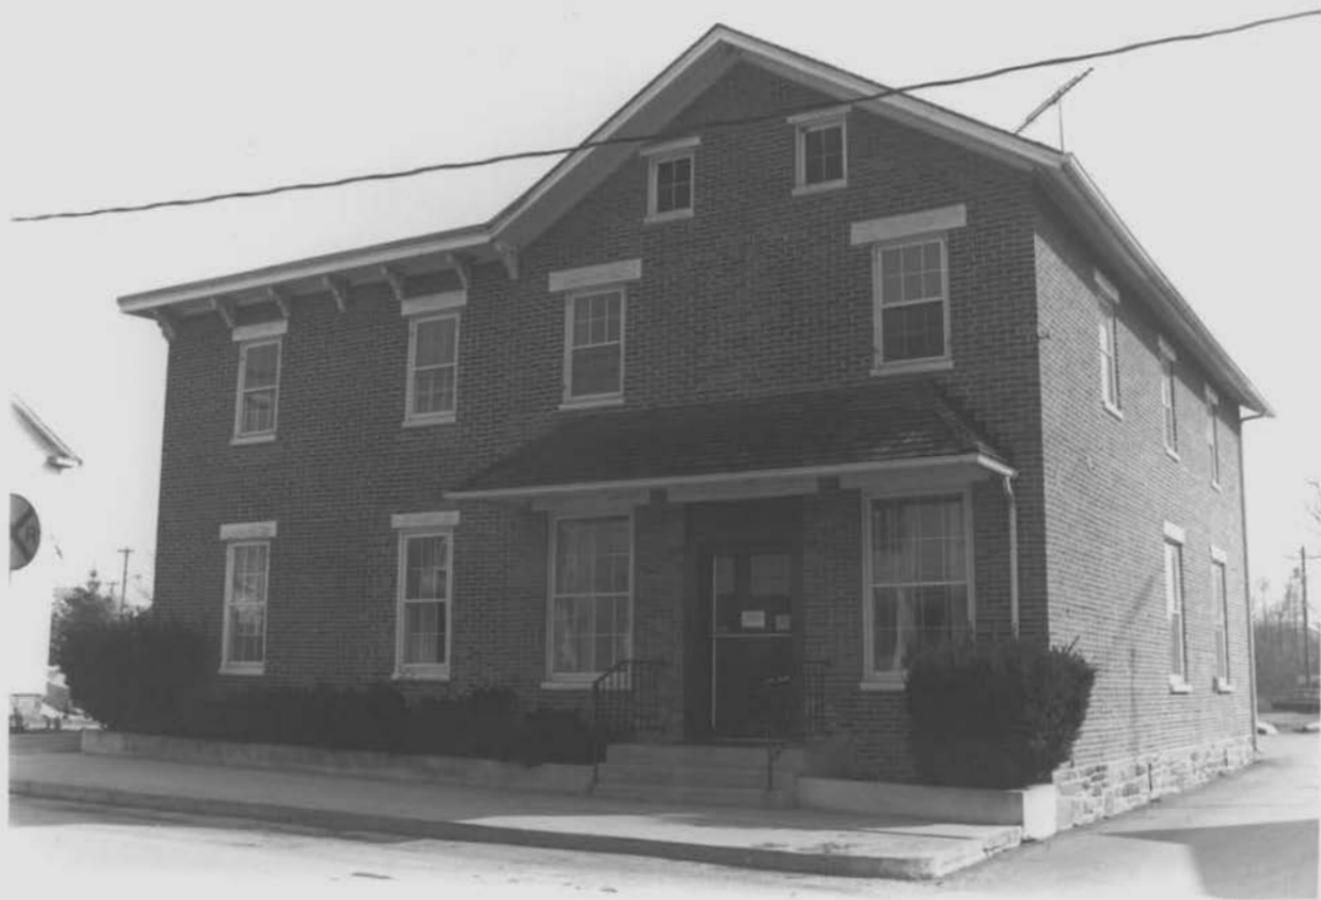
1. CARR-1166 Old Detour Bank
7569 Middleburg Rd
2. Carroll Co, Md.
3. Joe Getty
4. April 1986
5. Md. Hist. Trust, Annapolis, Md
6. n & w elev (camera facing se)
7. 1/1
