CARR-1239

Carpenter Shop

Springfield Hospital Center

# Maryland Historical Trust State Historic Sites Inventory Form

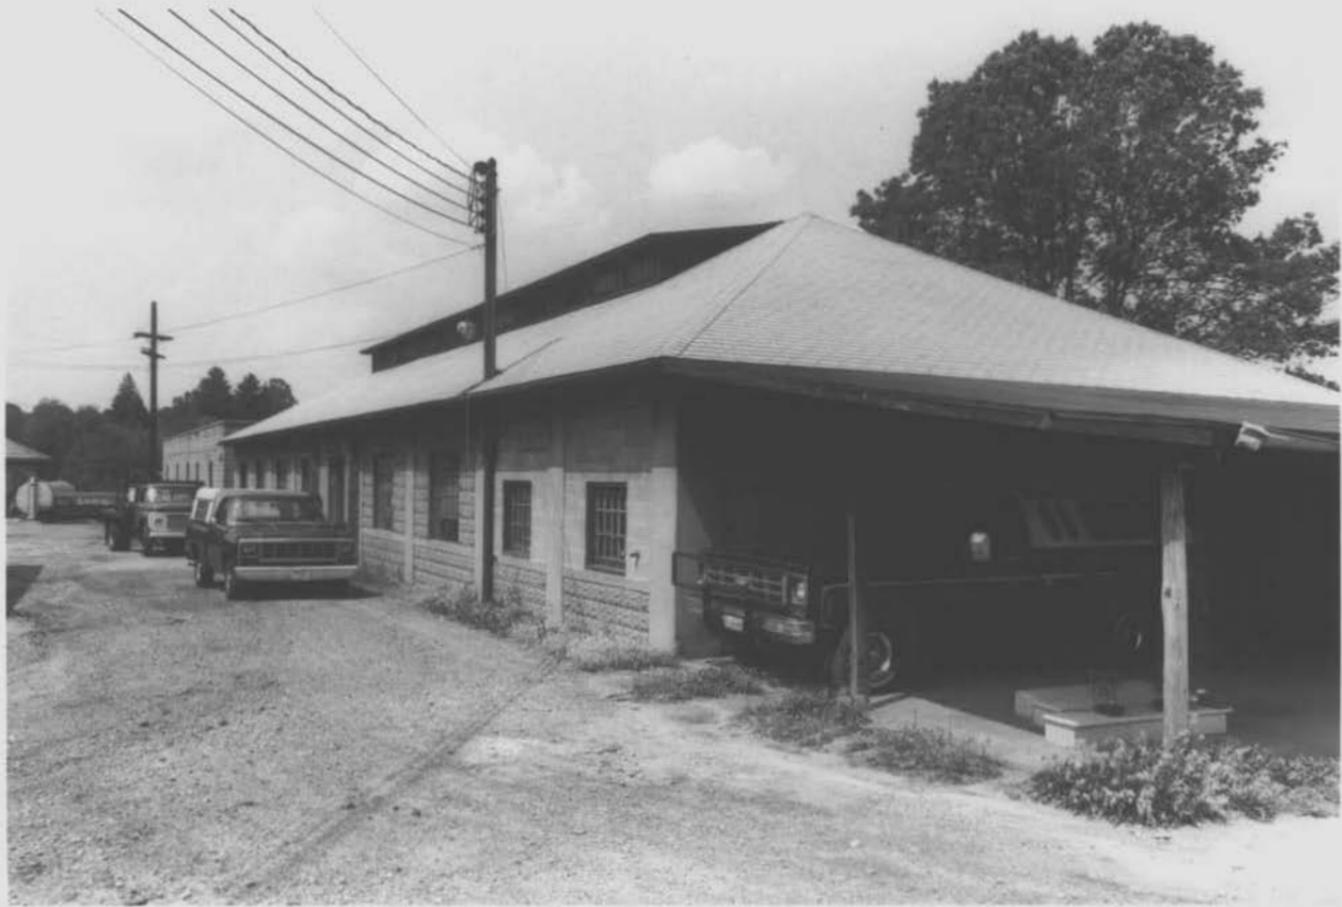
West and South

The central bay of the west face has been altered. Plywood laid in a diagonal direction covers the one bay area. The plywood surrounds the main entrance. The door is not original to the building. Sidelights flank the door. The southern most two bays of the east and west walls show a slightly different pattern. The cement bricks have smooth faces and the windows have a wooden sill and mullions. This portion of the building also exhibits a smooth cement slab just below the eave.

The attachment to the south wall is essentially an open area shielded by a lean-to roof. The south wall is visible under the lean-to roof area. The original double doors appear on the cement wall. The wooden doors exhibit an inverted cross pattern while a single row of header bricks form a vertical joint lintel. The original hardware is intact.
