CARR-1256

Staffhouse #12

Springfield Hospital Center

Maryland Historical Trust State Historic Sites Inventory Form

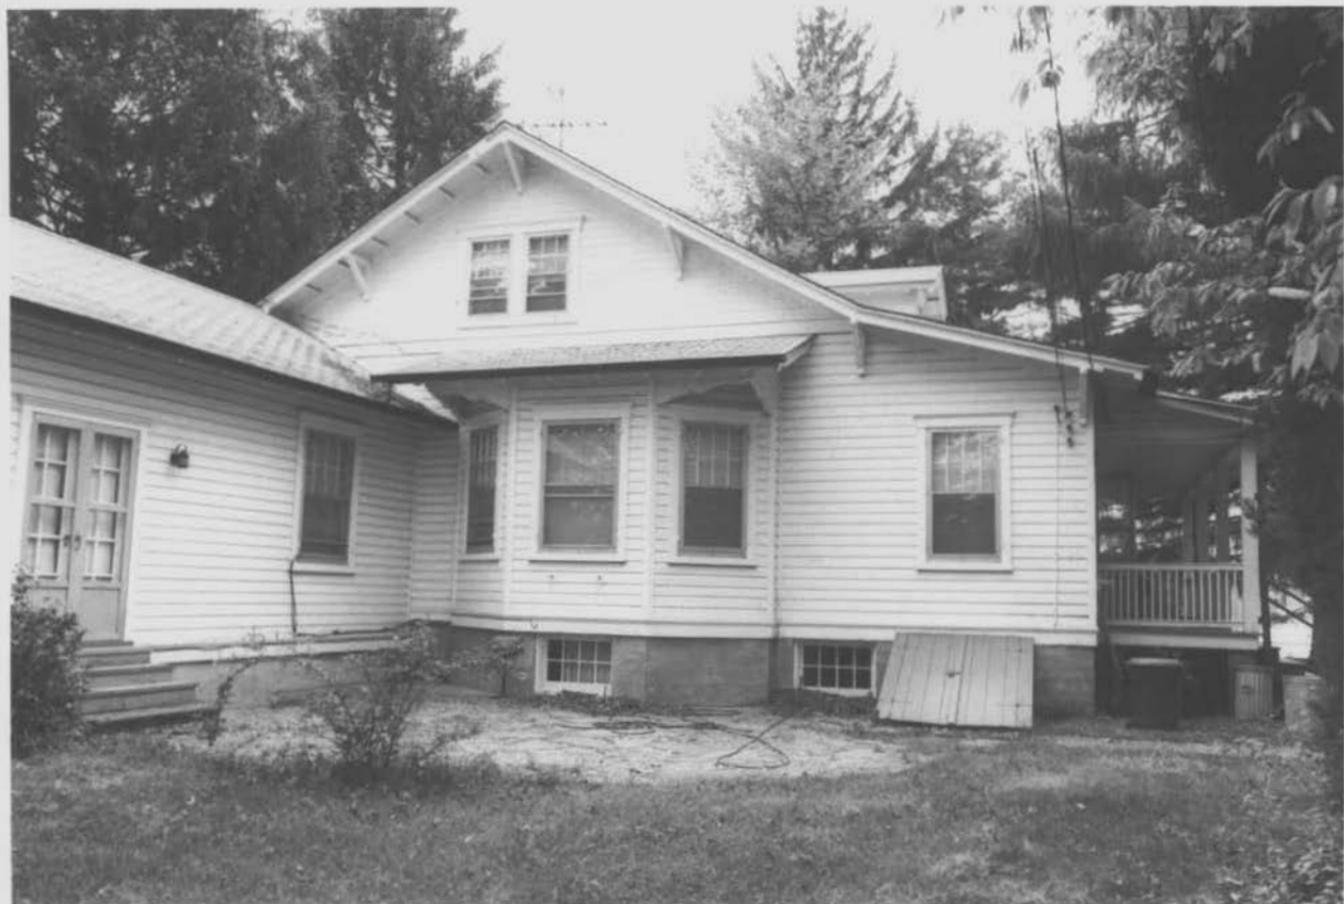
East

The attachment on the east wall is also covered by shiplap siding and a gabled roof. The attachment ends with a gable wall and an exterior brick chimney of a single flue. The fenestration repeats.
