CARR-1287

Andrew Dice Farm
3252 Tracey's Mill Road
Manchester (vicinity)

Maryland Historical Trust State Historic Sites Inventory Form

CARR 1287	Andrew Dice Farm-House	First Floor Plan	March 1992

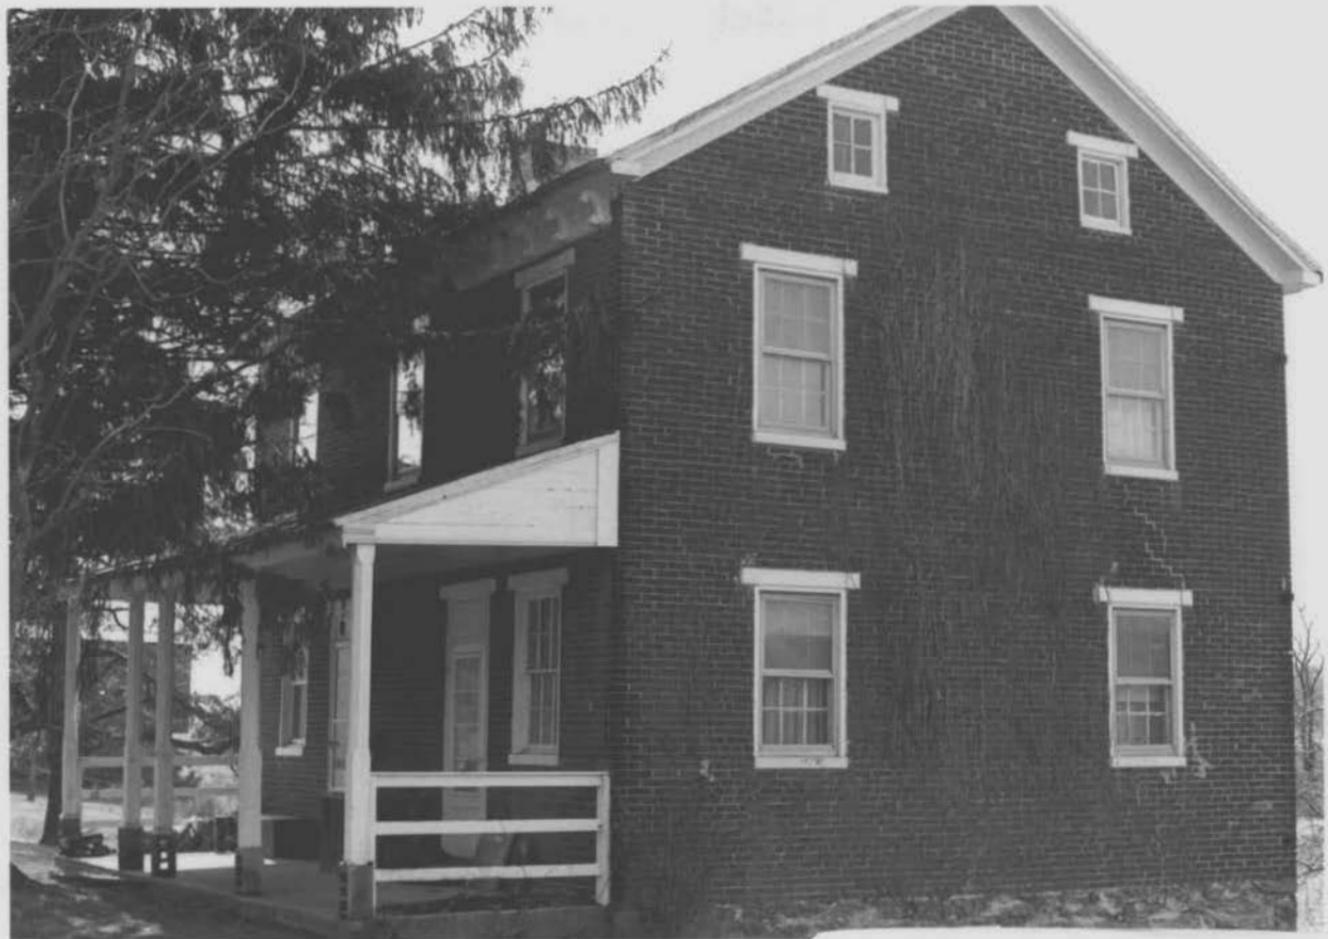
1/6

House: south-east elev.

The brick house is a banked two-story, four bay "Pennsylvania Farmhouse" plan structure with all-stretcher bond on the southern facade and 5-1 common bond on the other three elevations. The foundation wall, which is of rubble stone, is exposed on the north elevation. The southern facade faces the road and is the primary elevation. The two center bays contain doors with two horizontal panels above three vertical panels above two more horizontal panels above three more vertical panels. Above the doors are eight light casement transoms which are now covered from the outside. The remaining bays contain 6 over 6 double hung sash with wood sills and wood lintels with corner blocks. There is a one-story porch across the entire south elevation, supported by five chamfered posts. The original balustrade is gone, but had a top rail that was octagonal in

section and a bottom rail that was a "T" in section. Both rails were tenoned into the posts and pegged. It was not possible to determine the design of the vertical members between these rails. The porch deck is now concrete, set lower than originally, with the posts resting on CMU's set on end. The house has a gable roof covered with standing seam metal, and a flush brick chimney centered at either gable end. The front cornice has large scroll brackets, each one separated by two small scroll brackets, and one large bracket in profile at each end of the cornice.

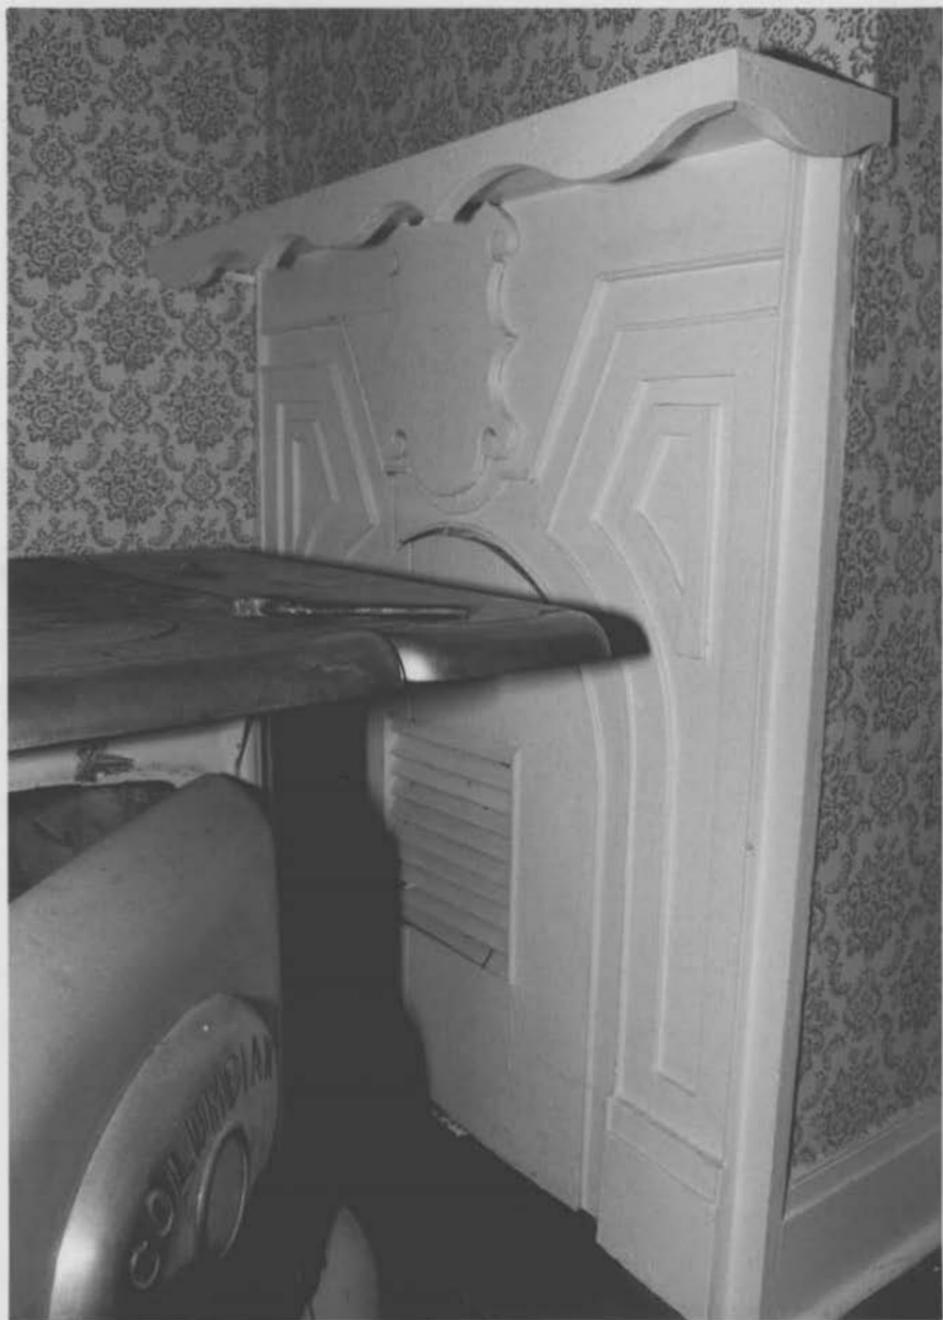
3/6

House - parlor mantel

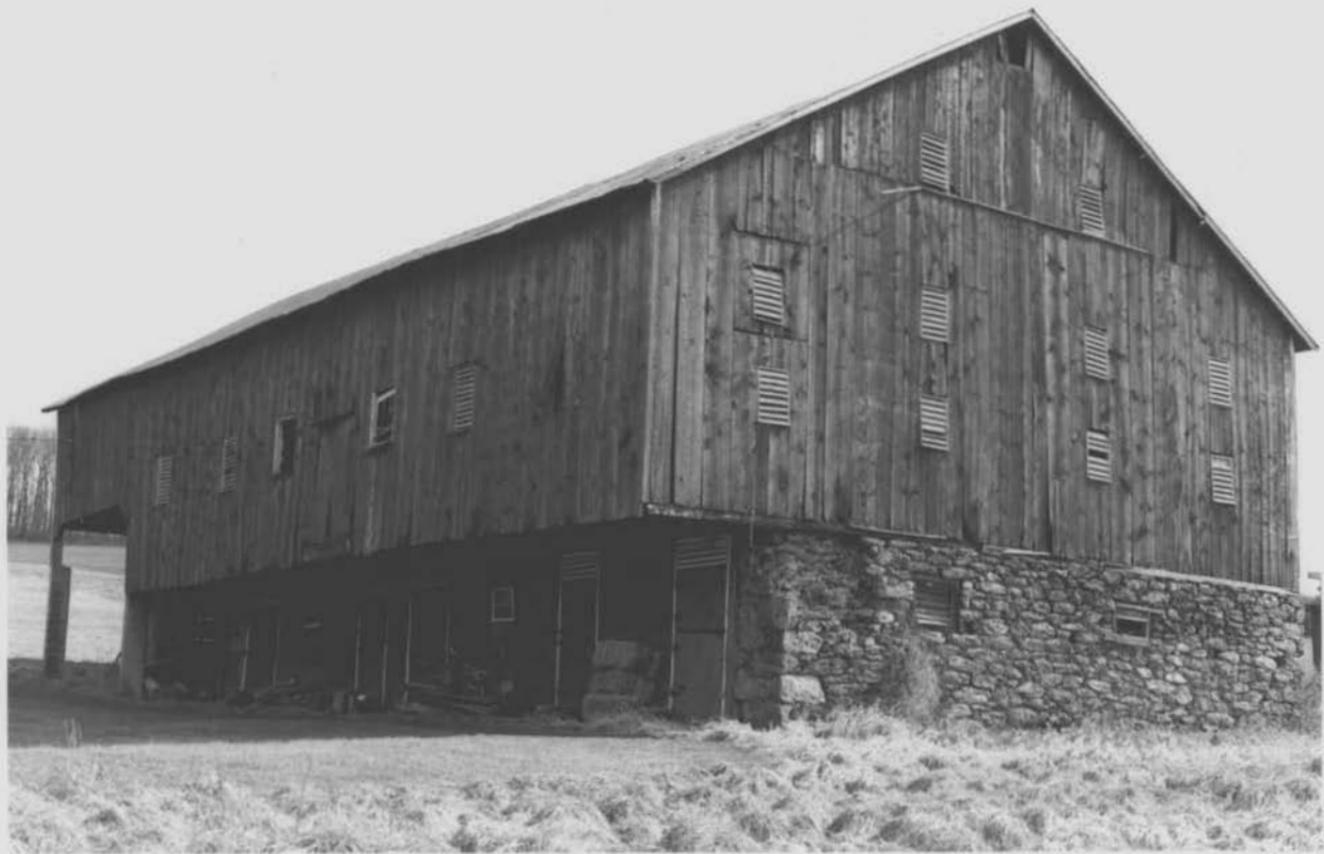
4/6

Barn - east; north elev.

The frame barn with vertical board siding faces east and is not actually banked, so an earthen ramp has been built up on the west side to reach the upper story. The lower story is rubble stone on three sides and horizontal boards on the east elevation under the forebay. This wall is seven bays, with five vertical tongue and grooved board dutch doors on strap hinges below horizontal wood slat vents. There is a three-light sash in the second bay and a four-light sash in the fifth bay. On the south end is an integral wagon shed with openings on the east and west and corn crib with horizontal slat siding on the southern end. The stables have been altered, but the interior arrangement was probably three pens divided by two aisles. There is a hoist for butchering under the forebay. The upper story of the forebay is also seven bays, with two wood louvered vents at each end, then a 6 over 3 sash, and double doors in the center.

The north elevation has two round section wood vents in the lower story, now covered by horizontal boards, and two rows of four louvered wood vents in the upper story, below one row of two vents in the gable end. The south elevation has one row of four vents and one row of two above the horizontal slats of the corn crib. The west elevation originally had two windows to the north, but the sash is now gone. There are large double doors, with a smaller door inset in the south door, in the center, and a large opening to the south of this. The wagon shed opening is at the very southern end of the west elevation. The barn has a gable roof of corrugated metal.

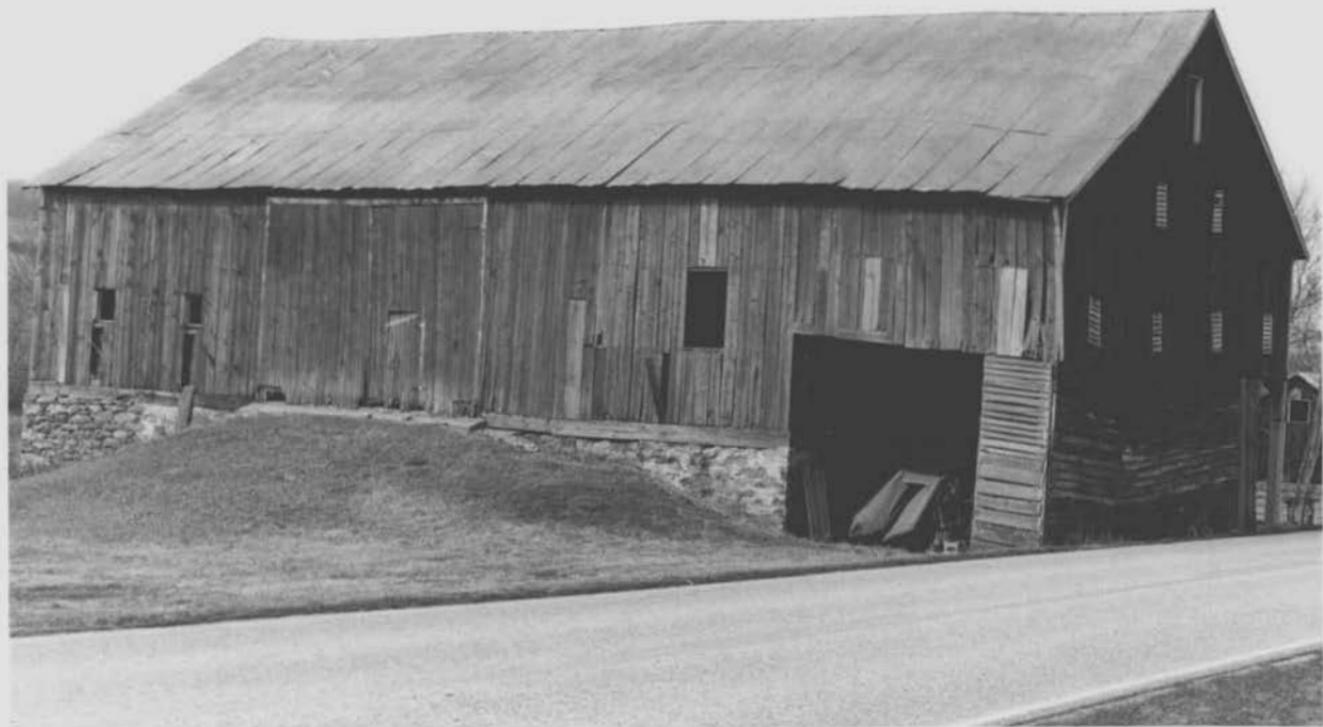
5/6

Barn - west & south elevs.

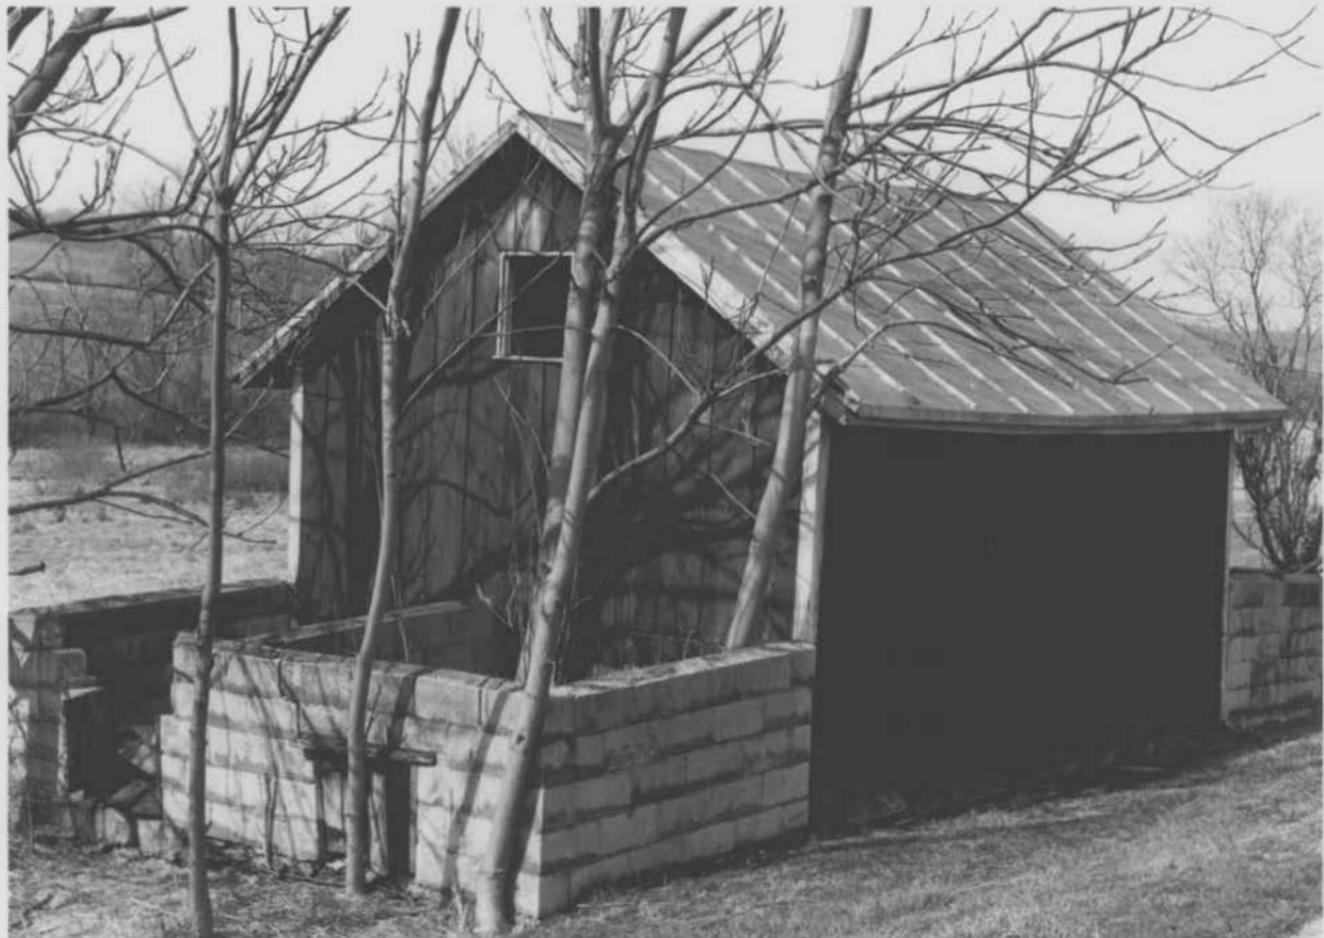
6/6

Hrg. per - west & south elevs.

The hog pen has a rubble stone foundation with vertical board siding and a standing seam gable roof. The south elevation has a central vertical board door flanked by an opening into the attic on each side. On each end, there is an opening into the attic, and two low openings into the pens. Attached to each end are CMU walls that create

two exterior pens each with an opening in each to outside. The frame of the building is hewn and mortised and tenoned, but the floor is concrete and the pens, which still survive but are not original to the structure, are of horizontal boards. The plan has a central aisle with two pens to each side.
