Maryland Historical Trust
State Historic Sites Inventory Form

historic BLOOMFIELD

and/or common McDonald Farm

street & number 402 Obrecht Road _____ not for publication

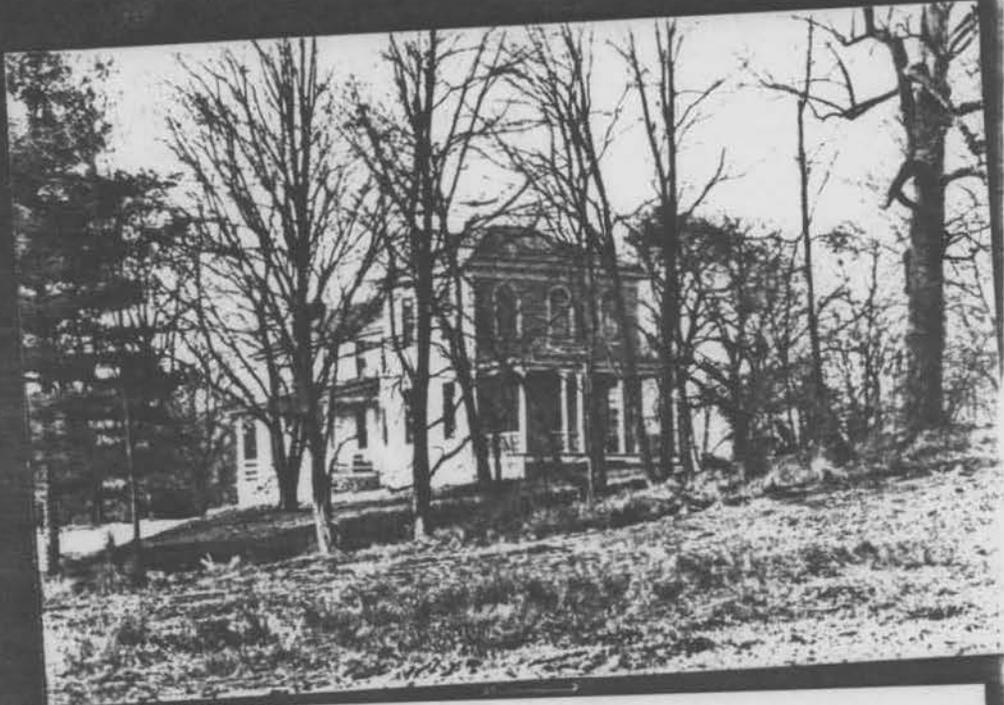
2

The house was built in three sections. The original structure was a three-bay by one-bay log house now serves as the north service wing of Bloomfield Manor. Its main facade faced east. The second phase of construction was a five-bay by two-bay frame structure built on to the south gable end of the original house. Its main facade faced south. During

the Victorian era, an Italianate style main block was added to the east gable end of the second structure. Its main facade faced east (Photo 2).

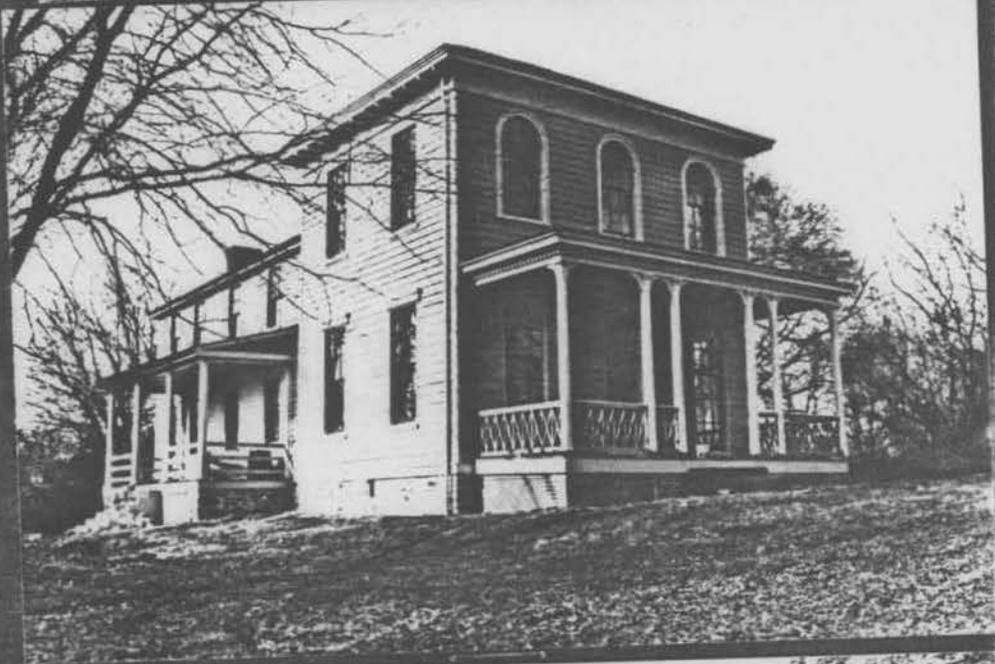
3

The total appearance of the house today is dominated by the Italianate style frame addition (Photo 3). The entire structure has an elongated L-shaped plan, although the plan could also be described as T-shaped (the third phase main block with the second phase being the base of the T) with a eastern service wing (the original structure). The house has stylistic features with its main facade and double tiered porches on the service wing that relate to the "country style" or "county seat" architecture of the Baltimore area. Therefore the architecture is somewhat unique to the more typical farmhouses found in most of Carroll County.

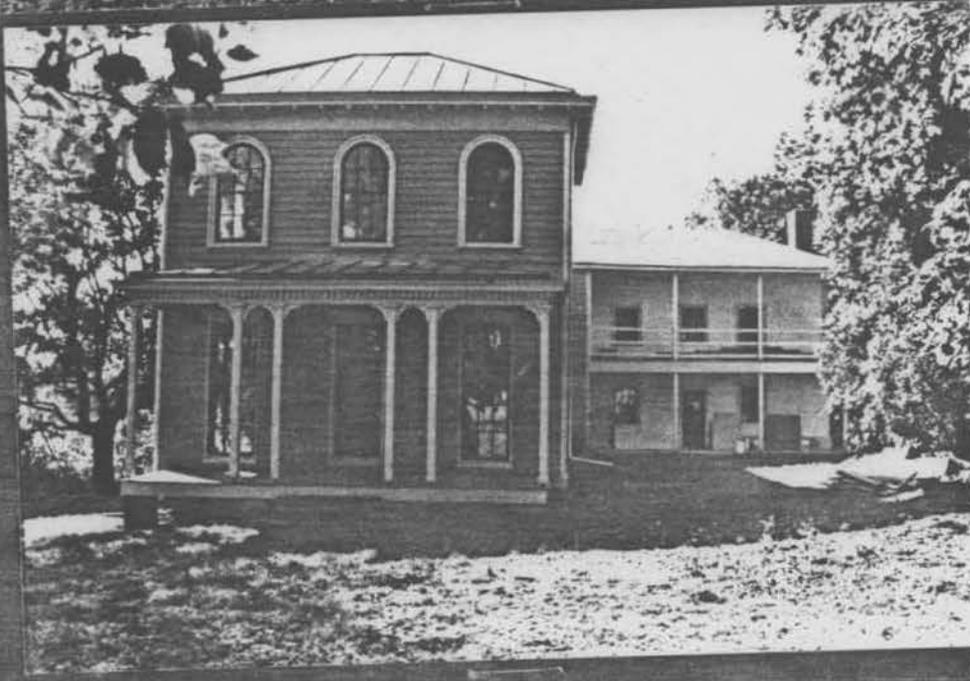
4
5
6

The main block of the third phase of construction is a two-story, three-bay by two-bay structure of frame construction (Photo 4). The main facade faces east and has a full-length, one-story porch. It has a hipped roof with standing-seam sheet metal (Photo 5). The roof contains a hidden gutter feature that is unusual in its design. Instead of being recessed into the roof design, the hidden gutter is suspended at the end of the hipped section of the roof and the design then is stepped down to a ledge that projects out for the eaves (Photo 6). There is a wide eave with a bracket cornice above a plain board frieze (Photo 7).

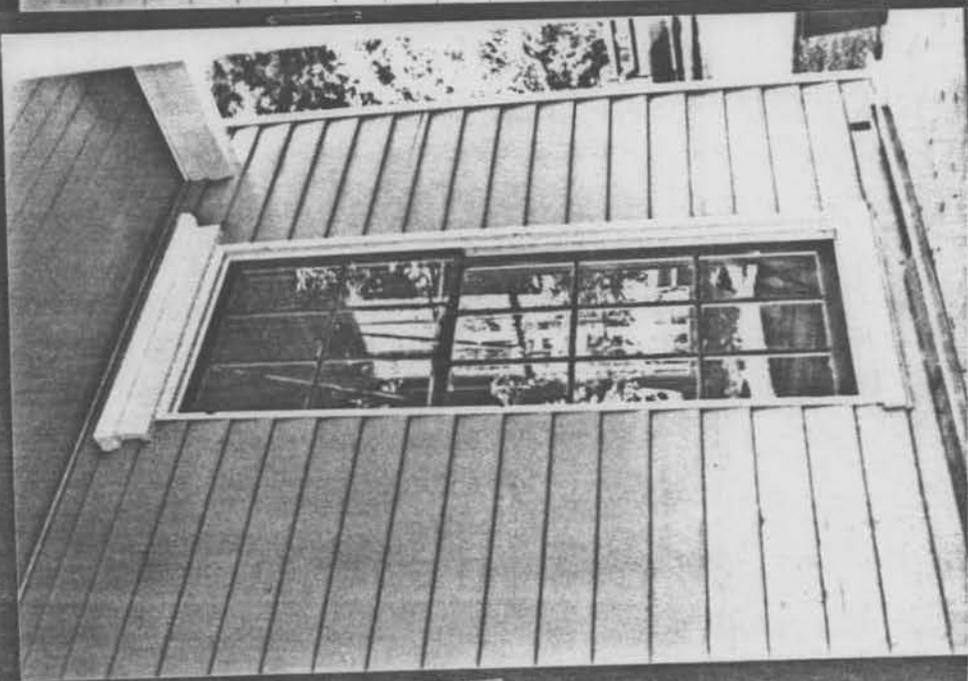
9

has a tall three-pane transom and a door with five horizontal panels (Photo 8). The wood trim for the windows and doors on the first story includes a molded wood decorative lintel. The first story windows are elongated reaching almost to the floor and ceiling of the porch (Photo 9). The second story has six-over-six windows with arched tops. The porch has chamfered posts with molded capitals (Photo 10). There are small serpentine brackets on the posts. The cornice is comprised of two sections: a lower dentil cornice and an upper molded cornice.

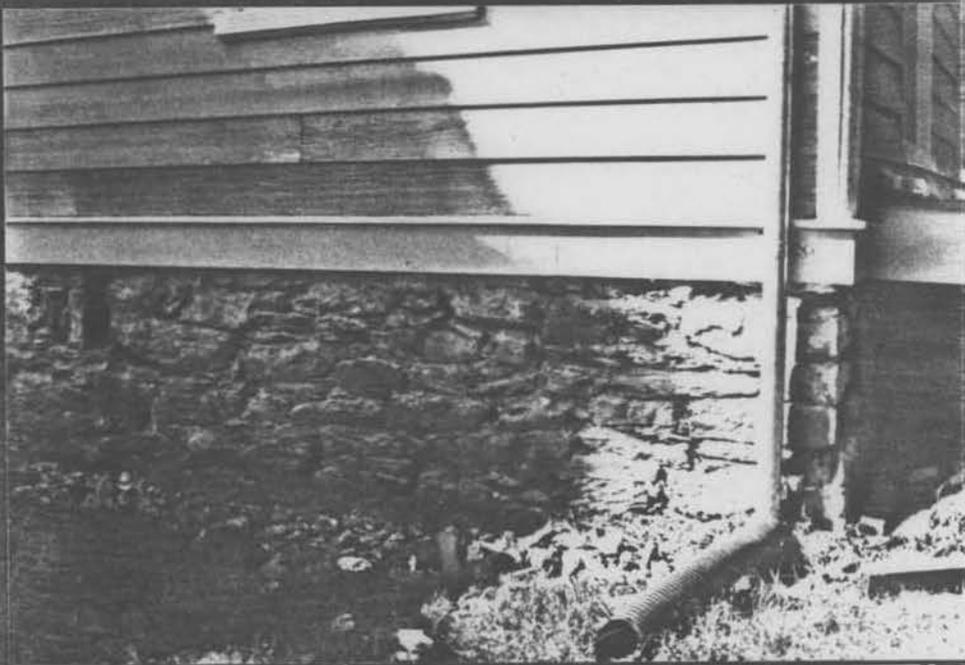
10
11
12

The exterior covering is wood siding with corner boards that have a molded corner joint (Photo 11). At the foundation level is a sill board with a projecting lip that serves as a splash board. The main block has a stone masonry foundation. The original paint colors were revealed during the restoration work on the rear facade in the northernmost section. In this area, the doorway off the ballroom led onto an outside porch. This porch was closed in during the mid-20th century and served as an interior hallway. When the lath and plaster of this later construction period was removed, the original siding, trim and cornice colors were revealed and these have been used for the exterior repainting. The body color is a light brown (Sherwin Williams Dormer Brown); the sash is an olive green (Sherwin Williams Rockwood Dark Olive); and the trim is an off-white beige (Sherwin Williams Sunporch).

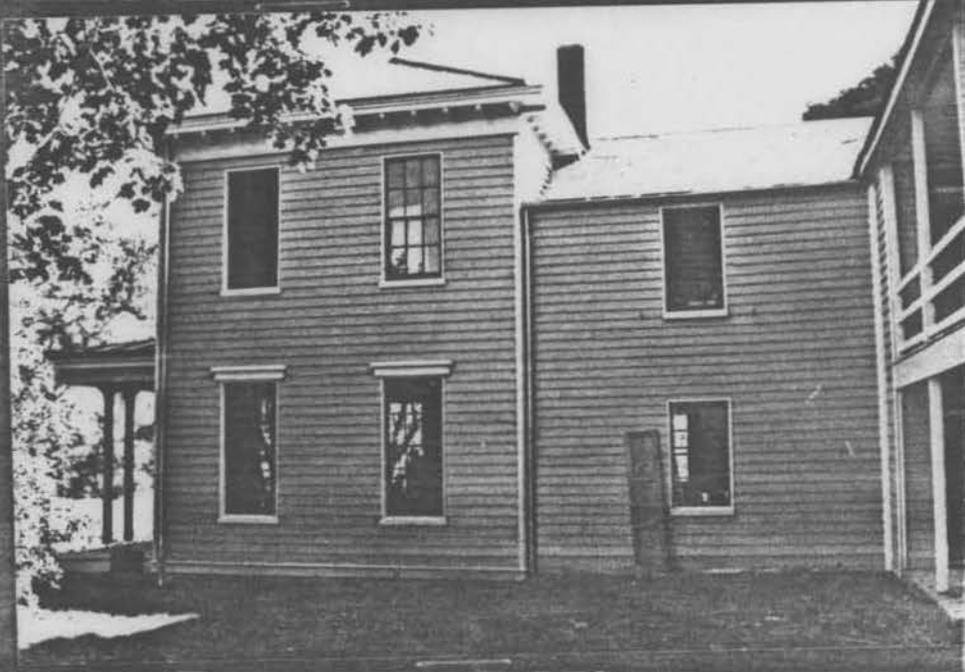
The north elevation of the main block has six-over-six windows on both the first and second stories (Photo 12). The south elevation has a similar arrangement of fenestration (Photo 13). The first story windows are taller and have a molded wood lintel (Photo 14).

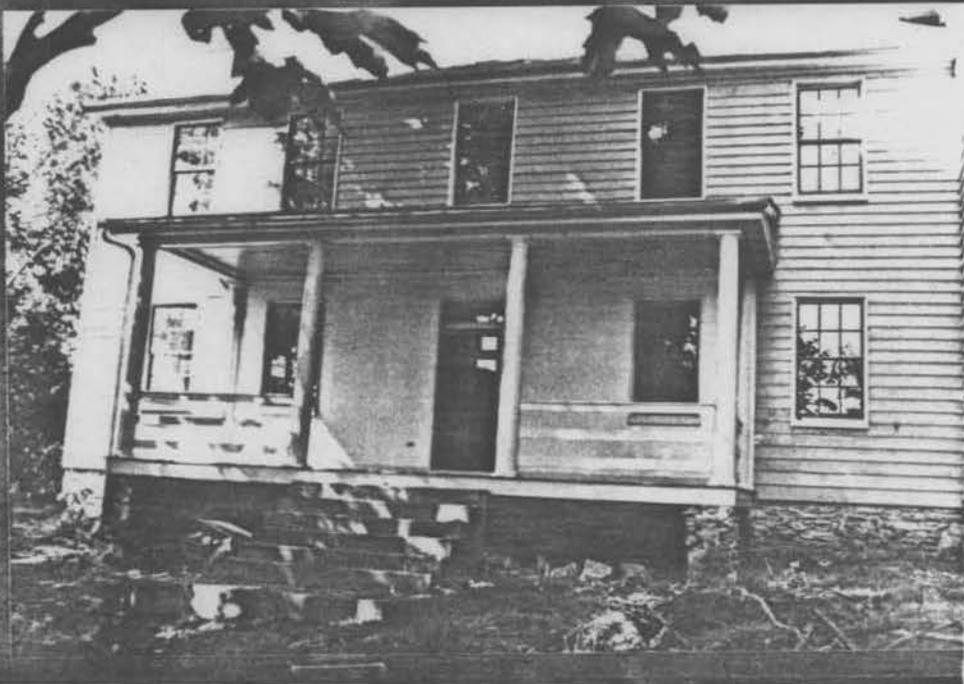
15

The second phase of construction is the five-bay by two-bay frame structure built on to the south gable end of the original house (Photo 15). Its main facade faced south. It has a stone foundation and a hipped roof. The main facade is arranged symmetrically with an offset spacing to emphasize the central entrance. The porch on this elevation does not run full-length but is one-story and three bays wide. The exterior sheathing is wood siding except for the area below the porch which is covered in stucco. The siding has corner boards with the identical design of the later main block indicating that the entire house was resided with the construction of the Italianate style addition.

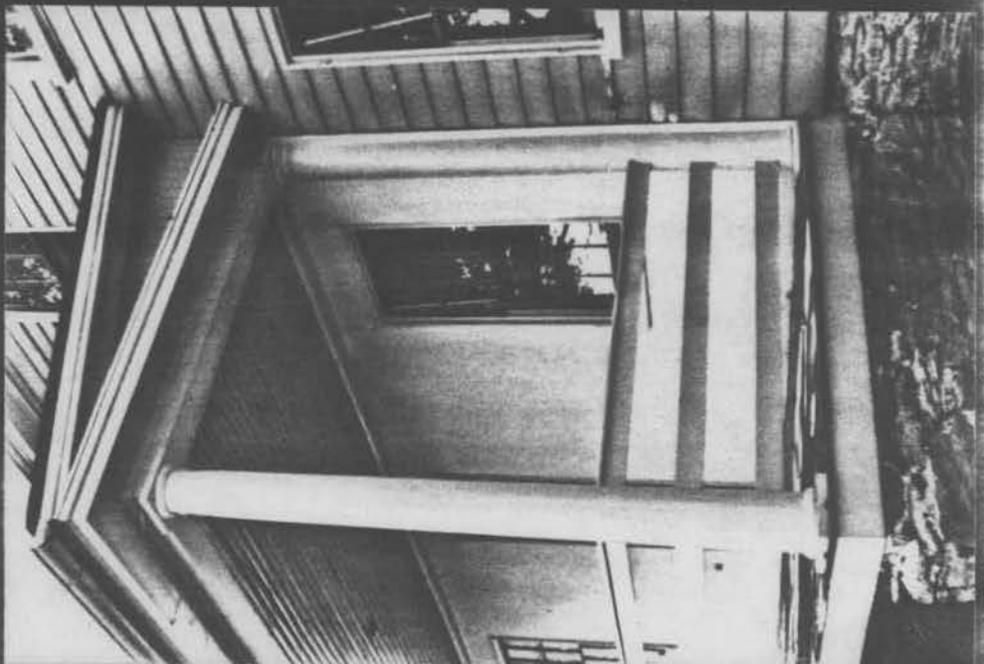
16

The porch is of stylistic interest because of its Greek Revival influence on what otherwise is a fairly representative vernacular farmhouse (Photo 16). It is supported on stone piers and has four columns with Tuscan capitals. At the corners against the facade are half-columns. The columns support a projecting box cornice with molded top. At the ends the slope and cornice of the shed roof forms a partial triangular pediment.

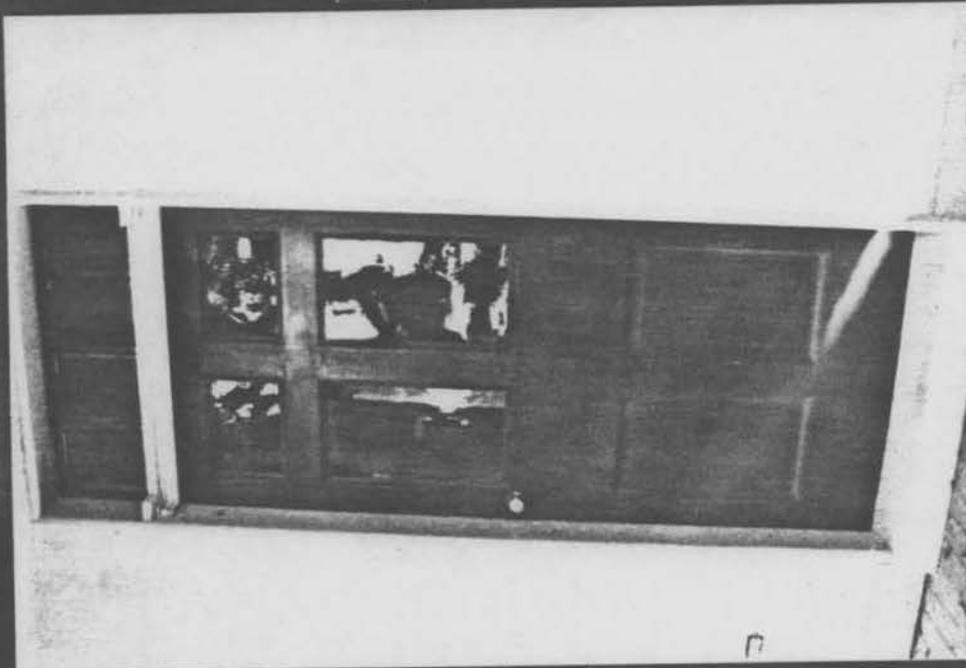
17

The central entrance has a half-round molded frame with a four-pane transom (Photo 17). The door is a six-panel door in which the upper four panels have been converted to glass panes. The windows on this section are six-over-six window with a half-round molded frame (Photo 18). Shutter dogs remain in place on the windows on this facade. There is a cellar entrance on this facade in the westernmost bay of the stone foundation (Photo 19). The west elevation has a wide spacing of the window in each of the two bays at the outer sides of the facade (Photo 20). Off-set from the center of the facade is a chimney with a corbeled cap projecting from the hipped roof.

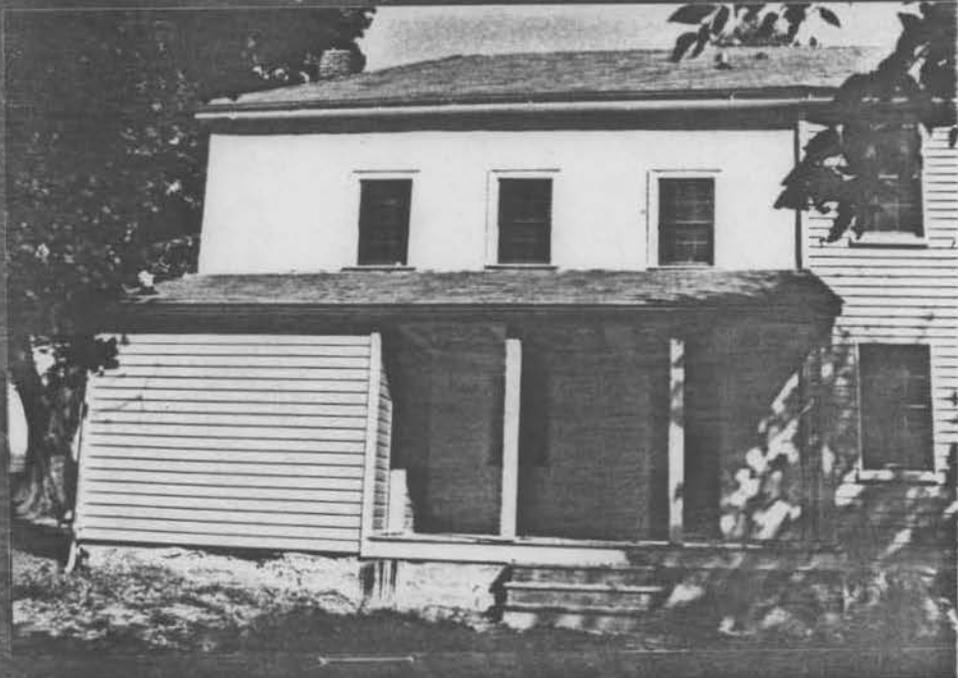
21

The west facade of the original structure is three bays wide and has a full-length, one-story porch (Photo 21). It is two stories with a hipped roof. The exterior surface is stucco. The three bays on the second story have small six-over-six windows with a quarter-round molded frame (Photo 22). They are in an asymmetrical arrangement. On the first story, the entrance to the main structure is in the southernmost bay. It has a door with a four-light upper section above three horizontal panels (Photo 23). In the central bay is a six-over-six window (Photo 24). A portion of the porch has been closed in with framing and wood siding as a storage room. It is unfenestrated on the west elevation and has an entrance on the south elevation (Photo 25). On the north elevation of the porch enclosure is a four-pane window.

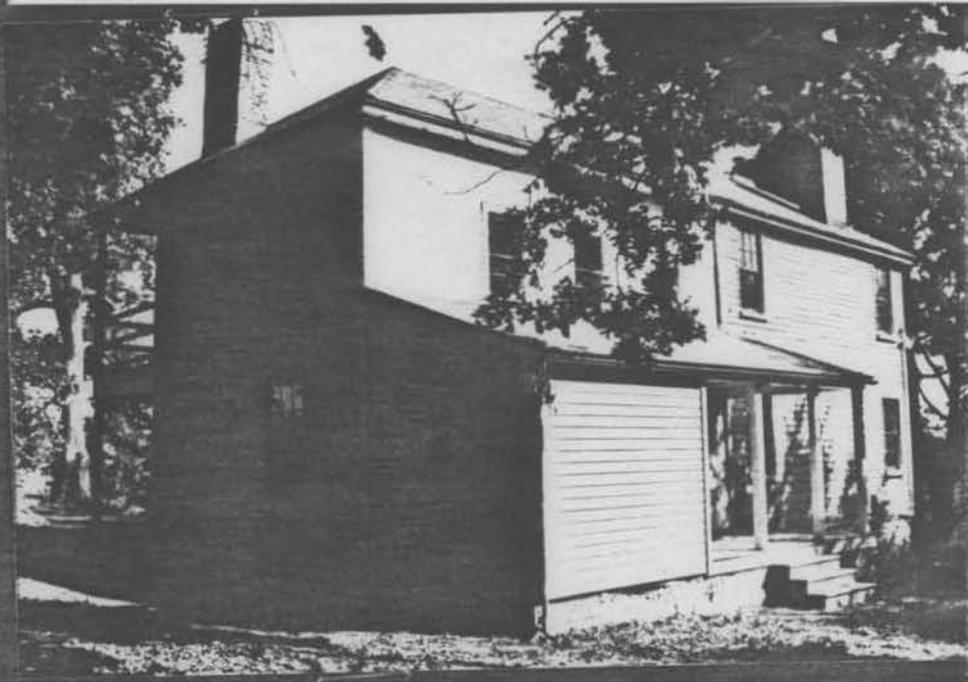
26

The north elevation of the original structure has a single window (Photo 26). It is located on the first floor and is a six-over-six design. There is a brick chimney with a corbelled cap projecting from the hipped roof. There is also north elevation of the second phase of construction (Photo 12) that has six-over-six windows and underneath the double-tiered porch of the original structure there are doors to the porch (Photo 27). The doors have four-pane transoms.

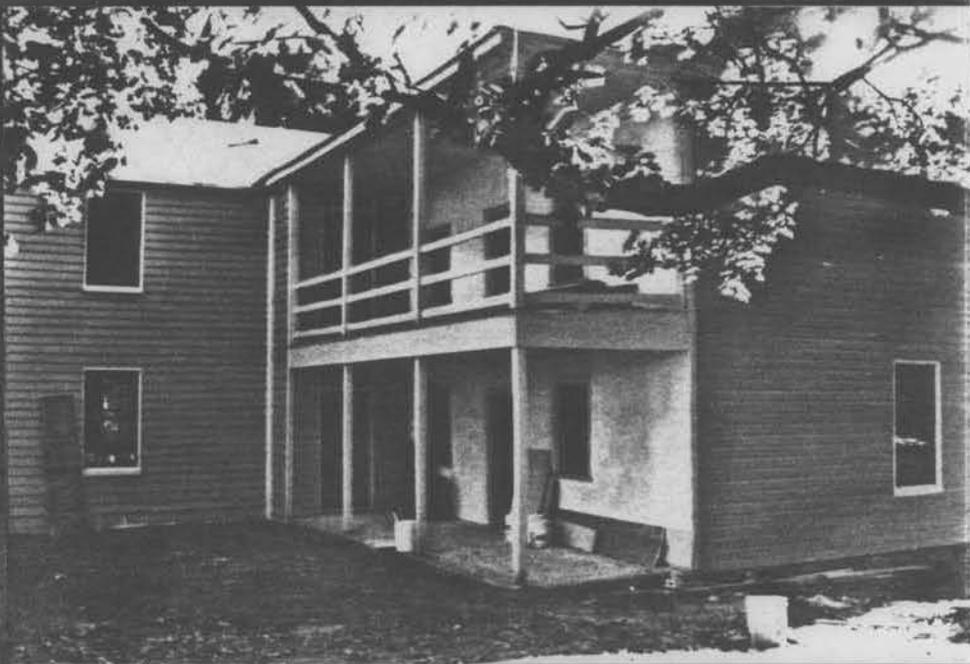
28

The east elevation of the original structure was substantially altered as part of the later additions. A double-tiered porch was added to the main facade (Photo 28). This type of porch was traditional for service wings on the L-shaped plan farmhouses of this region. The first story has a central entrance flanked by six-over-six windows. The second story has three six-over-six windows.

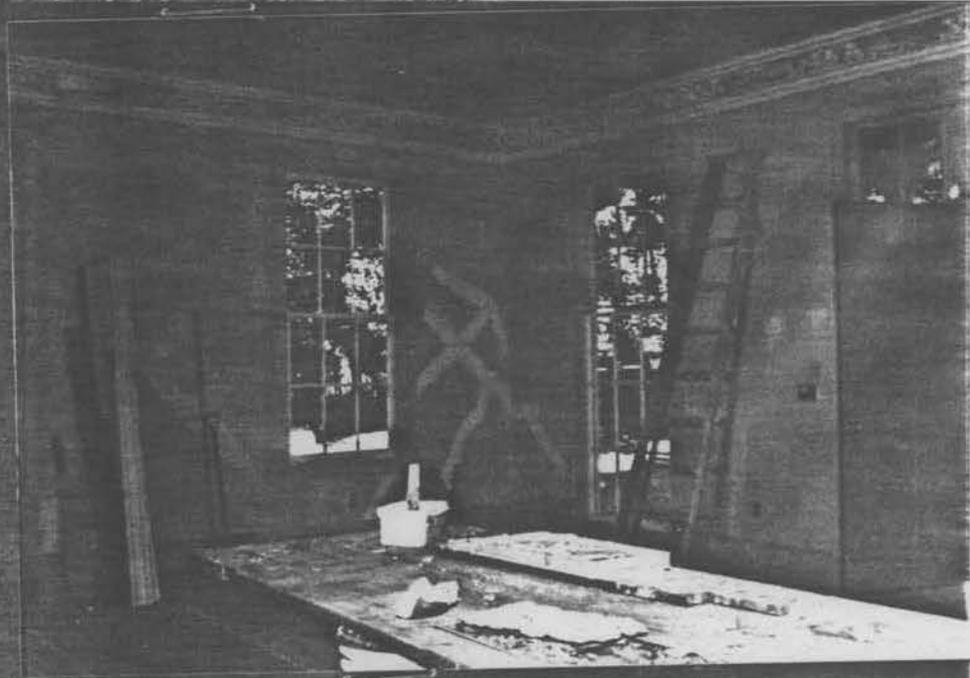
29

The first floor room served as a ballroom (Photo 29). Its design is marked by the tall ceiling, elongated windows on the east elevation, and ornate plaster cornice (Photo 30). There was a central ceiling medallion that was stolen from the house just prior to the transfer to the current owners (Photo 31). From the interior the three-pane transom above the door appears to be an adaptation of the upper sash of what was an original window at this location remodeled when the opening was converted to house a later five-panel door (Photo 32). The interior trim of the windows (Photo 33) and the door on this elevation are the same design rising from the baseboard with a beaded inner edge and molded outer edge. A similar molding runs along the top of the baseboard.

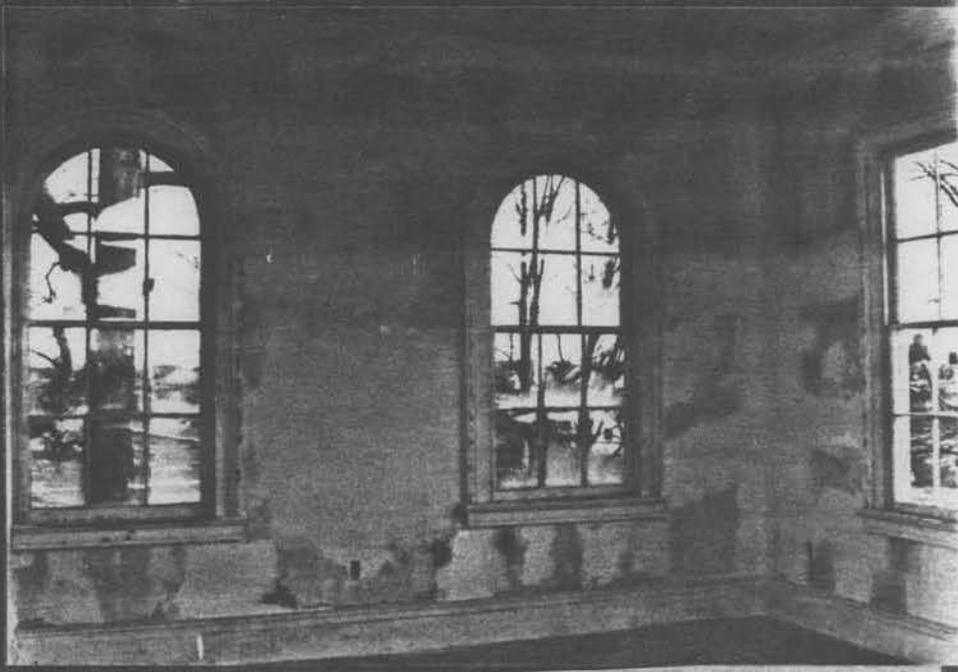
34

On the second floor, the windows on the east elevation have an arched design with a curved upper sash (Photo 34). The windows on the other elevations are rectangular. The window and door trim has an identical molding to the first story. The second floor has a two room plan with a narrow hallway running along the west side of the northern room. The southern room runs the full length of this section. The partition wall is located so that

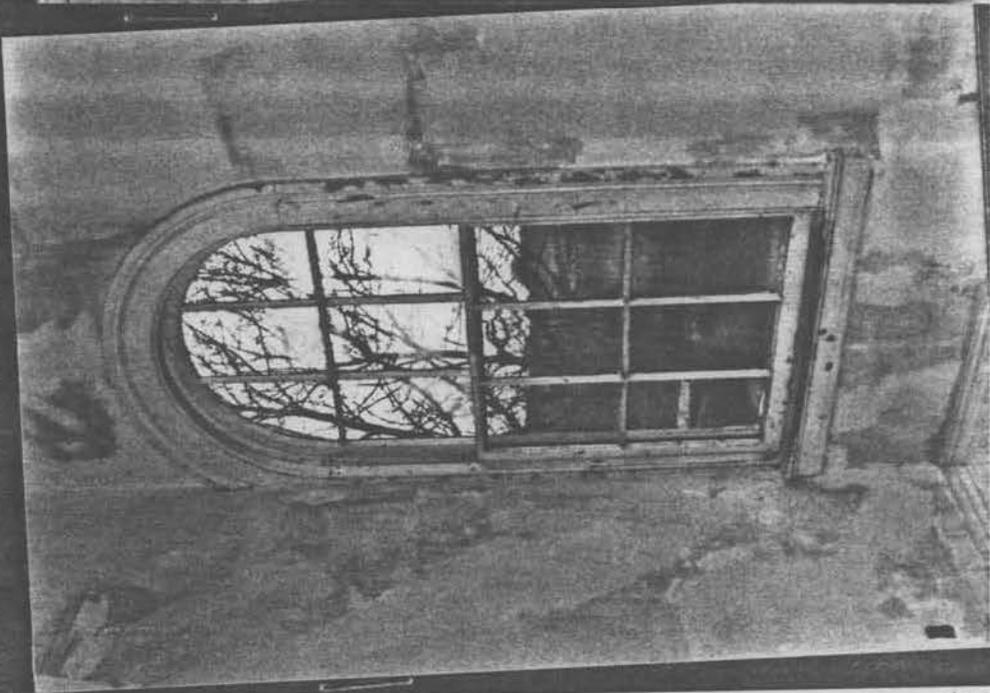
35

it intersects with the trim on the north side of the central window (Photo 35). At the west end of the partition wall, there is a four-panel door with original hardware (Photo 36).

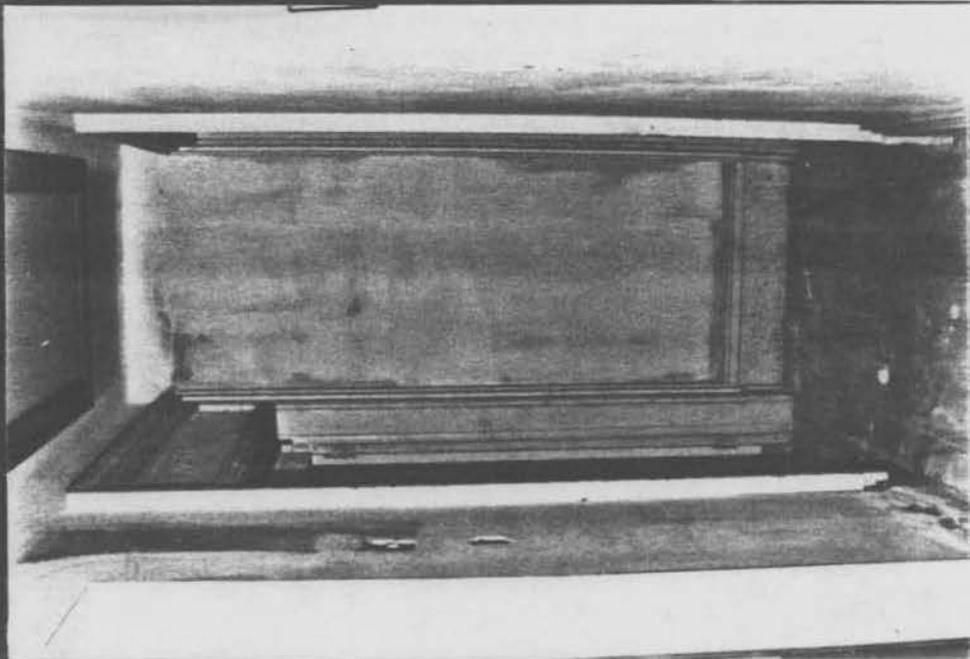
37

The short hallway has four doors leading into it (Photo 37). On the south side is the doorway to the south bedroom. On the west side, there is a modern doorway into the hallway on the southern side and the wood trim and door remain in place from when the entrance between the sections of the house used to be from a porch. The doorway on the east side is the entrance into the north bedroom.

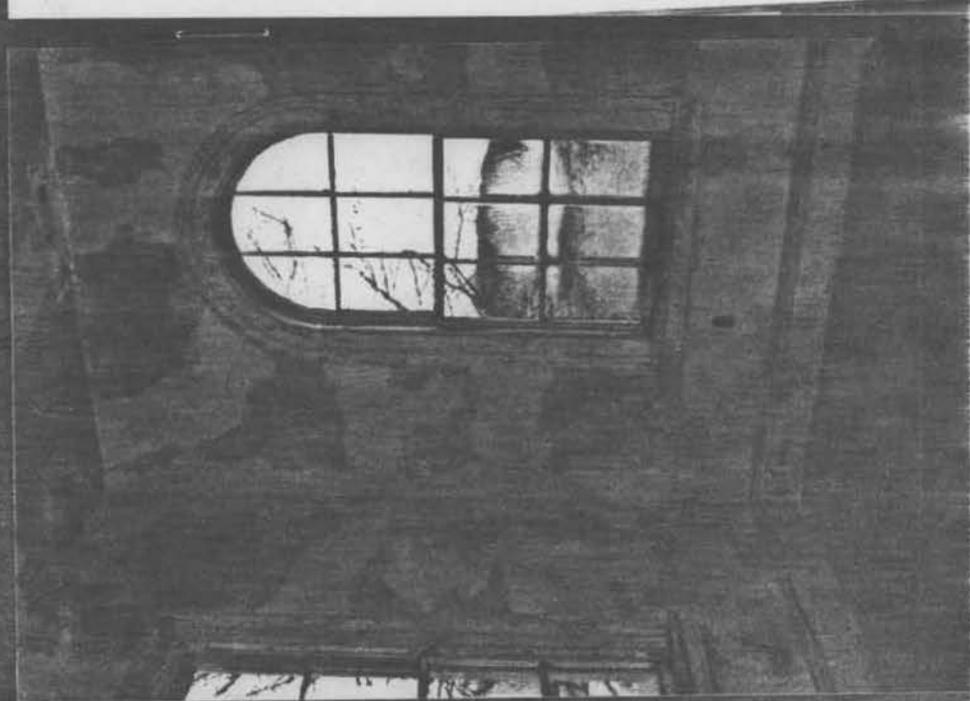
38

The north bedroom has a single arched window on the east elevation and two rectangular on the north elevation (Photo 38). The wood trim is identical to the trim in the south bedroom (Photo 39).

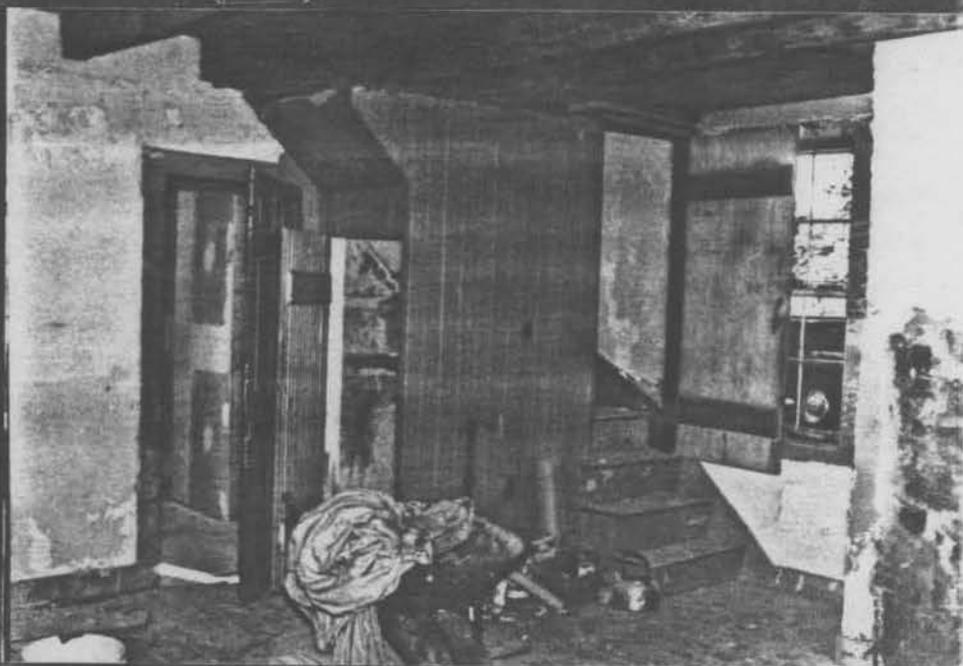
53

The stairway on the first floor was also changed. It is currently a corner stair boxed it with tongue-and-groove boarding (Photo 53). It is located in the northwest corner of the room and the kitchen fireplace is located on the north wall in the northeast corner (Photo 54). the rest of the room is open although evidence in the ceiling indicates that there was once a straight stairway boxed in along a partition wall in the original two-room configuration of the original house. The evidence includes an area of later floor boards that patched over the original stairway opening (Photo 56).

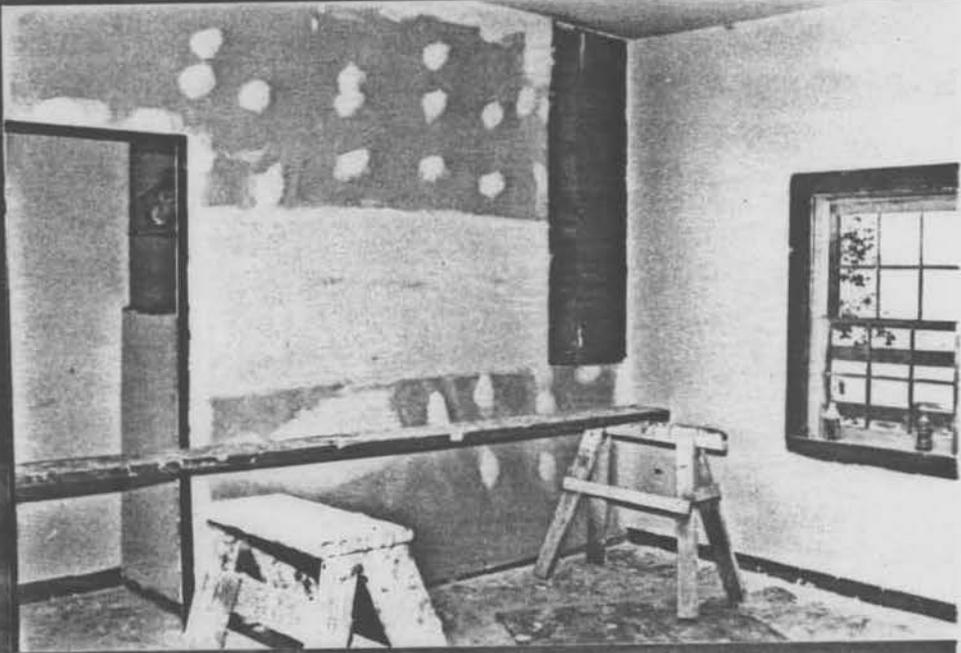
57

On the second floor of the original section, the northern room is a bedroom (Photo 57). There was a fireplace on the north wall but the mantelpiece was removed. The upper cupboard with a two-panel door remains intact on this wall. The southern room has been repartitioned for the modern uses of a bathroom and laundry room. A narrow hallway leads from the original section to the second phase of construction (Photo 58).

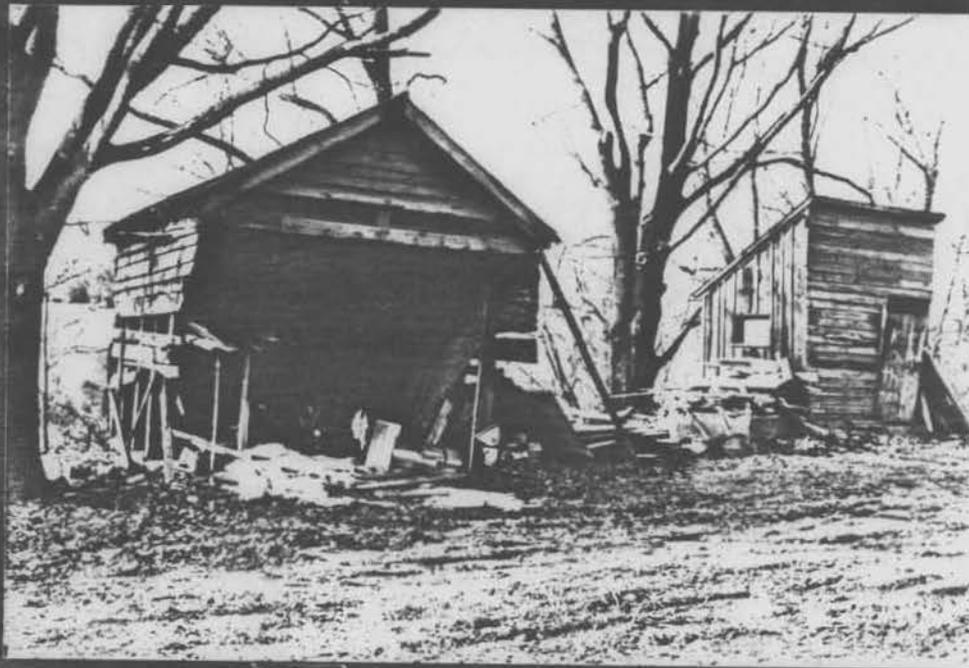
CARR-1294
58
59
60

gable roof (Photo 59). It is in a deteriorated condition but will be rehabilitated as part of the restoration project. It has a rectangular plan approximately 10 feet by 15 feet. The exterior has horizontal siding. The east elevation has an open such as a wagon shed with horizontal siding in the gable. The roof covering is corrugated metal.

On the north side of the shed is a frame well house (Photo 59). The plan is almost square (approximately 6 feet by 7 feet) and the structure covers a hand-dug well that is 3 feet in diameter and 40 feet deep. The structure has a shed roof that slopes downward to the west. The east elevation has German siding while the other three elevations are board and batten. The door has been relocated to the northern side of the east elevation but will be returned to the other side as part of the restoration.
