CONTRIBUTING RESOURCE
MARYLAND HISTORICAL TRUST
INTERNAL NR-ELIGIBILITY REVIEW FORM

Property Name: 3068 Westminster Street, Manchester, Maryland, Carroll County Survey Number: — CARR-1295

historic William Ross Shower House

#7. Description

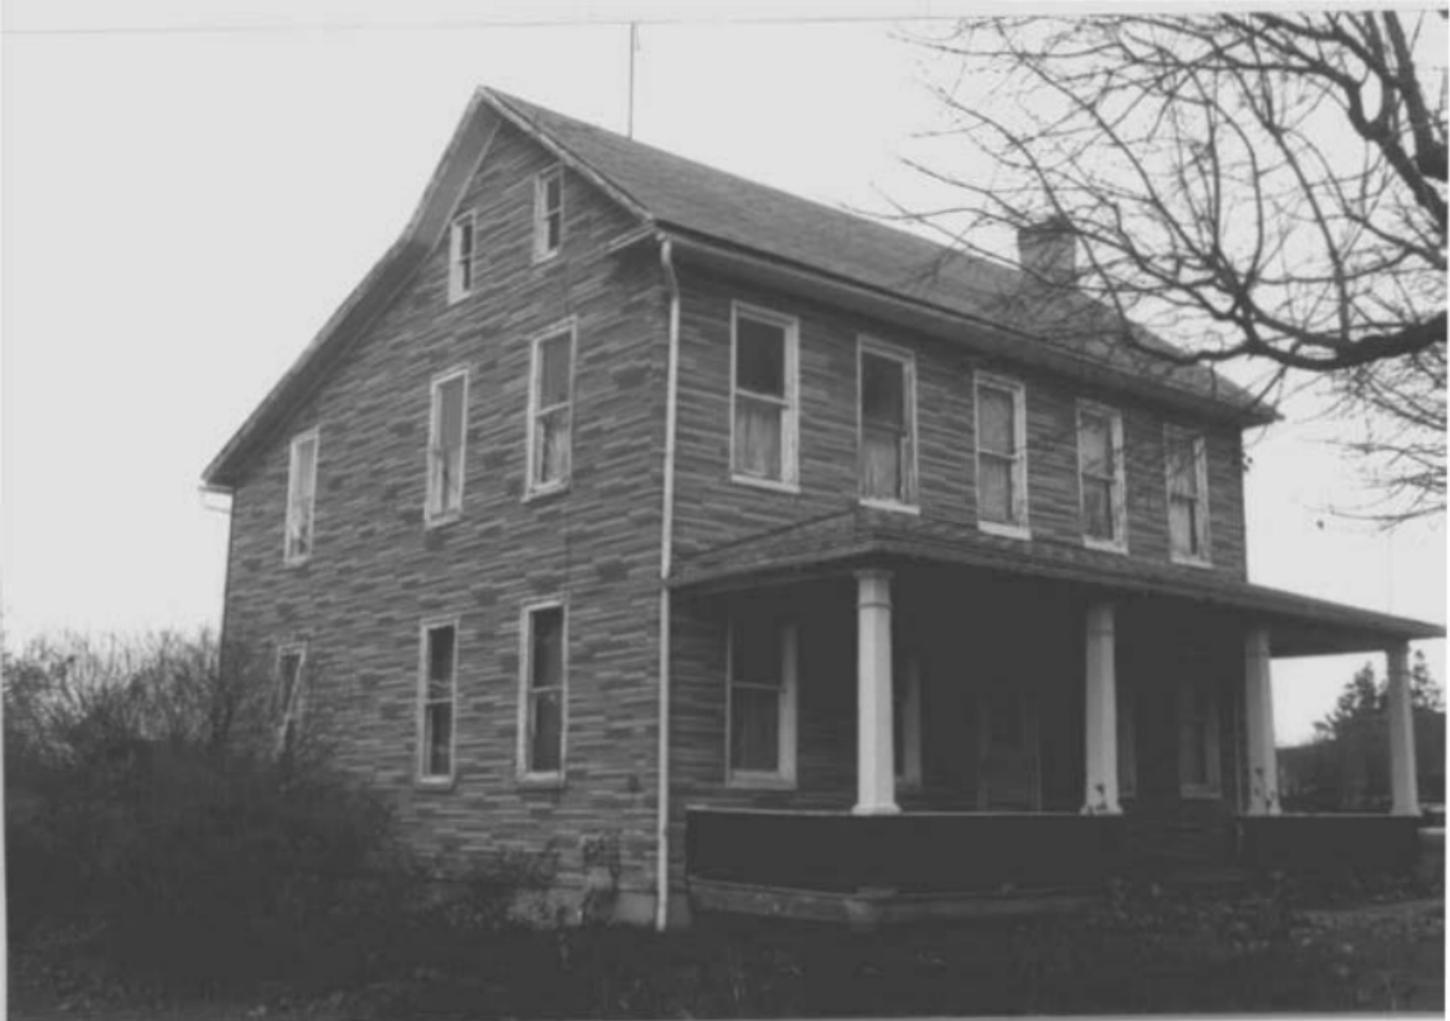
7/51

The William Ross Shower House is a vernacular style frame structure that was built in the 1920s. It is two-story building that contains an L-shaped plan (Photos 6 & 7). The L-shaped plan was a popular feature in this region from the late 18th century through the early

The southwest gable end of the main block has two one-over-one windows on each floor (Photo 7). In the gable are two smaller one-over-one sash windows. This elevation shows the angle of the roof in projecting out to cover the ell wing. The southwest elevation of the ell has a single one-over-one sash window on each story.

se & sw elevations

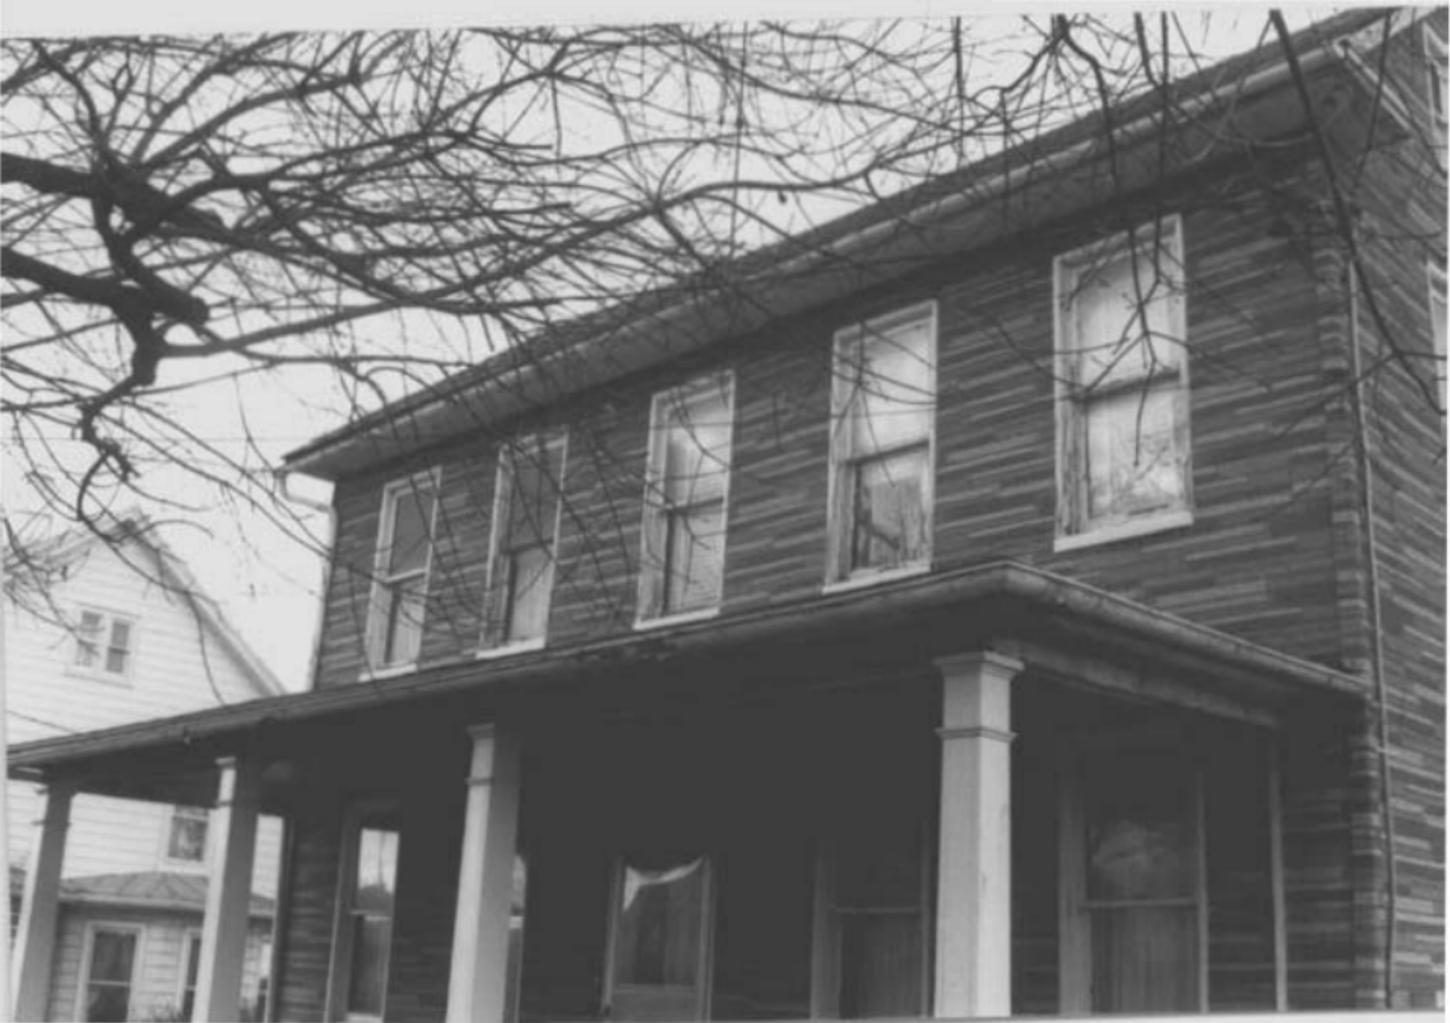
8/51

The main facade is symmetrically arranged with a central entrance on the first floor (Photo 8). The other bays on the first and second stories have one-over-one sash windows (Photos 8 & 9). There is a full-length, one-story porch with a hipped roof covered in asphalt shingles (Photo 10). The ceiling of the porch is a thin tongue-and-groove board painted white. The porch roof is supported by square posts with molded ornamentation (Photo 11). The porch posts sit on a railing covered in shingles. The porch has a tongue-and-groove board wooden deck.

se elevation

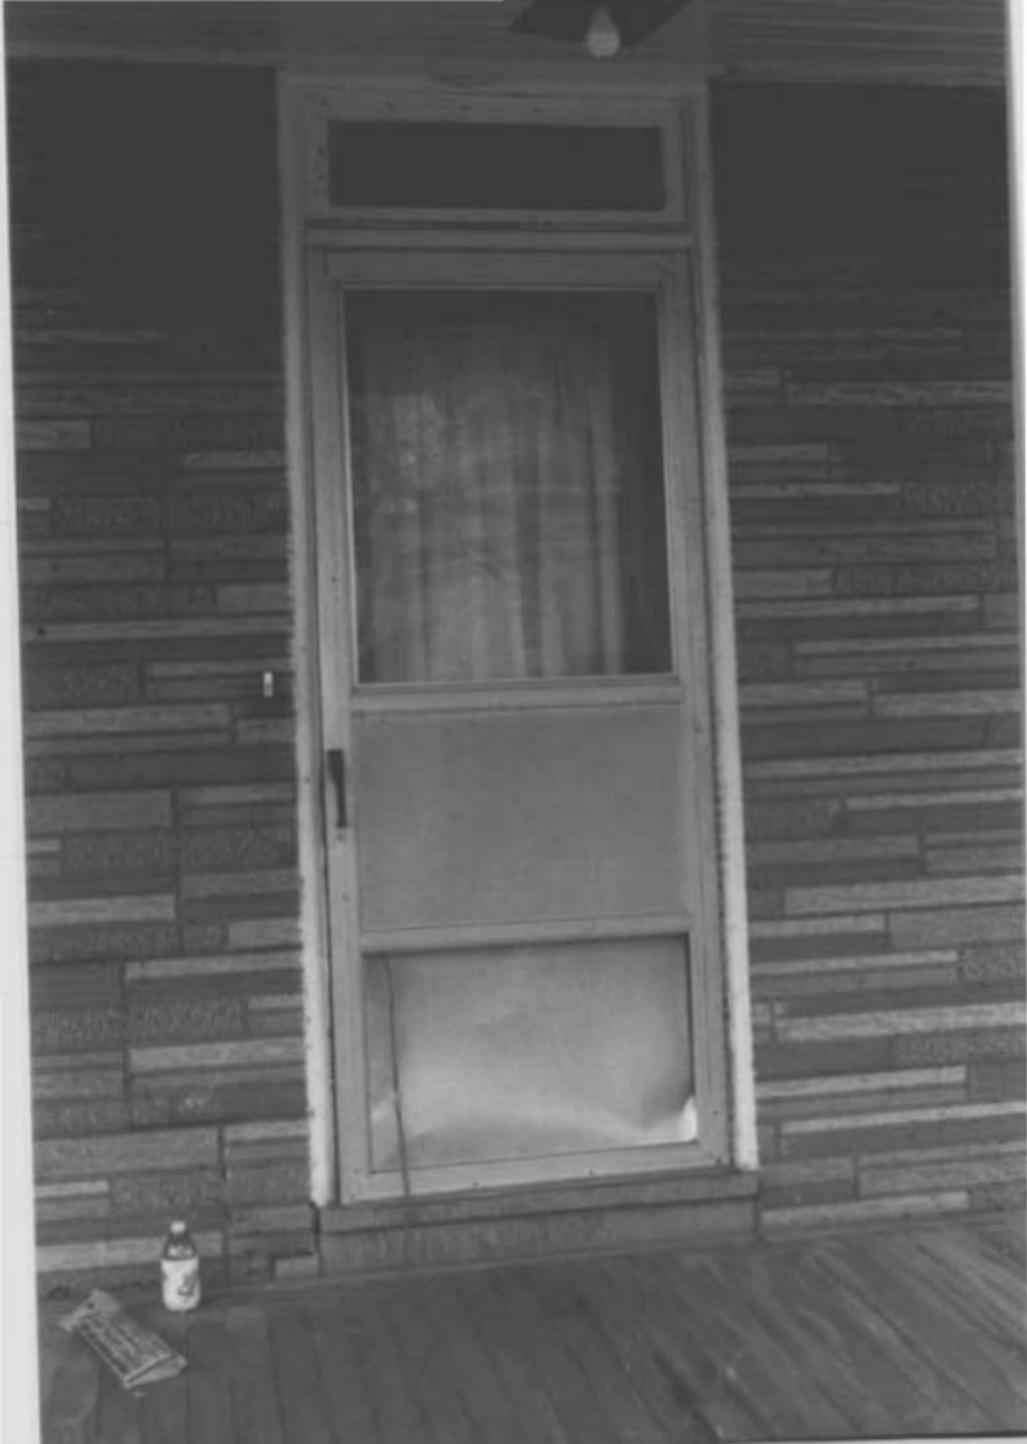
12/51

The central entrance contains a single door with a two-pane, horizontal transom above the door (Photo 12). The door has a single pane of window glass in the upper section and a single panel below. The door framing is a convex molding painted white. The exterior of the entrance has a single-pane wooden storm window over the transom and an aluminum storm door over the entrance. The window frames throughout the house have an exterior framing of a plain convex molding (Photo 13). The roofline has a plain boxed cornice that returns at the front gable ends (Photo 14).

se elevation - front door

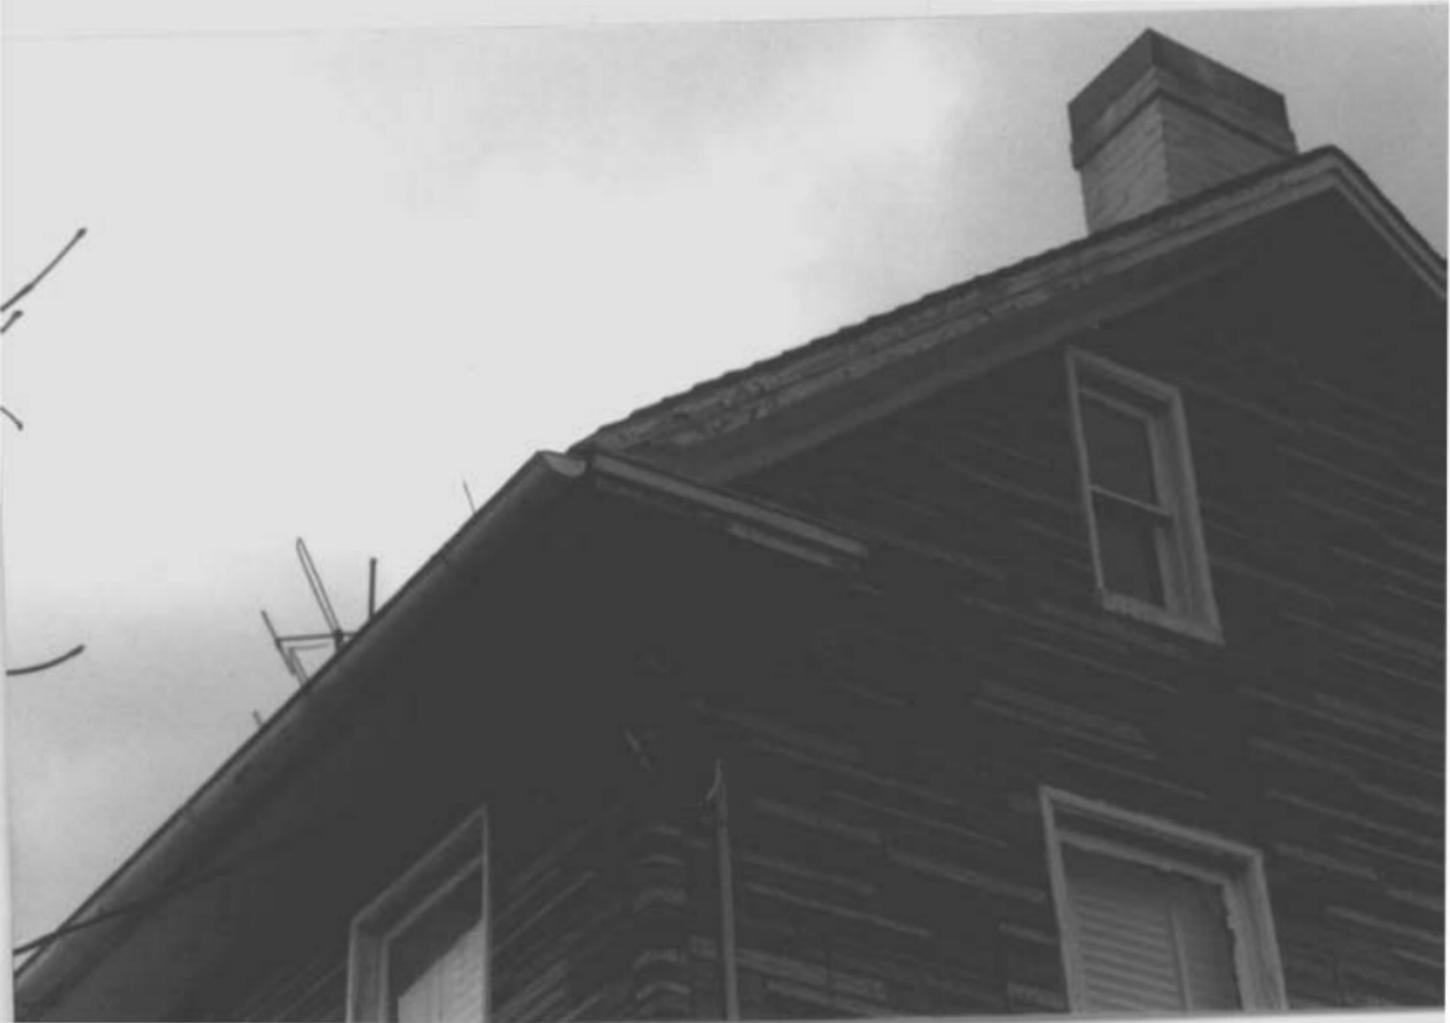
14/51

se elevation - cornice

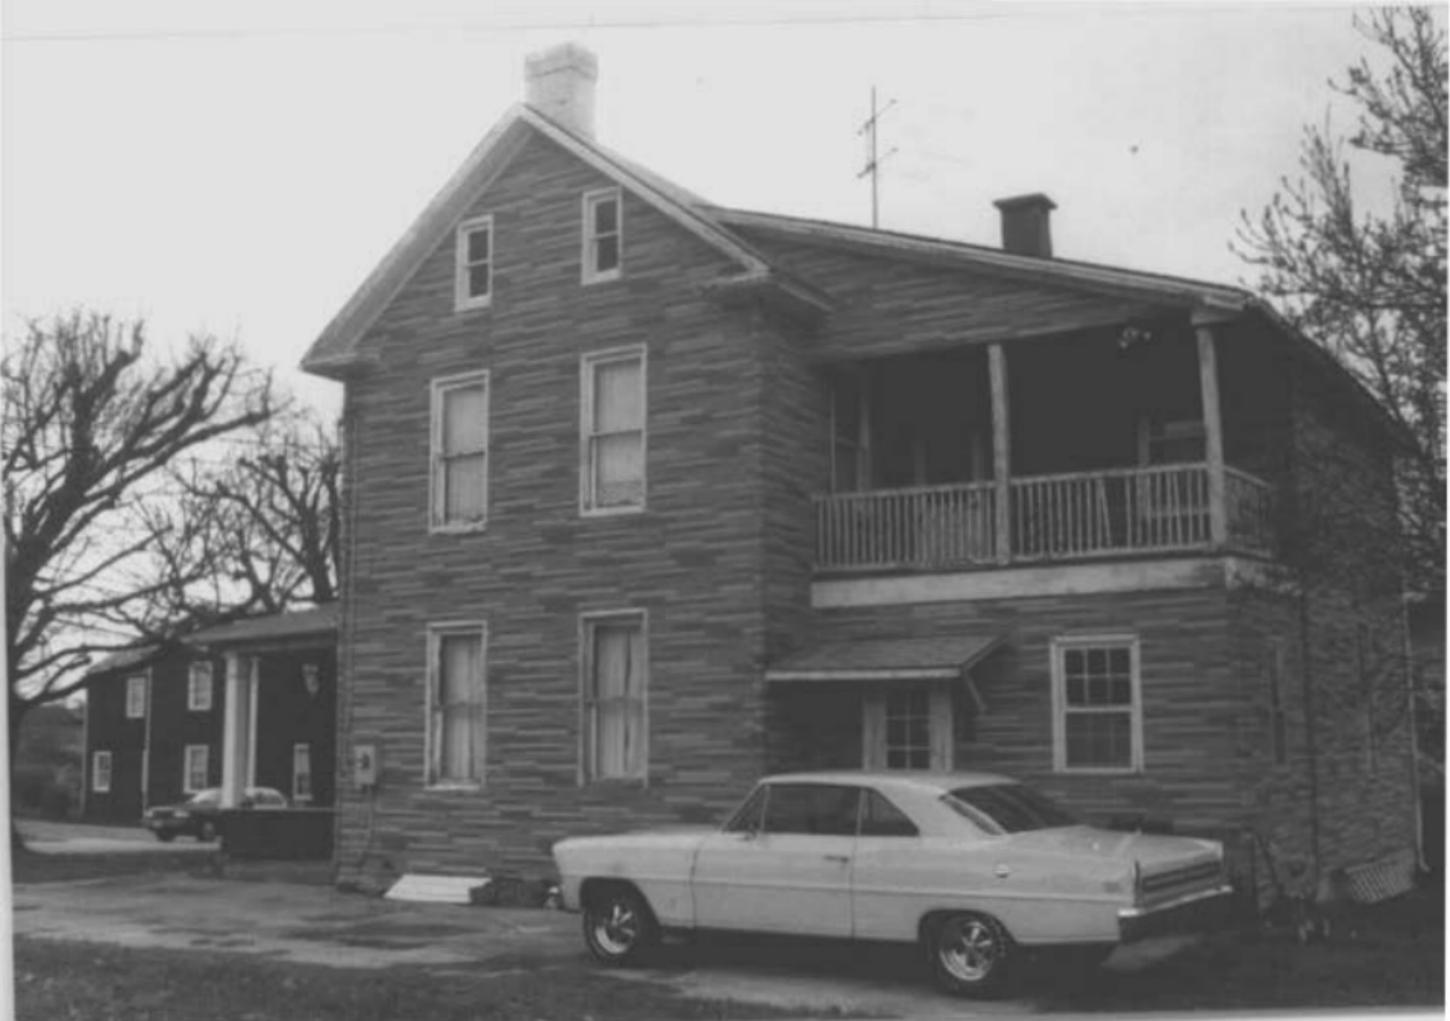
16/51

The northeast gable end of the main block has two one-over-one windows on each floor (Photos 15 & 16). In the gable are two smaller one-over-one sash windows. The brick chimney with the upper two courses projecting out as a cap is located at this gable end. On the inner side of the ell was a double-tiered porch. The lower portion of the porch has been enclosed for use as a laundry room (Photos 16 & 17). The northwest elevation of the ell wing has a single one-over-one sash window centrally located on the first floor.

The double-tiered porch on the inner side of the ell wing was a typical feature for domestic structures in the region (Photo 16 & 17). In this design, the shed roof projects out from the ell to cover the area of the porches. The first story of the porch is enclosed and has a doorway and a six-over-six window on the northeast elevation and a single four-over-four window on the northwest elevation. The doorway has a cantilevered shed roof that forms a small entrance porch. The second story of the porch is still open (Photo 18). It has plain square porch posts and a railing with square balusters. The second floor northeast elevation has a door and a one-over-one sash window to the porch. The northwest elevation onto the second floor porch has a single one-over-one sash window (Photos 19-21).

ne elevation

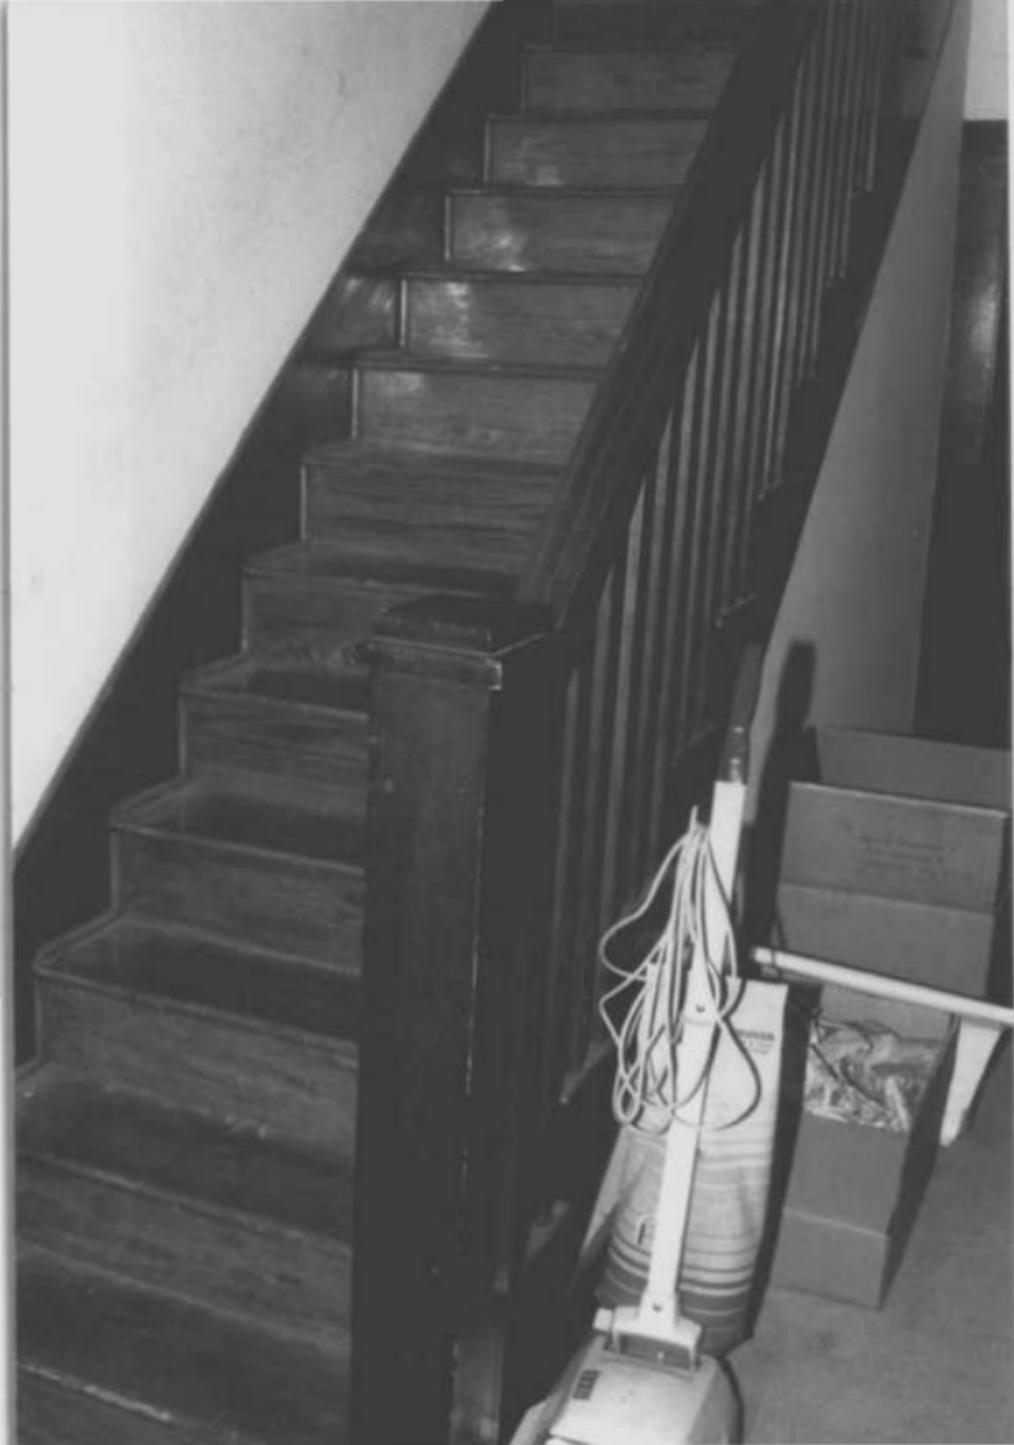
22/51

The staircase has a plain design with a square newel post and square bannisters supporting a shaped handrail (Photo 22). The stair ends are plain and the walls below the staircase as well as throughout the hallway are plastered. The exterior door has a two-pane, horizontal transom and the door has a single pane of window glass in the upper section and a single panel below (Photo 23). The interior doors are four-paneled with tall vertical panels on the upper section of the doors (Photo 24). The doorframes in the hallway consist of plain pine boards without ornamentation joined at the corners with butt-end joints (Photo 25). The woodwork of the doorframes, doors, stair risers, railing and bannisters has a natural finish and some of the interior doors have original hardware (Photo 26).

Hall - stairway

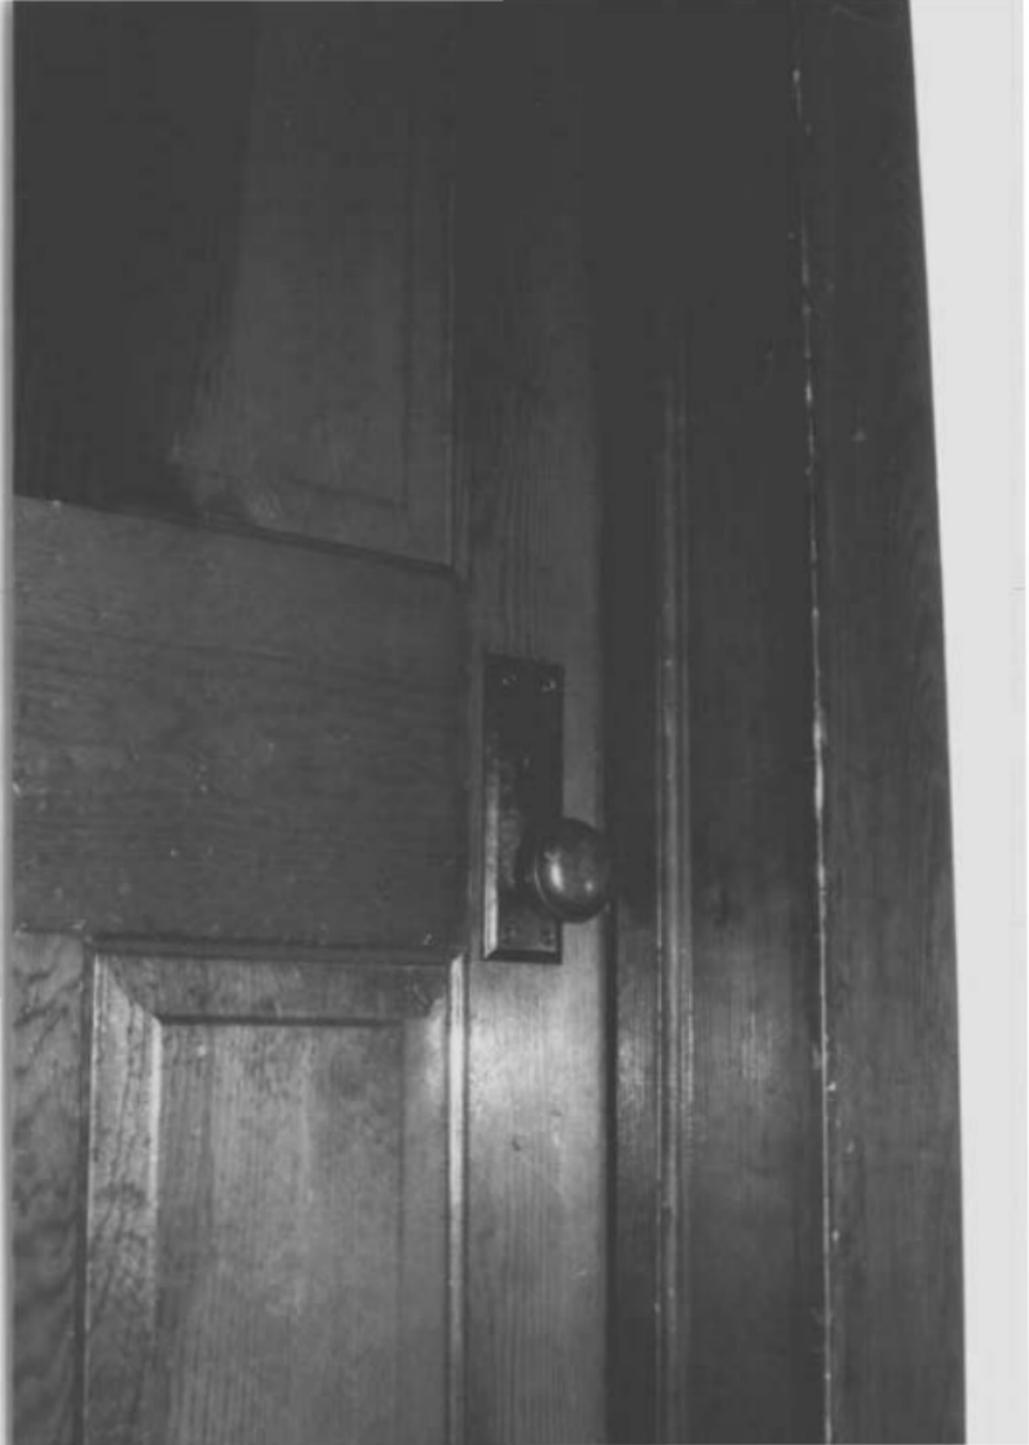
26/51

Hall - interior door - hardware

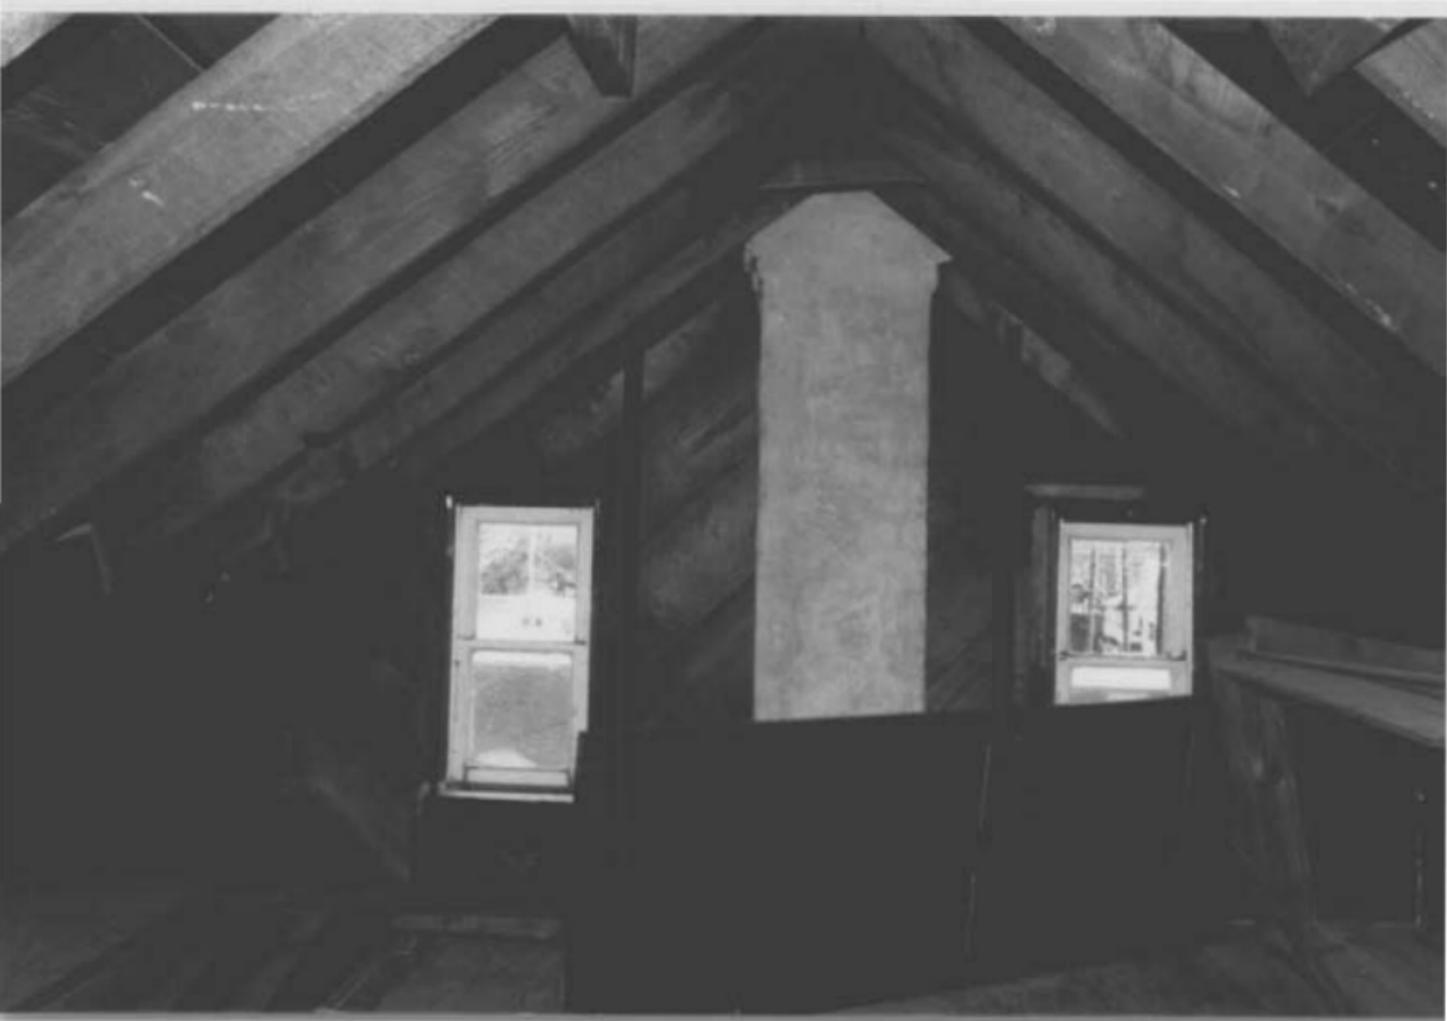
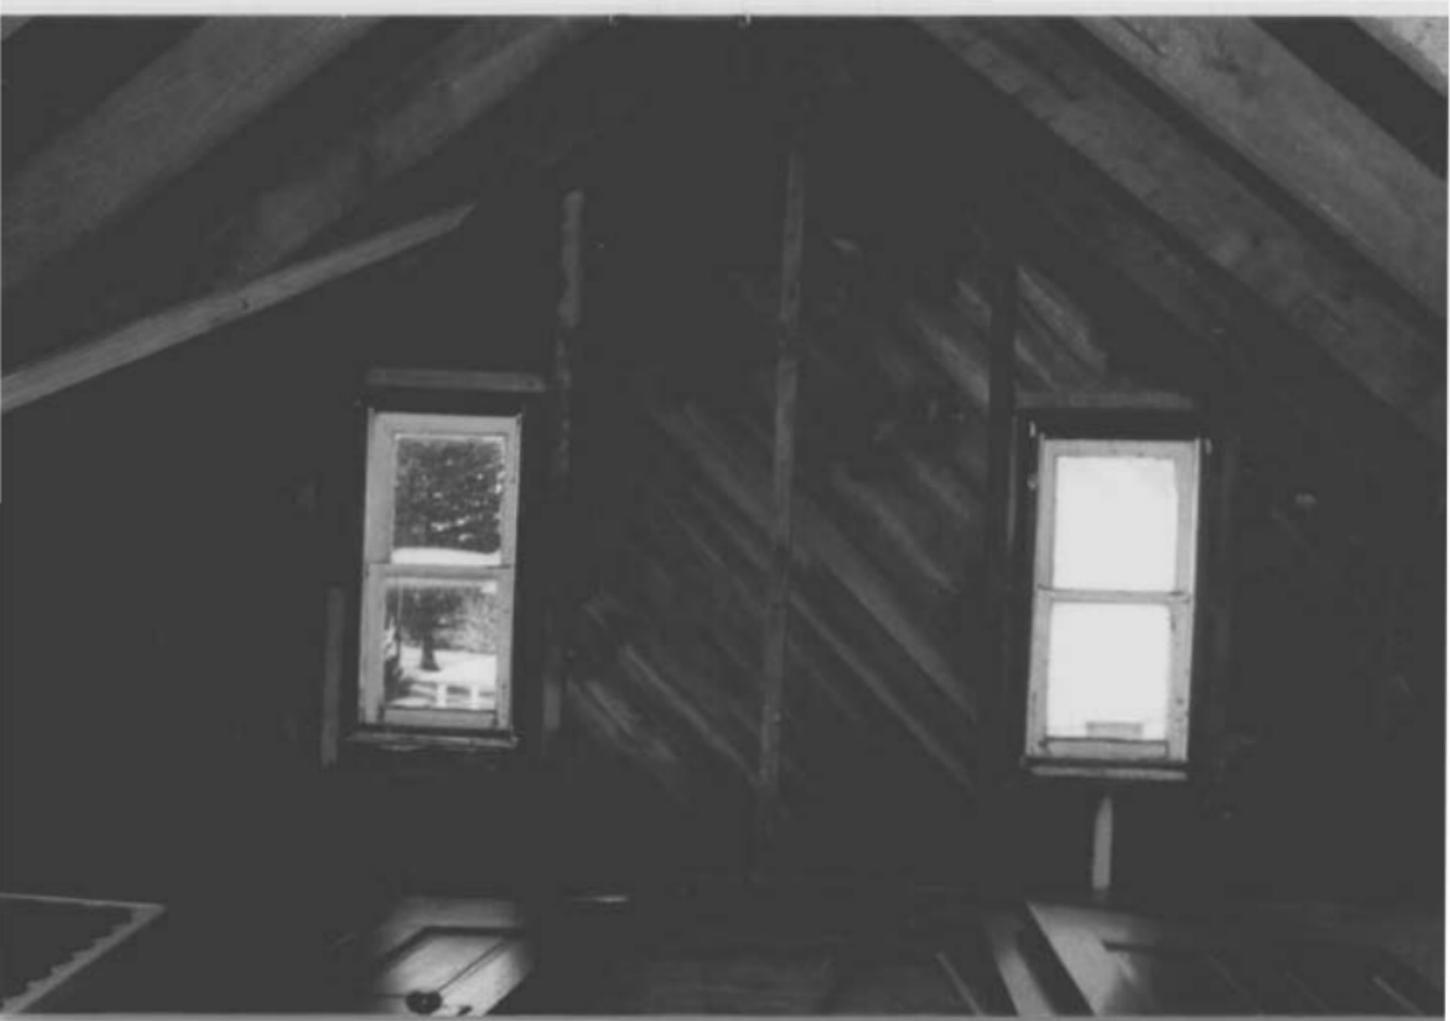
42/51

The attic is unfinished and shows the construction technology for the roof framing system (Photos 42 & 43). The building has a common rafter roof. The rafters are mill-sawn two-by-tens with butt-end joints at the peaks (Photo 44). The shed roof of the ell wing has two-by-ten common rafters that are attached to and project out from the roofing system of the main block (Photo 45). The common rafter are covered with a horizontal board sheathing. The gable ends have two-by-four studs and are covered with a diagonal board sheathing. There is a plain enclosed stairway to the attic with plaster walls (Photo 46).

Attic - facing ne

Attic - facing SW

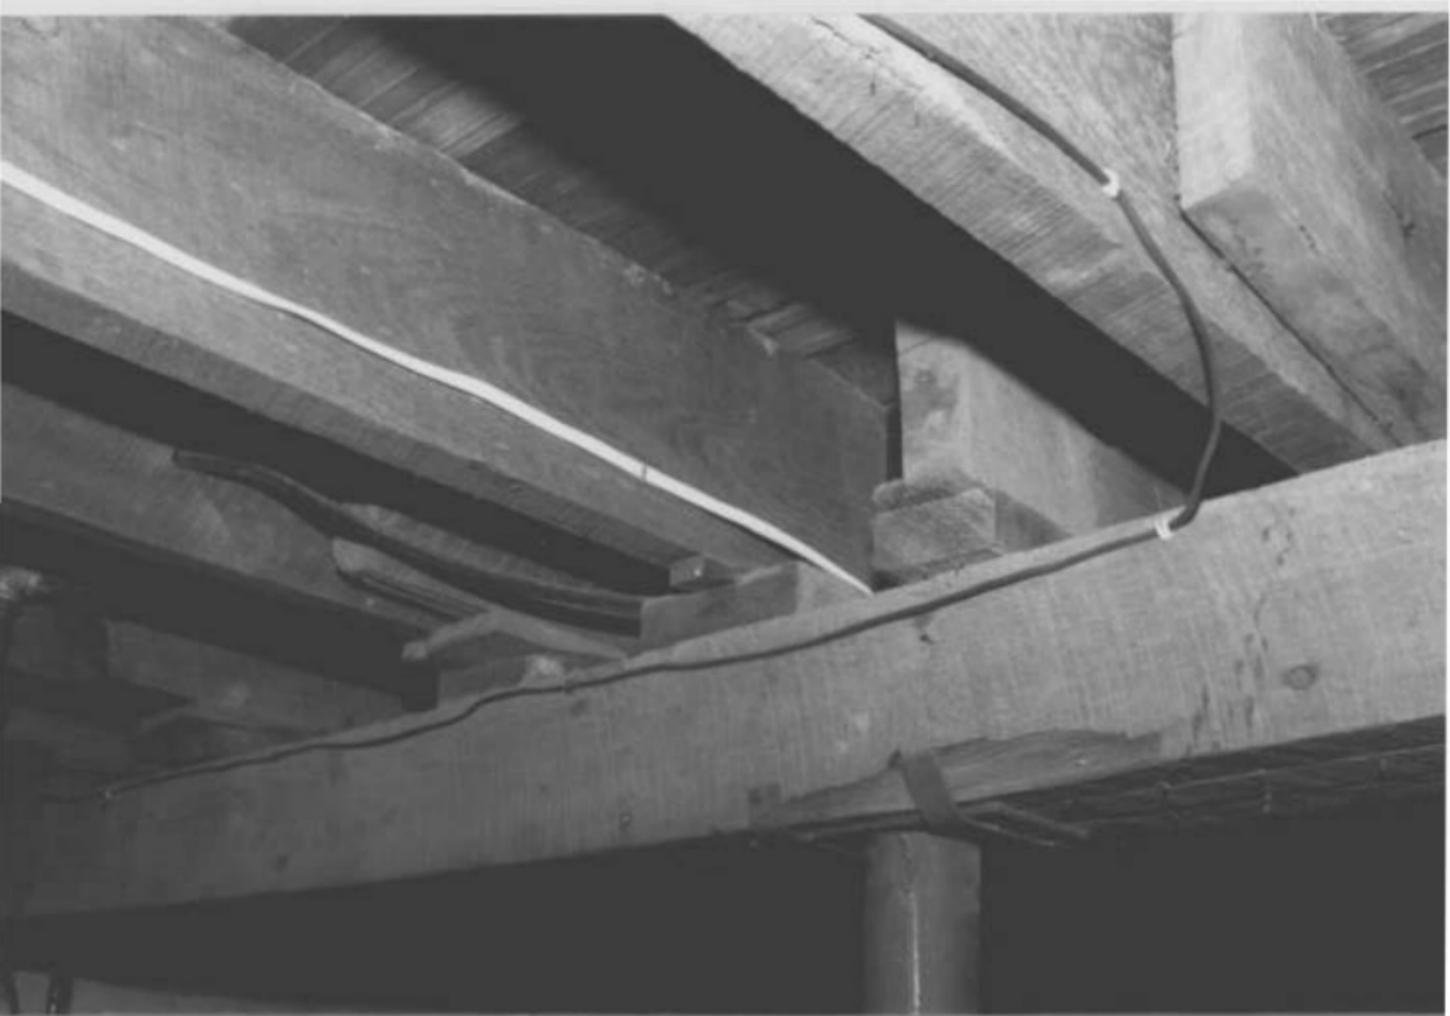
50/51

The basement has an open interior stair leading from the kitchen (Photo 47). It has a dirt floor and the interior wall are parged. The northeast, southeast and southwest wall each have two three-pane basement windows (Photo 48). The northwest wall has a crawl space under the ell. Centrally located between the two windows on the northeast wall is a cantilevered support for the brick stove flue located above (Photo 49). The basement is unfinished and the construction system for the first floor is visible. It consists of mill-sawn two-by-tens as floor joists supported by two major beams (made of three two-by-tens side-by-side) running through the house (Photo 50). This system has weakened and has been

reinforced by steel posts. The basement windows are single horizontal sash of three panes each (Photo 51).

Basement - floor joint detail
