**Addendum to  
Maryland Historical Trust  
State Historic Sites Survey Inventory Form  
CARR 1296**

1. **Name -** Historic Name - Dehoff/Ebaugh Farm  
Common Name - Oakmont Green

Property/District Name: Dehoff / Ebaugh Farmstead Survey Number: 1296

historic Dehoff/Ebaugh Farmstead

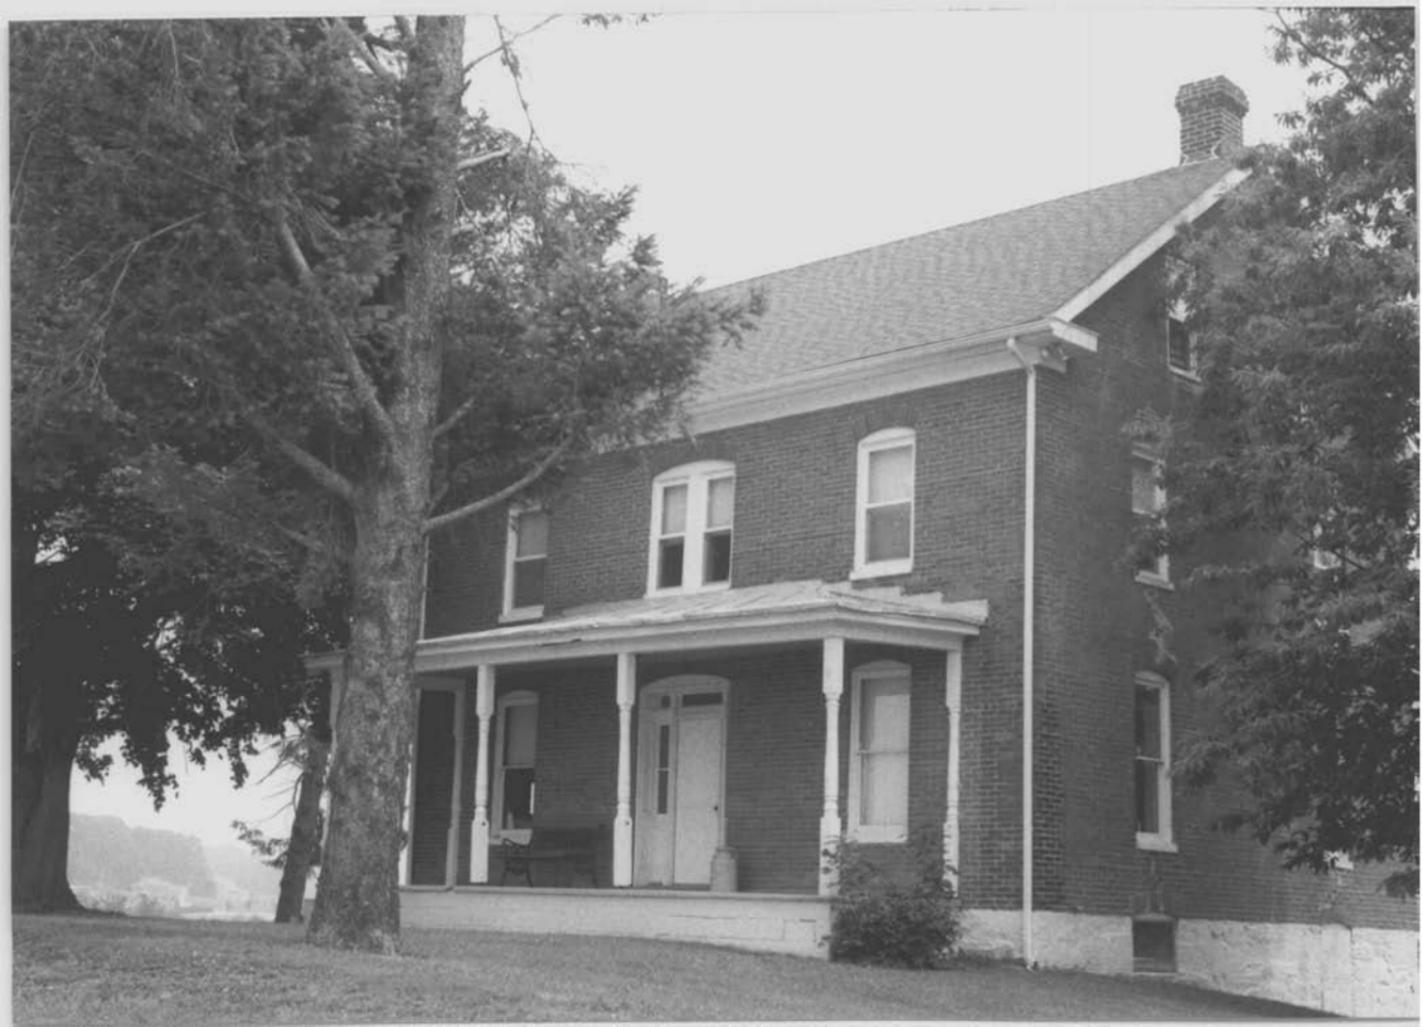
1. CARR 1296
2. Carroll County
3. Madeline Scheerer
4. June 1996
5. Maryland SHPO
6. DeHoff / Ebaugh Farmstead  
1296 Belmont Green  
main - west elev.
7. 1/4

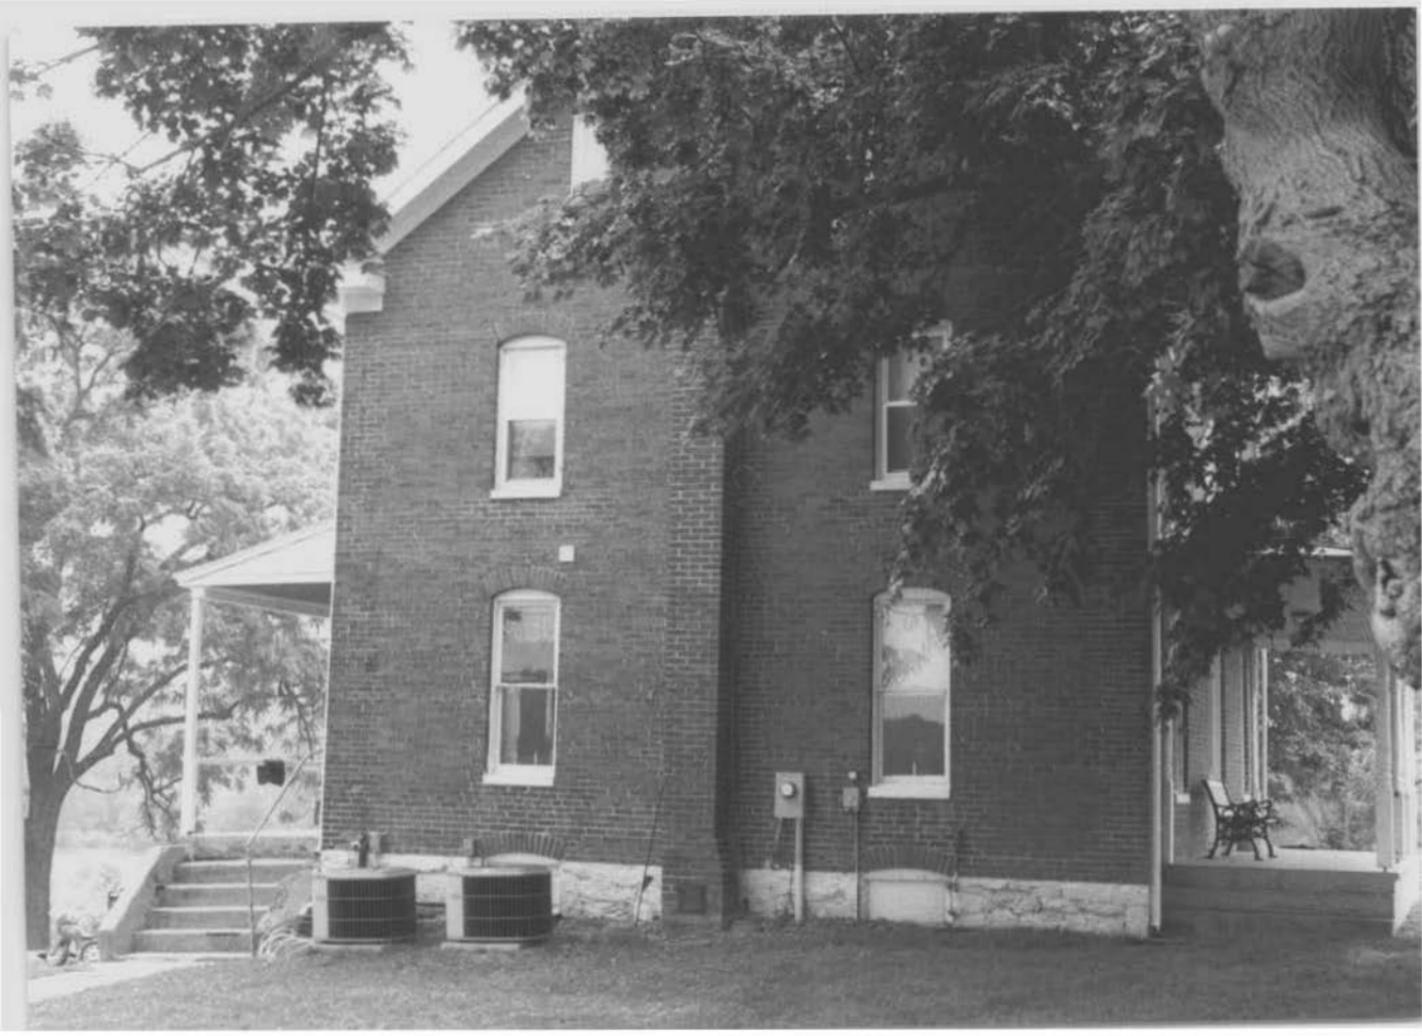
1. CARR 1296
2. Carroll County
3. Madeleine Scheerer
4. June 1996
5. Maryland SHPO
6. DeHoff / Ebaugh Farmstead  
1296 Delmont Green  
Main - North elev
7. 2/4

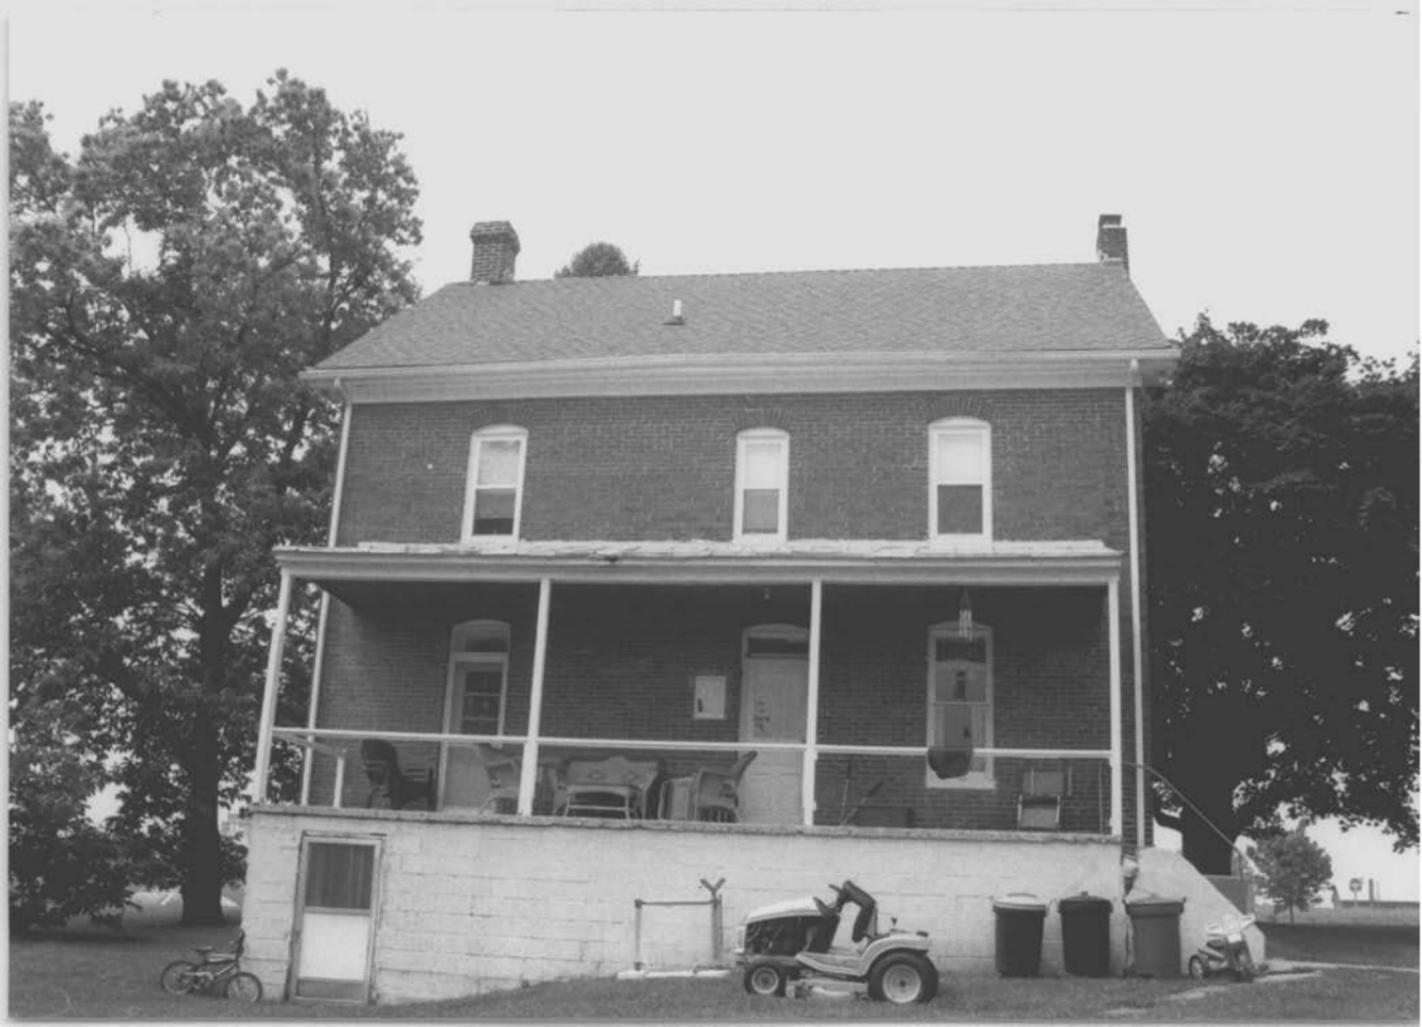
1. CA# 1296
2. Carroll County
3. Madeleine Scherer
4. June 1996
5. Maryland SHPO
6. DeHoff / Ebaugh Farmstead  
1296 Belmont Green  
main - east elev.
7. 3/4

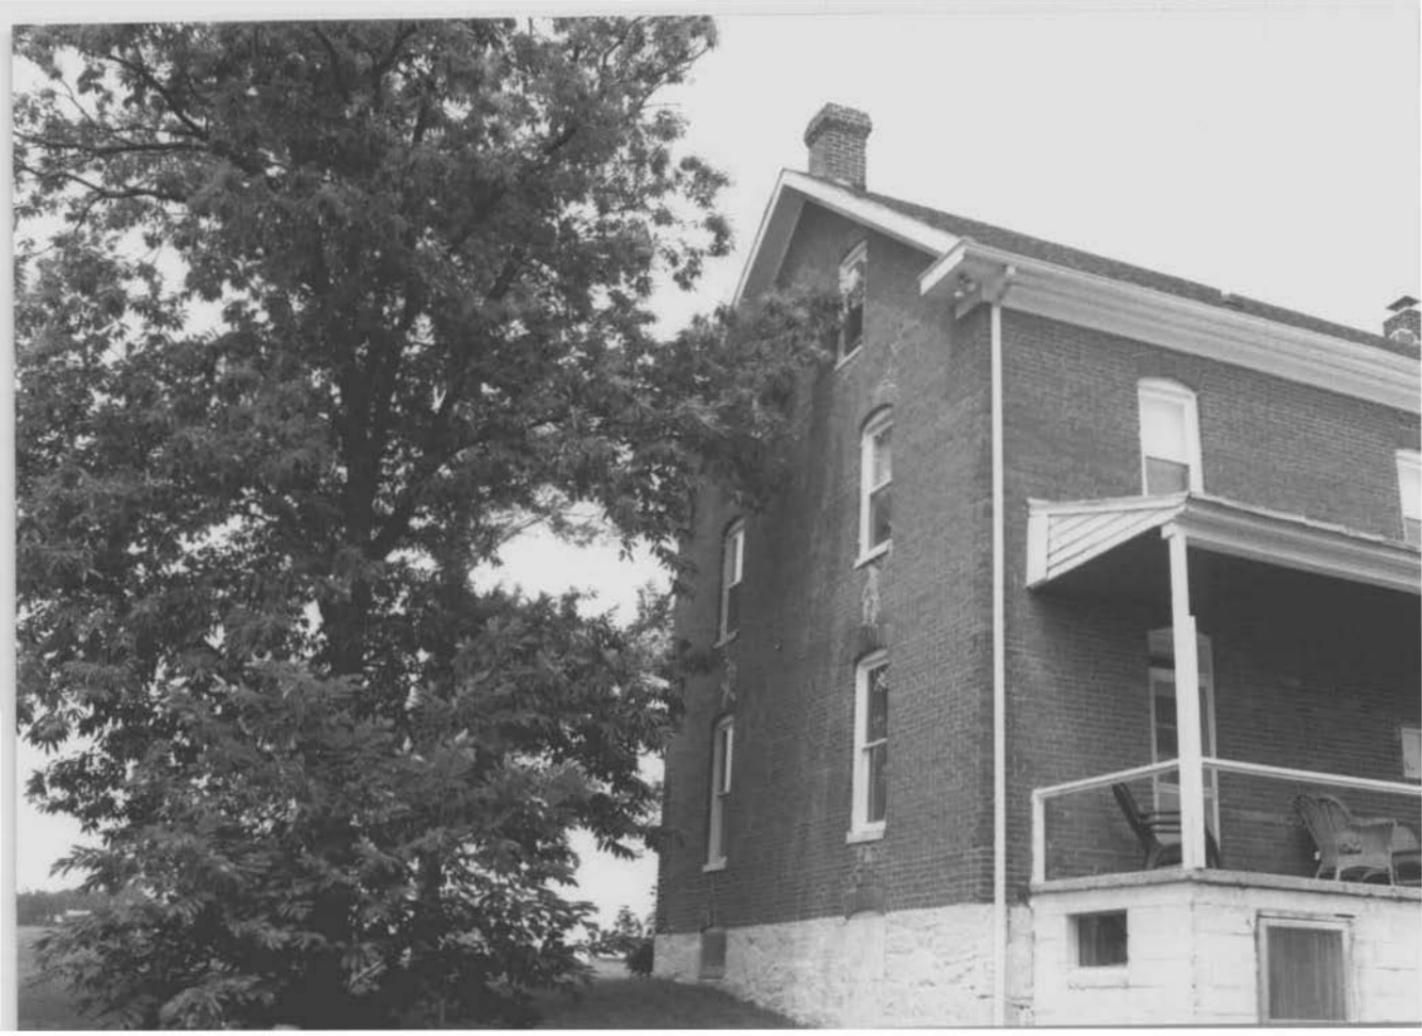
4/4/4

1. CARR 1296
2. Carroll County
3. Madeline Scheerer
4. June 1996
5. Maryland SHO
6. DeHoff / Ebaugh Farmstead  
1296 Delmont Green  
main - south elev.

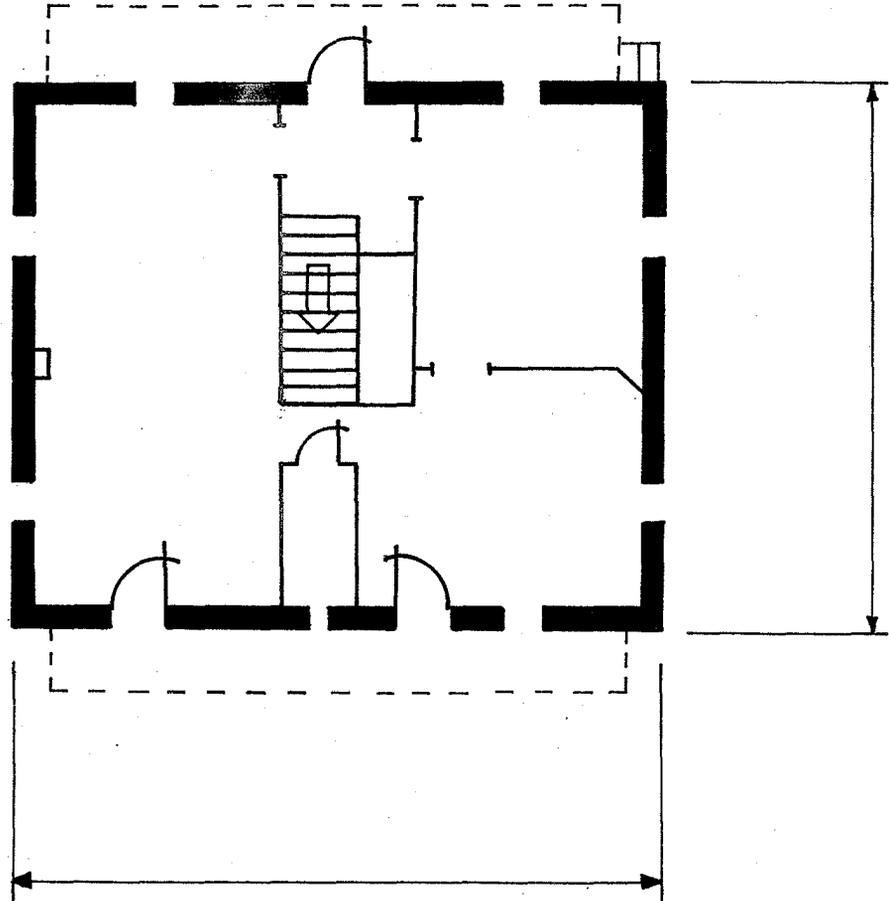
First Floor Plan  
not to scale  
1/17/91

The first floor of the structure is divided into three chambers flanking a central entrance hall. This hall is the location of a straight stair that provides access to the second story level. The stair unit, incorporating machine turned balusters and railing, survives intact. Surviving interior features include door architraves with corner blocks. A proportional first floor sketch plan accompanies this documentation.

Principal Dwelling  
Dehoff/Ebaugh Farmstead  
Carroll County, MD

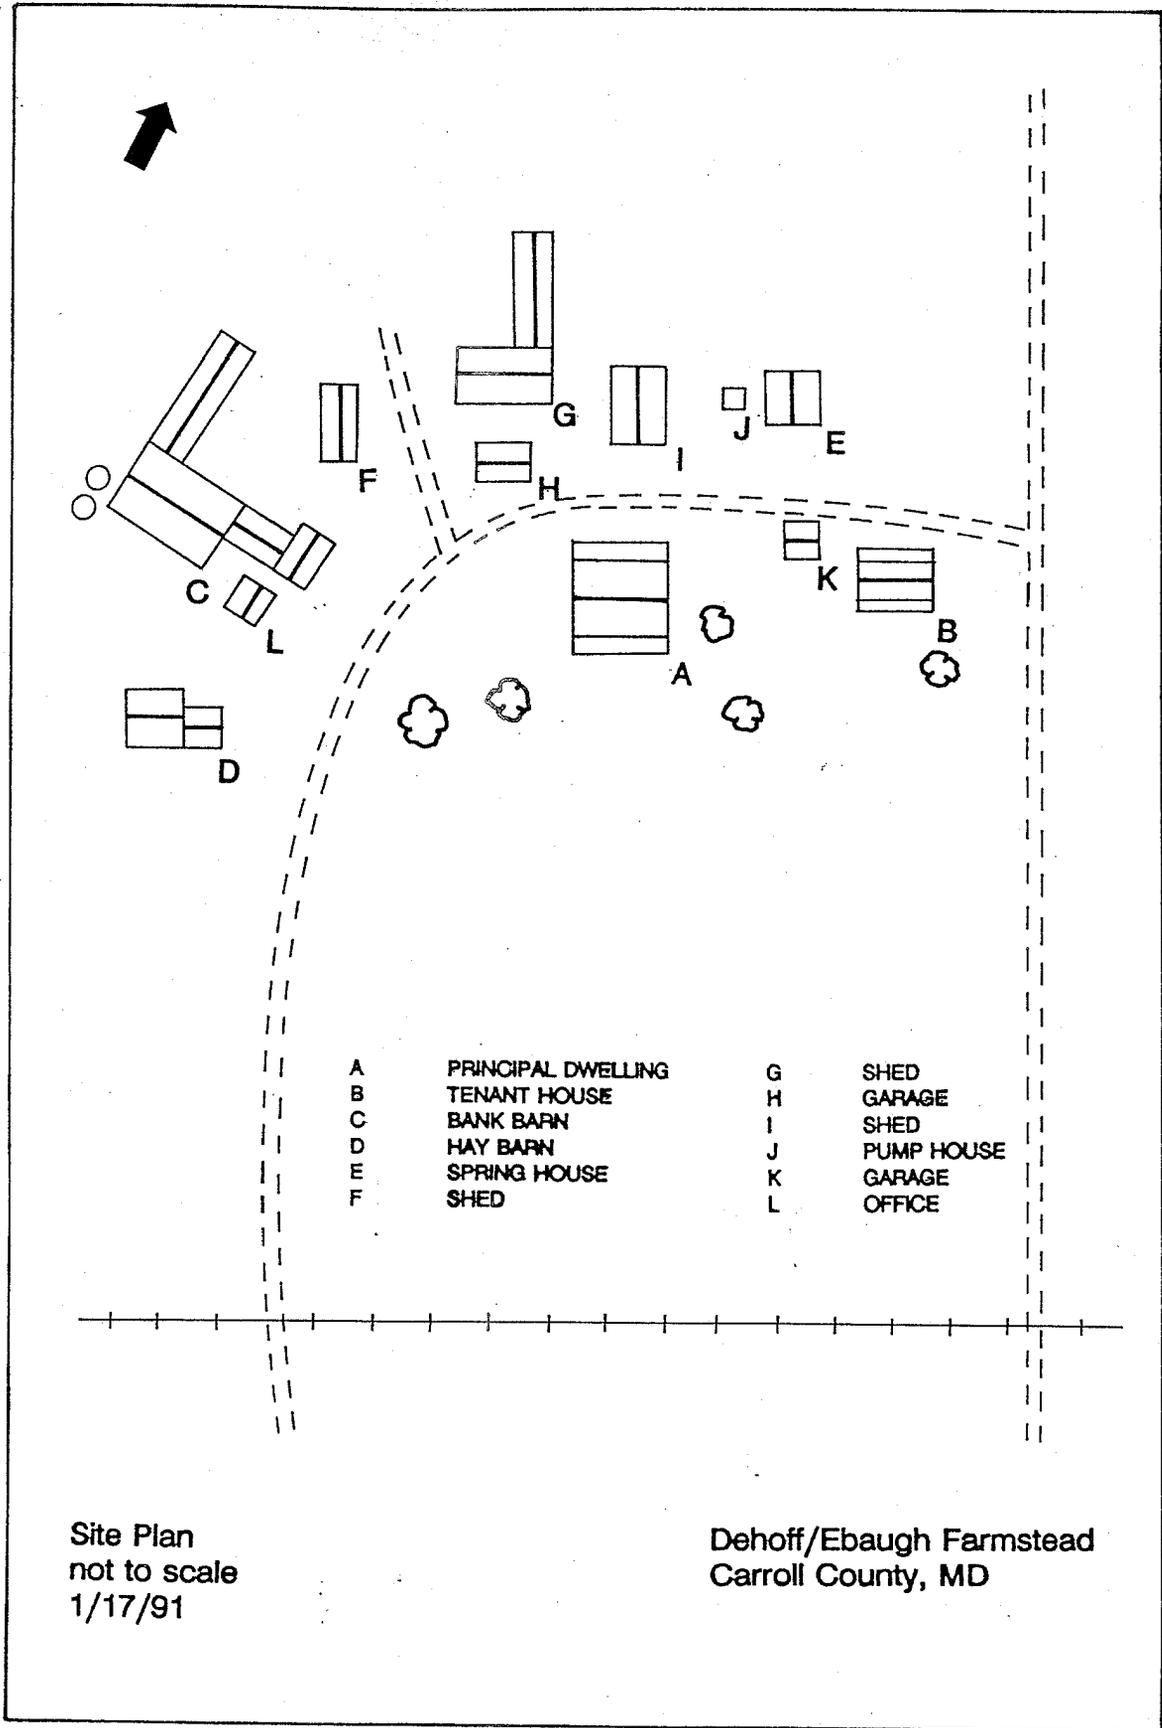
Site Plan  
not to scale  
1/17/91

The following descriptions of the buildings encompassed in the agricultural complex are keyed to the site sketch map. Each structure is represented in the accompanying photographic documentation.

Dehoff/Ebaugh Farmstead  
Carroll County, MD

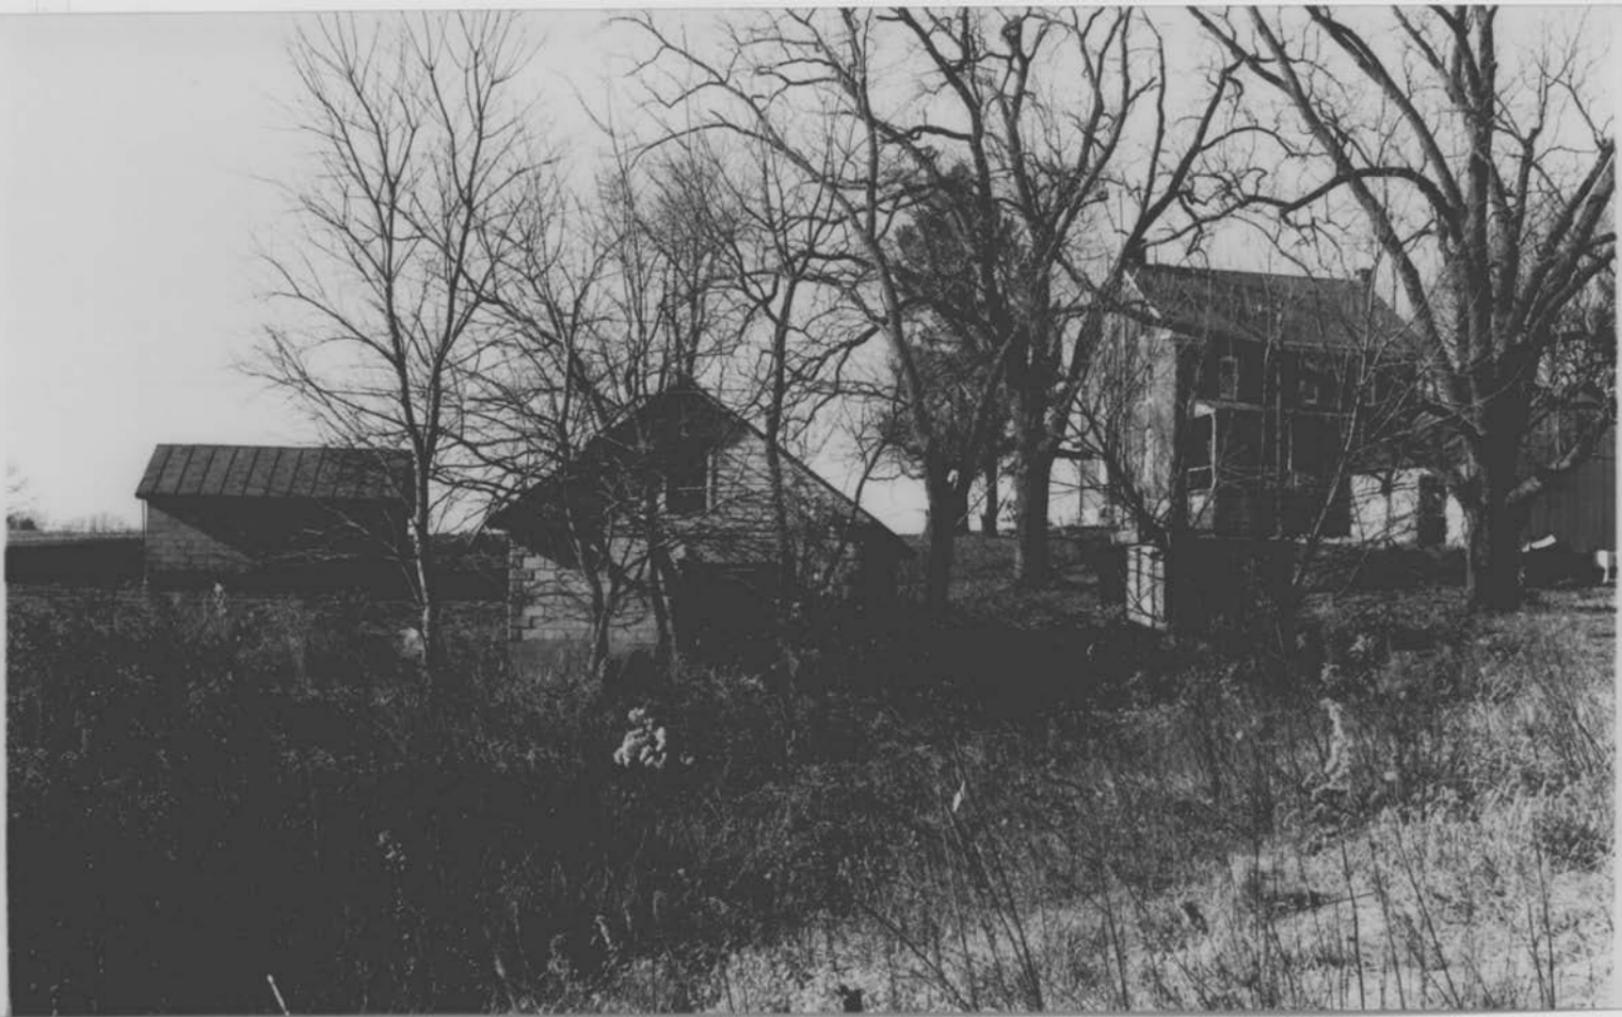
4 OF 28

SPRINGHOUSE (E), AND PRINCIPAL DWELLING

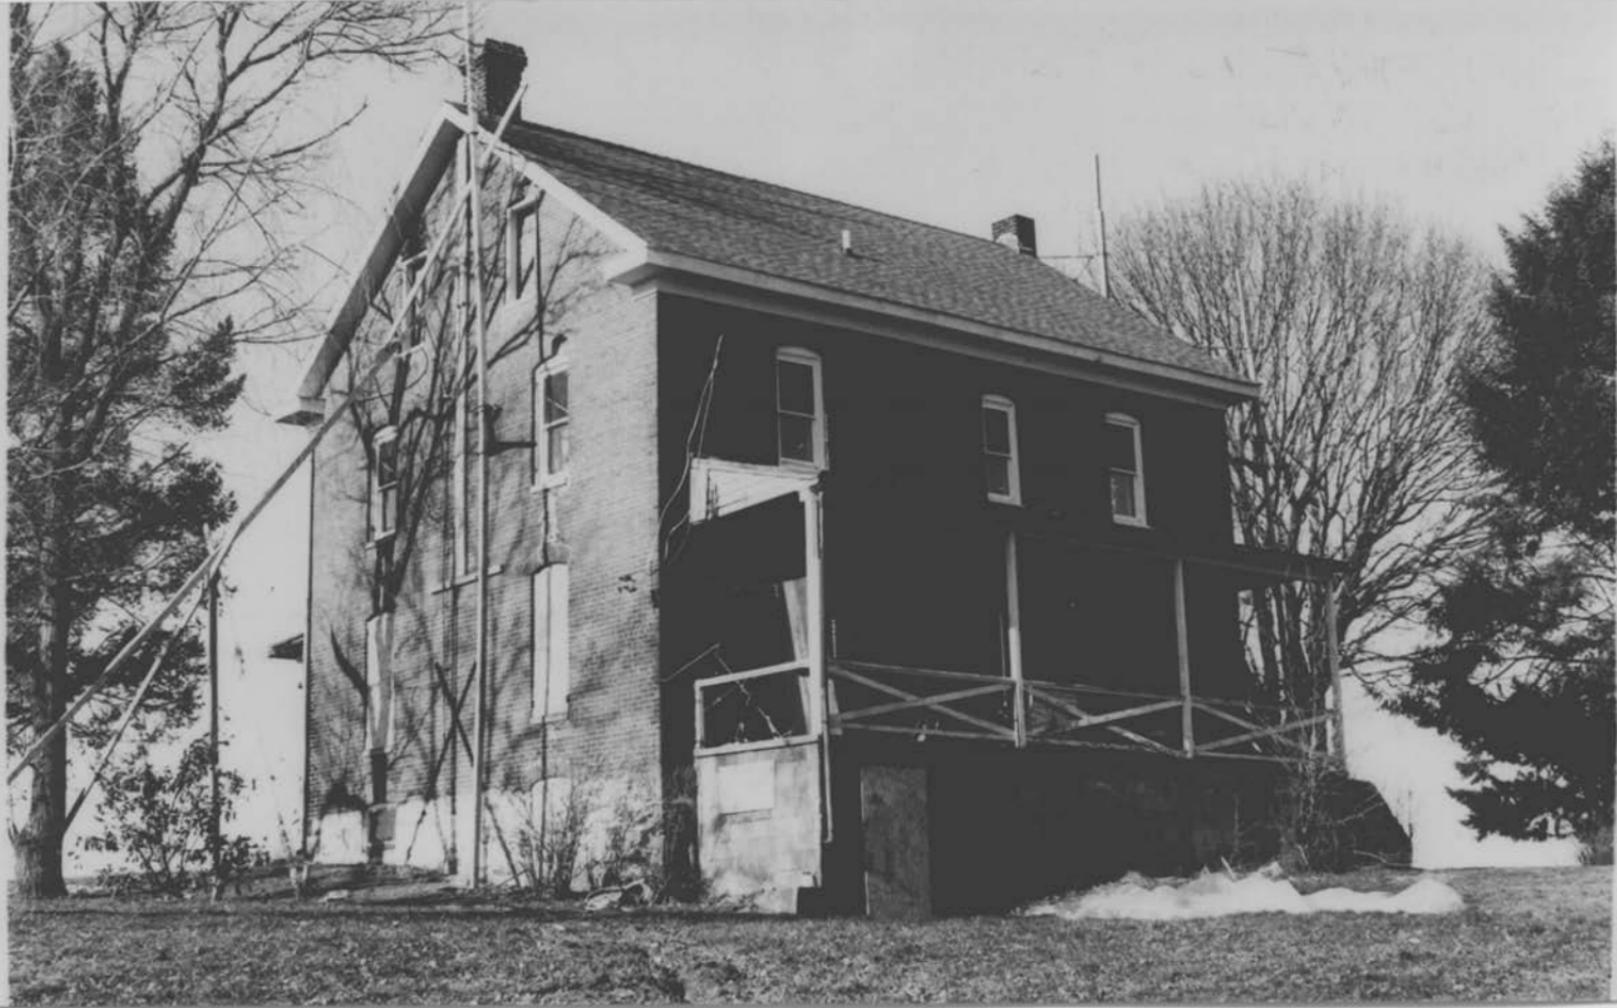
PHOTO 8 OF 28

The principal dwelling in the agricultural complex is a symmetrical three bay, two story, brick dwelling supported by a masonry foundation and terminating in a gable roof. Inspection of the building indicates a circa 1910 construction date; this date is supported by deed research. Modifications to the building, including the construction of a partial cinder block foundation and the renovation of the kitchen and bathrooms, was undertaken ca. 1960. The interior of the building was gutted by fire in 1990. This fire also destroyed the roof and the majority of the existing windows. Renovation of the building has been undertaken since the 1990 fire. This on-going work includes roof replacement, window replacement, and interior remodelling.

VIEW SOUTH OF PRINCIPAL DWELLING (A)

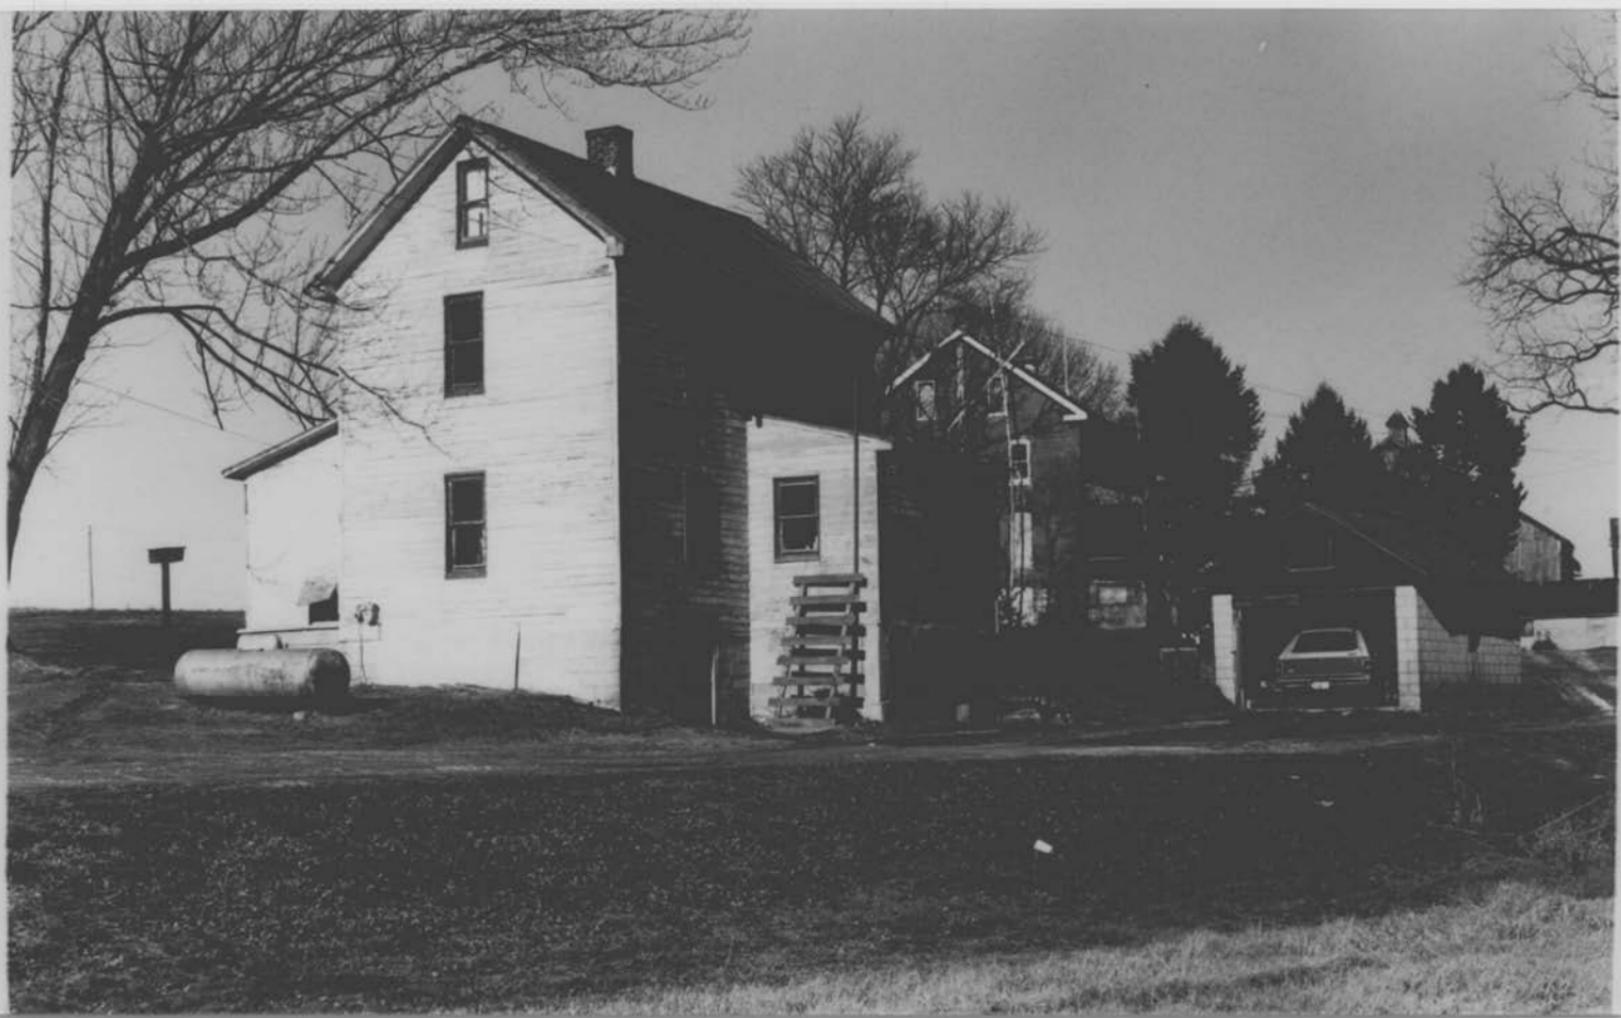
PHOTO 11 OF 28

VIEW SOUTHWEST OF TENANT HOUSE (B) AND GARAGE (K)

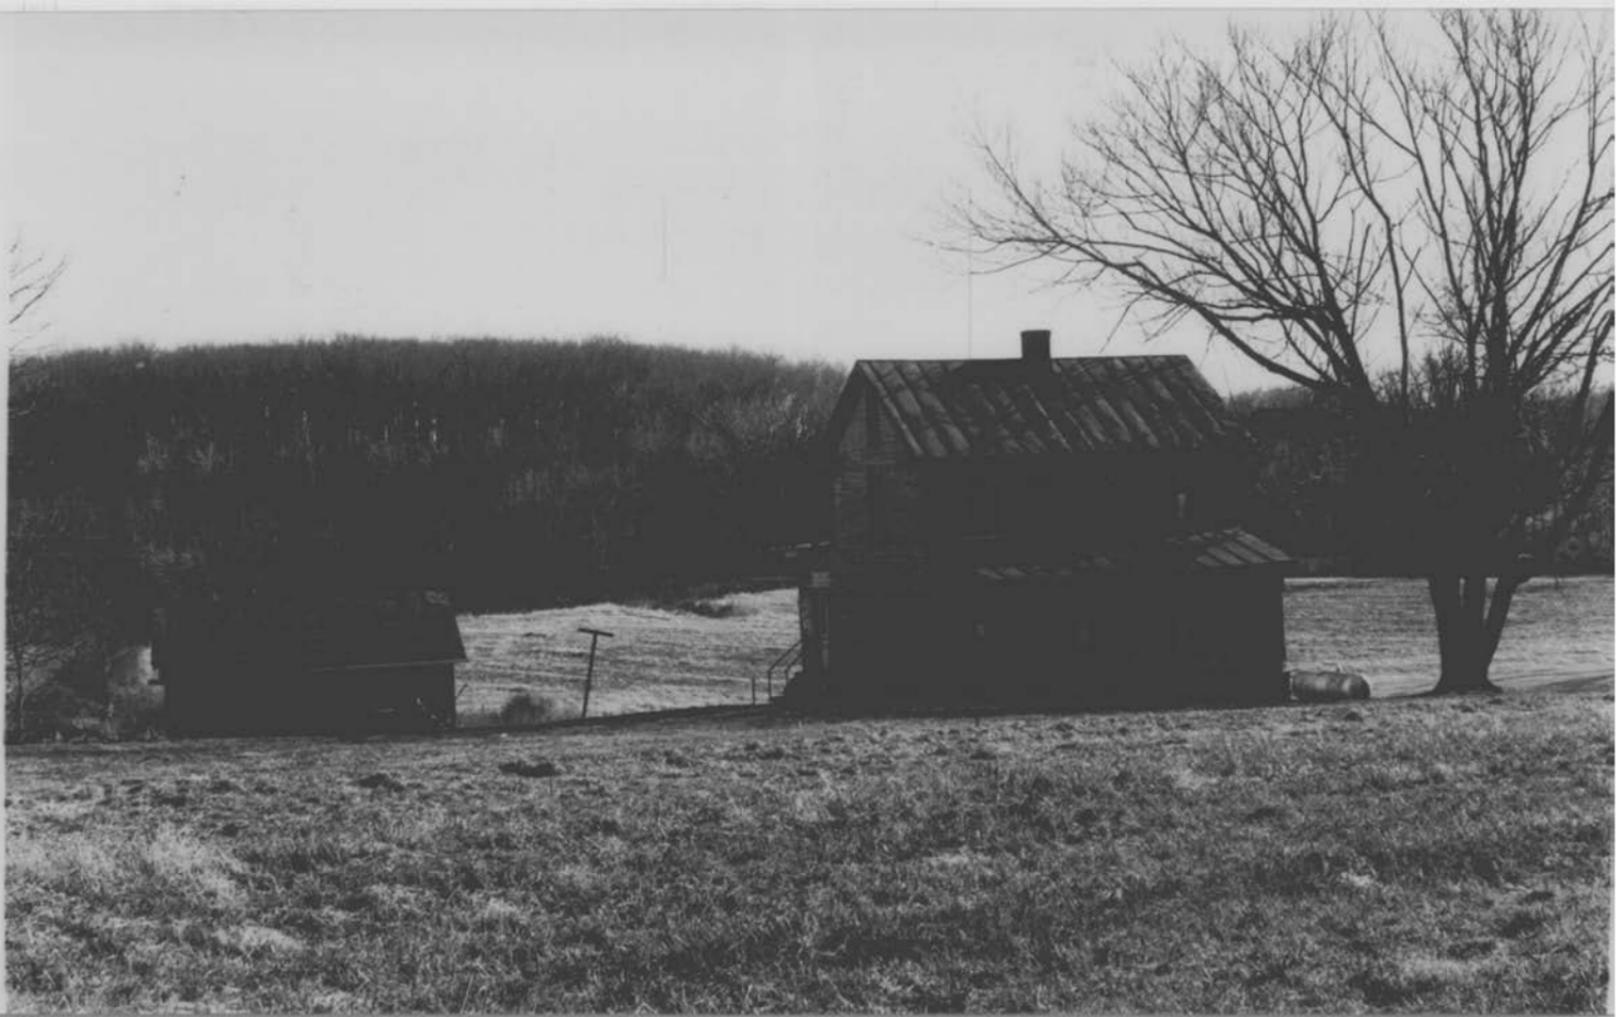
PHOTO 10 OF 28

VIEW NORTH OF GARAGE (K) AND TENANT HOUSE (B)

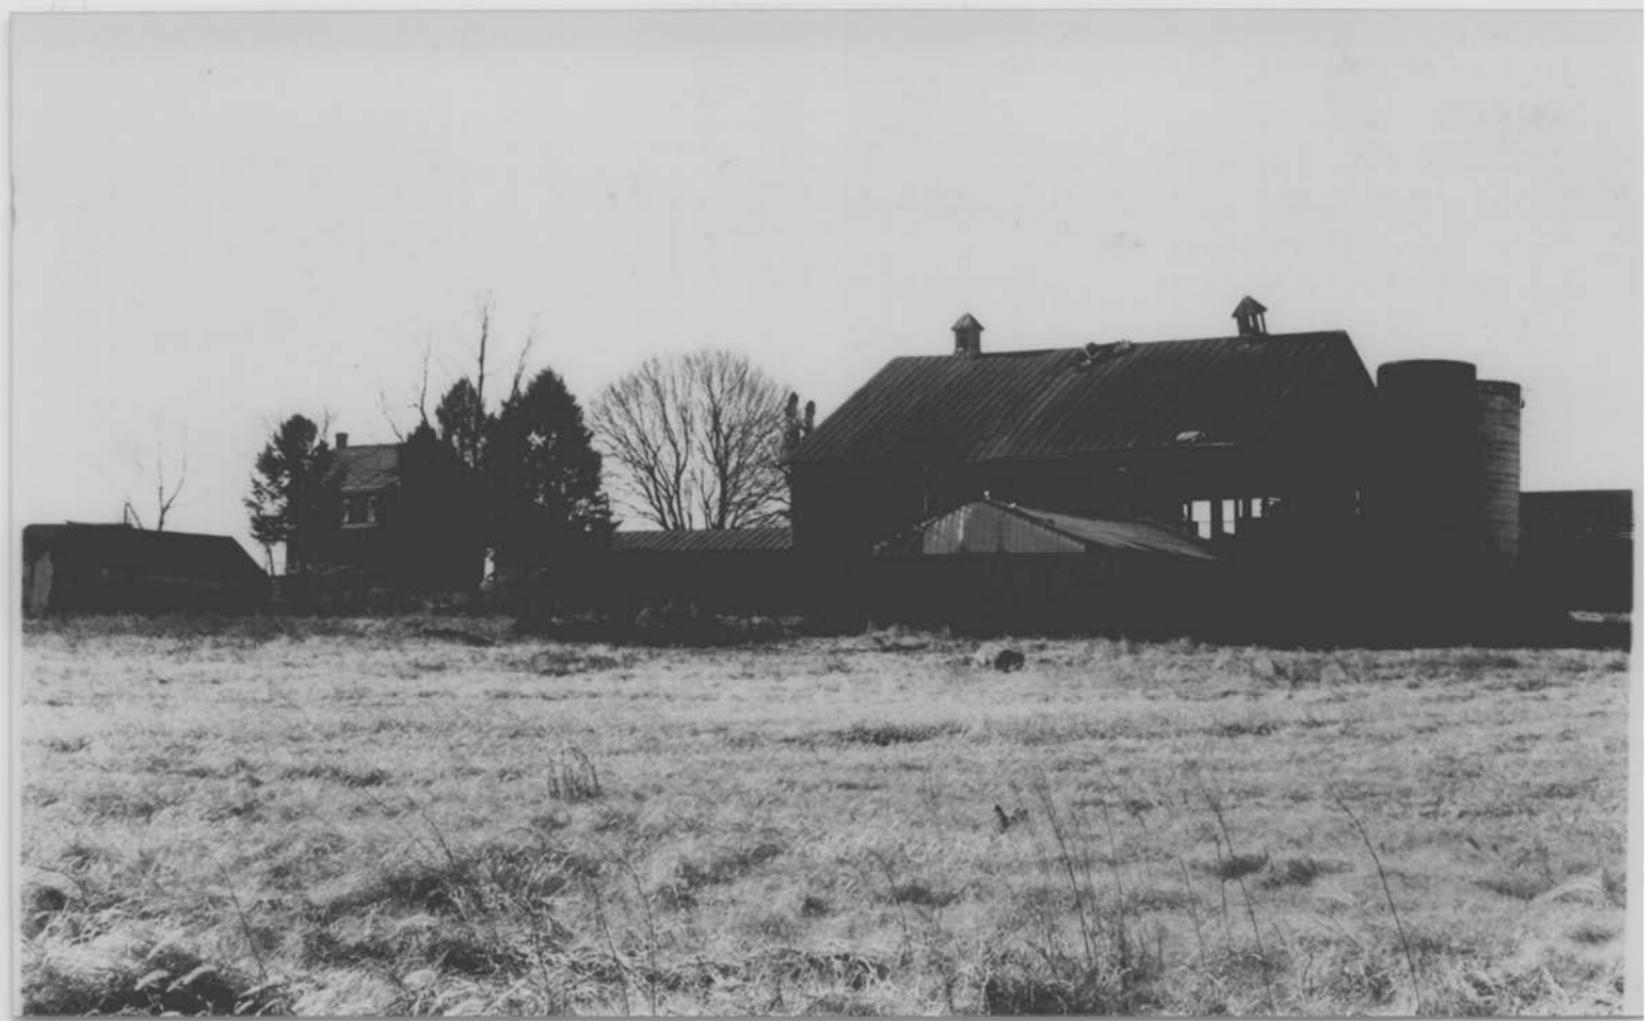
5 OF 28

VIEW SOUTHWEST LOOKING AT SHED (F). PRINCIPAL DWELLING (A),  
AND BANK BARN (C)
