CARR-1319

Cleveland Barnhart Farm
5244 Geeting Road
Union Mills

Maryland Historical Trust State Historic Sites Inventory Form

MARYLAND INVENTORY OF
HISTORIC PROPERTIES

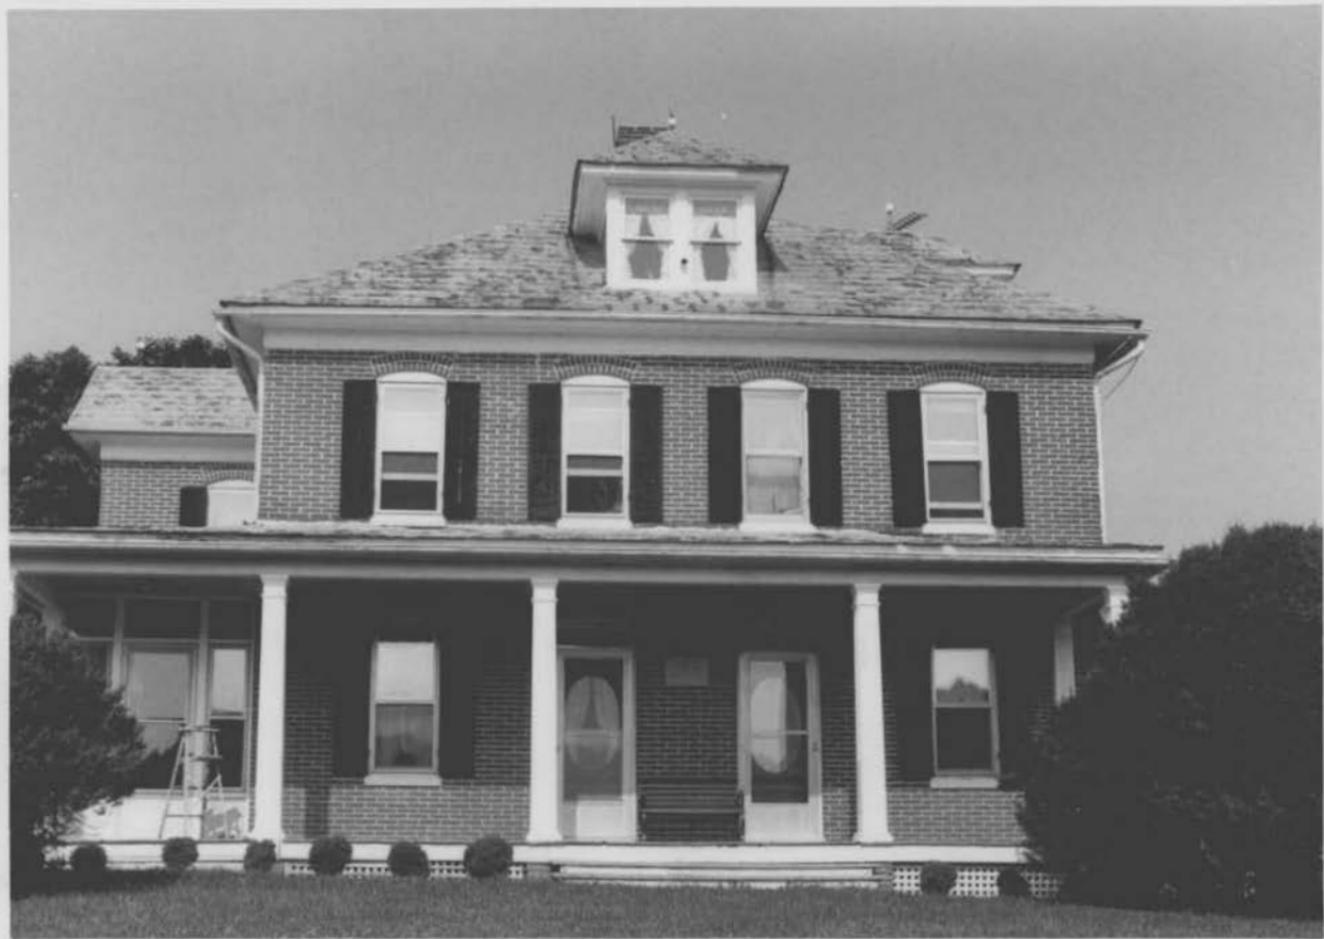
1/5

House: East elevation

The house is a 2½-story, four-bay by two-bay building that faces east. It has all-stretcher bond brick on the east elevation and 6-1 common bond brick on the remaining elevations. The house is a unique blend of "Pennsylvania Farmhouse" and Four-square features. It has 1/1 segmentally-arched windows with wood sills and blinds. There is a box cornice with a plain fascia board, a hip roof with slate, and a brick chimney at the peak of the hip. The east elevation has two center doors on the first story. Each has a large oval light above a lying panel, with a one-light transom. There is a datestone between the doors that is neatly carved with "Built by Cleveland Barnhart & Wife 1919." There is a hip-roof dormer with two 1/1 sash centered on the roof. A one-story porch wraps around the east and two-thirds of the south elevation. It has square, fluted Doric piers.

The south elevation is three bays, with a one-bay square projecting ell on the west bay. It is two stories tall, with a gable roof of slate. The gable end faces south and has a semi-circular one-light sash and decorative wood shingles with clipped corners. The center bay of the first story has a door, and the porch is glazed. The north elevation has two segmentally-arched one-light sash in the cellar and a dormer that matches the one on the east. The west elevation is four bays. The main block of the house is laid out on a traditional three-room plan, with an east-west wall dividing the house in half. The

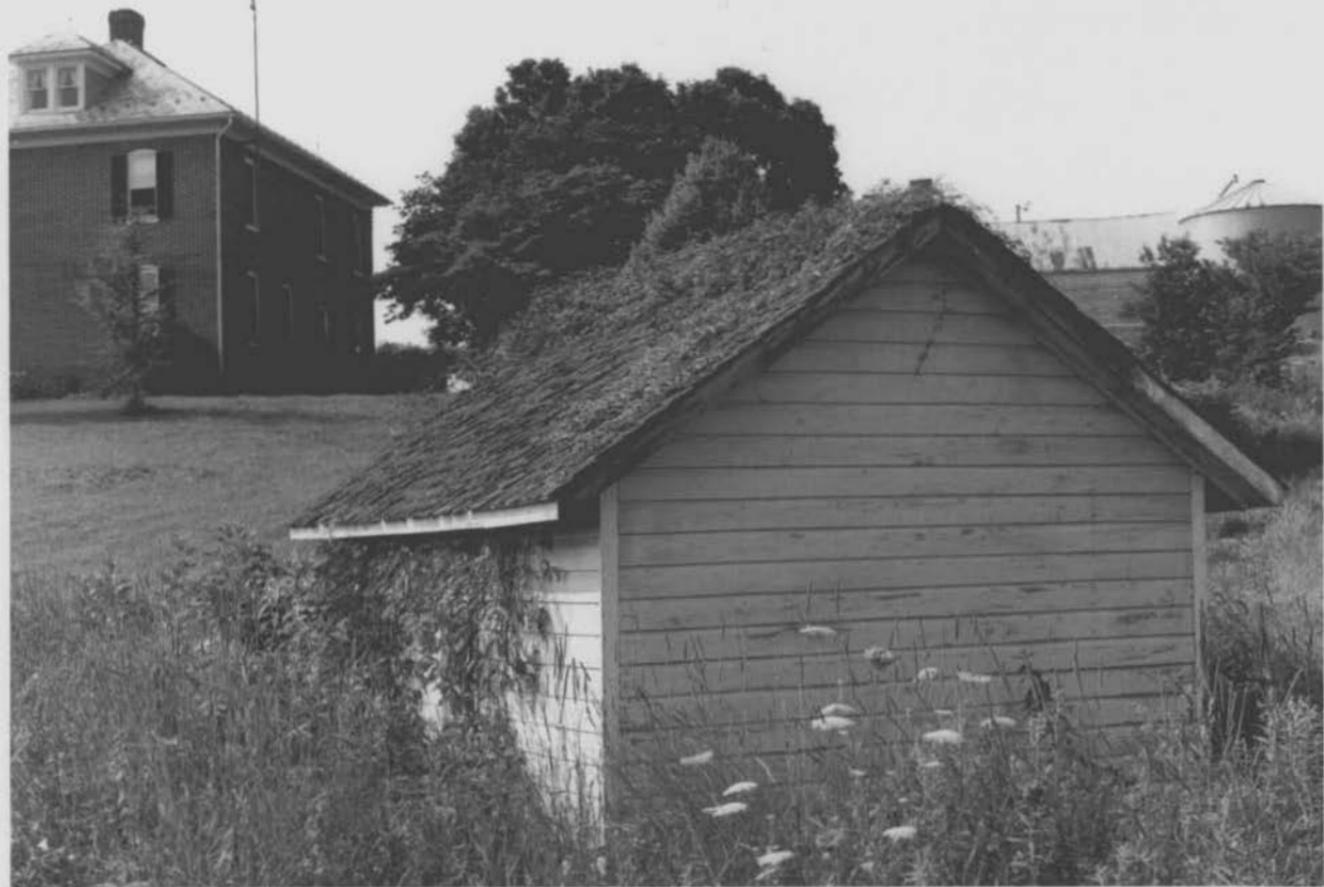
2/5

Springhouse - N.W. + N.E. elevation

The springhouse is northwest of the house, down hill from it. It has German siding with corner boards and a gable roof with wood shingles. There is a vertical board door on the southeast gable end and one 4/2 sash on both the northeast and southwest elevations.

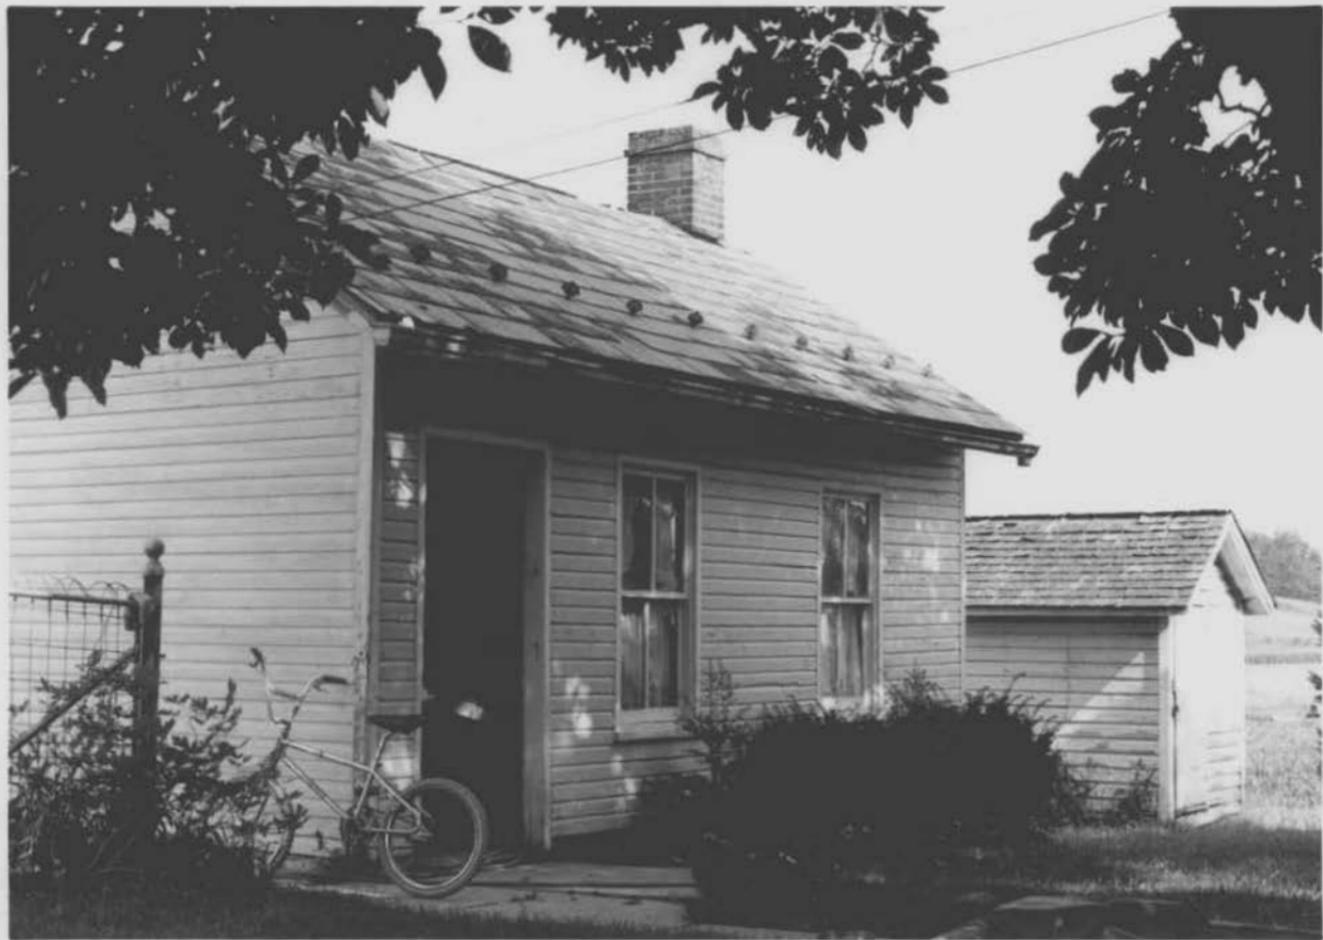
3/1

Summer Kitchen + Privy - south & east
elevations

Just west of the house is the privy, which has a concrete foundation, German siding with corner boards, and a wood-shingled gable roof. There is a beaded-edge-and-center vertical board door on the east gable end.

Just south of the privy is the summer kitchen. It, too, has a concrete foundation and German siding with corner boards. The gable roof has slate. It is three bays wide by one bay deep, with 2/2 sash. There is a door in the south bay of the east elevation. It has two panels at top and bottom, with a lying panel between. There is a small 2/2 sash in both the north and south gable ends, and a brick internal chimney on the north. The kitchen has a rectangular brick base about 18" high, with steel plate and two semi-circular-arched steel doors on the south side. There is no visible connection between this structure and the chimney above, but it could not be determined what changes may have been made to the structure.

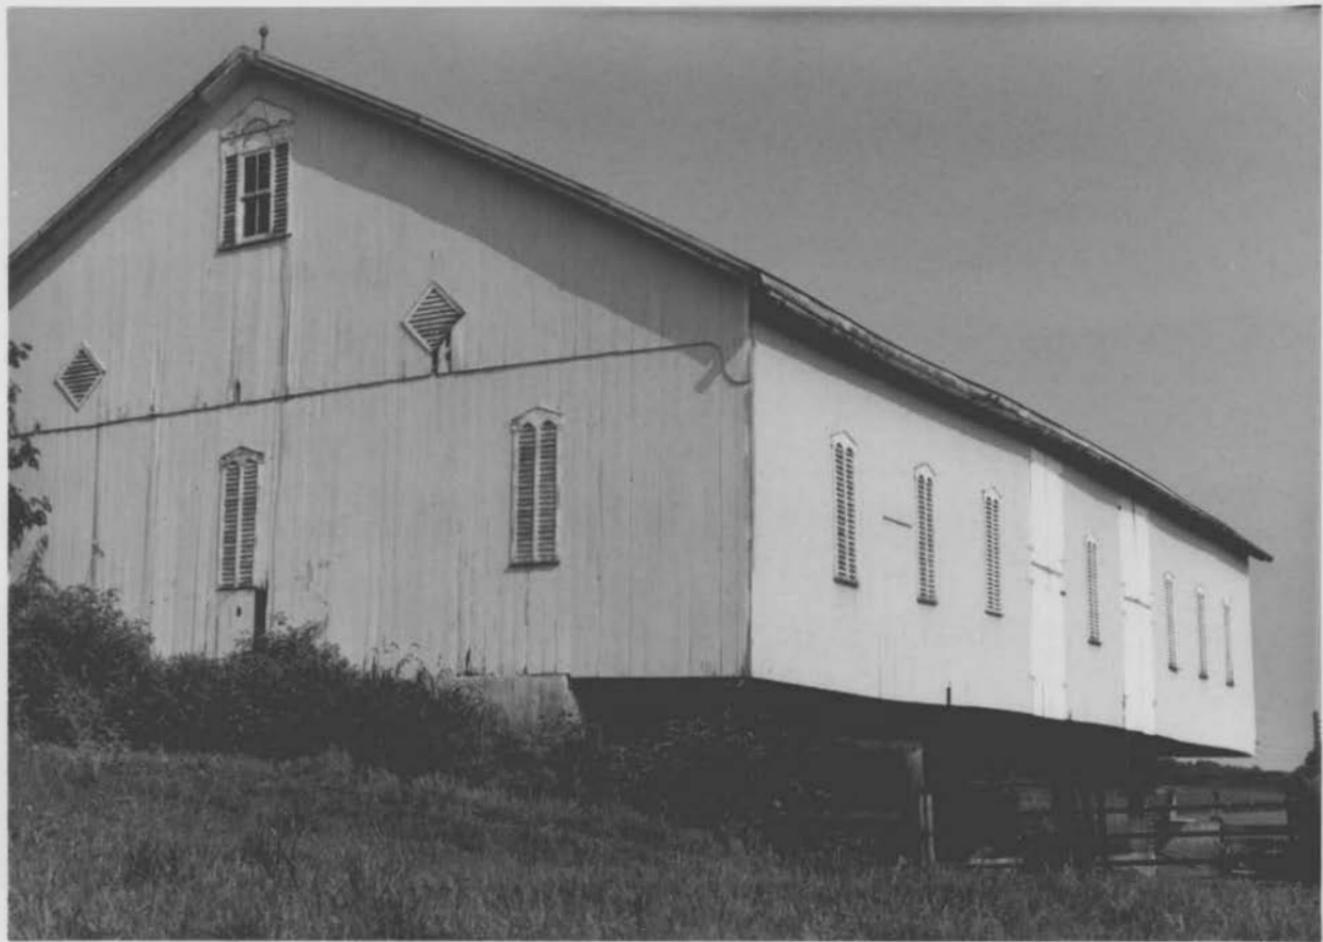
4/5

Barn - south + east elevations

Further south of these two buildings is a bank barn with forebay facing east. It was built in two stages. The lower story is of rubble stone, with horizontal, beaded-edge-and-center boards on the east, while the upper story has the same wood siding set vertically. The east elevation of the lower story has, from south to north: a missing door; a 6-light sash; a missing sash; a dutch door; double dutch doors with only one-quarter of the doors surviving; an opening in the siding; a dutch door; and another dutch door, on strap hinges. All of the doors match the vertical siding. The upper story has three vents, a pair of short double doors above a pair of taller ones, one vent, two more pair of doors, and three more vents to the north. The north elevation has two pair of 4/4 sash with concrete sills in the lower story. Above is a row of three wood louvered vents, a row of two diamond vents, and a 4/4 sash with a vent on each side in the peak. It has a gabled surround that, according to the owner, was painted "rebuilt in 1932". Though it has been painted over, the word "rebuilt" can still be read from the ground. The upper story of the south elevation matches the north, but without the painted date. The lower story was not visible due to overgrowth.

The west elevation has two vents with four-light sash below, on the north bays, two pair of double doors on rollers, and one vent to the south. The barn has five six-post, queen-post-truss bents. The four to the north are hewn and pegged, while that on the south end is sawn. The same pattern holds for the joists below. All of the rafters are 2 x 4's sawn and mitered at the ridge. They support a wood shingle gable roof now covered with corrugated metal. The interior of the upper story has a mow on the north with a granary at the west end, a threshing floor south of it, an old mow now converted to a floor, and a new mow on the south.

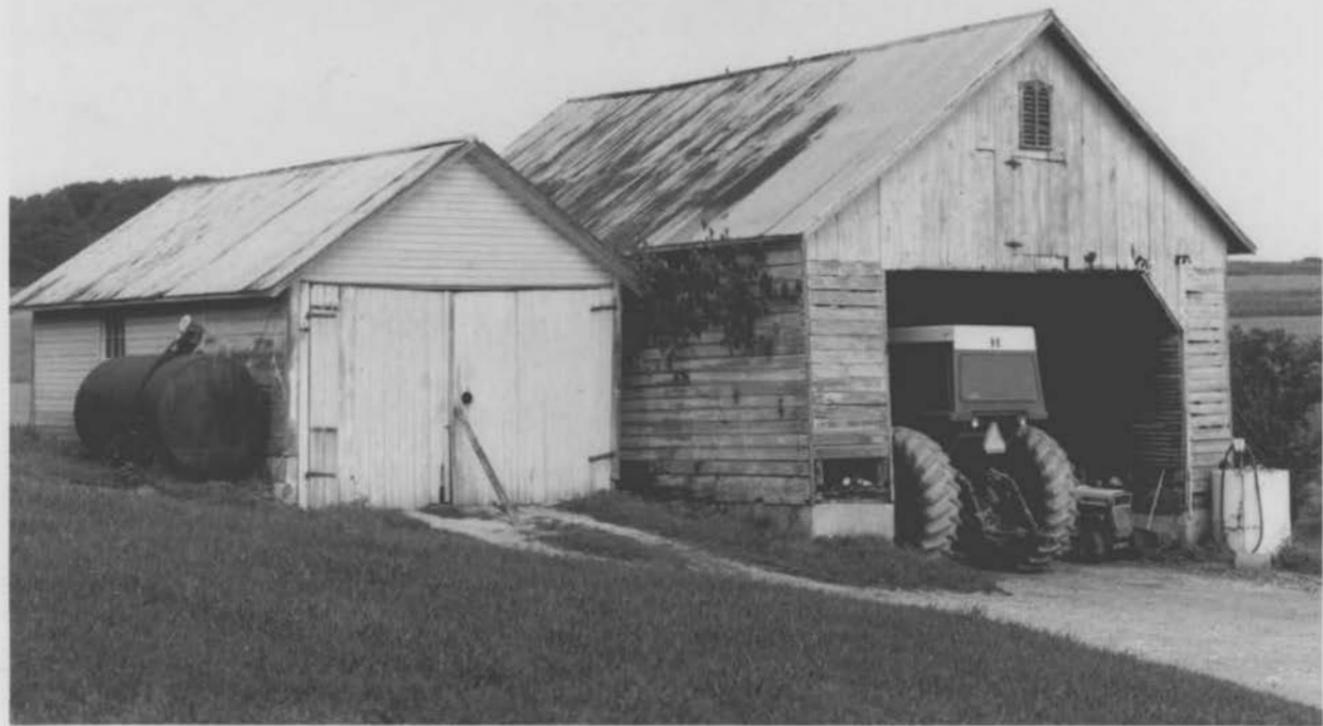
5/5

Shed + Corn Crib South - east

elevations.

South of the house is a cluster of farm buildings, including a corn crib/wagon shed with cribs on the north and south and large openings on the east and west. The cribs have horizontal boards, while the gable ends have vertical board siding and, on the east, a wood vent above a door. There is a corrugated metal gable roof. The frame is made of hewn, pegged posts with sawn members between that are approximately 3" square.

Just south of this structure is a shed with German siding and a corrugated metal gable roof. The roof was originally cantilevered on the east, but the space below has now been filled by lap siding and two beaded-edge-and-center vertical board doors on strap hinges on the east elevation. There is a 6/6 sash on the south elevation.
