CARR-1327

David Bachman Farm
4231 Wine Road

Maryland Historical Trust State Historic Sites Inventory Form

historic David Bachman Farm

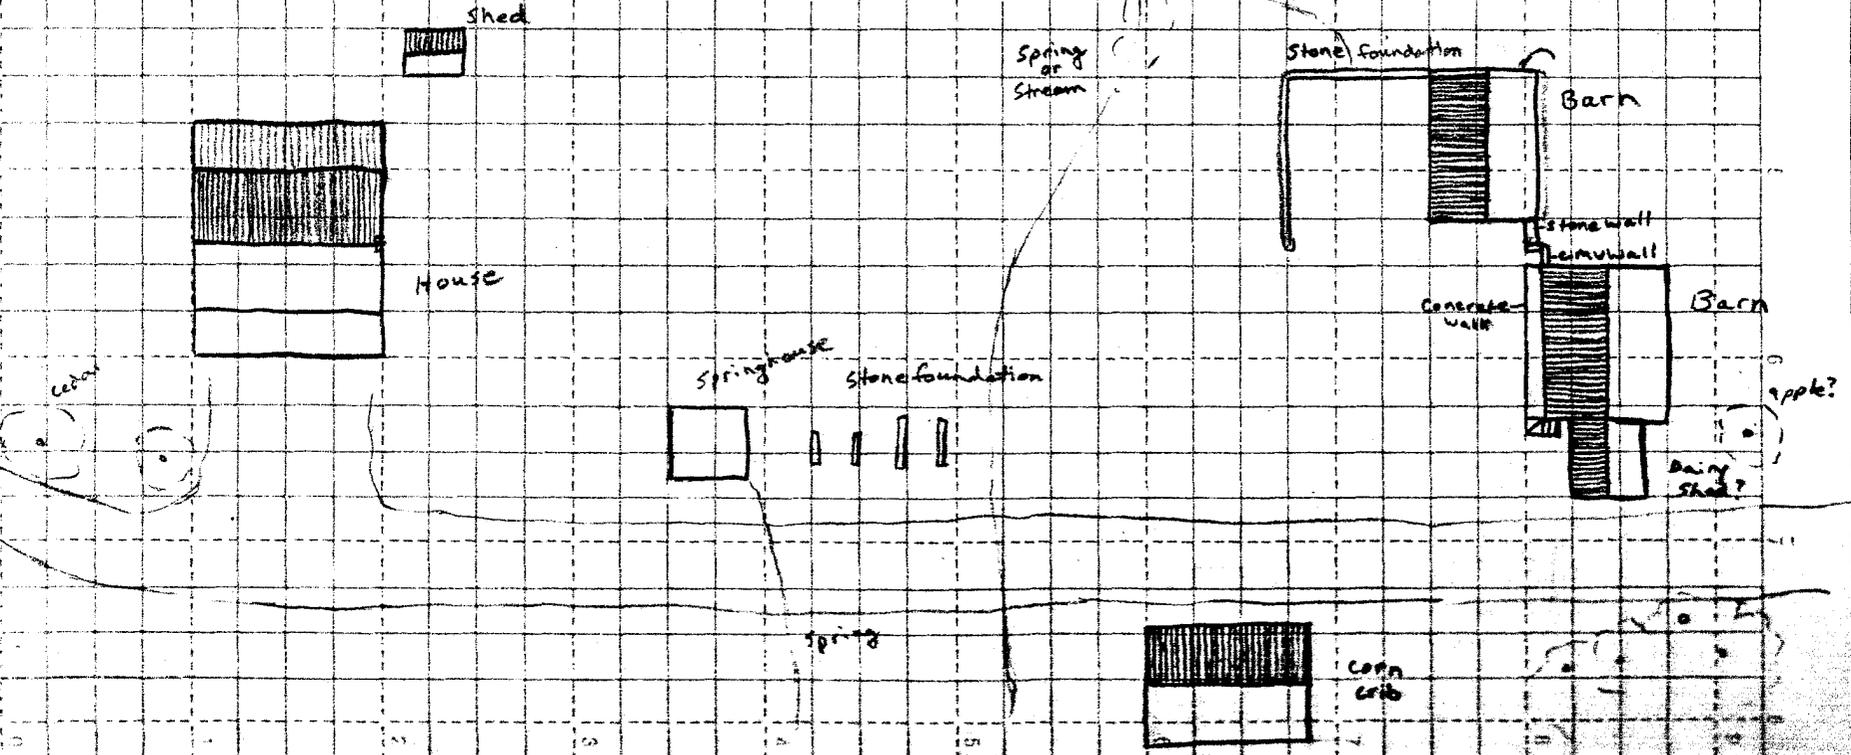
4231 Wine Rd
Site Plan

The David Bachman Farm is located at 4231 Wine Road, on the east side of the road, approximately 2½ miles northeast of Bachman's Mill and 2 miles west of Melrose. The house faces south, and sits in the middle of a long sloping hill that drops off toward the south. The complex consists of a brick farmhouse, a brick springhouse, two frame barns, a corn crib, and a laundry or shed building.

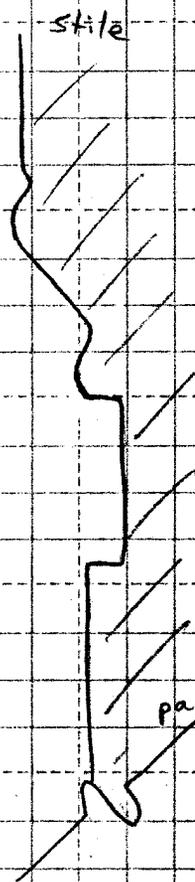
4231 Wine Rd
Moulding Profiles

Front Door Panel Mould

(heavily paint encrusted)

Front Door Surround

(lintels appear to match this)

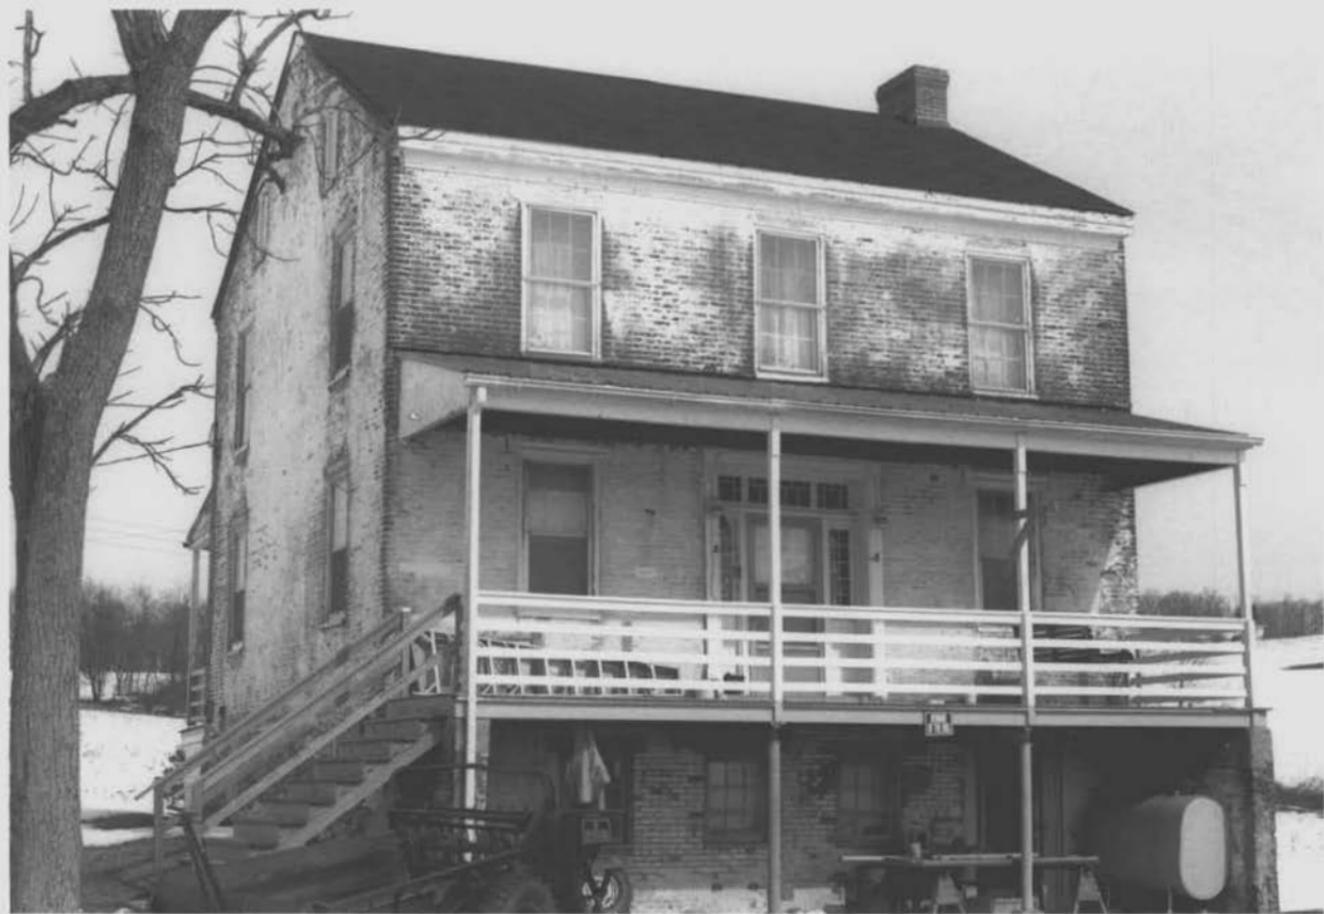
1/3

Neg. Loc.: Maryland Historical Trust
west : south elevations

The house is a two-story, banked, three-bay by two-bay structure with an exposed cellar wall on the south elevation. It has a rubble stone foundation, with 5-1 common bond brick on the exposed cellar wall of the south elevation, all-stretcher bond on the rest of the south elevation, and 5-1 common bond brick walls on the east, west and north elevations. The gable roof has asphalt shingles and a ridge running east-west. The south elevation cellar has four bays, with three 6/3 sash with wood lintels and beaded interior edge frames. The east bay has a door with six lights above a lying panel in the center, and two panels at the bottom. This door is set into an infilled opening that originally

The west elevation has two 4/2 sash in the cellar, in frames with a beaded interior edge, and with plain wood lintels. The first and second stories have two 6/6 sash with the same details as on the south. The gable end has two boarded-up openings with plain wood lintels and frames with a beaded interior edge. There are tapered rakeboards. The east elevation has two 6/6 sash in the cellar, but the north bay sash has been altered to a 1/1 now. These windows have beaded interior edges and plain wood lintels. The first and second story each have two 6/6 sash with the same details found on the south. There is also a new, small 1/1 sash on the second story, north of center. The gable end has two boarded openings identical to the west elevation.

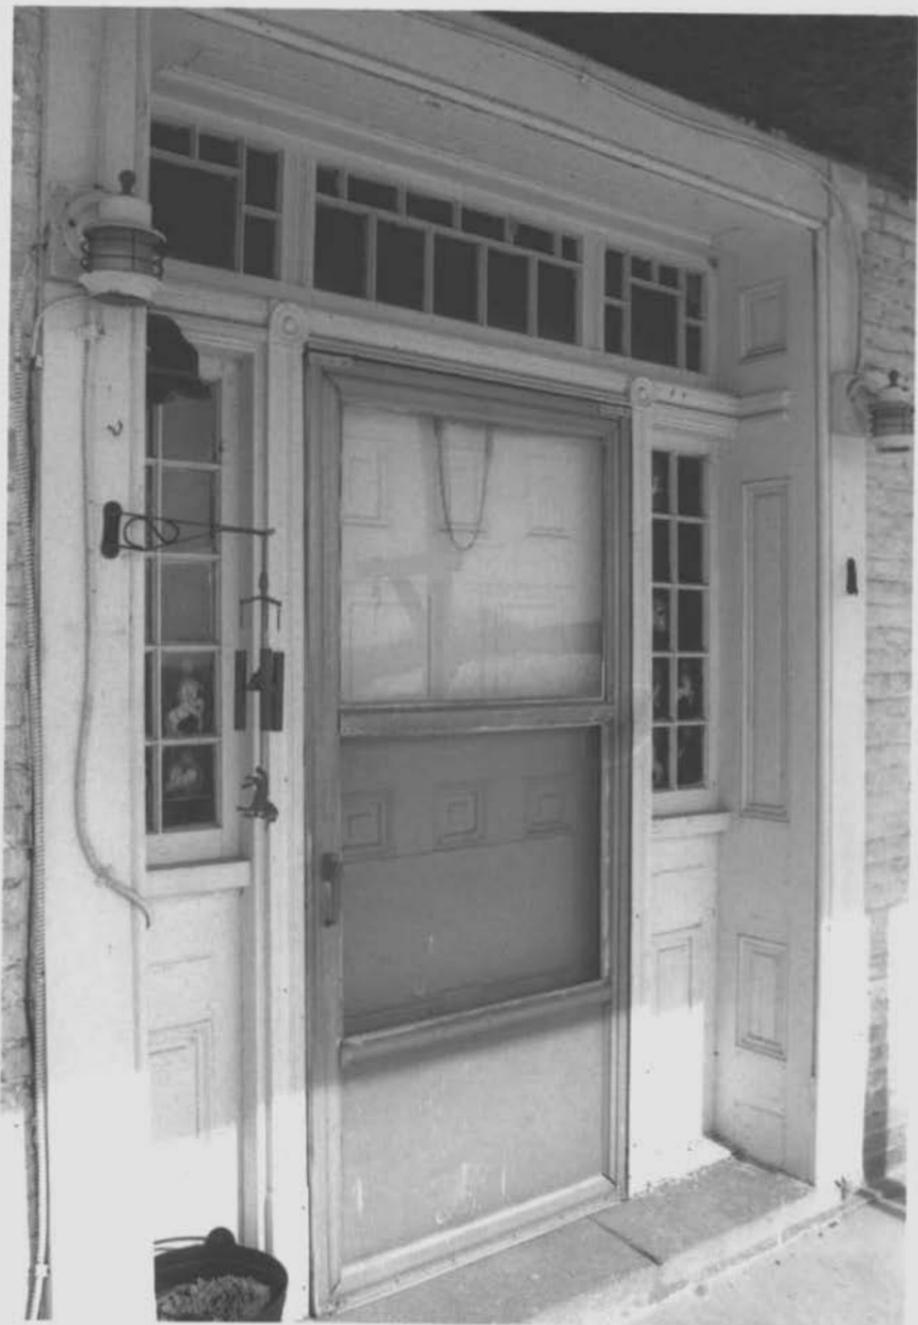
2/3

South elevation - doorway

held a very wide door. The door frame has a beaded interior edge. There is a raised one-story porch that has been rebuilt. It is supported by brick cheek walls, on either end, that are now topped by concrete. The first story has a central entrance with sidelights and transom. The door has three small panels at the top, two panels beneath it, three small square panels beneath them, then a wide rail, and two panels at the bottom. The sidelights have ten lights each, with a panel at the bottom. The transom is in three parts, with many odd-sized rectangular lights in each section. There is a panelled soffit and jambs, with ogee panel moulds, and a stone sill. There are two surrounds. Immediately around the door is a surround with an ogee moulding on either side of a sunken field, and with bulls-eye corner blocks. The entire entranceway has a plain wood surround with a beaded interior edge, and corner blocks bevelled on all four sides. On each side of the doorway is a 6/6 sash with a wood sill, wood lintel that has an ogee moulding on either side of a sunken field, bulls-eye corner blocks, and a frame with a beaded interior edge. The second story has three 6/6 sash with the same details. There is a box cornice with a fascia board underneath and a simple bed mould. There is a rebuilt interior brick chimney on the east end; it was destroyed by a tornado c.1990.

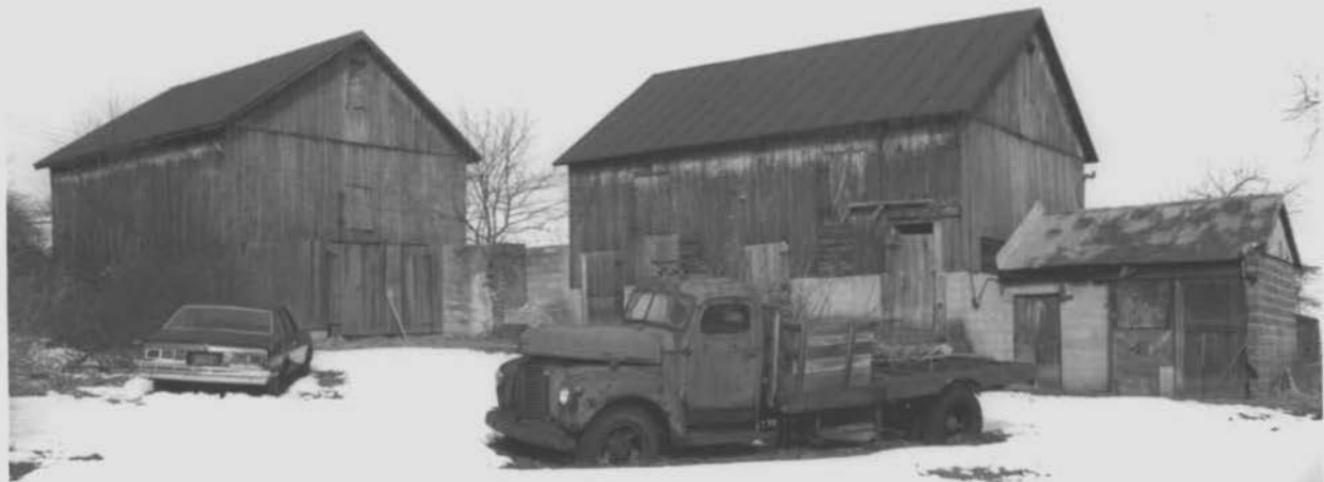
3/3

barns: dairy shed, west: south elevations.

Just northeast of the wagon shed is a frame ground barn of two stories, with a standing-seam metal gable roof. The foundation and bottom half of the first story is of CMU's. Above this is beaded-edge-and-center vertical board siding. Attached to the south side is a one-story, CMU dairy shed with a gable roof of corrugated metal. Just north of the barn is a second barn that is built partly on the stone foundation of a large, earlier barn. It, too, has beaded-edge-and-center vertical board siding and a standing-seam metal gable roof.
