CARR-1328

Joseph Harnish Tenant Farm
Taneytown (vicinity)

Maryland Historical Trust State Historic Sites Inventory Form

historic Joseph Harnish Tenant Farm

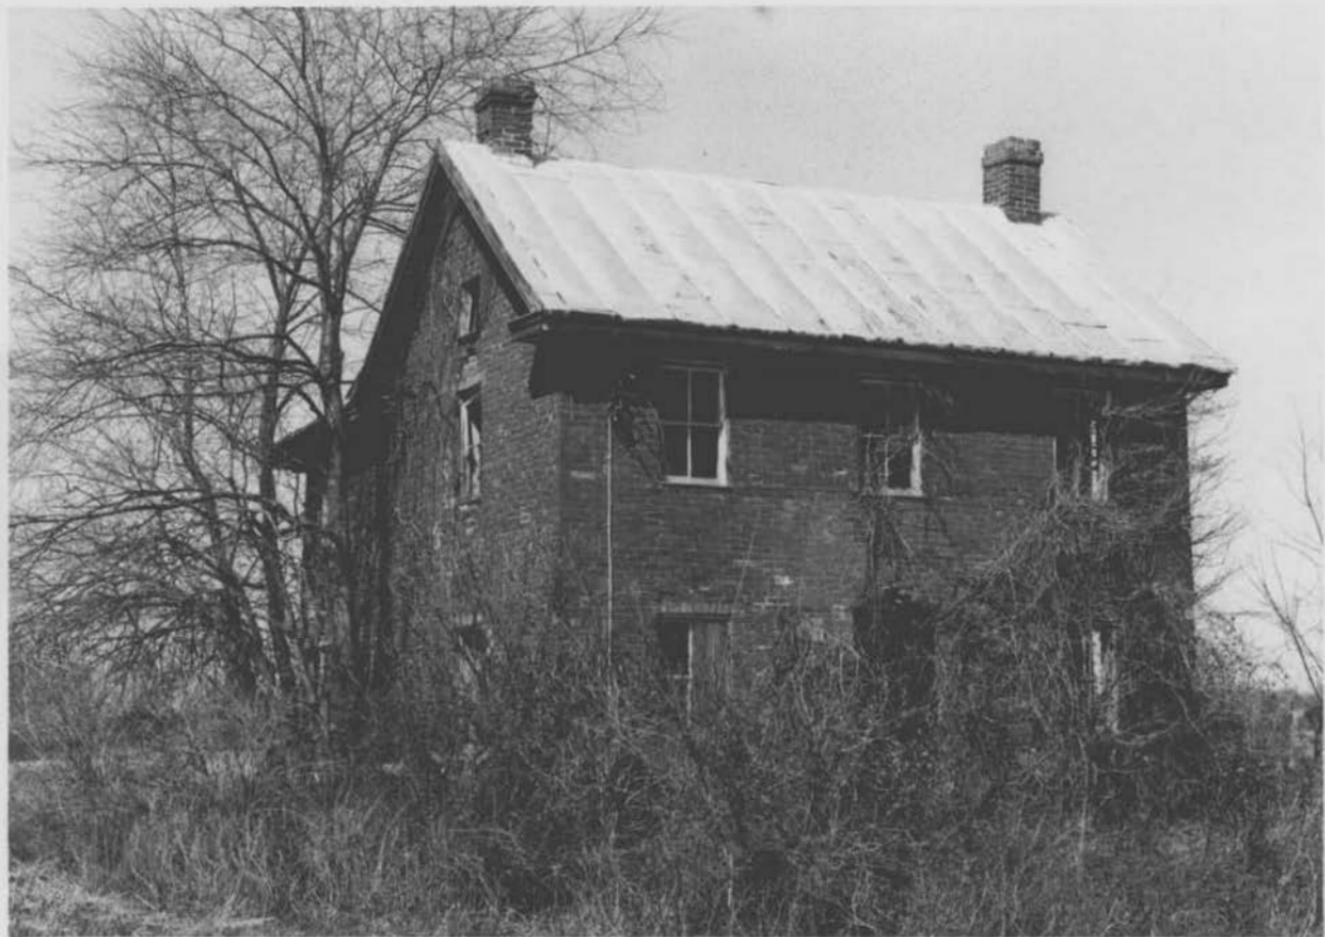
1/5

The house is a two-story, three-bay, stretcher bond, brick-cased frame, "T" plan building with a rubble stone foundation and a standing-seam metal gable roof. The box cornice has returns. The south elevation has a central entrance, but the door is missing. There is a charred, long, panelled shutter or door lying on the ground in front of the building. On either side of the entrance is a single 2/2 sash. The second story has three 2/2 sash. All the windows on this elevation have narrow wood board sills and the first story windows have rebuilt splayed brick jack arches and formerly had exterior shutters or blinds. The foundation had a vent with diamond-section wood louvers in the east and west bays. Only the east one survives. There was formerly a one-story porch across the front. The house also has an interior brick chimney with corbelled cap at each end.

Neg. Loc.: Maryland Historical Trust
west: south elevations

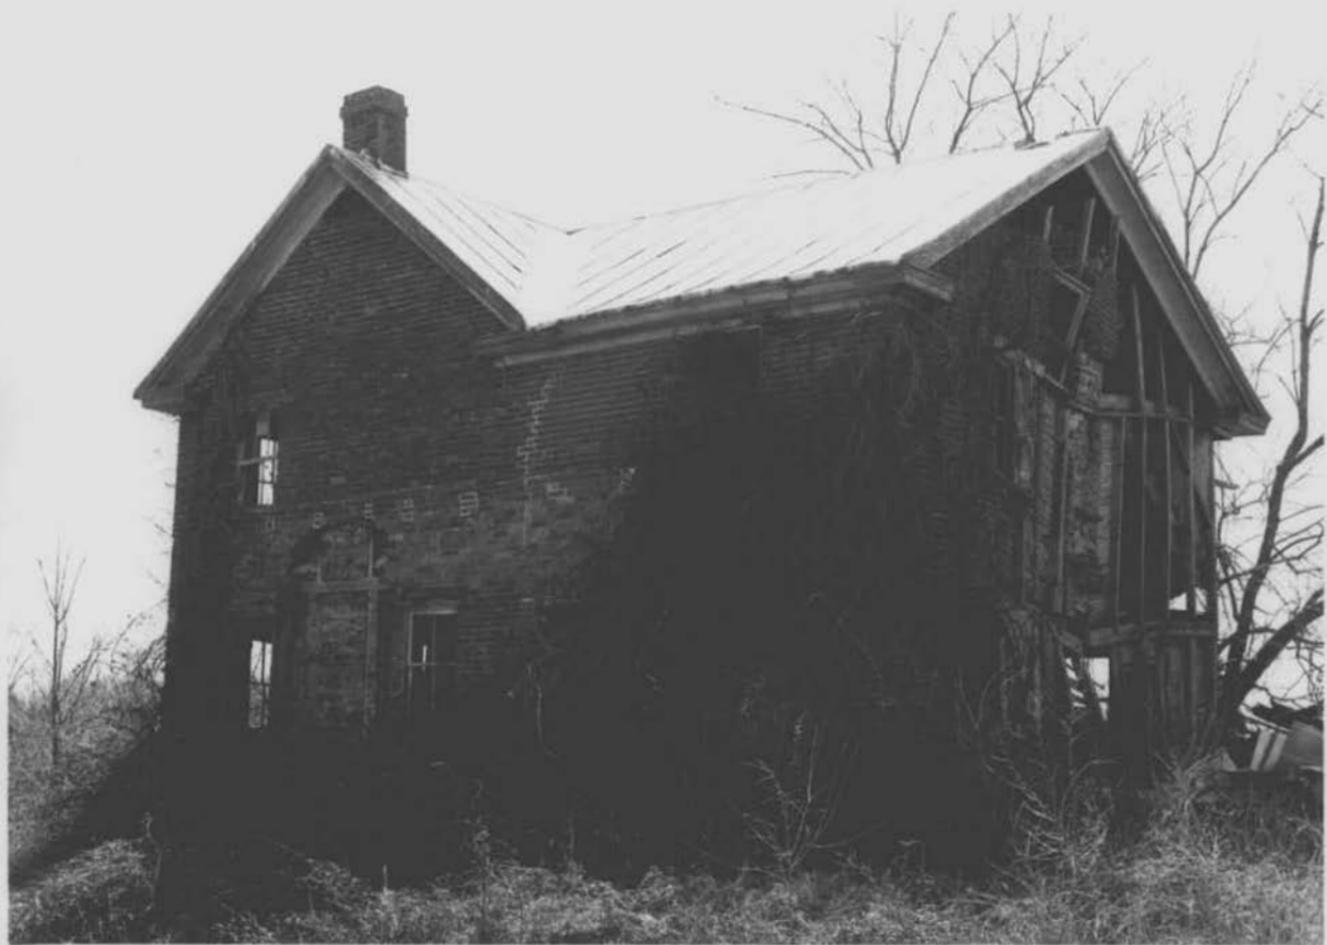
Portions of the framing of the house are exposed due to deterioration. The front sill and front girt are hewn, and the first-story joists are 3/4-round logs that run north-south. These support random-width pine floors. On the north elevation, the western half of the first story frame is hewn, with pegged mortise-and-tenon joints. Even some of the studs are pegged. The remaining studs appear to be sawn and nailed. There is sawn lath attached to them. The joists are sawn, are approximately 2x6, and are set into notches on top of the end girt. The first story flooring in the north room is about 2 1/2-inch wide pine running east-west. The rafters over the north end of the back building are sawn and are also about 2x6. They support wood lath and wood shingles, and have a ridge board that is approximately 1x6. There is also a lath nailed diagonally across the rafters to act as a wind brace. The brick veneer is tied into the chimney mass, with headers, only on the north elevation. The change in construction suggests the house was built of frame with a one-story rear ell, and the ell was later expanded into a full two-story back building, probably when the house was cased in brick.

~~east~~: north elevations

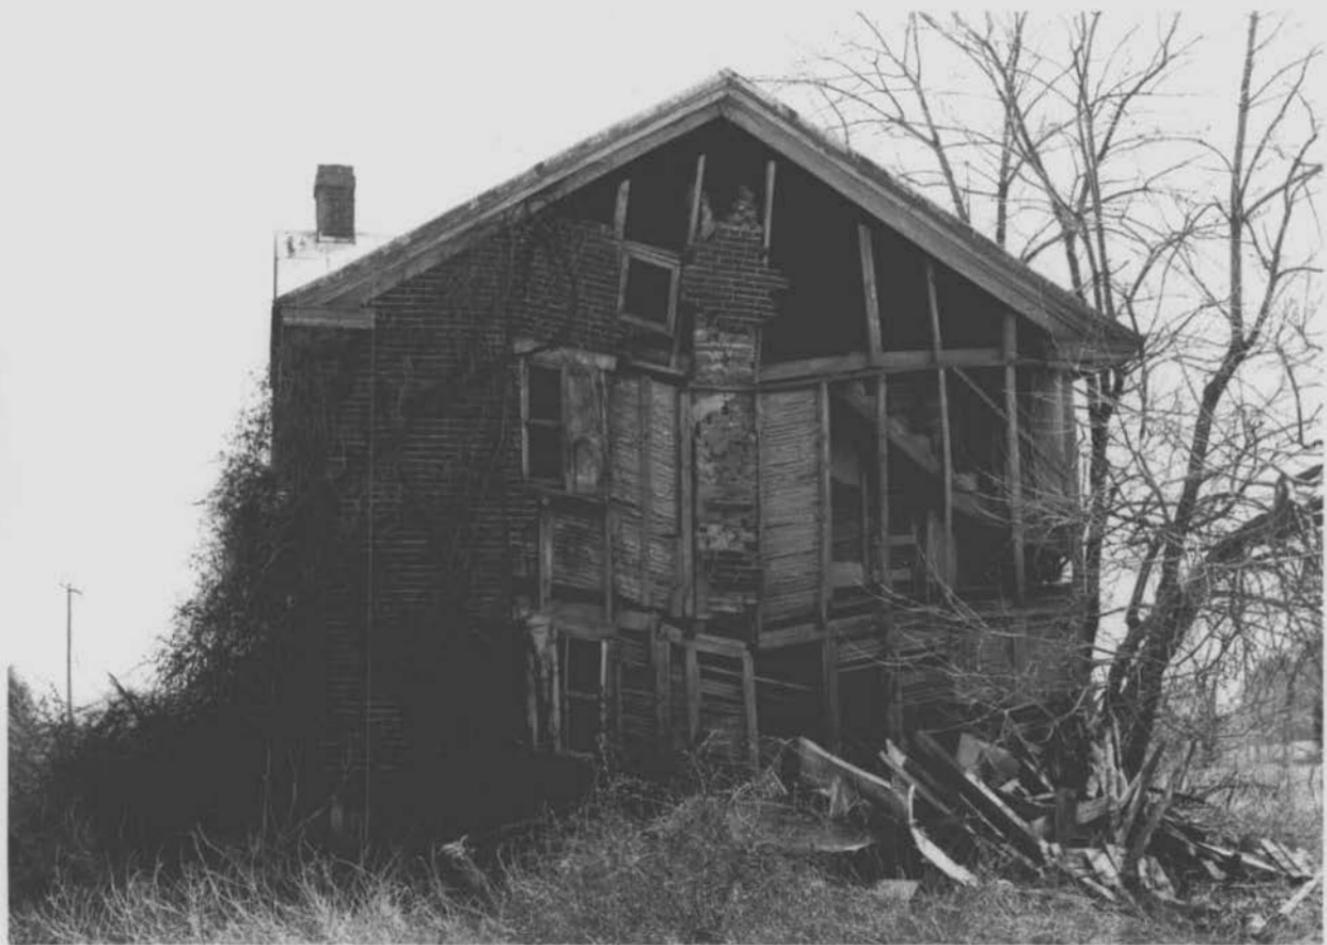
lintels and portions of paired, two panel shutters on both stories. There was formerly an interior brick chimney centered on the ridge, but it, and much of the brick veneer, have collapsed. There is a window opening just east of the chimney in the gable end. It formerly had a large wood lintel. The first story of the east elevation of the main block has a door opening in the south bay. Beneath it is a diamond-section wood louver vent. There is a 2/2 sash in the north bay of the main block, with a cellar entrance below this window. The south bay of the back building also has a door opening. The second story has a 6/2 sash in the south bay of the main block and a window covered by blinds in the north bay of the back building. There was apparently a one-story porch across the whole south elevation, but it was later removed and the holes for the rafter ends filled with brick. The lintels on the windows of this elevation are also wood.

Neg. Loc.: Maryland Historical Trust
north elevation
