CARR-1384

Foutz's Mill Farm (preferred); Centre Mills
Taneytown (vicinity)

Maryland Historical Trust State Historic Sites Inventory Form

historic Foutz's Mill Farm (preferred); Centre Mills

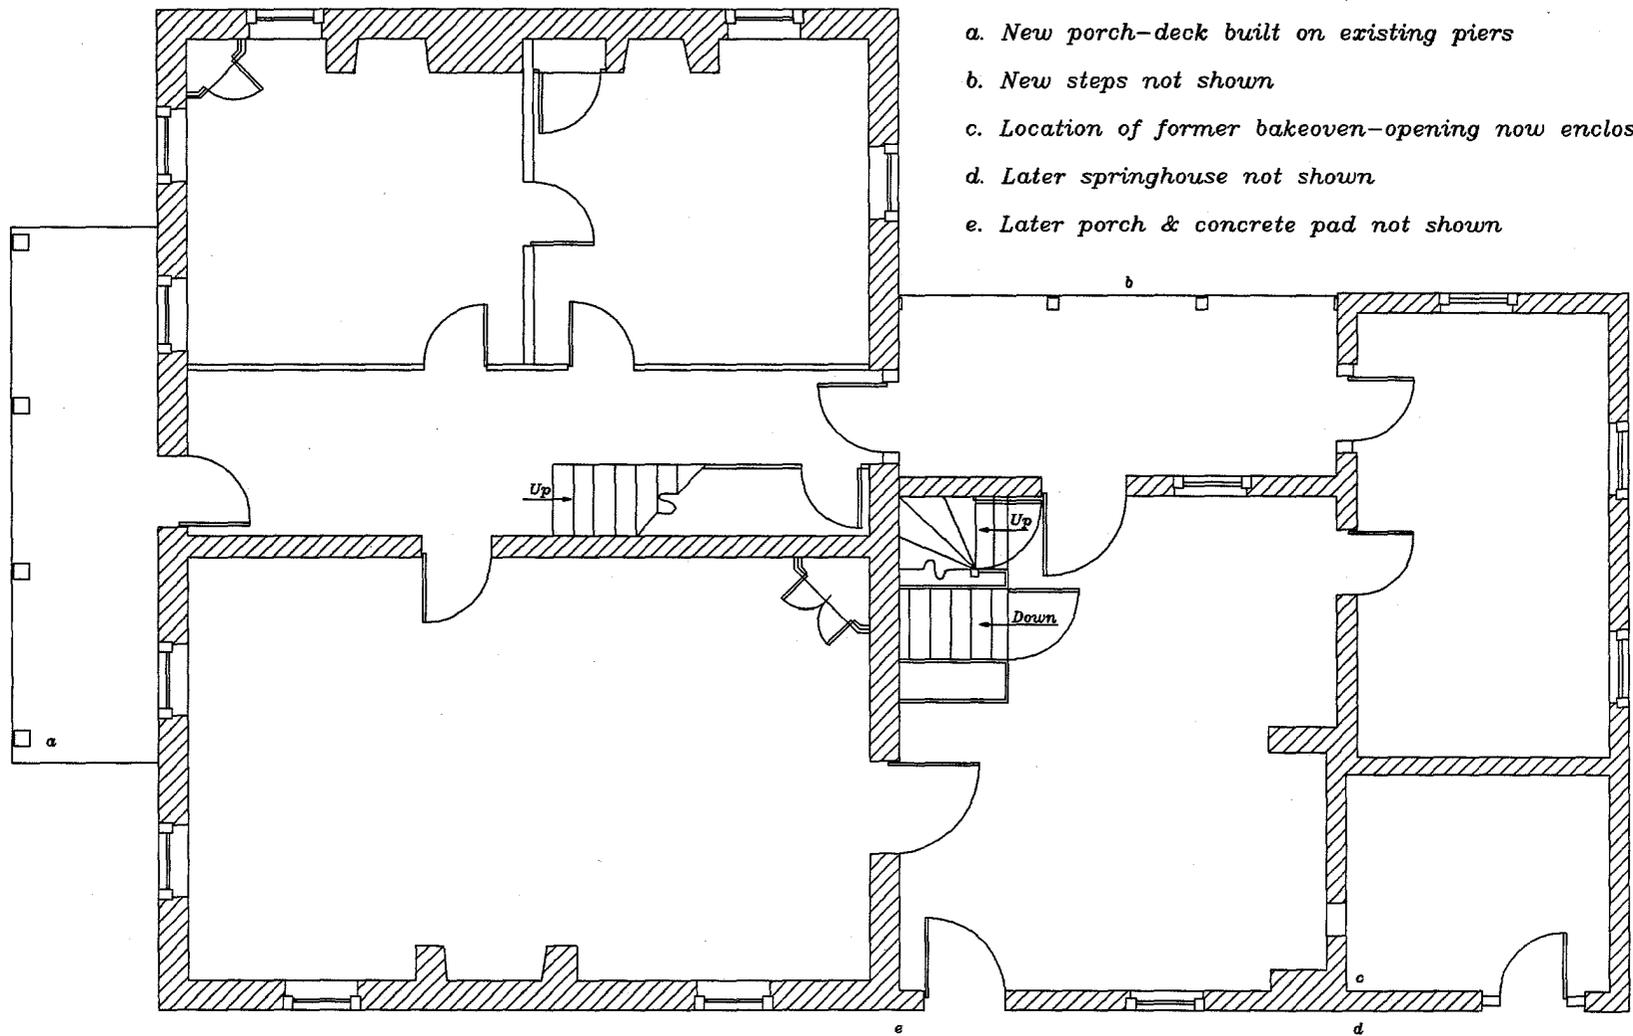
- a. New porch-deck built on existing piers
- b. New steps not shown
- c. Location of former bakeoven-opening now enclosed
- d. Later springhouse not shown
- e. Later porch & concrete pad not shown

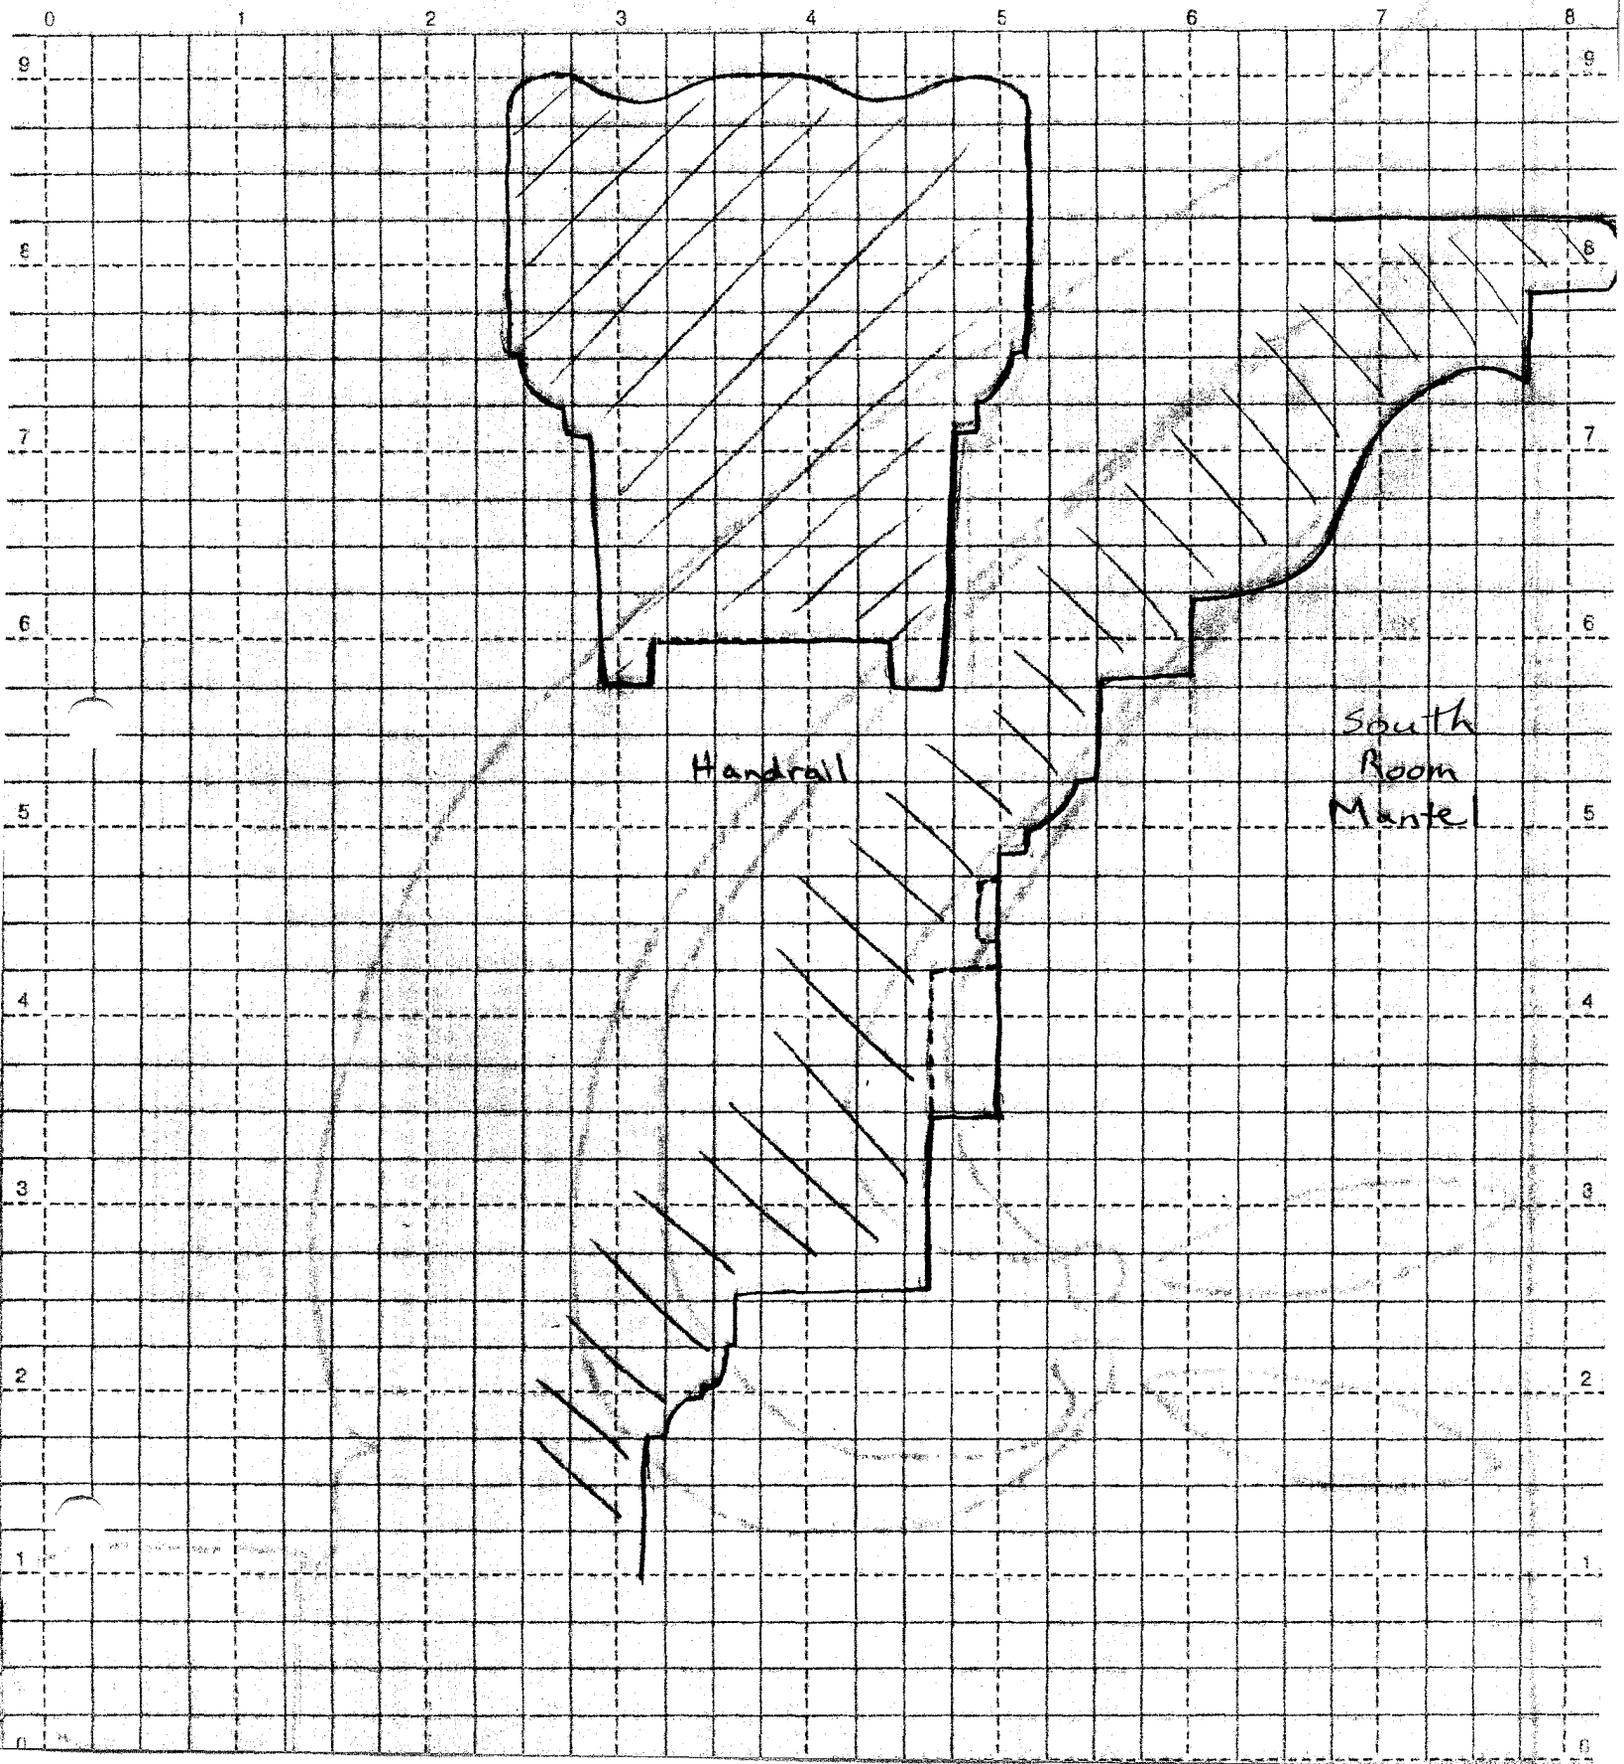
Clearview Rd.
Moulding Profiles

Handrail

South
Room
Mantel

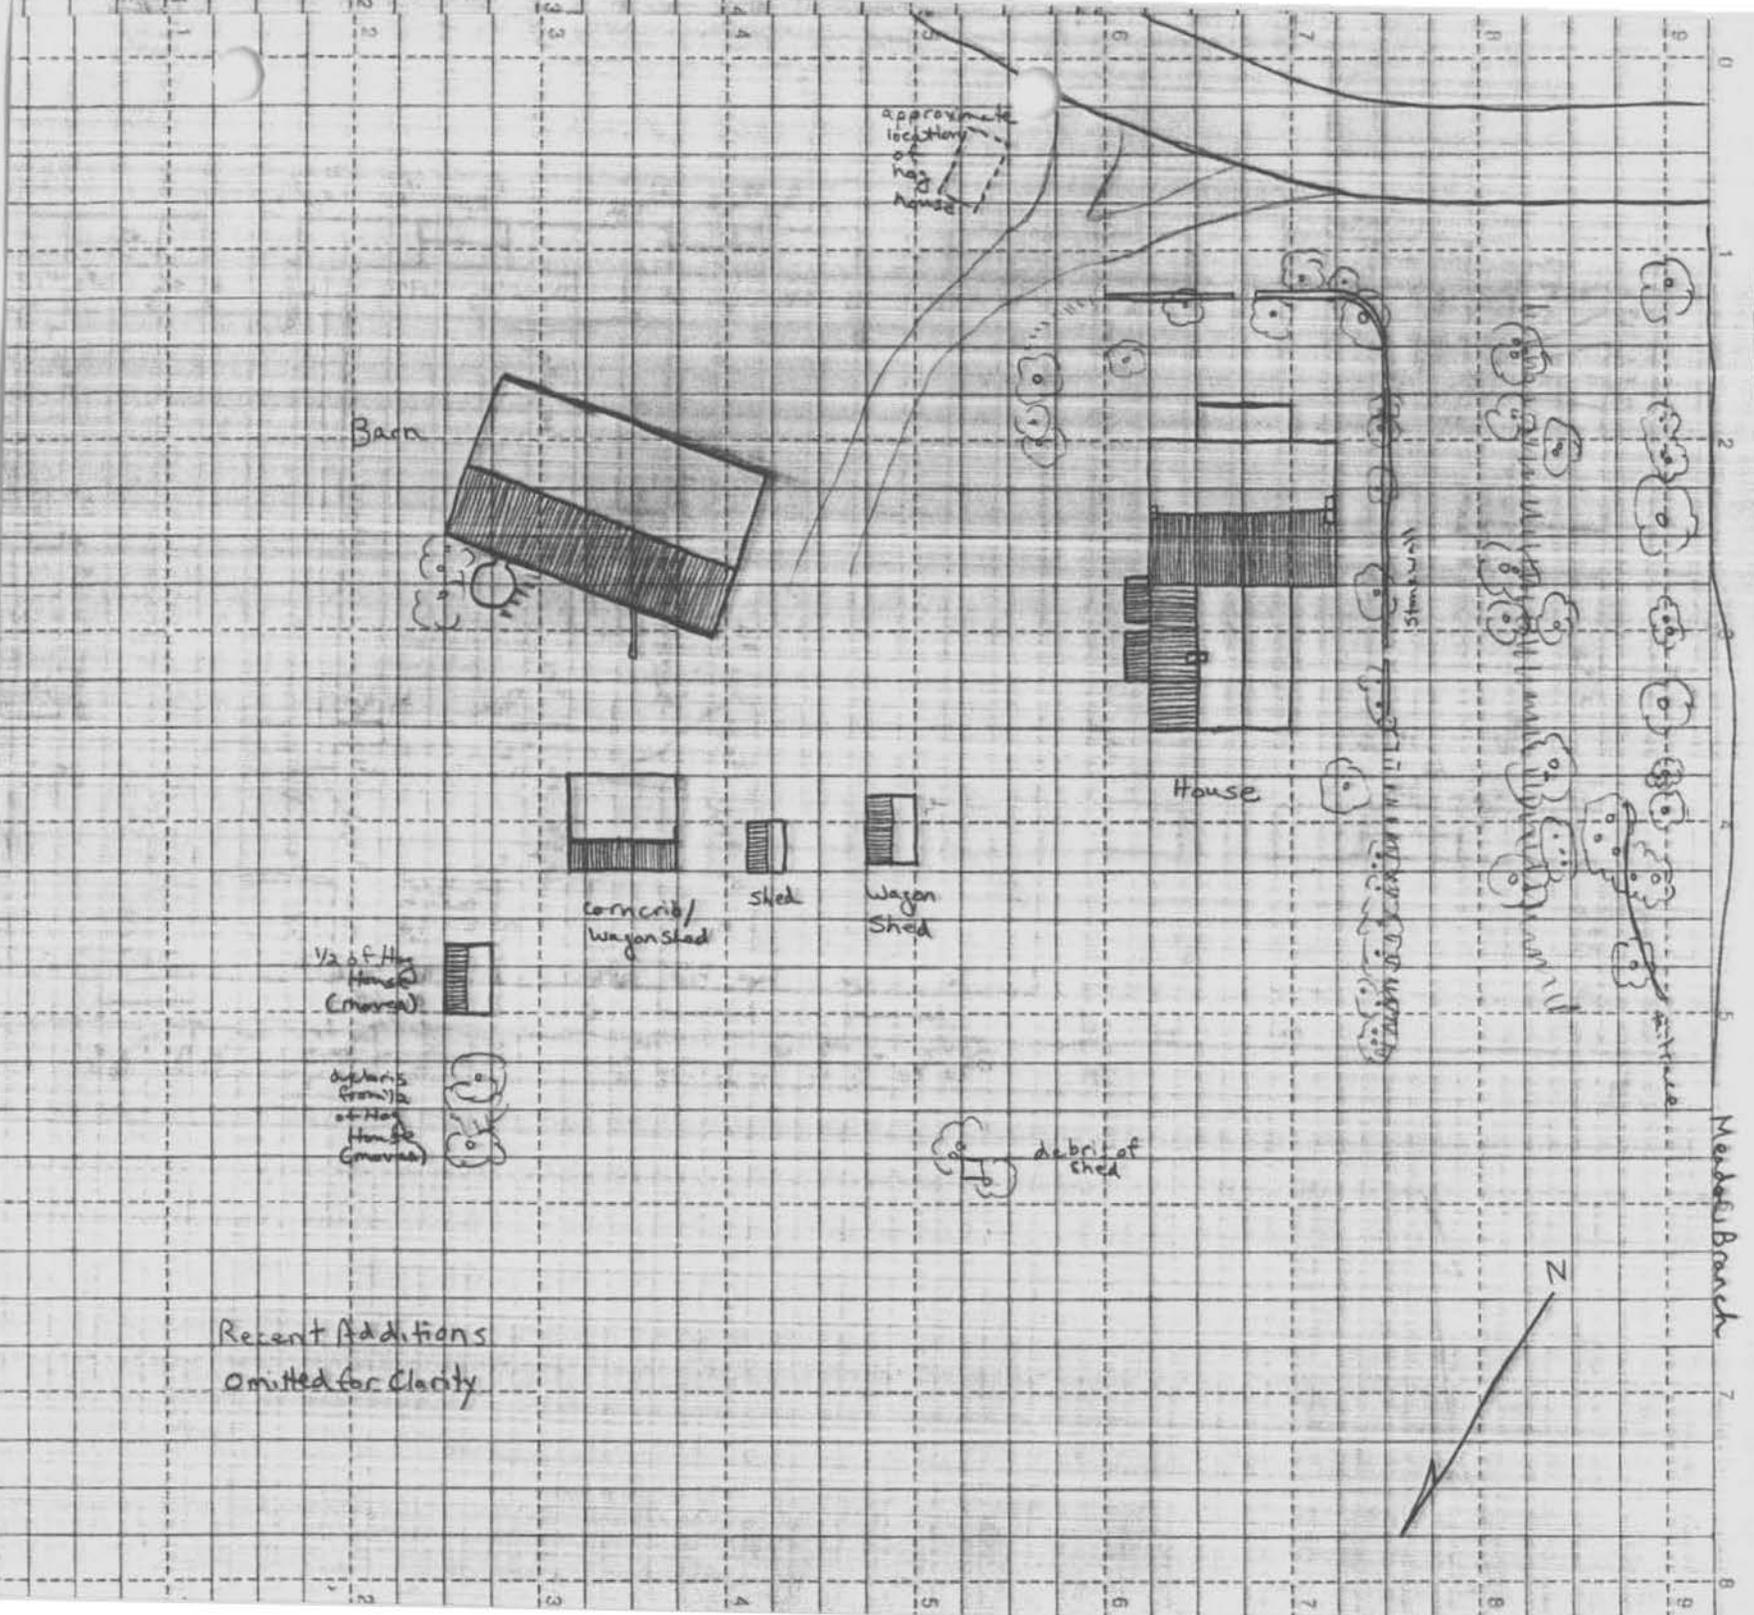
Charrivens Rd
Site Plan

Recent Additions
omitted for clarity

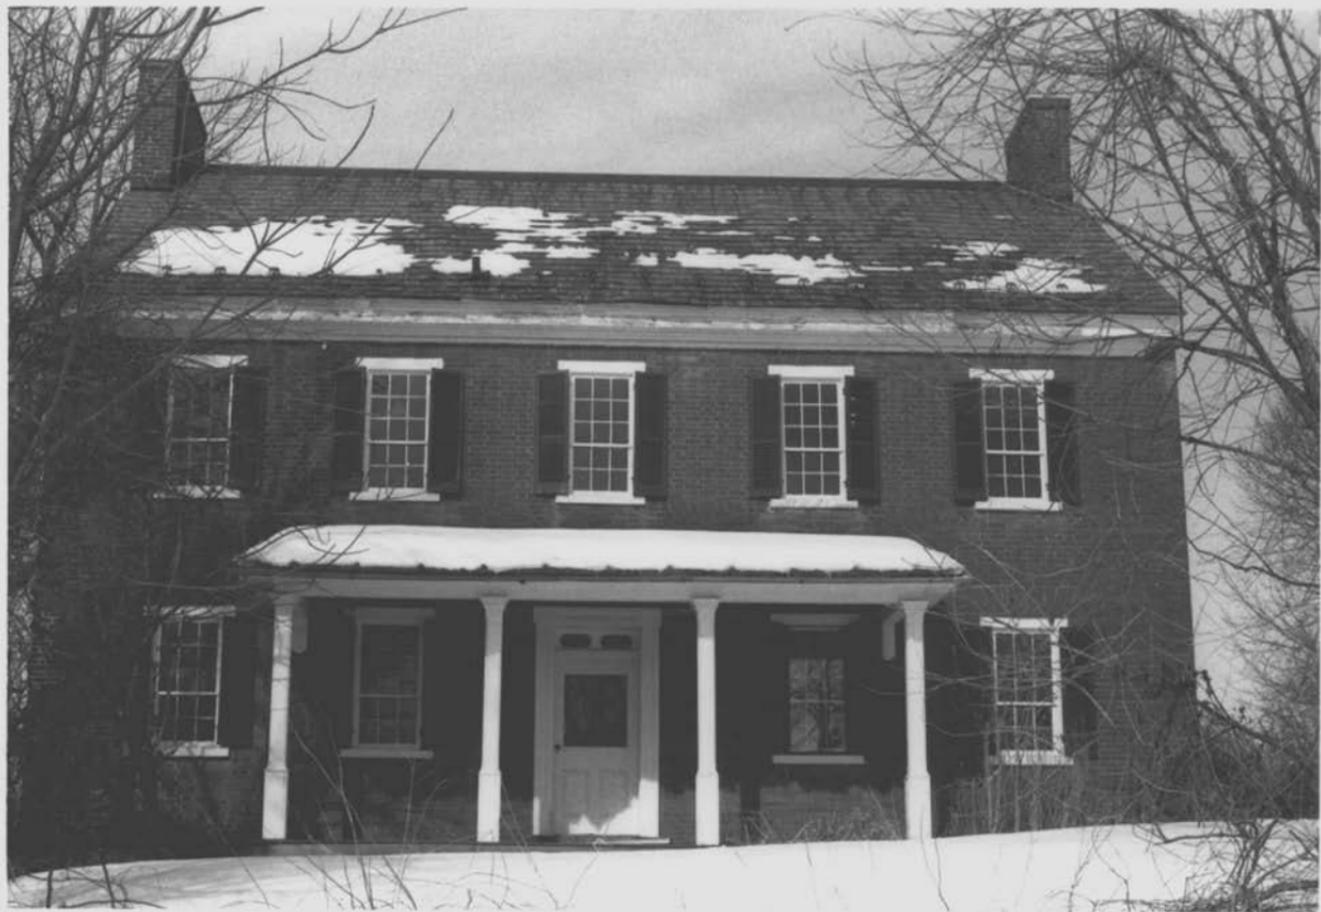
1/15

House - SE elevation

The house faces southeast and is banked on the northeast and northwest. It is a two-story, five-bay brick structure with a rubble stone foundation and a gable roof with slate and a northeast-southwest ridge that has metal roll flashing along it. There is a 1½-story brick ell on the northwest with a gable roof that has asphalt shingles and a northwest-southeast ridge. The southeast elevation has Flemish bond. The foundation has a 6/3 sash in a pegged mortise-and-tenon frame, with a wood sill and brick jack arch in the south bay. The east center bay has a brick jack arch, but the opening is hidden by the porch. The first story has a center entrance with a stone sill and a door with one light over two panels. The sunk, fielded panels have quirked ogee moulds. The head rail has a quirked Greek ogee, and there is a two-oval-light transom. The soffit, each jamb, and the pilasters and lintel of the surround each have a sunk, flat panel that is oval on the ends and has no panel moulds, but has bevelled inner edges. The door is flanked on each side by two 9/6 double-hung sash with wood sills and splayed brick jack arches. The frames are trimmed out with boards that are mitered at the corners and have beaded-interior edges. There are adjustable louvered blinds on most of the windows, or at least the hardware for blinds. There is a one-story, three-bay porch with a new deck and a standing-seam-metal shed roof. The square chamfered posts have quirked Greek ogee capitals that match the headrail of the door. The railings are now missing. There is evidence in the paint ghosts and brick infill that the original porch was one bay with railings along the sides. There also appear to be the remains of brick footings for the porch at this location. The second story has five identical 9/6 sash. The box cornice has a complex bed mould with an ogee at the bottom, a cavetto above it, and an ovolo at the top. The cornice has two ogees. There is an interior brick chimney on each end.

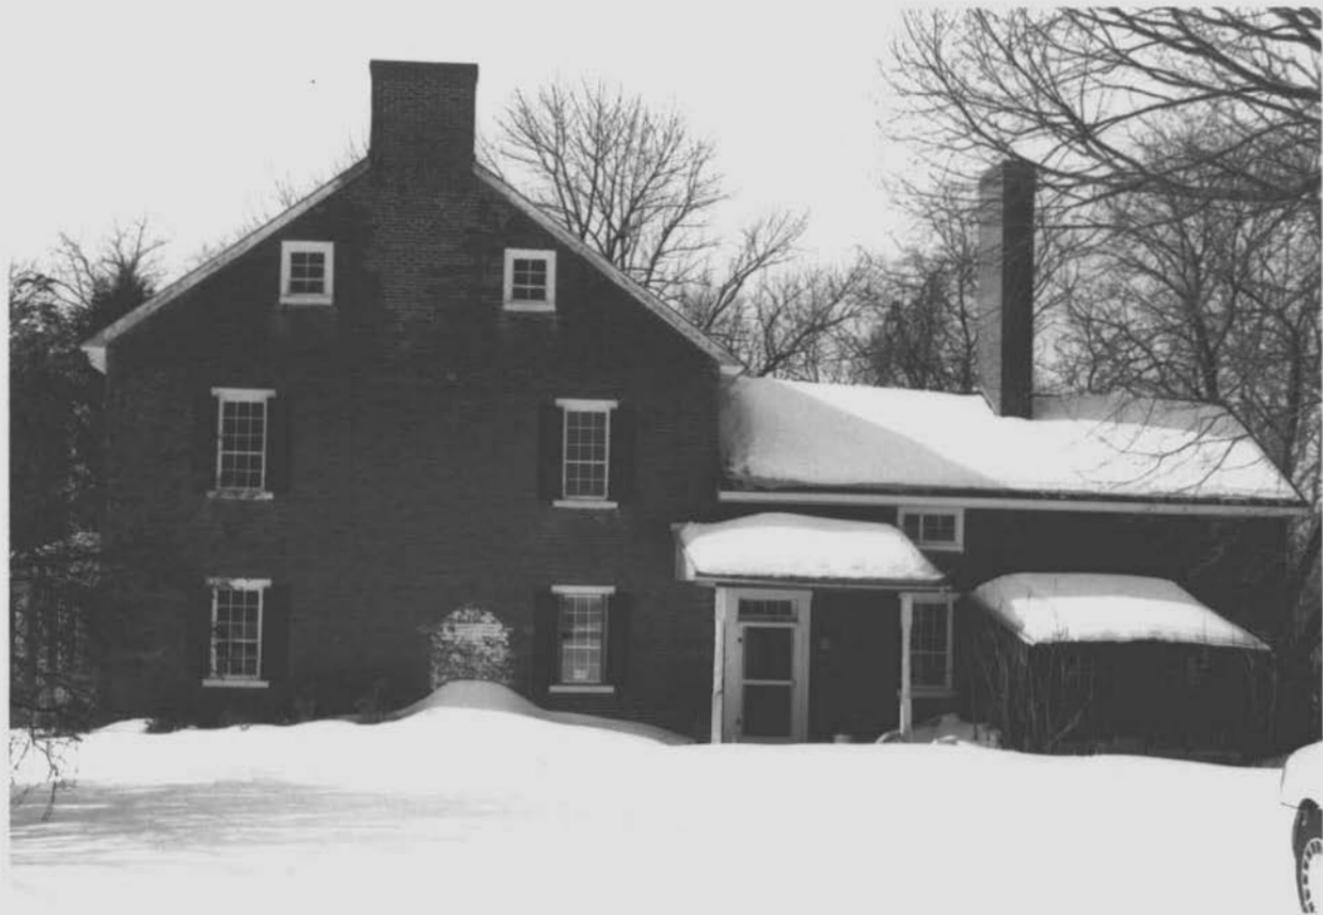
2/15

House - NE elevation

The northeast elevation is 5-1 common bond. The east bay of the foundation has a splayed brick jack arch above a four-light casement that is hinged at the top. The frame is butted at the corners. North of center is a hurricane door and a paint outline on the wall that suggests that there was originally an upright enclosure here with a semi-circular arched doorway. It extends well up into the first story, and has brick infill where wood nailers probably were. There is a semi-circular brick arch low on the wall, now covered by the hurricane door. The first and second stories each have two 9/6 sash like those on the southeast, and the gable end has two 4/2 double-hung sash with wood sill,

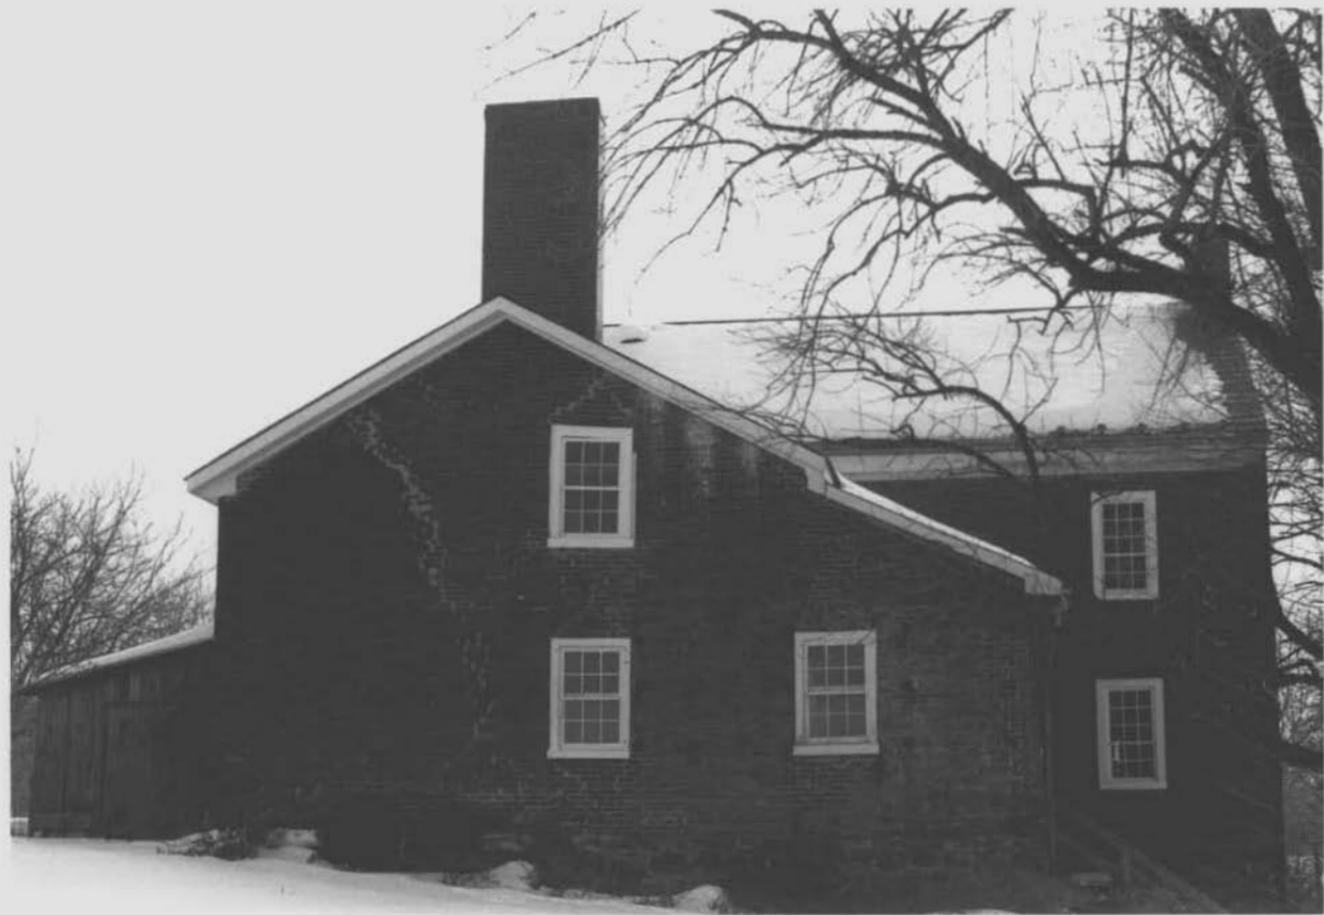
3/15

House - NW elevation

The northwest elevation of the main block of the house has a 6/3 sash in the foundation set slightly north of the west bay openings. It has a pegged mortise-and-tenon frame with a new wood sill and a splayed brick jack arch. There are a pair of two-panel shutters on strap hinges. The first and second stories have a typical 9/6 sash in the west bay, but with hinges, not pintels, to hold blinds. The first story has a door onto the porch, set west of center. The door and frame are identical to that on the southeast elevation of the wing. Above, on the second story, is a 6/3 sash with an ovolo moulding on the outer edge and pintels for blinds.

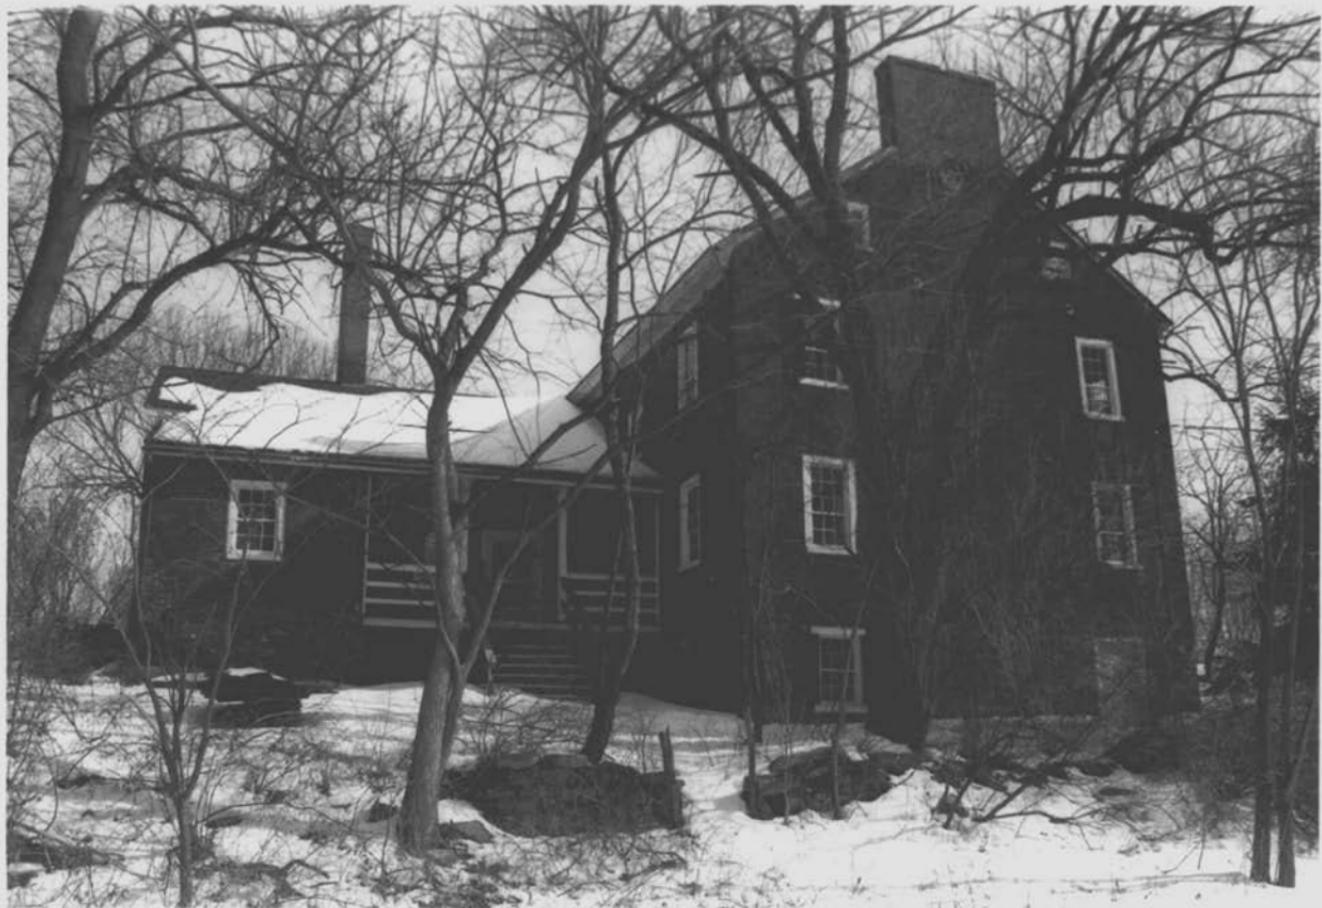
4/15

House - SW elevation

The southwest elevation of the main block has an exposed rubble stone foundation. The west bay has a 6/6 sash in a pegged mortise-and-tenon frame, wood sill, and splayed brick jack arch that retains evidence of striping. There are new shutters hung on original pintels. The south bay has a six-panel door like those found on the southwest porch. The pegged mortise-and-tenon frame has a beaded-interior edge and a splayed brick jack arch. The first and second stories have two typical 9/6 sash. The gable end has two 4/2 sash with wood sills and straight brick jack arches. The pegged mortise-and-tenon frames have an ovolo moulding on the outer edge. In the peak is a circle of brick voussoirs with recessed bricks in the center that apparently held a date plaque. The chimney has been rebuilt. The eaves have tapered rake boards.

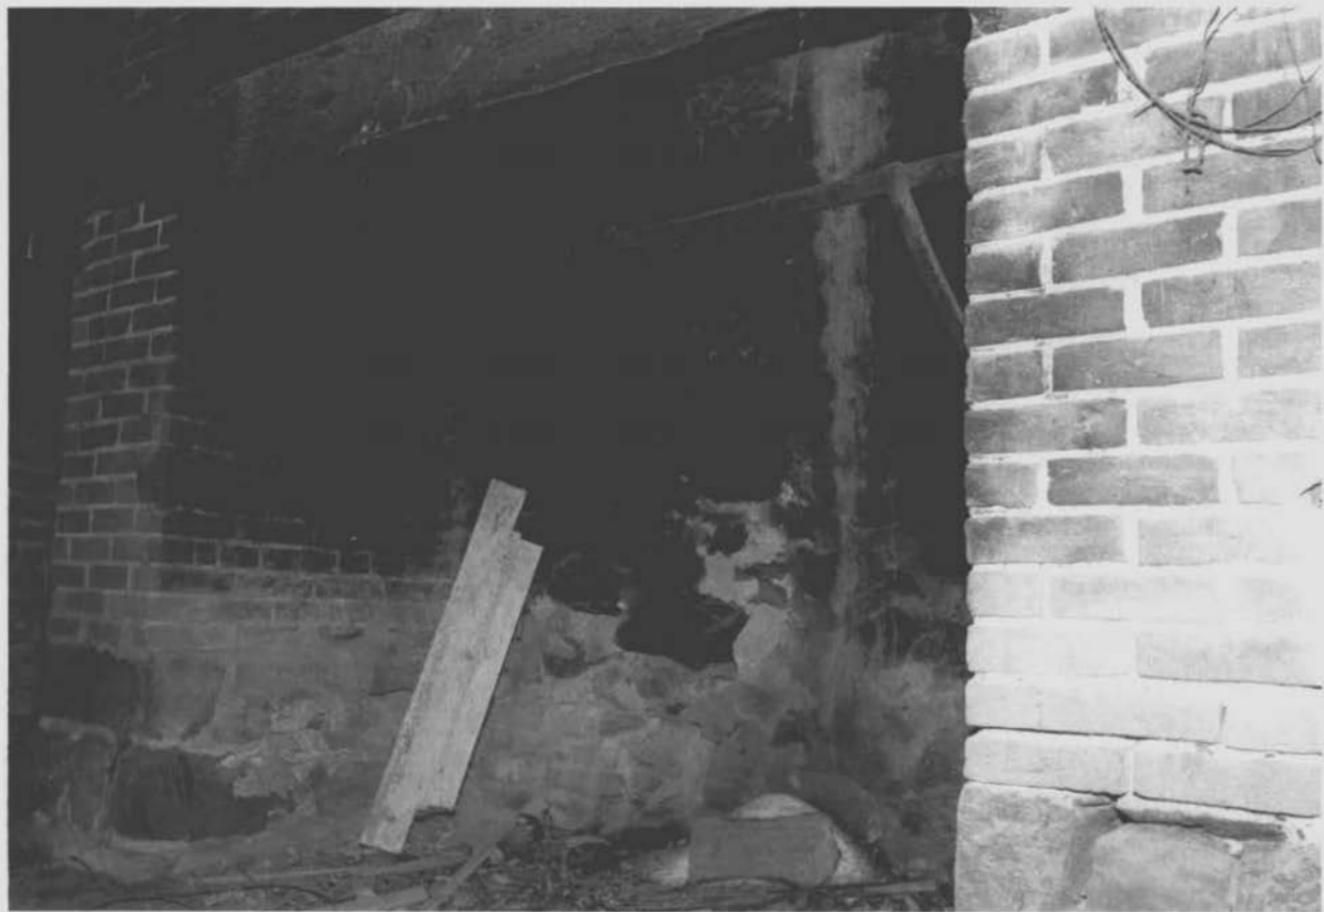
5/15

Cellar fireplace

The east cellar room has a dirt floor, plastered walls, and hand split lath with plaster on the ceiling. The northeast wall has a brick chimney buttress with a semi-circular brick arch and three shelves. It has a wood surround with some nails that appear to be wrought, but are very deteriorated. There are window openings on the southeast, near the center wall, and the northeast. They each have a four-light casement that is hinged at the top. The joists in this room run northwest-southeast, are $3\frac{1}{2}$ by $7\frac{1}{2}$ inches, and are mill sawn. The northwest wall of this room is stone and had a door to the southwest with a pegged mortise-and-tenon frame and a beaded-interior edge on the southeast side. The wood lintel is sawn. The door has random-width beaded-edge vertical boards and strap hinges on the northwest side.

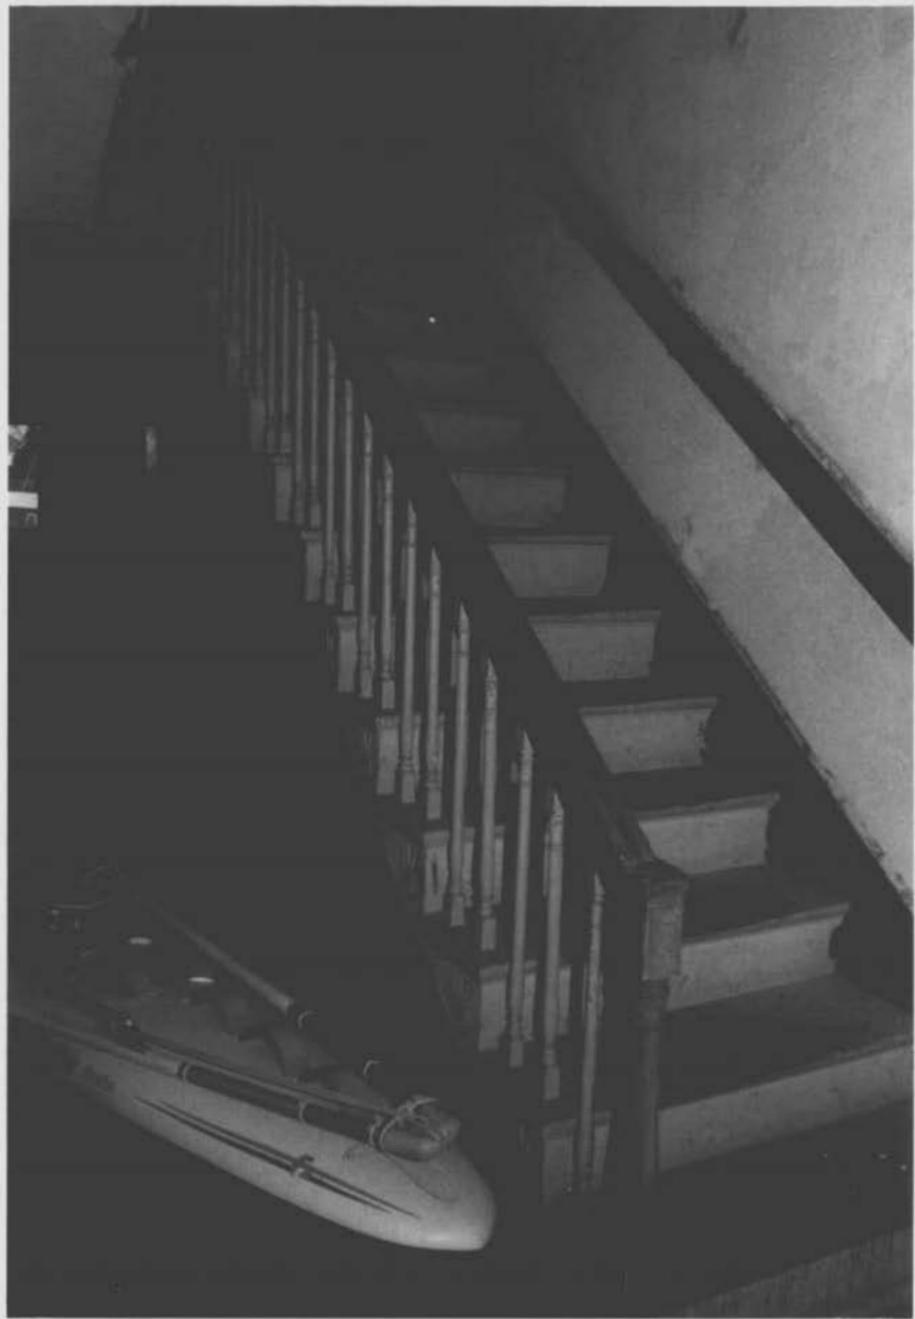
6/15

first story stairs

There is a dog-leg stair on the northeast wall with an open stringer that has sawn brackets. The panels under the stairs are flat and sunk, with ogee panel moulds. The reverse sides of the panels have the bevels. There is a turned newel, turned balusters, and a hand rail that is moulded on the top. There is a six-panel door under the stairs to the closet. The surround has a beaded-interior edge and an ovolo on the outer edge. The rear (northwest) door has interior strap hinges, a cast-iron box lock, and an ovolo on the edge of the frame.

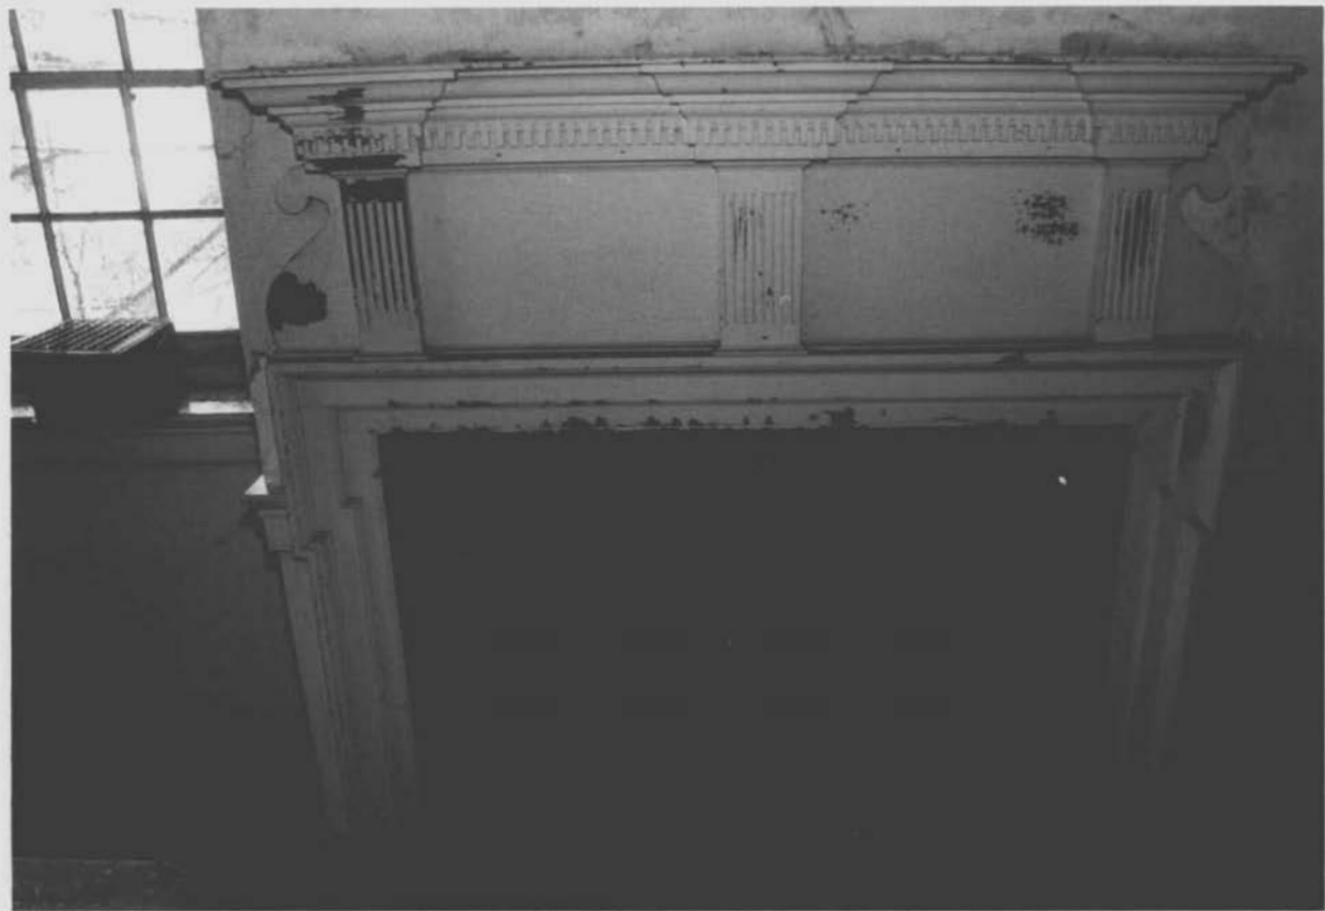
7/15

S. room - mantel

The mantel has a crosseted, broken field surround with an ovolo at the break, a large ovolo applied to the outer edge, and a bead on the inner edge. The frieze has three fluted pilaster strips, with sawn brackets on the outer sides of the end strips. Above them is a dentil course with drill holes in the interdentils, an ovolo above, and a large ogee at the top. The mantel shelf is a thin board. The mantel also had a two-tone paint scheme. Much of it was an olive green. The pilaster edges were green, but the inner area was brown, as were the dentils. There is a peg rail on the northwest wall, with a door in the center that has a wrought-iron thumb latch and appears to have originally been painted olive green.

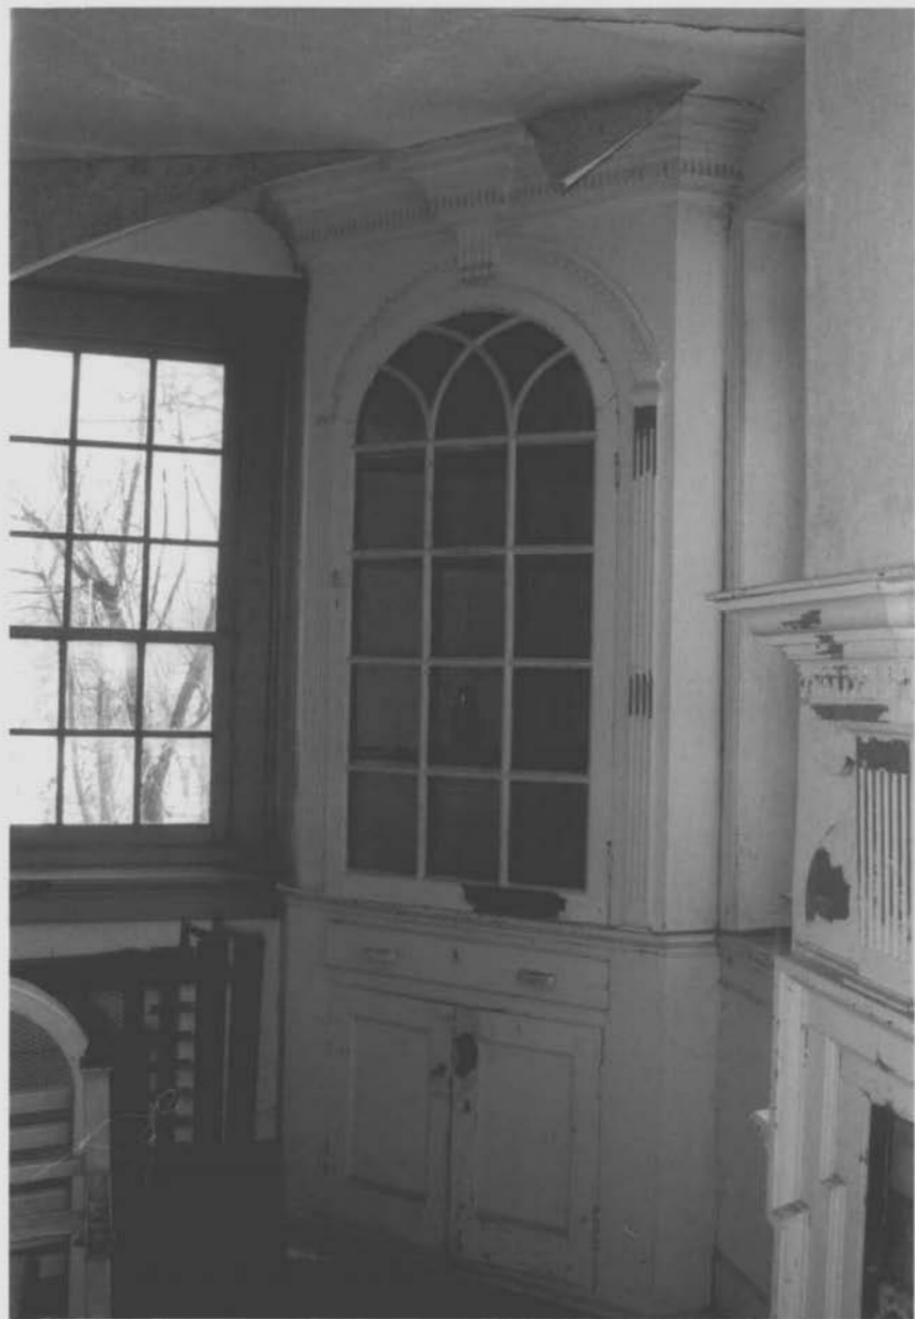
8/15

Neg. Loc.: Maryland Historical Trust
S. room - cupboard

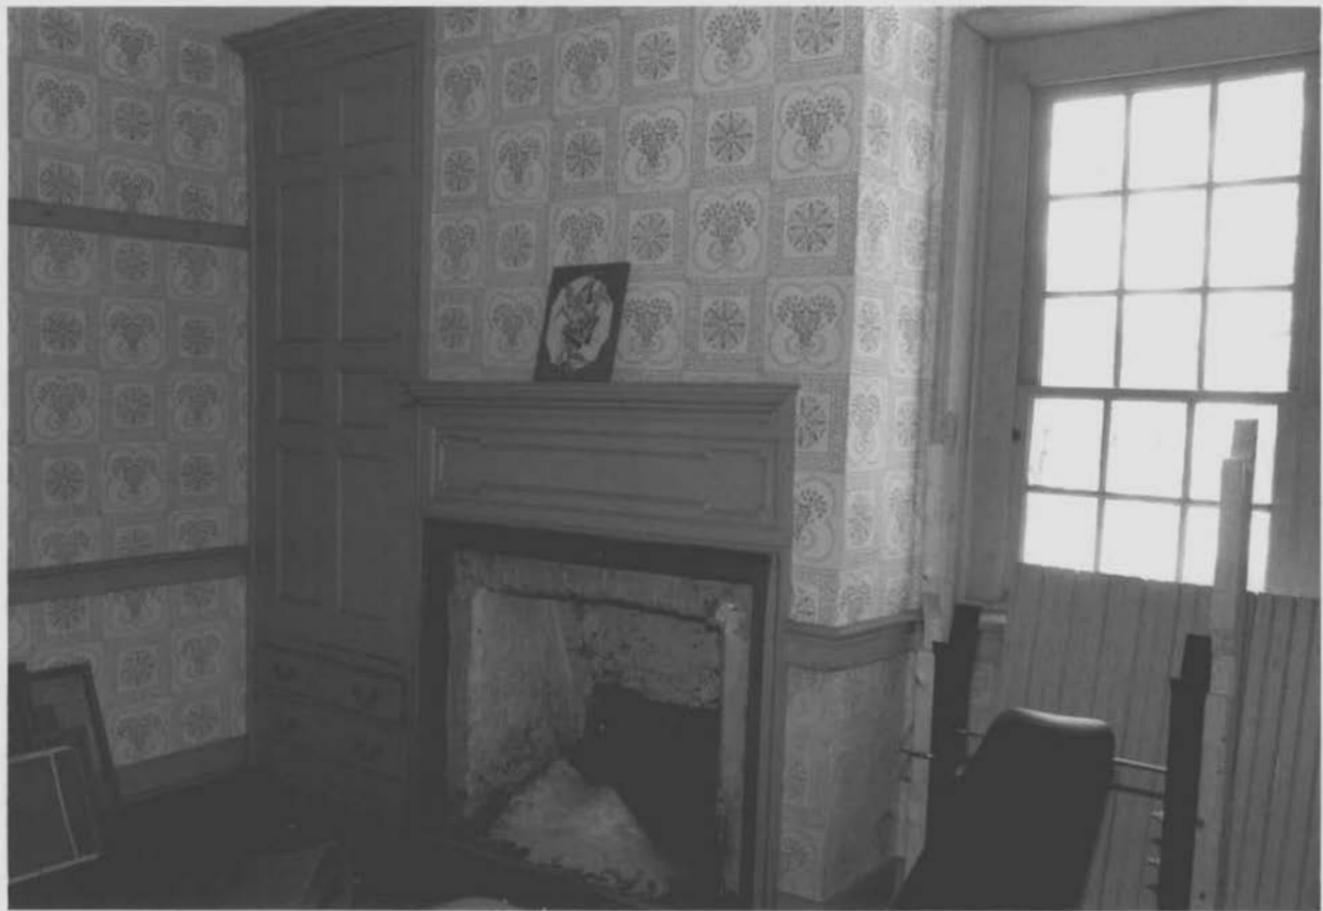
9/15

west room - SW elevation

The west room has the same baseboard and chair rail as the passage, and a random-width pine floor. There is a fireplace on the southwest wall that is shallow and parged, with a bevelled inner edge. The mantel has a beaded-interior edge surround with an ovolo on the outer edge. The frieze has a sunk, flat panel with an ogee panel mould, and a raised applied moulding set inside it. The bed mould has a cavetto below an ovolo. Southeast of the fireplace is a built-in cupboard with two drawers at the bottom and an eight-panel door above. The panels alternate between small at the top, then long, then small, and long ones at the bottom. They are sunk, flat panels with ogee panel moulds. The surround has a beaded-interior edge and an ovolo on the outer edge. There is a cornice on the cupboard that is identical to the mantel bed mould, with a cavetto below an ovolo. The door is hung on cast-iron butt hinges, and the reverse of the panels are bevelled. There is a peg rail on the northwest wall, to the north, and on the southeast wall, to the south.

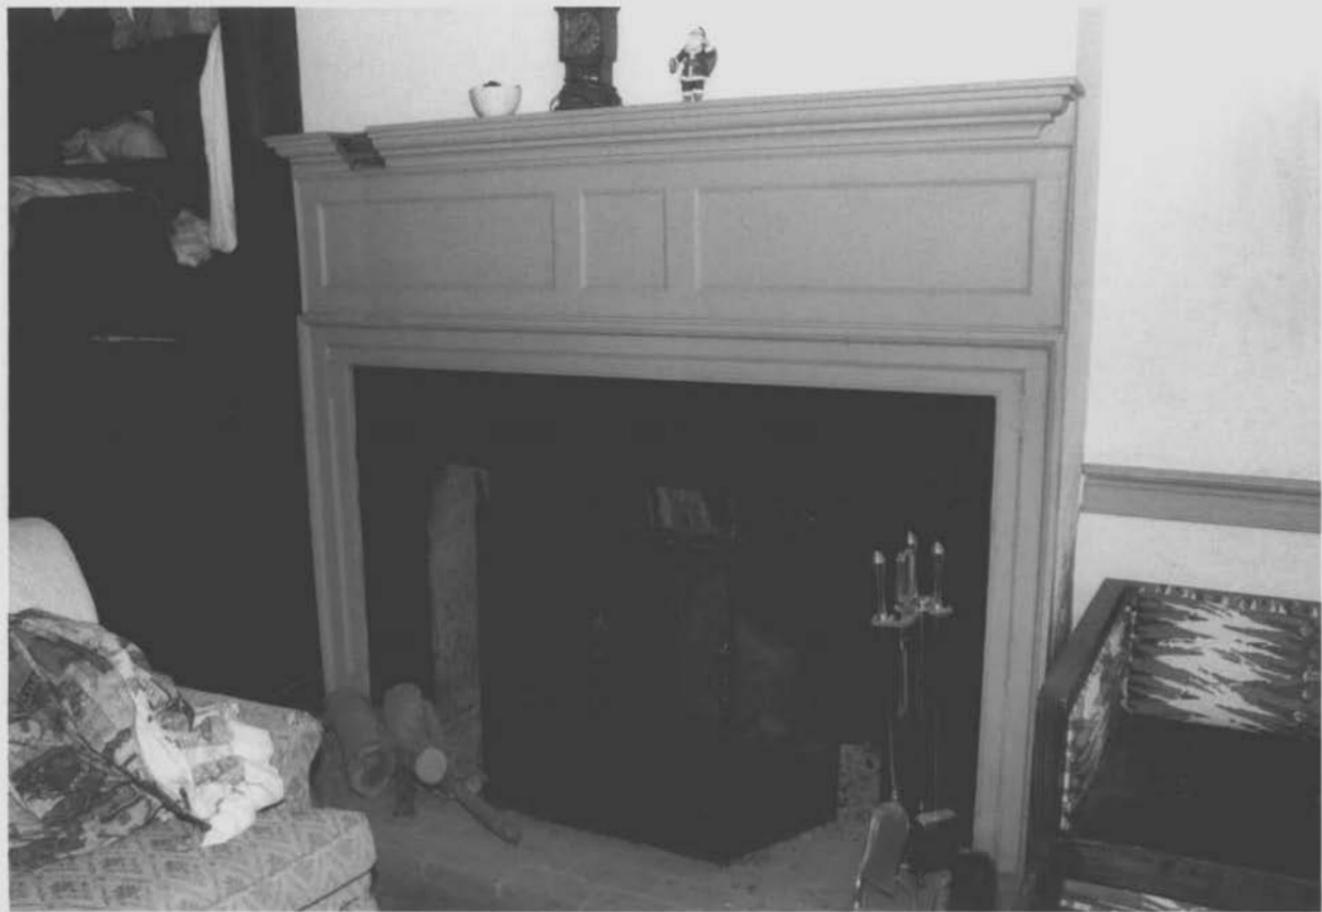
10/15

N.E. room mantel

The northeast room has a fireplace centered on the northeast wall. It has been re-plastered, and has a new hearth. The mantel surround has a beaded-interior edge, a broken field with a small ovolo at the break, and a large ovolo at the outer edge. The frieze has three panels, the center one being square. The panels are flat and sunk, with ovolo panel moulds. The bed mould has a cavetto below an ovolo. The baseboard, chair rail, and windows match those throughout the rest of the house. There is now a steel I-beam running northeast-southwest across the center of the ceiling to support the summer beam, which was originally plastered over and never exposed. A wall of sheetrocked studs was removed from this location when the I-Beam was installed. A channel has been cut into the mantel to hold one end of the wall. The random-width floor appears to be oak. There is a corner cupboard in the west corner. It has two doors below with a sunk, flat panel that has an ovolo mould, in each. These are on cast-iron butt hinges. Above them is a drawer, and at the top of the cupboard are two three-panel doors that match those below. They have a beaded-interior edge surround. There is a dentil cornice with a cavetto and ovolo above. On either side of the cupboard are peg rails on the wall. The northwest wall has a wide door into the ell. It is hung on self-rising hinges and has a cast-iron box lock. The door jambs have an ovolo run on the
