CARR-1384

Foutz's Mill Farm (preferred); Centre Mills
Taneytown (vicinity)

Maryland Historical Trust State Historic Sites Inventory Form

historic Foutz's Mill Farm (preferred); Centre Mills

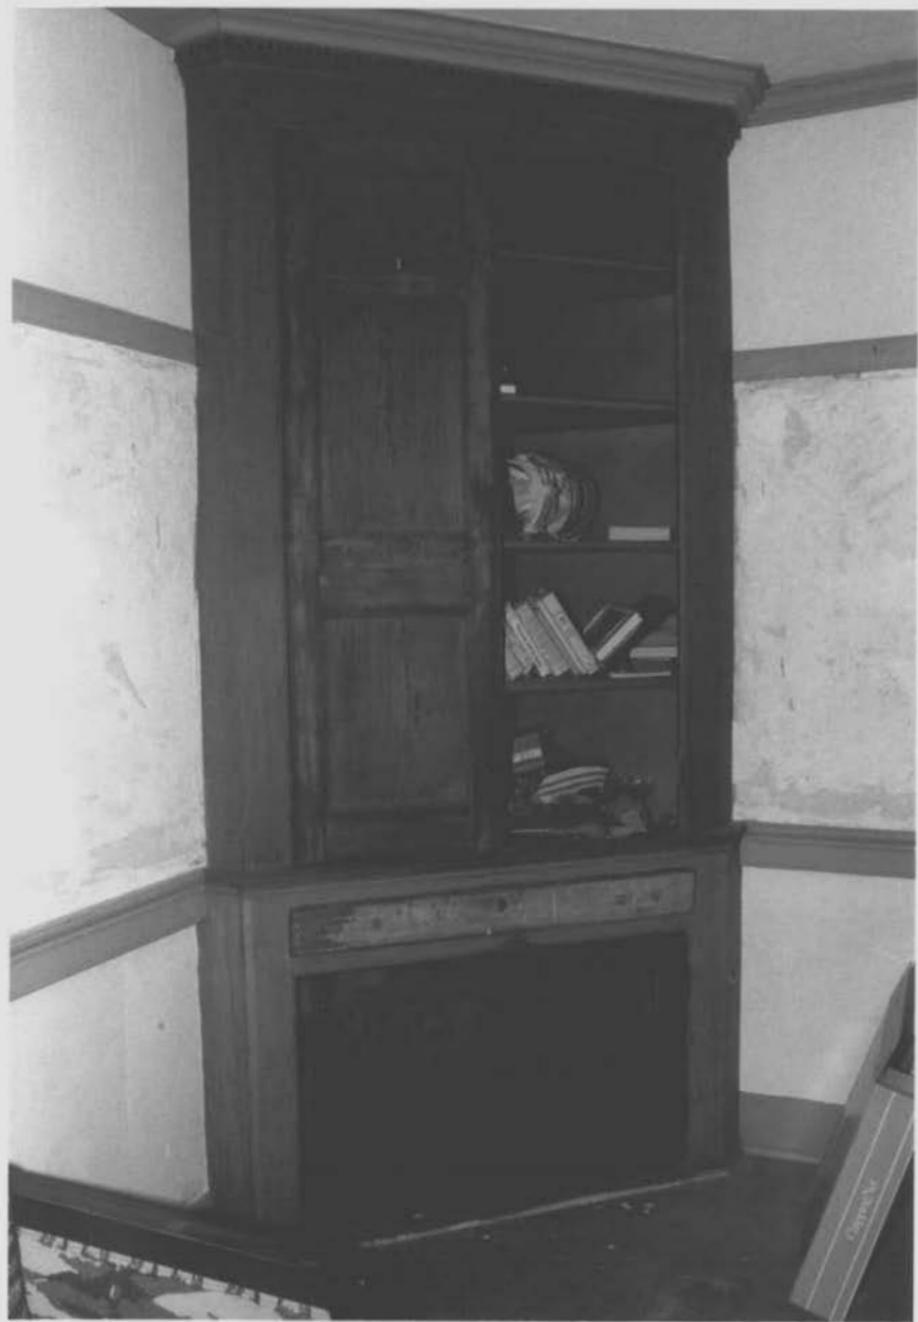
11/15

N.E. room cupboard

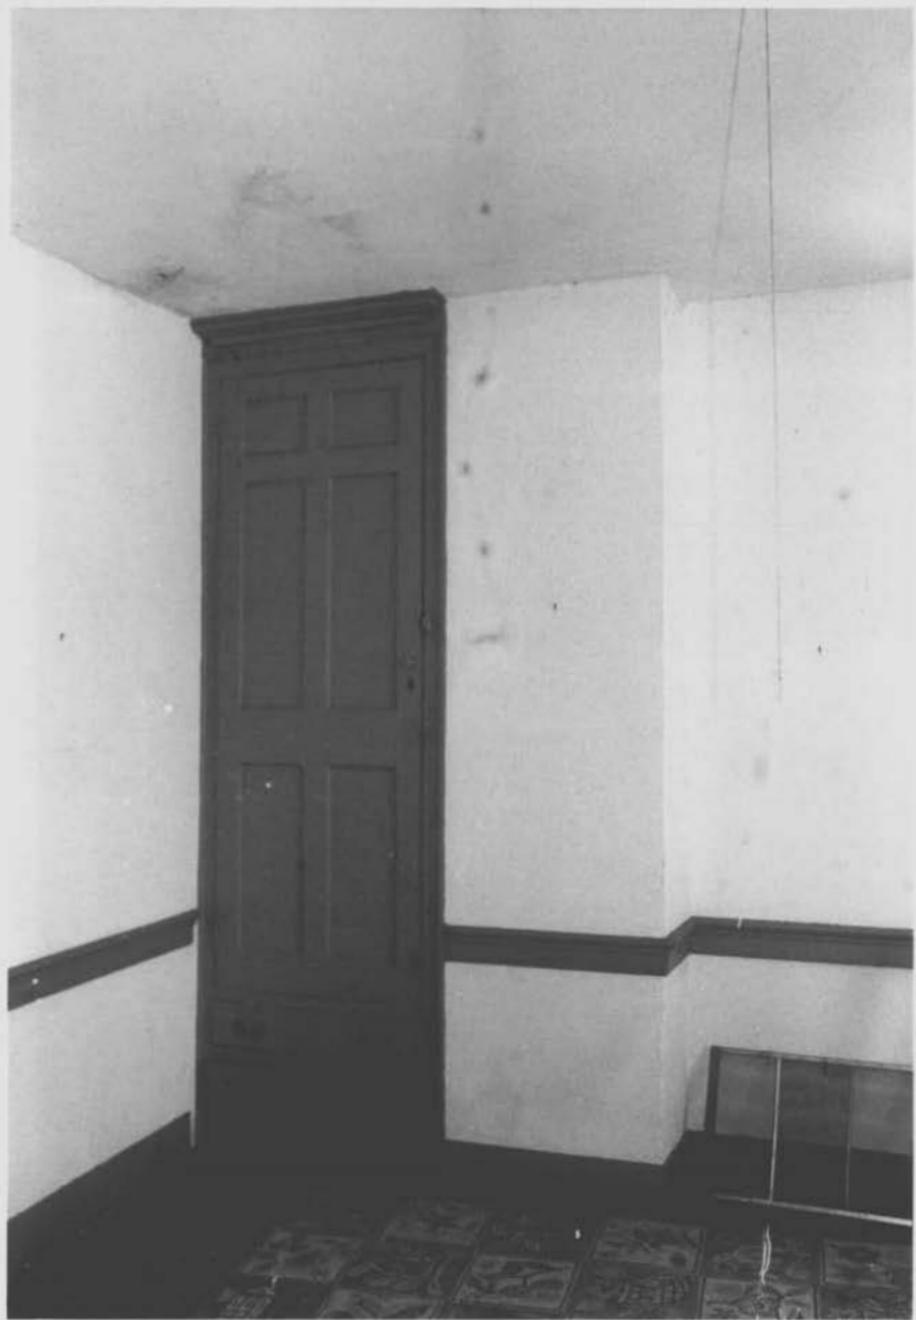
12/15

House- west chamber closet

The west chamber has the typical baseboard and chair rail. The surrounds here have the beaded-interior edge and ovolo on the outer edge only. There is a peg rail on the northeast wall. The random-width pine floors run northeast-southwest. There is a built-in closet in the south corner, southeast of the flue. It has two drawers at the bottom and a six-panel door above that has sunk, flat panels and ovolo moulds. It is hung on butt hinges, and the reverse of the panels are bevelled. The door surround has a beaded-interior edge and an ovolo on the outer edge. The door is hung on later butt hinges. The east chamber also has the same floor, baseboard, and chair rail. It has a fireplace with splayed jambs on the northeast wall. The mantel surround has a beaded-interior edge and an ovolo on the outer edge. The hearth has been removed. There is a peg rail with wrought-iron pegs on the northwest wall.

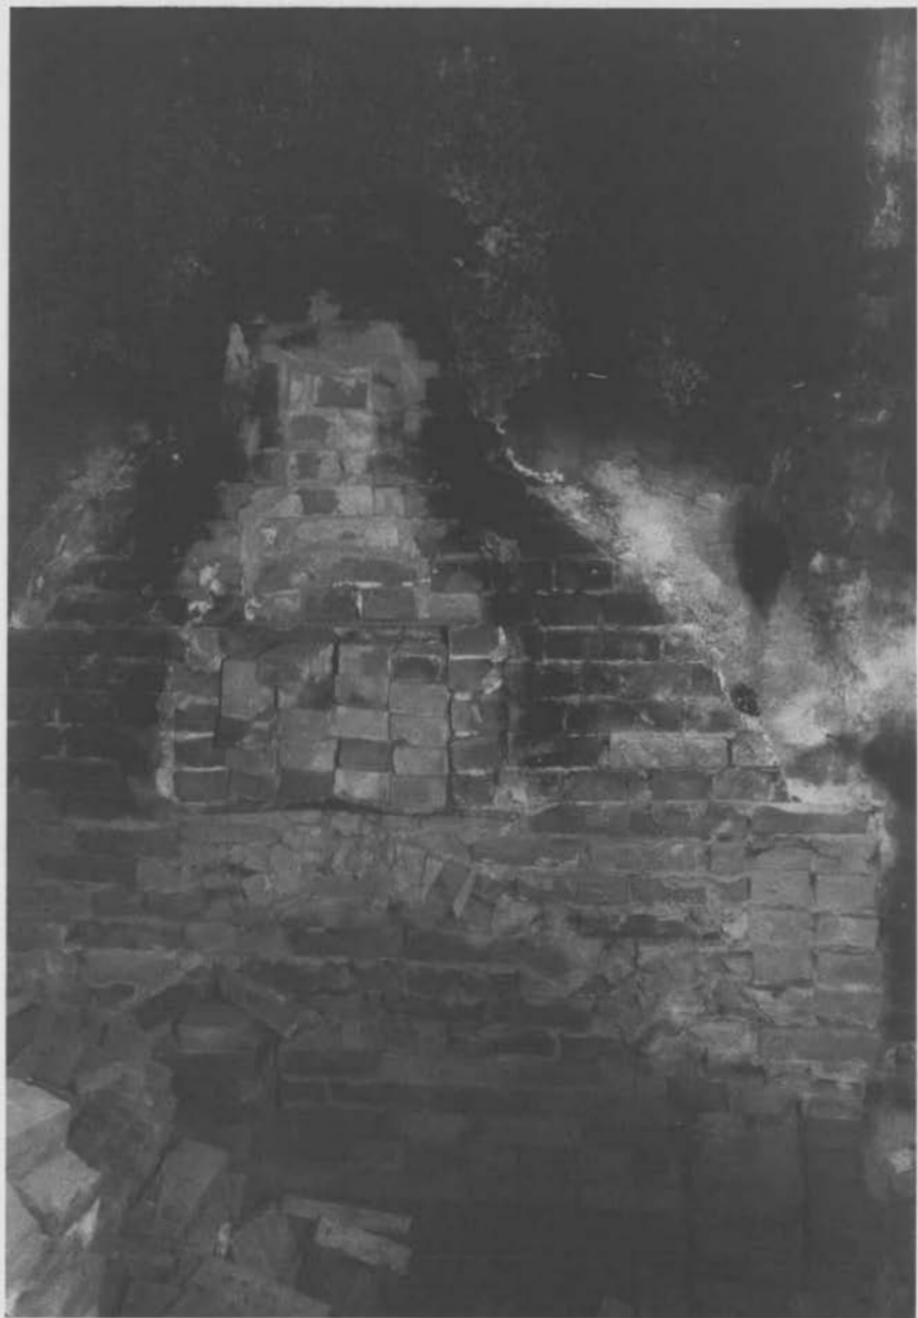
13/15

smokehouse - northwest elevation - interior

The north room is a smokehouse that is only accessible from the outside. It has a dirt floor and was open to the roof. It formerly held a bakeoven, which was in the east corner. It apparently had a squirrel-tail flue that connected to the kitchen flue. The domed oven was accessible from the kitchen fireplace, and apparently the clean-out below was also. The ceiling of the clean-out was a semi-circular brick arch that supported the brick floor of the oven. The oven was about 5 feet 7 inches by 6 feet, and at its highest was about 6 feet 7½ inches tall. The oven floor was about 3 feet 1 inch above the ground.

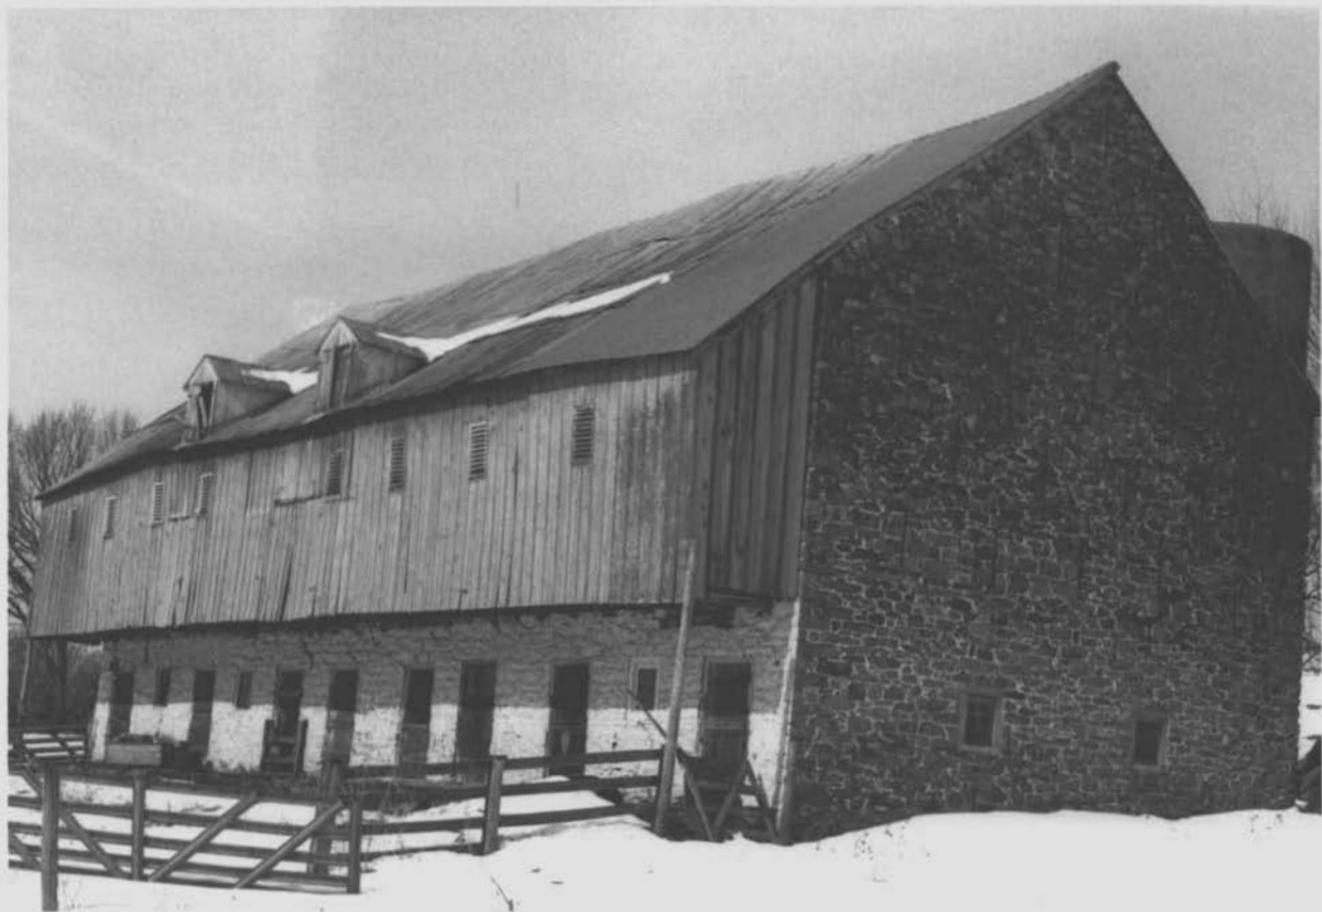
14/15

Barn - S & E elevations

There is a stone bank barn located about 75 feet northeast of the house. It is 86 feet $9\frac{1}{2}$ inches long and 36 feet 2 inches wide, plus a 6 foot 5 inch forebay, which faces south. The south elevation is stone on the lower story. From west to east there is a door, window, door, window, three doors, an altered door, a door, window, and door. The doors are vertical-board dutch doors on strap hinges that have rounded ends. The door frames are mortised and tenoned and pegged. The windows are six-light sash set into a pegged mortise-and-tenon frame that originally had five vertical bars. The upper story has vertical board-and-batten siding. From west to east there are three vents, a pair of doors, a vent, a pair of doors above another pair of doors, and four vents. There are two gable-roofed dormers. The barn has a gable roof with corrugated metal and an east-west ridge. The south side of the gable has a longer slope than the north side. The east elevation, on the lower story, has two six-light sash like those on the south. The upper story has five slit vents, with four above them, then three above, then two in the gable end and one in the peak. The west elevation has a concrete buttress on the lower story and two six-light sash like those on the south. The upper story has five slit vents, with four above them, one of which was filled when the stone work was repaired, and three vents above them. The gable end has vertical-board siding and a six-light sash.
