CARR-1388
Reindollar-Mehring Farm
Taneytown (vicinity)

Maryland Historical Trust State Historic Sites Inventory Form

historic Reindollar-Mehring Farm

street & number 5055 Francis Scott Key Highway (MD 194) not for publication

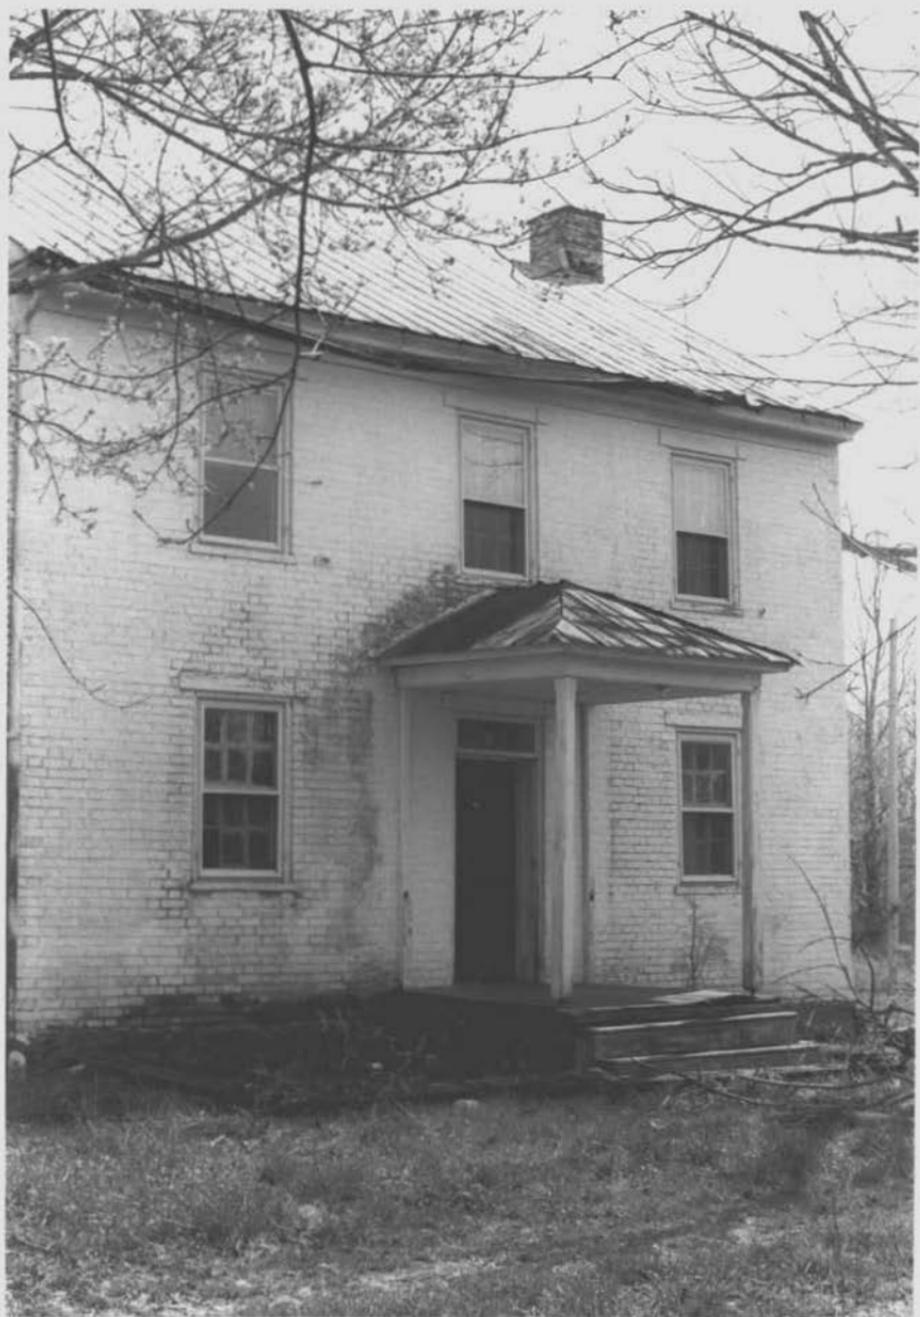
1/7

Neg. Loc.: Maryland Historical Trust
house - north elevation

The house faces north and is a three-bay by two-bay, two-story structure with a rubble stone foundation, Flemish bond brick on the north elevation, 5-1 common bond brick on the other elevations, and a gable roof of inverted V-seam metal with an east-west ridge. The north elevation has a center entrance with an eight-panel door. The top six panels are square and the bottom two rectangular. They all have sunk fields with

Greek ogee panel moulds. There is a stone sill and a 15-light transom. The bullnose frame has a single large panel at transom level and one panel on the soffit. These all have flat sunk panels with Greek ogee moulds identical to the door. Above the transom is a wood lintel with corner blocks. To each side of the door is a 6/6 double hung sash with a wood sill, a wood lintel with corner blocks, a bullnose moulded frame, and shutter hardware. There is a one-story, one-bay, hipped-roof porch in the center bay. It has two square posts with chamfered corners and a box cornice with an ogee moulding. The porch originally had railings on the sides. The second story has three 6/6 sash with the same details, and with cast iron shell-pattern shutter holdfasts. There is a wood box cornice with a fascia board underneath. The cornice cymatium has a Greek ovolo at the top with an ogee underneath. There is an interior brick chimney on each end.

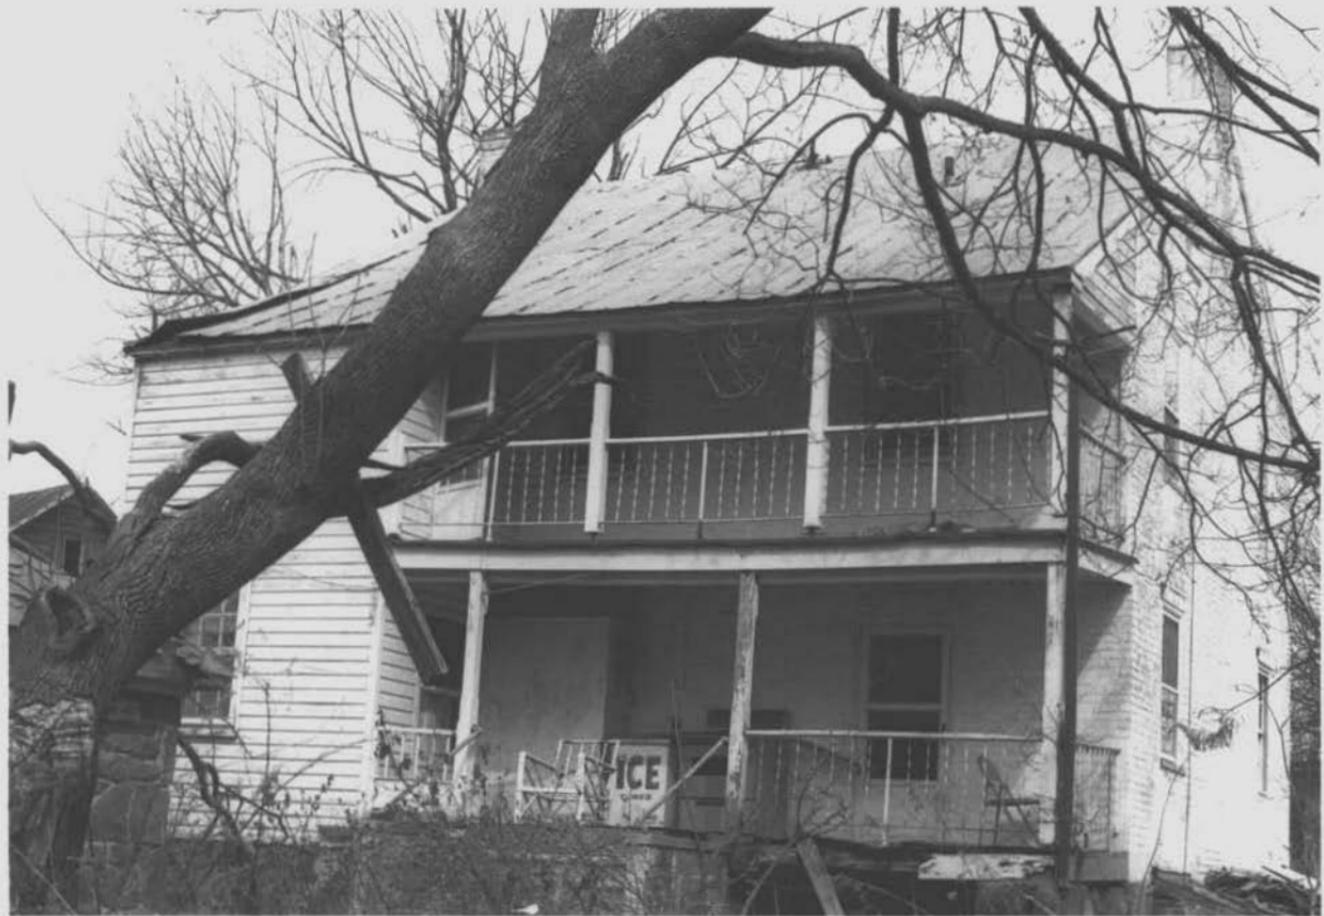
2/7

Neg. Loc.: Maryland Historical Trust
house - south elevation

The south elevation foundation, in the east bay, has a wood vent like that on the east elevation, with a four-light sash behind it. There is a stone pier in the middle of the porch and a stone wall in the west bay, under the enclosed portion of the porch. This wall continues under the east elevation of the enclosed portion, and has a beaded-edge vertical-board door in it with a beaded-interior-edge frame and a cast-iron box lock. The first story has a four-panel door with sunk fields and ogee moulds in a beaded-interior-edge frame. The door in the center bay is now covered by a later enclosure, but the bullnose frame and transom are visible. The east bay had a window that has been converted to a door. It has a beaded-interior-edge frame and a four-panel door with sunk, fielded panels and ogee moulds. The second story has German siding in the west bay. The east elevation of the enclosed portion has a doorway; the door is now missing. The center and east bays have the typical 6/6 sash. The two-story porch has a shed roof that continues the slope of the house roof. The porch has a new deck and railings, though a piece of the old rail survives. It had a horizontal-board bottom rail with semi-circular cut outs on both ends, and small, square-in-plan vertical balusters. The square, chamfered porch posts appear to have been moved on the first story.

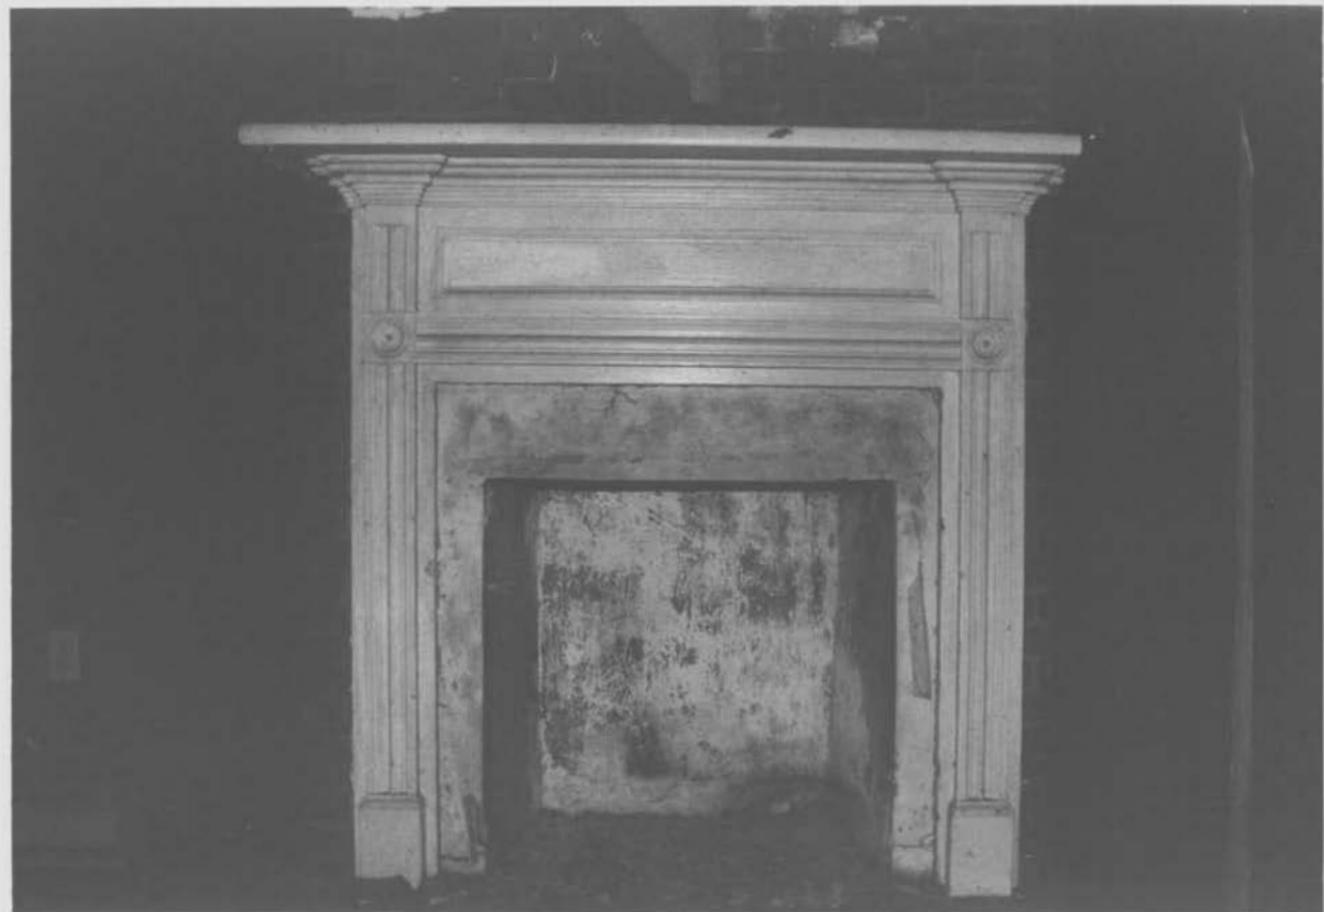
3/7

house - northeast room mantel

The northeast room has a fireplace on the east wall, to the south, that has splayed, plastered jambs. The wood mantel architrave is a symmetrical moulding with a Greek ovolo on either edge and a lancet profile in the center. The bulls-eye corner blocks have the same pattern, run circular. The frieze has sunk, flat panels with Greek ogee moulds. The bed mould has two Greek ovolos at the top, then an astragal, three fillets, and an astragal at the bottom. The southwest corner of the room is canted. This appears to be a later alteration when the stairs were moved to the east about three feet. The southeast room has now been converted to a bathroom. The door architrave trim has a broken field with a cavetto at the break, and a beaded interior edge. The southwest room has a large fireplace on the west wall, to the north. It has brick with straight jambs, and is parged. The mantel has a plain wood surround and shelf. The bed mould has a chamfer along the bottom corner, with a bead below it. The rear, center bay door is now gone, but the architrave and transom survive and match those on the front. On the east wall is a door to the cellar that is identical to the front door. On

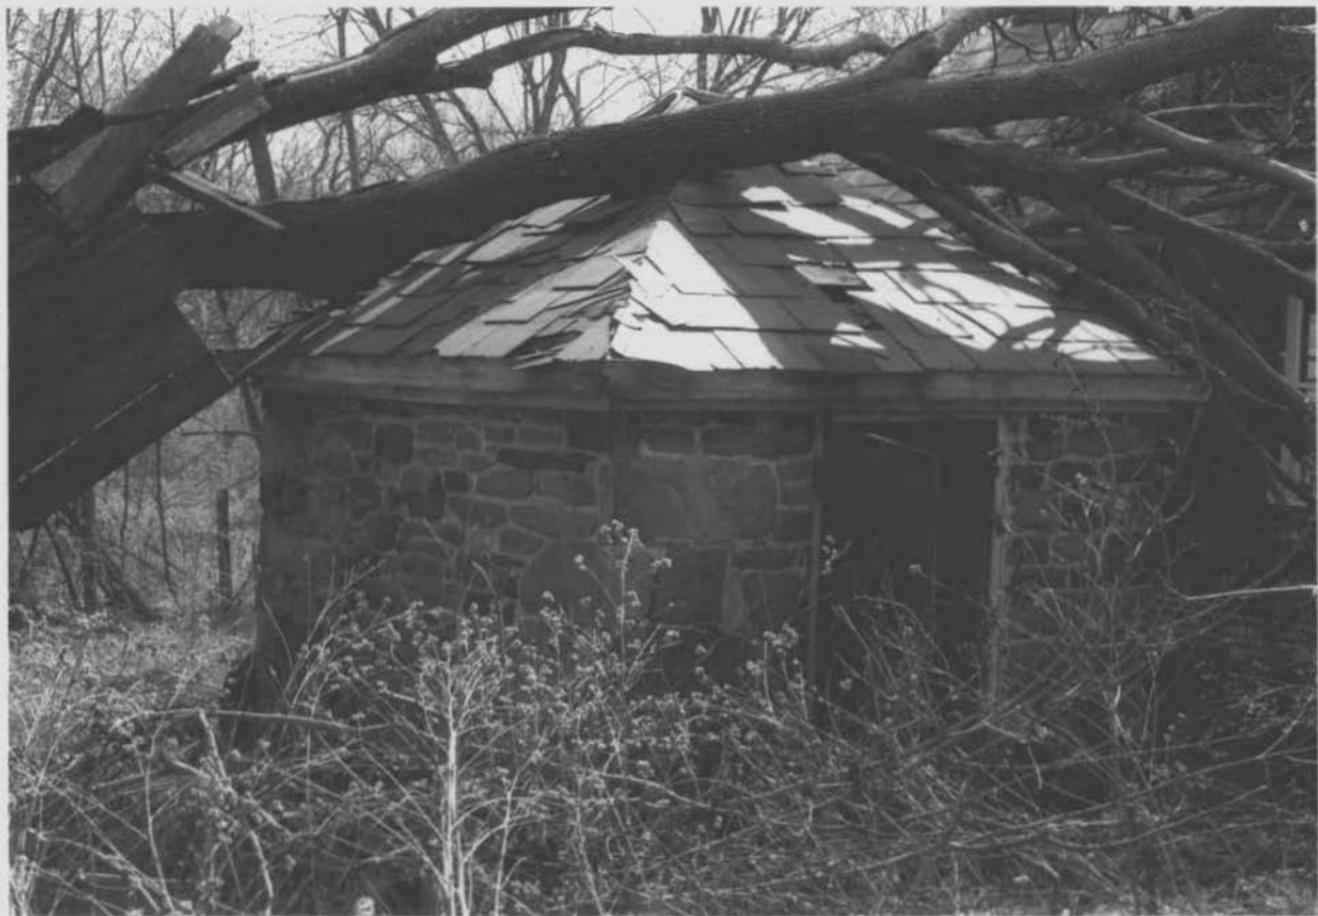
4/7

Smokehouse - east & north elevations

There is a rubble stone smokehouse about 15 feet south of the house that has some quoining at the corners. The hipped roof is covered with slate that has been badly damaged by a large fallen tree limb that still rests on the roof. The north elevation has a beaded-edge vertical-board door, and the door jambs are circular-sawn. The interior walls are plastered. There are many joists running north-south that appear to be mill-sawn and were used to hang meat on. The rafters are circular-sawn.

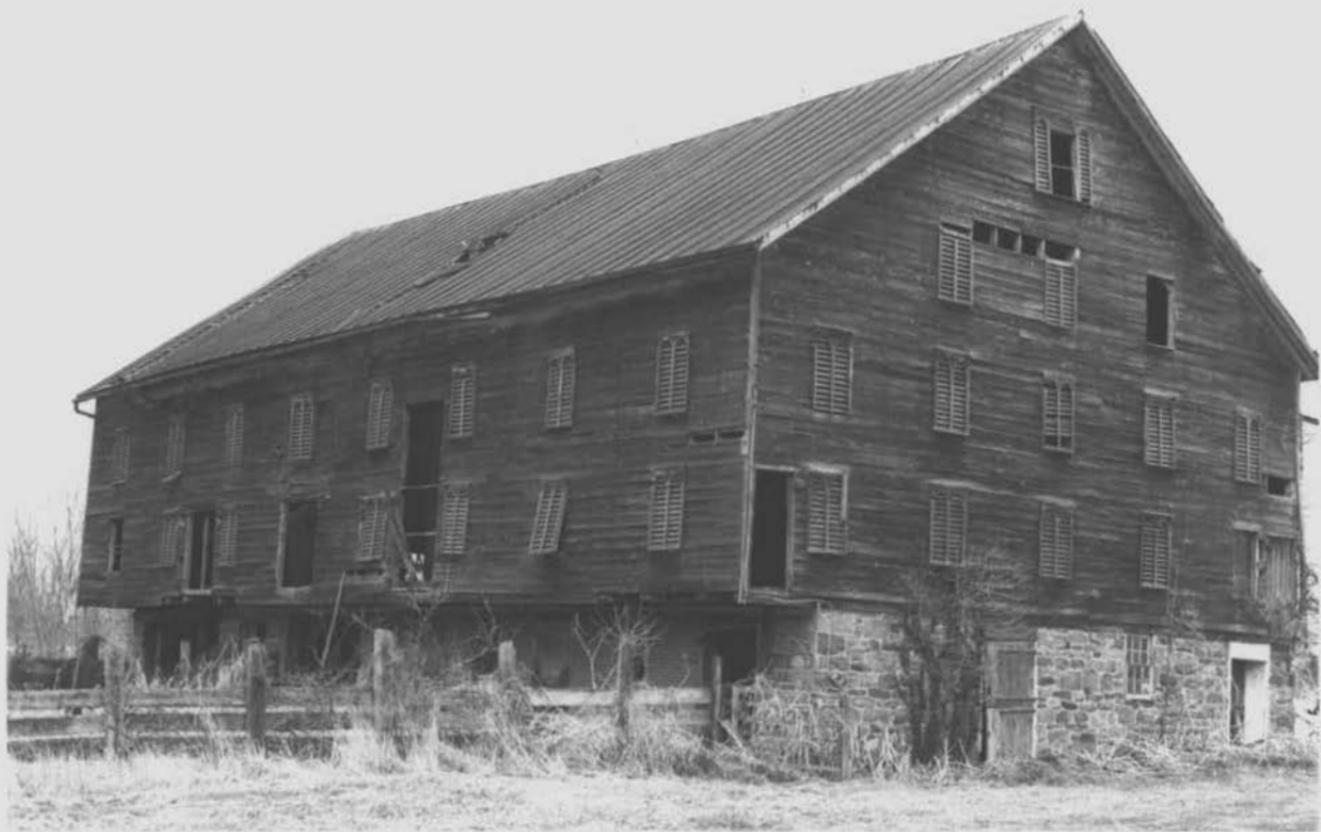
6/7

barn - south & east elevations

There is a bank barn with a south-facing forebay about 75 feet northwest of the house. The lower story has rubble field stone, with 7-1 common bond brick on the south elevation. The upper story is clapboard. The gable roof has an east-west ridge with inverted V-seam metal on the south and slate on the north. The south elevation, on the lower story, has from west to east, a widened opening that was probably a door and a window, a vertical-board dutch door on strap hinges, a wide opening that was probably a window and door, a matching door, a vent opening with round holes in the jambs, another matching door, a vent converted to a 4/2 sash, and a matching door. Some of the strap hinges are tapered to a point and others have a rounded end. The upper story has two wood louvered vents above two vents, a door opening, a vent above a vent, a door opening above a door opening, and three vents above three vents. The east elevation, on the lower story, has a vertical-board dutch door on strap hinges to the south, a 6/6 sash, and a door opening to the north. The upper story has a door opening in the forebay at the south corner, five vents to the north, and a vertical-board door at the north corner. Above the five vents are five more vents, with three vents above them. Centered in the gable end is a window opening flanked by a vent on each side.

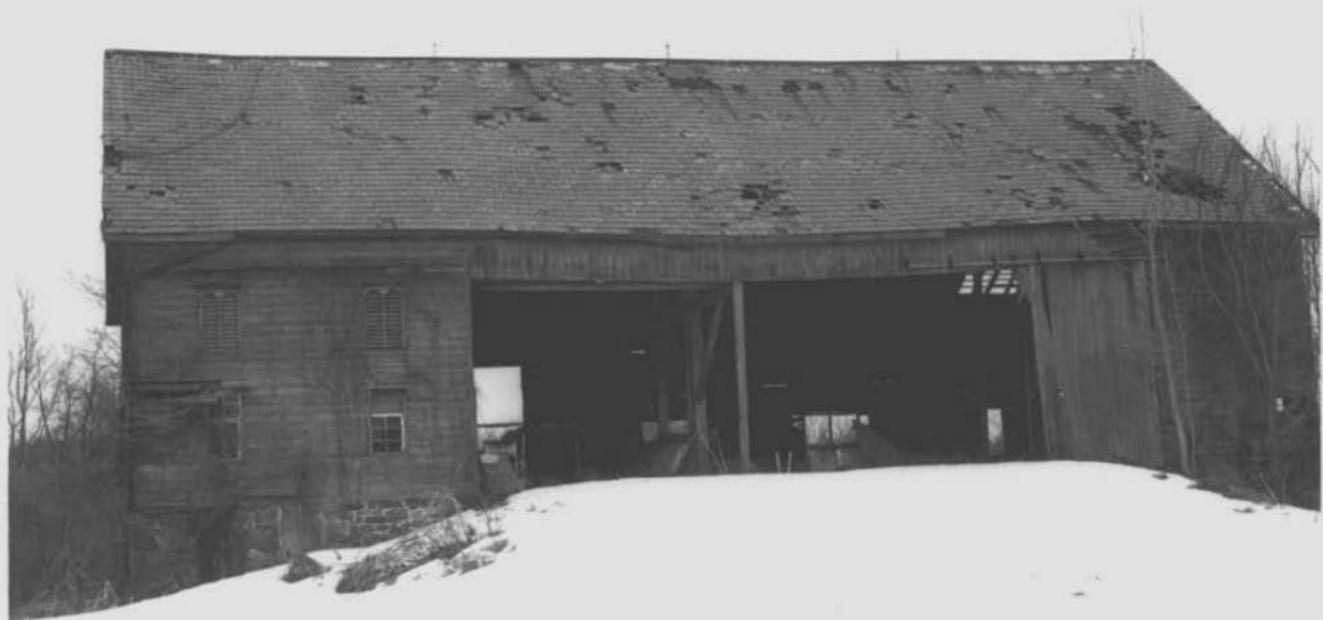
7/7

barn - north elevation

The north elevation has a boarded-up opening in both the east and west bays of the lower story. The upper story had two pair of beaded-edge-and-center vertical-board wagon doors on rollers, but only one door now survives. To the east are two window openings with infill of other sash, and two wood vents above. To the west are two vents over two vents. The west elevation has a vertical-board dutch door that opens in the north bay of the lower story. To the south are two openings that are glazed now. The upper story has five vents, with five above, then three vents, and a window opening flanked by a vent on each side, in the peak.
