Maryland Historical Trust State Historic Sites Inventory Form

Survey No. CARR-1402

historic Sensinig-Ecker House

street & number 207 Main Street not for publication

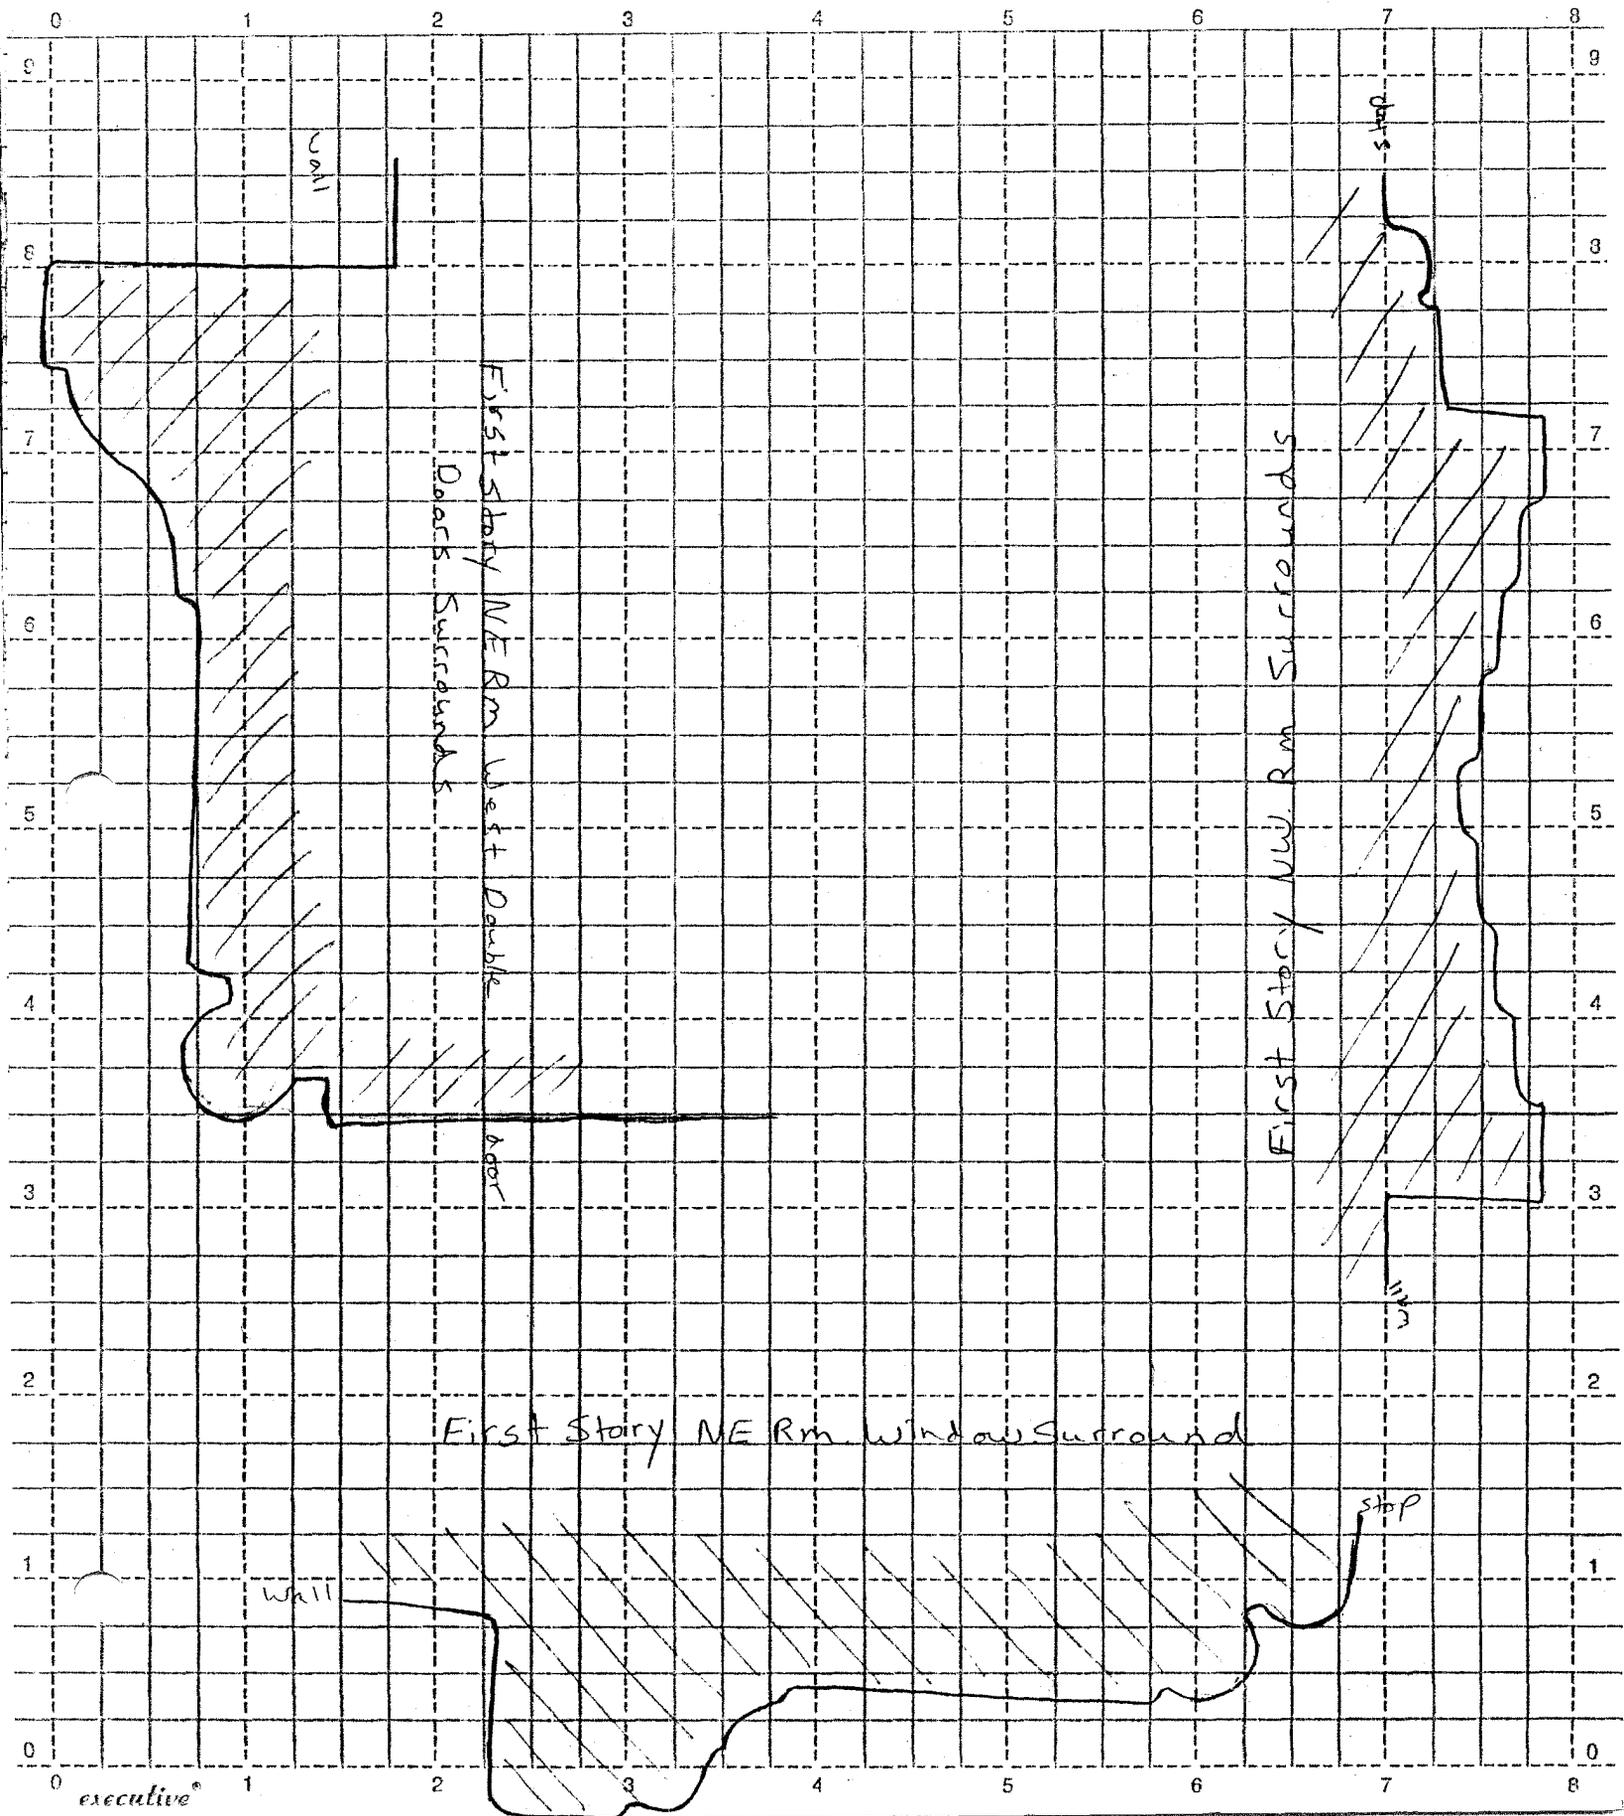
207 Main St. - New Windsor
Moulding Profiles

baseboards in this room are new. The architrave trim is symmetrical with nine fillets, one being in the center, set in a stair step pattern. The center is thus recessed. The architrave also has a beaded interior edge and bulls-eye corner blocks that consist of five stair-stepped fillets. There is a fireplace on the west wall that is bricked in. It has a wood mantel that is segmentally arched. There are applied flat mouldings in the spandrels and a pendant drop in the center. The mantel shelf is sawn with an ogee profile. The south wall has a six-panel door set to the east that has sunk fields and ogee panel moulds. The cast iron rim lock is marked "patented May.5.1863. June 7.1864." This door leads to the stair landing which is one step up from the northwest floor level.

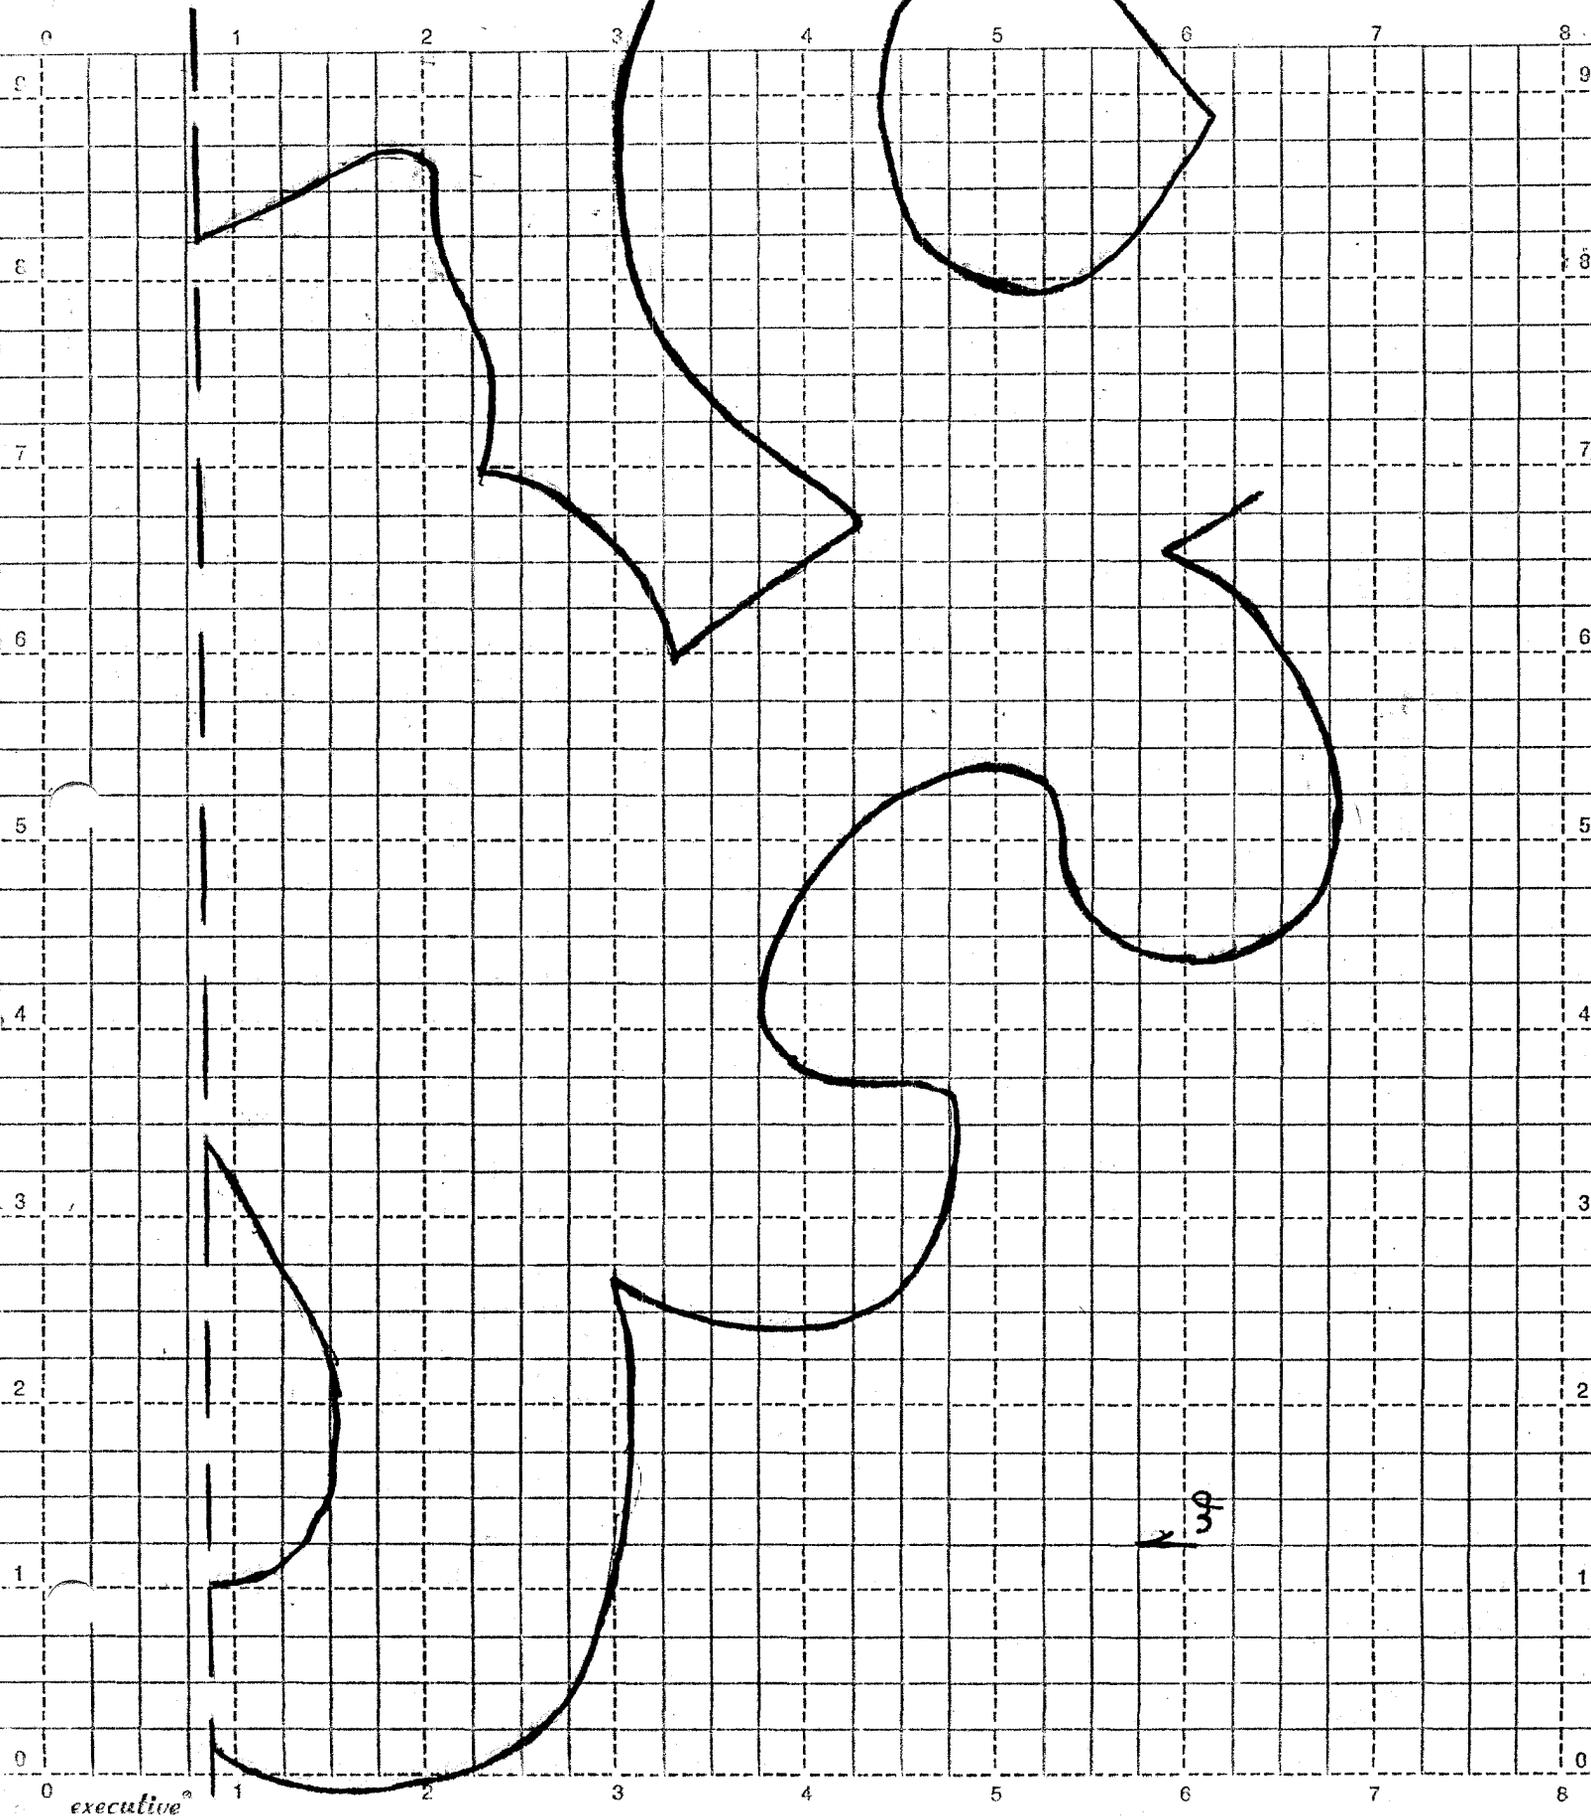
207 Main St. - New Windsor
Porch Bracket Profile

The Sensinig-Ecker House is located at 207 Main Street, New Windsor, in western Carroll County, Maryland. The house is situated on the south side of the street and faces north toward Main Street. It is a four-bay by two-bay, two-story structure with a rubble fieldstone foundation, German siding, and a gable roof with standing-seam metal. The house appears to be a frame structure, and not log. The north elevation has a door in the east-center bay that has one light over two bolection-moulded panels. The door is framed by pilaster strips with Greek ogee caps, has a plain frieze, and a cornice with cavetto moulding. There is a single oval-light transom above the door. The remaining three openings on the first story have 2/2 sash with architrave trim that has a large interior bead and an astragal moulding across the top. The windows have blinds and cast iron shutter hold-fasts in a rosette pattern. There is a one-story, two-bay porch centered on the first story. It has a half-hip roof with standing-seam metal, two large turned posts with jigsaw brackets and an ogee bed mould. The second story has four typical 2/2 sash. There is a boxed cornice with 15 pairs of jigsaw brackets.

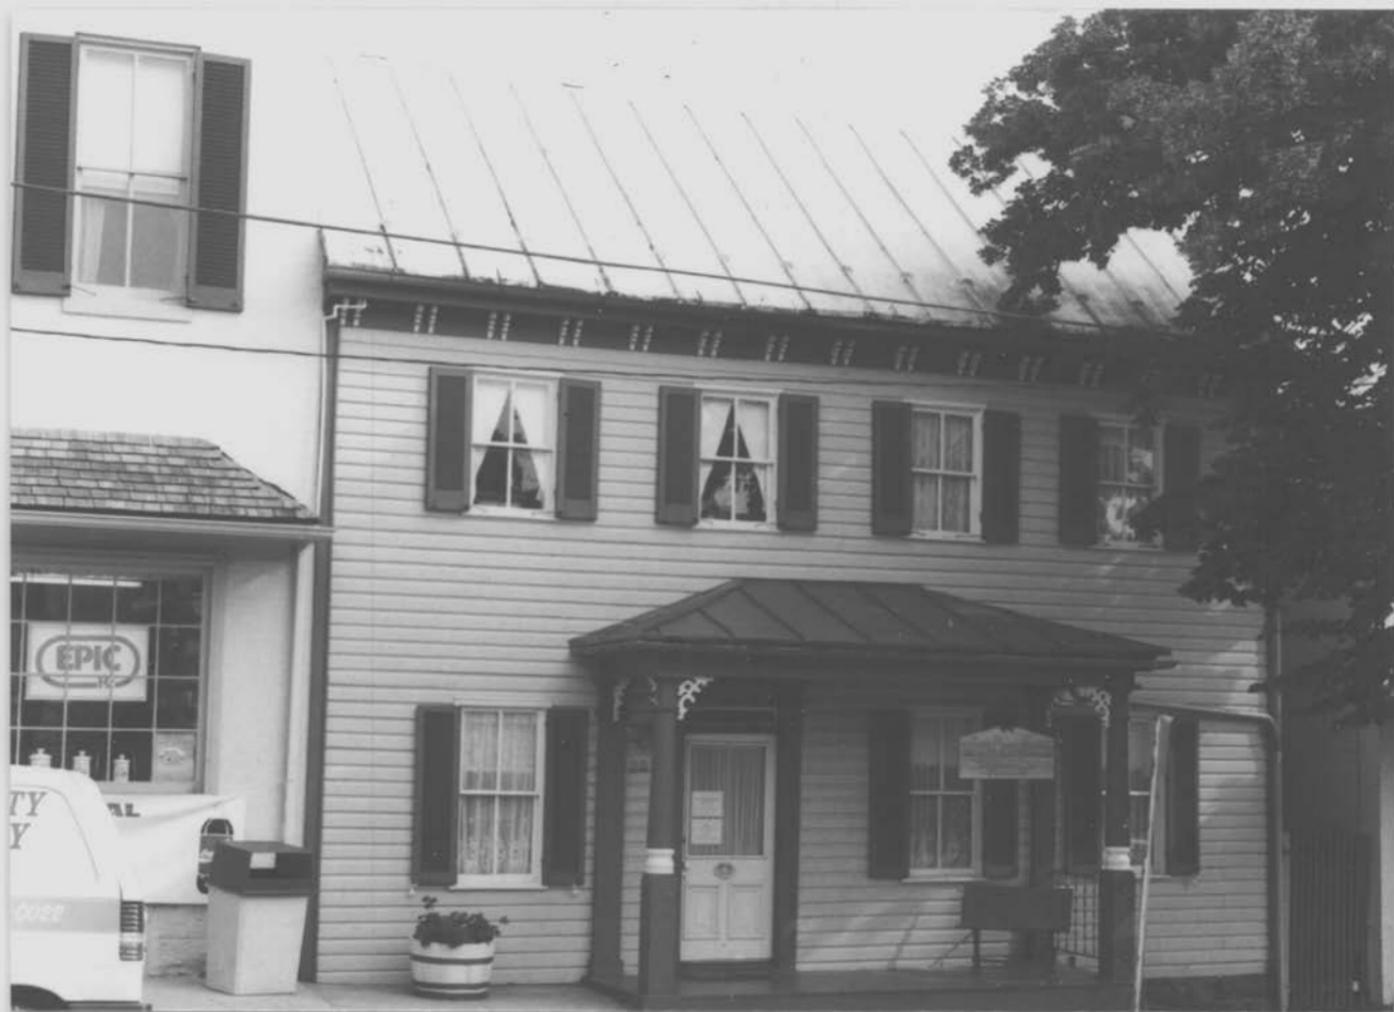
1/3

Neg. Loc.: Maryland Historical Trust
north elevation

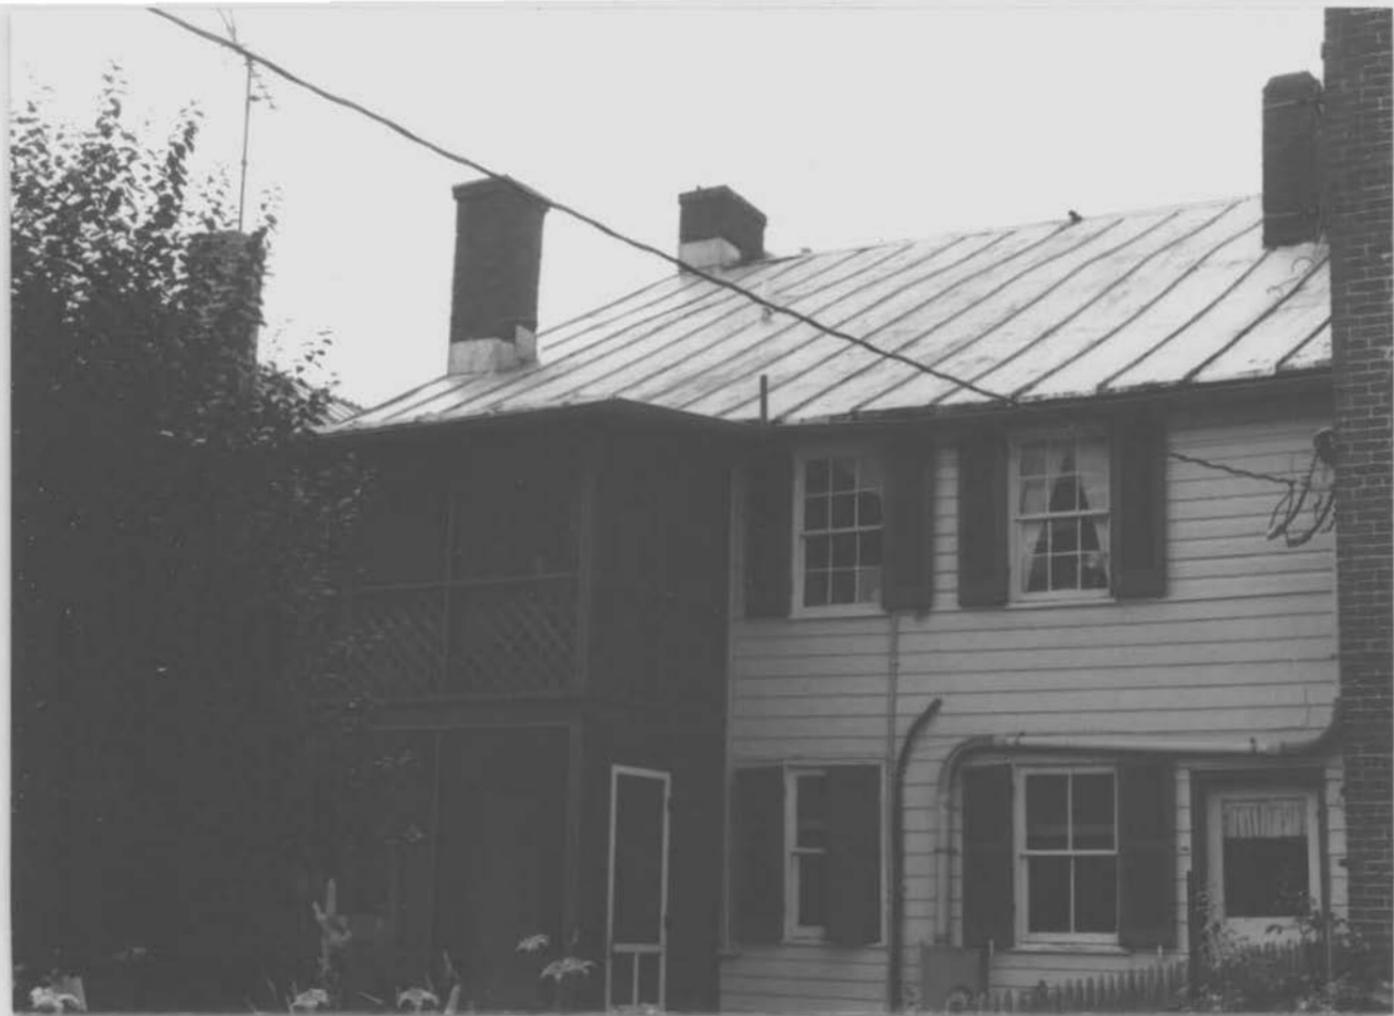
The south, or rear, elevation is six bays. It has a rubble stone foundation of Sam's Creek metabasalt and clapboard siding. The first story, from west to east, has a 6/6 sash in a beaded interior edge surround that is miter cut. Then is a six-panel door that has sunk fields and ogee panel moulds. The architrave matches that on the north windows. East of the door is a 6/6 sash with a typical architrave and shutter hardware. Next come two 2/2 sash with a typical architrave, and the east bay has a door with one light over two panels. The panels have sunk fields and bevelled panel moulds. The architrave on the door matches the north elevation trim.

The second story of the south elevation has clapboard siding up to the window sill level where there is a moulding, and then has German siding above this. There is a 6/6 sash with typical architrave set between the west bay and the west-west-center bay. There is a beaded-edge vertical board door with a four light sash in the west-center bay, and this has a plain surround. The east-center bay has a 6/6 sash with typical architrave trim. The east-east-center bay also has a 6/6 sash with typical architrave, and there is no opening in the east bay. There is a later two-story porch on brick piers in the west three bays. The roof has a salt box profile with the long side on the south. There is an interior brick chimney on the west, centered on the ridge, another on the west, set south of the ridge, and one near the east, set south of the ridge.

South elevation

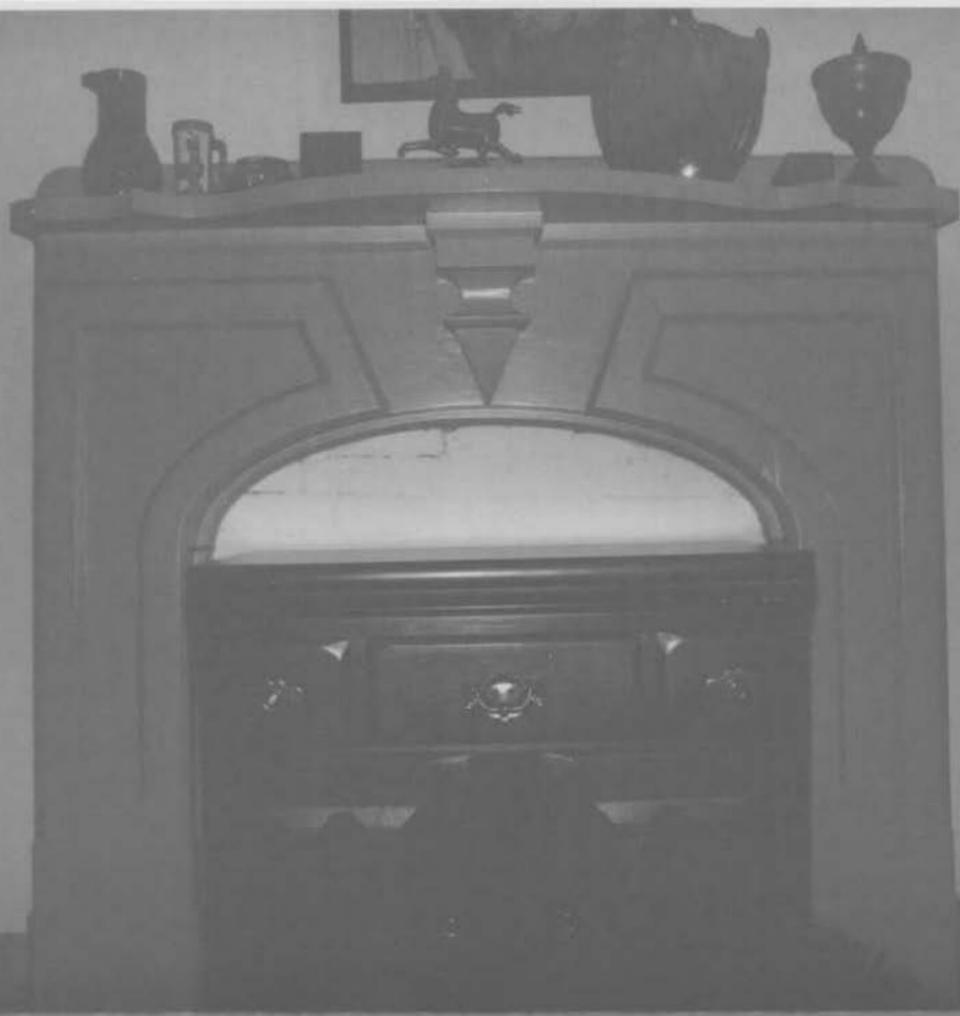
3/3

Neg. Loc.: Maryland Historical Trust
northwest room mantle
