CARR-1408

Sensenev Farm Tenant House
Linwood (vicinity)

Maryland Historical Trust State Historic Sites Inventory Form

historic Senseney Farm Tenant House

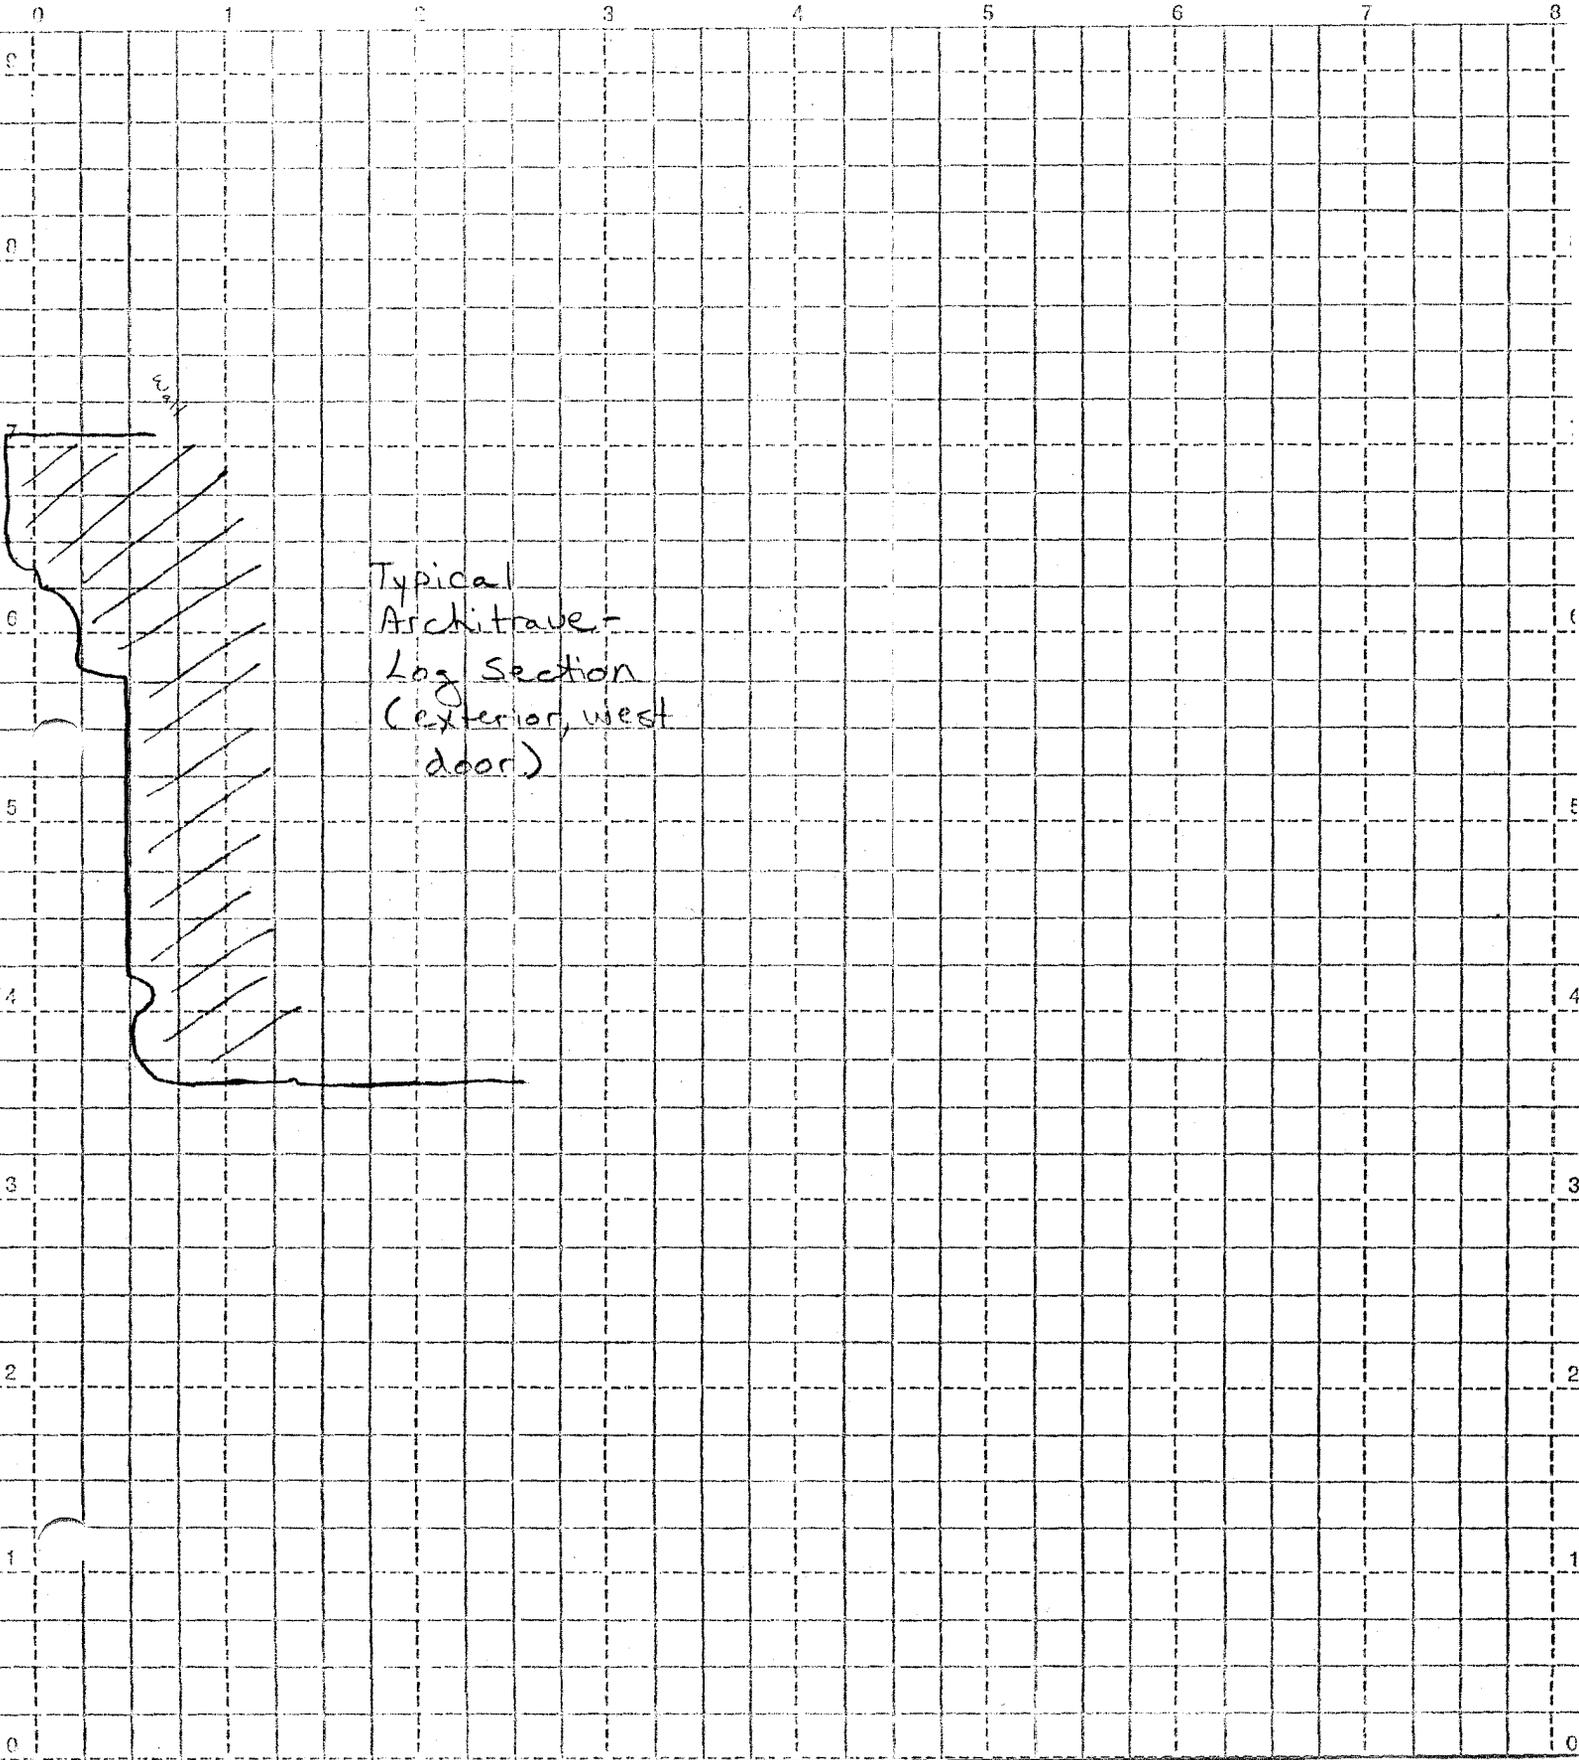
Moulding Profile

Typical
Architrave -
Log Section
(exterior, west
door)

On the west elevation, the first story has a center entrance with a two-panel door. The panels have sunk fields and quirked Greek ogee panel moulds. The architrave has a cavetto backband and a beaded interior edge. On either side of the entrance is a former 6/6 sash with the same architrave. The vertical-board siding on this elevation is mill sawn and fastened with cut nails. The logs beneath the siding are whitewashed. There is a one-story, one-bay porch that has a concrete deck. The porch has been vandalized, but originally had

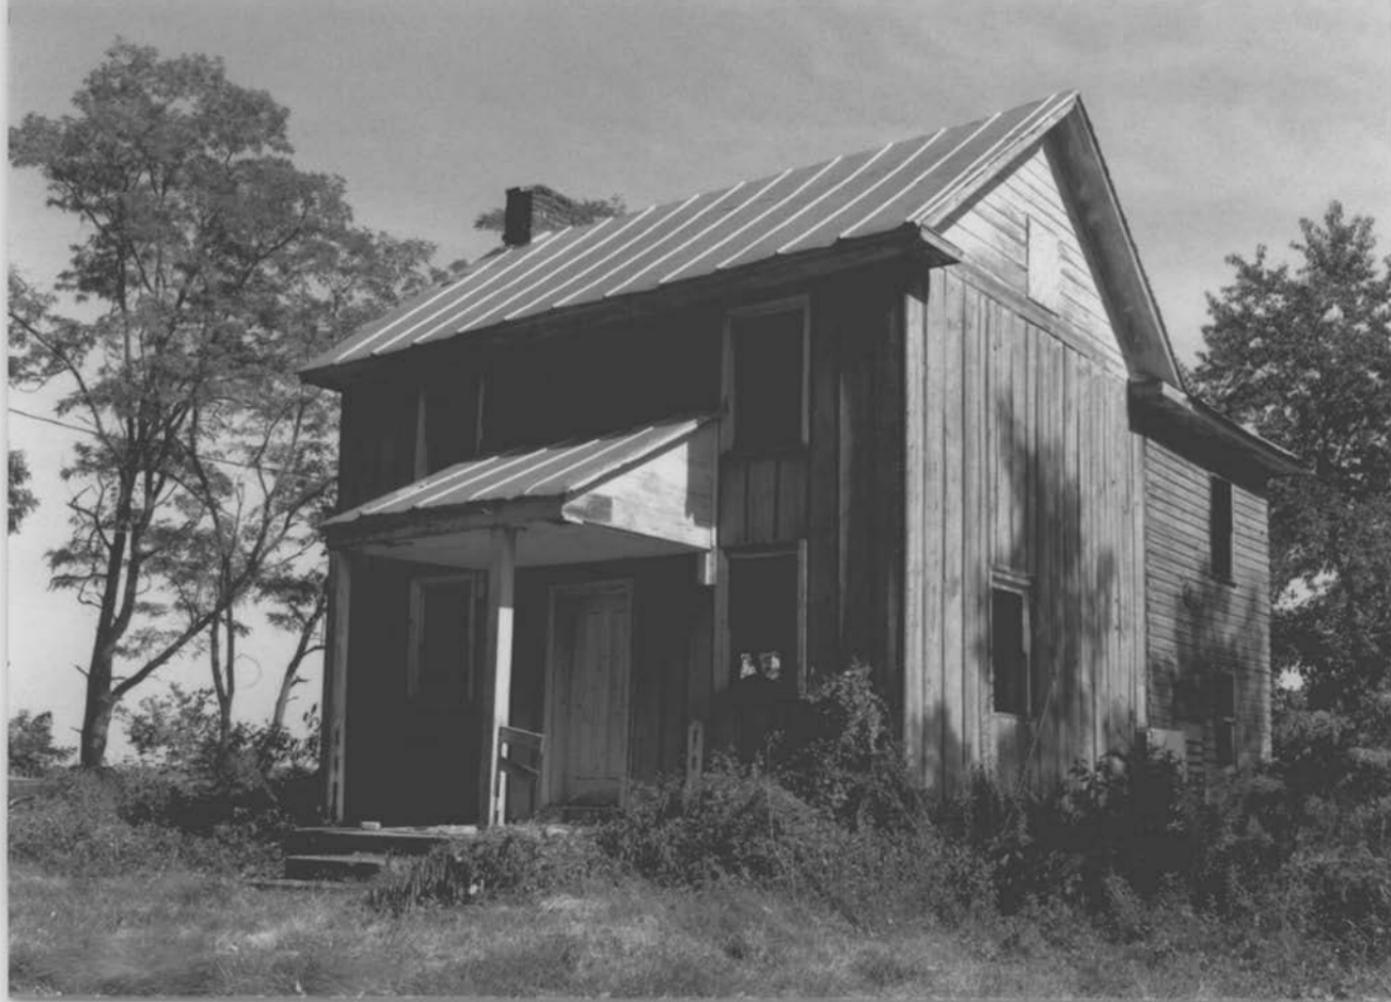
1/3

Neg. Loc.: Maryland Historical Trust
west and south elevs.

The south elevation of the main block has stone stairs that lead down to a doorway in the east bay for the foundation. This doorway has a vertical-board door. On the first story, is a former 6/6 double-hung sash set west of center. It has a typical architrave. The second story has no openings. The gable end has a boarded-up opening and has weatherboard siding.

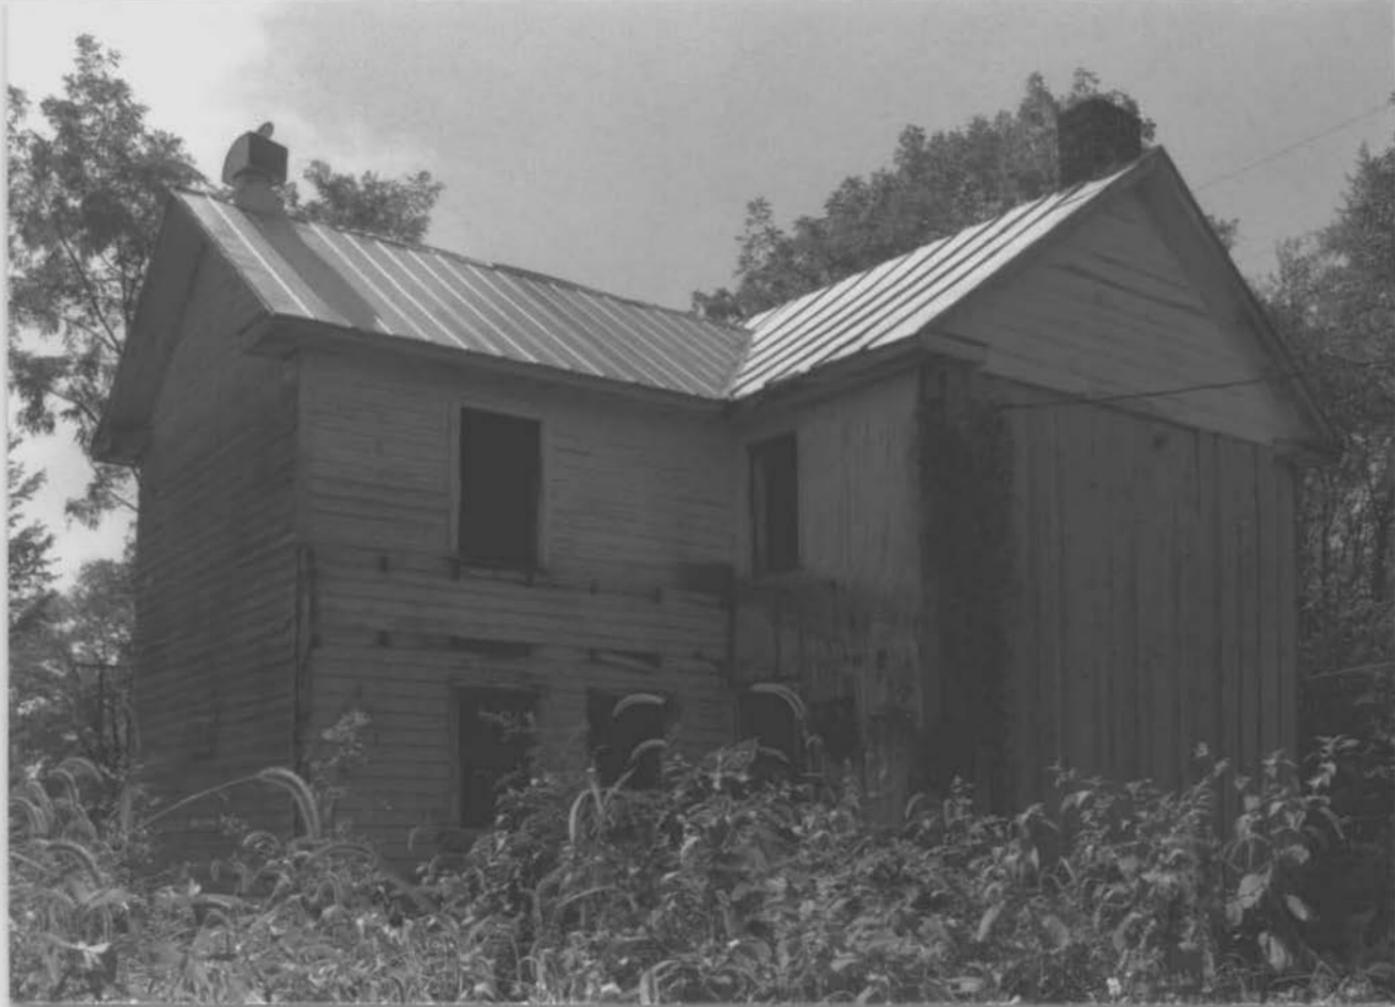
2/3

Neg. Loc.: Maryland Historical Trust
East and north elevs.

On the north elevation most of the vertical-board siding is circular sawn. There are no openings on this elevation. The gable end has random-width weatherboards. There is an ell addition attached to the east elevation at the center and south bays of the main block of the house. The north bay of the east elevation of the main block still retains its battens on the siding. The battens are wide and thin and have chamfered edges. The first story has a doorway, and the second story a window opening.

The north elevation of the ell on the first story has a window opening to the east, and a door opening to the west. The second story has a window opening to the east with nothing in the west bay. The ell originally had a shed-roof porch that was one story and was two-bays wide. The ghost of the profile of this porch can be seen on the east elevation of the main block. The east elevation of the ell has German siding and no openings. The south elevation of the ell also has German siding. The first story has a beaded-edge, vertical-board door set to the west that is now boarded over. The east bay has a former 6/6 sash set in a plain frame. The second story has nothing in the west bay. The east bay has a window opening with a plain frame. There is a wood-boxed cornice with returns and an interior brick chimney on the east end.

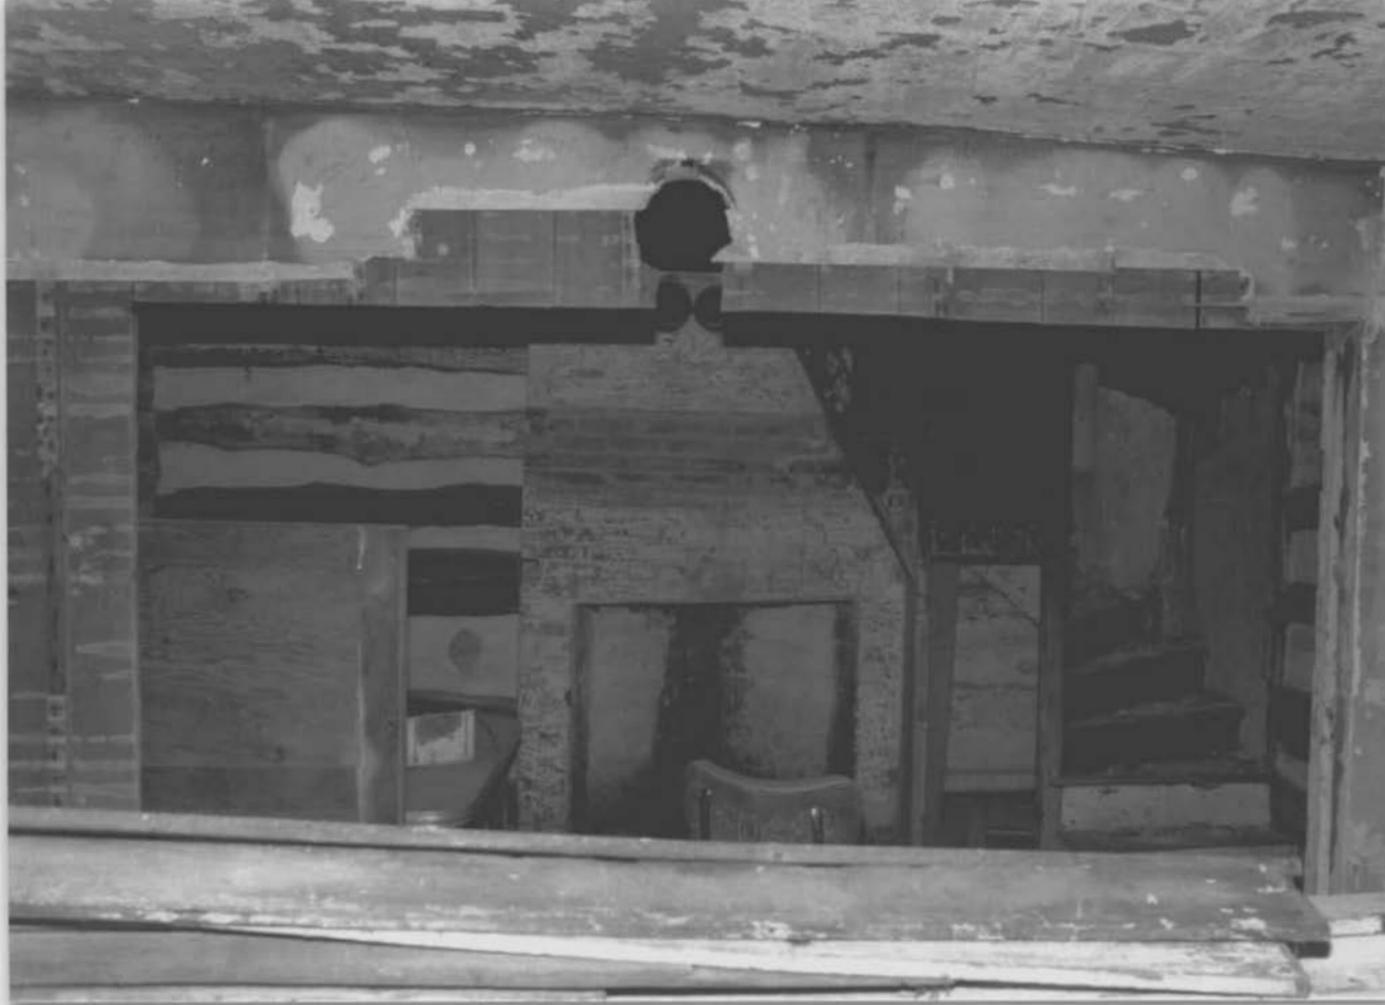
3/3

Interior - 1st story, view north

The first story is divided into two rooms by a beaded-edge, random-width, vertical-board wall that runs east-west and is set north of the center entrance. The boards appear to alternate between having tongues on both sides and having grooves on both sides. The west door opens into the south room. It has a random-width floor that runs north-south and is face-nailed with cut nails. The level of this floor is lower than that in the north room by about the thickness of the boards. The walls are plastered over vertical lath that appears to be circular sawn and fastened with cut nails. The openings have an architrave with a cavetto backband that is applied, and a beaded interior edge. The door on the west elevation has the same architrave. It has two panels with sunk fields and applied, quirked Greek ogee panel moulds. It is hung on cast iron butt hinges. The lock is missing. The door has an earlier grained finish under later paint. The north wall of the vertical boards is covered with horizontal lath and plaster and has a baseboard of German siding. There is a large opening in this wall that is a later alteration. Earlier, there was an average-size door hung on butt hinges on this wall. The rest of the room has a baseboard with a beaded top edge. The ceiling is plastered.

In the north room the floor has random-width boards that run east-west. They are face-nailed with wrought nails. The ceiling and walls have had their lath and plaster removed. The joists are mill sawn and are 6½ to 7½ inches deep by 2¾ inches wide. They are spaced 23½ to 25 inches on centers. There is a brick fireplace centered on the north wall. It is shallow, has splayed jambs, and has a metal lintel. There is a brick hearth, and there is no mantel now. The fireplace is whitewashed. The east wall has a doorway to the outside that appears to be an original opening. There is an enclosed winder stair in the northeast corner that has beaded-edge vertical boards. It had a door that was hung on cast iron butt hinges. The boards that enclose the stair alternate between having tongues with beads on both sides and grooves on both sides. The toenails in the board wall are not visible for inspection. Underneath the stair is plaster over both mill-sawn and circular-sawn lath that is attached with cut nails.
