CARR-1410

Michael Morelock, Jr. Farm
Westminster (vicinity)

**Maryland Historical Trust
State Historic Sites Inventory Form**

Survey No. CARR-1410

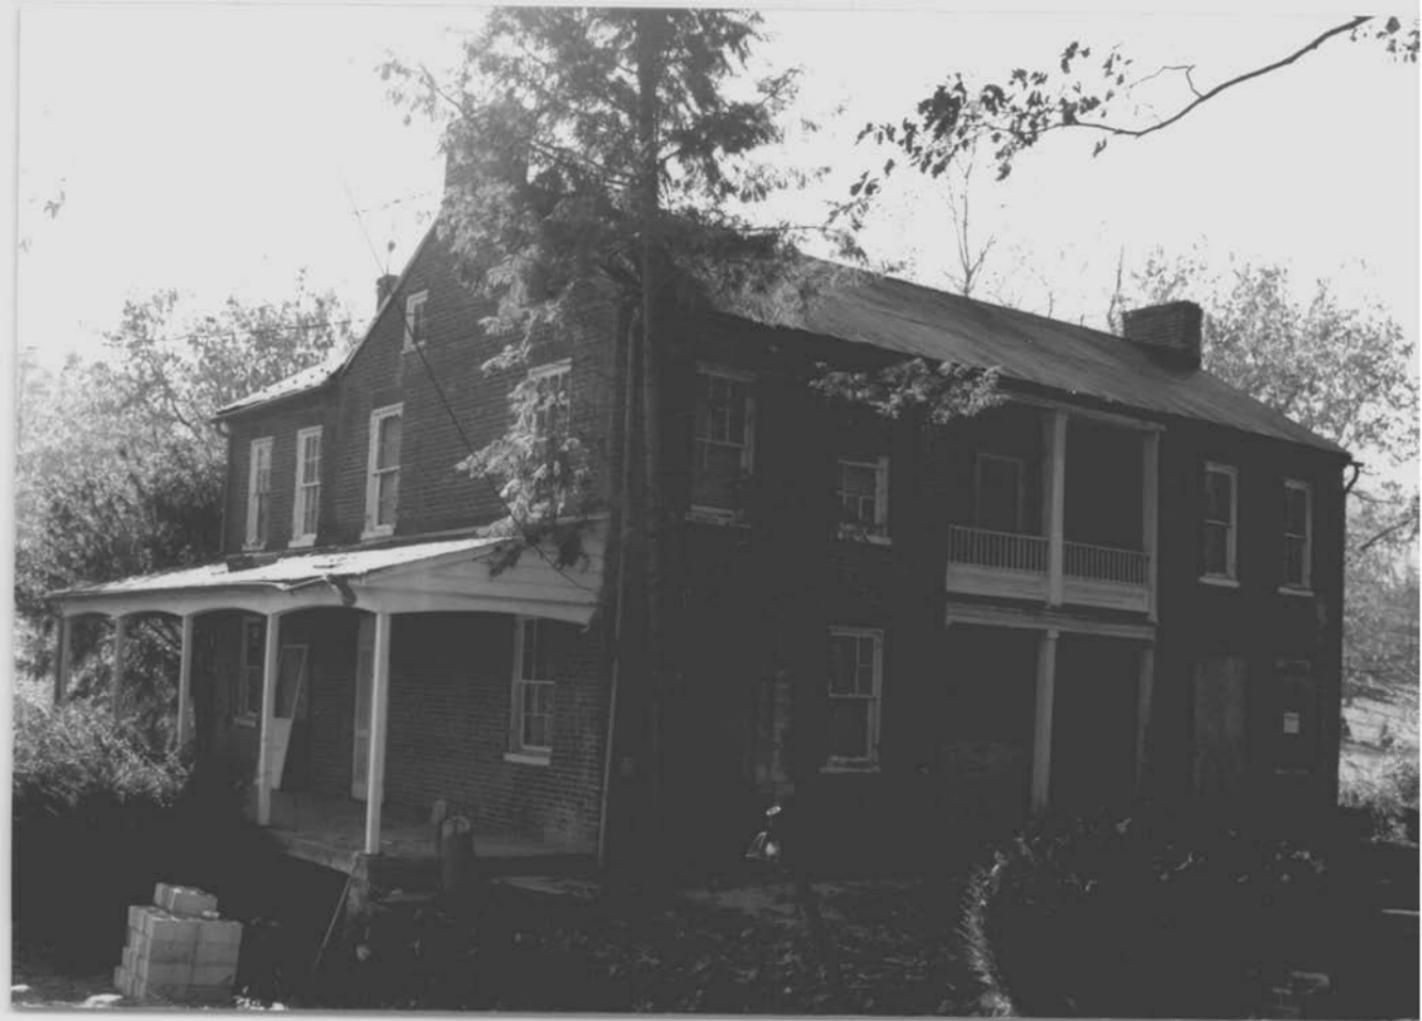
1/4

Neg. Loc.: Maryland Historical Trust
northeast & northwest elevs.

The northwest elevation has running bond brick. The first story has the two center bays recessed and filled with a two-story porch. From north to west, on the first story, there is a boarded-up window opening, then a 6/6 double hung sash in a bullnose frame with a wood sill, a splayed brick jack arch, and blinds. The two western bays are boarded up, but appear to have typical 6/6 sash. In the recess on the first story, the southwest elevation has a six-panel door with three tall narrow panels set above three short narrow panels. The

The northeast elevation has an exposed foundation of brick. The ell and the main block are all set in the same plane. The east bay of the ell has a 6/6 sash in a beaded-interior-edge frame with a wood sill, a splayed brick jack arch, and shutter hardware. The east-center bay, also in the ell, has a beaded-edge, vertical-board door in a beaded-interior-edge frame with one panel in each jamb and one in the soffit. The panels have sunk fields with no panel moulds, and the doorway has a splayed brick jack arch. The door is hung on cast iron butt hinges. The north-center bay, which is in the main block, has a door with six lights over two panels. The panels have sunk fields and no moulds. The door frame and paneled jambs are identical to those in the east-center bay. There is a plain header course acting as the lintel. The north bay is in the main block and has a 6/6 sash like that found in the east bay of this elevation foundation. There is a new concrete porch deck set on brick piers at the first story level of this elevation. The brick cheek wall on the southeast appears to be original, as does the rubble stone cheek wall on the northwest. The first story, from east to north, has in the east bay a typical 6/6 sash. The east-center bay has a boarded-up door opening that contains a newer six-panel dutch door with typical jambs and soffits found on this house. It also has a splayed brick jack arch and a transom but this area has been bricked in. The doorway has a bullnose frame below the transom area suggesting that one was not there originally, or that there was a different arrangement to the transom than on the other doors. The north-center bay has door-height blinds and behind them a four-panel door. The bottom panels have sunk fields and quirked Greek ogee-and-bevel moulds. The top panels have ovolo moulds. The transom bar appears to have had a moulding that has now been removed. There is a four-light transom. The paneled soffit and jambs match those on the northwest elevation. This door has been closed off, and there are now shelves added in here. The north bay has a typical 6/6 sash. This elevation has 5-to-1 common bond brick with striping or penciling. There is a one-story, four-bay porch on this elevation with four new square wood posts. It has V-grooved wood board ceiling that is wirenailed, and a shed roof with asphalt shingles. The second story has four typical 6/6 sash. The gable end of the main block has two four-light sash like those on the southwest, and has tapered wood rakeboards.

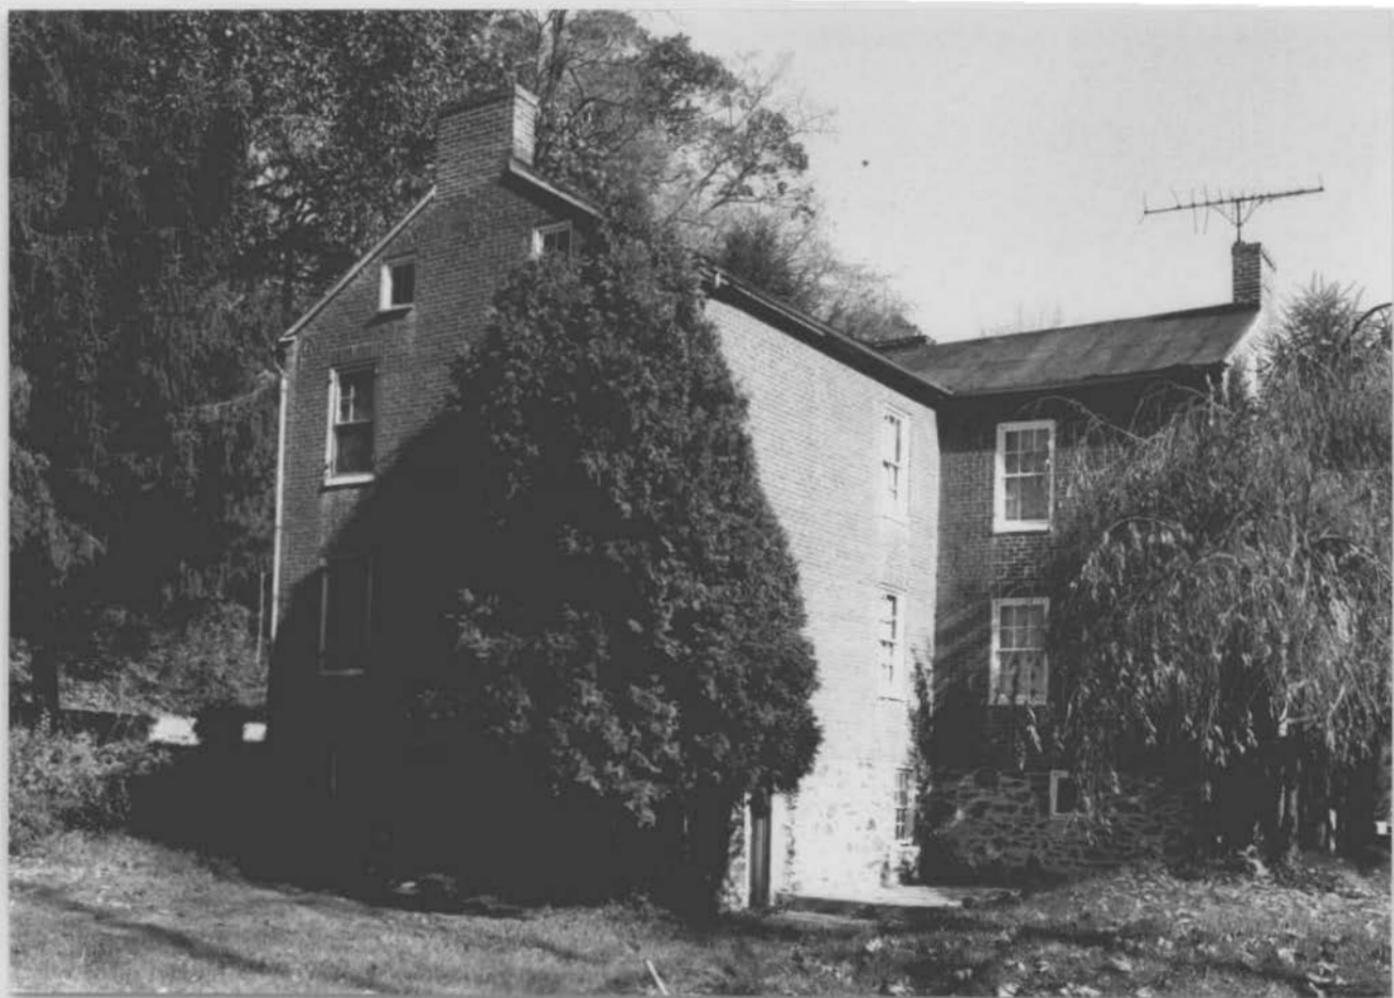
2/4

Southwest: southeast elevs.

The southwest elevation has an exposed foundation with two four-light sash in beaded-interior-edge frames. They have a wood sill and a splayed brick jack arch. This elevation has 5-to-1 common bond brick, with two typical 6/6 sash on both the first and second stories. The gable end has two four-light sash in bullnose-moulded frames with wood sills, but no lintels. There are tapered wood rakeboards.

The southeast elevation of the main block has an exposed foundation. The south bay has the remains of a tongue-and-grooved, vertical-board door set in a narrowed later opening. Behind this door are V-grooved, vertical-board double doors. Two iron bars act as a lintel for the header course above this door opening. The east bay of the foundation has a 6/6 double hung sash in a beaded-interior-edge frame. There is a concrete sill, a splayed brick jack arch, and shutter hardware. On the first and second stories there are no openings in the south bay, while the east bay has a typical 6/6 sash. The walls on this elevation are mostly 5-to-1 common bond brick, but also have 4-to-1, 6-to-1 and 7-to-1. The cornice has three corbelled header courses.

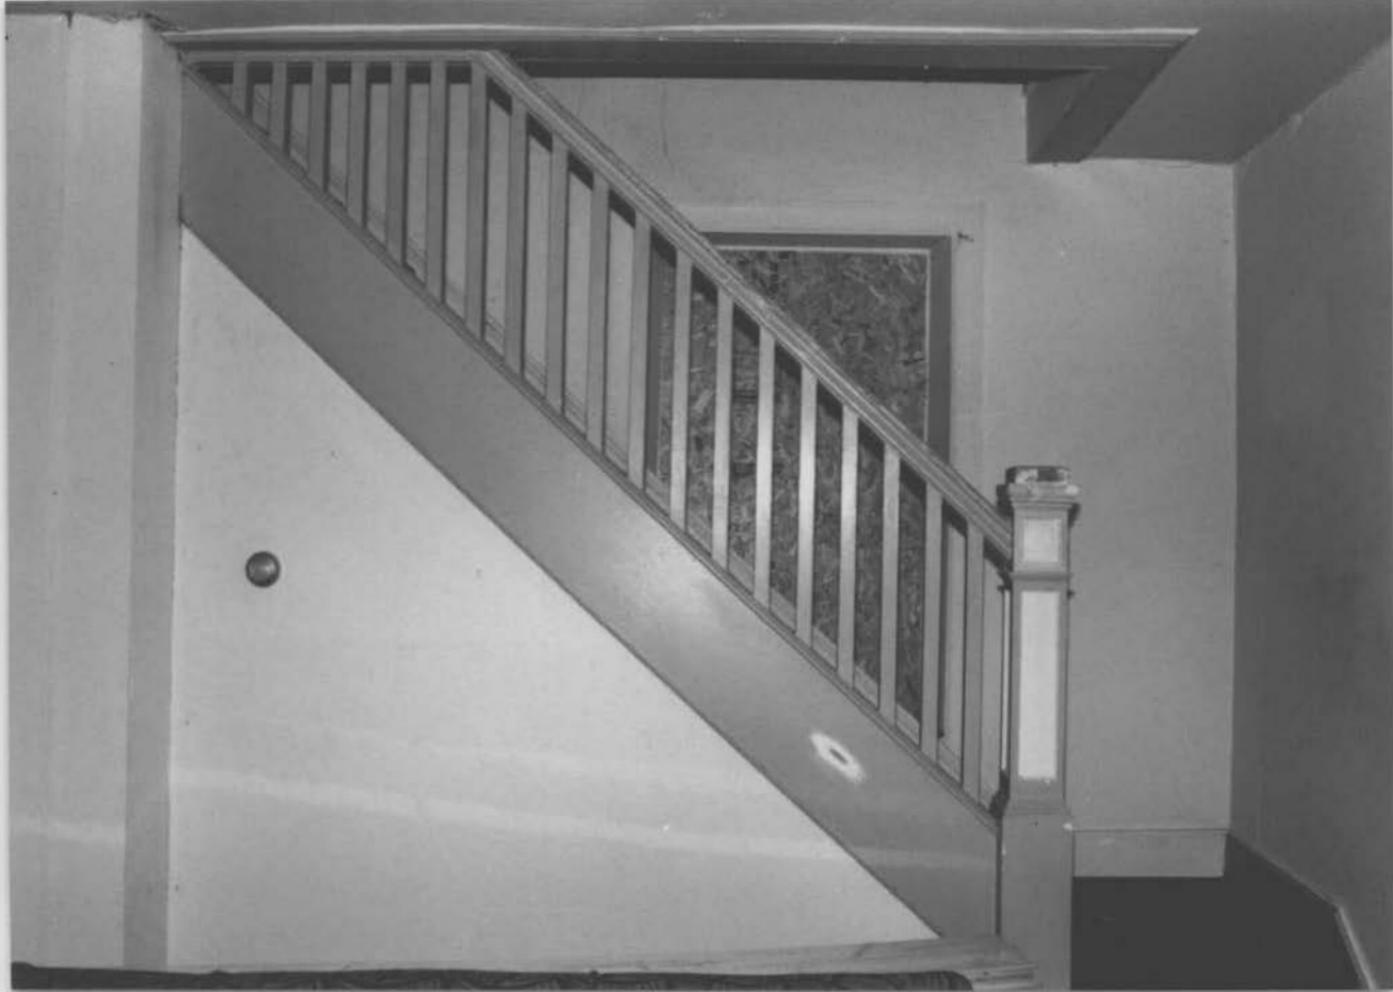
3/4

1st story stairs

The first story has a center entrance hall, single-pile plan with a single room in the ell. The center hall has a dog leg run of stairs along the southeast wall, with a closed stringer of square-in-plan balusters, a moulded handrail, and a square newel post of oak. It is paneled, with sunk flat panels that have small ovolo panel moulds. There are two steps up to a landing in the south corner. The stairs appear to date from about the 1920's. The stairway cuts through a window on the southeast elevation. The window architrave has a small ogee on the inner edge and a small ogee at the break between the field and the plain backband. On the ceiling around the stair opening is a flat trim board with a quirked ogee-and-bevel moulding at the junction of this board with the ceiling plaster. The rear stringer of the stairs has a quirked ogee-and-bevel moulding along the top edge suggesting that an original staircase was located in the same position. There is random-width pine flooring that runs northwest to southeast. The boards range from 5 to 5½ inches wide, but most are 5 inches wide. They are face-nailed with cut nails, and some of the boards are of a wood other than pine. The baseboard has a quirked ogee and bevel on the top. The architraves are symmetrical and are concave, with a beaded interior edge and plain corner blocks. The window sill has a quirked ogee on the bottom edge, with a broken field beneath it and a beaded bottom edge. The window jambs are splayed, but have plain boards. There is a door on each side of the hall leading to the rooms on each end, and a door under the stairs to the rear ell as well as a door under the stairs to the cellar. The cellar door has four panels with sunk fields and no panel moulds. It has a plain cast iron rim lock. The architrave has a large quirked Greek ogee and bevel with a plain backband. The door is hung on plain cast iron butt hinges. The doors to the other rooms have sunk fields with no moulds on the center entrance hall side. They have cast iron rim locks with mineral knobs on the front door.
