**NATIONAL REGISTER OF HISTORIC PLACES
REGISTRATION FORM**

historic name Orendorff, John, Farm

CARR-1425
Orendorff, John, Farm
Carroll County, MD

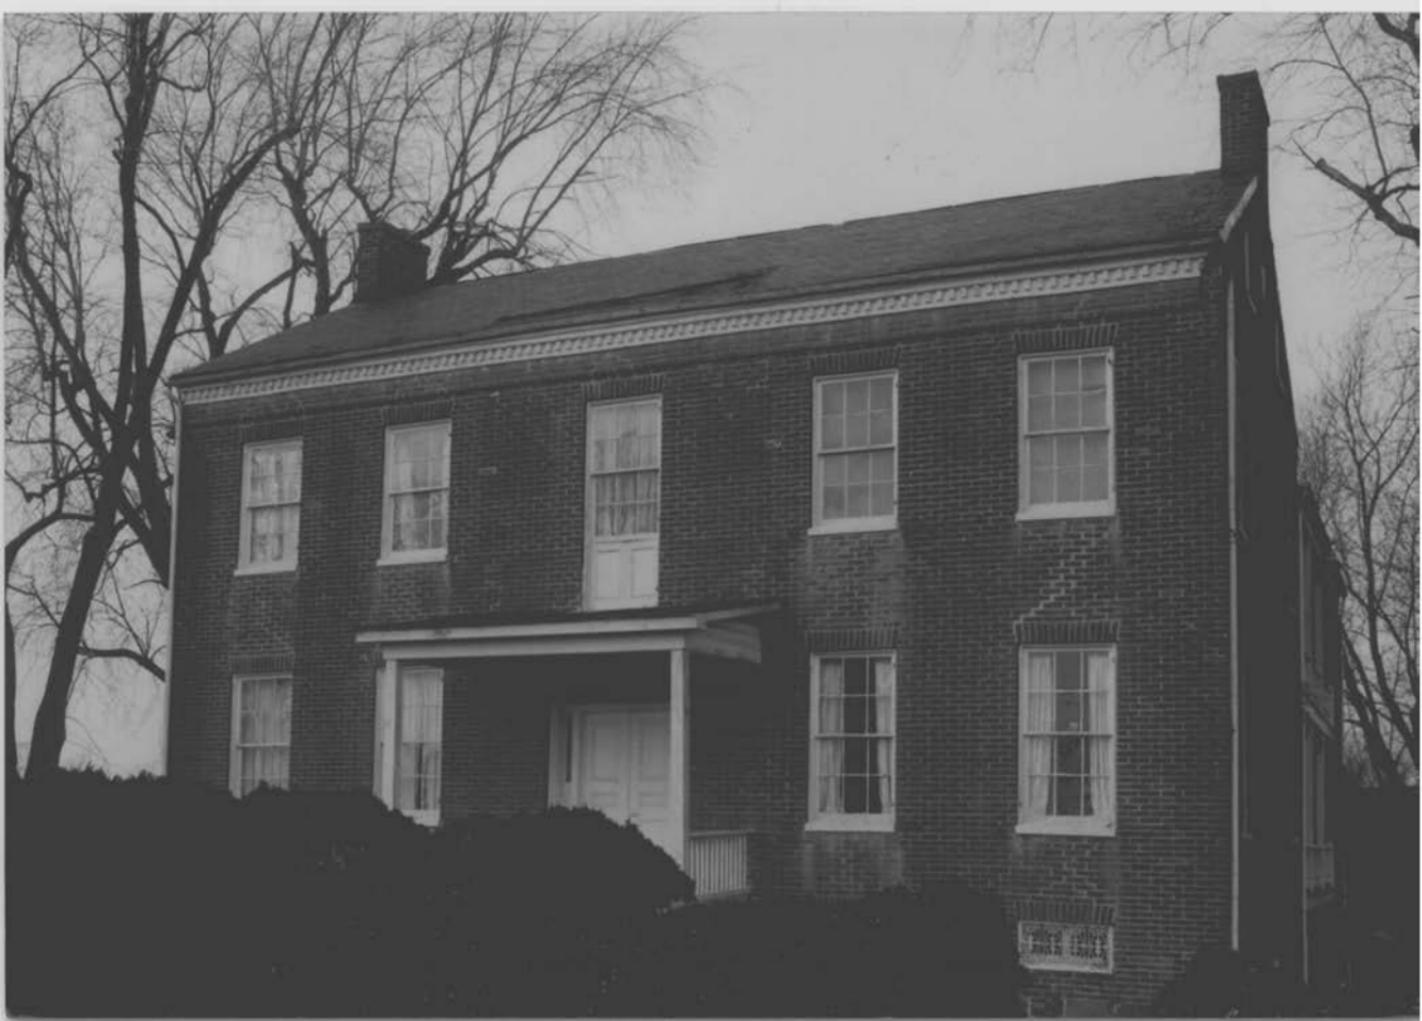
12

House - west side south elev.

The west elevation of the main block has 5-to-1 common bond brick. The foundation has two paired one-light casements like those on the south elevation, but without grills. The first and second stories have two 6/6 sash each. The gable end has two 2/2 sash in a bullnose frame with a wood sill and a straight brick jack arch. There are insulators for a lightning rod down the center of this elevation. The rakeboards have been altered.

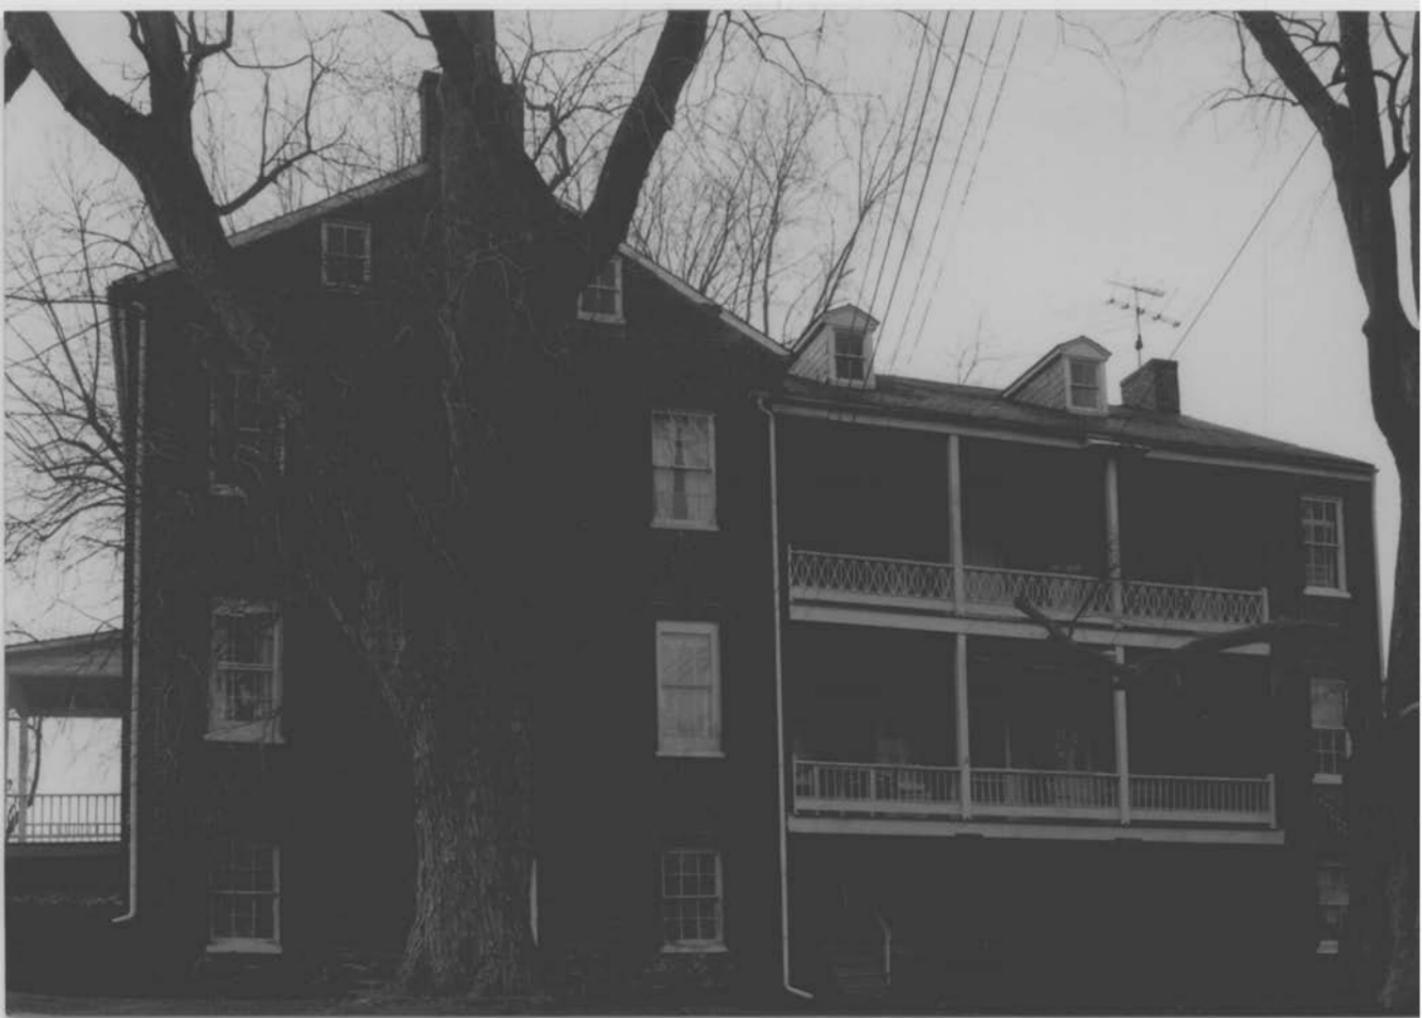
1/13

Neg. Loc. Maryland Historical Trust
House - South elev.

iron grill with a fleur de lis in the four end bays. The center bay has a brick porch foundation that is not tied into the house. The first and second stories have running bond. The first story has a center entrance with paired doors. Each half has three panels, with a lying panel in the center and a square panel at the bottom. There are sidelights with two lights over two panels. These panels line up with the door panels. There is also a six-light transom. The transom bar is fluted, as are the sidelight stiles. There is a marble sill and a bullnose frame. There is a one-story, one-bay porch with two square posts that have square-in-plan balusters on each side of the porch. The porch has a wood box cornice and an inverted-V-seam metal shed roof. There are two 6/6 double-hung sash on each side of the door. They each have a wood sill, a splayed brick jack arch, and a bullnose frame. They had blinds with cast iron shell-pattern shutter holdfasts. The sash are pegged. The second story has four shorter 6/6 sash. The center bay has a typical 6/6 sash with a jib window that has two one-panel doors below the sash. The brick cornice has a projecting brick frieze and brick dentils with three corbelled courses above. There is an interior brick chimney on each end, centered on the gable ridge.

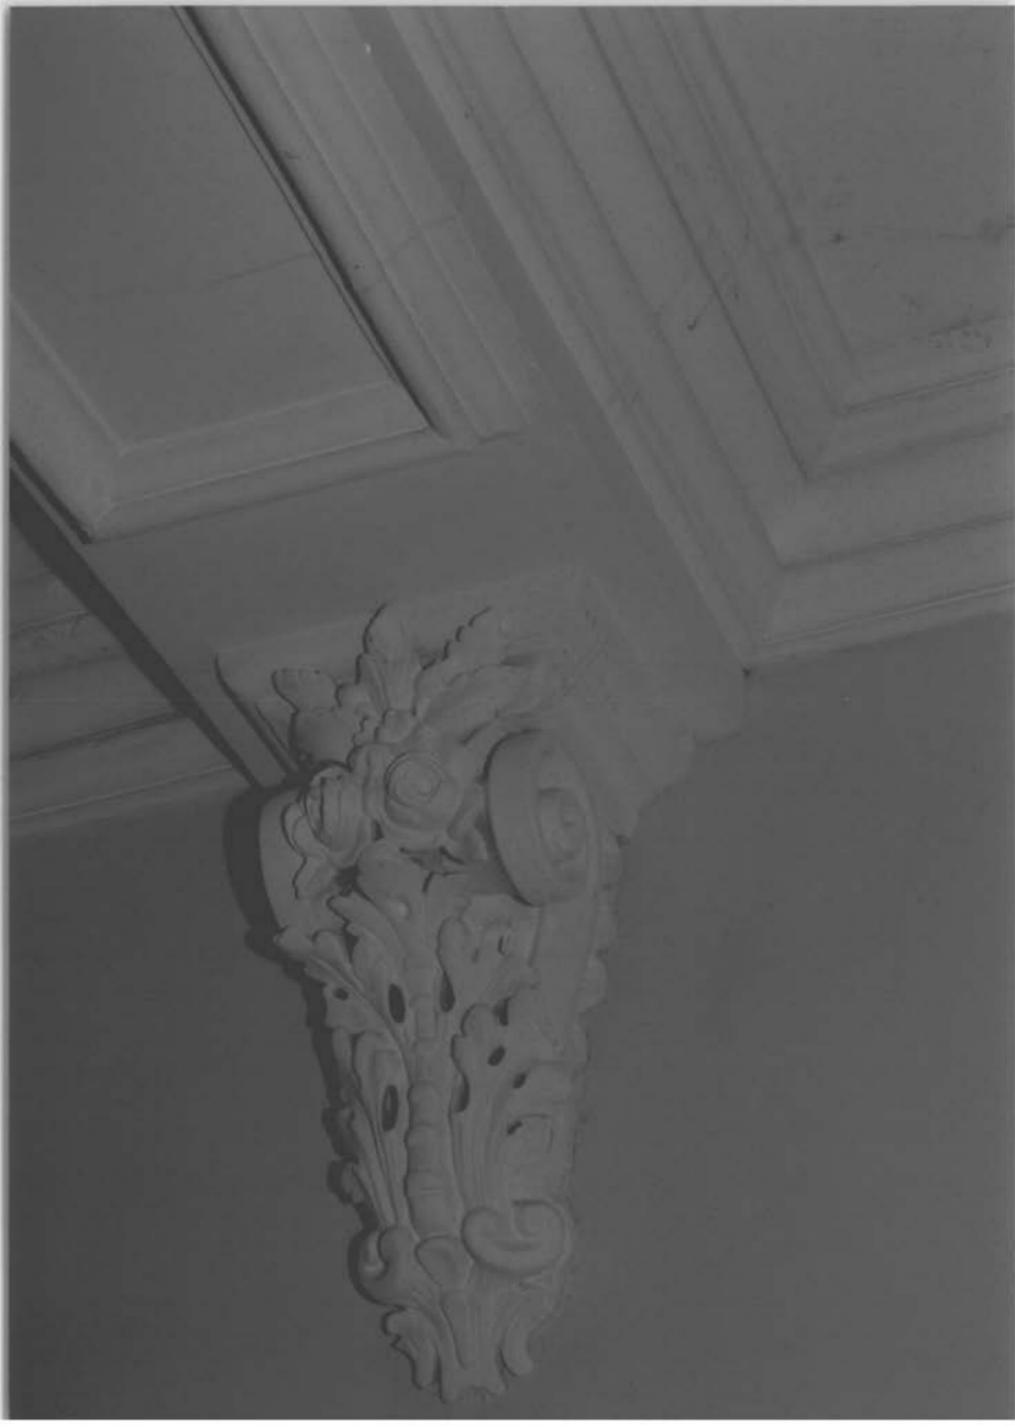
5/18

Neg. Loc.: Maryland Historical Trust
west room ceiling medallion

The west room is one large room with 5½ to 6-¾ inch wide, random-width flooring that runs north-south. The baseboard, architrave, doors, and cornice all are identical to the passage. This room also has a plaster band on the ceiling that has a torus flanked by a cavetto on either side. In the center of the room, running east-west, is a beam that may or may not be structural. The soffit has the same plaster band as is found on the ceiling, done to create two panels. Each end of the beam has a plaster bracket. It has a volute with an acanthus leaf under it and two rosettes on it. There is a Greek cavetto and ovolo above the volutes. The west wall has two identical fireplaces that have slightly splayed plastered jambs and a brick hearth. They have a wood mantel with plain pilaster strips and a plain frieze that has a segmental, depressed arch. There is a bevelled bed mould and a plain shelf. The window jambs are splayed, and there is one panel underneath each window that has a recessed field and a quirked Greek
