National Register of Historic Places
Registration Form

historic name STONER-SAUM FARM

other names/site number CARR-1435

**United States Department of the Interior
National Park Service****National Register of Historic Places
Continuation Sheet**STONER-SAUM FARM
Carroll County
MarylandSection number 7 Page 1**DESCRIPTION SUMMARY:**

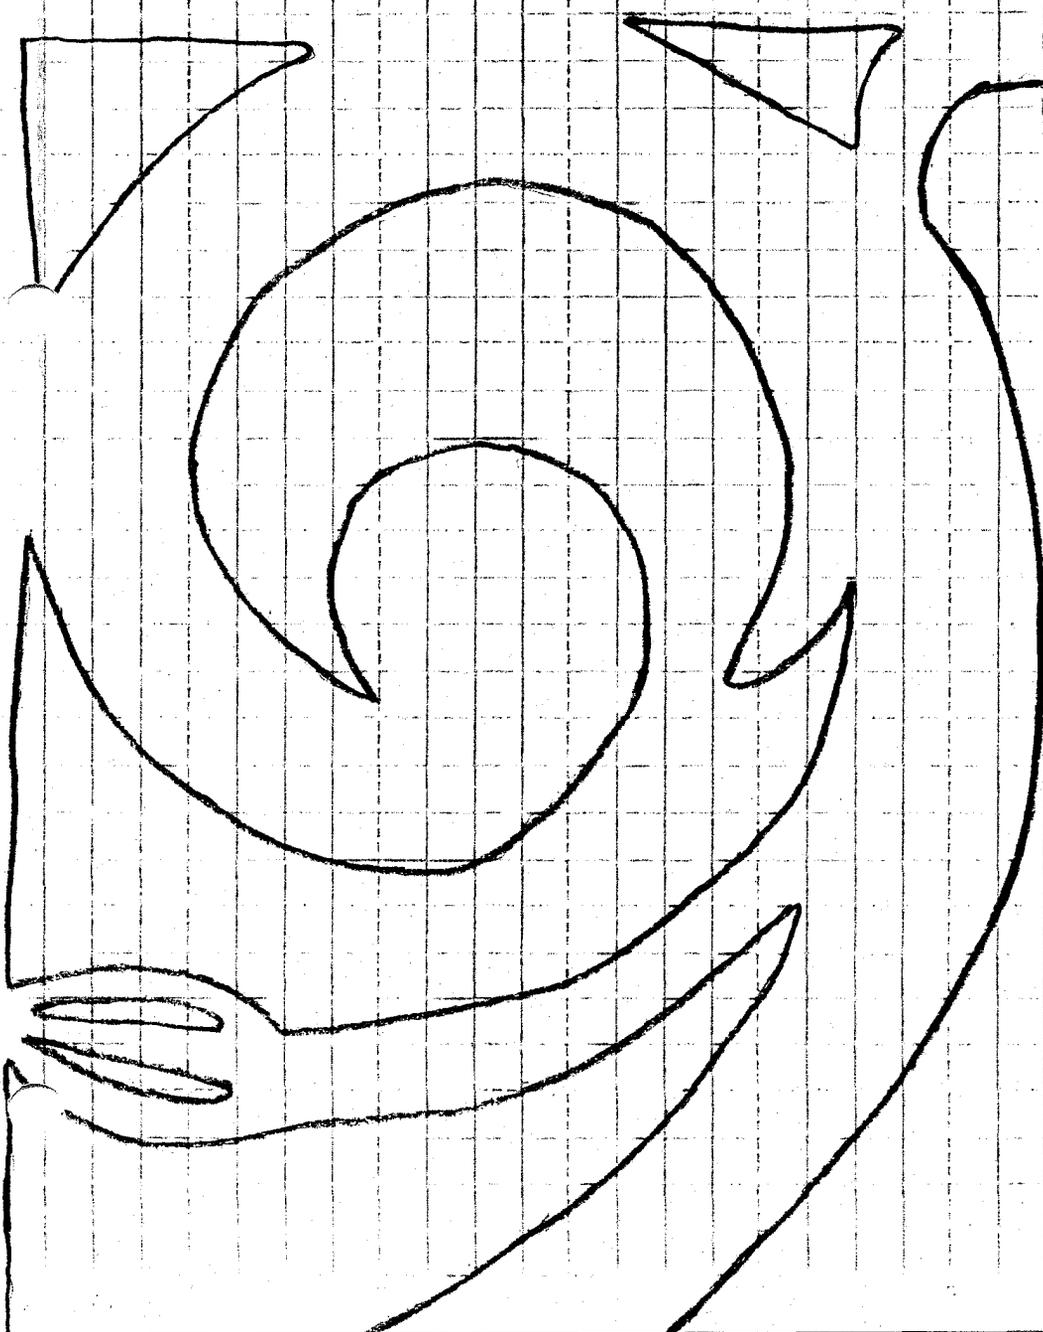
1A/4

1500 McKinstry Mill Rd
Stair Bracket

and stiles. There is a large cast iron rim lock with a brass knob that is set partly into the door. The chairrail along the stairs matches the profile of the hand rail. The interior doors have six panels with sunk fields, and ogee panel molds run on the rails and stiles. The original finish appears to be varnished, or grained and varnished. The doors are hung on butt hinges. The rim locks have been replaced with mortised locks that have stamped knobs and rubber covers like the one found in the cellar. The reverse sides of the doors are sunk, flat panels with no panel molds. There is a two-flight run of stairs on the north wall, with a landing at the west end. These stairs have an open stringer with foliate sawn brackets that contain a flower bud. The stringer has a beaded bottom edge. There are rectangular balusters with projecting beads at the corners. The hand rail is molded with a cavetto under each side and a bead at the bottom corners. There is a turned, tapered newel. There are beaded-edge vertical boards beneath the stringer, and a new doorway and two-panel door underneath the stairs.

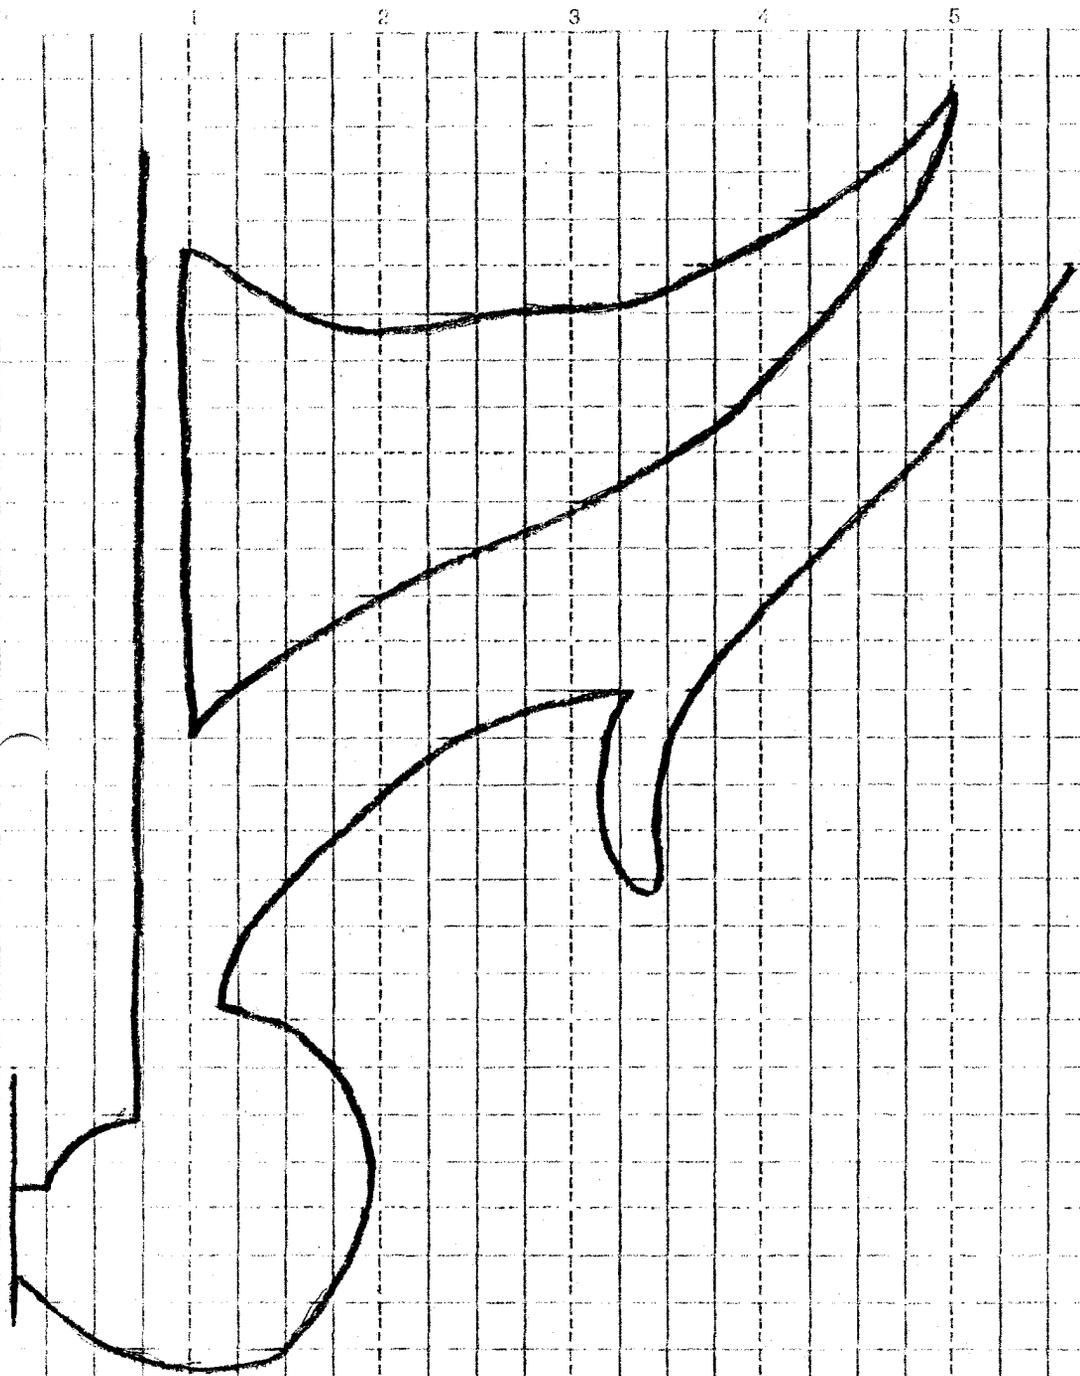
13/4

1500 McKinstry Mill Rd
Stair Bracket & Moulding Profiles

Baluster Profile

Handrail Profile

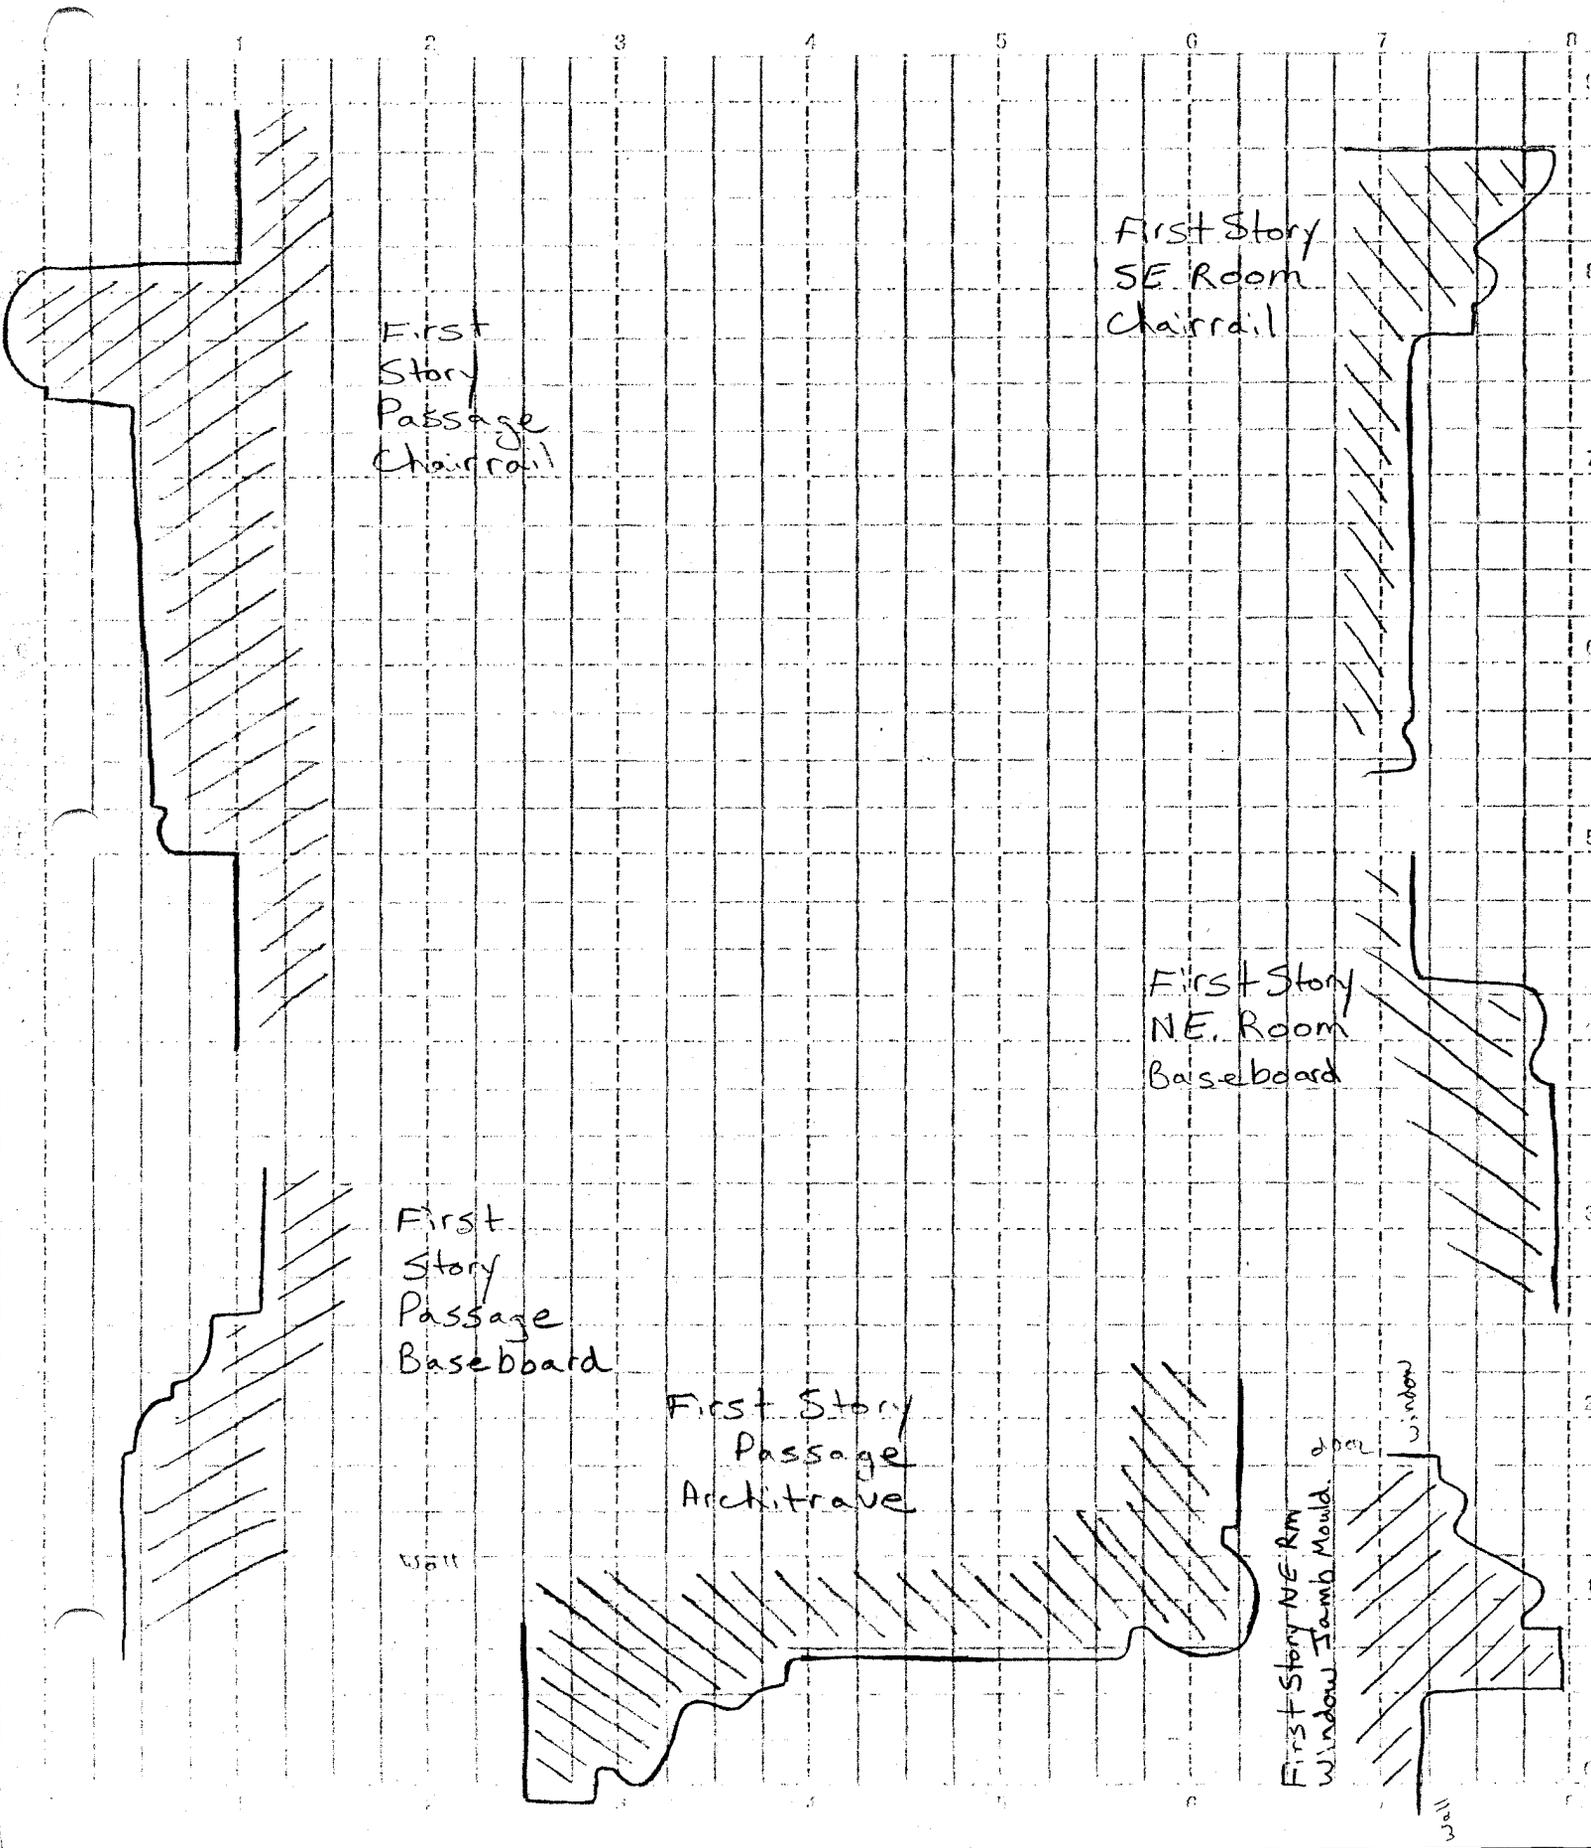
(2/4)

1500 McKinstry Mill Rd Moulding Profiles

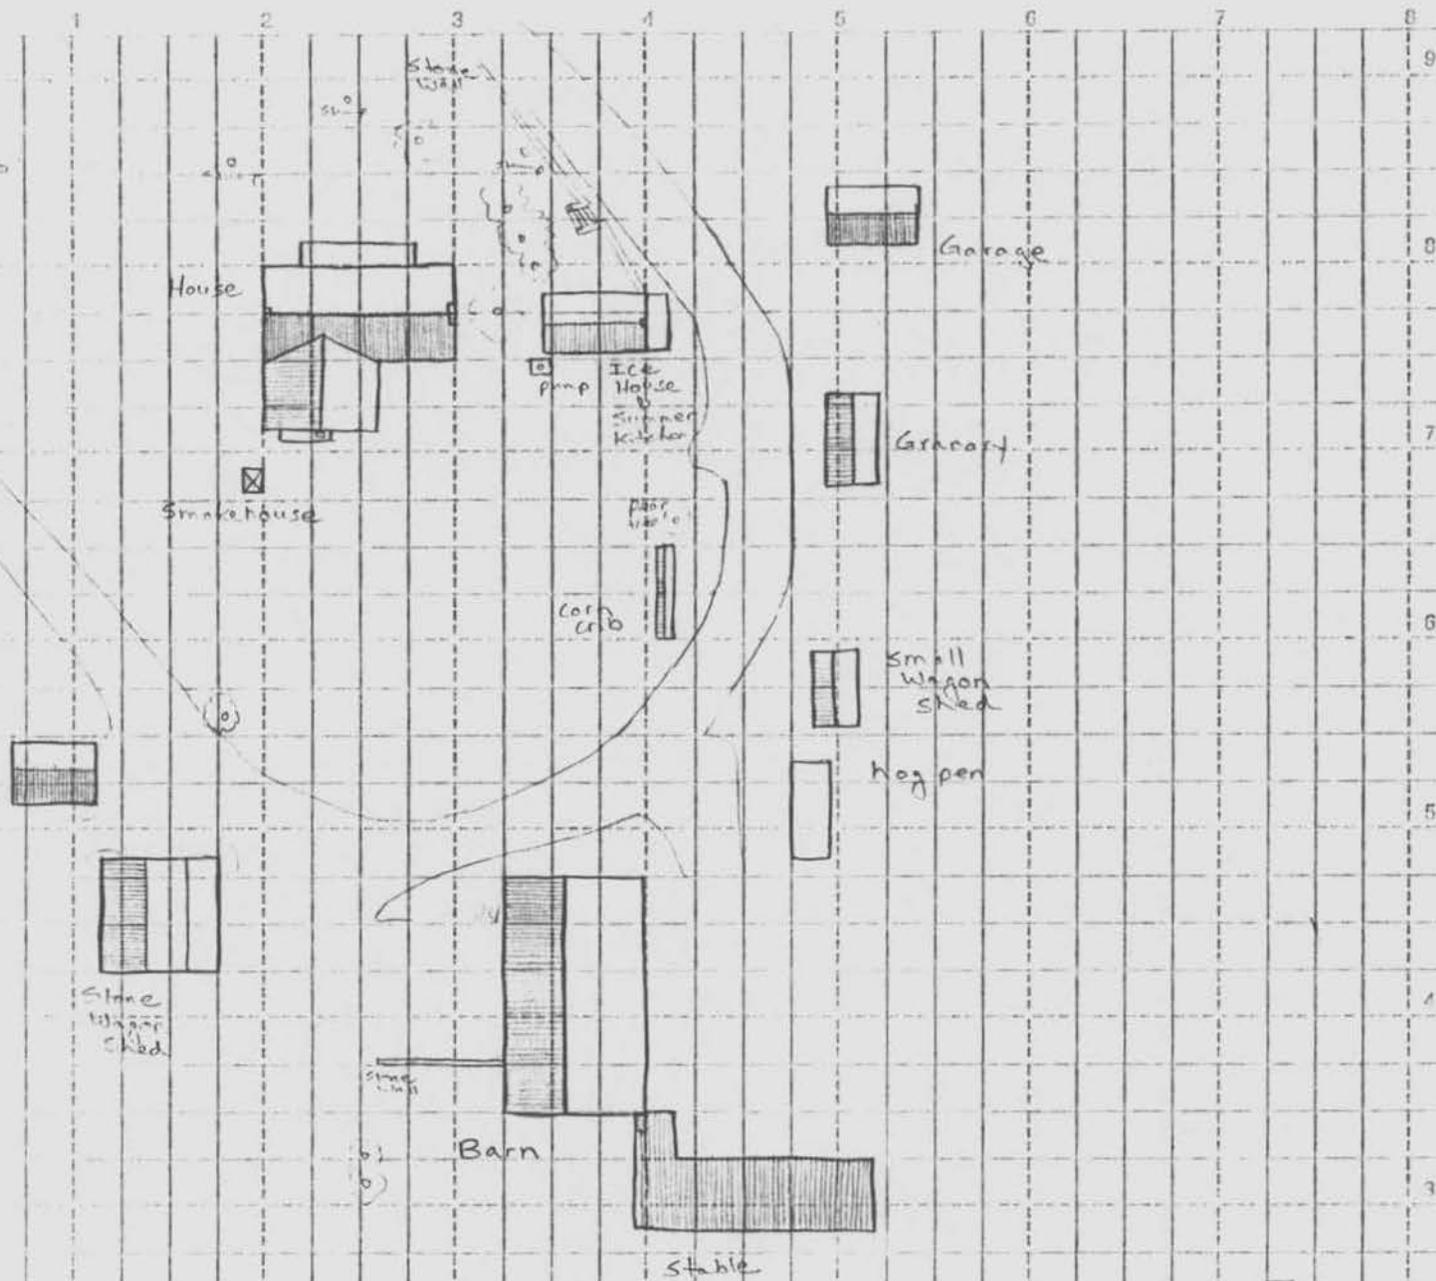
4/4

1500 McKinstry's Mill Rd Site Plan

Recent Additions
omitted for clarity

The Stoner-Saum Farm is located at 1500 McKinstry's Mill Road near the settlement of McKinstry's Mills in western Carroll County, Maryland. It is sited on generally flat ground near Sam's Creek. The complex consists of a brick house, a frame bank barn, a brick smokehouse, a stone ice house and summer kitchen, a stone wagon shed, and several other frame farm outbuildings. The house faces east, and is a two-story, five-bay by two-bay structure with a rubble stone foundation, Flemish bond brick on the east elevation, 5-to-1 common bond brick on the other elevations, and a gable roof of standing-seam metal, with a north-south ridge. On the east elevation, the first story has a center entrance and a four-light transom. There is a wood box cornice with a bed mold comprising a lozenge molding above a pearl molding. The east elevation has a one-story, three-bay porch with four turned posts, and a half-hip roof of standing-seam metal. The gable ends each have an eight-light oval window. There is an ell on the west end of the house that is three bays by one bay, and has a gable roof of standing-seam metal with an east-west ridge. The northwest cellar west wall has a brick kitchen fireplace. The first story has a center passage with two rooms to the south and one room to the north, plus an ell with one room in it. There is a two-flight run of stairs on the north wall, with a landing at the west end. These stairs have an open stringer with foliate sawn brackets that contain a flower bud. The second story has a center passage with four rooms in the main block and a stair passage. The smokehouse is built of 6-to-1 common bond brick with a hip roof. There is an ice house about 25 feet south of the house. It is built of rubble stone and has a gable roof. It is banked into the hill on the north side. The north elevation is approximately 3 feet high to the eaves. The gable end has German siding, with a vertical-board door on machine-cut strap hinges. The dirt floor of the ice house is approximately 20 feet below the level of the eaves. Attached to the south side of the ice house is a summer kitchen. The summer kitchen is also of rubble stone. It has a gable roof. The stone shed has rubble stone walls on the north and south sides, with battered buttresses at the four corners. It is open on the east and west sides. There is a bank barn with a south-facing forebay. The upper story has a hay mow on each end and three center threshing floors. The forebay is framed separately from the rest of the barn. The roof is supported by a purlin post truss.

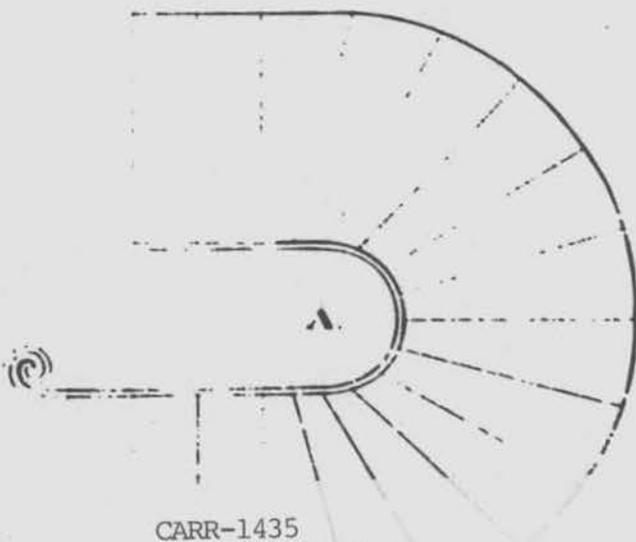
Height of the Stairs divided for risers

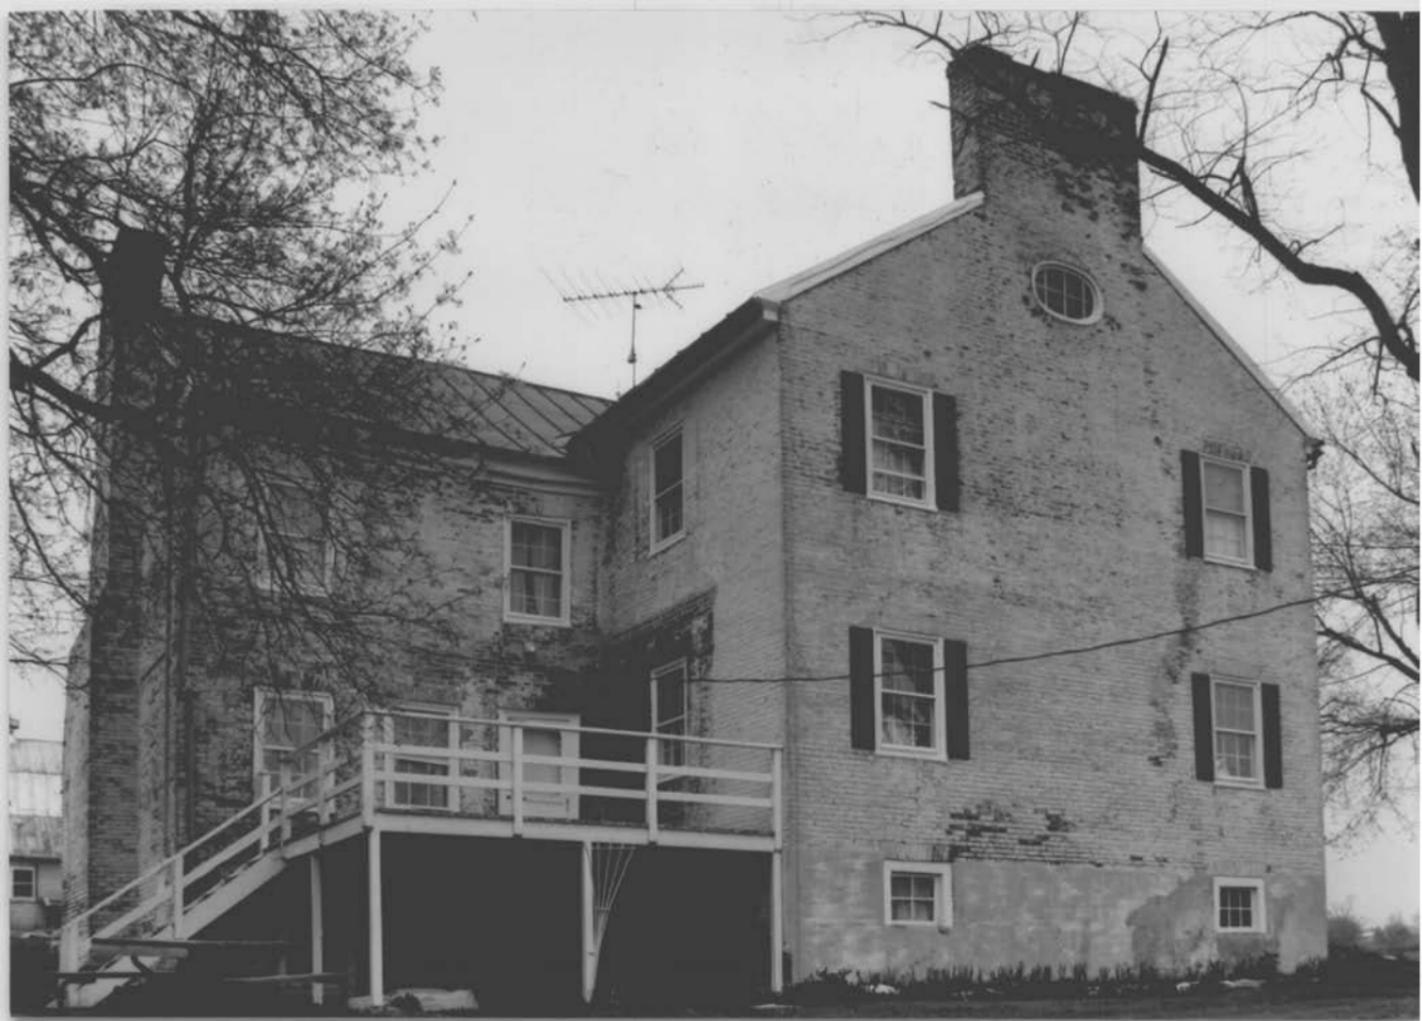
3/15

Neg. Loc.: Maryland Historical Trust
house - w. & s. elevs.

The house faces east, and is a two-story, five-bay by two-bay structure with a rubble stone foundation, Flemish bond brick on the east elevation, 5-to-1 common bond brick on the other elevations, and a gable roof of standing-seam metal, with a north-south ridge. On the east elevation, the first story has a center entrance that has a marble sill with wash. The door frame has a quirked ogee and bead backband and a beaded interior edge. The door has been altered to have nine lights over two panels. The panels have sunk fields and ogee panel molds. There is a four-light transom. On either side of the doorway are two 2/2 double-hung sash with wood sills and splayed brick jack arches. The window frames have double beads and contain pintles to hold strap hinges for shutters. The house currently has new fake shutters. The second story has five 6/6 sash with the same sills, lintels, frames and pintles as the first story. There is a wood box cornice with a bed mold comprising a lozenge molding above a pearl molding. There are two ogees at the top of the cornice. The east elevation has a one-story, three-bay porch with brick piers, four turned posts, and a half-hip roof of standing-seam metal. There is an interior brick chimney on each end with lightning rods on the ridge between the chimneys.

On the south elevation there is an exposed foundation of parged brick. The west bay of the foundation has a four-light sash, and the east bay has a six-light sash. Both of these windows have mortised-and-tenoned-and-pegged frames with diamond-in-section holes for horizontal wood louvers. They also have splayed brick jack arches. The first and second stories each have two typical 6/6 sash. The gable end has an eight-light oval window with brick voissiors. There are tapered rakeboards with beaded bottom edges. The west elevation of the main block has some 7-to-1 common bond in

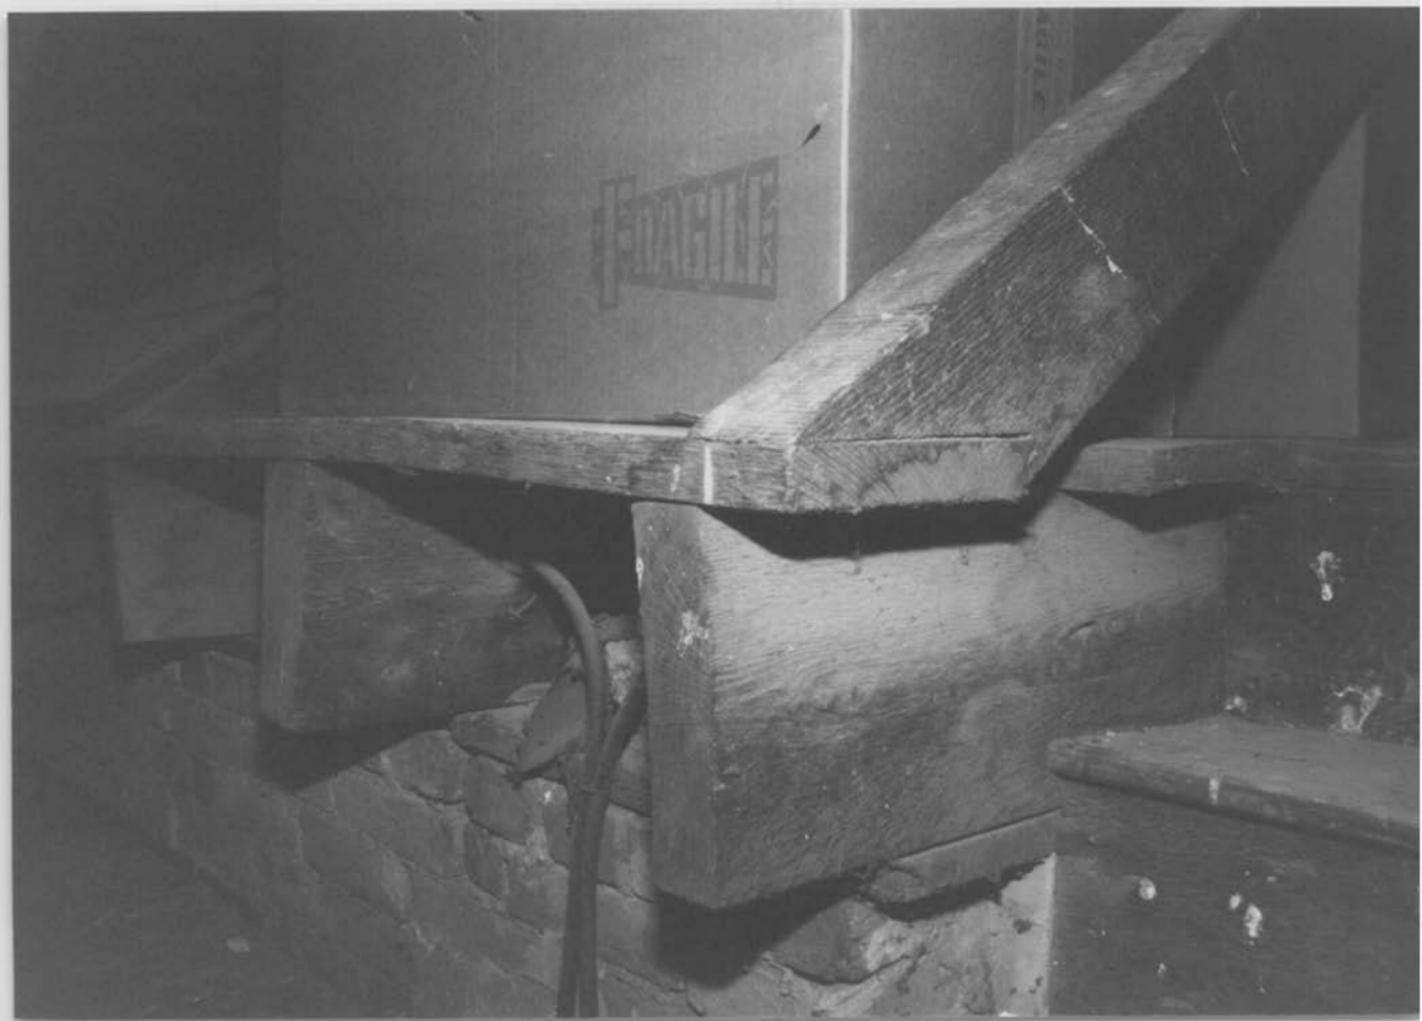
9/15
2542

rafter-false plate detail

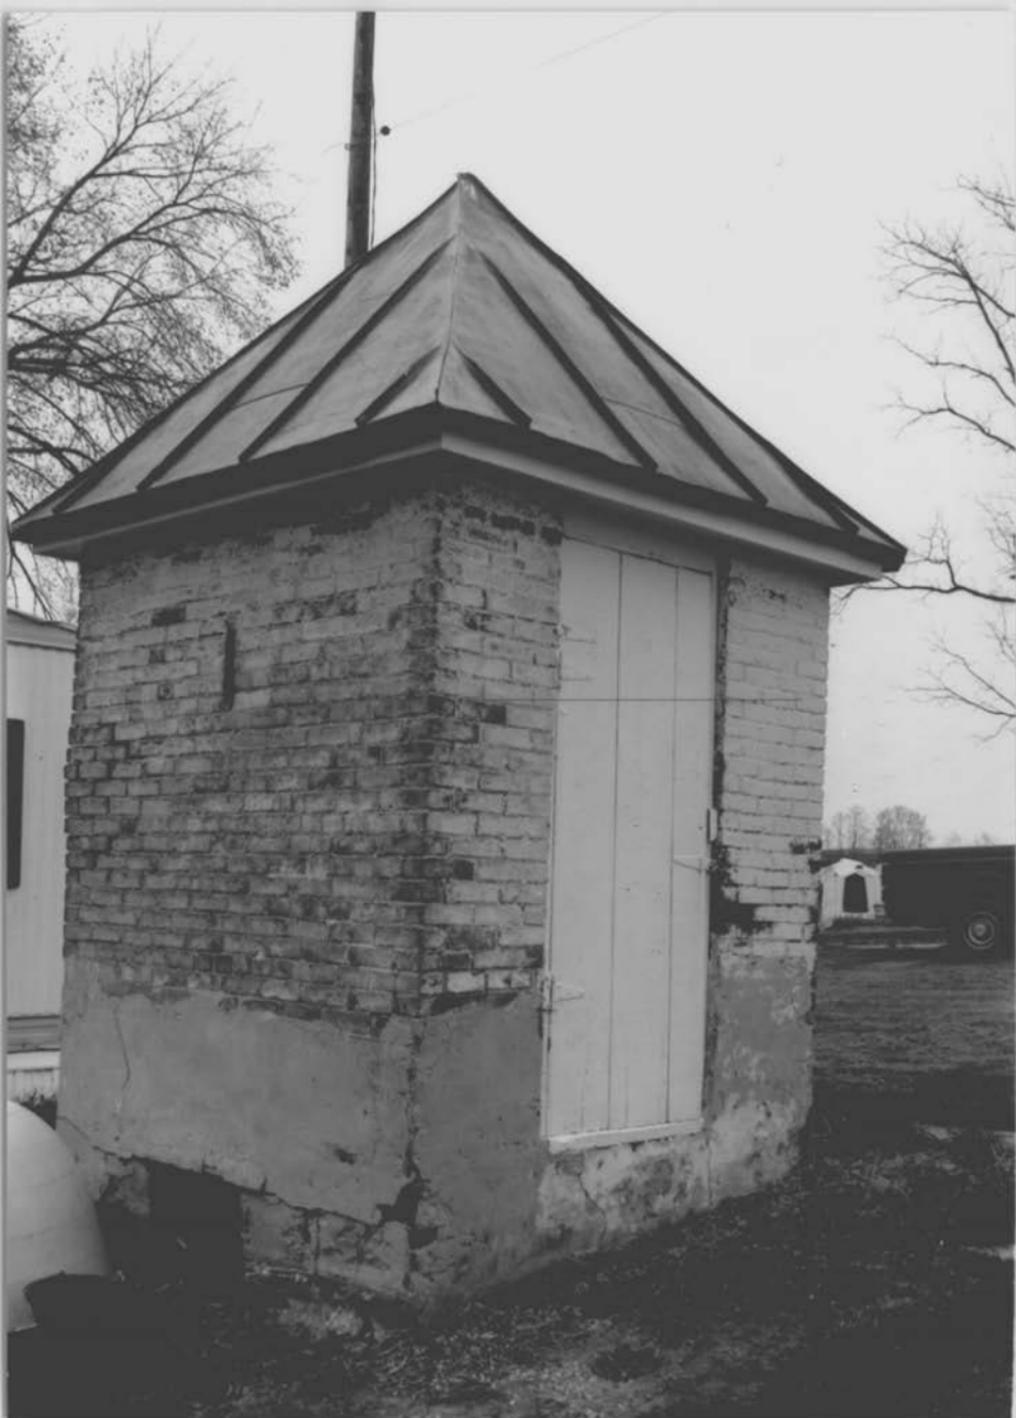
10/15

Stoner-Sawm Farm
1500 McKinstry's Mill Rd.
Carroll County, Maryland
Photo: Kenneth M. Short
Date: April 1995
Neg. Loc.: Maryland Historical Trust
Smokehouse - S. & E. elevs.

There is a smokehouse about 12 feet northwest of the house. It is built of 6-to-1 common bond brick, with a hip roof that has standing seam metal, and a wood box cornice. The east elevation has a new vertical-board door on new hinges. It is set in a beaded-interior-edge frame, and has part of a rim lock fastened to it. The north elevation has a slit vent. The south elevation foundation has a firebox opening in the foundation, and there is a slit vent above. There are no openings on the west elevation. The interior of the smokehouse is parged and has a square sawn tree in the center. The rafters are mill sawn and are approximately 2 x 4's. They support lath and wood shingles.

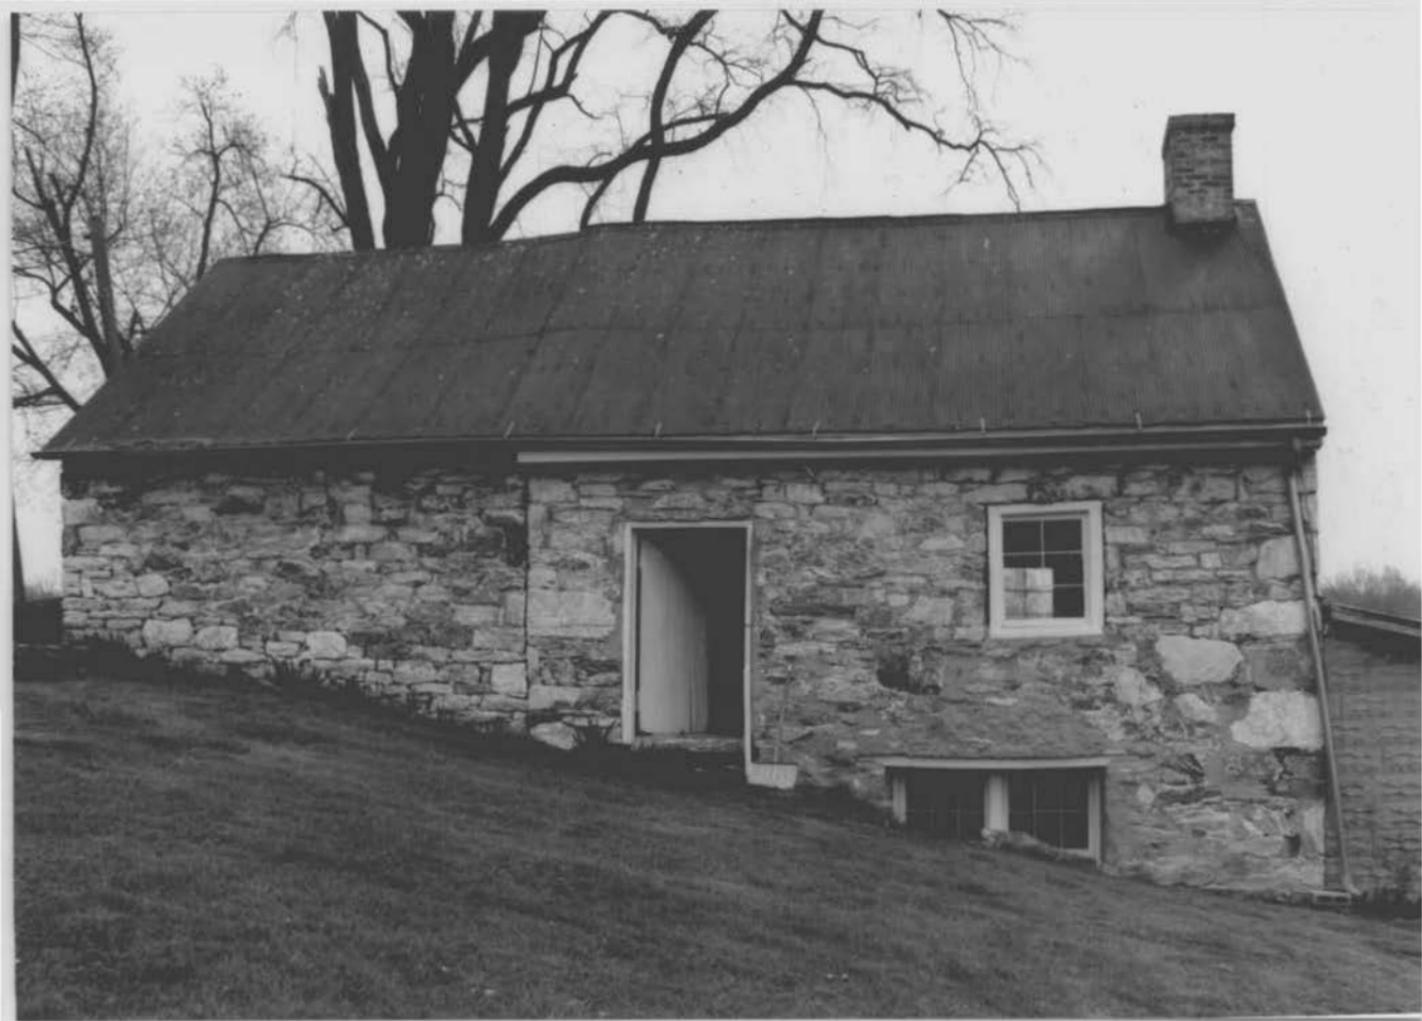
Icehouse-Summer Kitchen - east elev.

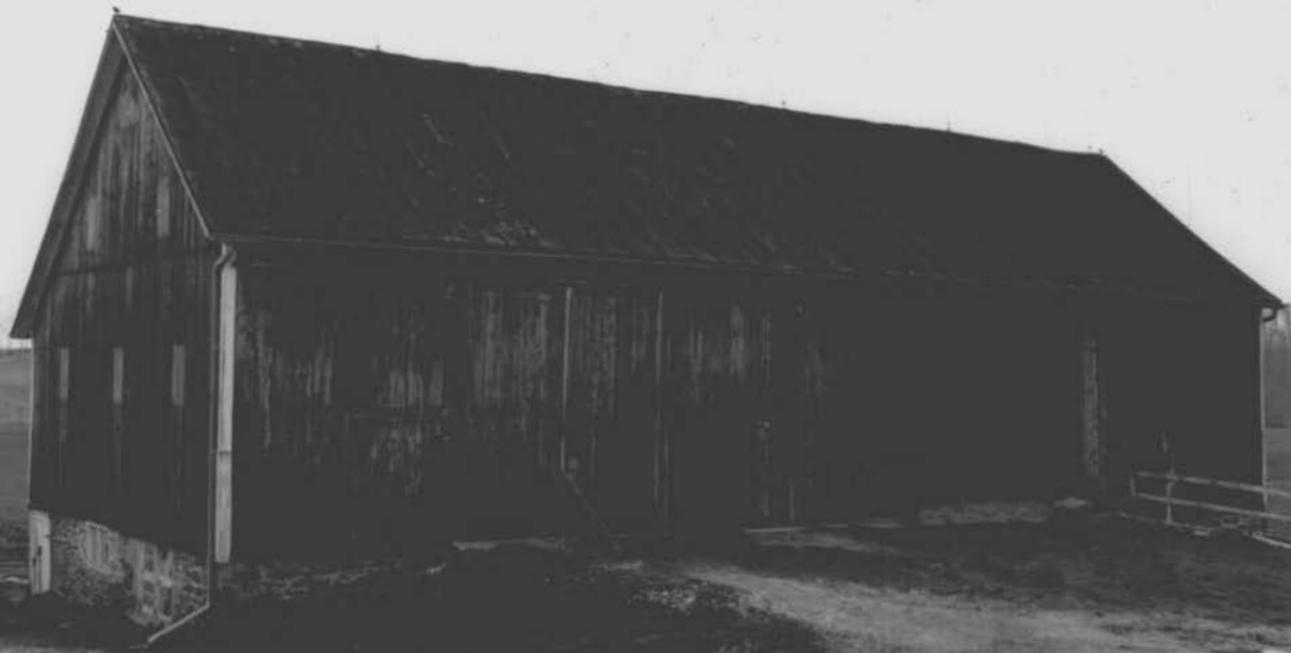
14/15

barn - E. & N. elevs.
