CARR-1453
2911 Bird View Road
Gamber (vicinity)

Maryland Historical Trust State Historic Sites Inventory Form

Survey No. CARR-1453

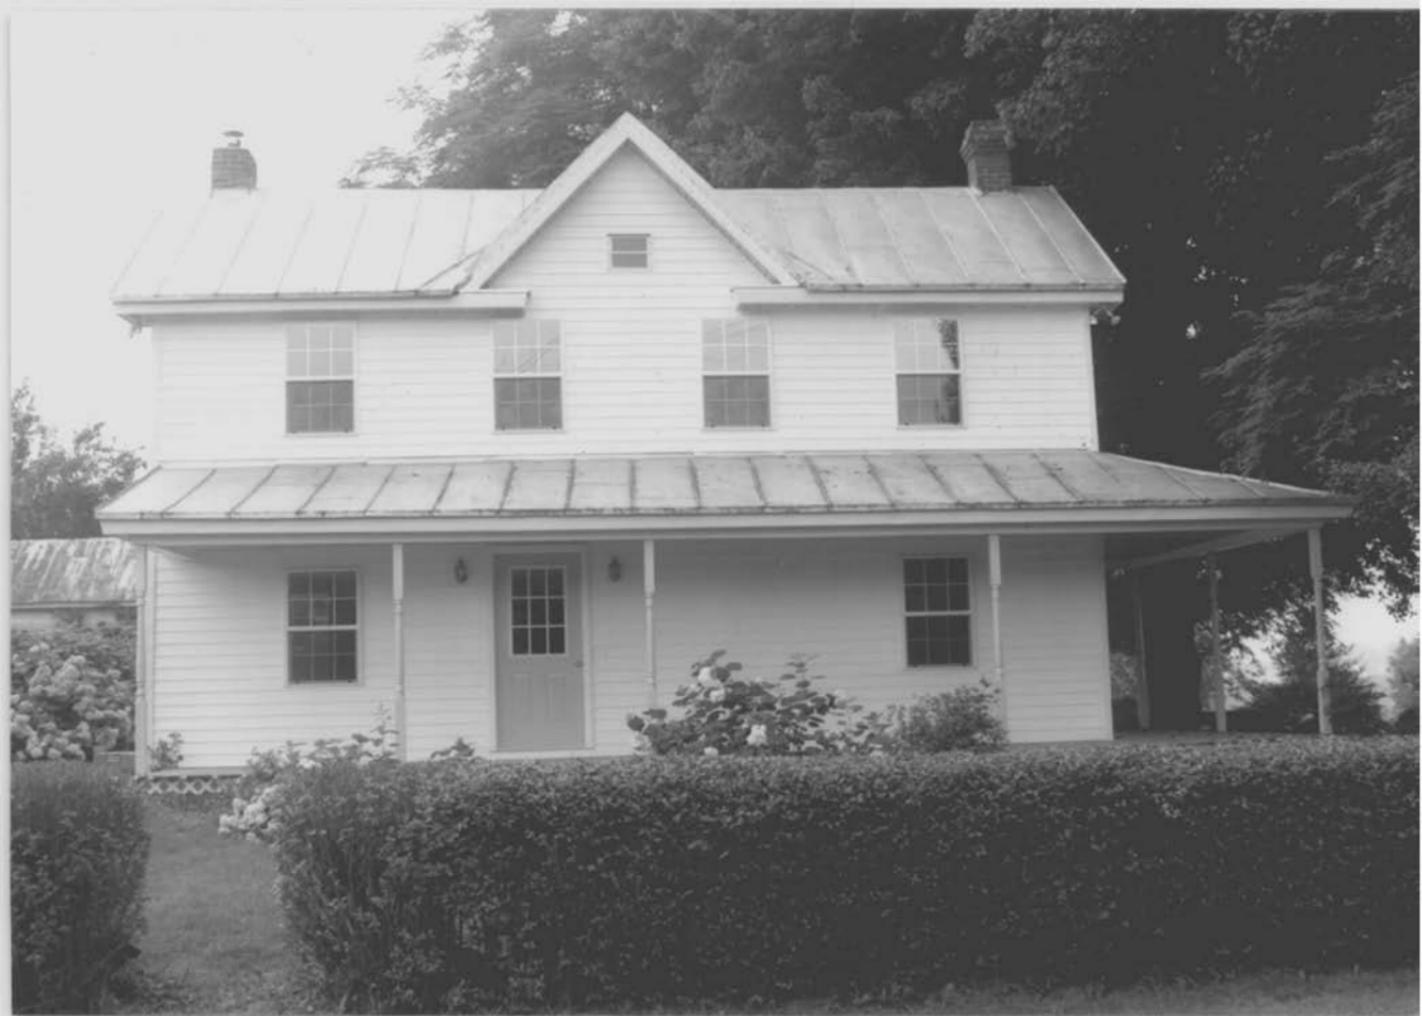
1/3

The house is a 2½-story, four-bay by two-bay, T-plan structure with a rubble stone foundation, aluminum siding, and a standing seam metal gable roof with an east-west ridge. The house faces north toward the street, and was apparently originally a Pennsylvania farmhouse plan, as the first-story has from east to west a window, a door, no opening, and a window. The windows in this house are all new 6/6 sash, and the doors are also new. There is an interior brick chimney on each end. There is a one-story, shed-roof porch with standing-seam metal on the north elevation, and it wraps around on the west. The porch has turned posts. The ell appears to have had a projecting pantry on the east elevation, with a porch between it, but this is now infilled. There is a new one-story enclosed room in the southwest crook, or re-entrant angle, of the T. There is an interior brick chimney on the south elevation of the ell.

Neg. Loc.: Maryland Historical Trust
house - N. elev.

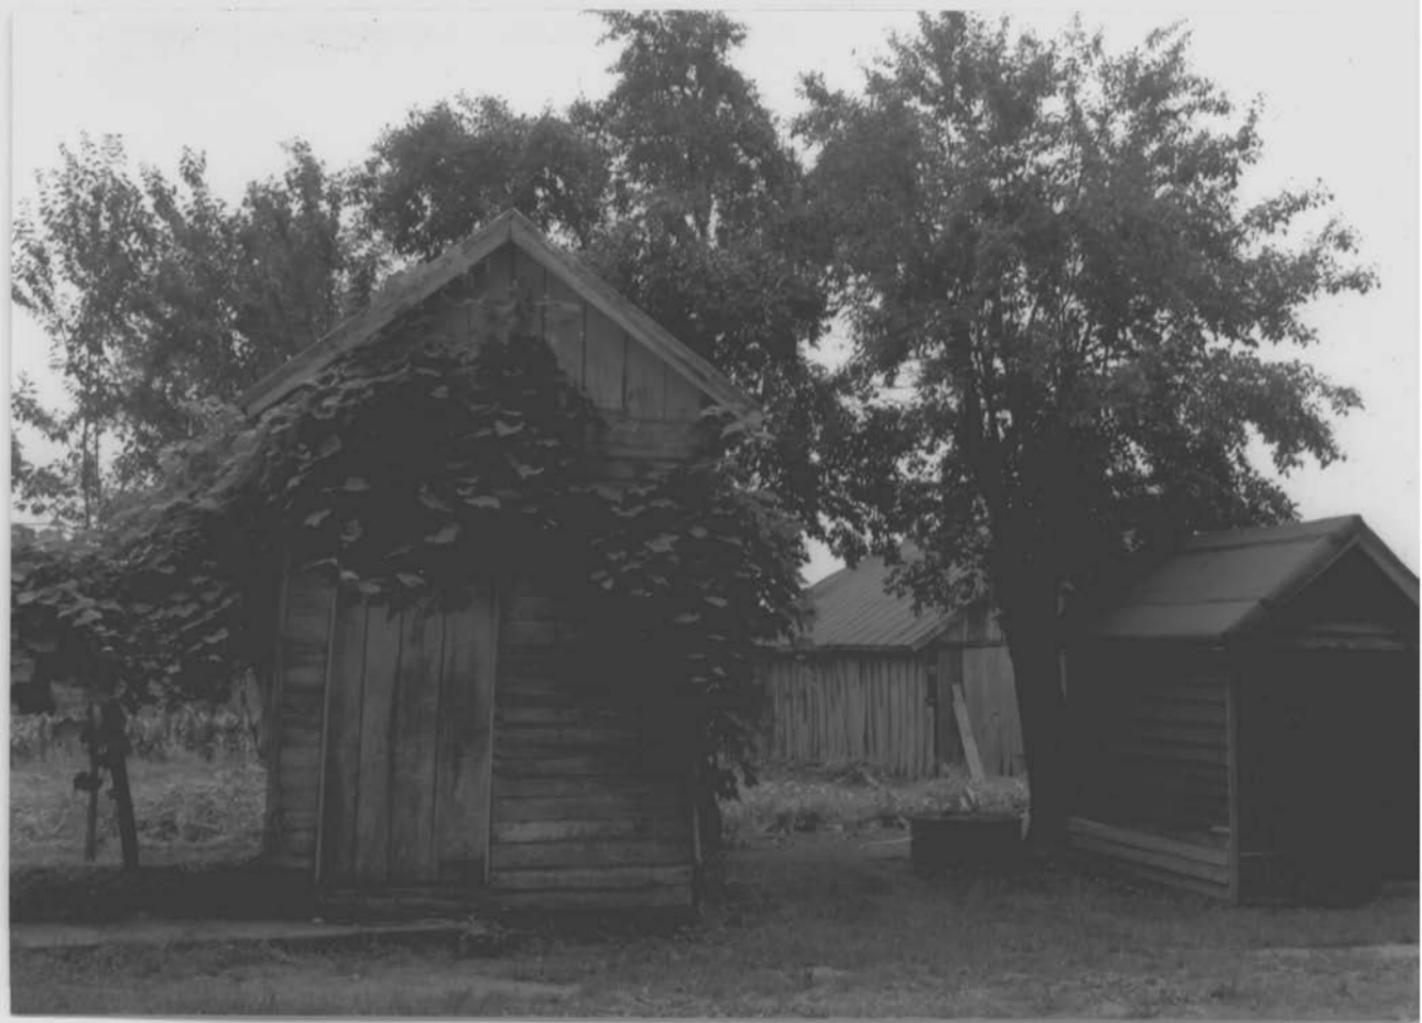
2/3

About 10 feet southeast of the house is a circular-sawn 2 x 4 shed. It is a one-story, one-bay square building with a mixture of weatherboards and German siding. It has a gable roof with an east-west ridge and inverted V-seam metal. The west elevation has a vertical-board door and the north elevation a four-light sash. On the interior, part of the walls are sheathed with horizontal tongue-and-grooved boards, and there are stairs along the east wall that lead to the upper story. There is a smokehouse that is one story and one-bay square. It has German siding and weatherboards, and a gable roof with asphalt roll roofing and an east-west ridge. The west elevation has a vertical-board door. The smokehouse is built of 2 x 4 circular-sawn timber with rafters that are mitered at the ridge.

2911 Birdview Rd.
Carroll County, Maryland
Photo: Matt Hankins
Date: July 1995
Neg. Loc.: Maryland Historical Trust
~~Shed~~: Smokehouse w. elevs.

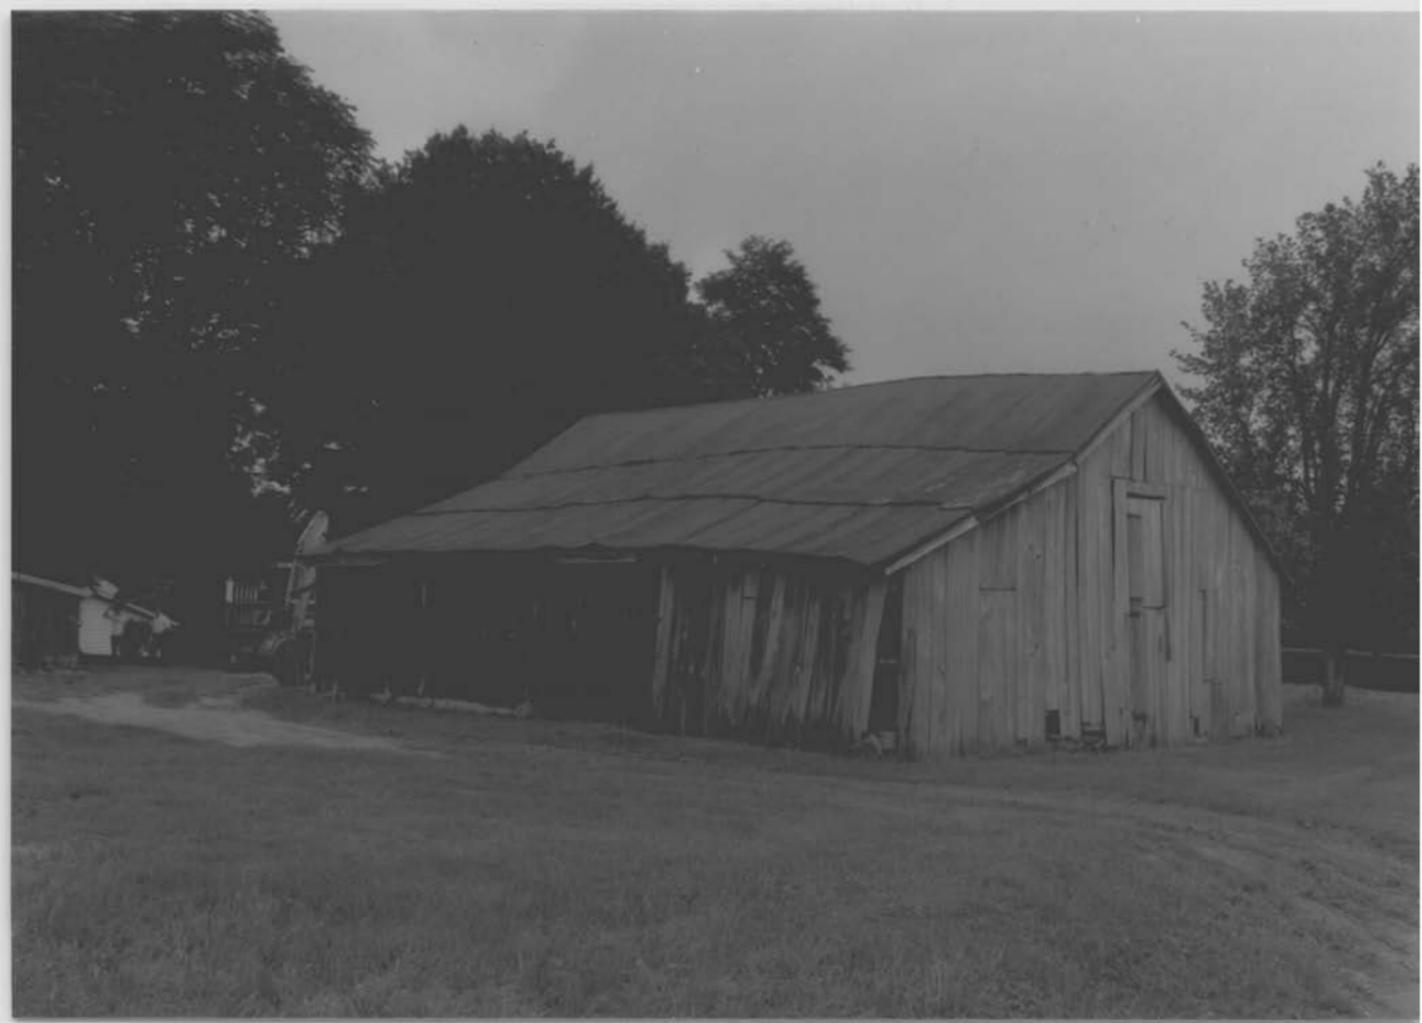
3/3

About 30 feet east of the smokehouse is a ground barn with vertical-board siding and a gable roof of inverted V-seam metal with an east-west ridge. The west elevation has a wagon door on strap hinges and a second one on butterfly hinges, with several doors to the south. The south elevation has three dutch doors on strap hinges. The north elevation has a wagon door on strap hinges at the east end. The barn has been added onto in several periods. The original section is the center and west two bays and is built with a mortised-and-tenoned-and-pegged, circular-sawn frame. On the east end, the center and north bays were added, and were also built with a mortised-and-tenoned-and-pegged, circular-sawn frame. The whole south end of the building was added all at one time and the northwest corner of the building appears to have been added last. It has a circular-sawn 2 x 4 frame.

Neg. Loc.: Maryland Historical Trust
Barn - south; east elevs.
