CARR-1454

Peter Ritz Farm  
Mexico (vicinity)

# Maryland Historical Trust State Historic Sites Inventory Form

The Peter Ritz Farm is located at 624 Leister's Church Road. The complex consists of a frame house, a summer kitchen, a frame bank barn, a binder shed, and a wood shed. The house is a three-bay by two-bay, two-story structure that is banked on the northwest and has a two-bay ell on the northwest elevation. The southeast elevation foundation is thus exposed. The foundation is rubble stone. There is new weatherboard, and the gable roof has standing-seam metal. The first story has a center entrance with a new door and a one-light transom and two new 6/6 sash. There is a one-story raised porch with a shed roof of standing-seam metal. The second story has new 6/6 sash in the end bays with no opening in the center bay. The summer kitchen is a one-story, one-bay square building, with a rubble stone foundation, weatherboards with corner boards, and a gable roof of standing-seam metal over wood shingles. There is an interior brick chimney on the southwest end. The bank barn has a rubble stone lower story with horizontal boards under the forebay, and a vertical-board upper story.

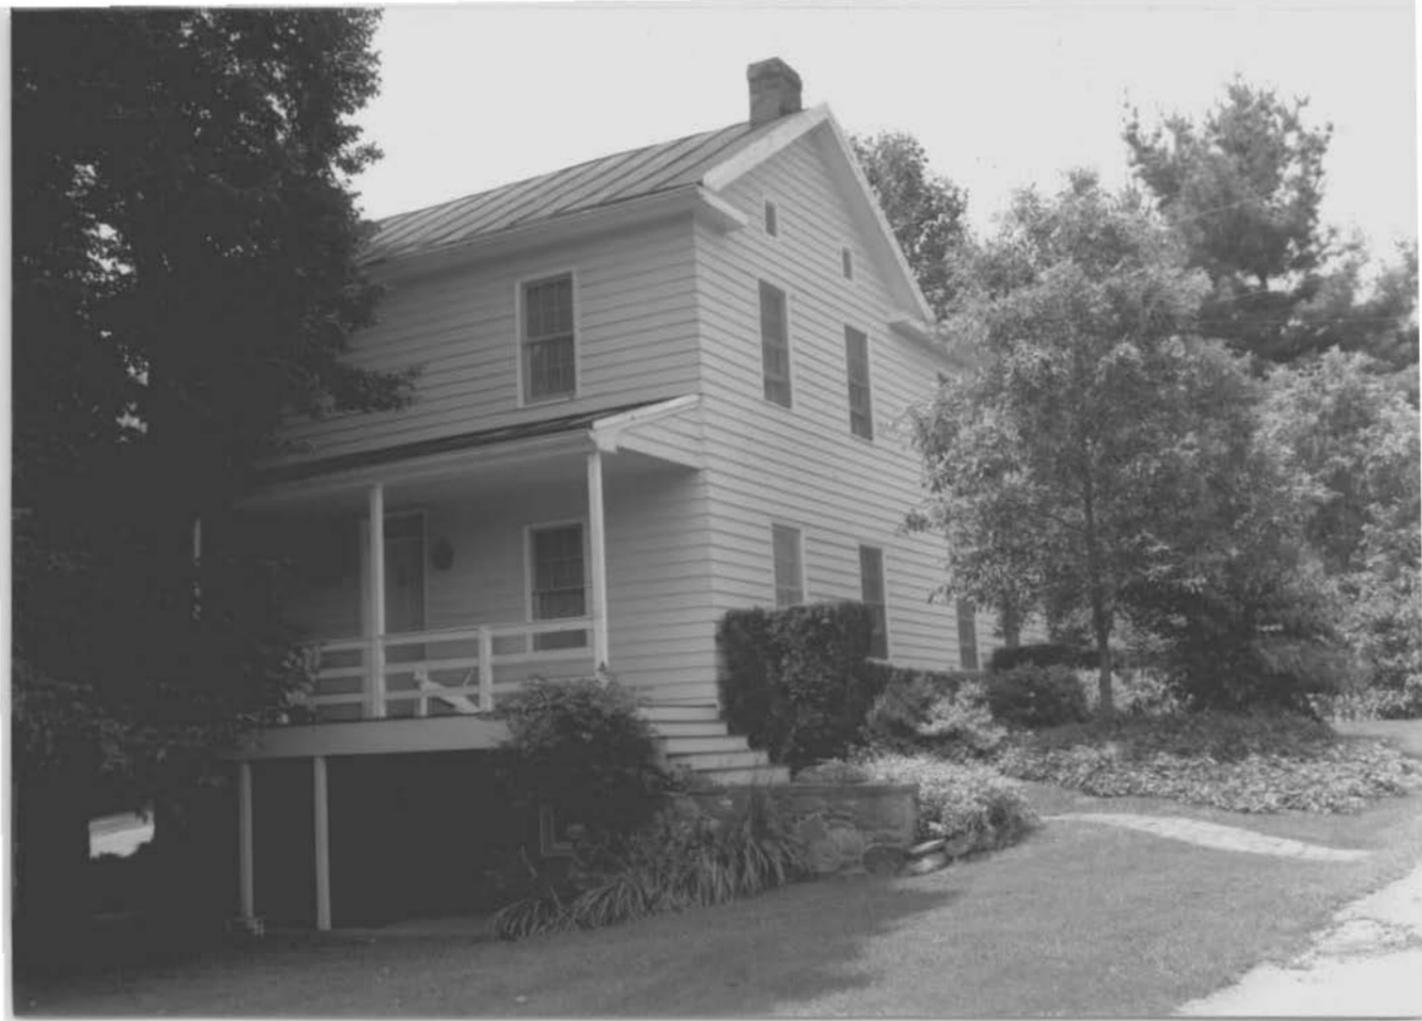
1/3

Neg. loc.: Maryland Historical Trust  
house - SE elev.

The house is a three-bay by two-bay, two-story structure that is banked on the northwest and has a two-bay ell on the northwest elevation. The southeast elevation foundation is thus exposed. The foundation is rubble stone. There is new weatherboard, and the gable roof has standing-seam metal and a northeast-to-southwest ridge. There is an interior brick chimney on each end with new brick. The southeast elevation foundation has a new door in an original opening in the south bay and two new 6/6 sash. The first story has a center entrance with a new door and a one-light transom and two new 6/6 sash. There is a one-story raised porch with a shed roof of standing-seam metal. The porch has a new railing and four new posts. The second story has new 6/6 sash in the end bays with no opening in

the center bay. There is a wood box cornice with returns. The southwest elevation foundation has a new 6/6 sash in the south bay. The first and second stories have two new 6/6 sash, and there are two louver vents in the gable end. The southwest elevation of the ell has a one-story porch with a shed roof of standing-seam metal. The south half of the porch is enclosed. The second story has two new 6/6 sash. The gable roof of the ell has standing-seam metal and a southeast-to-northwest ridge. The northwest elevation of the ell has a new exterior brick chimney. The northeast elevation of the main block has two new 6/6 sash on the first and second stories, and two louvered vents on the gable end. The ell has two new 6/6 sash on both the first and second stories.

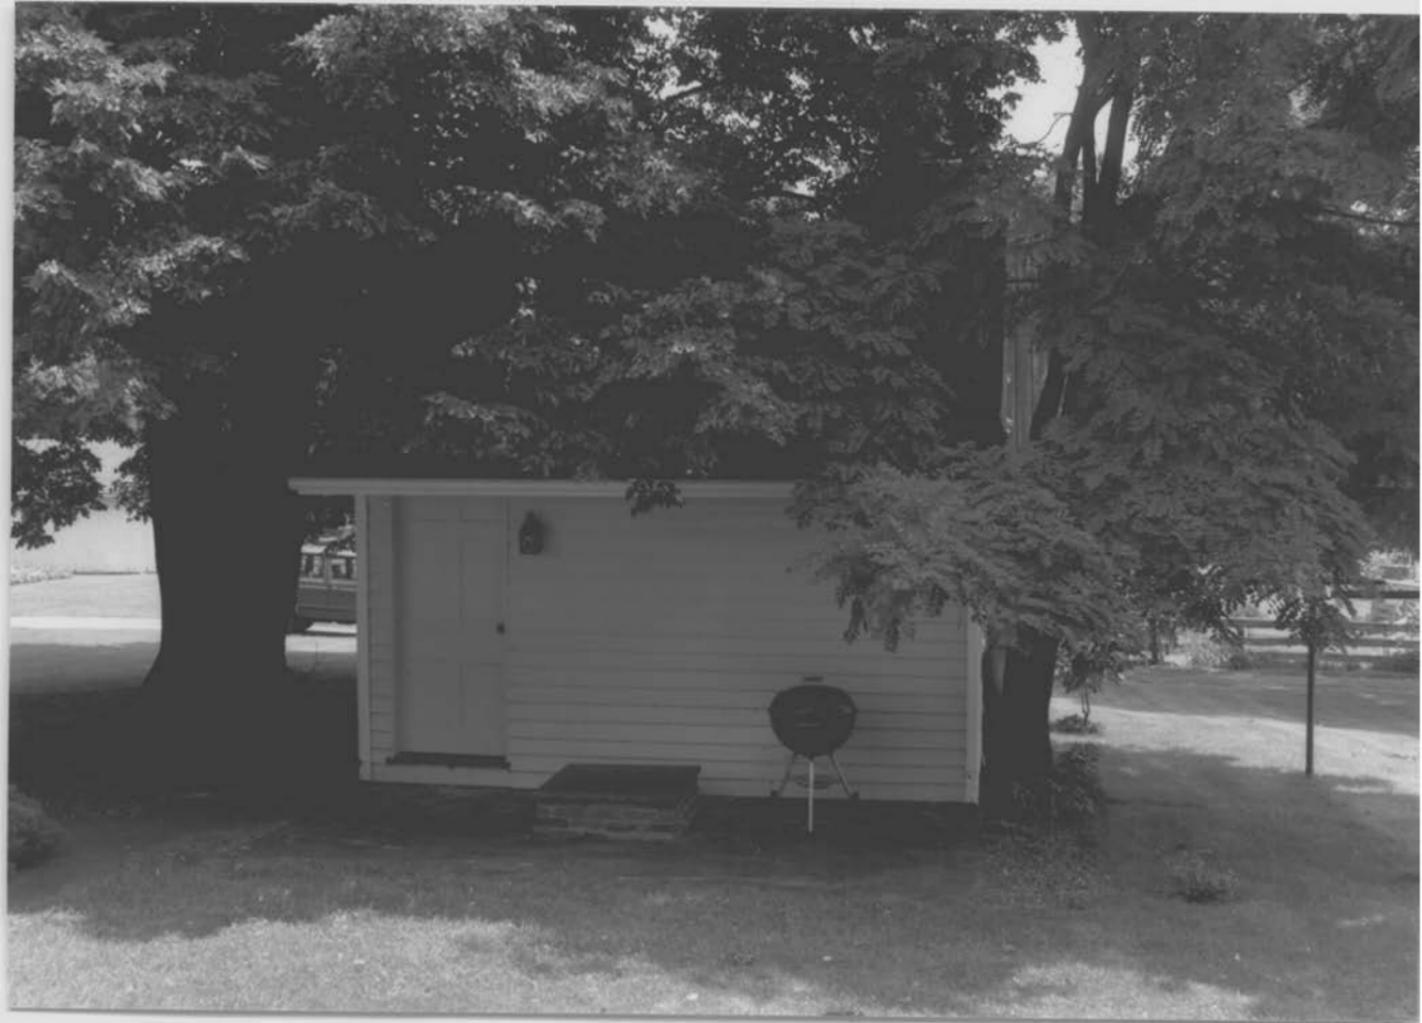
2/3

Neg. Loc.: Maryland Historical Trust  
Summer Kitchen - NW elev.

There is a summer kitchen about 10 feet south of the house. It is a one-story, one-bay square building, with a rubble stone foundation, weatherboards with corner boards, and a gable roof of standing-seam metal over wood shingles with a northeast-to-southwest ridge. There is an interior brick chimney on the southwest end and a new pent roof added the northwest. The northwest elevation has a new six-panel door set to the north. The northeast and southeast elevations have a 1/1 sash. The building is of 2 x 4 construction. The southwest wall has a brick fireplace with straight jambs and a trammel crane. The wood mantel tree is circular sawn. The building has a floored attic with a ladder nailed to the studs in the south corner.

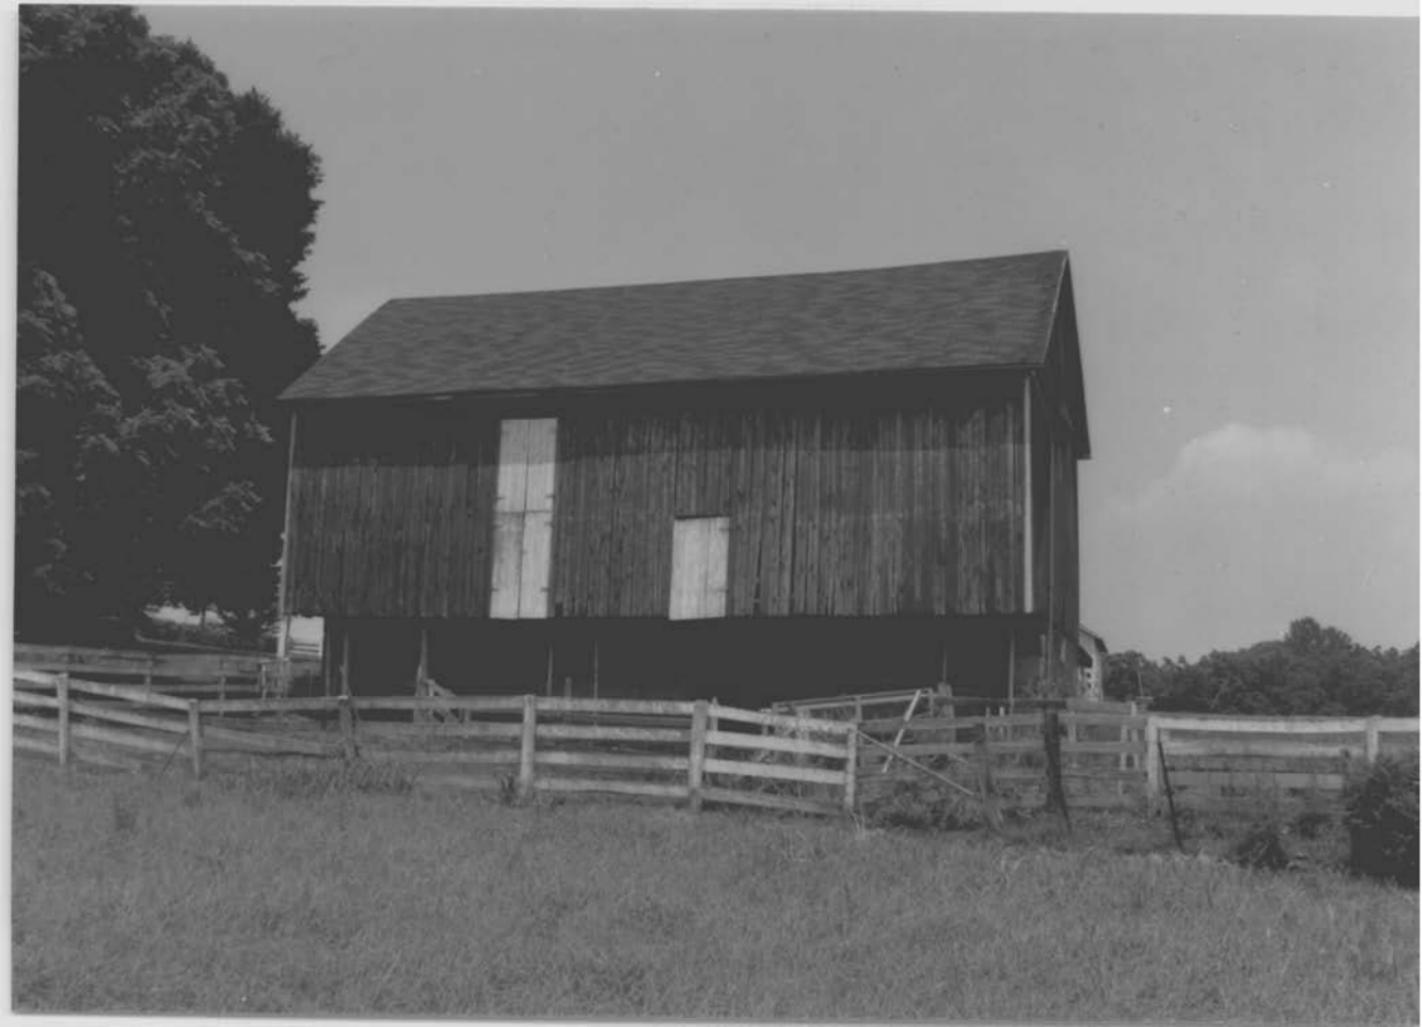
3/3

Neg. Loc.: Maryland Historical Trust  
barn - SW elev.

There is a bank barn about 50 feet southeast of the summer kitchen. It has a rubble stone lower story with horizontal boards under the forebay, and a vertical-board upper story. The forebay faces southwest. The gable roof has asphalt shingles and a southeast to northwest ridge. The northeast elevation upper story has two pair of wagon doors on rollers in the center. The northwest elevation has a six-light sash on the lower story and no

openings on the upper story. The southwest elevation lower story has two vertical-board dutch doors on strap hinges, a wide opening south of this, and another dutch door in the south bay. The upper story has vertical-board double doors on strap hinges over identical doors with a similar door to the south of them. The southeast elevation is identical to the northwest elevation. The lower story has a summer beam that is circular sawn on all four sides and joists that are circular sawn on top and bottom. The forebay wall is of heavy-timber frame. The upper story has two center wagon floors with a hay mow on each end and a granary in the north corner. It has a circular-sawn, heavy-timber, mortised-and-tenoned-and-pegged frame. Each bent has four posts, and there is a Queen post truss supporting the roof. The roof has 2 x 4 rafters that are mitered at the ridge, and there is a hay track. The southeast bay of the barn was added later. On the interior upper story door is painted "H. M. 1916."
