MARYLAND INVENTORY OF
HISTORIC PROPERTIES

Survey No. CARR-1455

**Maryland Historical Trust
State Historic Sites Inventory Form**

historic George Croft Farm

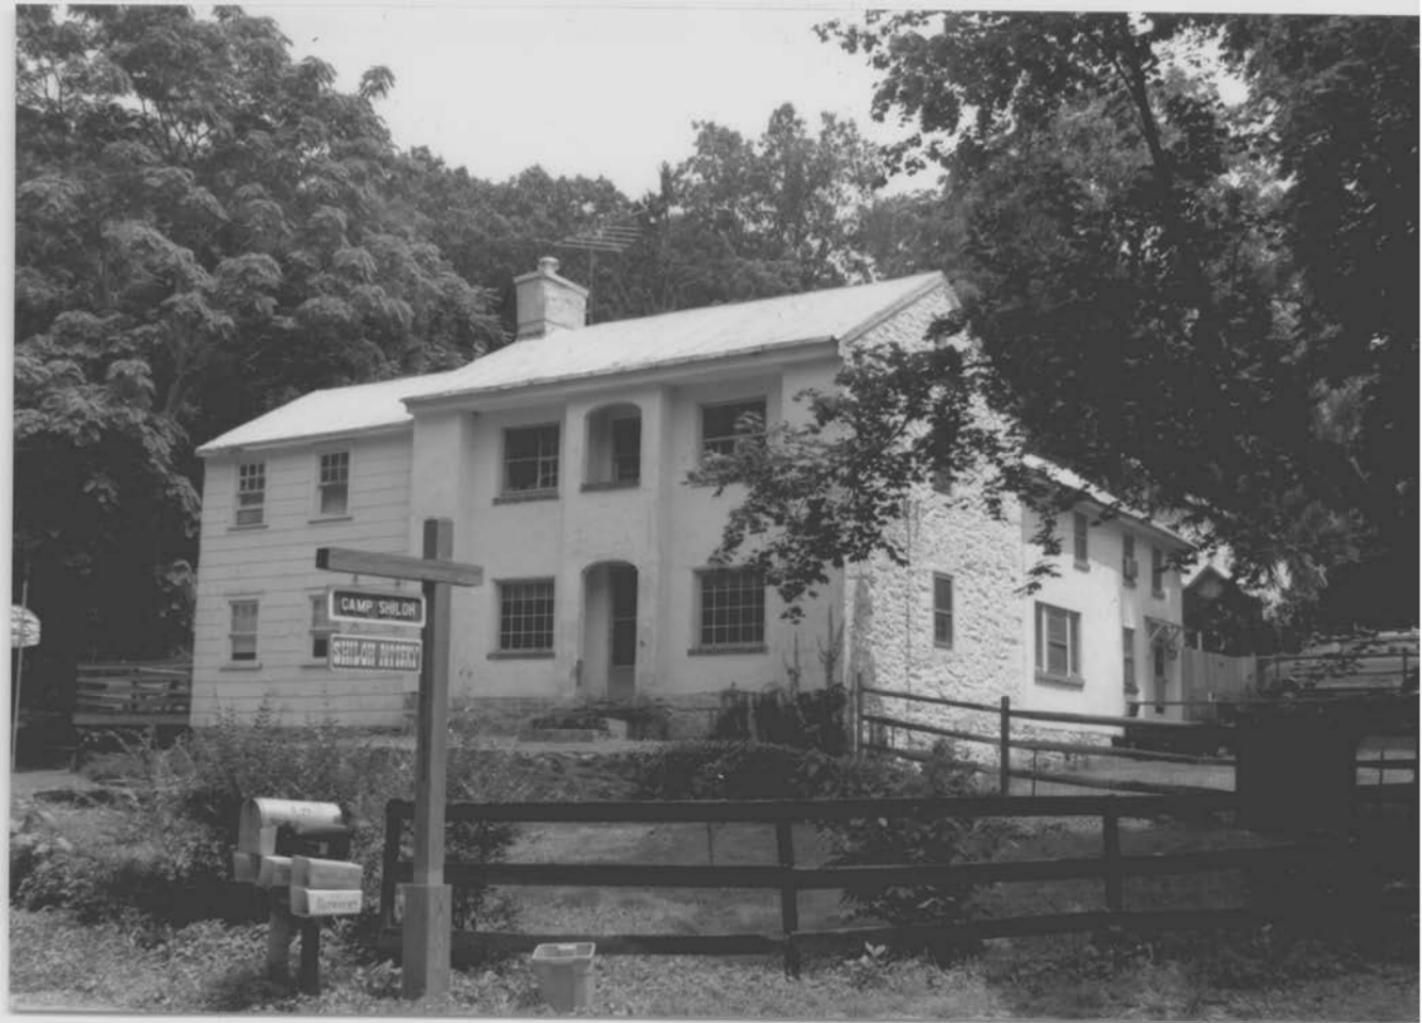
1/5

The house is a two-story, three-bay by one-bay rubble stone structure, with stucco on the northwest elevation, and a gable roof of standing-seam metal with a northeast to southwest ridge. The house faces northwest toward the road. On the northwest elevation, the first story has a projecting center bay with a segmentally-arched opening leading toward the recessed center entrance. This is flanked by two twenty-light sash with brick sills. The second story has a center bay that is segmentally arched and has a brick sill. In the recess

house-NW: SW elevs.

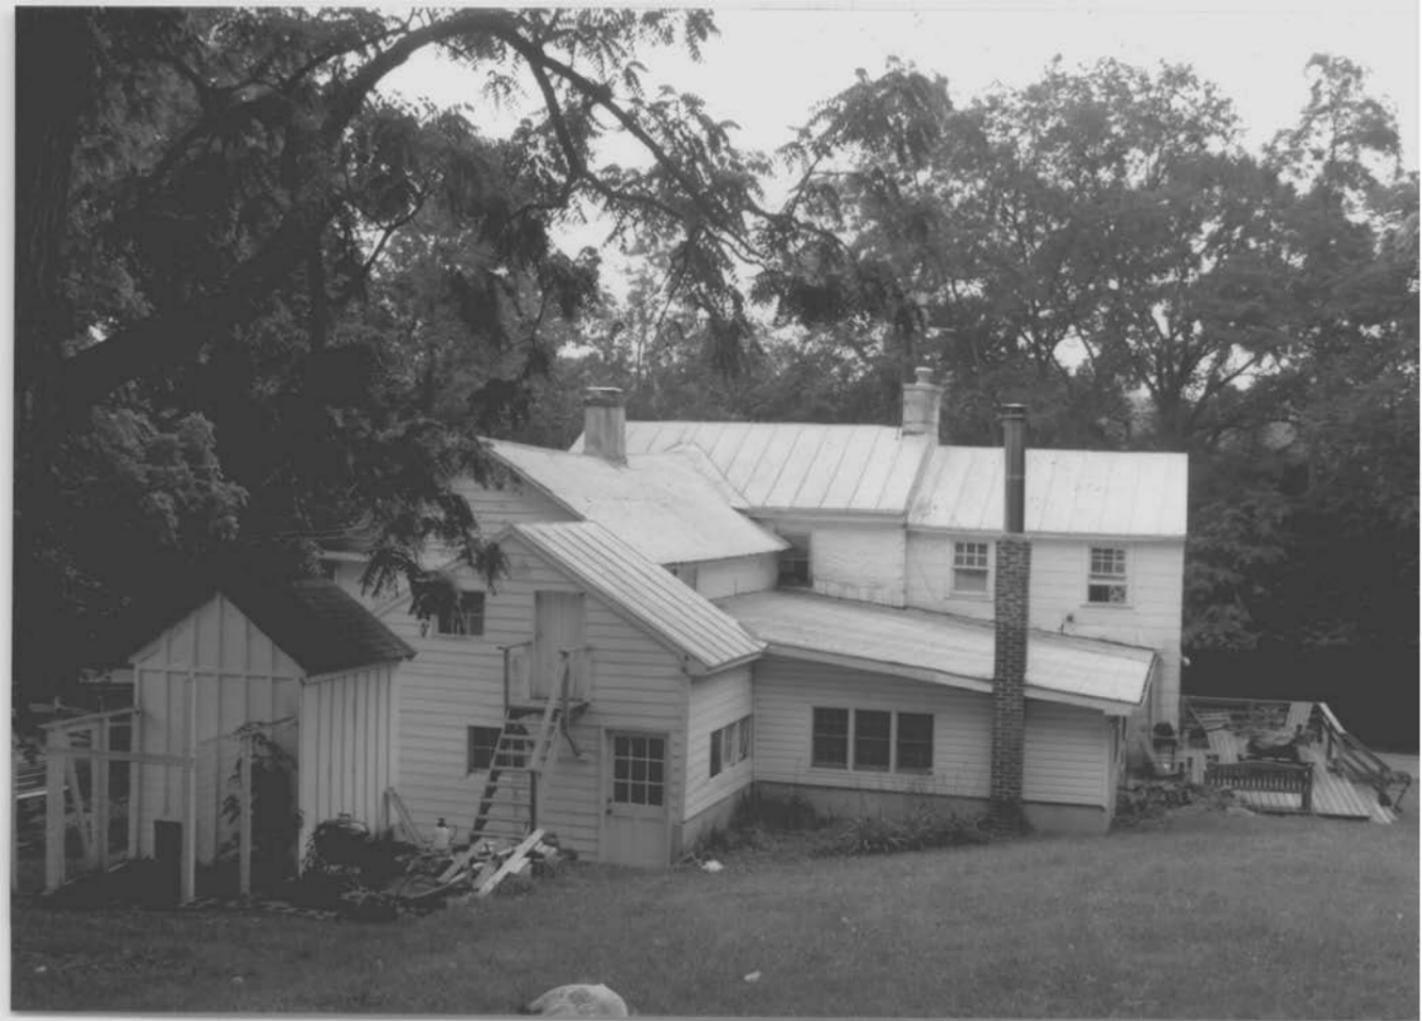
2/5

are two eight-light casements. On either side of the center bay are also two eight-light casements with brick sills. Most of the rubble stone northwest wall was taken down and rebuilt in stuccoed frame to create this current configuration. There is a two-story, two-bay addition on the northeast end of the house that has a rubble stone foundation and asbestos-shingle siding. The gable roof has standing-seam metal and a northeast-to-southwest ridge. The first and second stories each have two 6/1 sash.

house - SE ; NE elevs.

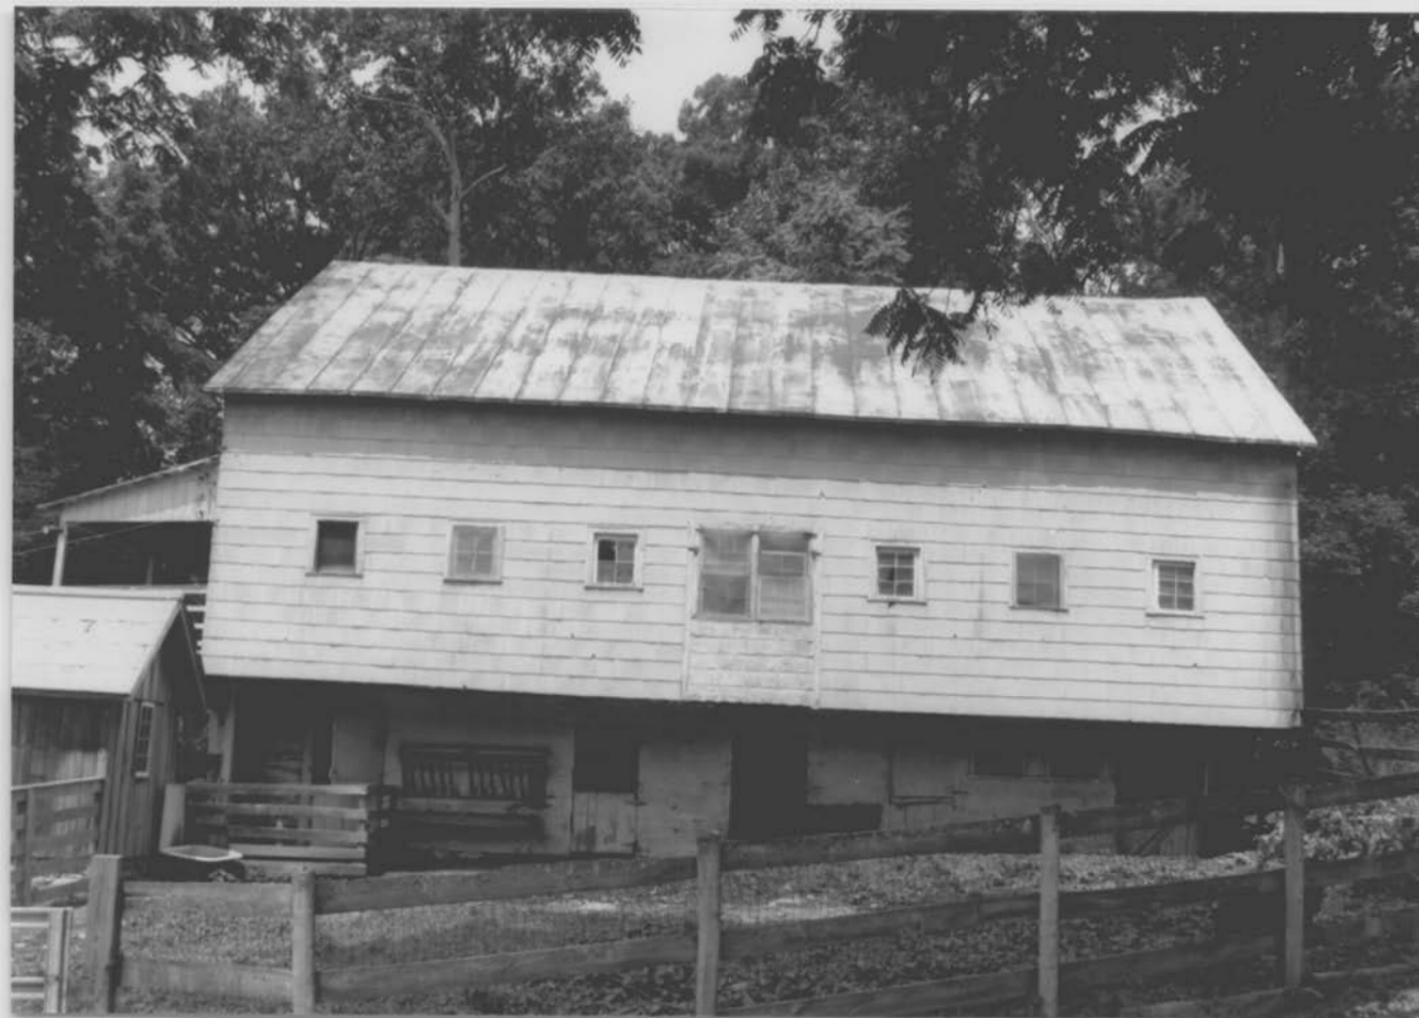
4/15
9

There is a bank barn about 60 feet southeast of the shed. It has a rubble stone lower story with vertical boards on the lower story forebay wall. The upper story has asbestos shingles on the northwest and southwest elevations, some board and batten on the northwest elevation, asphalt shingles on the southeast elevation, and board and batten on the northeast elevation. It has a gable roof of standing-seam metal with a northwest to southeast ridge. The forebay of the barn faces southwest. The lower story of the southwest elevation has four vertical-board dutch doors to the west, then two window openings, and another dutch door in the south bay. The upper story has a center double-door opening that has been converted to two 6/6 sash. There are three small window openings on either side. The southeast elevation has a wide opening on the upper story and two window openings in the lower story. The northwest elevation has a porch added to it, and the porch has been infilled to the north. Above the porch roof is painted "CAMP [SH]ILOH." The northeast elevation has a shed-roof addition over the wagon doors with a louver vent both to the north and east of these doors. The lower story has two hewn summer beams with four posts under each, and with splayed half-lap scarfs. The joists are all one piece and are hewn on top and bottom inside the barn and on all four sides under the forebay. The stall arrangement has been altered. The upper story has been altered for use by the camp. It has three bays with a center threshing floor and one mow on each side. There are four hewn bents that are mortised and tenoned and pegged, with Queen post trusses supporting the roof. The rafters are ¾-round logs with a ridge pole.

Neg. Loc.: Maryland Historical Trust
barn - SW elev.

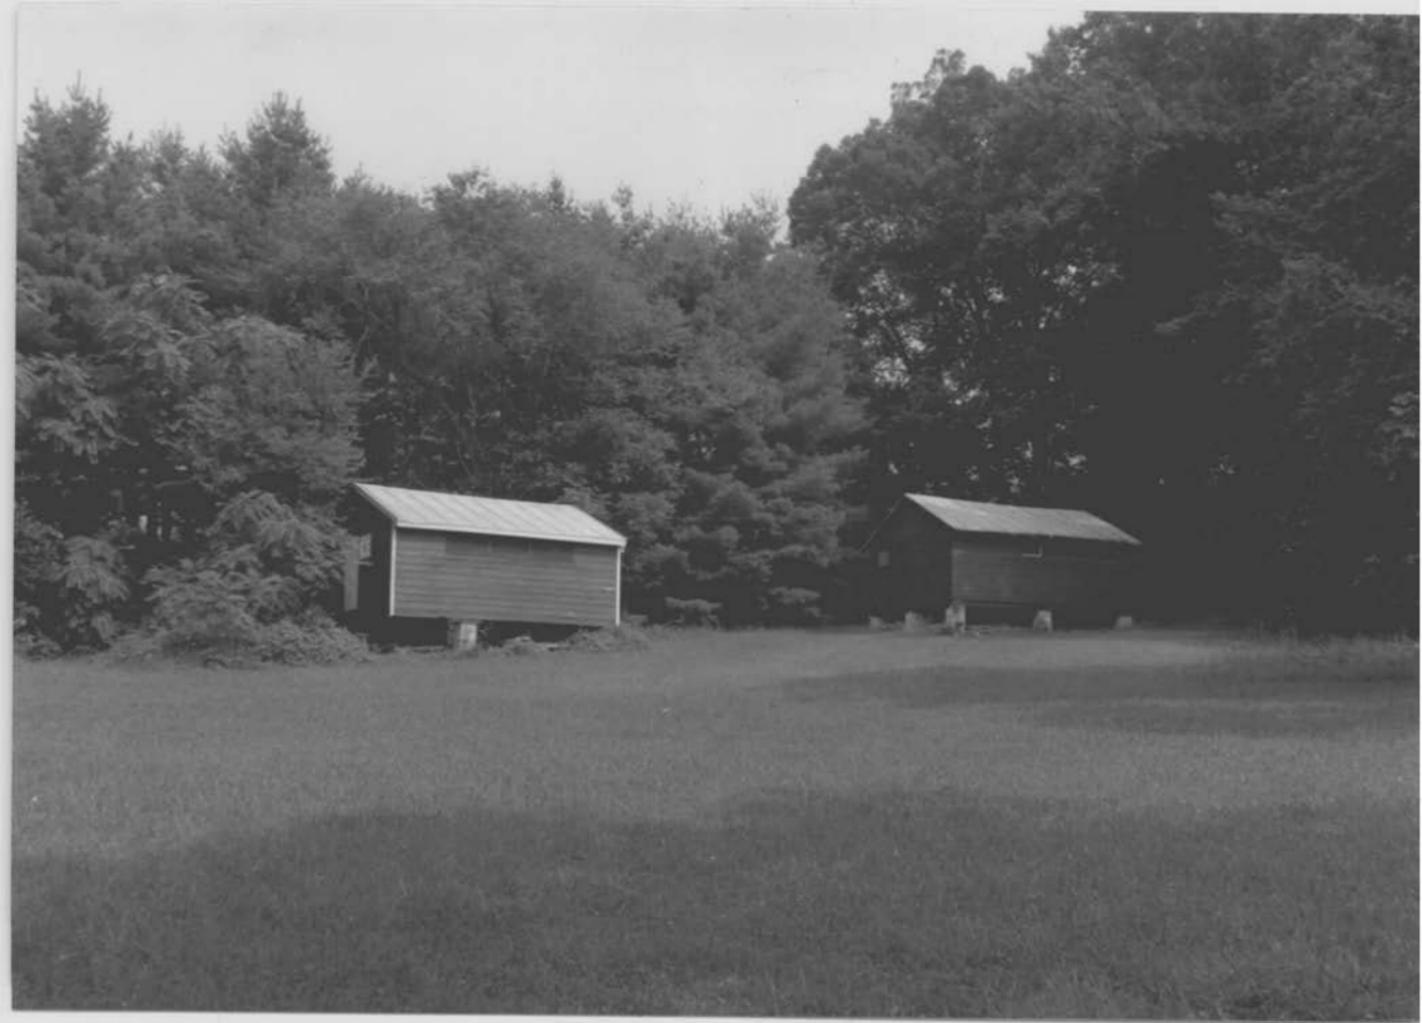
5/5

Also on the property are approximately twelve cabins of 2 x 4 construction with either clapboard or German siding. They are one-room buildings with a small bathroom attached to the rear. They each have a gable roof with standing-seam metal and a door on the gable end. Most of these buildings were moved here from other camps, according to the owner.

Cabins - NW elevs.
