CARR-1459

Taneytown Bank and Trust Company Building
Taneytown

Maryland Historical Trust State Historic Sites Inventory Form

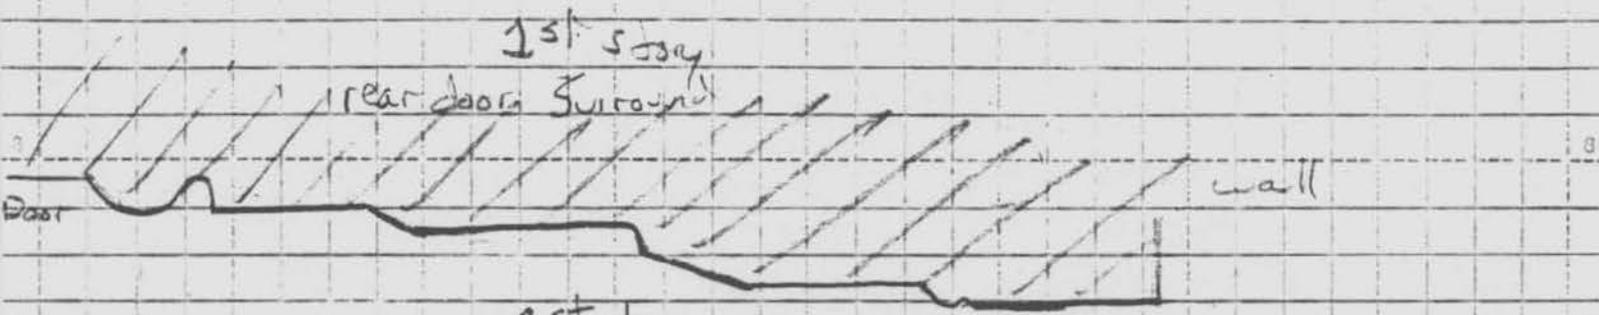
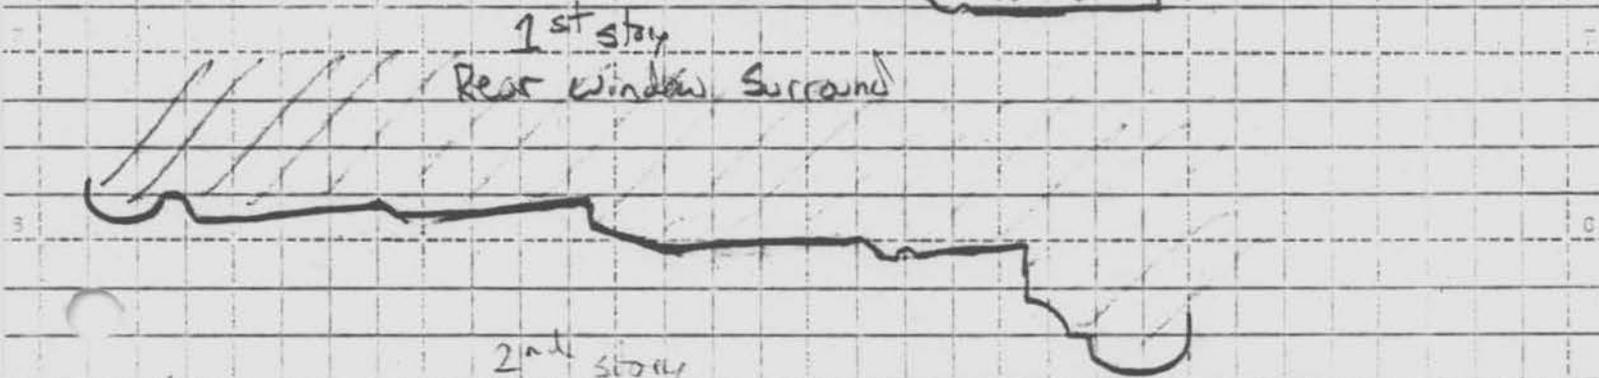
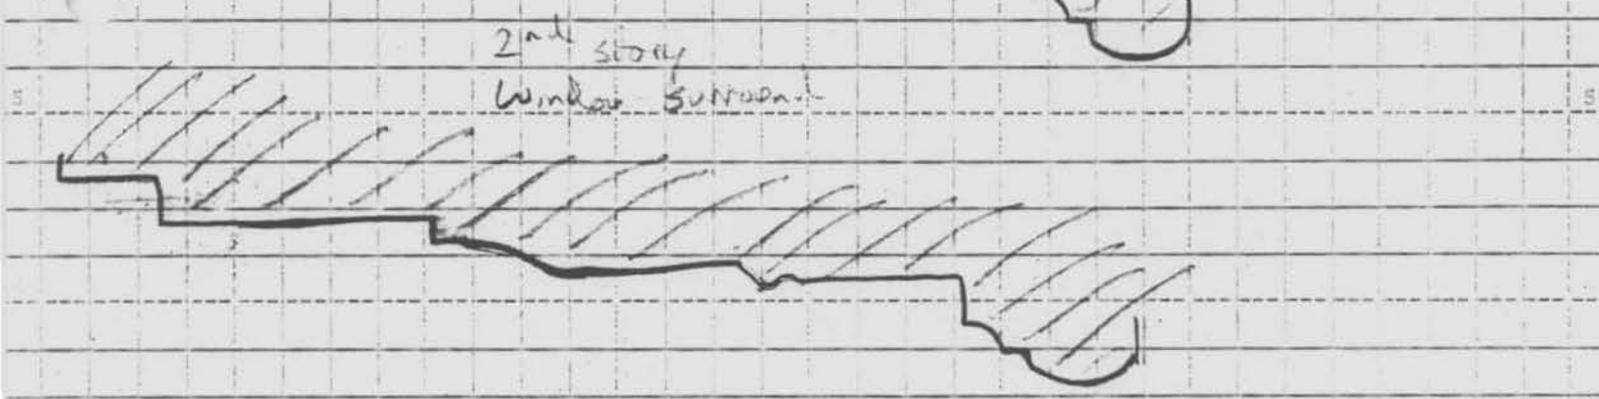
Tanentawa Bank
moulding, plaster

The first story has been completely remodeled and has new mouldings that have an old profile, with a quirked ogee and bevel and a beaded interior edge. The second-story plan has been mostly or completely altered. The original architrave appears to have had a backband with a bullnose and a small cavetto inside of it. There are several four-panel doors on the second story that may be original. There is a change in floor level in the middle of the building, the eastern half being one step higher than the western half. The floor level at the eastern half is level with the sills of the east windows.

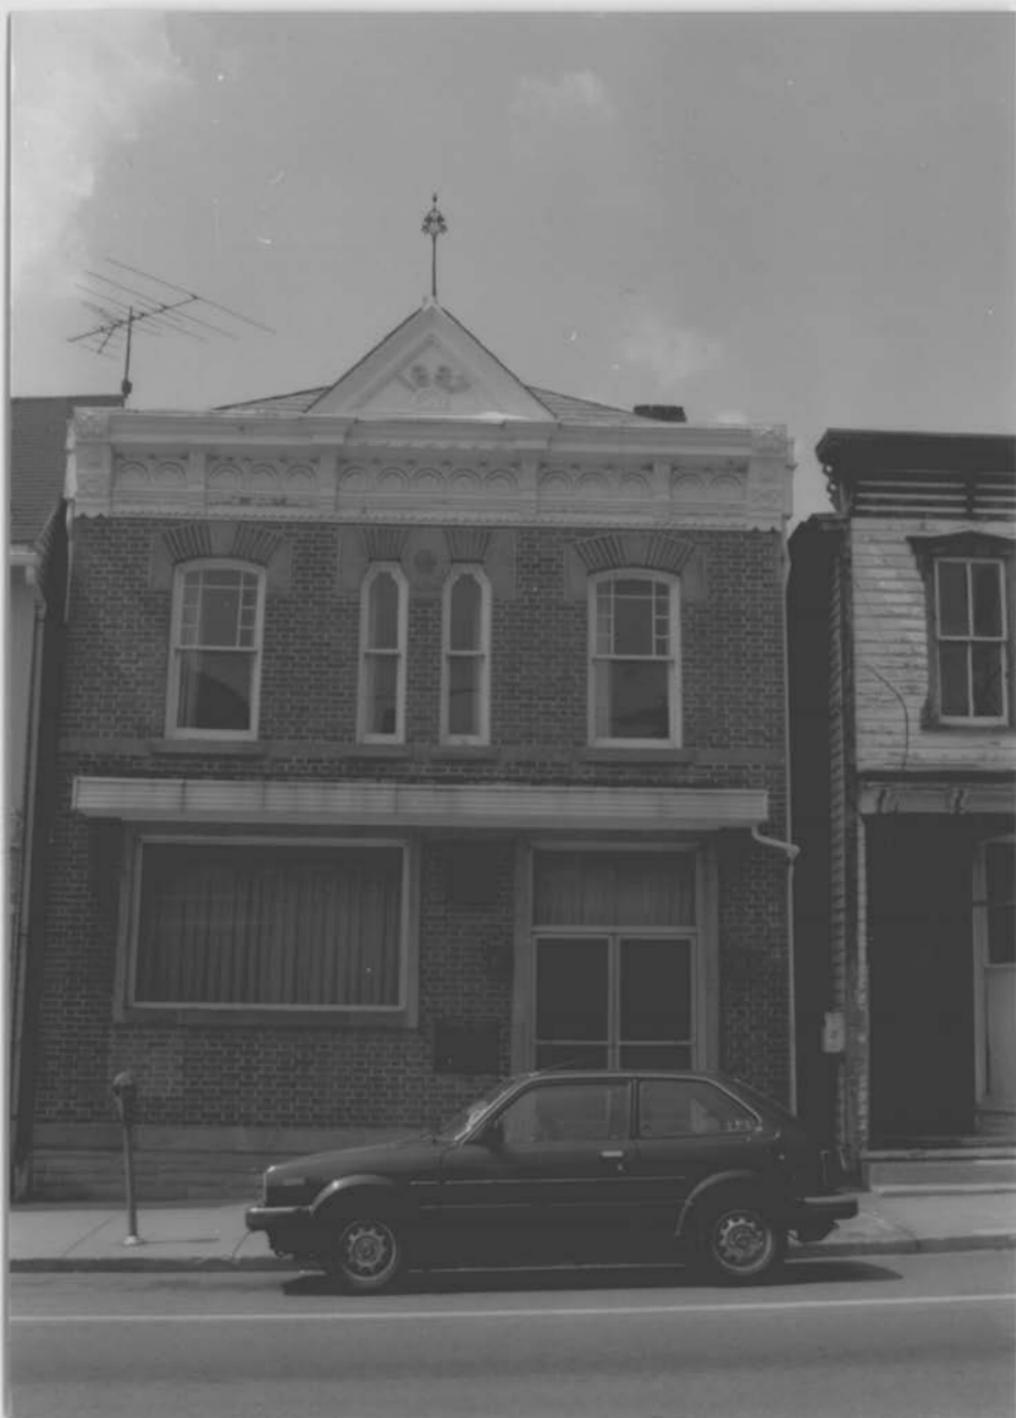
1/3

The Taneytown Bank and Trust Company Building is located at 24 East Baltimore Street in Taneytown, in northwestern Carroll County, Maryland. The building is located on the west side of the street and faces east. It is a two-story, three-bay brick building, with a hip roof of slate and a pediment on the east elevation. The east elevation foundation is rubble stone covered by formstone. Above it is a water table that appears to be granite. The east elevation has Flemish bond brick work. The first story has a new window opening to the south with an architrave that appears to be granite. To the north is a new door opening with the same stone trim. There is a small new metal pent roof between the first and second stories and a granite belt course. The second-story, center bay has two 1/1 sash with shouldered depressed arches. The arch has a stone voissior on each end and one in the center. They appear to be granite. The center voissior is carved with a four-lobed leafy design. There are brick voissoirs between the stone voissoirs. The end bays have segmentally-arched Queen Anne sash above a single-light sash. There is a pressed-metal cornice with brackets, and segmental arches in the frieze between the brackets. There are large end brackets that have fleur de lis, and there is a pediment in the center with "1887". There is also cast iron roof cresting with a finial.

east elev.

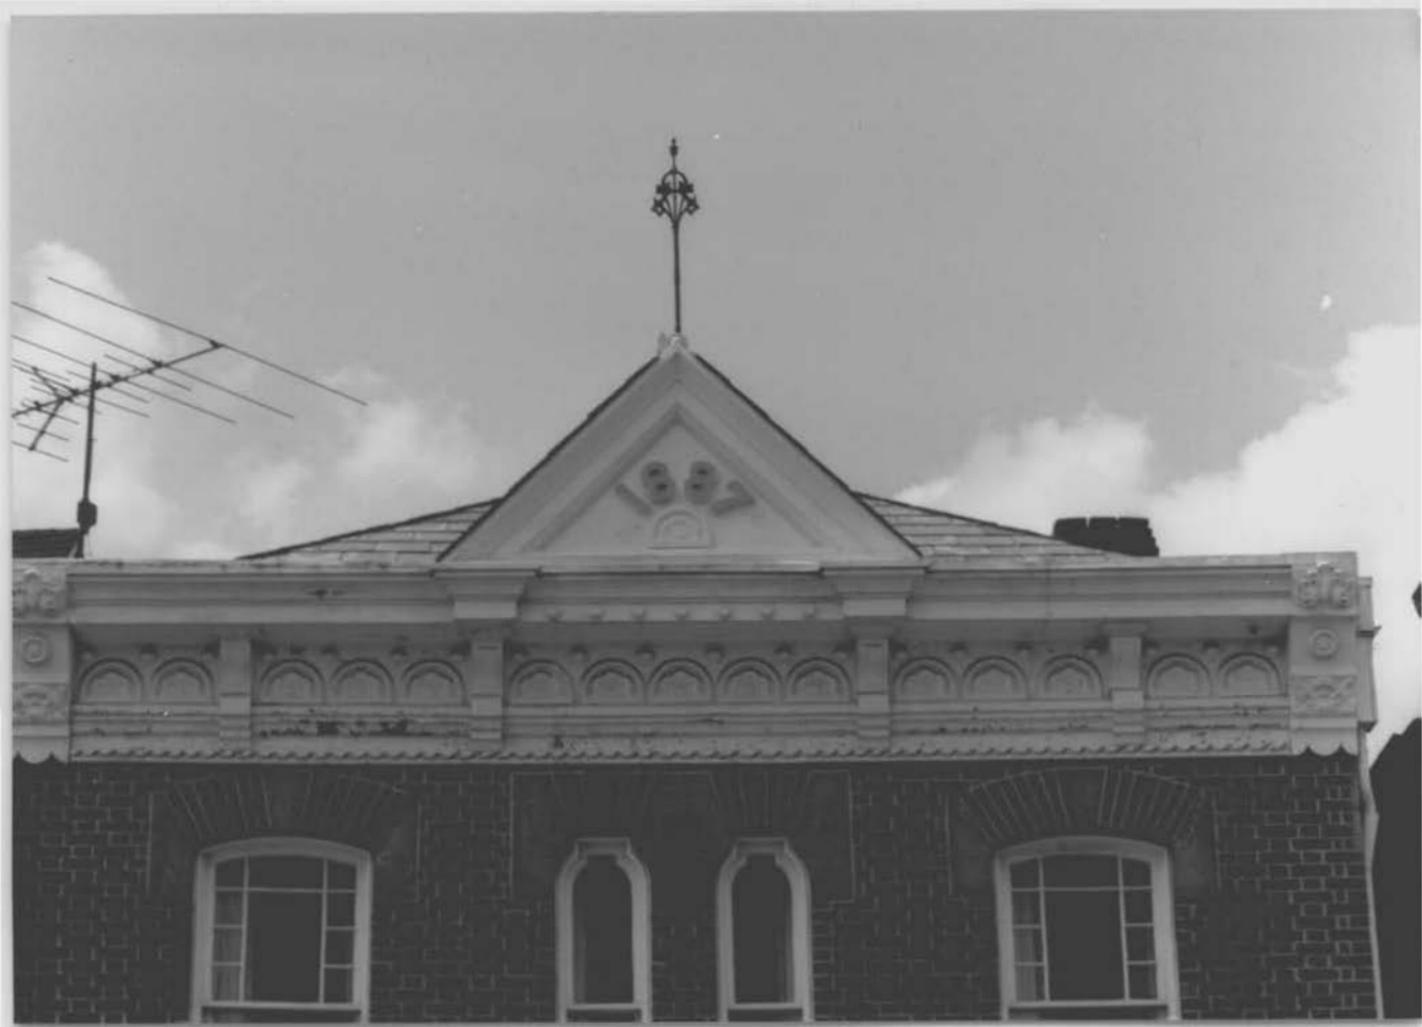
2/3

Neg. Loc.: Maryland Historical Trust
east elev. - pediment

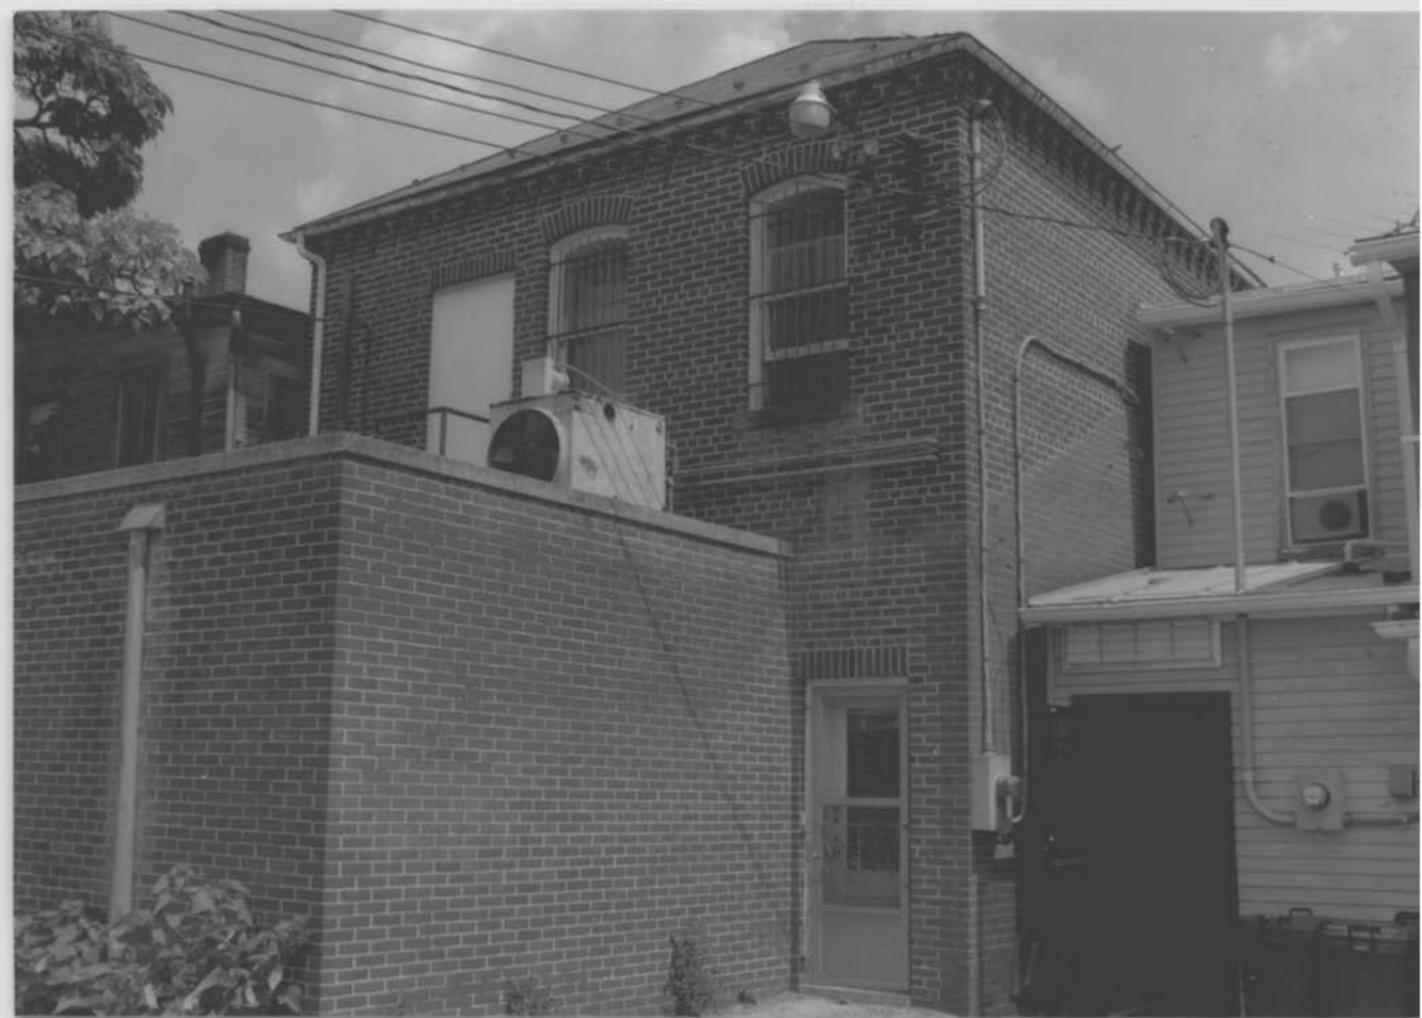
3/3

On the west elevation, the north bay of the first story has a segmentally-arched 1/1 sash with steel bars. There is a hurricane door to the cellar beneath this window. A new brick vault has been added to the center of this elevation. The south bay has a door with one light over one panel. The second story has new brick and mortar and a new door in the north bay. The center and south bay windows match the first story. The cornice is identical to the north elevation. The roof is hipped on the west. The south elevation is basically inaccessible, but has the same cornice as the north elevation.

W. & S. elevs.
