CARR-1460
McGee Farm
Carrollton (vicinity)

Maryland Historical Trust State Historic Sites Inventory Form

historic McGee Farm

Survey No. CARR-1460

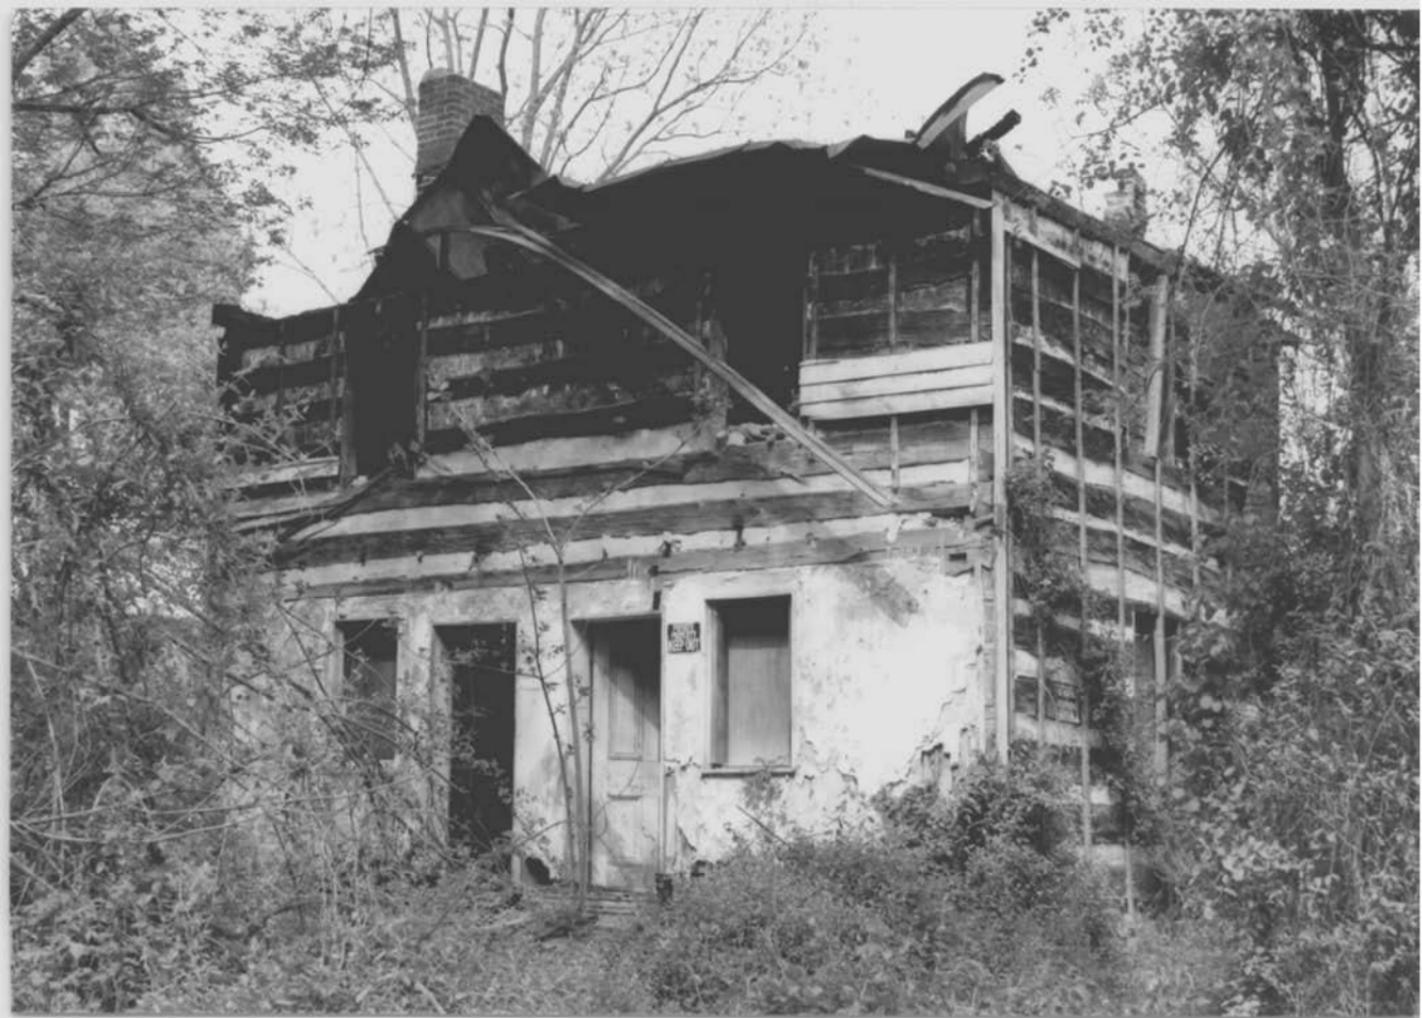
72211 NINETEEN
51
55
1/2

The Magee Farm is located on the east side of Reese Road, approximately 1 mile north of Reese and approximately $\frac{3}{4}$ of a mile southwest of Carrollton. The house is located about 100 feet north of a small stream. The site slopes generally from north to south toward the stream and consists of a log house, a frame bank barn, a frame shed that may be a hog pen, and a frame smokehouse. The house is a two-story, four-bay by one-bay, V-notched-corner log structure. It formerly had a gable roof with a north-south ridge and standing-seam metal, but the building has suffered from a fire, and the roof has collapsed into the building. The west elevation on the first story has rough-casting on vertical lath that appears to be riven. There are two central four-panel doors, and a window opening on either side of them. There was a one-story, four-bay porch on this elevation, as there are four mortises in one of the logs for the porch joists. The log with the mortises is set above the rough-casting. There is no siding, whitewash or rough-casting on the logs where the porch roof covered them. This feature, in conjunction with the mortises in the log, suggest that the porch was an original feature. The logs are notched on top and bottom to accept the joist ends of the second story. The second story of the west elevation has vertical nailers with some clapboard attached. There is a window opening in each end bay. One rafter foot appears to be notched and tapered to lap over the top log. There is an interior brick chimney on the north end, and the remains of a small interior brick chimney on the south end.

The north elevation has clapboard on vertical nailers and corner boards. There are no openings. The south elevation has vertical nailers and one central window opening on both the first and second stories. This opening is at least partially blocked by the brick chimney,

which must be a later addition. The east elevation was not entirely accessible, but appears to have a window in the south bay and a door in the north bay on the first story. There is no evidence of an interior log wall partition.

Neg. Loc.: Maryland Historical Trust
house - w. & s. elevs.

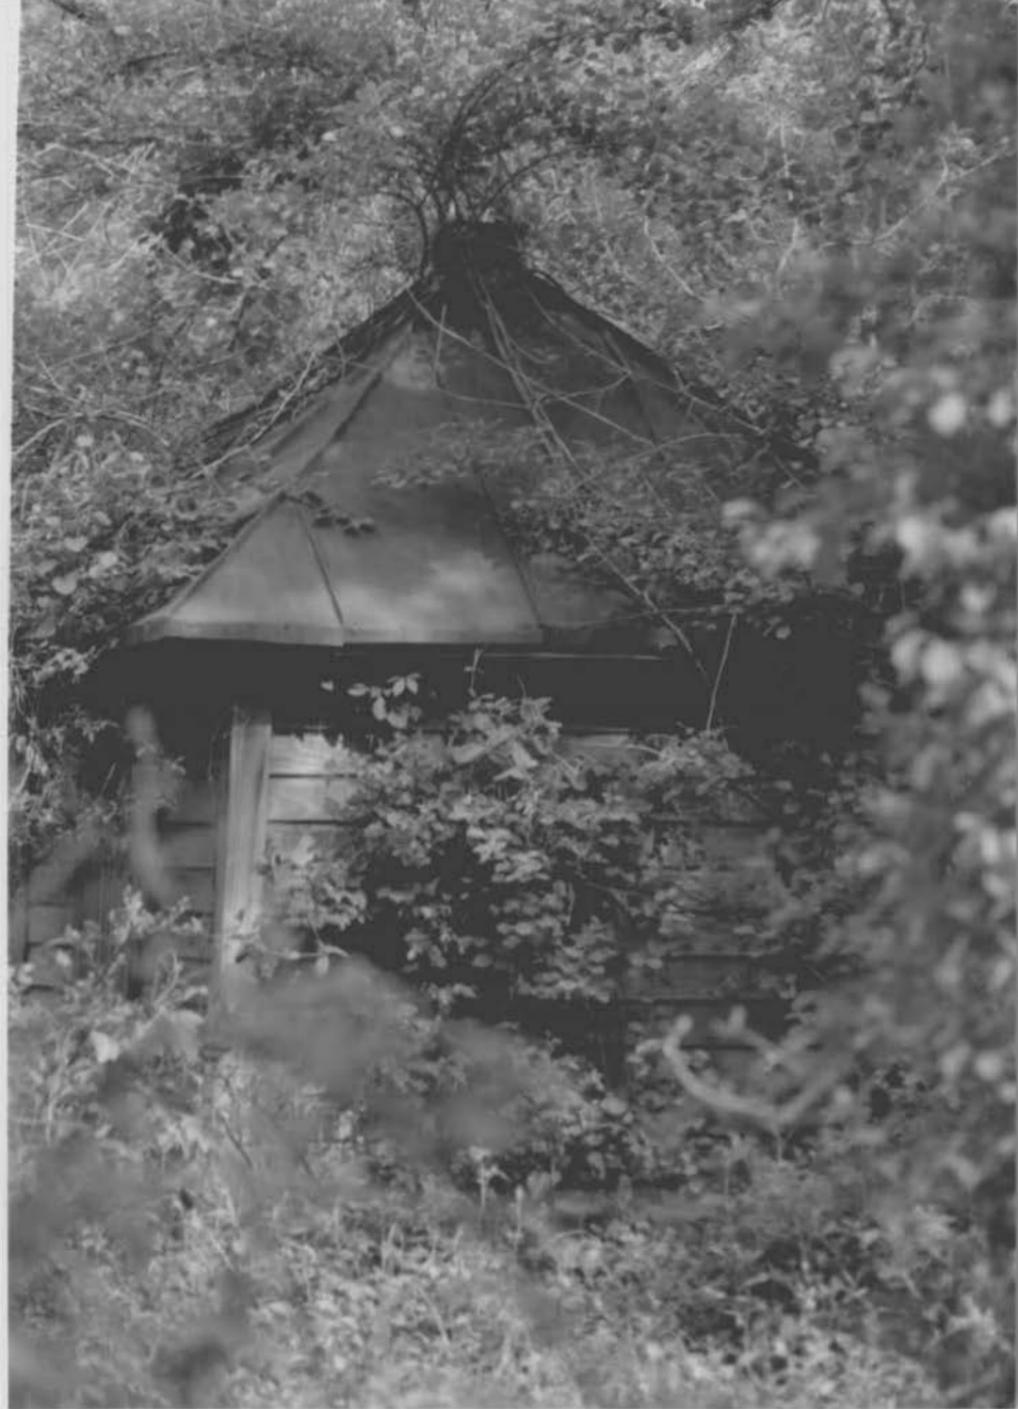
2/2

About 20 feet south of the house is a smokehouse. It is a one-story, one-bay square clapboard structure with corner boards and a hip roof of standing-seam metal. It appears that the peak of the hip has a wood box. There is a door on the north elevation.

Neg. Loc.: Maryland Historical Trust
Smokehouse - N. & W. elevs.
