INDIVIDUAL PROPERTY/DISTRICT
MARYLAND HISTORICAL TRUST
INTERNAL NR-ELIGIBILITY REVIEW FORM

Property/District Name: David Reindollar Farm Survey Number: CARR-1461

Project: Mountain-Brook Development Agency: COE

MARYLAND INVENTORY OF
HISTORIC PROPERTIES

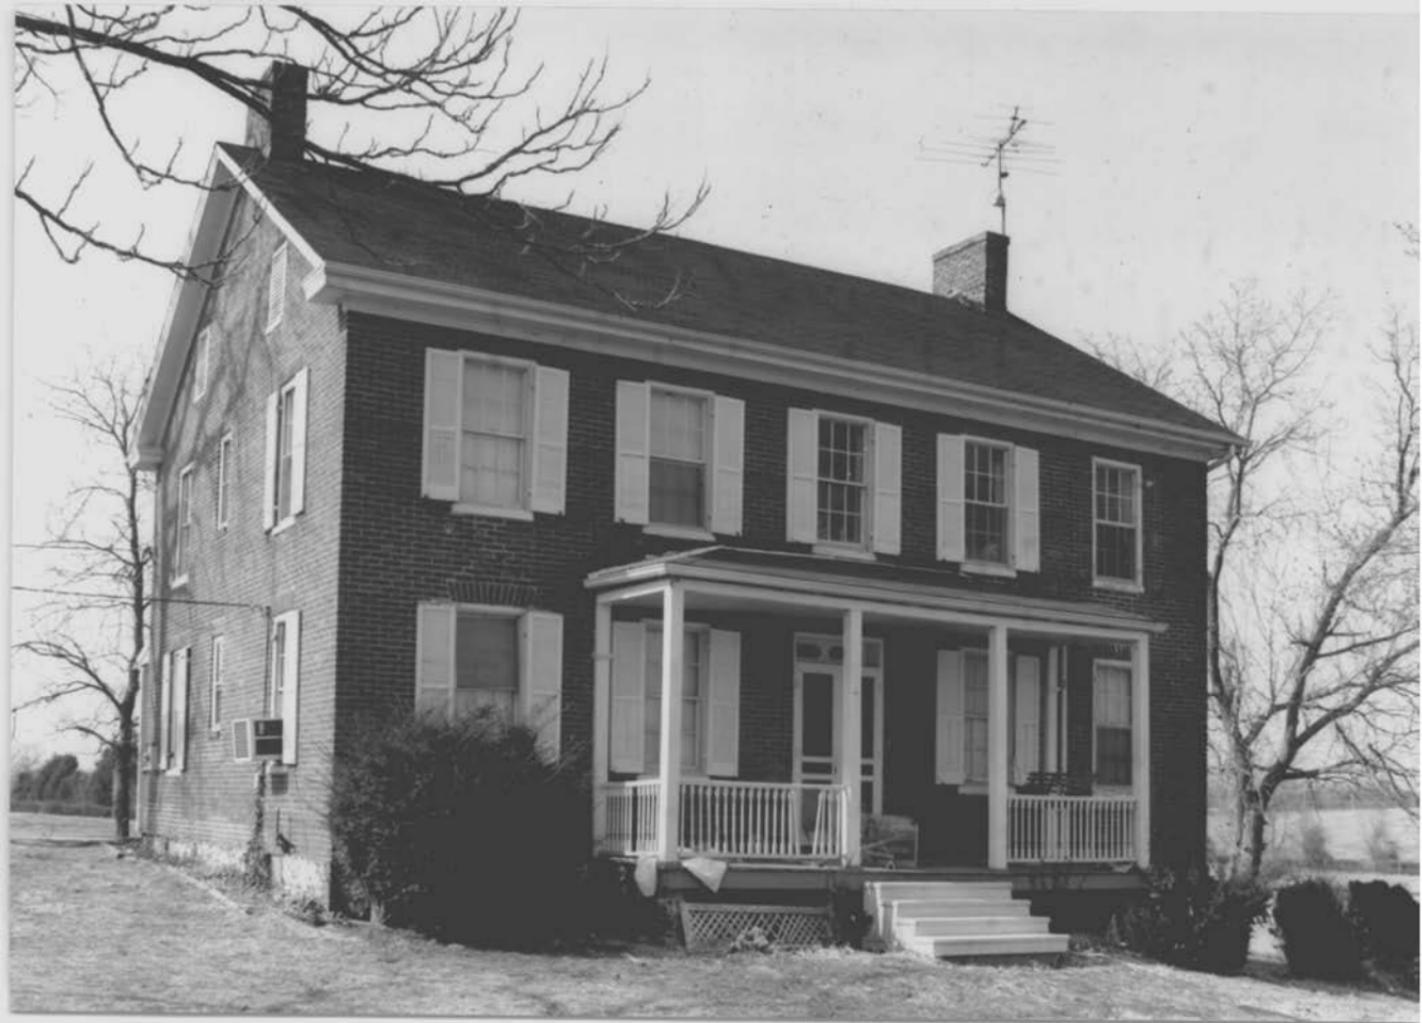
1/8

SE elev.

The house faces southeast toward the road and is a two-story, five-bay by two-bay structure, with a rubble stone foundation of local brownstone, running bond brick on the south elevation, and 7-to-1 common bond brick on the rest of the elevations. There are traces of penciling, but it appears that the brick was not painted, only the joints were penciled. The house has a gable roof of asphalt shingles with a northeast-southwest ridge. There is a wood box cornice with returns, and the bed mould has a fascia. There is an interior brick chimney on each end.

of the foundation, and a 2/2 double-hung sash in the east bay. The first story has a center entrance with double doors, each having four panels with bolection mouldings. The door jambs have two panels. There is a two-oval-light transom, and the jamb and soffit have one panel each. There is a brownstone lug sill and splayed brick jack arch. On either side of the doorway are two 6/6 double-hung sash. The top sash are fixed. The sills are wood, and there are splayed brick jack arches. They have blinds, and the bottom half of them are adjustable. There is a one-story, three-bay porch with new railings and a half-hip roof with asphalt shingles. There are four square posts. The porch formerly had brackets. The second story has five typical 6/6 sash.

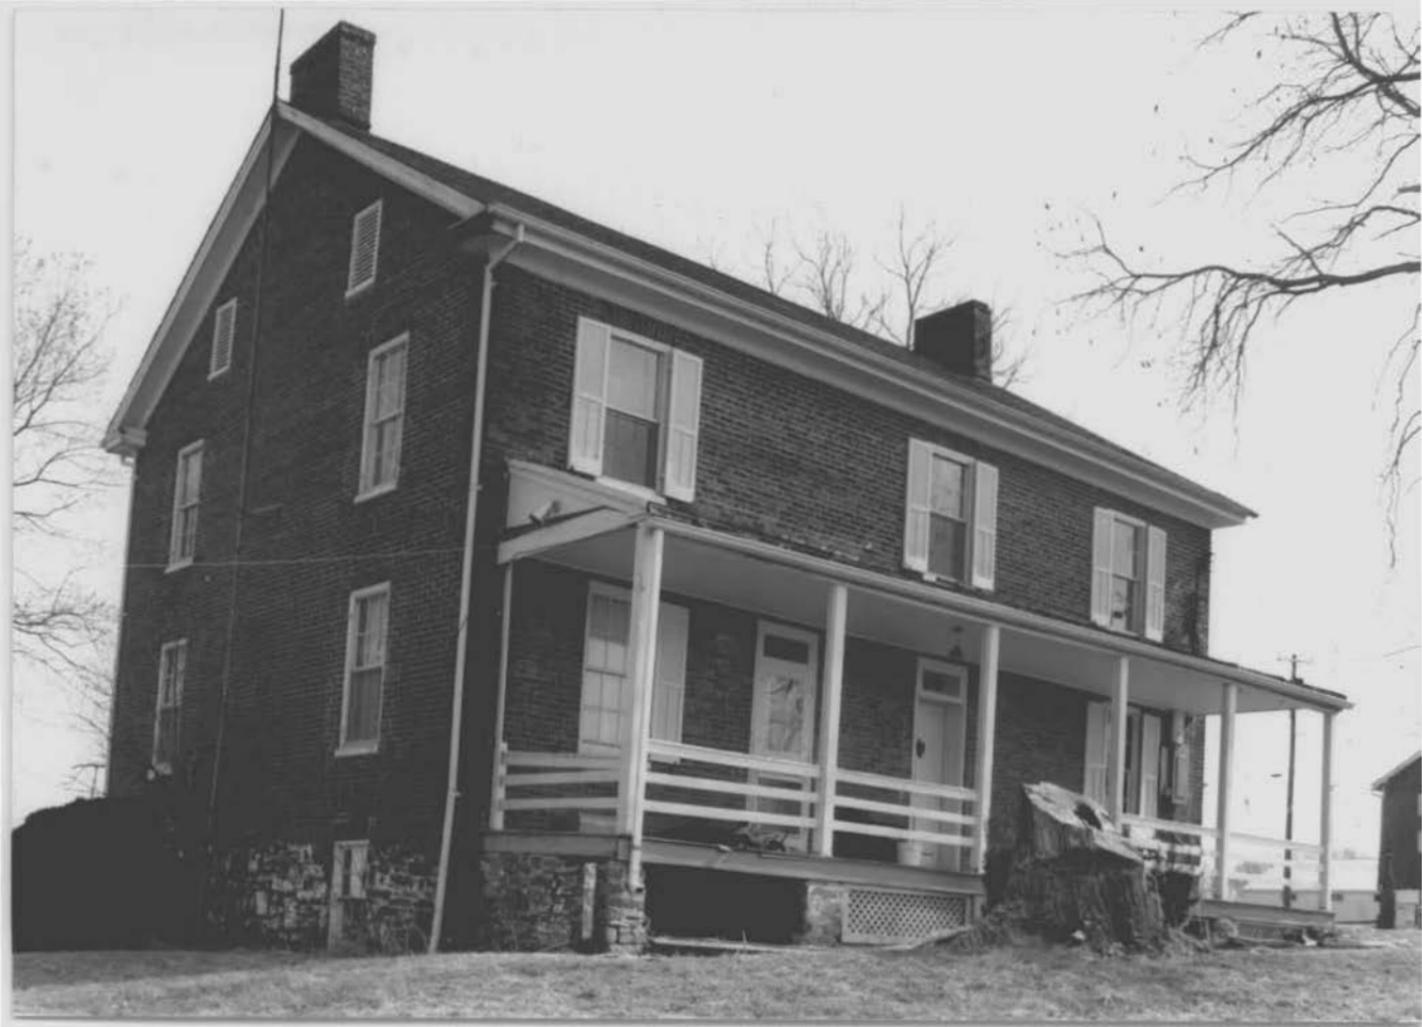
$\frac{3}{8}$

NE & NW elevs.

On the northwest elevation, the first story has, from west to north, a typical 6/6 sash, a door with two lights over two panels and a four-light transom, a door with four panels and a four-light transom, no opening, and a typical 6/6 sash. There is a five-bay, one-story porch, with a shed roof of standing-seam metal, and six posts with three horizontal rails between them. The second story has three typical 6/6 sash, one each in the end bays and the center bay. The cornice is identical to the southeast elevation.

The northeast elevation has a beaded-edge, vertical-board door with a four-light sash in the east bay of the foundation. The north bay has a typical 6/6 sash. The first and second stories have two typical 6/6 sash. The gable end has two typical wood louvered vents.

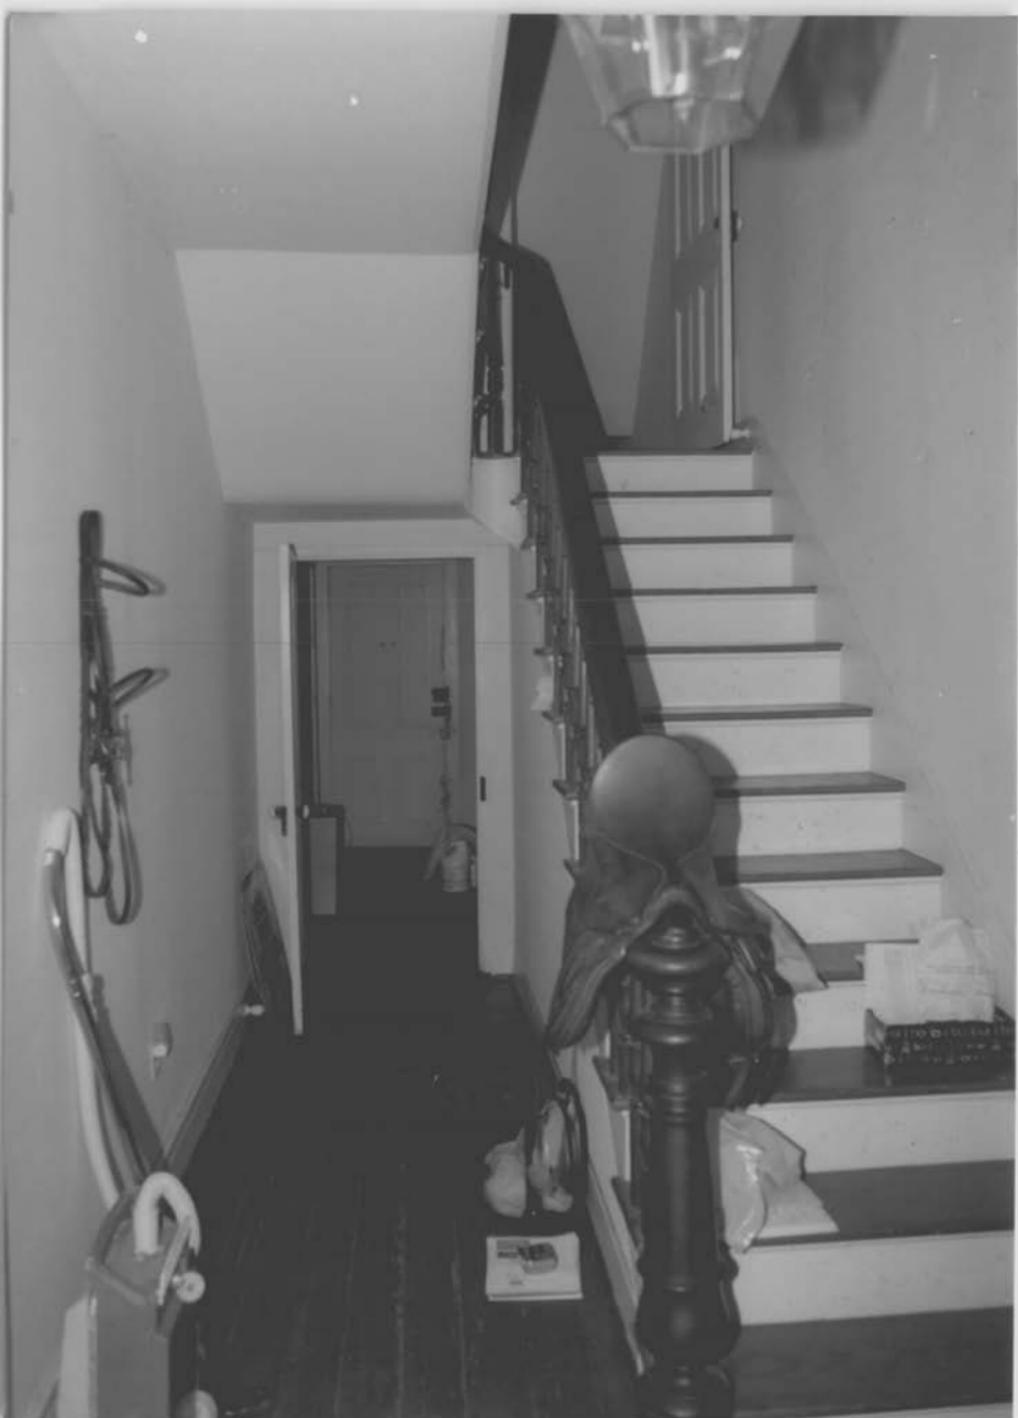
3/8

Neg. Loc.: Maryland Historical Trust
Passage - view NW

The first story has a center-passage, double-pile plan. The flooring is tongue-and-grooved pine that runs northwest-southeast throughout the house. It is face-nailed with cut nails. The center passage has a dog-leg stair on the northeast wall that has an open stringer, turned oak balusters, and a turned newel. The northeast wall is brick with plaster on it. The interior doors have four panels. The passage is divided in half by a wall with a four-panel

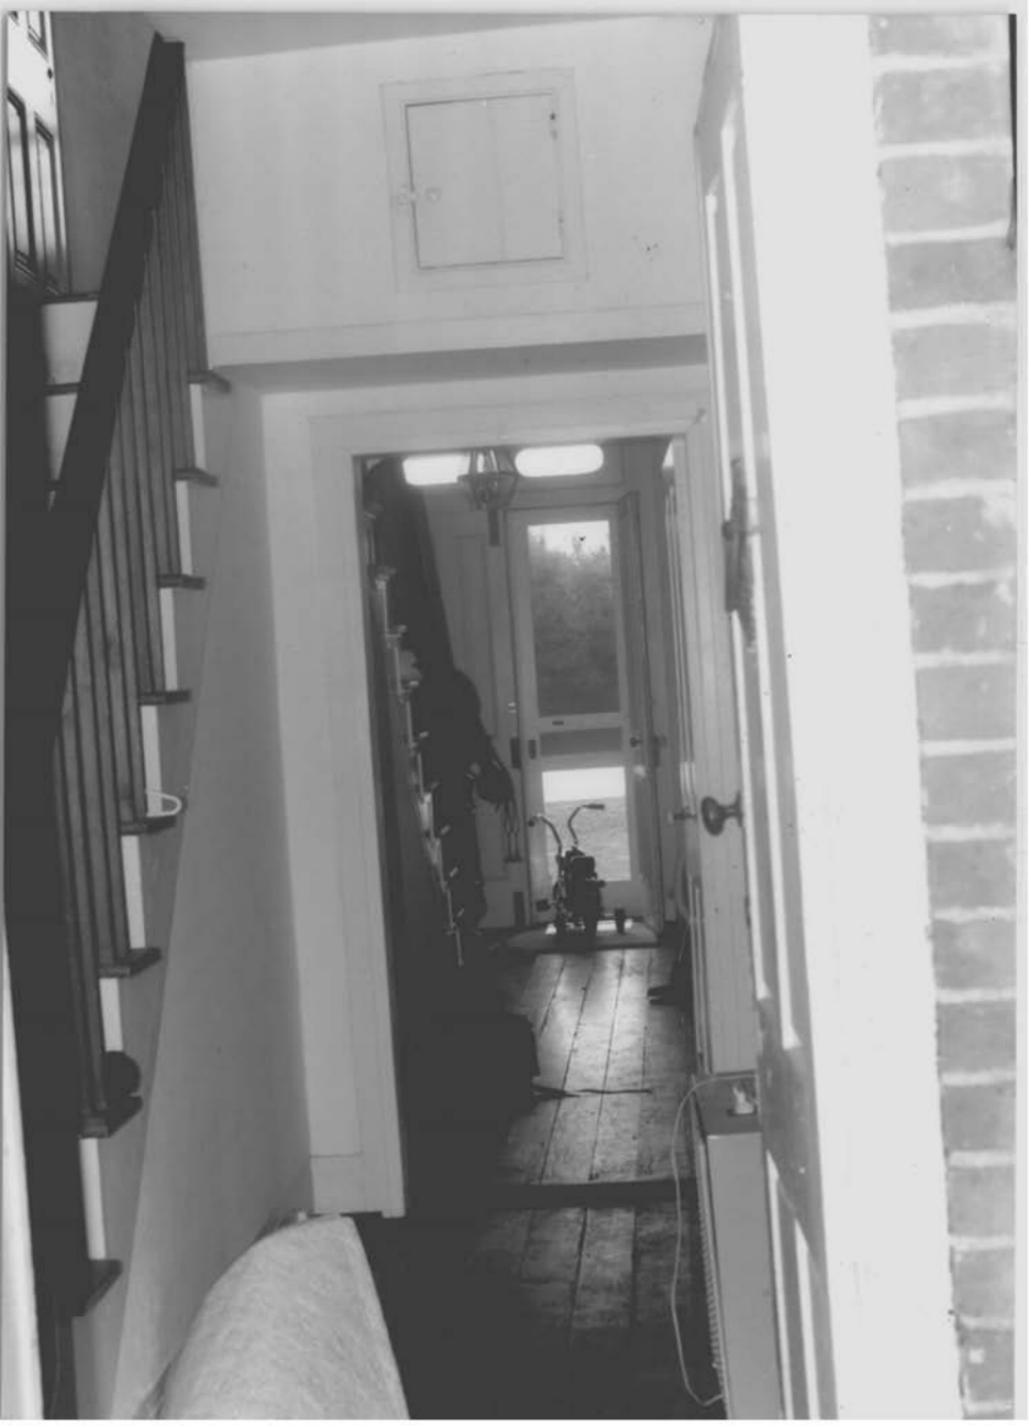
4/8

Neg. Loc.: Maryland Historical Trust
passage - view NW

door. The northwest side of the passage has an open stringer, two-flight stair along the northeast wall with a landing along the southeast and stairs that continue to the northeast. This stairway has rectangular balusters and a simpler turned newel.

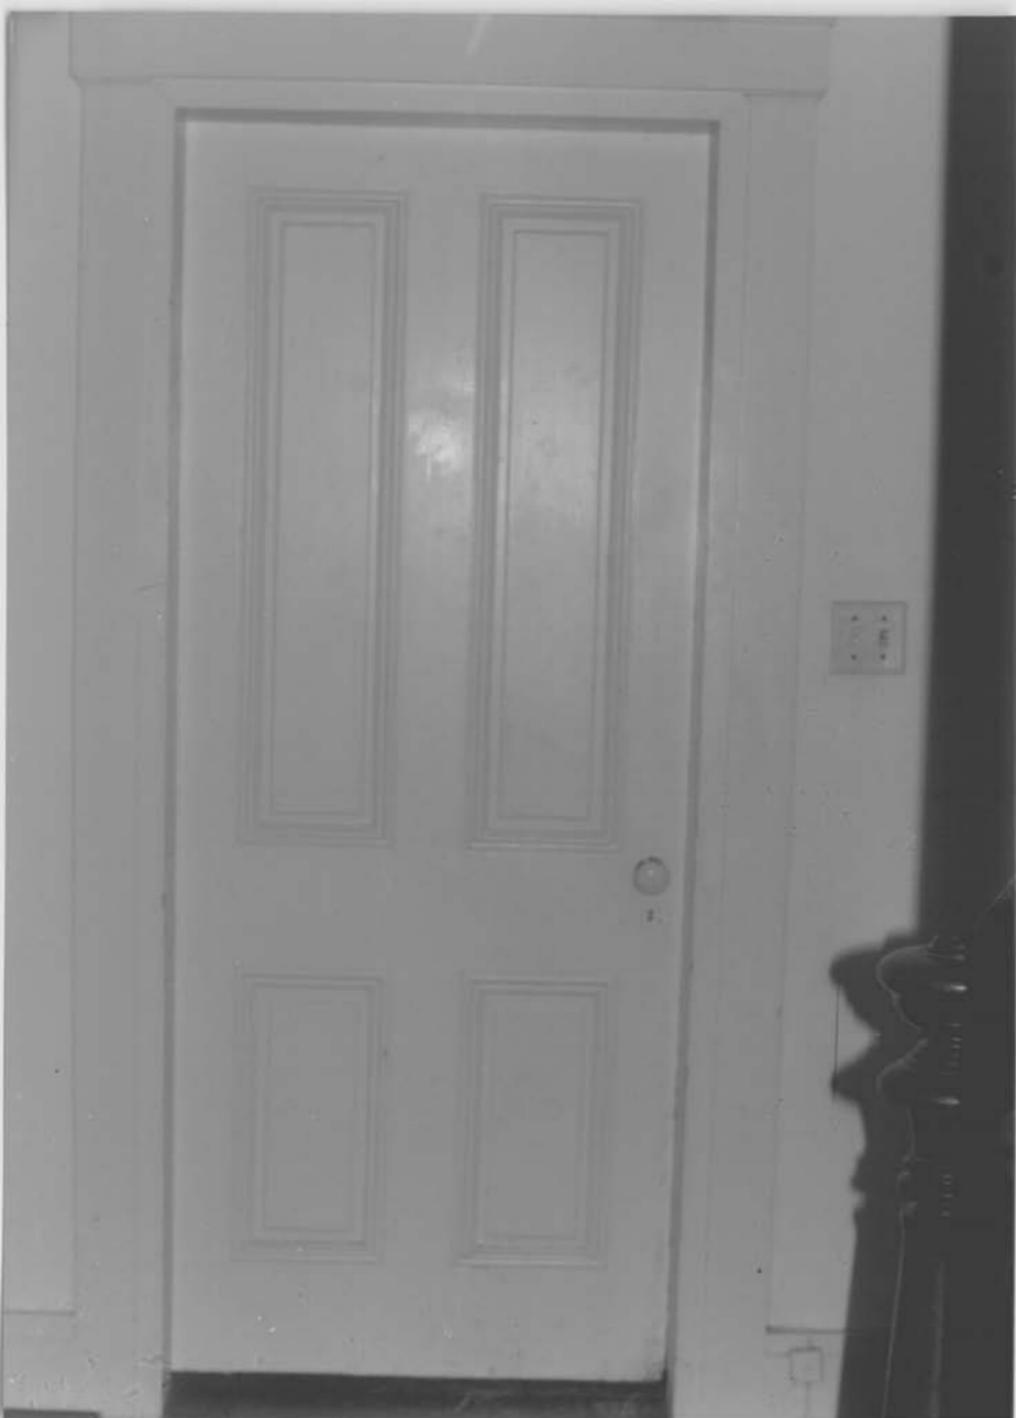
5/8

Neg. Loc.: Maryland Historical Trust
door architrave

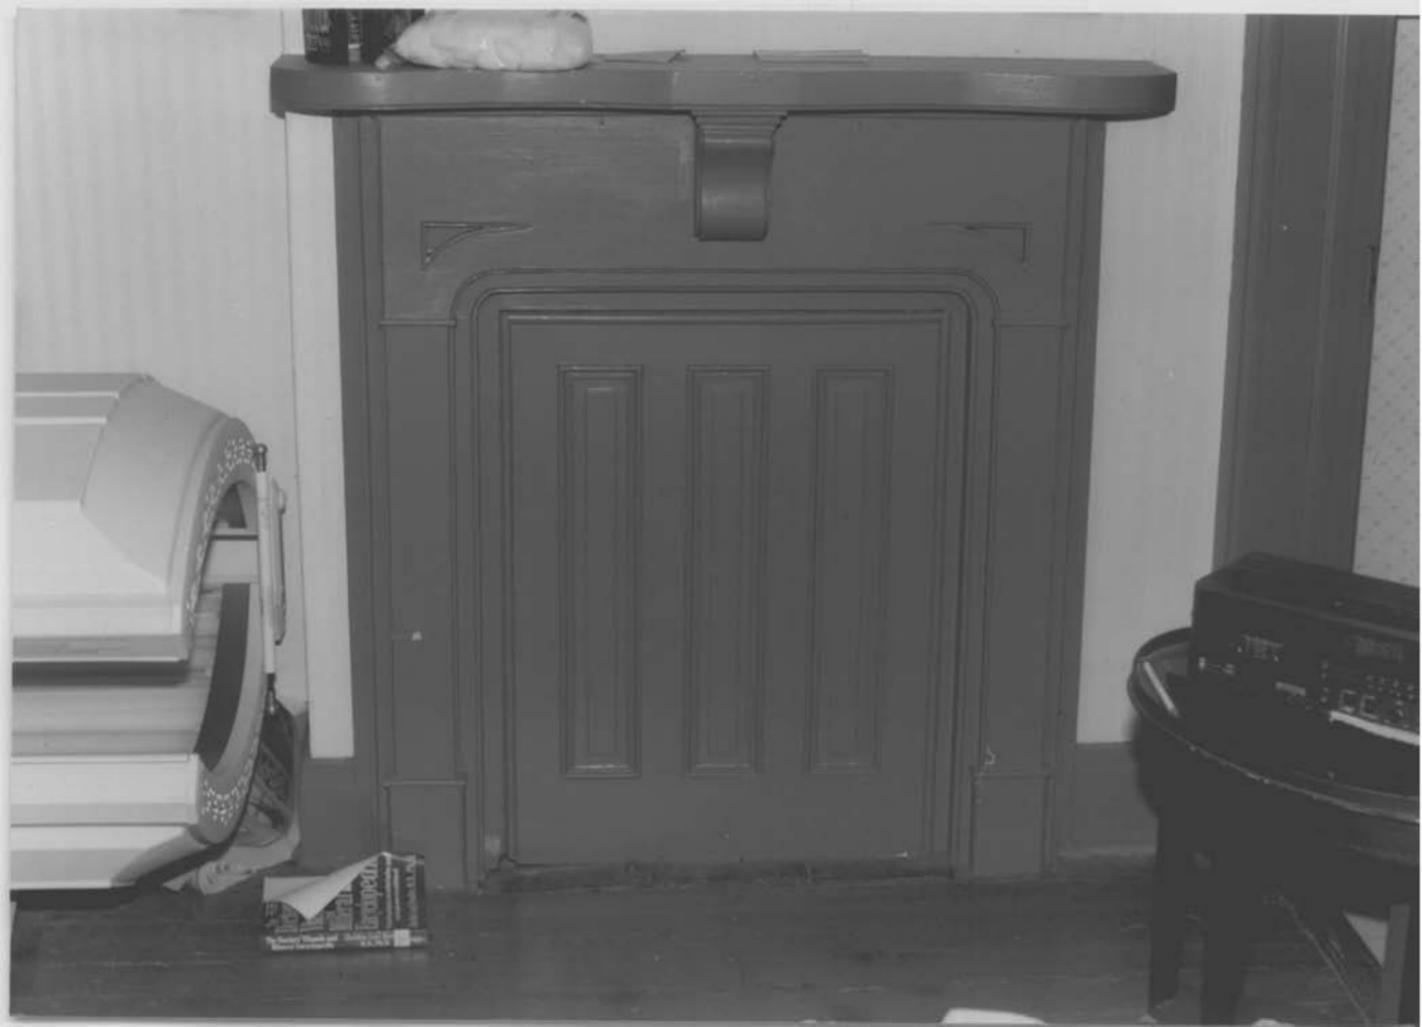
6/8

Neg. Loc.: Maryland Historical Trust
South room mantel

The south room has a mantel on the southwest wall that is identical to that in the east room. It has a small brick hearth. The fireplace opening has an infill of three vertical panels that appears to be original. The northwest wall has two doors, one to the north side and one to the west side. The doors themselves are later two panel doors, but the openings appear to be original. They apparently formerly led to the west room, but the west room has been altered and they now lead to a closet and a bathroom. The original west room had a wood mantel on the southwest wall with plain pilaster strips and a segmentally-arched frieze. This mantel survives in situ in the rearranged room that is now a bathroom.

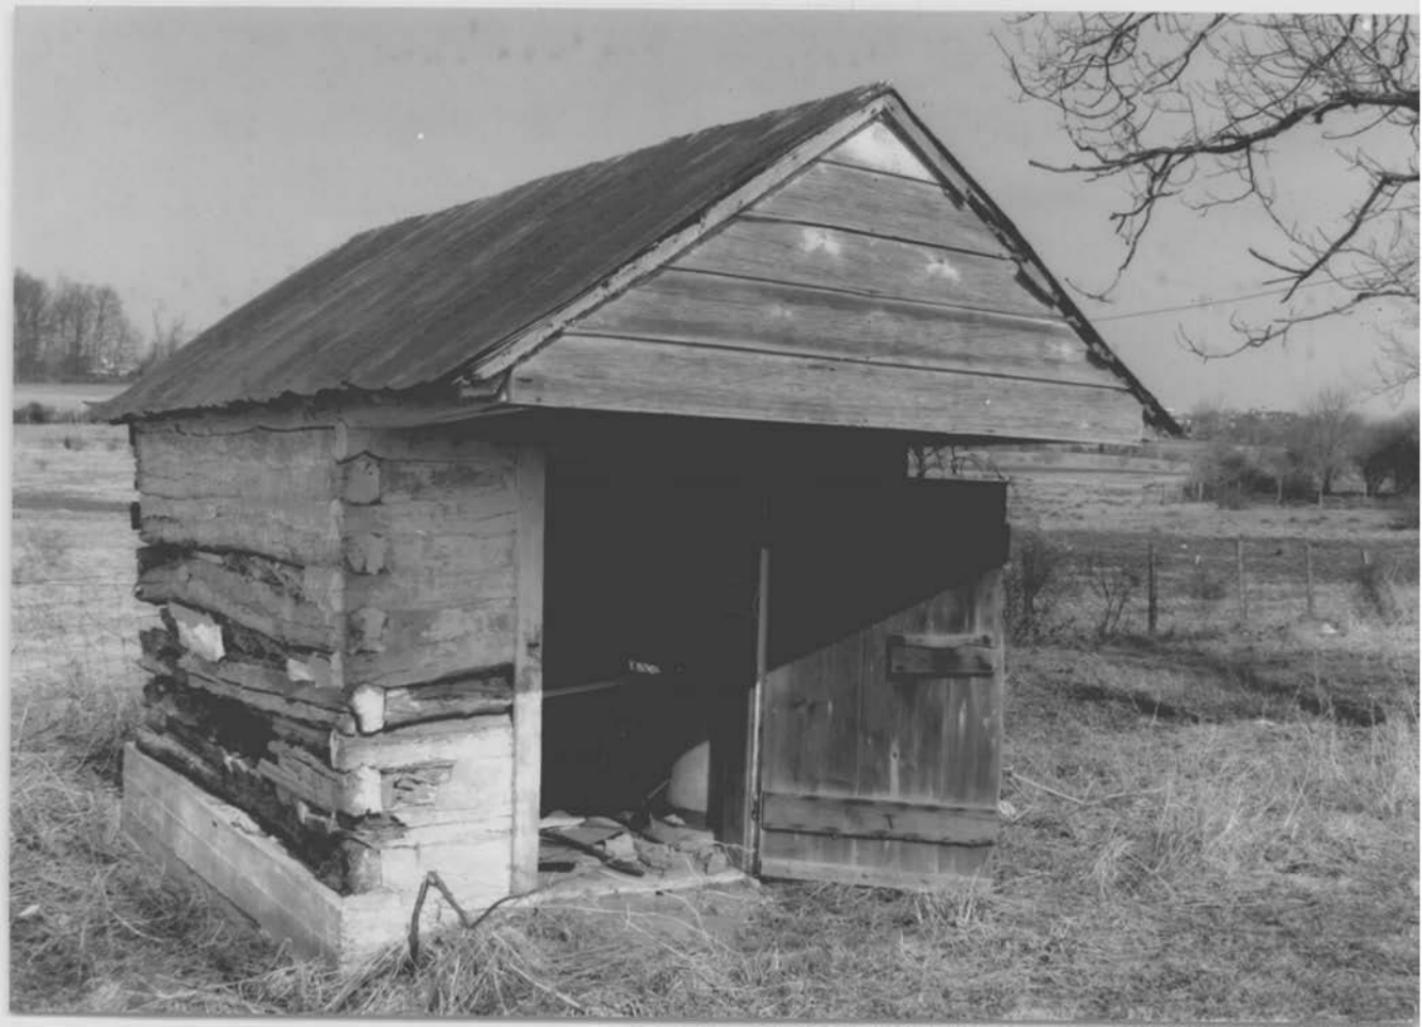
7/8

Neg. Loc.: Maryland Historical Trust
Smokehouse - NW & SW elevs.

About 30 feet north of the house is a log spring house with V-notch corners. It is set on a concrete foundation and may have been moved here. It is very deteriorated. The chinking is mostly of wood. It has a gable roof with an east-west ridge. It is cantilevered

on the west. The roofing has inverted V-seam metal. The logs are hewn on the sides. The top plate is hewn on all four sides. The rafter ends are exposed. The west elevation has a vertical-board door on strap hinges. The gable end has half-lap siding. The rafters are sawn, and have a half-lap and peg at the ridge. The interior has exposed logs and is blackened as if it was used for a smokehouse at some point. There are stones set in the ground as a walkway from this building to the rear elevation of the house suggesting that it may be in its original location.

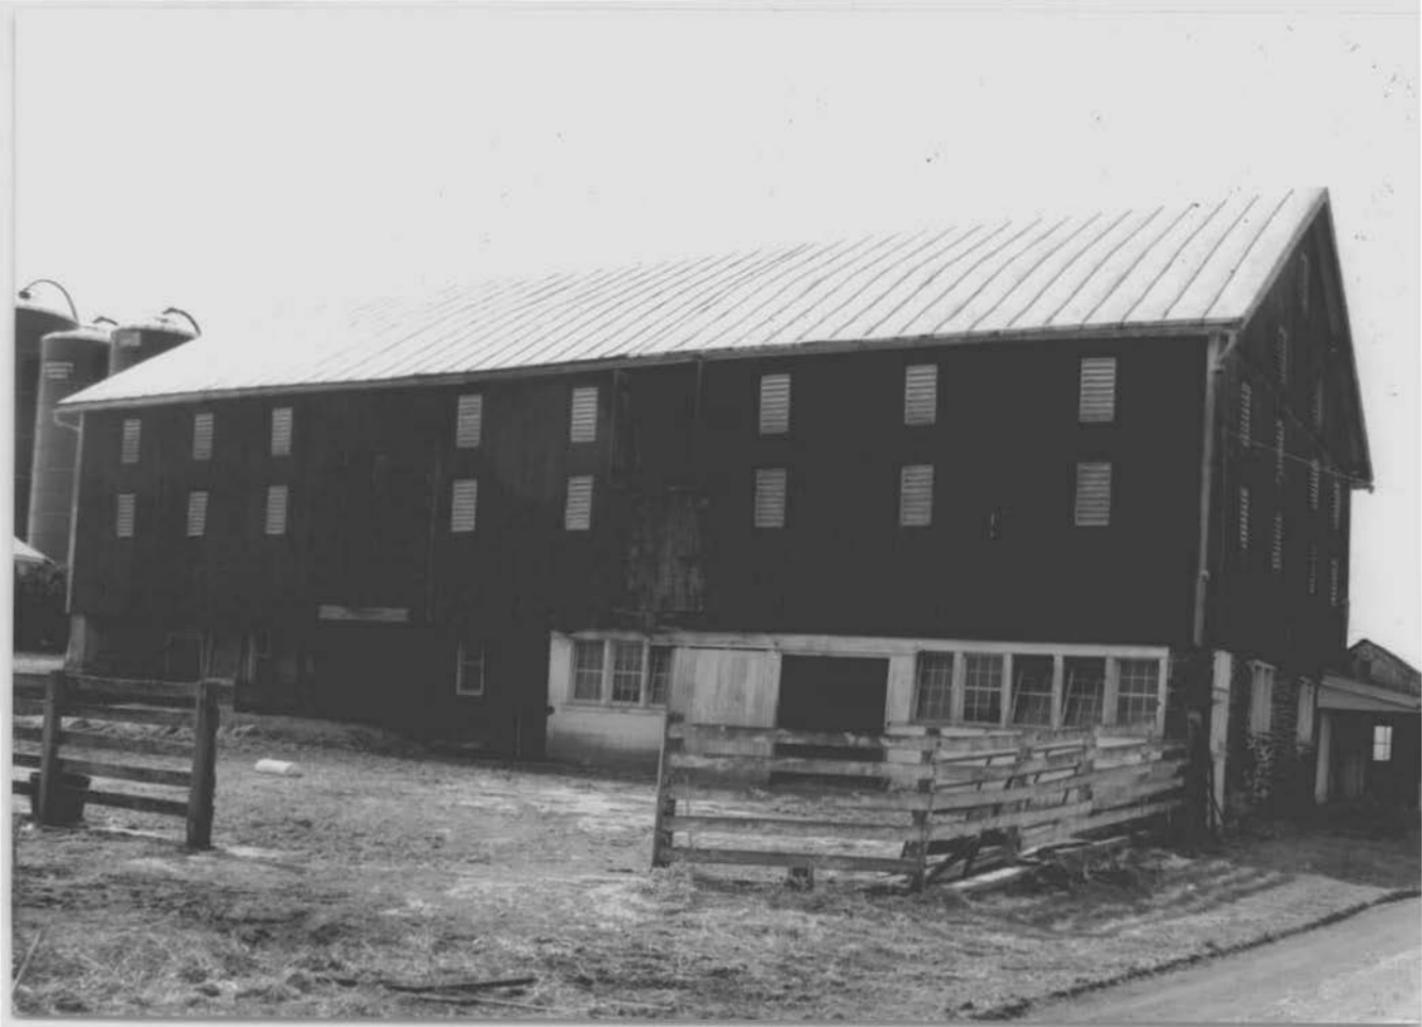
8/8

Neg. Loc.: Maryland Historical Trust
barn - SE elev.

About 100 feet southwest of the house is a bank barn with a forebay that faces southeast. The lower story has rubble stone on all four sides, with a stone end wall under each end of the forebay. The upper story has vertical-board siding, and the gable roof has standing-seam metal with a northeast-to-southwest ridge. The lower story of the southeast elevation has a Dutch door, a 4/? sash, an altered wide opening, a 4/? sash, a typical door, and a CMU addition under the forebay with twelve-light tilting sash. The upper story has three vents over three vents, double doors, two vents over two vents, double doors over double doors, and three vents over three vents.

The northeast elevation has a vertical board on strap hinges under the forebay. This is not the original door. There are then two paired openings and a vertical-board door on rollers in an original opening in the north bay. There is a CMU one-story addition on the north corner. The northwest elevation has a ramp to the upper story, which has two pair of wagon doors on rollers in the center, with two vents over two six-light sash on the north end, and two vents over two vents in the west end. The lower story has a paired opening at the north end. The southwest elevation has three openings on the lower story, two of which are boarded and one has a frame with holes for horizontal wood louvers. The upper story has four vents with four vents above them, two vents above them in the gable end, and one vent in the peak.

The lower story northeast end of the barn has been altered as a dairy parlor. The southwest end has two hewn summer beams with four posts under each. The joists are, for the most part, reused timber. The wall by the ramp is partially collapsed. The upper story has two center threshing floors with a hay mow on each end and a granary in the north corner. There are five hewn bents that are mortised and tenoned and pegged, with four posts to each bent and a Queen post truss supporting the roof. There are sawn rafters that appear to be half lapped and pegged at the ridge. The bents have been considerably altered and have members cut out, and there is some deterioration to the barn.
