CARR-1489

Pickett Mill Property  
Winfield (vicinity)

**Maryland Historical Trust**  
**State Historic Sites Inventory Form**

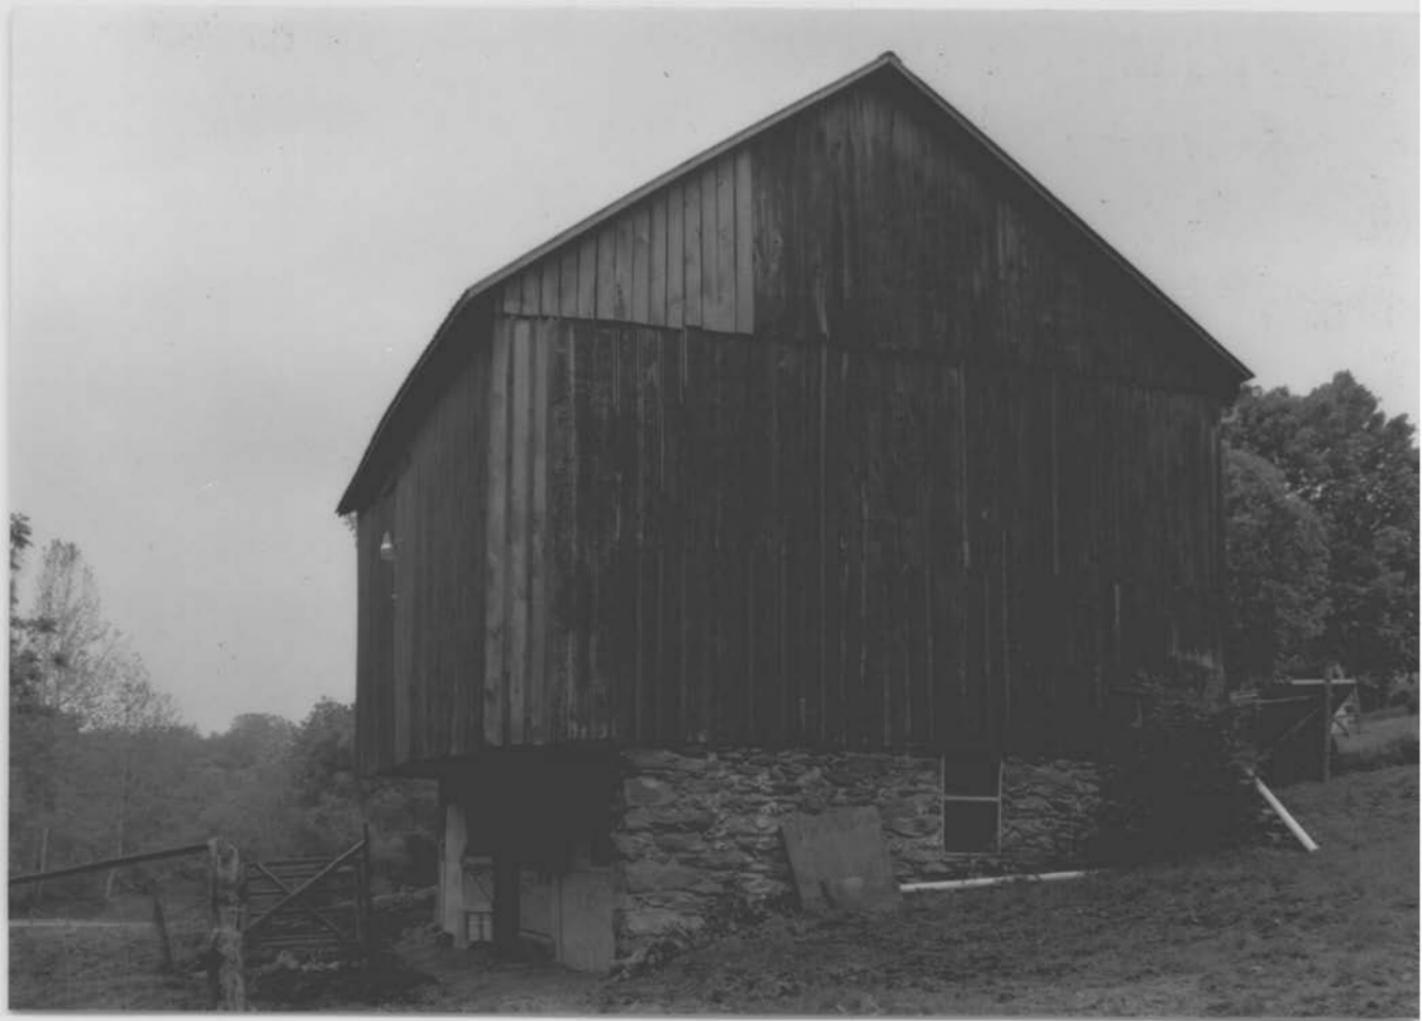
1/2

Also on the property is a bank barn with a forebay that faces northeast. The northeast elevation on the lower story has some horizontal board-and-batten siding with a center dutch door on strap hinges that have round ends. There is a large opening on either side that had a door on rollers, but now has plywood infill. The upper story has beaded-edge-and-center vertical boards and had a center door on rollers, but is now infilled. The southeast elevation lower story has board-and-batten siding with two window openings. The upper story has board-and-batten siding with no openings. The northwest elevation has a new window in an original opening in the lower story, and board-and-batten siding in the upper story with no openings. The southwest elevation has center wagon doors on rollers with board-and-batten siding. The barn has new inverted V-seam-metal roofing, with a northwest-to-southeast running ridge. It has a gable roof.

Neg. Loc.: Maryland Historical Trust  
barn - NW elev.

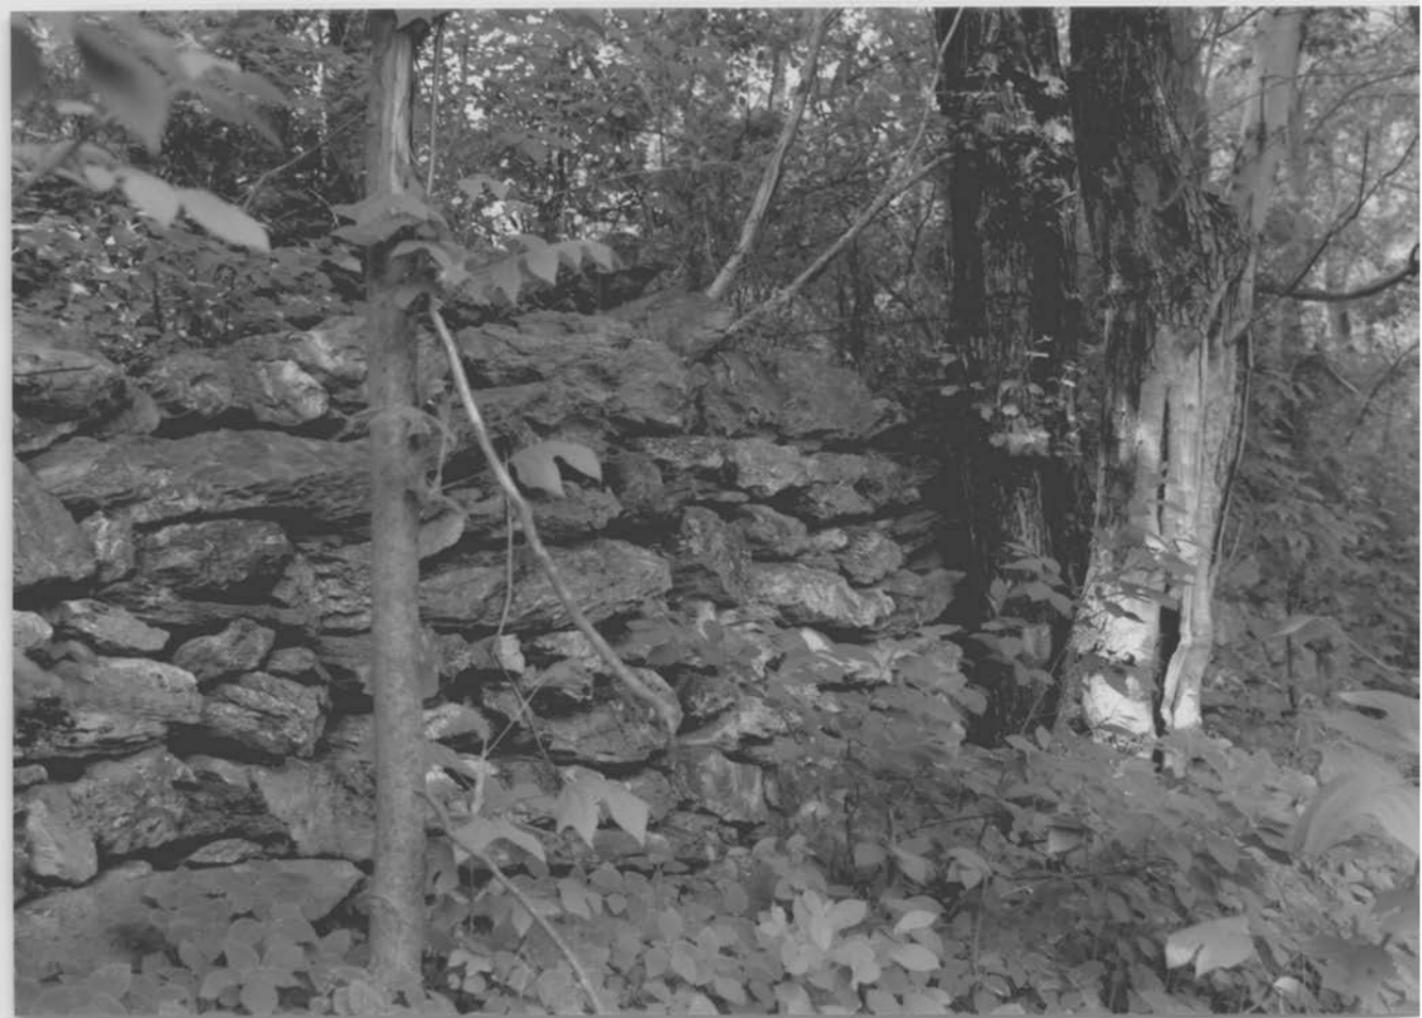
2/2

The Pickett Mill property is located on the west side of Skidmore Road, near the intersection of Braddock Road, about 1 mile southwest of Winfield in southwest Carroll County, Maryland. The property contains a house that was built in 1948, according to the tenant, and was added onto in 1960-61. There is a mill dam of dry laid stone on the property. According to the tenant, it measures about 560 feet long, and the dam was pretty much intact until a few years ago when tropical storm Hugo caused flooding that damaged it.

Neg. Loc.: Maryland Historical Trust  
near Braddock Rd., dam - partial view
