CARR-1491

William T. DeVries Farm
Eldersburg (vicinity)

Maryland Historical Trust State Historic Sites Inventory Form

MARYLAND INVENTORY OF
HISTORIC PROPERTIES

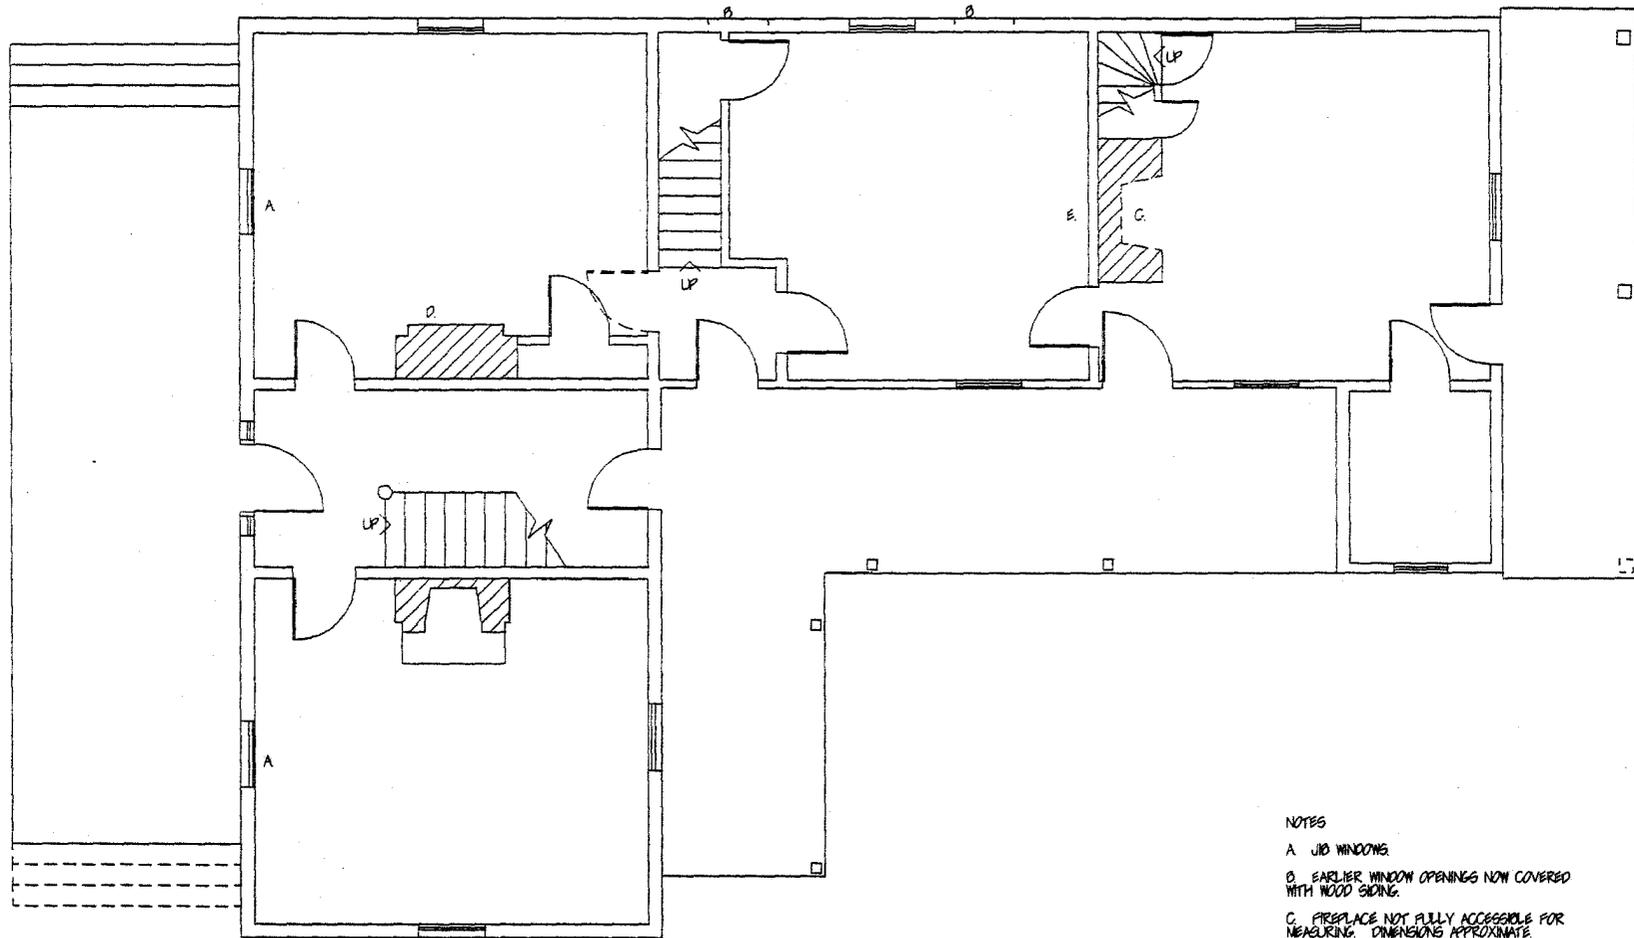
FIRST FLOOR PLAN

- A JIB WINDOWS
- B EARLIER WINDOW OPENINGS NOW COVERED WITH WOOD SIDING
- C FIREPLACE NOT FULLY ACCESSIBLE FOR MEASURING. DIMENSIONS APPROXIMATE
- D FIREPLACE OPENING COVERED BY HATCHED SLATE COVER
- E HATCHED SLATE MANTEL AND COVER HERE NOT SHOWN. NO FUNCTIONAL FIREPLACE.

The first story has a center-passage, single-pile plan with two rooms in the ell. The passage has a dog leg stair on the southeast wall, with an open stringer, a turned walnut newel, a moulded walnut handrail, turned balusters, and sawn brackets. The doors throughout the house have four panels. The passage is completely open beneath the staircase.

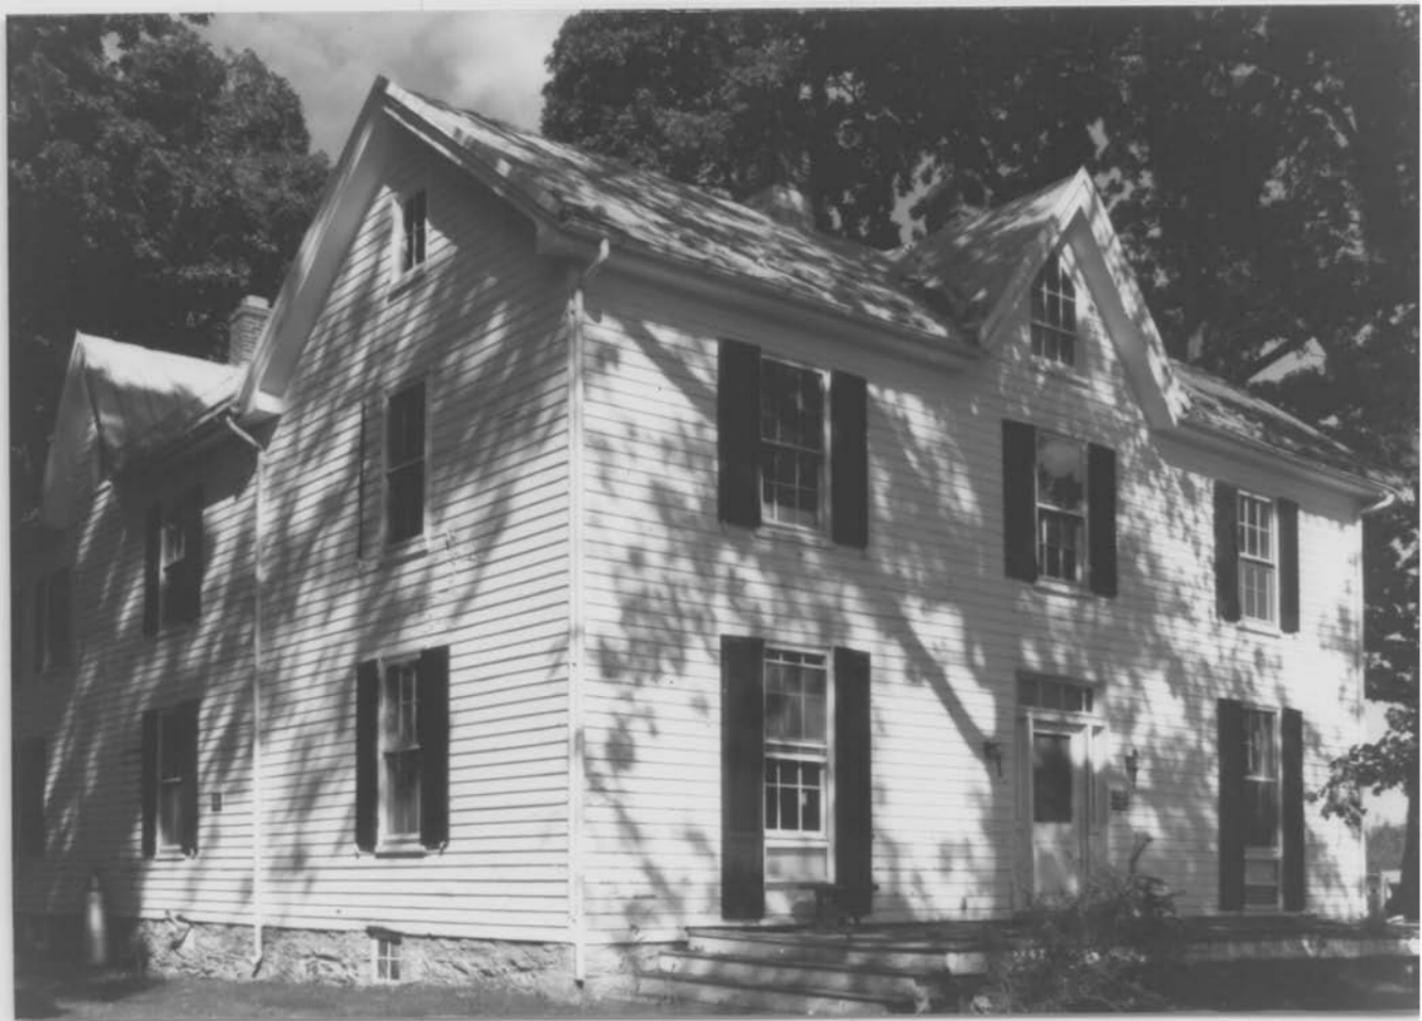
1/10

SW 1/4 NW elevs.

The house is a 2½-story, three-bay by one-bay frame structure, with a rubble stone foundation, weatherboards with corner boards, and a gable roof of standing-seam metal with a northwest-to-southeast ridge. The house faces southwest and has an ell on the northeast elevation. The ell has a gable roof of standing-seam metal with a northeast-to-southwest ridge. On the southeast elevation is a deteriorated porch deck three bays wide. It is supported by four stone walls that run northeast to southwest. There is no evidence that it was ever roofed. The first story has a center entrance with one light over two panels in the door. There are sidelights and a five-light transom. The door is flanked on either side by a 6/6 sash, with two one-panel jib doors below each sash, and with exterior blinds with one panel in the bottom of each. The house sill is exposed and is hewn. The second story has three 6/6 sash with blinds. There is a wood box cornice and a central gabled wall dormer with a 6/3 sash. The top sash is gabled. There is an interior brick chimney with a smoke

The northwest elevation is built all in one plane. It is three bays, with a corner board between the north and the center bays. The first story has a typical 6/6 sash to the north, a closed-up window opening, a 6/6 sash, a closed-up window opening, and a 6/6 sash. The second story has, from north to west, two 6/6 sash, a corner board, three low closed-up openings, the top of the center one having a 6/6 sash, and a 6/6 sash in the west bay. A central gabled wall dormer covers part of the north and center bays. The dormer has a lancet shaped 2/2 sash. The corner board does not extend up into the dormer. The gable end of the main block has a four-light sash.

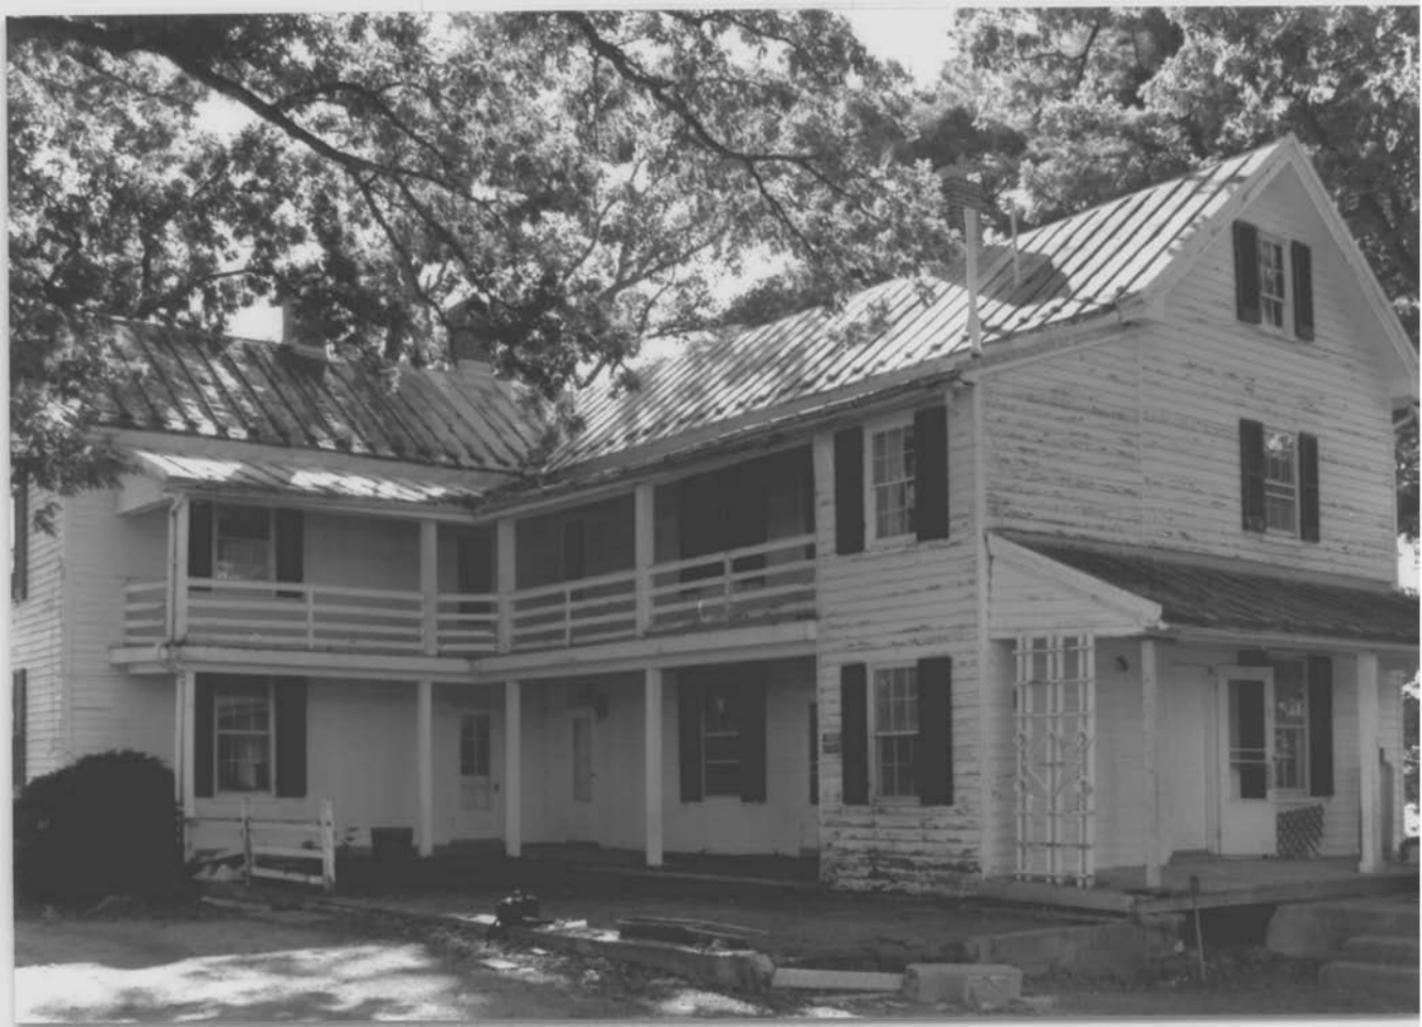
2/10

SE & NE elevs.

The northeast elevation is two bays, with a corner board between the pantry siding on the east and the ell siding to the north. The first story has no opening in the east or pantry bay. There is a four-panel door just north of the corner board and a typical 6/6 sash centered on the ell. The second story has a typical 6/6 sash in the center, and the gable end has a 6/3 sash. There is a one-story porch across the whole northeast elevation, set on three rubble stone walls running northeast to southwest. It has a shed roof of standing-seam metal, and two of its three boxed posts survive. There is an interior brick chimney between the northeast and center bays.

The southeast elevation of the ell is five bays. The first story has, from south to east, a four-panel door with a two-light transom, a typical 6/6 sash, a four-panel door where the corner board is, a typical 6/6 sash, and a projecting pantry with a typical 6/6 sash. The second story has a door with four lights over two panels, then evidence of a low window that has been infilled and is across from the center of the three infilled windows on the northwest elevation. Next comes a typical 6/6 sash, then a four-panel door that has a corner board above it, then a typical 6/6 sash which appears to have been moved two feet to the south. The pantry has a typical 6/6 sash.

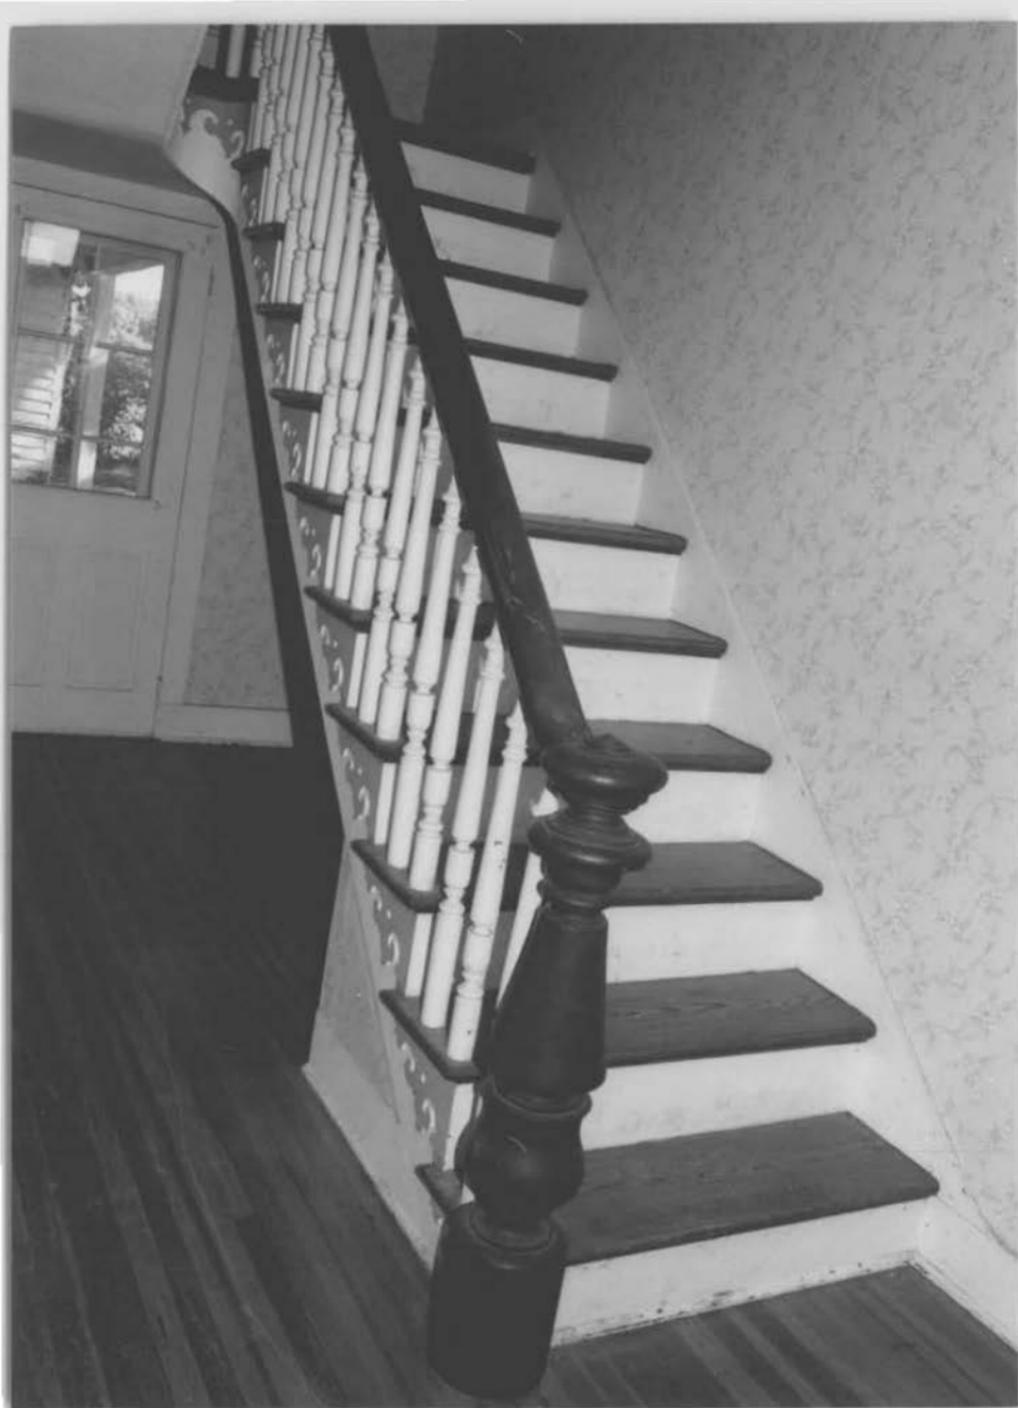
3/10

Neg. Loc.: Maryland Historical Trust
Stairway

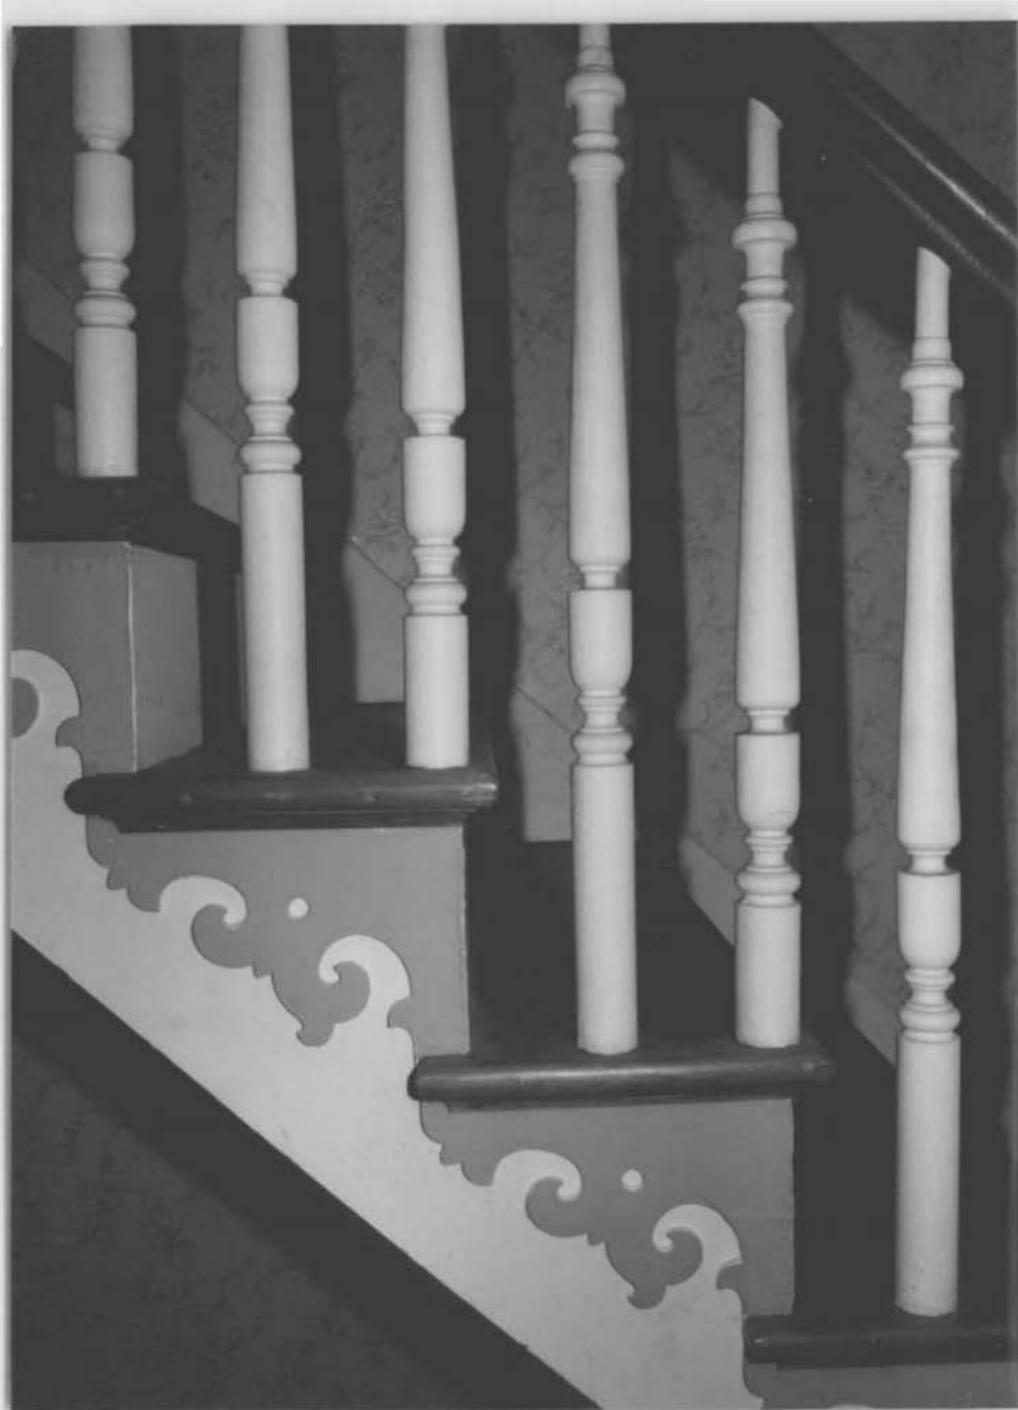
9/10

Stair brackets

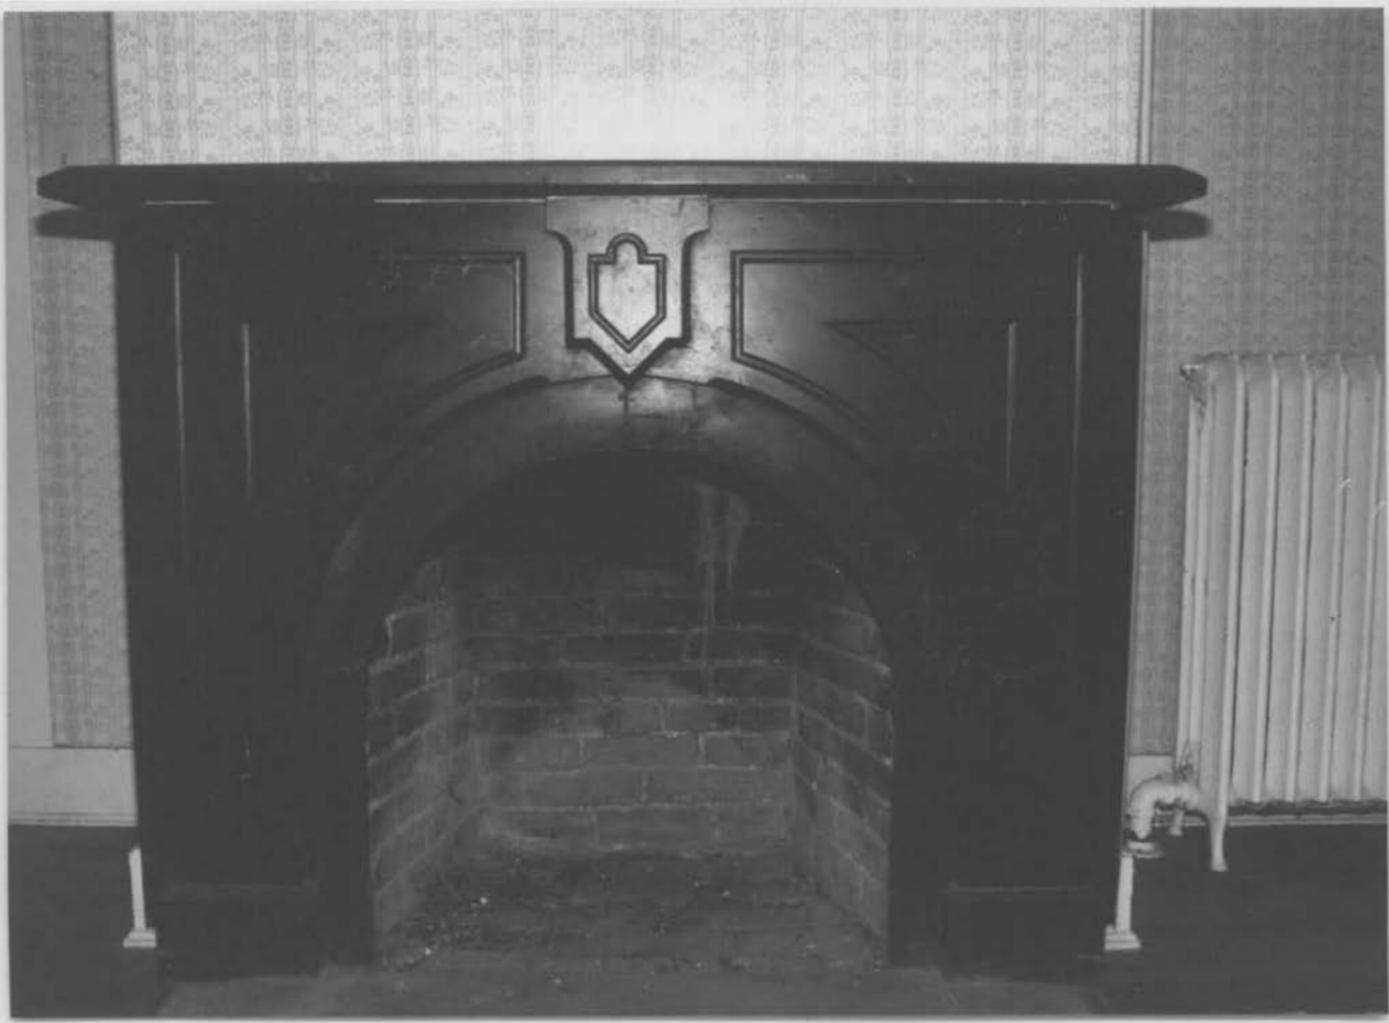
5/10

Neg. Loc.: Maryland Historical Trust
SE room mantel

The southeast room has a fireplace on the northwest wall with a marbled slate mantel painted black with white veining. It has a semi-circular arch, and grooves cut in the spandrels and the center cartouche. This is not the original mantel, but is a later addition and alteration as the firebox has a plaster surround and then a veneer of brick on the outside of it, to which the mantel is attached.

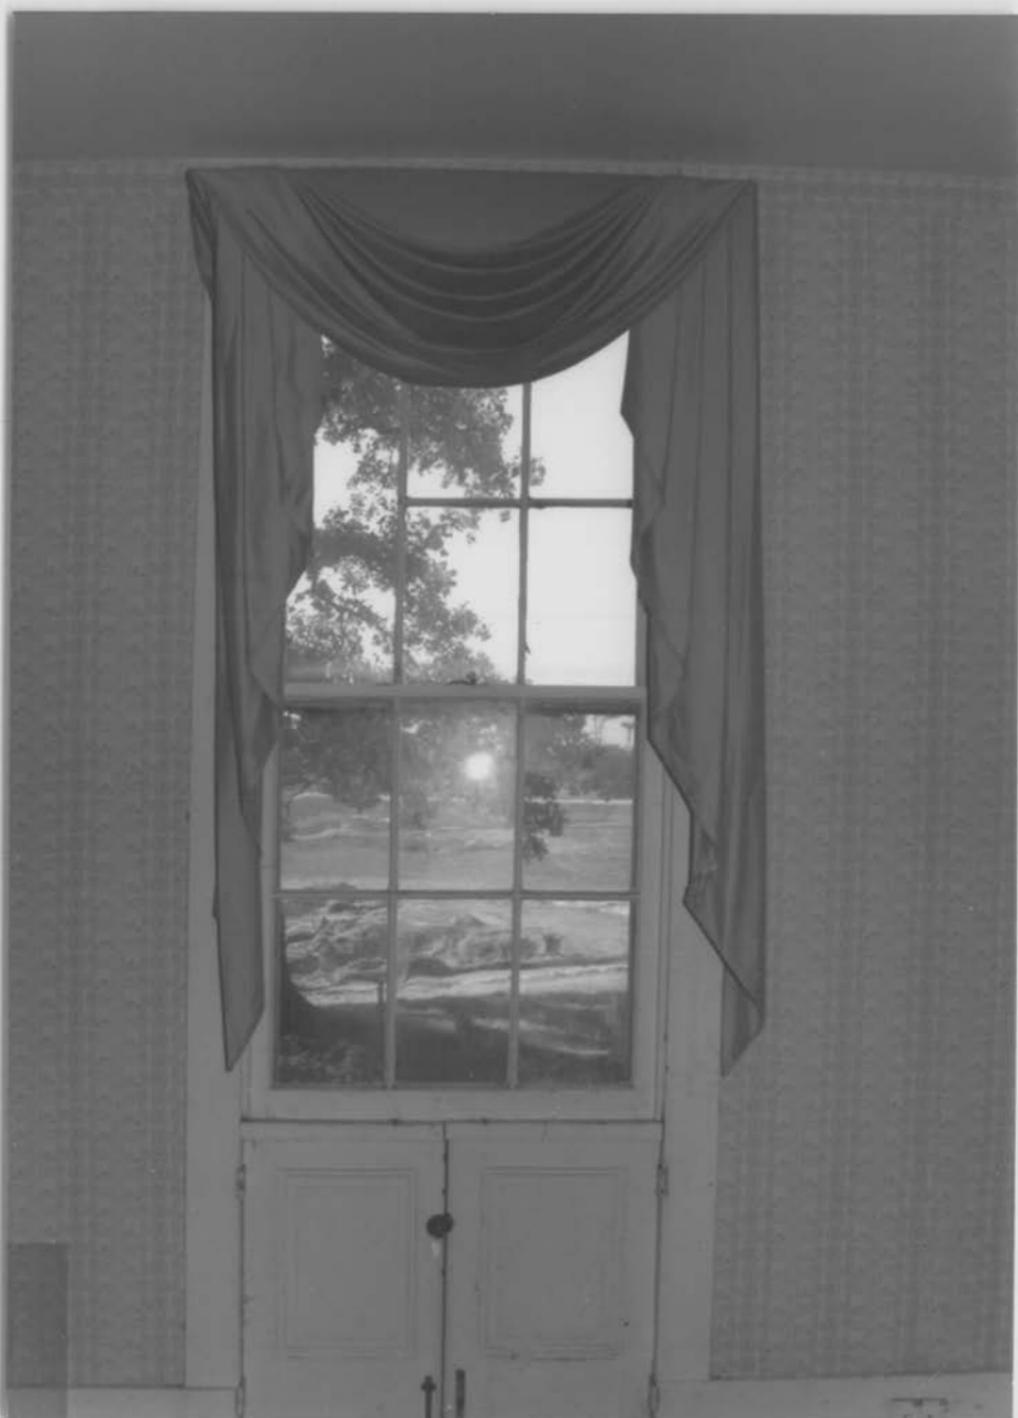
6/10

SE room jib window

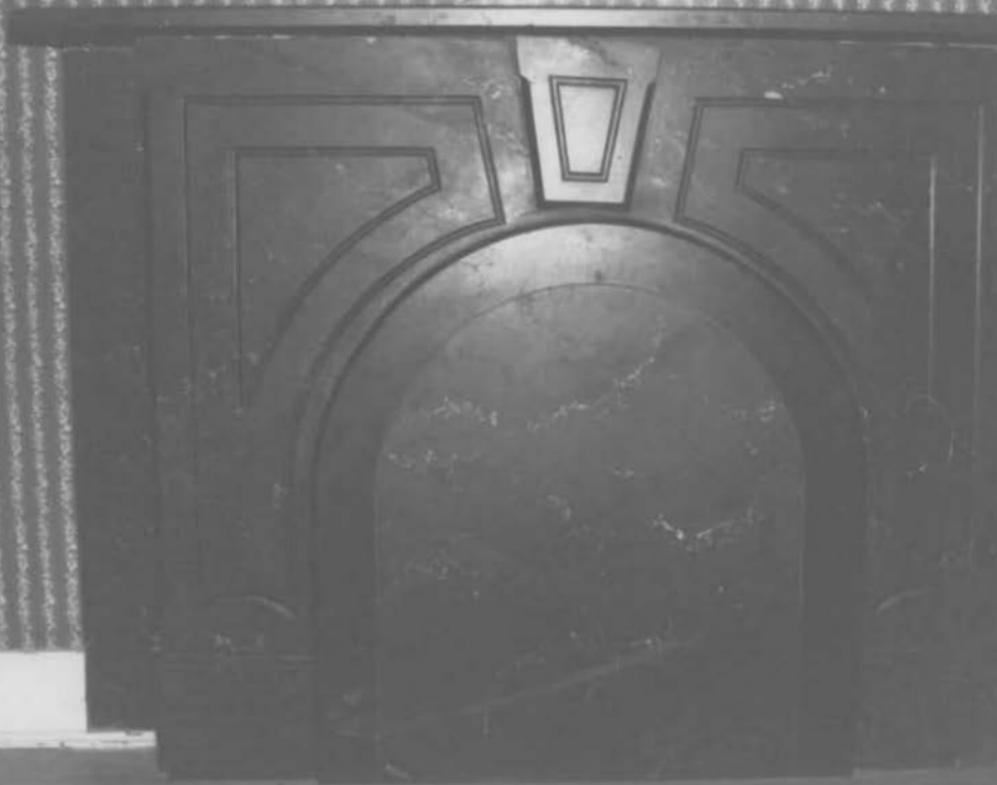
7/10

NW room mantel

The northwest room has a central fireplace on the southeast wall that is closed off with a marbled slate cover that matches the marbled slate mantel. This mantel has a semicircular arch very similar to that in the southeast room, but has a simpler cartouche. The mantel is painted a reddish-brown with white veining. East of the mantel is a typical door leading to a large closet. On the northeast wall is a doorway to an enclosed stair passage that runs northwest-southeast. The stair has a winder at the top and a small landing at the bottom, with a door on the southeast to the exterior. There is also a door on the northeast that leads to the center room.

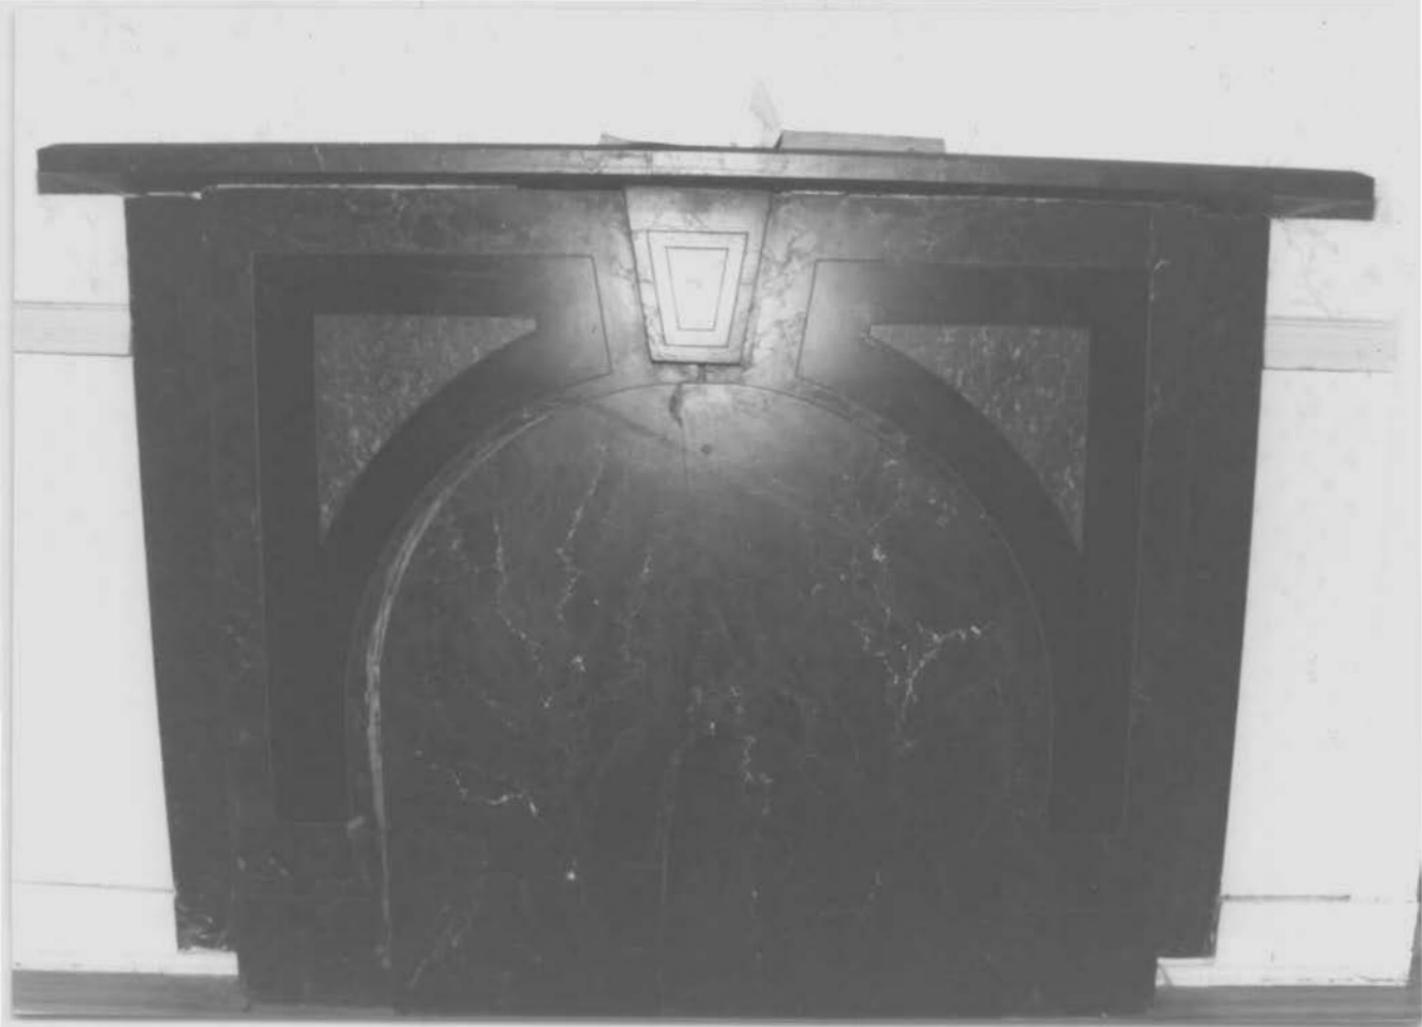
8/10

Neg. Loc.: Maryland Historical Trust
center room mantel

The center room has a chairrail. The southwest wall has a typical door leading to a closet beneath the rear stairs. The northeast wall has a fireplace that is flush with the wall and projects out into the northeast room. It has a marbled slate mantel with three types of painting. It is semicircular arched, and has a marbled slate cover of reddish brown with white veining. The spandrels have black bands with a red and white pattern inside them. The simple cartouche is painted the same way, and the narrow shallow grooves have gold paint in them. East of the mantel is a typical four-panel door to the northeast room.

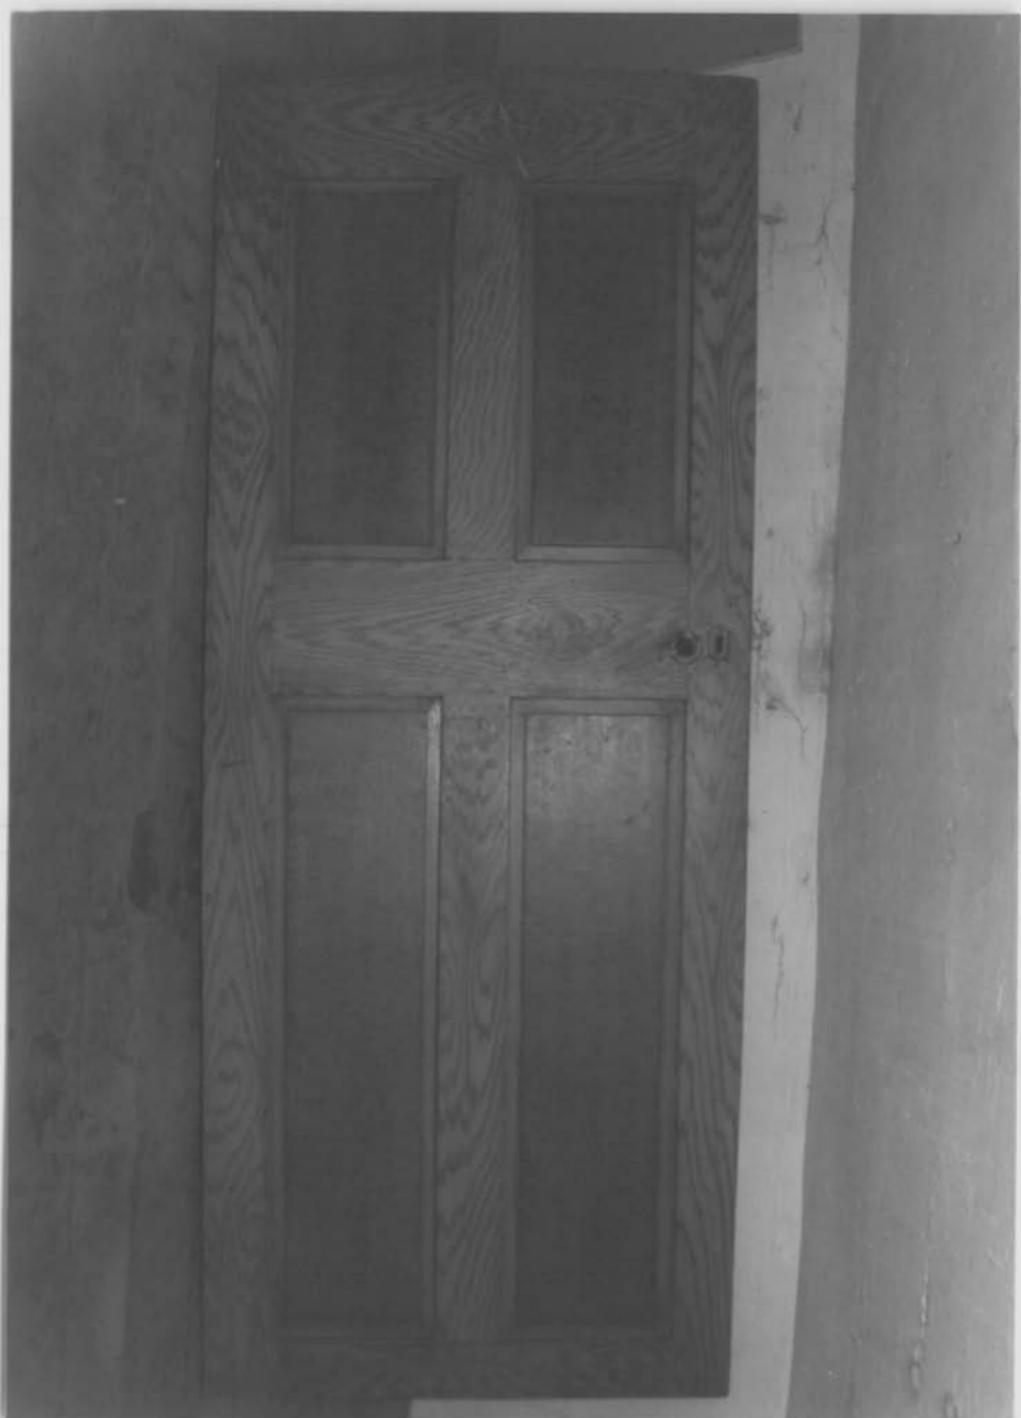
9/10

grained door in attic

The attic has plastered walls and ceiling. Some of the flooring appears to be reused lumber. There are attic rooms on the northwest and southeast that have vertical-board doors. There is a four-panel door stored in the attic that has both sides grained. The rails and stiles appear to imitate oak, while the fields appear to be grained to imitate a walnut burl. The center attic appears to have always been finished and has a small radiator on the northeast wall. The northeast attic formerly had a radiator on the northeast wall. The rafters are 2 x 4's, with a birdsmouth cut at the rafter foot that laps over a false plate. The rafters in the northwest attic room are of larger dimension. This attic room also was apparently finished from the beginning.

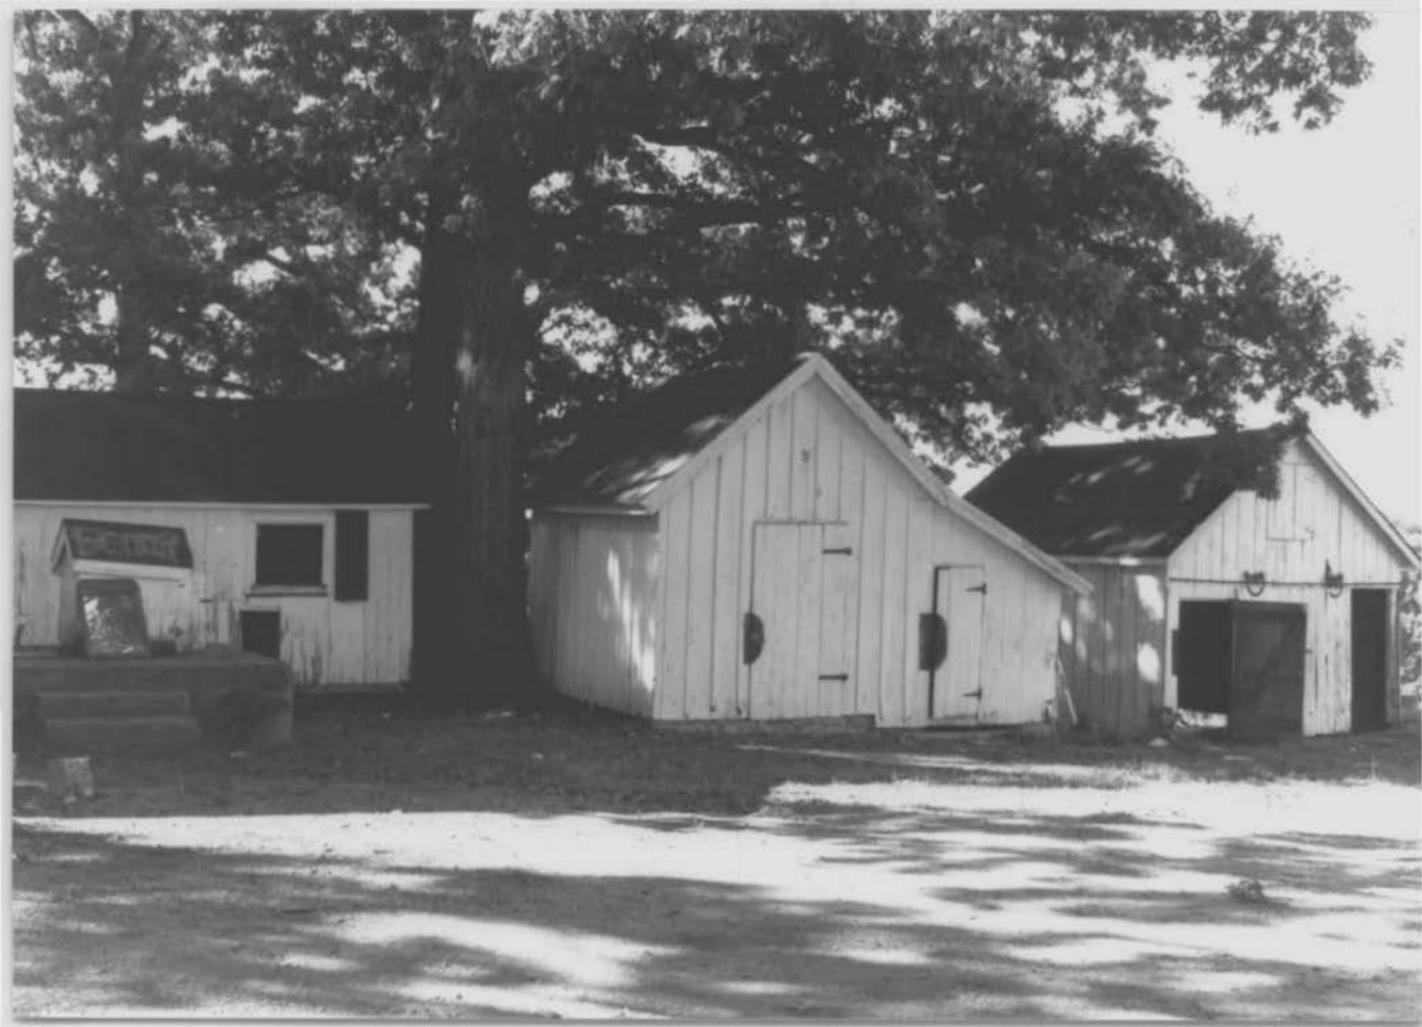
10/10

Neg. Loc.: Maryland Historical Trust
outbuildings - SE elevs.

About 2 feet northwest of the well is a poultry house with a rubble stone foundation, beaded-edge-and-center vertical-board siding, and a gable roof of asphalt shingles with a northeast to southwest ridge. The southeast elevation has a window opening and a small door opening below it. The southwest elevation has a four-panel door. The northwest
