Maryland Historical Trust
Inventory of Historic Properties Form
Maryland Route 30/Manchester Bypass Project

1. Name (indicate preferred name)historic Rhodes Farmand/or common Raver Farm**2. Location**street & number 7314 Hanover Pike not for publicationcity, town Melrose vicinity congressional district 6thstate Maryland county Carroll**3. Classification**

Survey No. CARR-1500

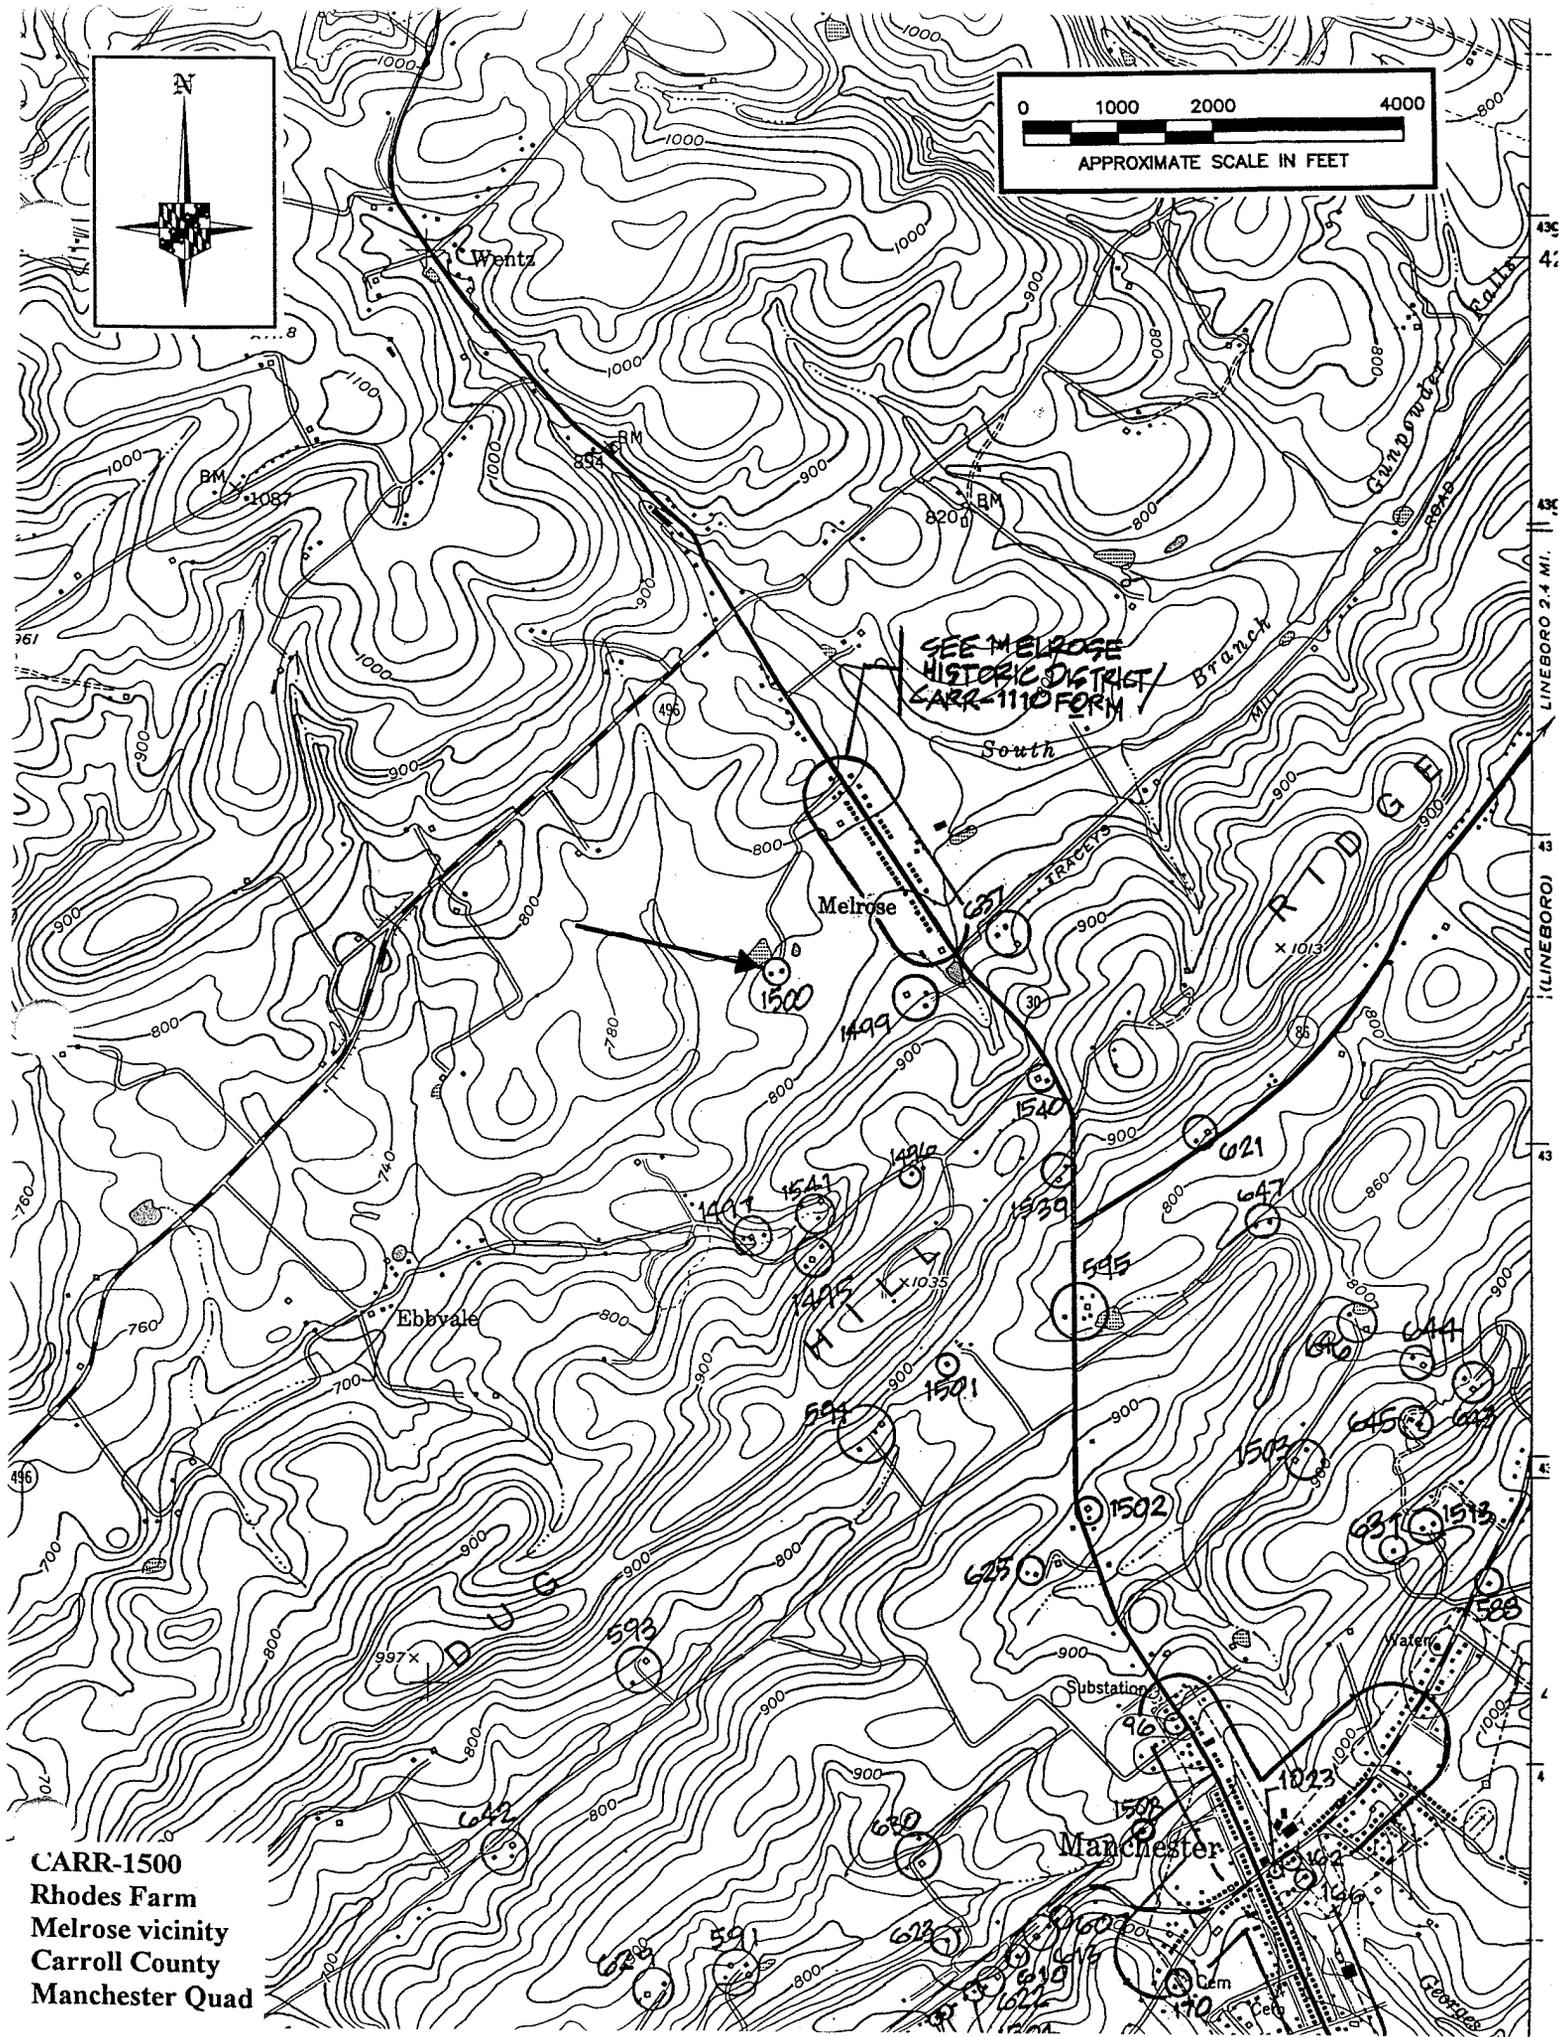
CARR-1500
Rhodes Farm
Melrose vicinity
Carroll County
Manchester Quad

ADD	-	Addition
CC	-	Corn Crib
CH	-	Carriage House
CKH	-	Chicken House
CS	-	Cow Stalls
G	-	Garage
GR	-	Generator Room
HP	-	Hog Pens
MB	-	Main Barn
MH	-	Main House
MR	-	Milk Room
OB	-	Outbuilding
OH	-	Outhouse
PH	-	Pump House
RC	-	Root Cellar
S	-	Shed
SB	-	Secondary Barn
SH	-	Summer House
SK	-	Summer Kitchen
SPH	-	Spring House
ST	-	Stables
TH	-	Tenant House
W	-	Well

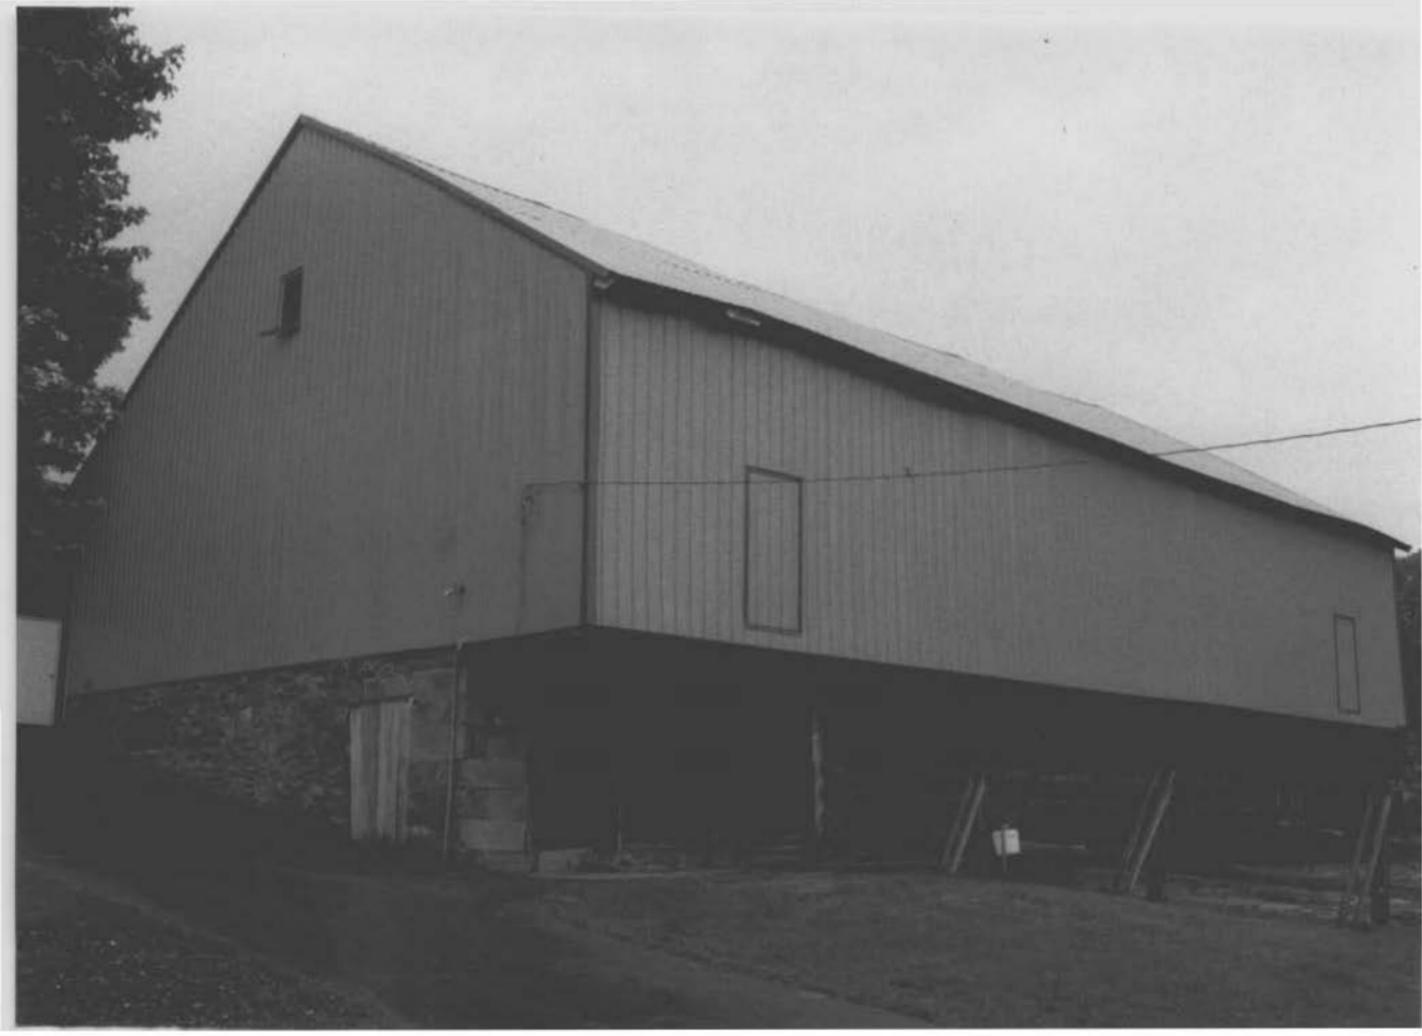
The two-and-a-half story, fieldstone foundation bank barn has been covered in metal sheets on its upper levels, obscuring the original fabric. There are traces of logs in the upper level but evidence points to the structure being a fieldstone barn. The unsupported forebay faces west and the metal gable roof is parallel to the road. The seven bay by four bay structure retains its original form despite alterations. A unique feature of the barn is the side ramp on the south elevation.

1. CARR: 1500
2. Carroll County
3. Madeline Scheerer
4. June 1996
5. Maryland SHPO
6. Raver House
7314 Hanover Pike
Northeast elevation - barn
7. 1/6

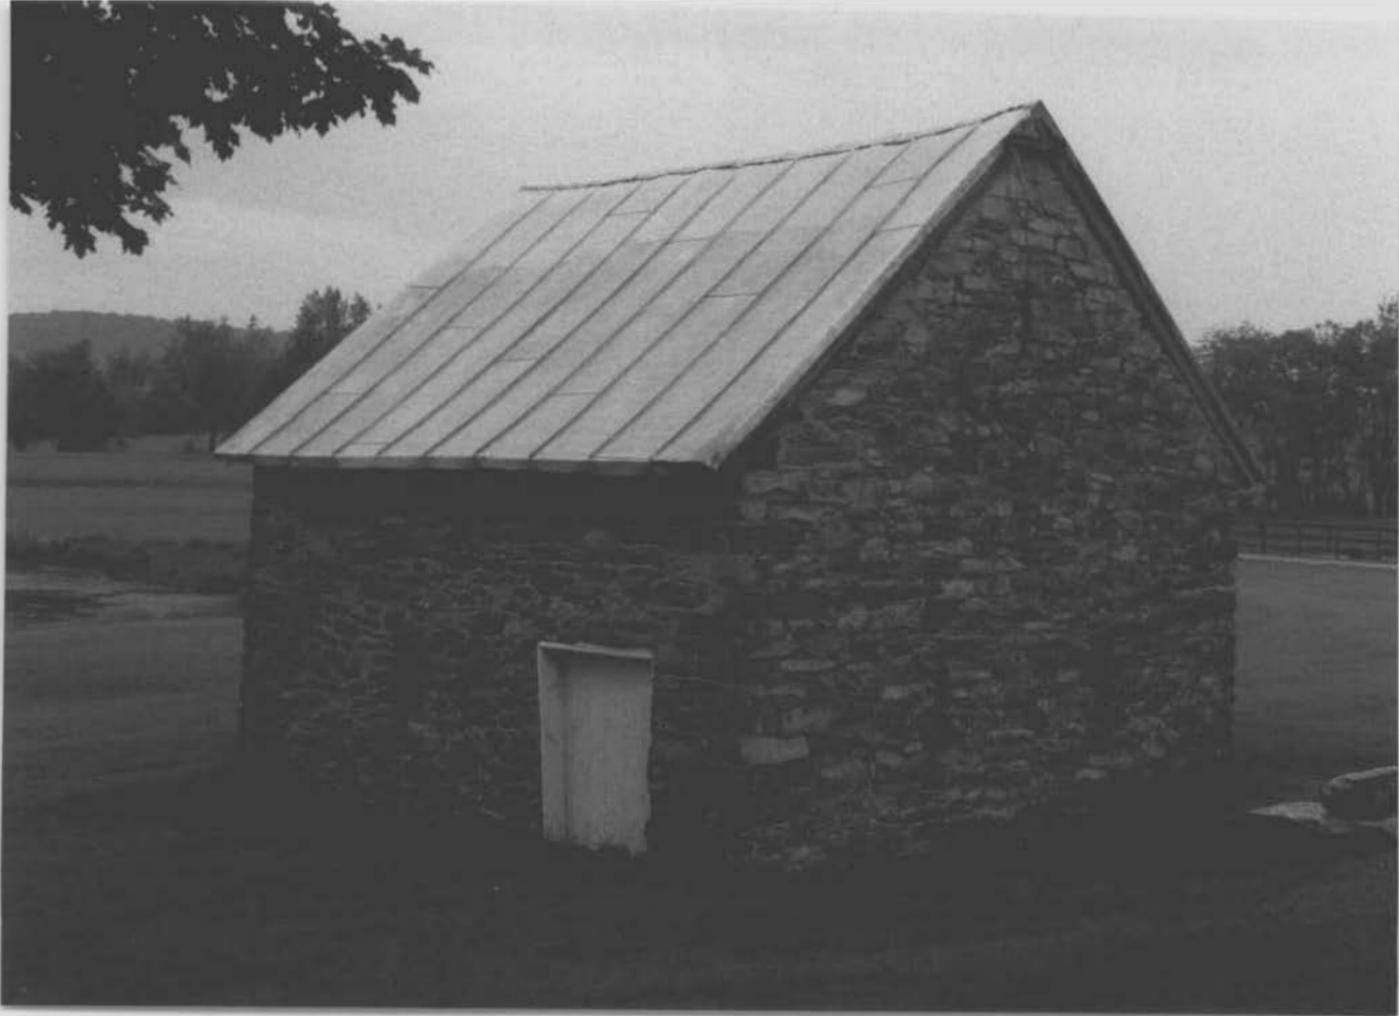
This 1-1/2-story structure is 2 bays by 2 bays with a metal gable roof parallel to the road. Fenestration consists of two slits cut into the fieldstone walls on north, east and south elevations and one window slit and plank door on the principal [west] facade. There are window slits in the loft area gable ends. Brick remains south of the building could either be a well or bakehouse chimney. This may have been the original house used until the main house was built. There is a spring within the building and a loft on the upper story, according to the owner. The building may have been used as a spring house or summer house after the main house was erected.

1. CARR 1500
2. Carroll County
3. Madeline Scheerer
4. June 1996
5. Maryland SHPO
6. Raver House
7314 Hanover Pike
SW Elevation - springhouse
7. 216

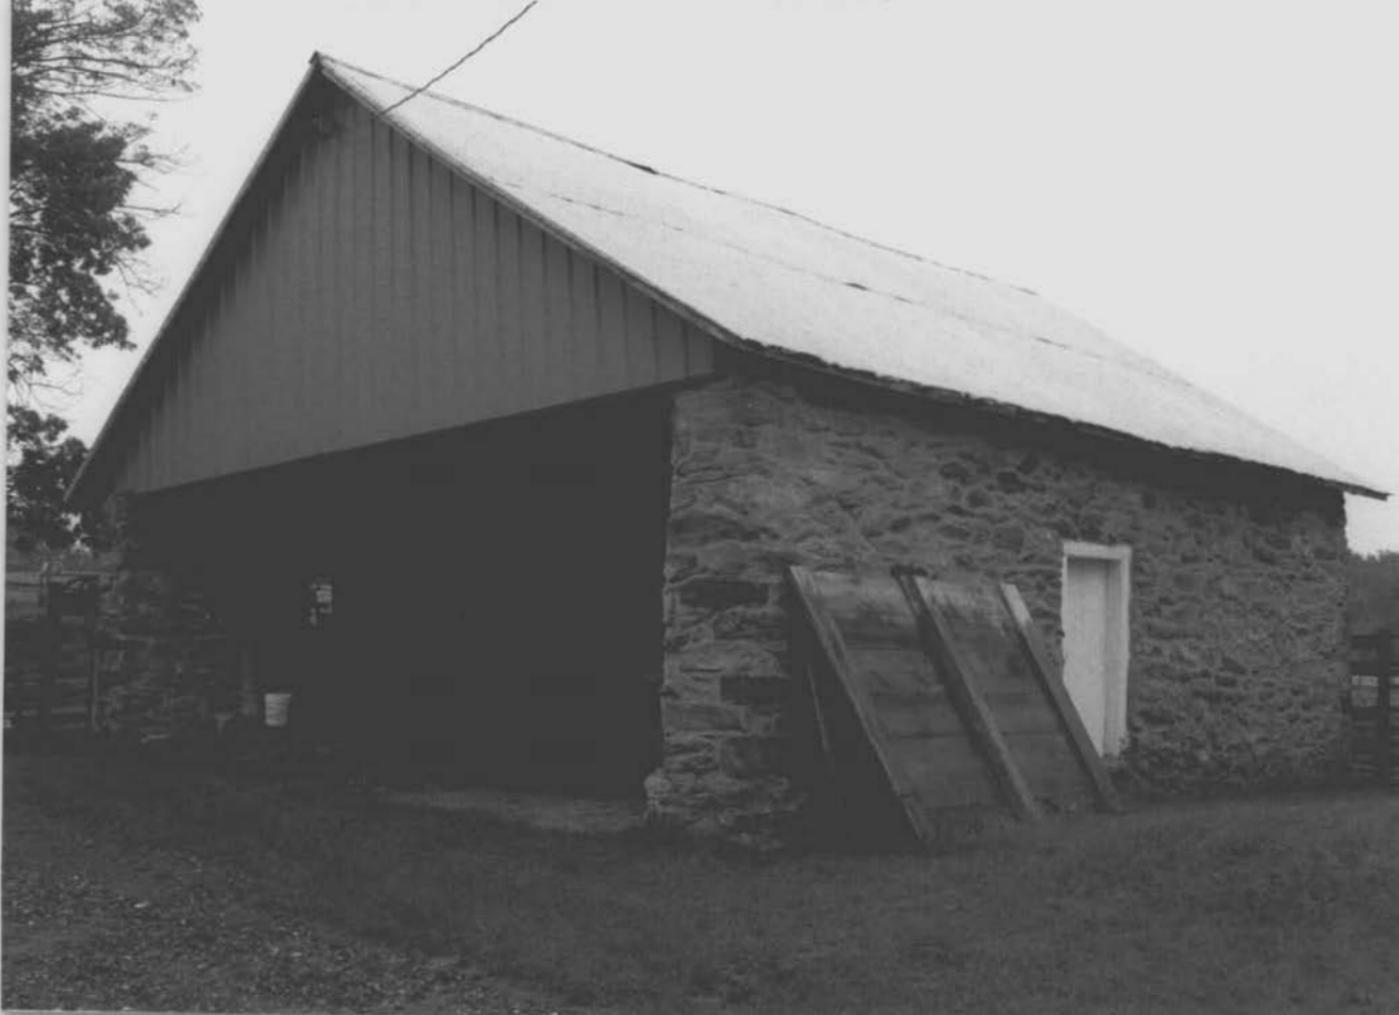
The one-and-a-half story, three bay by two bay fieldstone structure west of the barn may have been erected as a house to shelter farm workers or members of the extended family. The principal [east] facade wall has been removed as have the sash. Metal sheeting replaced the original cedar shingles on the gable roof which is perpendicular to the road. There are three casement windows on the remaining elevations, one on each side, and a wide plank door on the north elevation. There is no evidence of a spring within the structure or nearby, likely eliminating this structure as a potential spring house. Though there is no indication of an extant chimney or fireplace hearth, it may originally have had an exterior fieldstone chimney. It is possible that the missing wall on the east side contained the chimney and fireplace hearth, which would account for the lack of these features. The structure is less refined in its construction than the building labeled as the Fieldstone House, which suggests that it may have predated that structure or been used for servants.

1. CARR 1500
 2. Carroll County
 3. Madeline Scheerer
 4. June 1996
 5. Maryland SHPD
 6. Raver House
7 314 Hanover Pike
NE elevation - small house
- 7 3/6

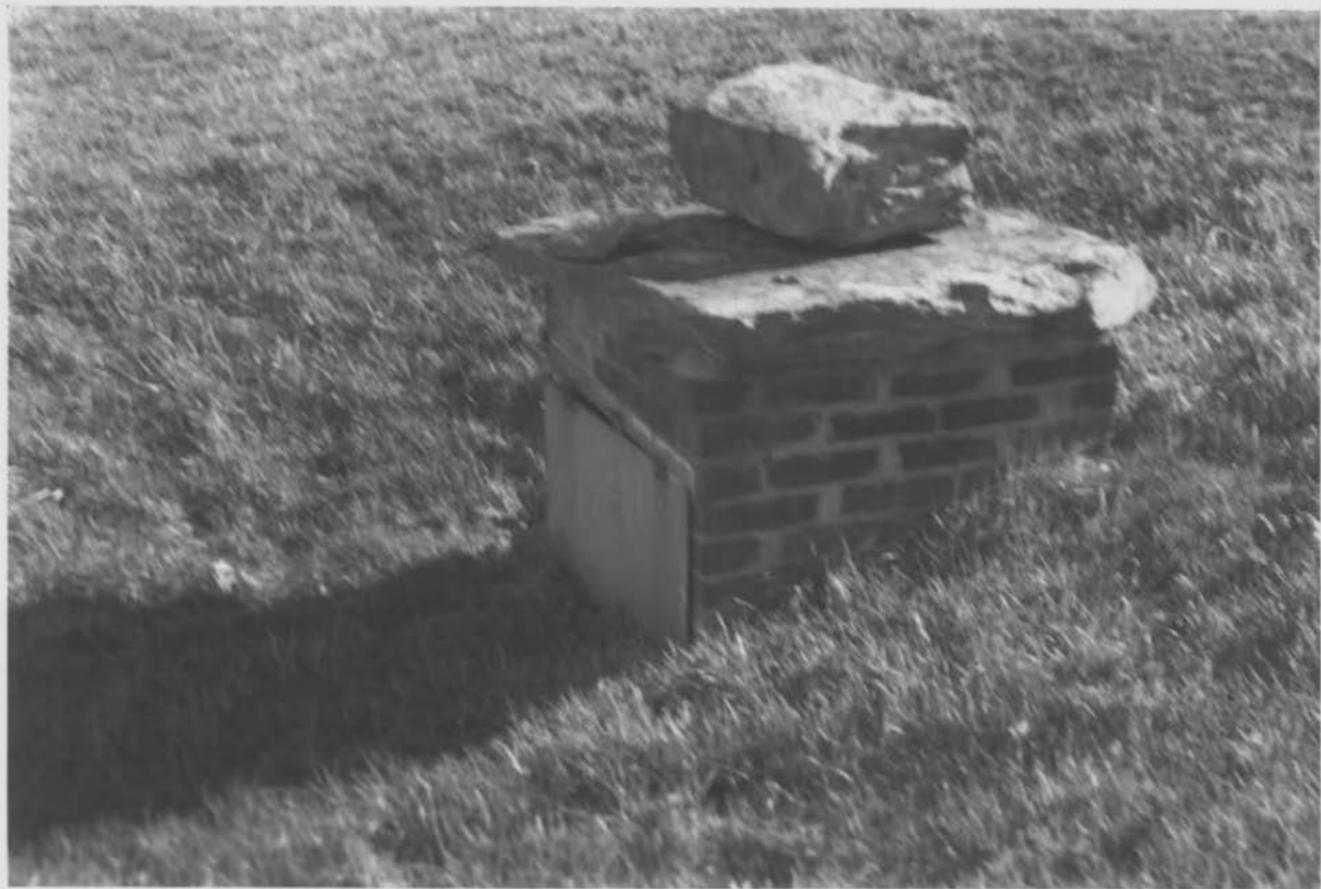
According to the owner, the original well for the Fieldstone House was located to its southwest. The area holds a fieldstone ruin covered in high grass with an indent in the center that may have been the original well. A later well was dug on the south side of the Fieldstone House and its presence is indicated by the remains of a brick chimney covering the well site. The chimney may have been part of a mid-19th-c. smokehouse, but the owner has indicated that there was a well in that area prior to the erection of the brick structure.

1. CARR 1500
2. Carroll County
3. Madeleine Scheerer
4. March. 1997
5. Maryland SHPO
6. Rhodes Farm
Chimney remains/well site
7. 5/6

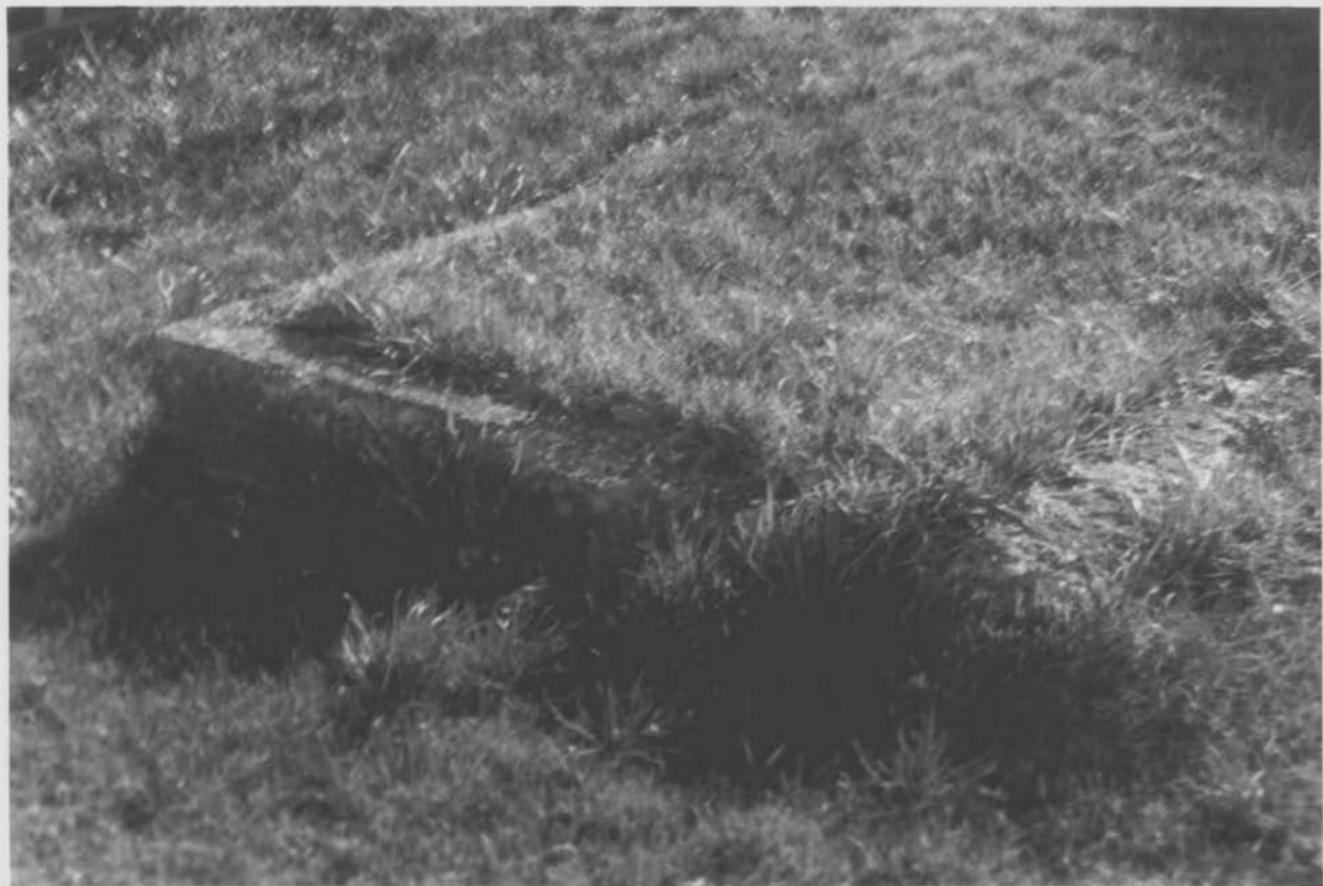
7. 6/6

well - w of Fieldstone House
