7. Description

Survey No. CARR-1503

The Shindler House is a two-and-a-half story farmhouse with English barn, and two modern storage structures. The complex forms a No Courtyard Layout.

CARR-1503
John Herboch Farm
Manchester vicinity
Carroll County
Manchester Quad

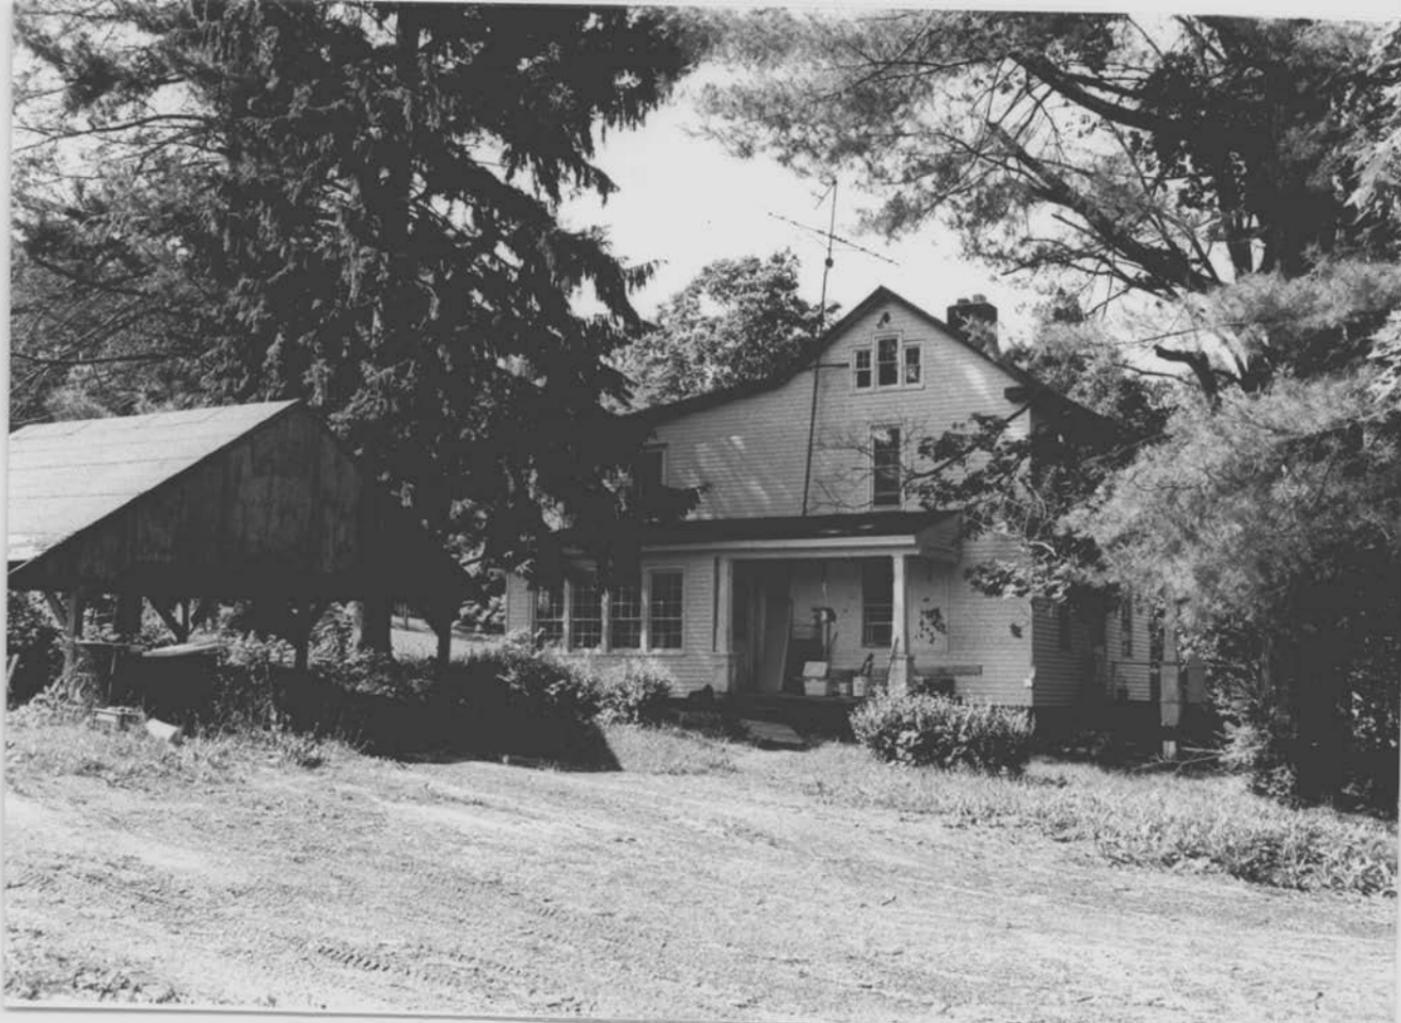
The 2-1/2 story, three bay by two bay, clapboard house is covered in vinyl siding with a metal gable roof and cornice returns. An interior brick chimney is located on the west gable end and the roof ridge line is parallel to the road. A pedimented roof entry porch is located on the main [north] facade and a first floor bay window has been constructed on the west elevation. The fenestration pattern is irregular with one-over-one wood, double-hung windows on all first story elevations; six-over-six windows on the second story all elevations, a small diamond shaped 4 lite window on the center bay of the upper level, north facade. The windows on the upper level, gable ends are unusual with a group of three four-over-one sash.

1. CARR : 1503
2. Carroll County
3. Madeline Scheerer
4. June 1996
5. Maryland SHPO
6. Shindler House
3118 Fenwick Rd.
main/corner - NW elev.
- 7 1/3.

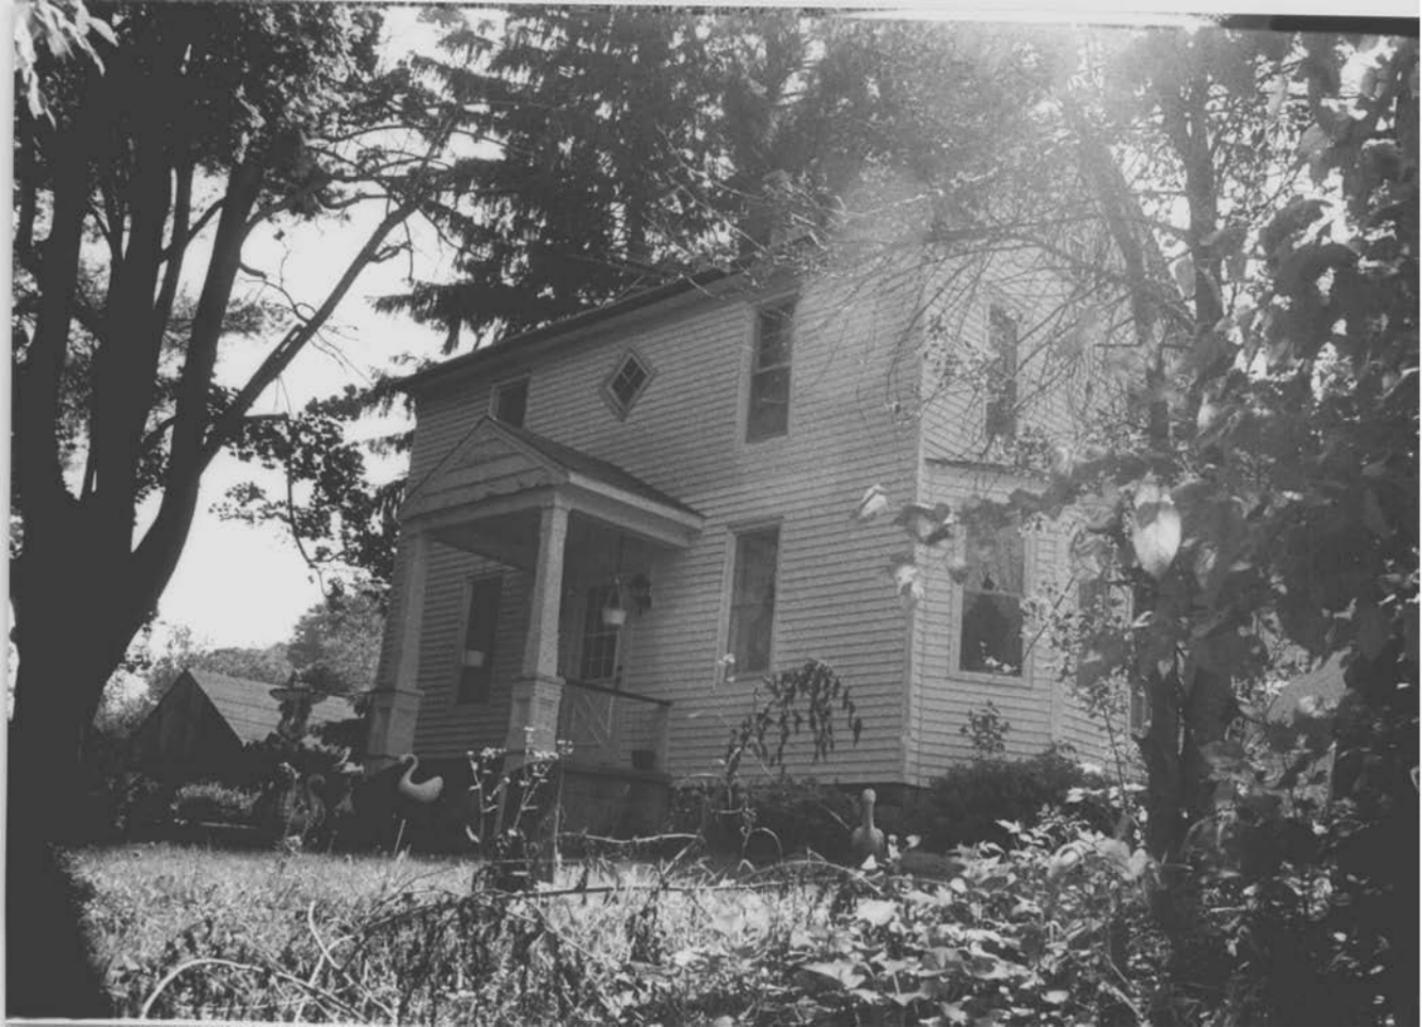
1. CARR: 1503
2. Carroll County
3. Madeline Scherer
4. June 1996
5. Maryland SHPO
6. Shindler House
3118 Fernin Road
main - North elev
7. 2/3

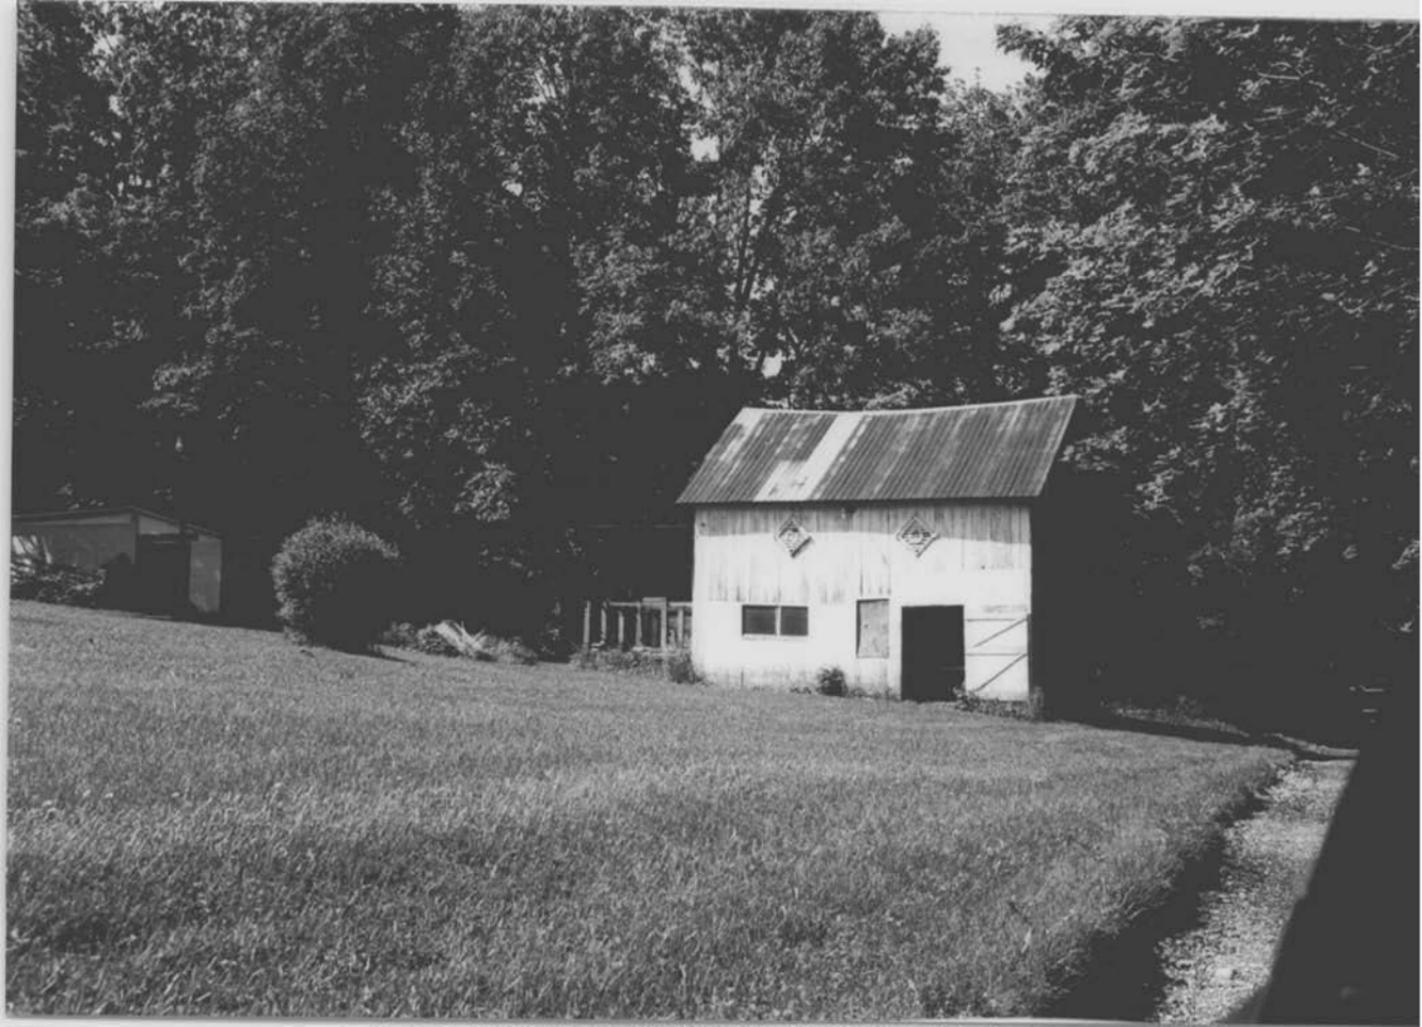
The 2-1/2 story frame on fieldstone foundation English barn is located to the west of the main house. Two bays by two bays with a metal gable roof perpendicular to the road. Wood ventilator windows are located on the east and west elevations. Diamond shaped with a saw tooth dentil border and a ring in the center, the ventilators are unusual for the project area

1. CARR: 1503
2. Carroll County
3. Madeline Scheerer
4. June 1996
5. Maryland SHPO
6. Shindler House
3118 Fenier Road
Barn - east elev.
7. 3/3
