Survey No. CARR-1511

#### *House (1840-1860)*

CARR-1511  
P. Wareheim Farm  
Millers vicinity  
Carroll County  
Lineboro Quad

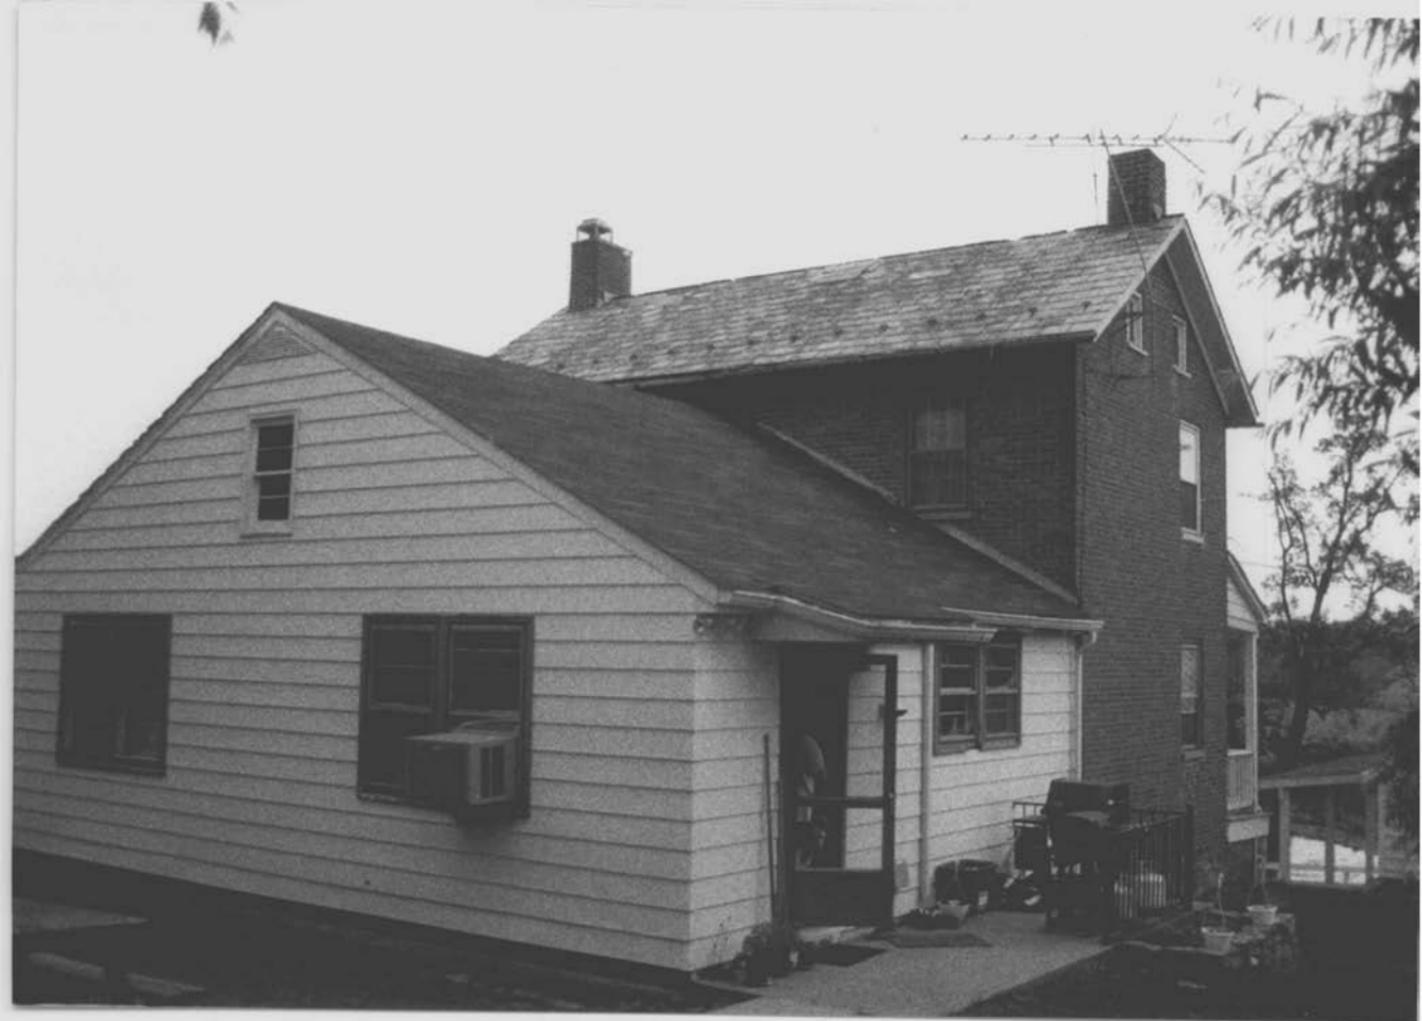
1. CARR 1511
2. Carroll County
3. Madeleine Scheerer
4. June 1996
5. Maryland SHHO
6. Deer Valley Farm  
3913 Miller Station Road  
main SW elev
7. 1/10

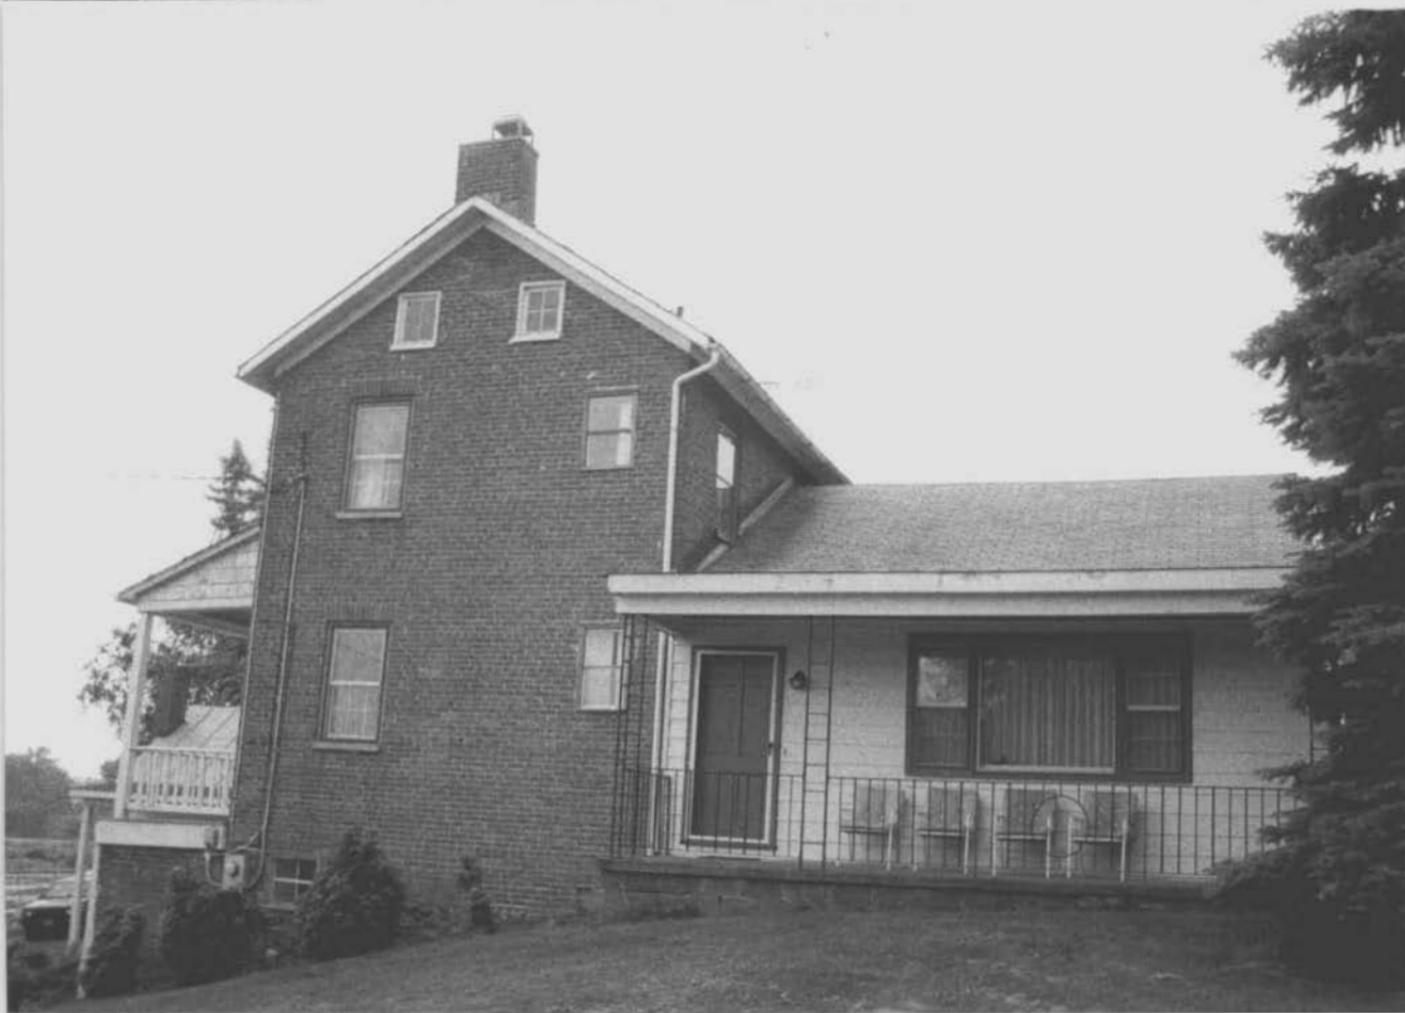
1. CARR 1511
2. Carroll County
3. Madeleine Scheerer
4. June 1996
5. Maryland SHPO
6. Quiet Valley Farm  
3913 Miller Station Road  
main - west elev.
7. 2/10

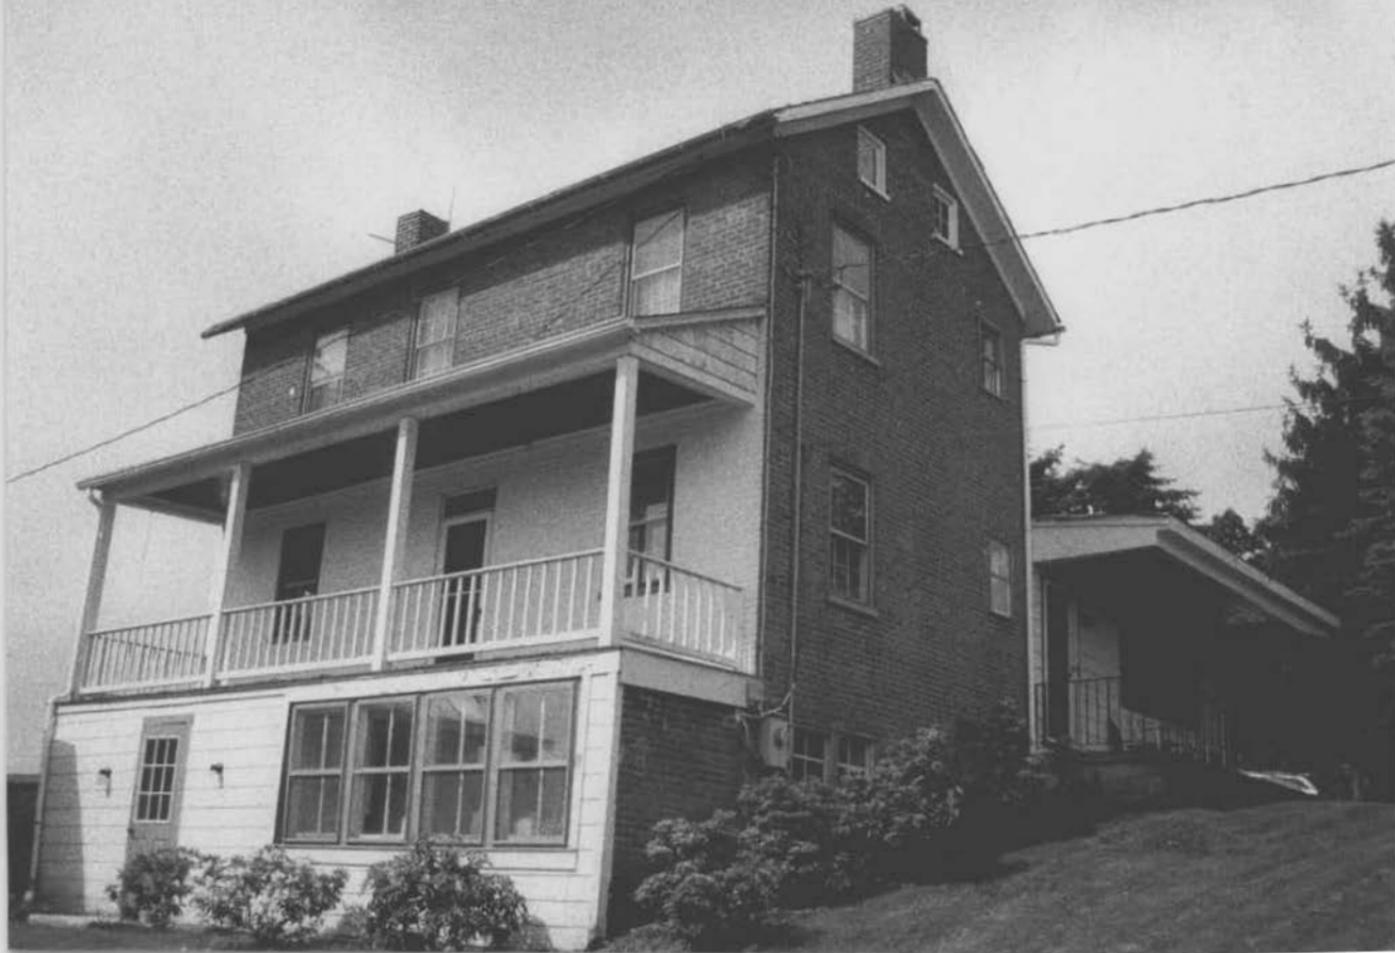
1. CARR 1511
2. Carroll County
3. Madeline Scheerer
4. June 1996
5. Maryland SHPO
6. Quiet Valley Farm  
3913 Miller Station Rd  
Main - north elev.
7. 3/10

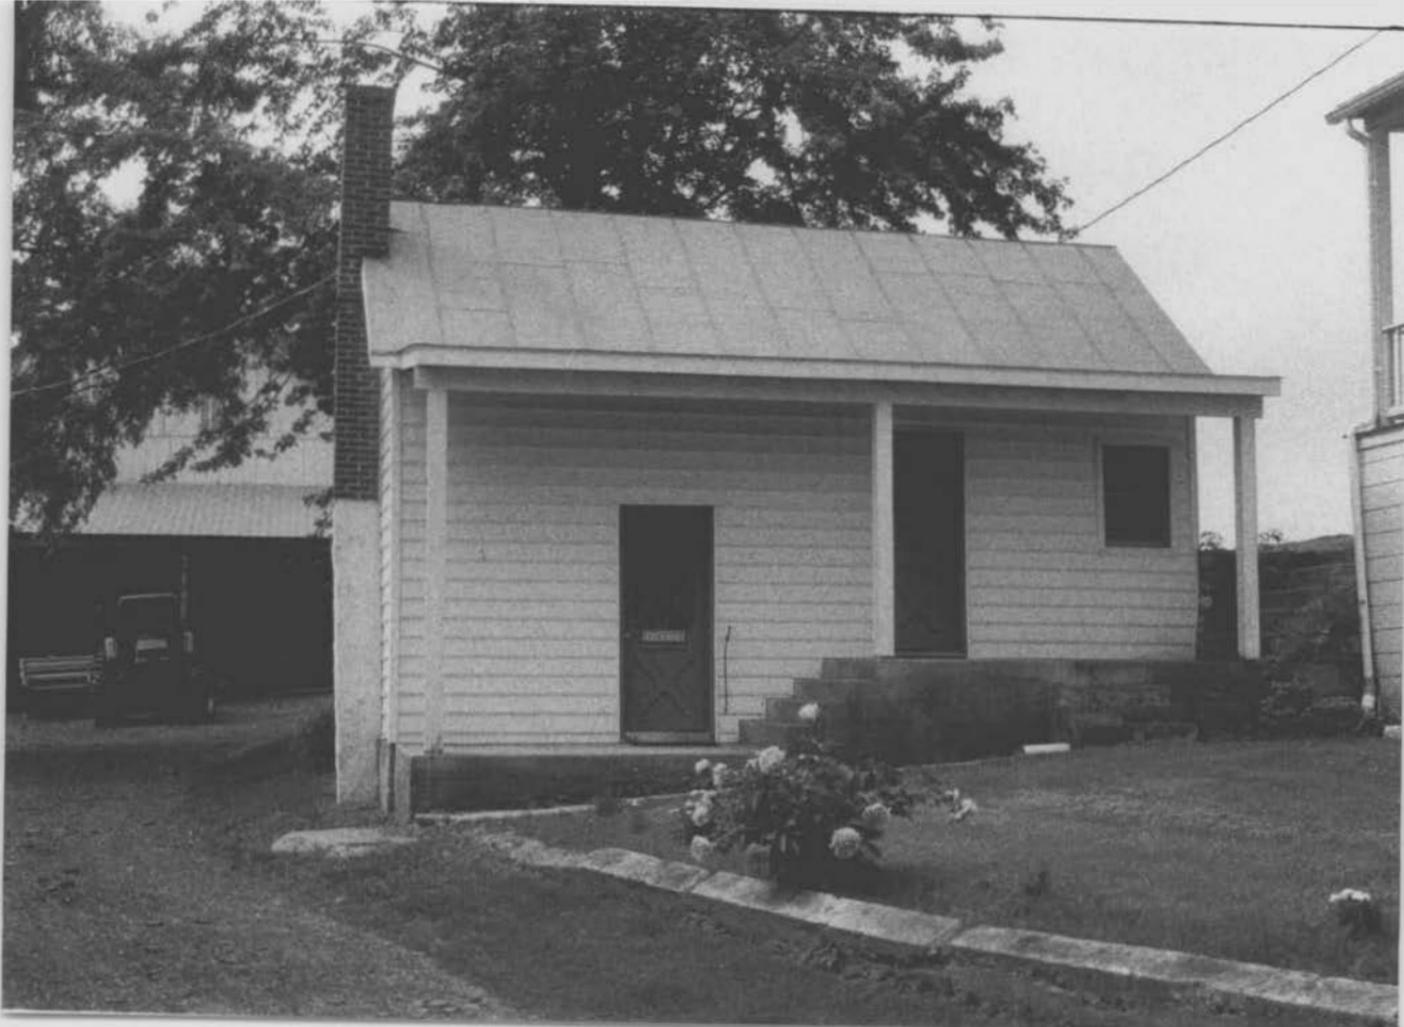
1. CARR 1511
2. Carroll County
3. Madeleine Scherer
4. June 1996
5. Maryland SHPO
6. Quiet Valley Farm  
3913 Miller's Station Rd  
spring house - NW elev.
7. 4/10

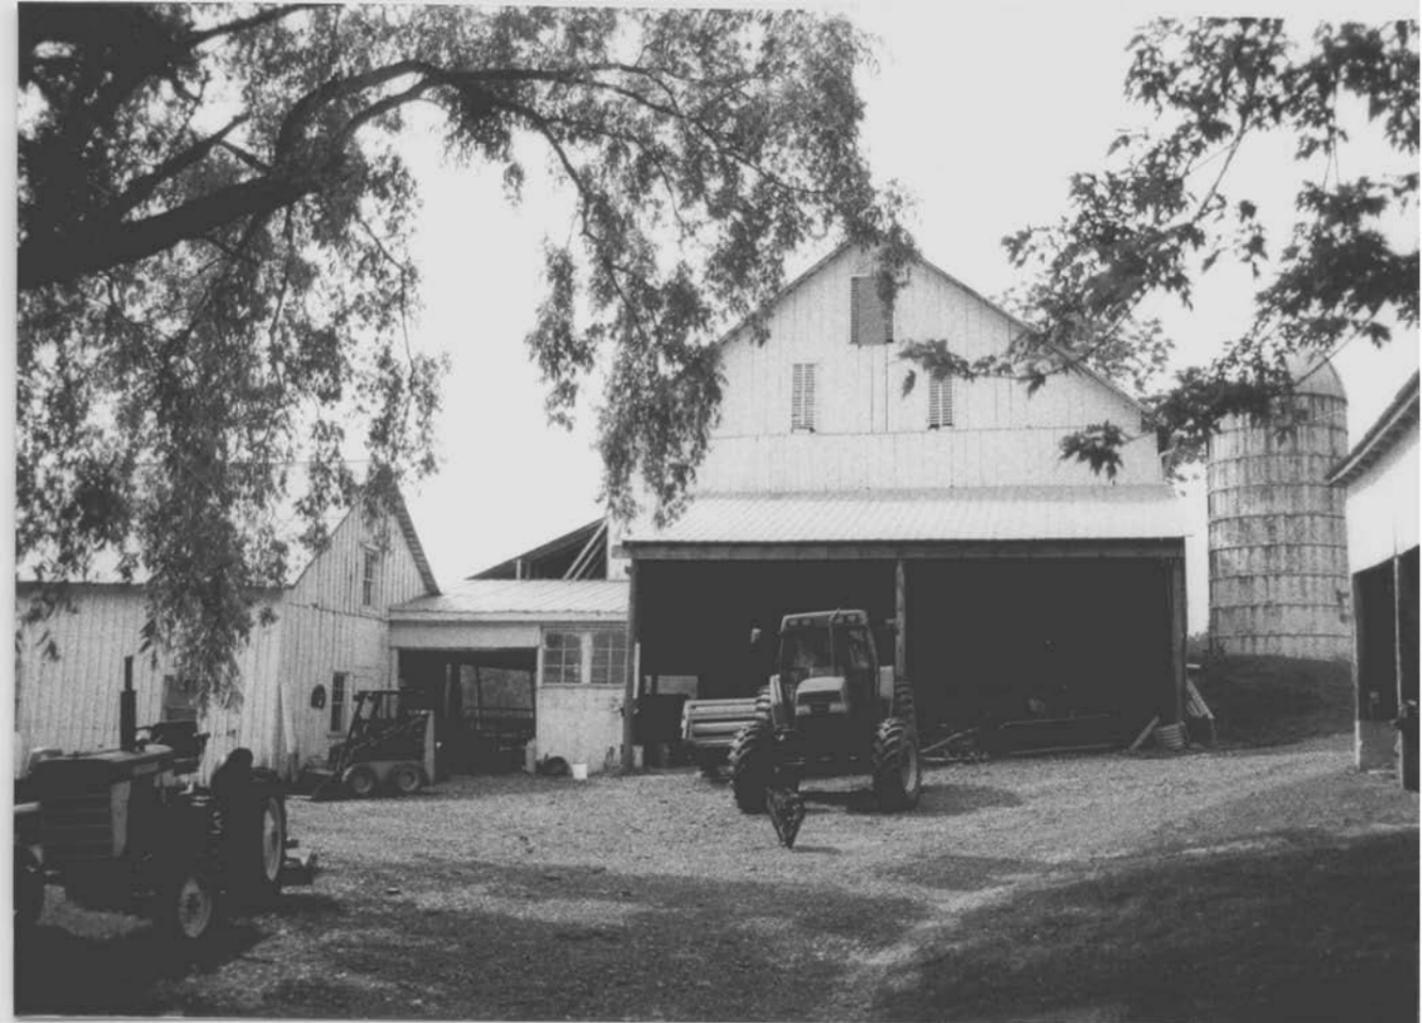
1. CARR 1511
2. Carroll County
3. Madeleine Scheerer
4. June 1996
5. Maryland SHPO
6. Quiet Valley Farm  
3913 Miller's Station Rd  
Barn - North elev.
7. 5/10

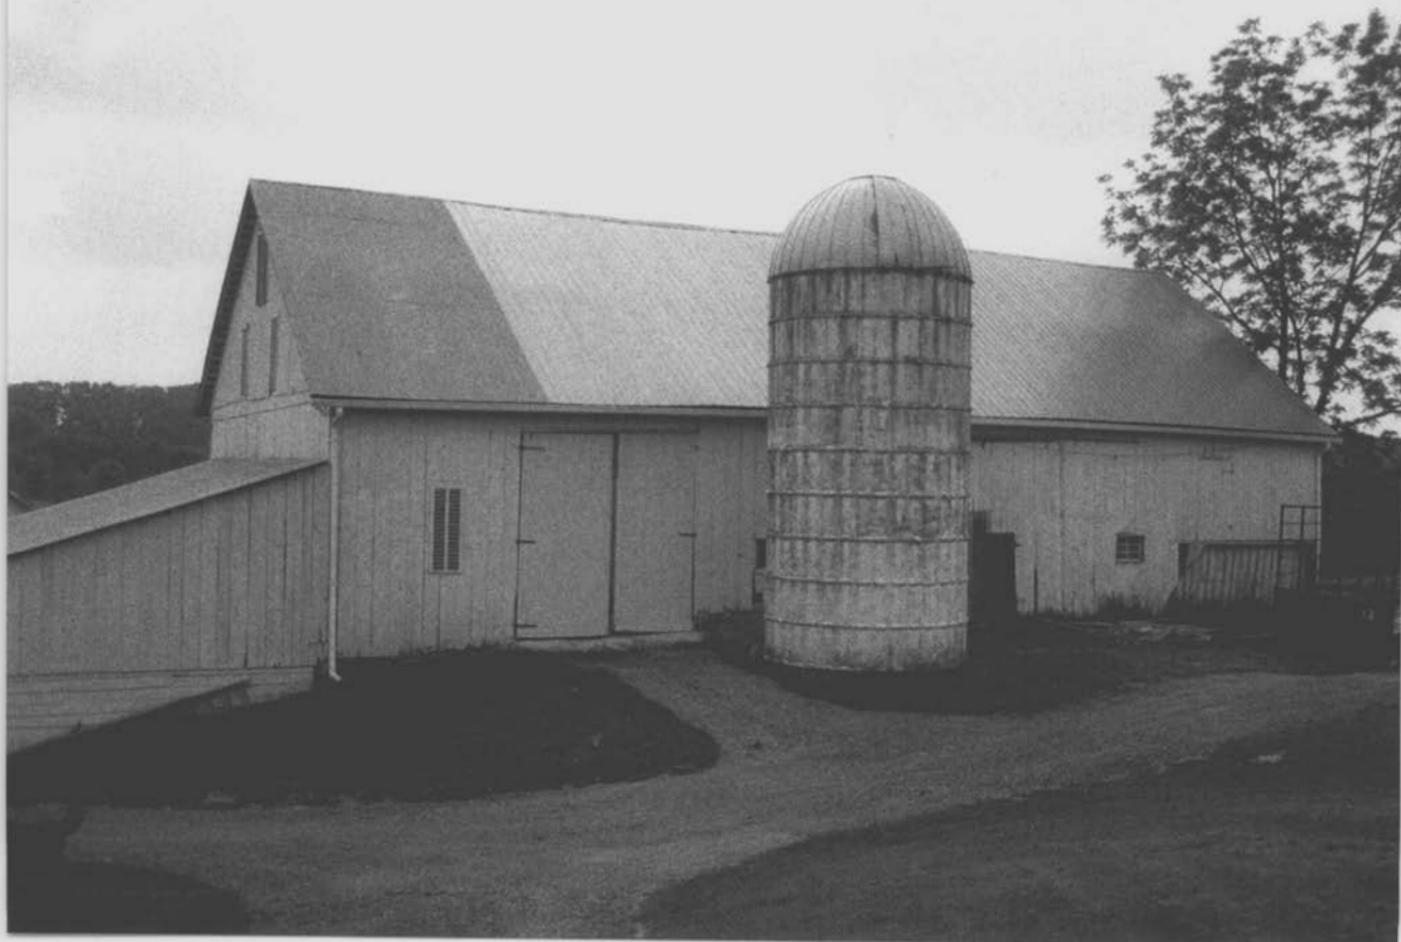
1. CARR 1511
2. Carroll County
3. Madeline Scheerer
4. June 1996
5. Maryland SHPO
6. Quiet Valley Farm  
3913 Miller's Station Rd  
Barn - west elev.
7. 6/10

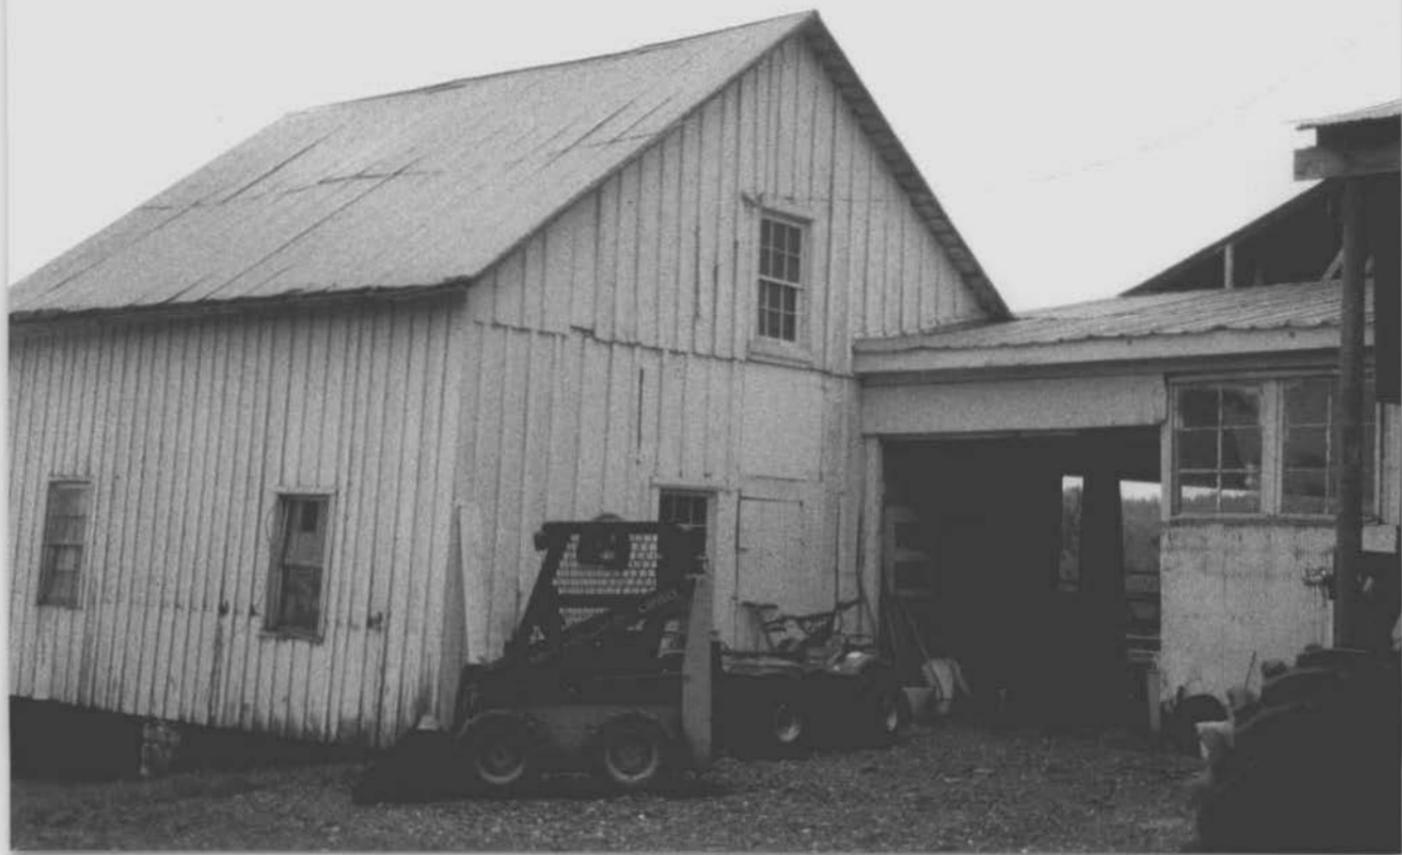
1. CARR 1511
2. Carroll county
3. Madeline Scheerer
4. June 1996
5. Maryland SHPO
6. Quiet Valley Farm  
3913 Miller's Station Rd  
Shed - NW elev
7. 7/10

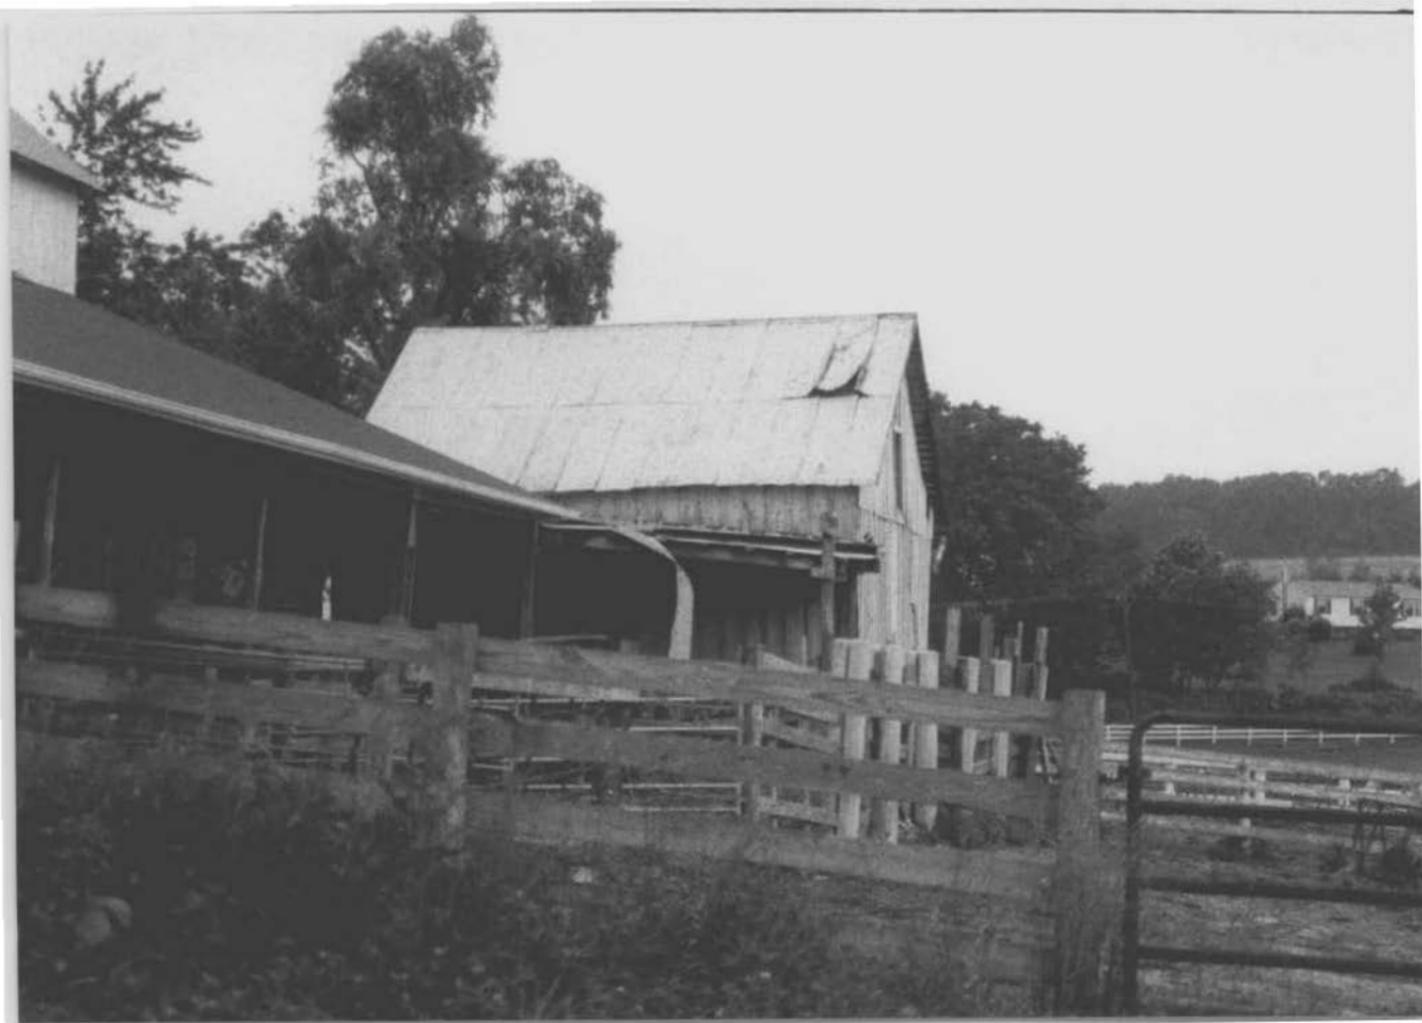
1. CARR: 1511
2. Carroll County
3. Madeleine Scheerer
4. June 1996
5. Maryland SHPO
6. Quiet Valley Farm  
3913 Miller's Station Rd  
Shed - SE elev.
7. 8/10

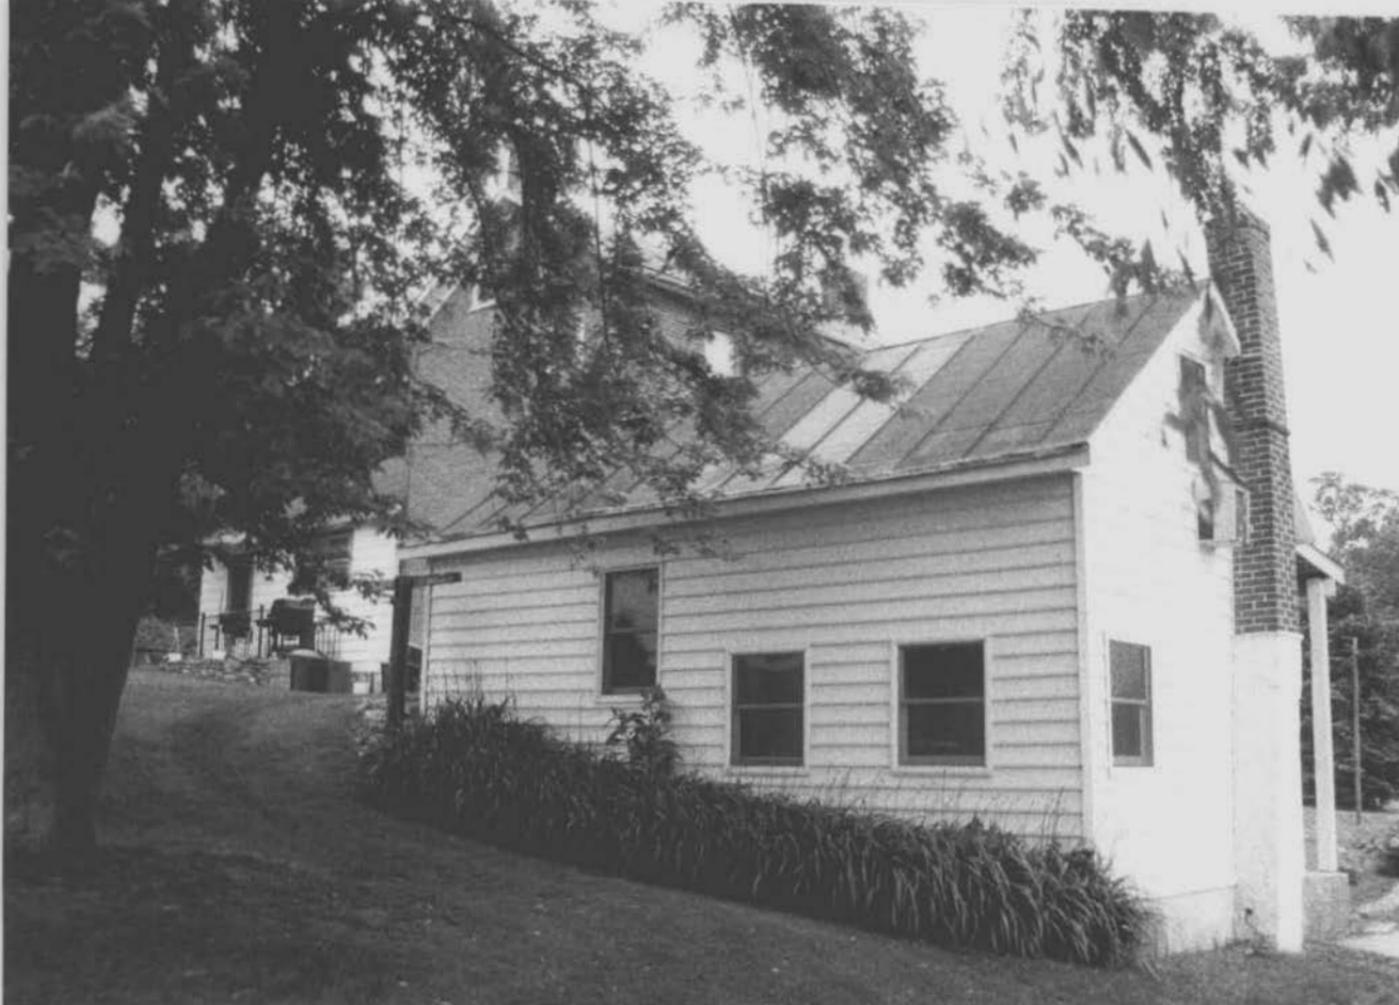
1. CARR 1511
2. Carroll County
3. Madeleine Scheerer
4. June 1996
5. Maryland SHPO
6. Quiet Valley Farm  
3913 Miller's Station Rd  
Spring house / main - SE elev.
7. 9/10

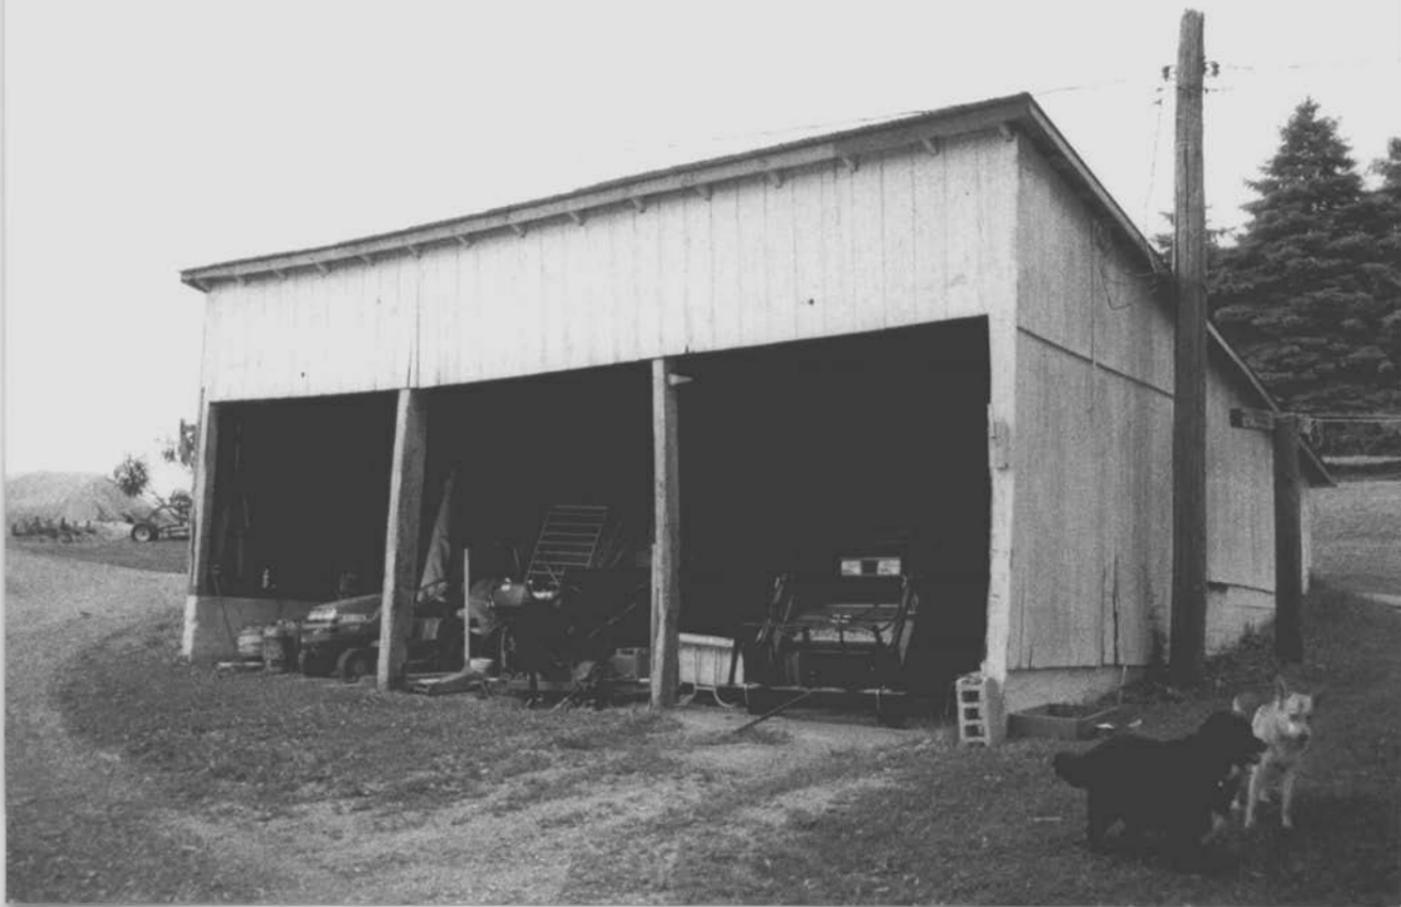
1. CARR: 1511
2. Carroll County
3. Madeleine Scheerer
4. June 1996
5. Maryland SHPO
6. Quiet Valley Farm  
3913 Miller's Station Rd  
garage - SE elev.
7. 10/10
