CARR-153
IRON AND TENSION
Westminster
Private

INVENTORY FORM FOR STATE HISTORIC SITES SURVEY

Iron and Tension

Happy Hollow Kennels

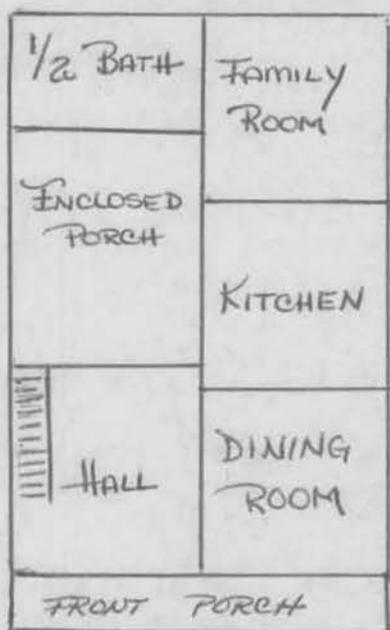
WALL STRUCTURE HAS REMAINED THE SAME.

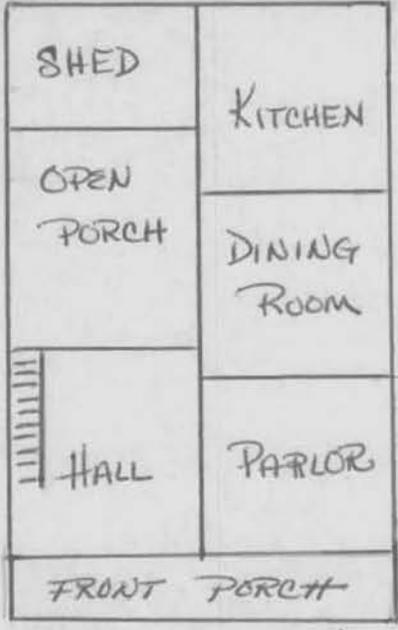
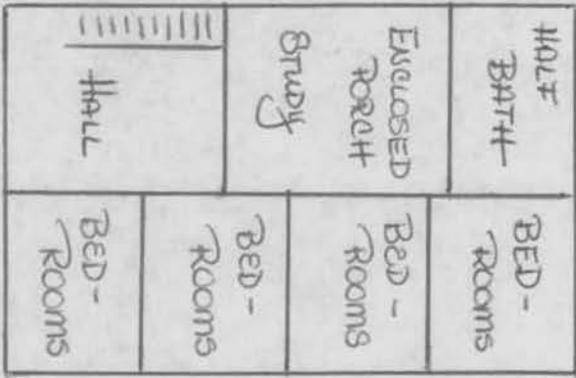
- NOT TO SCALE -

Above is the plan, past and present for downstairs. The upstairs is much the same as it had been but for the enclosed porch and half bath.

Wall structure, up and down has not been changed. In fact, no changes in general save for the modern conveniences. Some walls were panelled, the basement and kitchen. Otherwise all walls are plaster, some with panelled wainscot. Floors are all random width hardwood boards, but only upstairs are still naked. On the first floor, because of rotting, they have been covered with linoleum. The ceilings are nine feet in height, Window and door trim are plain wood upstairs, with cornice downstairs. Window sills are over one foot deep in the outside walls. Doors have two tiers of moulded panels (four panel) and box locks. The side hall plan has an open-string stairway, one run with turned balusters and a round newel. The railing goes around the landing on the second floor.
