Maryland Historical Trust
Inventory of Historic Properties Form
Maryland Route 30/Manchester Bypass Project

1. Name (indicate preferred name)historic S. Sterner Houseand/or common Caltrider House**2. Location**street & number 2626 Ebbvale Road not for publicationcity, town Melrose X vicinity of congressional district 6thstate Maryland county Carroll**3. Classification**

Survey No. CARR-1541

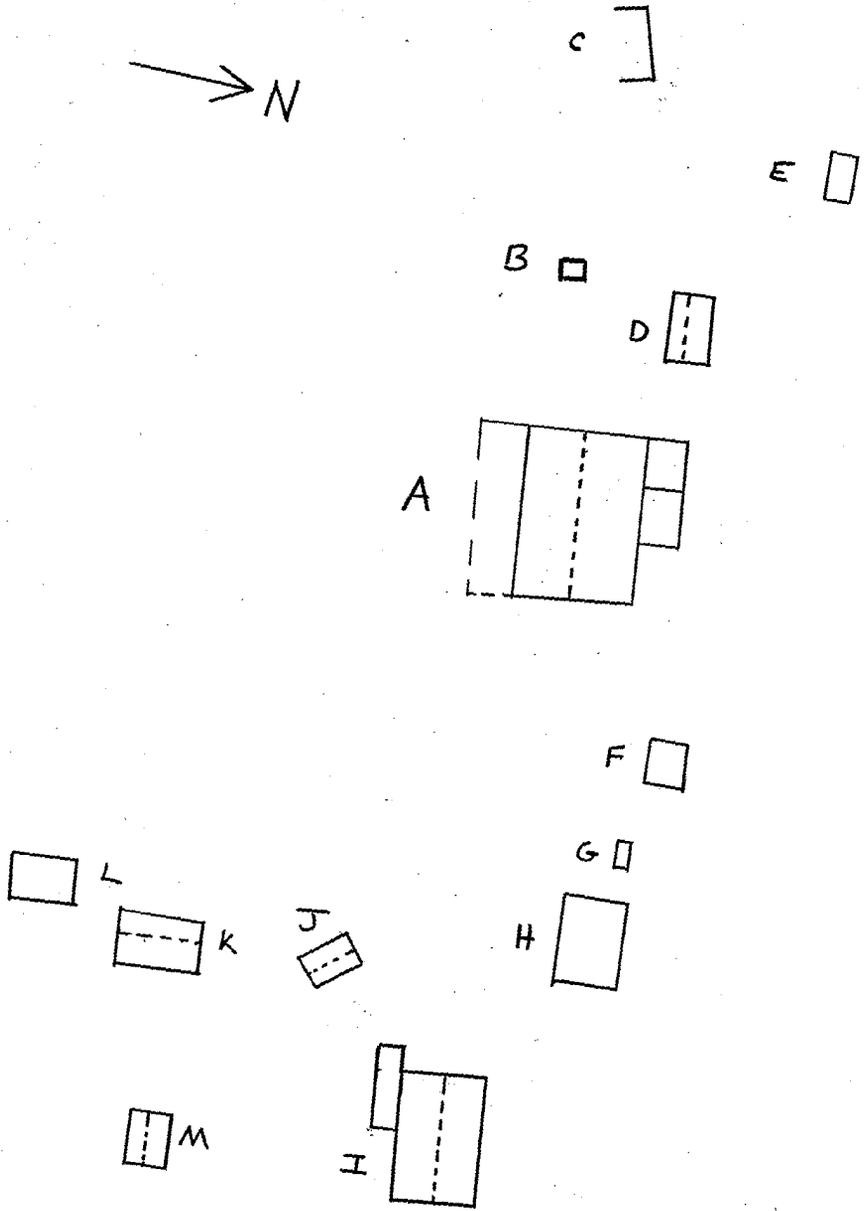
CARR-1541

House (1880-1910) [A]:

Springhouse (early/mid 20th c.) [B]:

Equipment shed (early/mid 20th c.) [C]:

Shed (early/mid 20th c.) [D]:

Coop (early/mid 20th c.) [E]:

Shed (early/mid 20th c.) [F]:

Privy (early 20th c.) [G]

Coop (early/mid 20th c.) [H]:

Bank barn (early 20th c.) [I]:

Shed (early/mid 20th c.) [J]:

Shed (early/mid 20th c.) [K]:

Shed (mid 20th c.) [L]:

Garage (early/mid 20th c.) [M]:

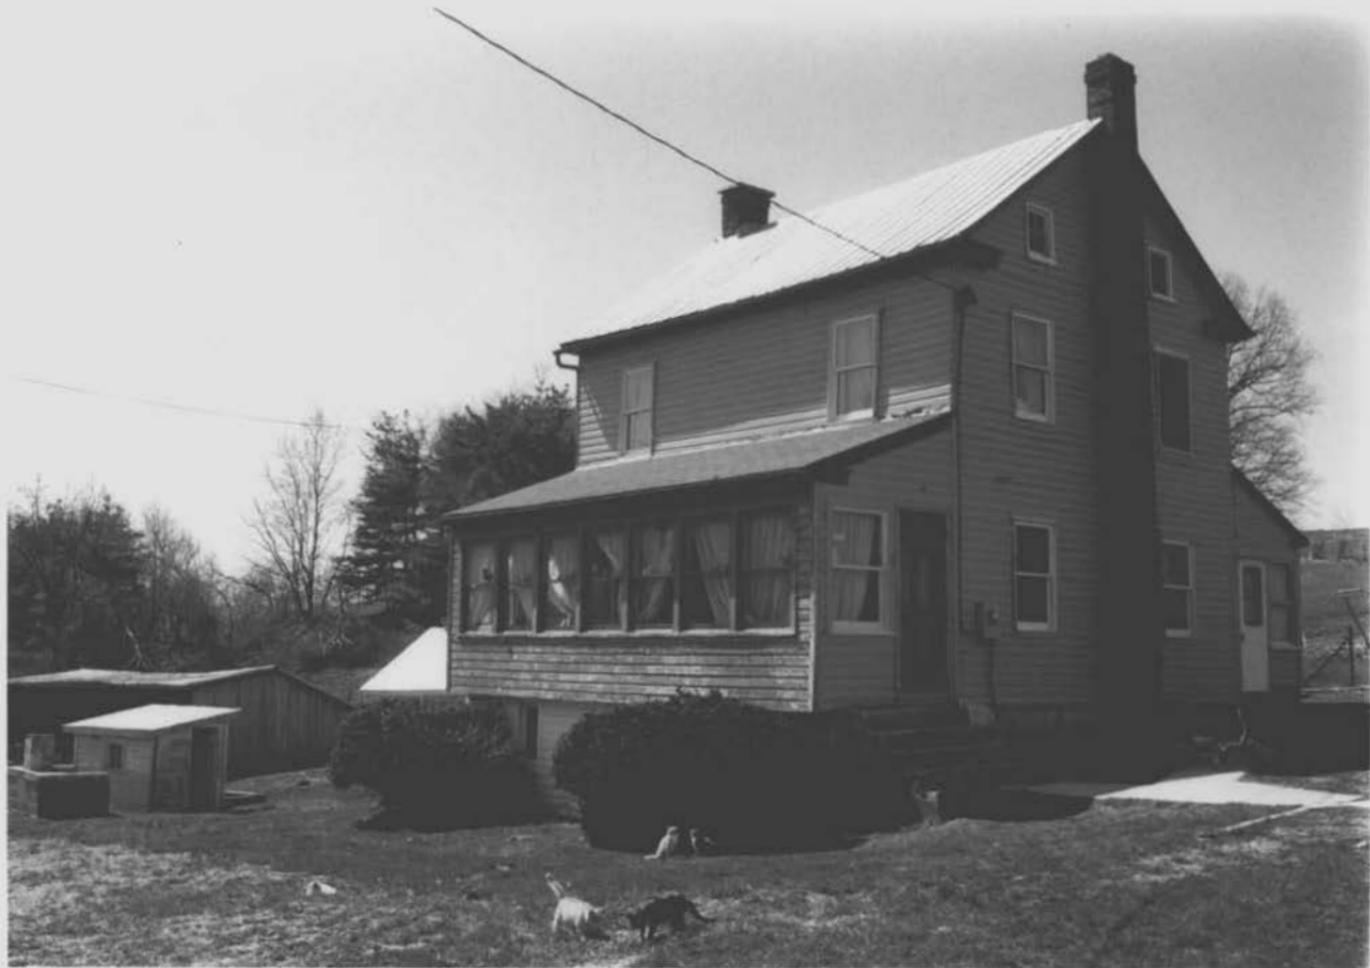
2/9 of 3x5s

This much-altered farmhouse is two stories tall, one room deep, and topped by a gable-end roof. This basic I-house form was utilized throughout the county during the nineteenth and early twentieth centuries. The south-facing front elevation is raised above a banked basement. This is particularly apparent at the enclosed, later-added, shed-roofed porch extending across the first-story facade, which is raised a story above the ground. The porch obscures the number of bays at the first story, but there appear to originally have been four. Only two bays light the second story of the front facade. German siding sheathes the front elevation and also the east-facing side elevation, which is two bays deep and marked by an exterior brick flue stack and cornice returns. The west-facing side elevation, also marked by cornice returns, originally held two bays, but the rearmost bays have been covered with the asphalt siding that sheathes the elevation. An interior-end chimney stack rises at this elevation. The north-facing rear elevation of the house is covered with asphalt siding and extended by a pair of shed-roofed ells, one two stories tall, the other rising a single story. The one-over-one sash of all of the house's windows appears to be a later replacement. The seam metal roof is also not original.

House, S & E elev

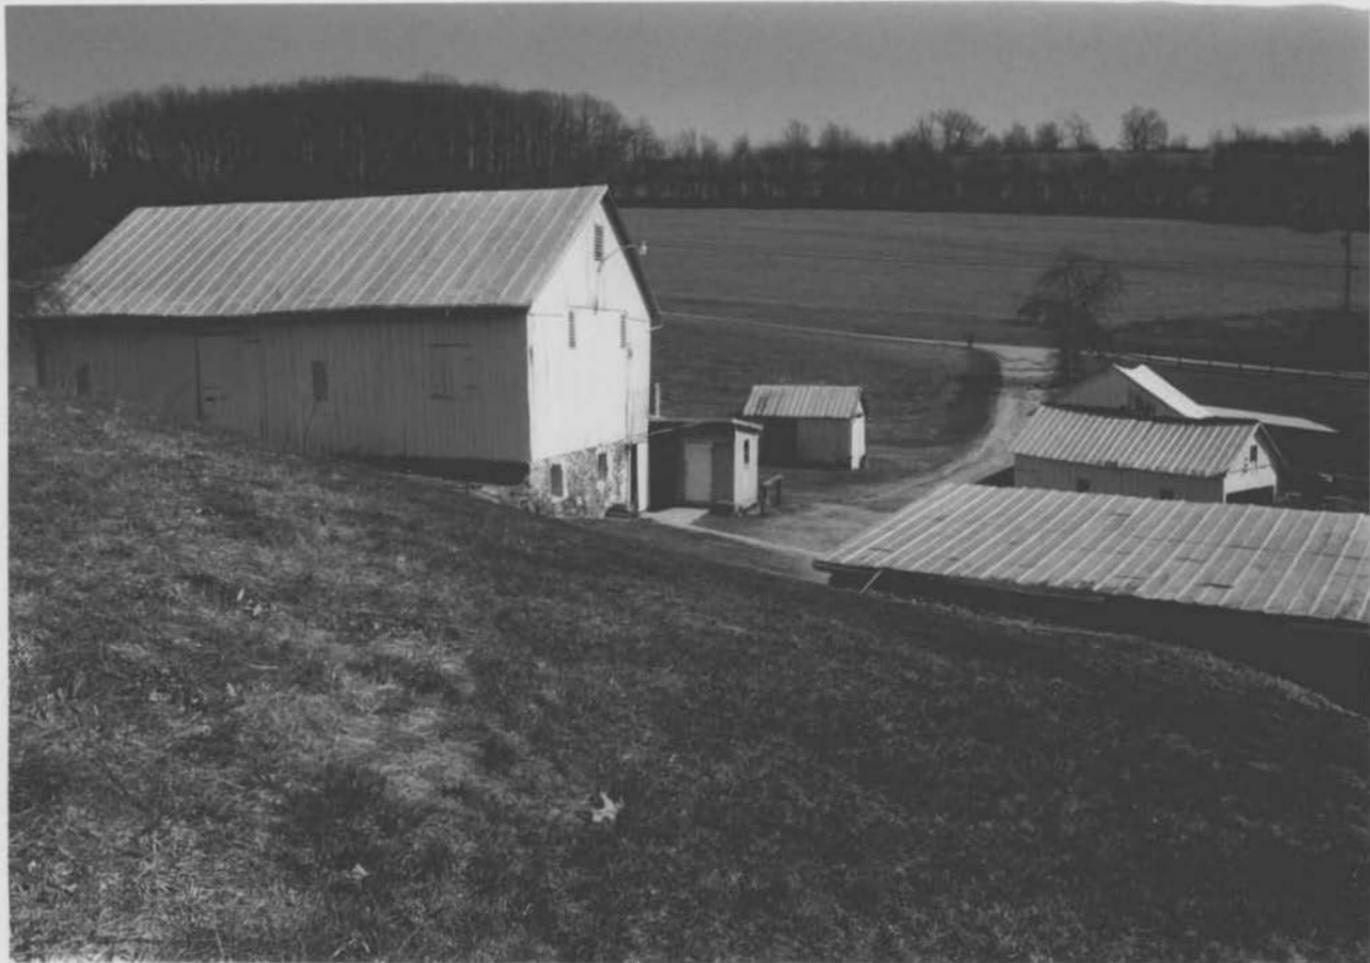
7/9 of 3x5s

This former farmstead is located on a hill rising south of Ebbvale Road. The much-altered frame farmhouse utilizes the common I-house form and appears to have been erected in the late nineteenth or early twentieth century. The 12 outbuildings, four of which are located to the house's west and eight to the east, appear to date from the early or mid twentieth century. The largest of these is a frame forebay bank barn.

FARMSTEAD looking S
