**Maryland Historical Trust  
State Historic Sites Inventory Form**

and/or common 93 Liberty Street

Survey No. CARR-1543

### Section 7: Description of 93 Liberty Street (Route 27), Westminster, Maryland

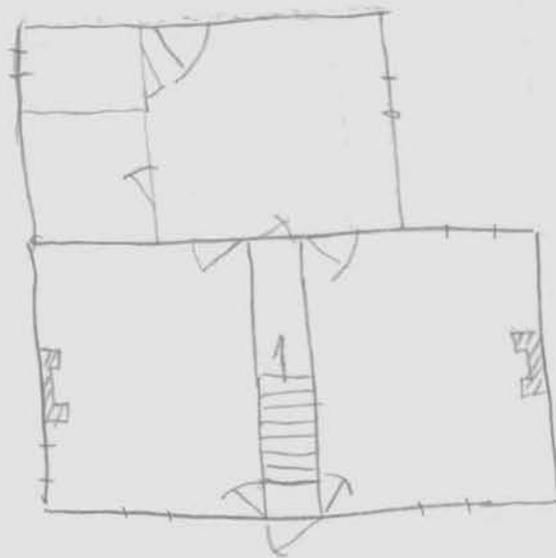
First Floor

The first floor apartment is accessed through the rear of the building, from the deck and mirrors the upper apartment's floorplan. The door in the rear wing of the building leads into a kitchen which has a restroom and washroom on the now enclosed porch on the right. A doorway leads into the main block of the building opens into a bedroom which has a fireplace. The fireplace has been closed in, but has an electric heater embedded in the

**Floorplan of 93 Liberty Street, Westminster Maryland**

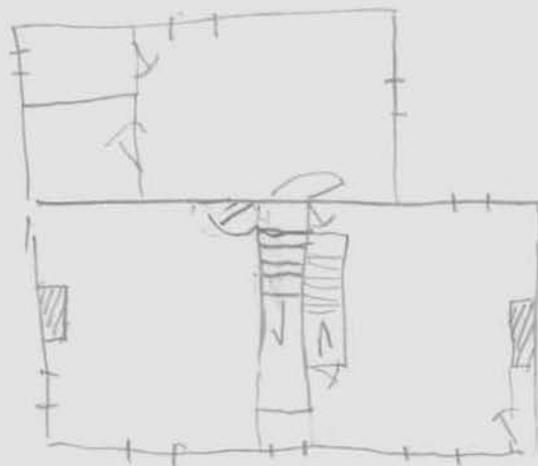
Second Floor

At the top of the steep, enclosed stairs is another small square hall space surrounded by three doorways and the stairs. Directly to the right is a living room which is a rectangular room and features a original built-in closet and a section of the chimney stack of the first floor fireplace; the round ghost of a hole for a stovepipe connection is visible. Also in this room is the straight stair entrance to the attic. Directly facing the first floor - second floor stairs is a large room currently used as a kitchen. This room is in the wing. On the left inside the kitchen are two doors leading into the two rooms made out of the original second floor porch. The first room contains hookups for washer and dryer, and the furthest room is the restroom, containing toilet, bathtub and sink. The third large and final room on the second floor is used as a bedroom. Like the living room, it contains an upper portion of the chimney from the fireplace below. Surviving trimwork includes door frame moldings, corner blocks and baseboard. Original surviving interior hardware consists of cast iron carpenter locks, cast thumbblatches, and cast hinges of styles indicative of the 1890's. The trim and hardware seen on the second floor is common throughout the house.
